UTN: 20160526H

Our Reference: S235-1804R-RJ SJN6S

**VEHICLE ACCIDENT DAMAGE RE-INSPECTION ASSESSOR REPORT**Accident involving SJN6S and XD8265U on 16/03/2017**1. REFERENCE**

<i>Registration No.</i>	SJN6S	<i>Odometer reading</i>	77,279
<i>Make/Model</i>	Lexus GS300	<i>Odometer previous</i>	76,777
<i>Chassis number</i>	JTHBH96S705052824	<i>Regn. Year</i>	13-Jun-2007
		<i>Colour</i>	Black

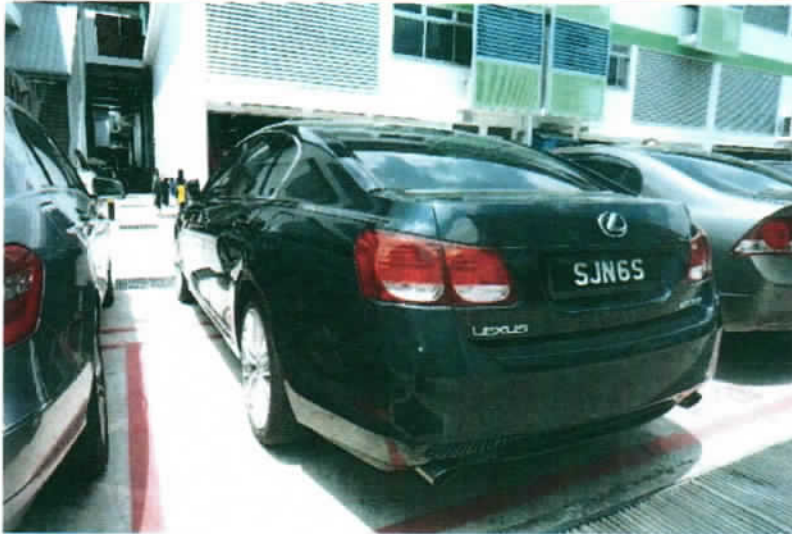
1/13: Rear View Left

Side swipe of a light nature to the rear rhs fender

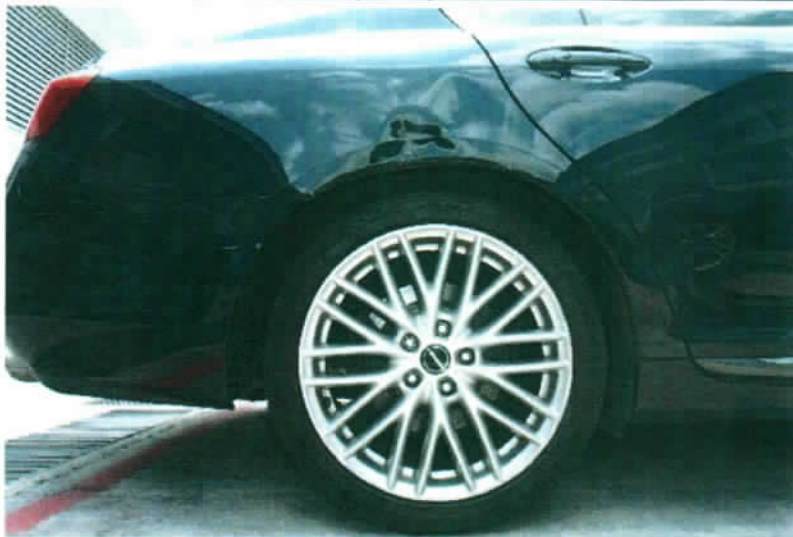
4/13: Photographs of Damaged Parts
