Affiliated to Federation Internationale Des Experts En Automobile			
CHINA TAIPING INSURANCE (S) PTE LTD		Ref : CS/CTI18001225/Aqb	
3 ANSON ROAD #16-00 SPRINGLEAF TOWERSINGAPORE 079909		Date : 19-01-2018

Preliminary Advice

Vehicle No	: GBG4626H	Accident Date	: 07/01/2018
Make	: NISSAN NV200	Policy No.	: DMCVSN30658717000
Assignment Date	: 19/01/2018	Excess	: S\$450.00
Date of Inspection	: 22/01/2018	Est. Duration of Repair	: 8.00
Inspection At	: SMRT AUTOMOTIVE SERVICES PTE LTD (WOODLANDS) 60 WOODLANDS INDUSTRIAL PARK E4 SINGAPORE 757705

VEHICLE DAMAGE INSPECTION REPORT

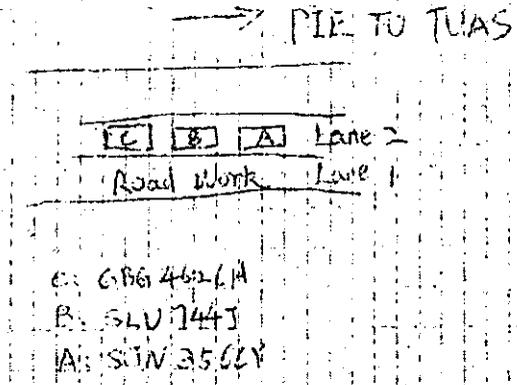
SKETCH PLAN

On 07th Jan 2018 about 3.40 PM, I drive company van G86 462 LA to office for weekly meeting, at Thomson area. I saw there was Road work at Lane 1, so I change lane to lane 2. I saw there was a bit jam in front so I slow down the speed, but suddenly the front SUV (SLU 744 J) stop, I immediately press the break but it was too late my van hit the front car (SLU 744 J) and the air bag also come out, after I come out from my van, I realised there was another car (SUN 35 02 Y) also hit. We (the three car drivers) exchanged contact number and recorded each other's IC. there was no body injured.
