Your Ref: DMCPHQ17-004318  
Our Ref : CS/EQI18001369/N

31 January 2018

**TECHNICAL INVESTIGATION REPORT OF FIRE INCIDENT INVOLVING THE INSURED VEHICLE GBB 504D ON 13 JANUARY 2018**

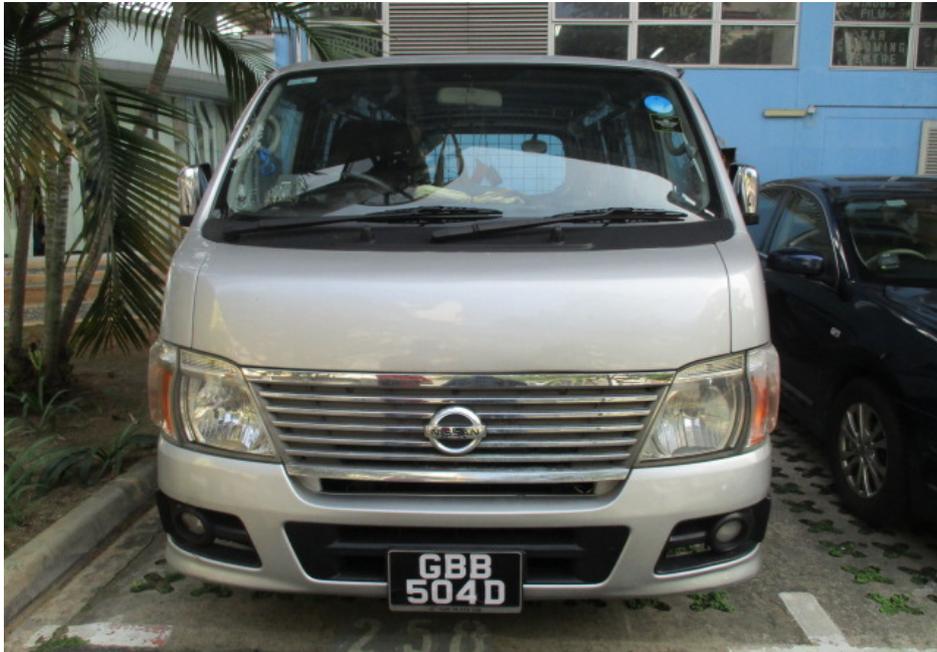
**Photo 1** shows the general view of the front portion of the Insured Vehicle at the time of our inspection. The exterior body of the Insured Vehicle was relatively unaffected by the fire.

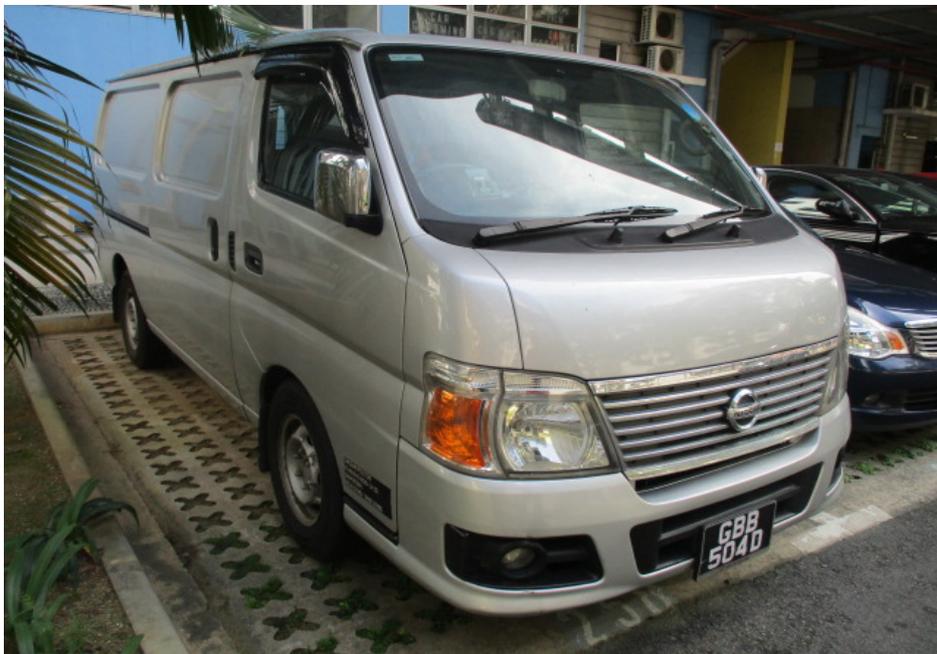
**Photo 2** shows the general view of the right portion of the Insured Vehicle at the time of our inspection. The exterior body of the Insured Vehicle was relatively unaffected by the fire.

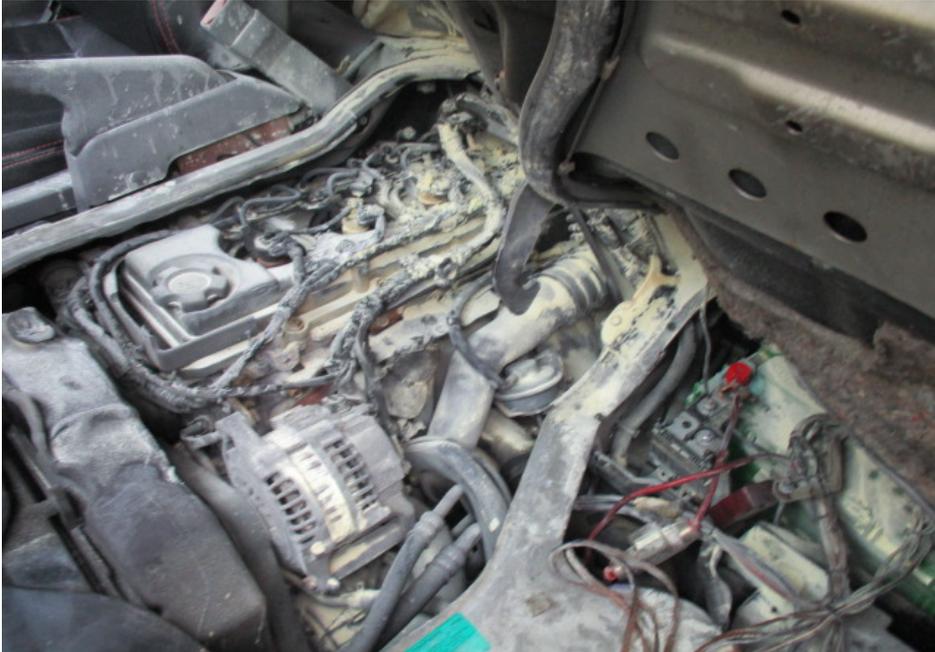
5. The exterior body of the Insured Vehicle had not sustained any visible fire damage. However the engine compartment of the Insured Vehicle was observed to be burnt and/or melted.
6. The fire had resulted in the components in the engine compartment of the Insured Vehicle to be burnt. Affected parts had included the battery and engine block, amongst others. See photos 1 – 4 below.

**Photo 3** shows a general view of the engine compartment of the Insured Vehicle which was covered in fire extinguisher residue at the time of our inspection. Most of its engine components were found to have been affected as a result of the fire.

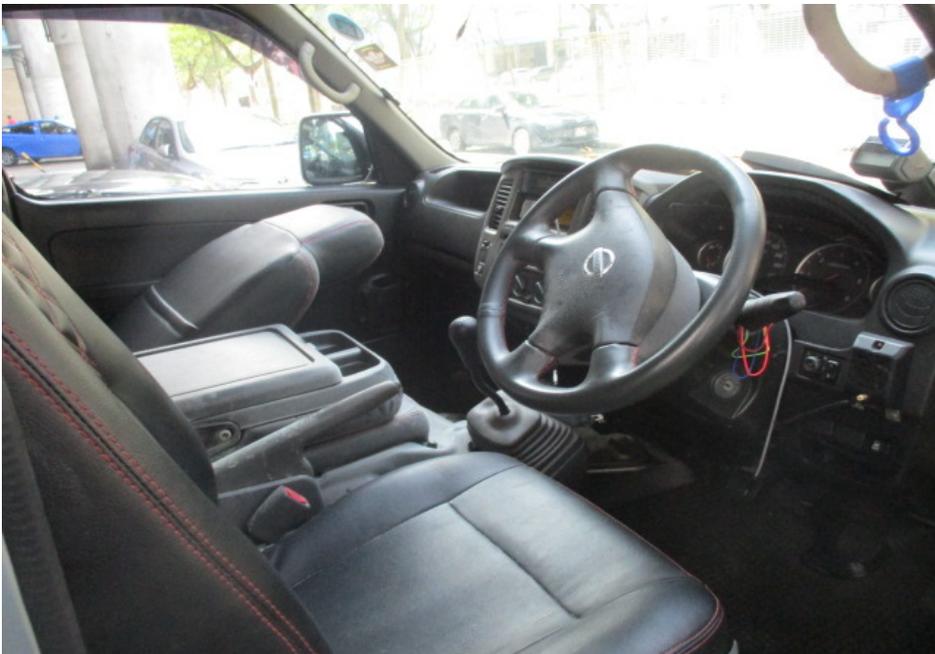
**Photo 4** shows the interior compartment of the Insured Vehicle, which was observed to be relatively unaffected by the fire.

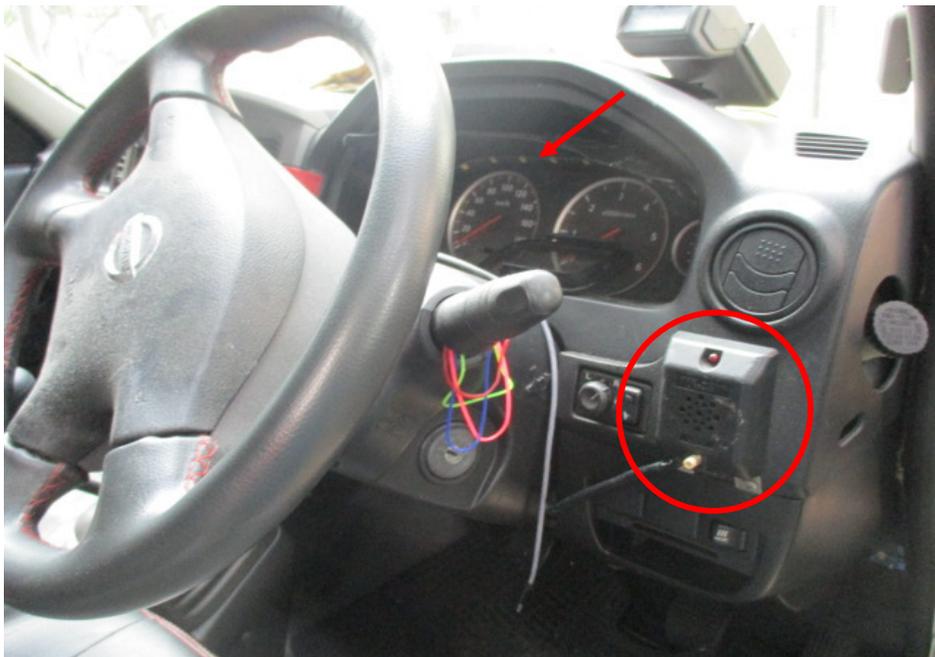
7. At the time of physical inspection of the Insured Vehicle, we had found several additionally fitted electronic and/or electrical component(s) on the Insured Vehicle. These included a vehicle speed limiter, 2 LED light strips, 2 aftermarket speakers and a fuse breaker. All these fitted components were not the standard type for the Insured Vehicle. See photos 5 - 12 below.

**Photo 5** shows the 1st LED light strip fitted above the speedometer (arrowed) and the vehicle speed limiter device fitted beside the steering wheel of the Insured Vehicle (circled) upon our inspection.

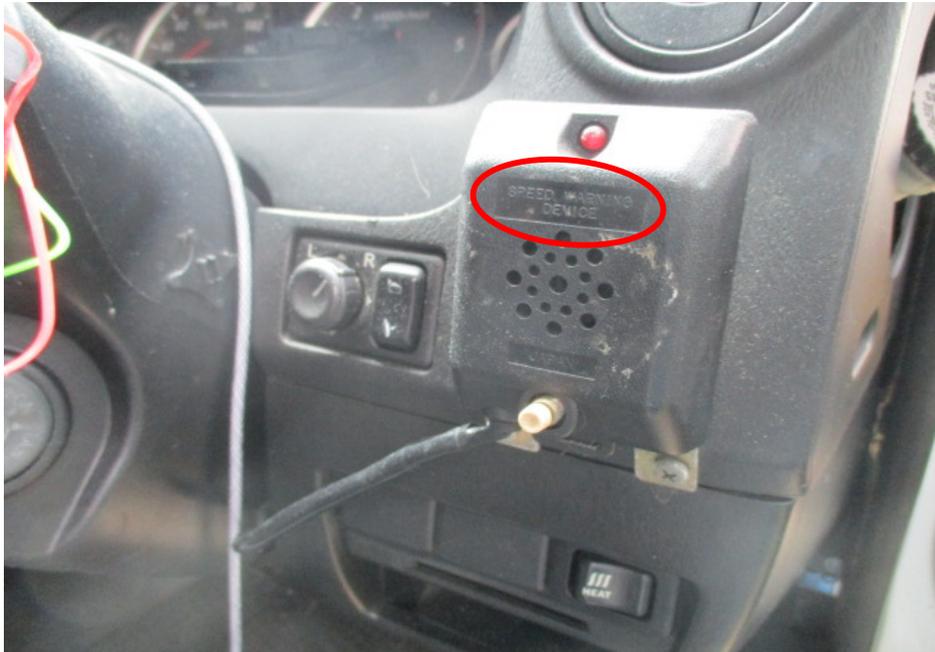
**Photo 6** shows a closer view of the speed limiter device fitted beside the steering wheel of the Insured Vehicle (circled) upon our inspection.

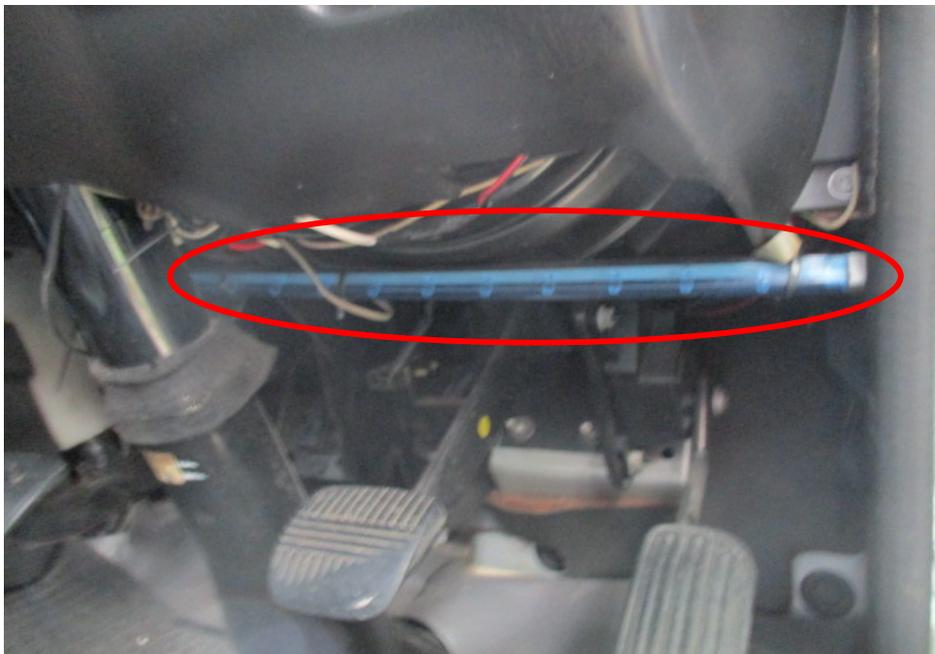
**Photo 7** shows the 2nd LED light strip fitted above the foot pedals of the Insured Vehicle (circled) upon our inspection.

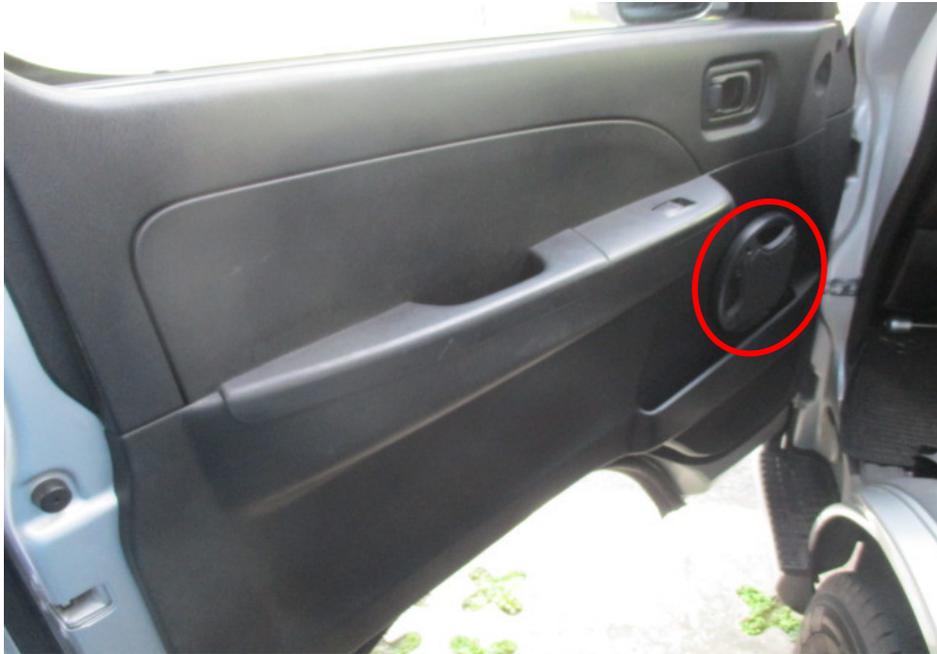
**Photo 8** shows the 1st aftermarket speaker fitted at the front passenger door panel. The brand of the speaker was 'LANZAR' (circled).

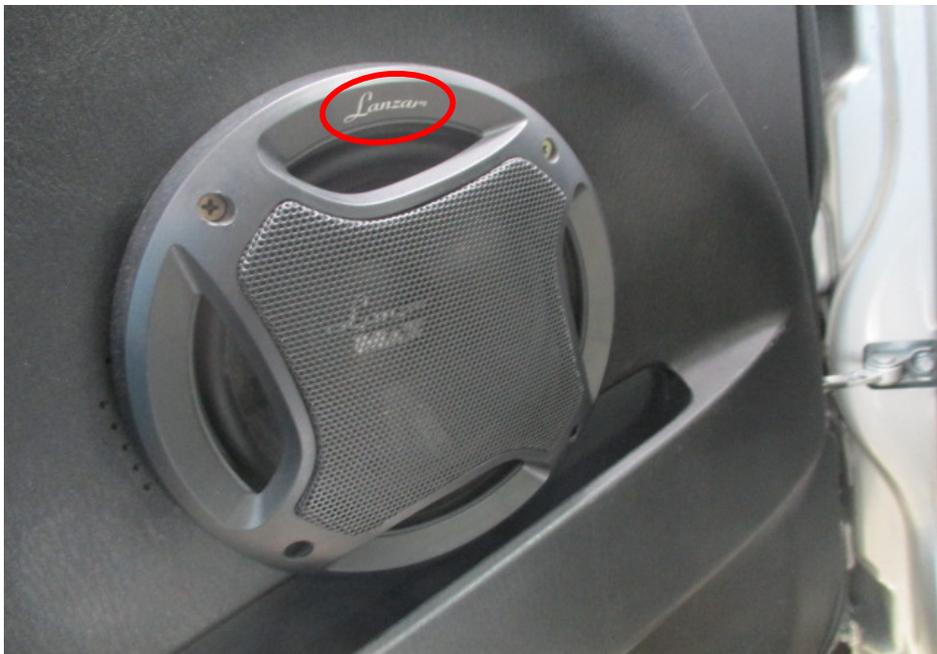
**Photo 9** shows a close up view of the aftermarket speaker fitted at the front passenger door panel. The brand of the speaker was 'LANZAR' (circled).

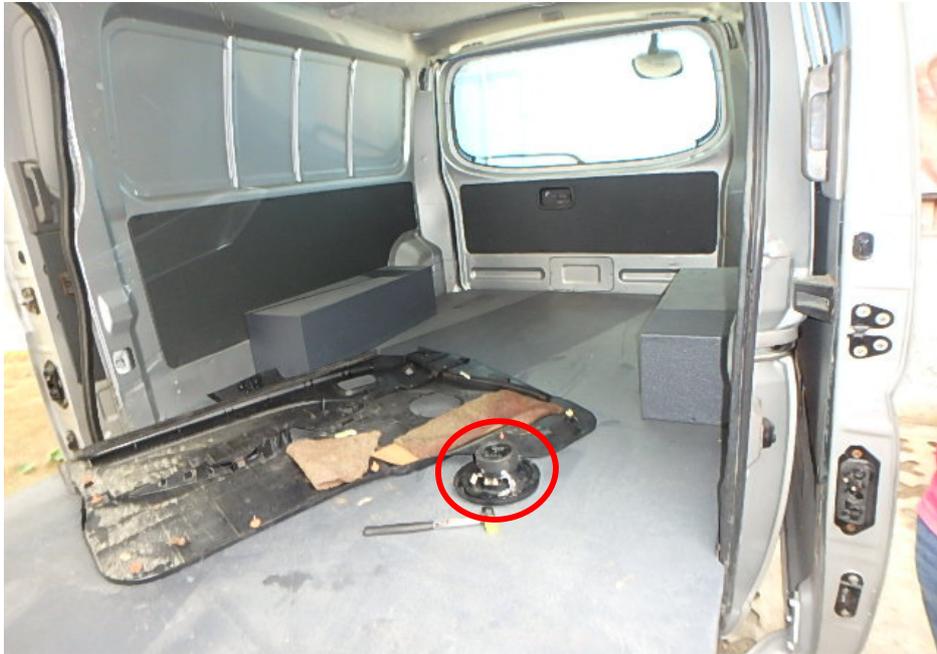
**Photo 10** shows the 2nd aftermarket speaker fitted at the driver door panel. The brand of the speaker was 'LANZAR' (circled).

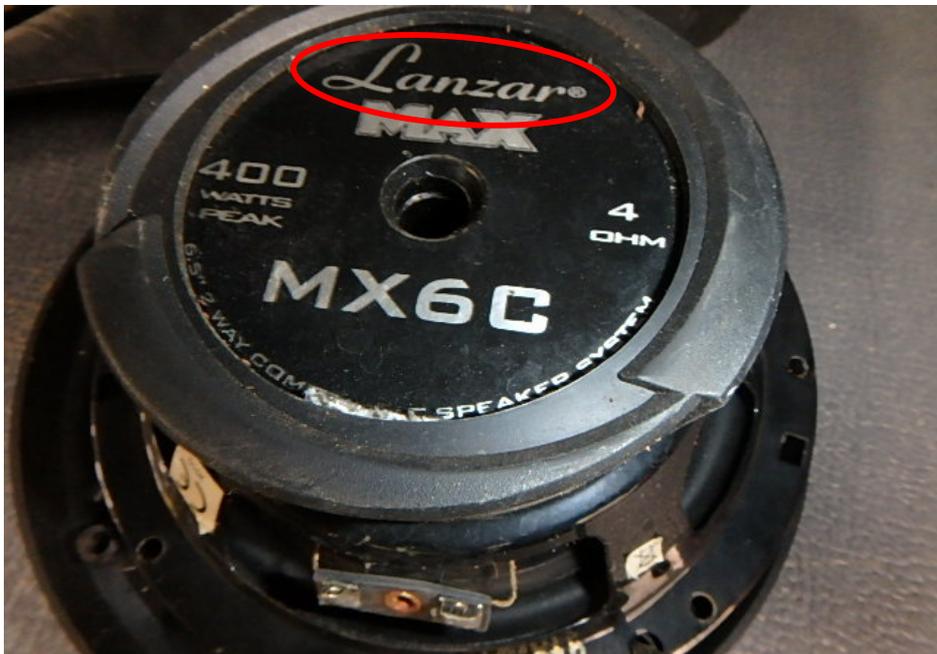
**Photo 11** shows a close up view of the 2nd aftermarket speaker fitted at the driver door panel. The brand of the speaker was 'LANZAR' (circled).

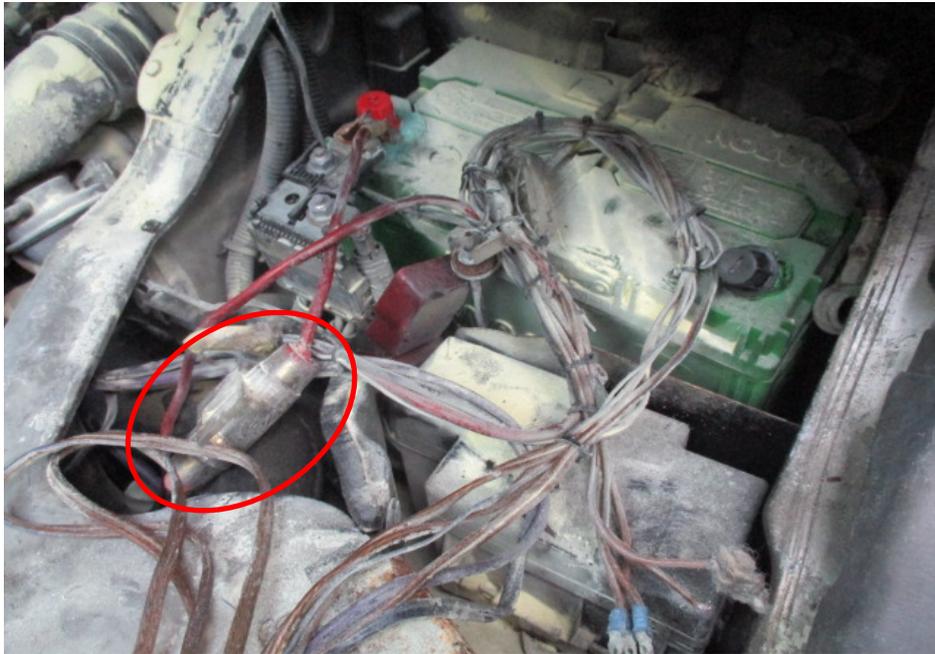
**Photo 12** shows the fuse breaker (circled) that was connected to the battery of the Insured Vehicle at the time of our inspection.

33. We are further of the opinion that the additionally fitted electrical/electronic components found on the Insured Vehicle could have possibly caused overloading to the electrical system of the Insured Vehicle.

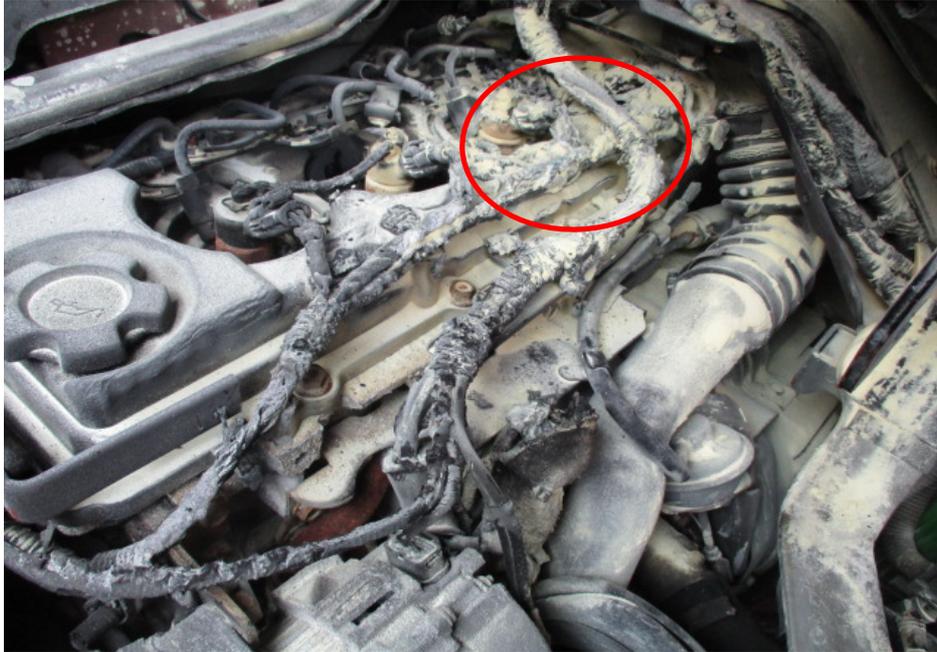
9. Upon closer examination of the engine compartment, in particular to the engine block which was covered in fire extinguisher residue, we had found faint traces of greenish residue on several burnt stretches of original factory fitted wirings around the centre area of the engine compartment. The presence of such greenish residue indicates internal heating of copper wires, a sign of an electrical short circuit occurring. The greenish residue is normally left behind from oxidation as a result of chemical reaction involving the copper wires. We also observed that the negative terminal of the battery had partially melted. These physical evidences would then appear to suggest that the cause of fire to the Insured Vehicle could have possibly been due to electrical in nature. See photos 13 - 17 below.

**Photo 13** shows the burnt stretches of original factory fitted wirings covered in fire extinguisher residue around the engine block, which is in the immediate vicinity where the fire to the Insured Vehicle had likely started. Faint traces of greenish residue were found on some of the wirings (circled). The presence of such greenish residue suggests occurrence of an electrical short circuit.

30. Having investigated and technically analysed the damages of burnt nature to the Insured Vehicle, we are of the view that the cause of fire to the Insured Vehicle was of electrical in nature. For this particular case, the fire had originated along the wirings around the engine compartment. The wirings were original factory wirings inside the engine compartment of the Insured Vehicle.

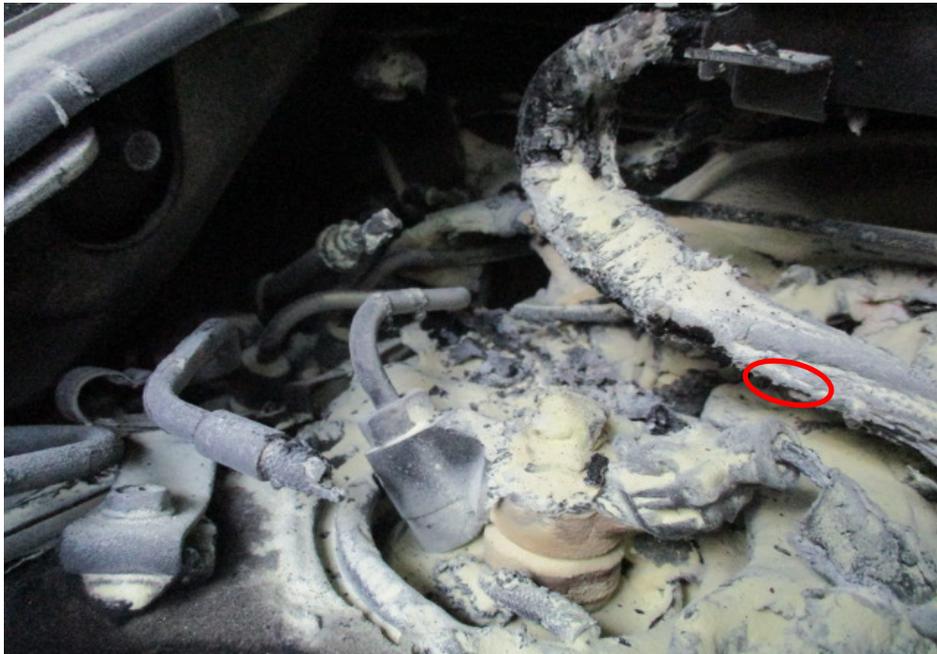
**Photo 14** shows a closer view of the faint traces of greenish residue found on some of the melted stretches of original factory fitted wirings (circled).

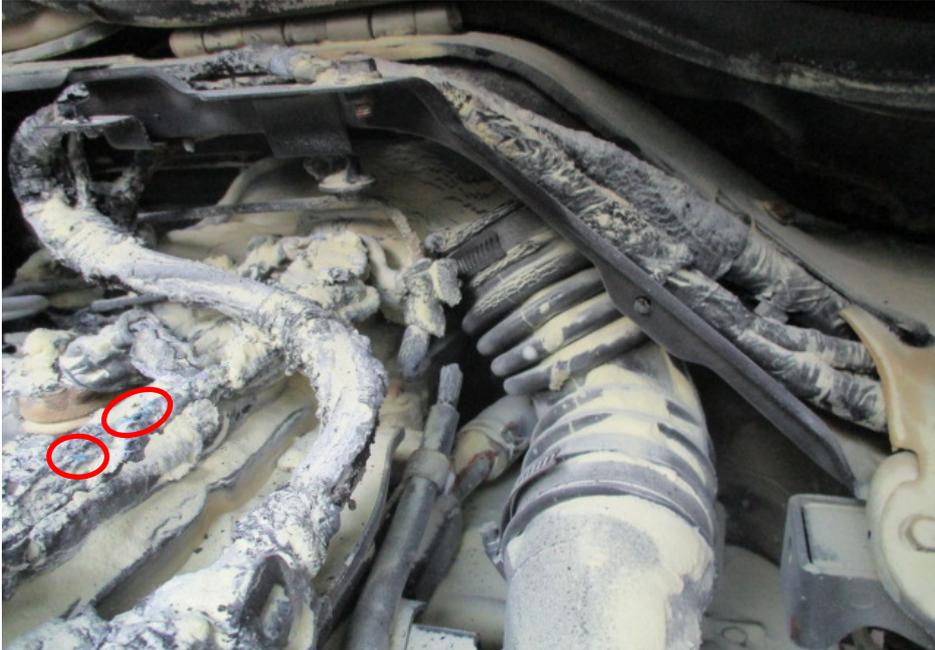
**Photo 15** shows a closer view of the faint traces of greenish residue found on some of the melted stretches of original factory fitted wirings (circled).

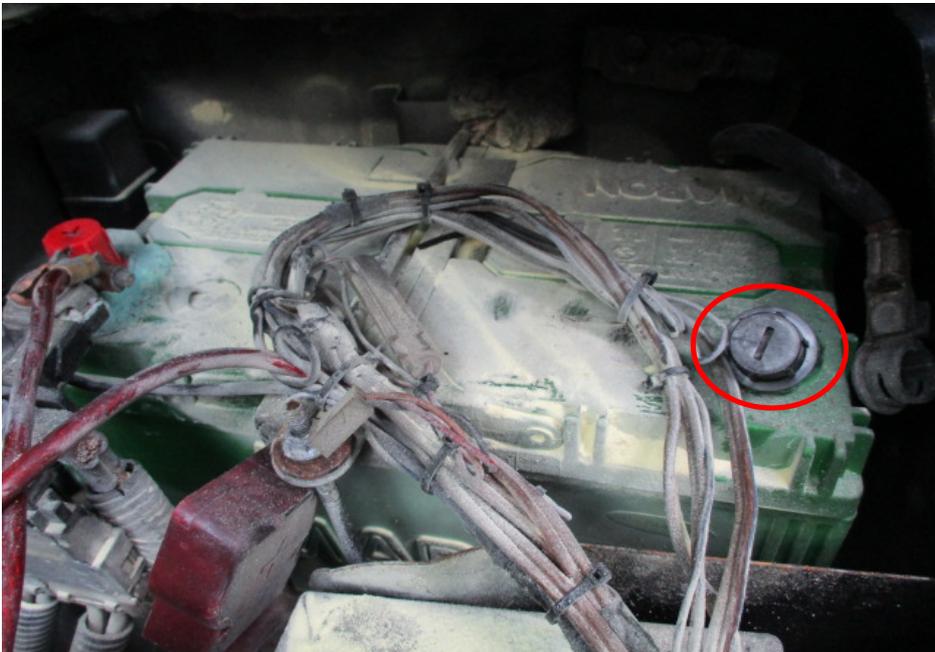
**Photo 16** shows the partially melted negative terminal of the battery of the Insured Vehicle (circled).

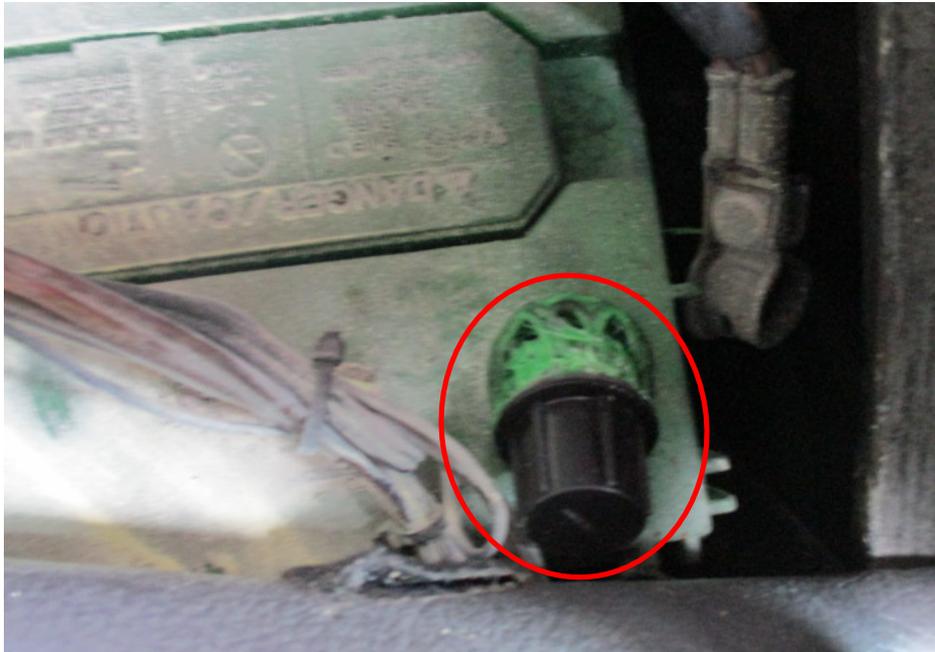
**Photo 17** shows a close up view of the partially melted negative terminal of the battery of the Insured Vehicle (circled).

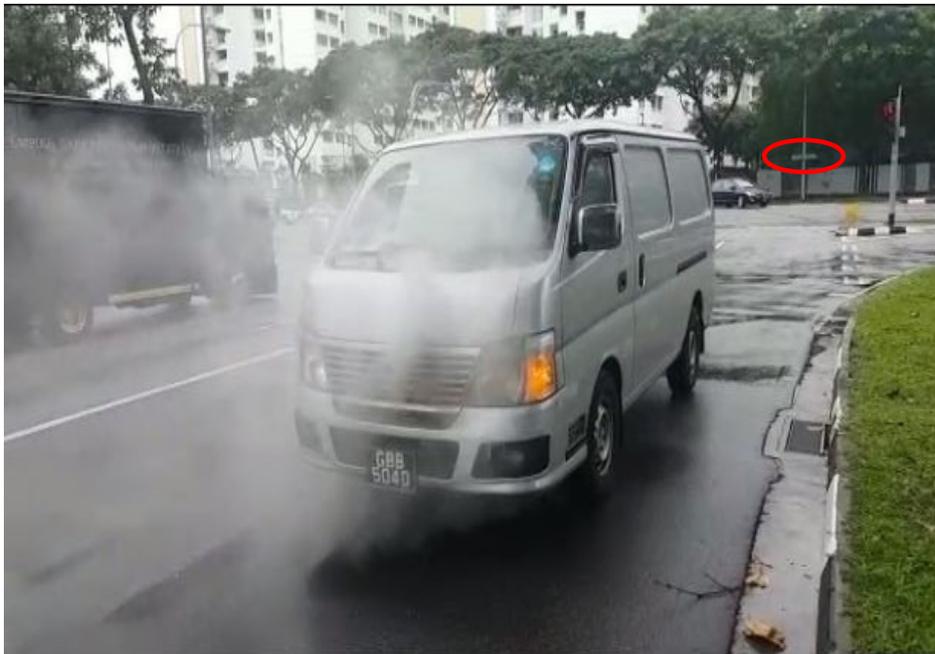
**Photo 18** shows thick smoke emitting from the front bonnet of the Insured Vehicle. In general, the information that could be gathered from this photograph had corresponded to the events that were related to us by Mr Yau, which is he had stopped the Insured Vehicle by the left side of the road after turning left into Ubi Avenue 3 from Paya Lebar Road (circled).

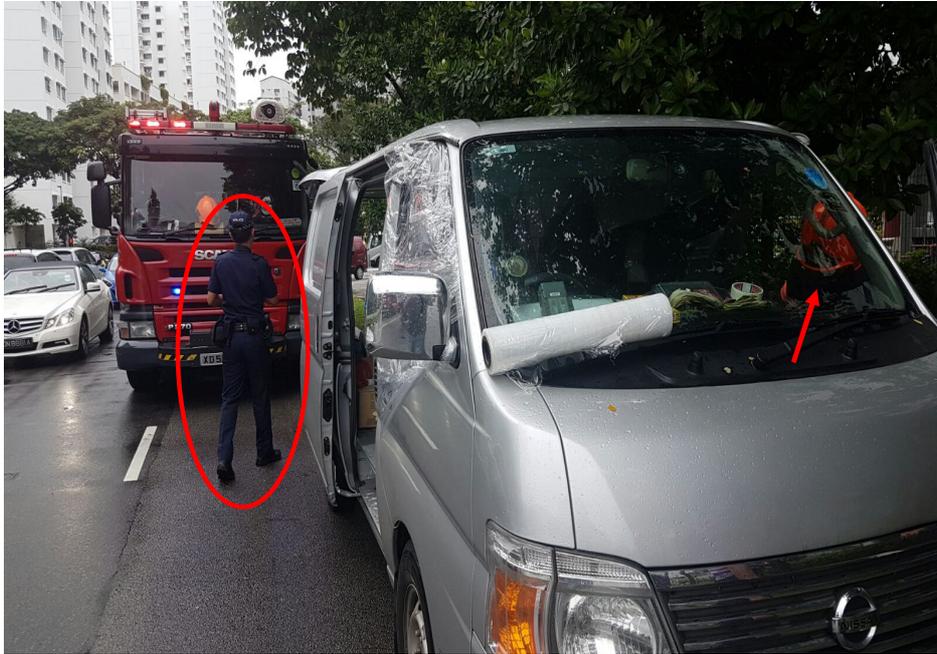
**Photo 19** shows a firefighter making sure that the fire had been completely extinguished (arrowed). In general, the information that could be gathered from this photograph had corresponded to the events that were related to us by Mr Yau, which is the police (circled) and SCDF were present at the incident location.

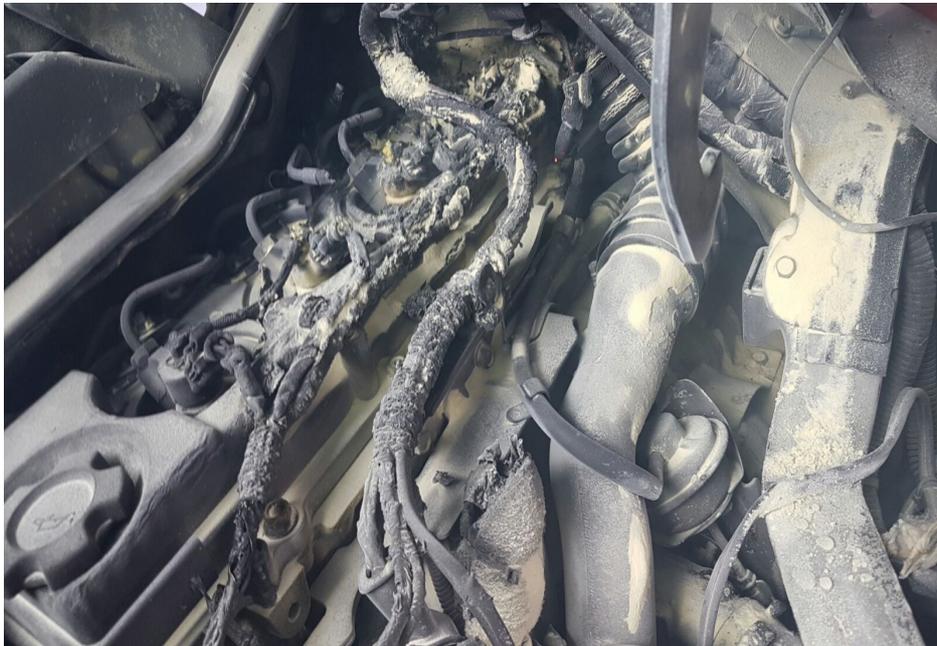
**Photo 20** shows the engine compartment of the Insured Vehicle post- incident. In general, the damages sustained to the engine compartment and the fire extinguisher residue found on the burnt stretches of wirings had corresponded to the events that were related to us by Mr Yau, which is the fire had started from the engine compartment.
