Your Ref: DMCPHQ17-004318
Our Ref : CS/EQ118001369/N

31 January 2018

TECHNICAL INVESTIGATION REPORT OF FIRE INCIDENT INVOLVING THE INSURED VEHICLE GBB 504D ON 13 JANUARY 2018

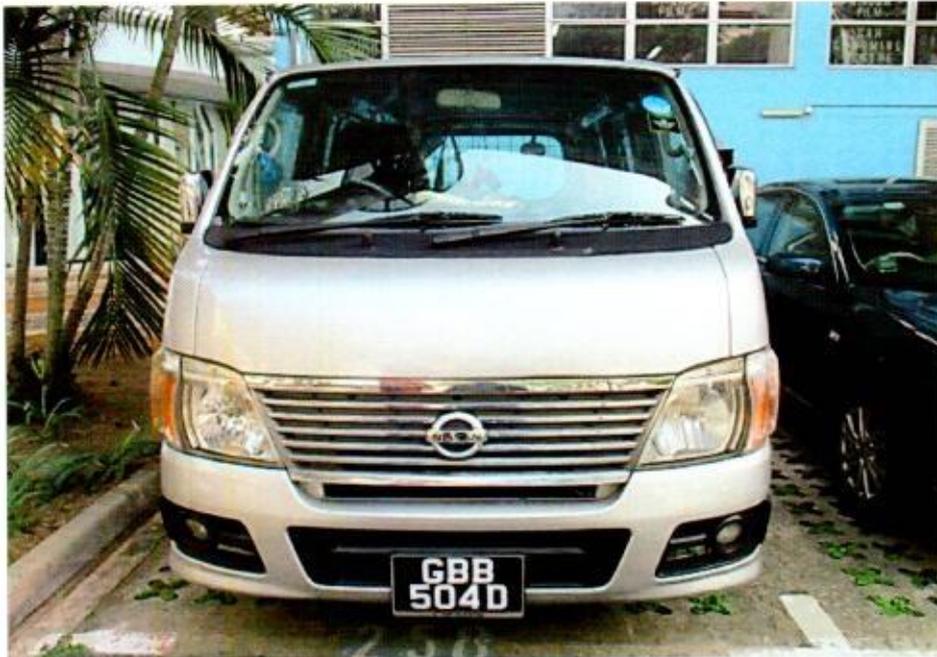
Photo 1 shows the general view of the front portion of the Insured Vehicle at the time of our inspection. The exterior body of the Insured Vehicle was relatively unaffected by the fire.

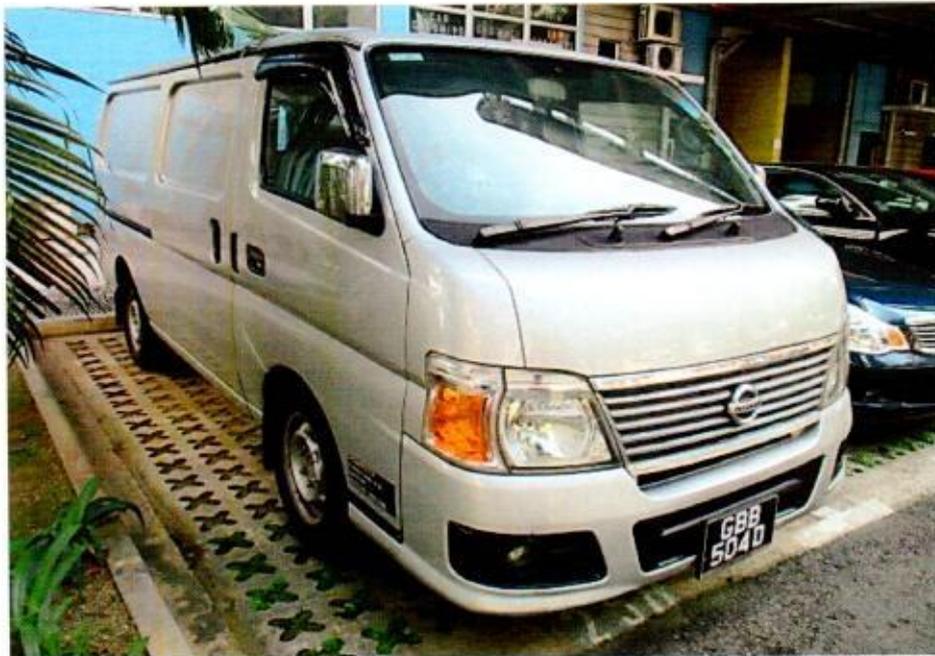
Photo 2 shows the general view of the right portion of the Insured Vehicle at the time of our inspection. The exterior body of the Insured Vehicle was relatively unaffected by the fire.

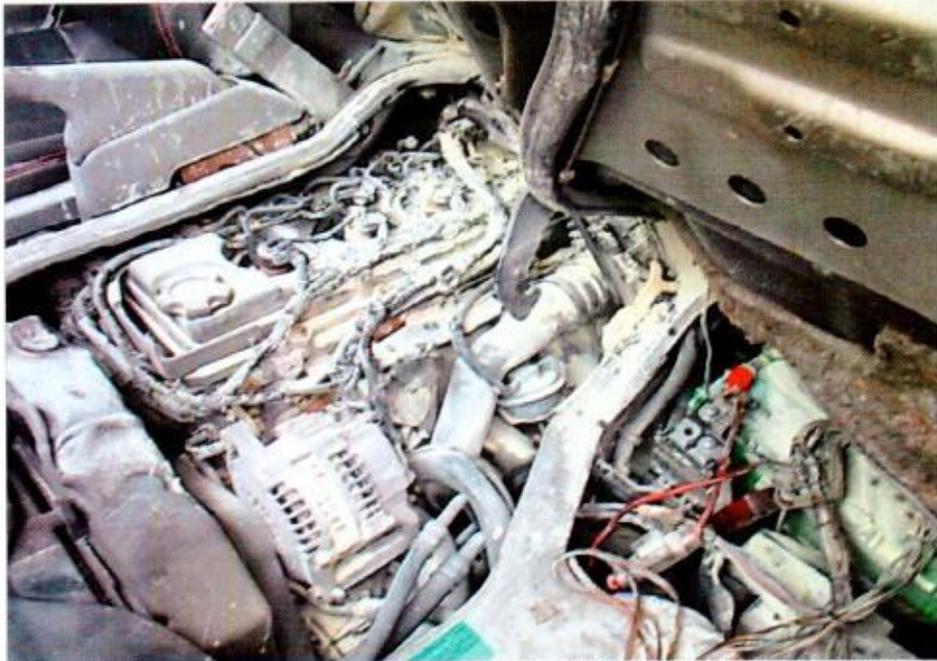
Photo 3 shows a general view of the engine compartment of the Insured Vehicle which was covered in fire extinguisher residue at the time of our inspection. Most of its engine components were found to have been affected as a result of the fire.

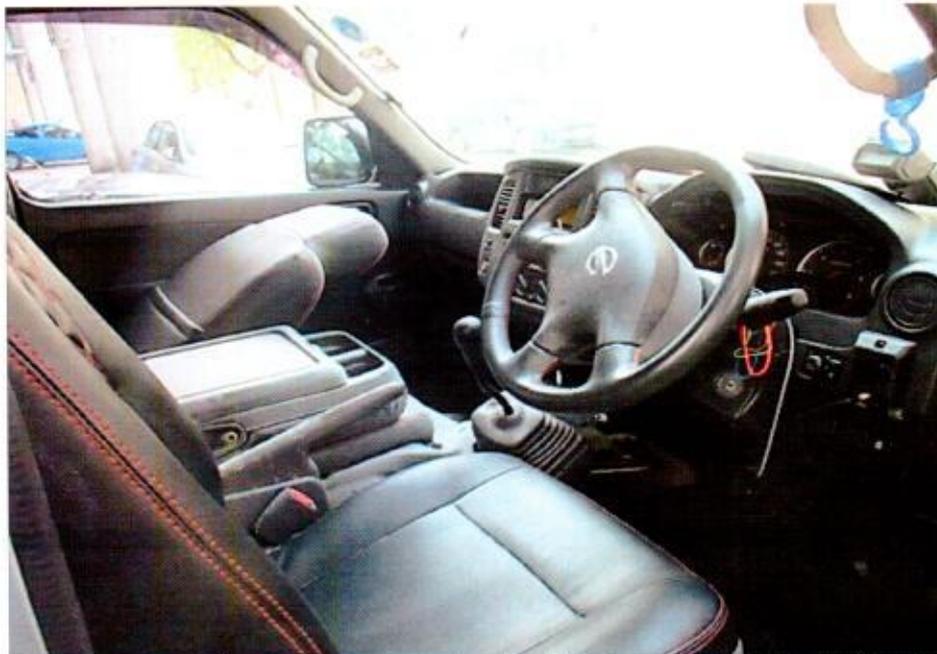
Photo 4 shows the interior compartment of the Insured Vehicle, which was observed to be relatively unaffected by the fire.

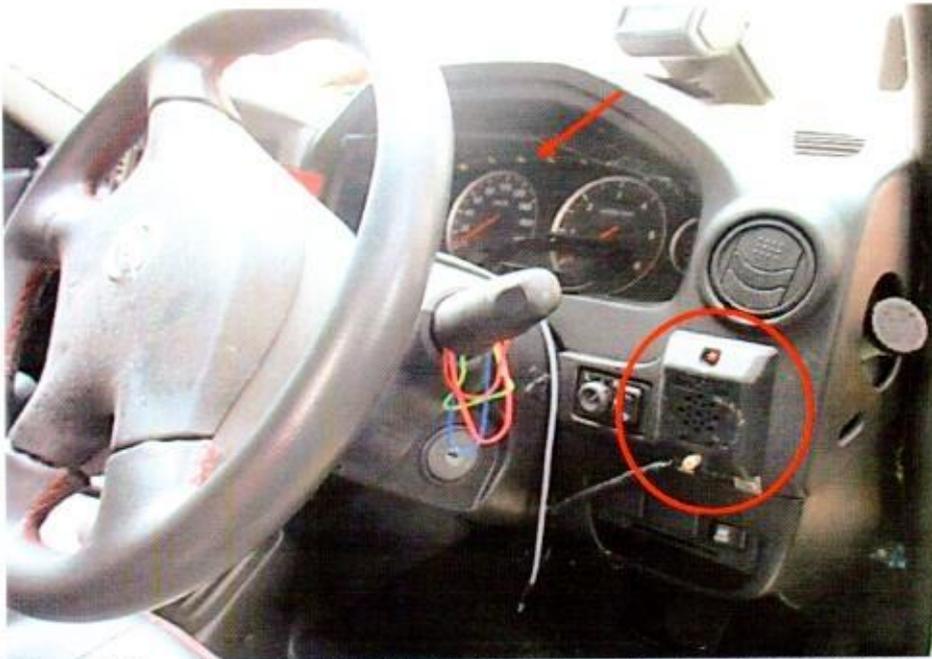
Photo 5 shows the 1st LED light strip fitted above the speedometer (arrowed) and the vehicle speed limiter device fitted beside the steering wheel of the Insured Vehicle (circled) upon our inspection.

33. We are further of the opinion that the additionally fitted electrical/electronic components found on the Insured Vehicle could have possibly caused overloading to the electrical system of the Insured Vehicle.

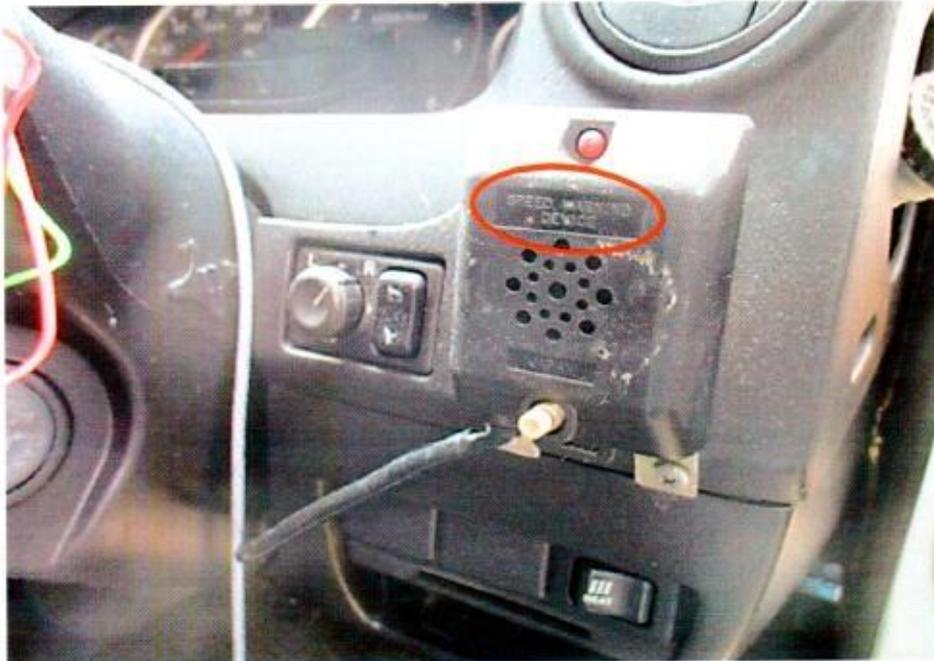
Photo 6 shows a closer view of the speed limiter device fitted beside the steering wheel of the Insured Vehicle (circled) upon our inspection.

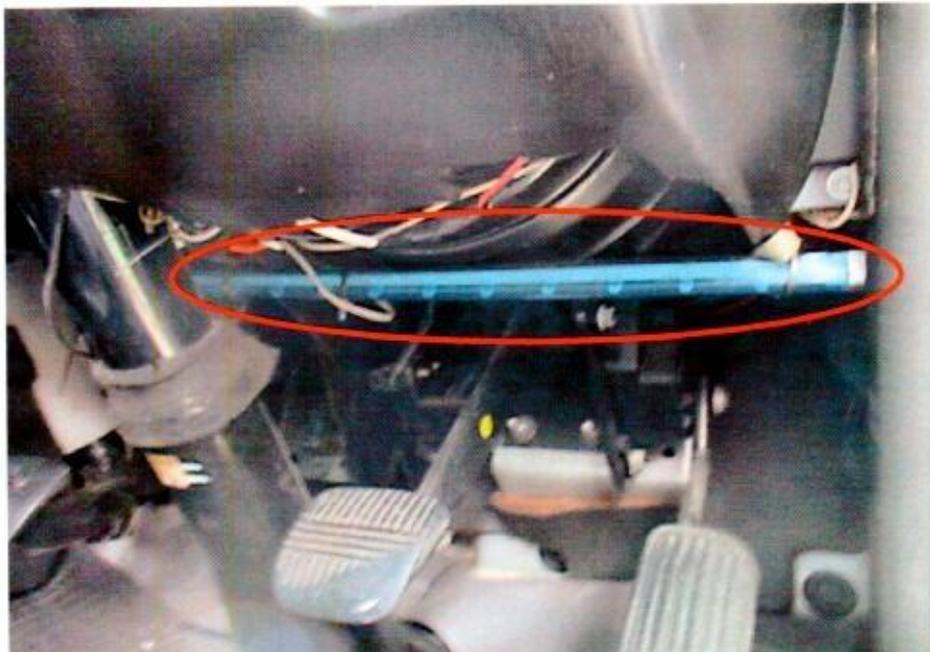
Photo 7 shows the 2nd LED light strip fitted above the foot pedals of the Insured Vehicle (circled) upon our inspection.

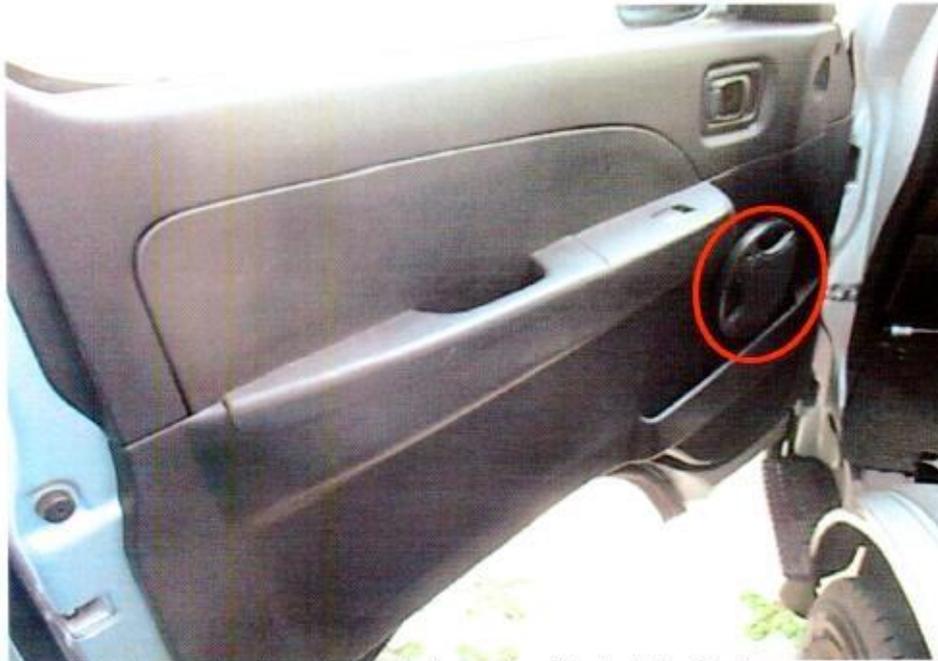
Photo 8 shows the 1st aftermarket speaker fitted at the front passenger door panel. The brand of the speaker was 'LANZAR' (circled).

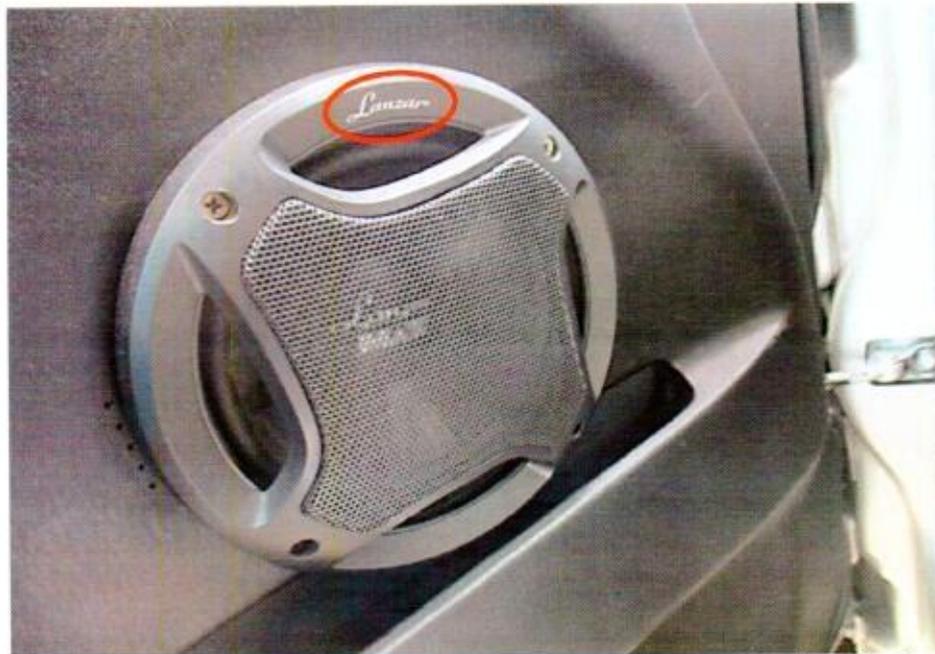
Photo 9 shows a close up view of the aftermarket speaker fitted at the front passenger door panel. The brand of the speaker was 'LANZAR' (circled).

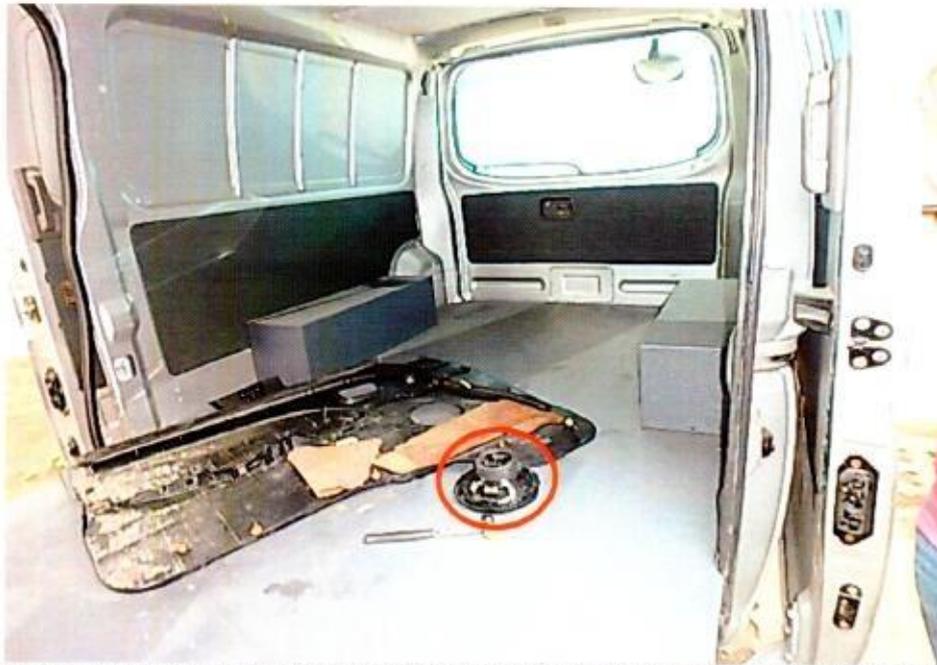
Photo 10 shows the 2nd aftermarket speaker fitted at the driver door panel. The brand of the speaker was 'LANZAR' (circled).

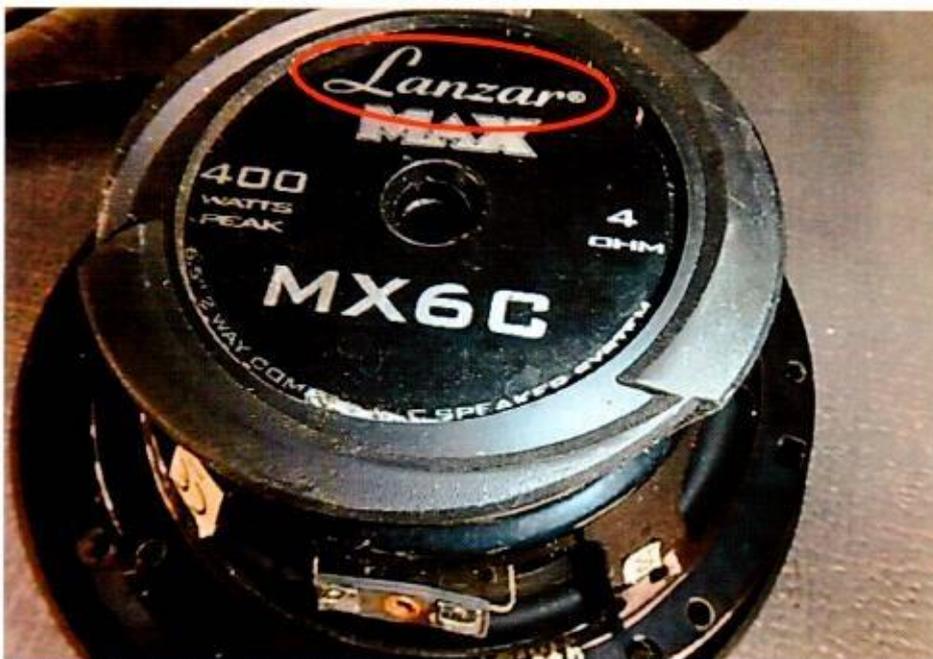
Photo 11 shows a close up view of the 2nd aftermarket speaker fitted at the driver door panel. The brand of the speaker was 'LANZAR' (circled).

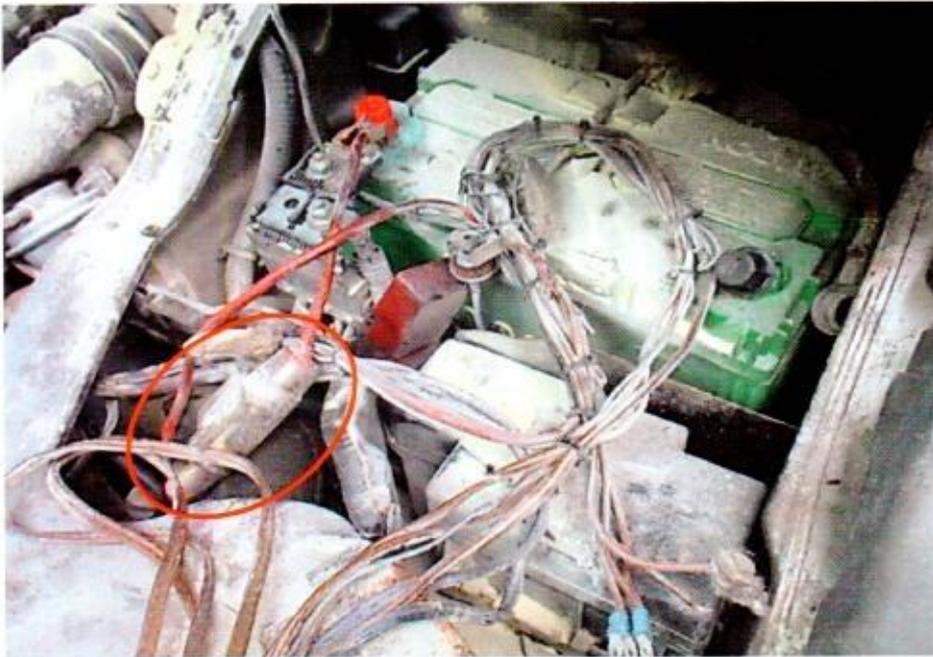
Photo 12 shows the fuse breaker (circled) that was connected to the battery of the Insured Vehicle at the time of our inspection.

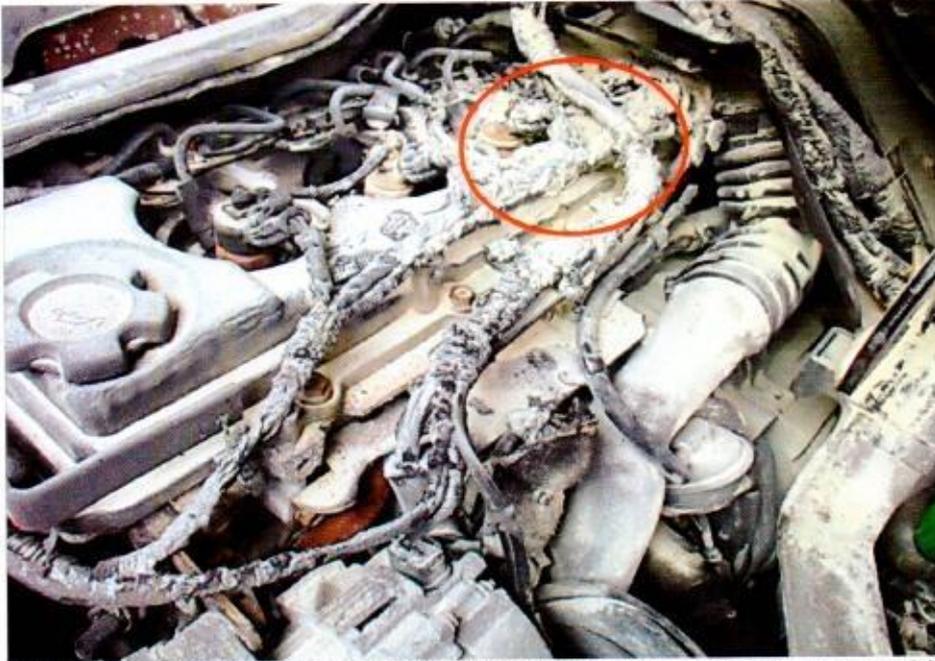
9. Upon closer examination of the engine compartment, in particular to the engine block which was covered in fire extinguisher residue, we had found faint traces of greenish residue on several burnt stretches of original factory fitted wirings around the centre area of the engine compartment. The presence of such greenish residue indicates internal heating of copper wires, a sign of an electrical short circuit occurring. The greenish residue is normally left behind from oxidation as a result of chemical reaction involving the copper wires. We also observed that the negative terminal of the battery had partially melted. These physical evidences would then appear to suggest that the cause of fire to the Insured Vehicle could have possibly been due to electrical in nature. See photos 13 - 17 below.

Photo 13 shows the burnt stretches of original factory fitted wirings covered in fire extinguisher residue around the engine block, which is in the immediate vicinity where the fire to the Insured Vehicle had likely started. Faint traces of greenish residue were found on some of the wirings (circled). The presence of such greenish residue suggests occurrence of an electrical short circuit.

30. Having investigated and technically analysed the damages of burnt nature to the Insured Vehicle, we are of the view that the cause of fire to the Insured Vehicle was of electrical in nature. For this particular case, the fire had originated along the wirings around the engine compartment. The wirings were original factory wirings inside the engine compartment of the Insured Vehicle.

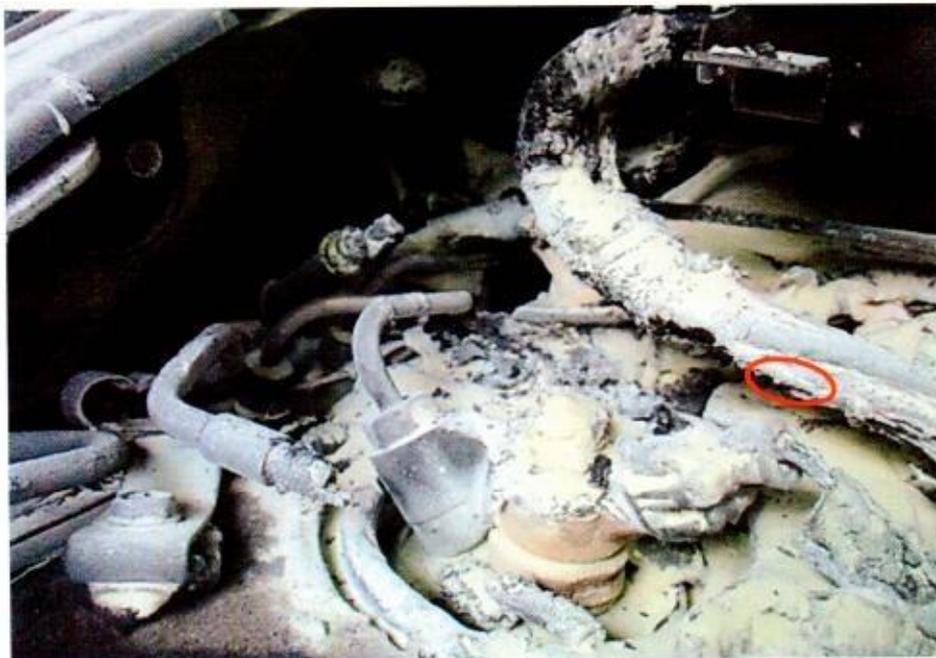
Photo 14 shows a closer view of the faint traces of greenish residue found on some of the melted stretches of original factory fitted wirings (circled).

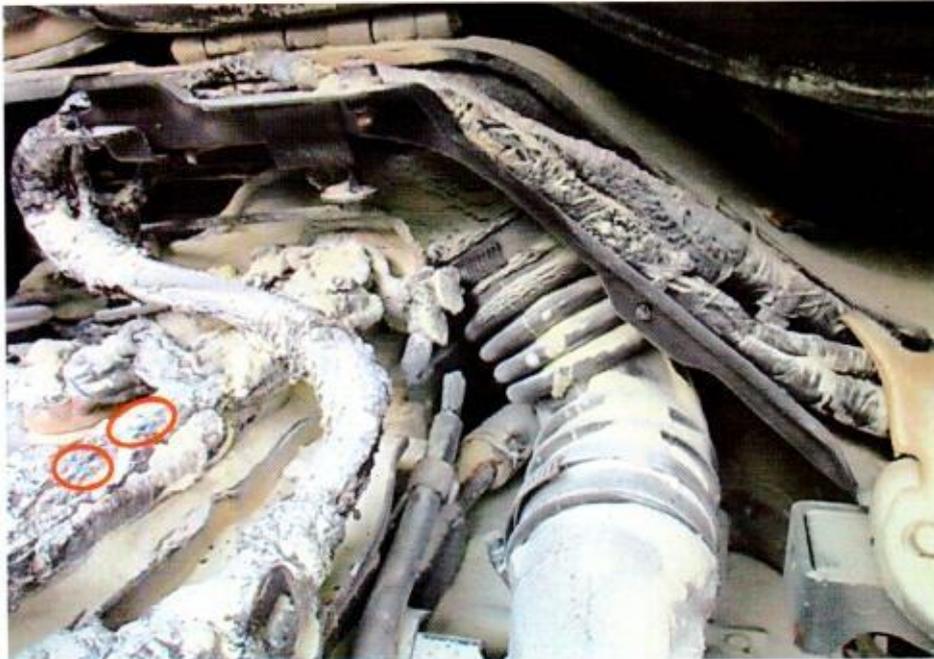
Photo 15 shows a closer view of the faint traces of greenish residue found on some of the melted stretches of original factory fitted wirings (circled).

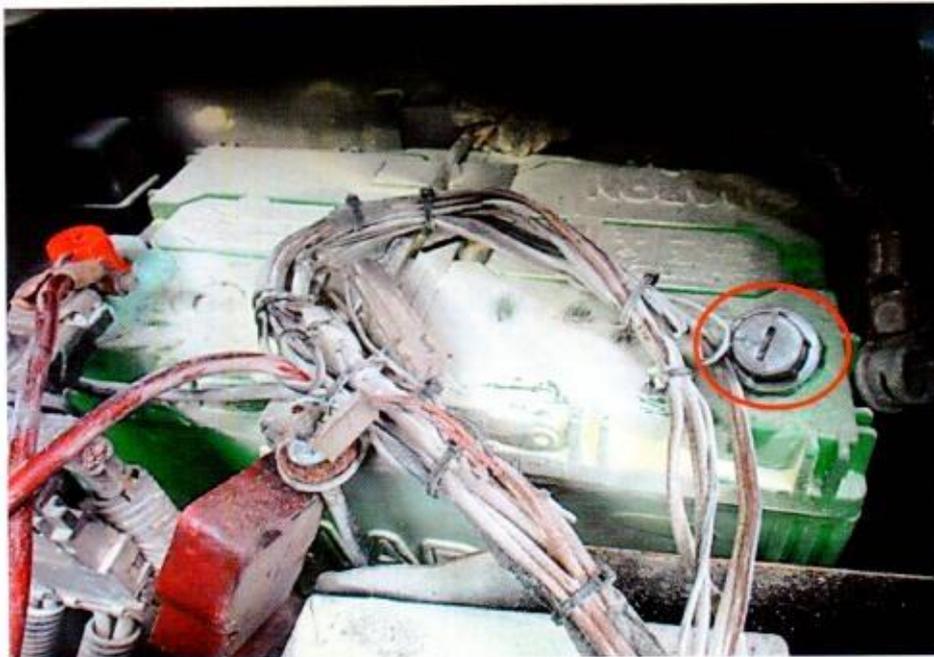
Photo 16 shows the partially melted negative terminal of the battery of the Insured Vehicle (circled).

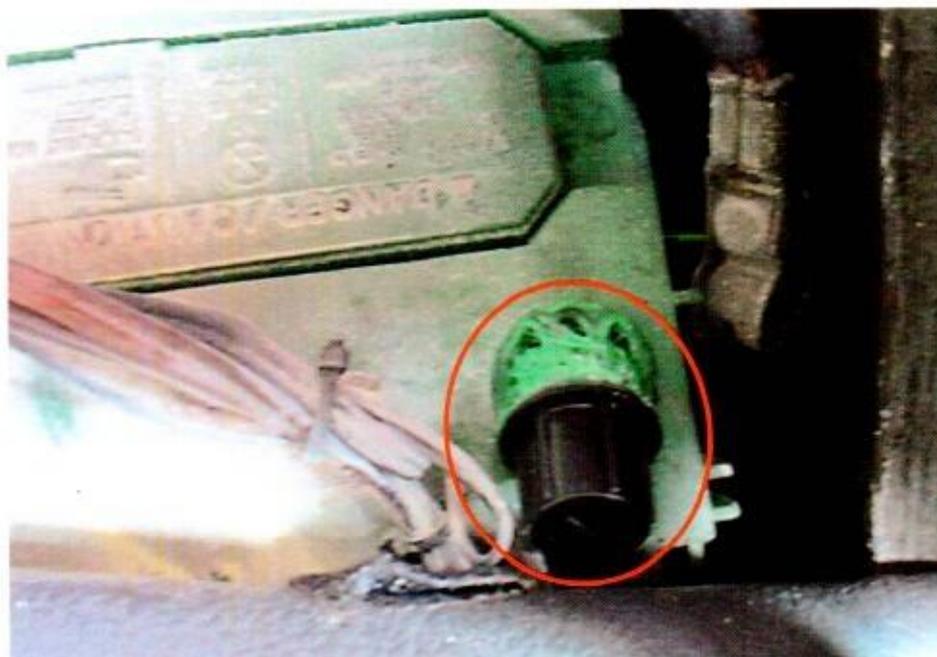
Photo 17 shows a close up view of the partially melted negative terminal of the battery of the Insured Vehicle (circled).

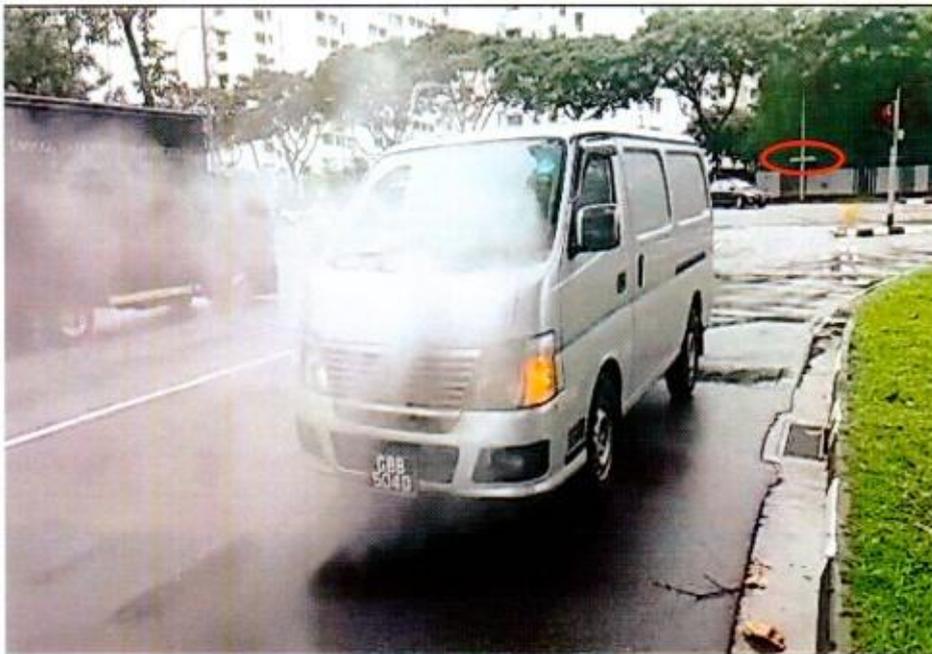
Photo 18 shows thick smoke emitting from the front bonnet of the Insured Vehicle. In general, the information that could be gathered from this photograph had corresponded to the events that were related to us by Mr Yau, which is he had stopped the Insured Vehicle by the left side of the road after turning left into Ubi Avenue 3 from Paya Lebar Road (circled).

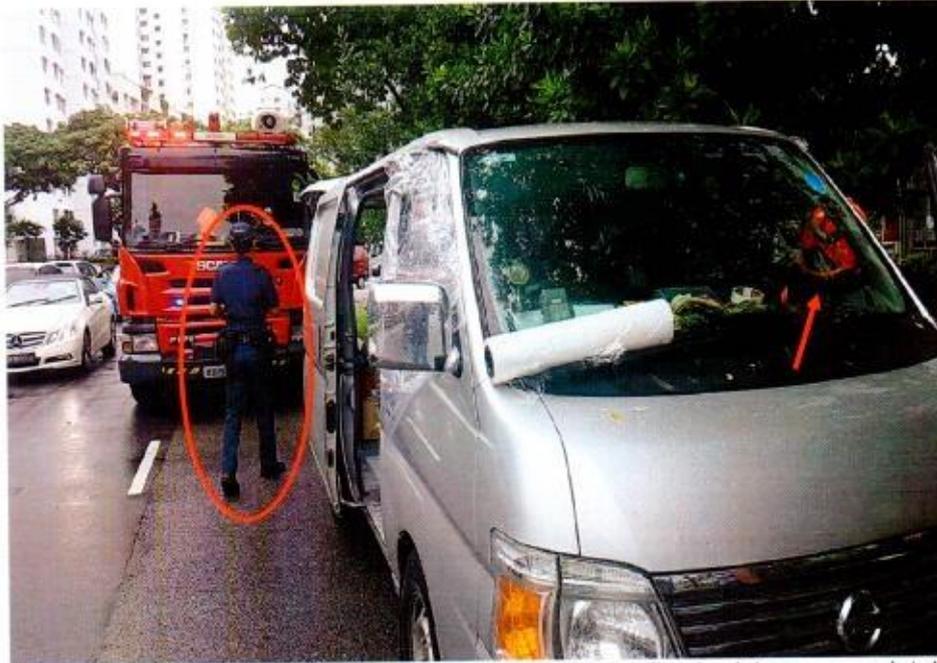
Photo 19 shows a firefighter making sure that the fire had been completely extinguished (arrowed). In general, the information that could be gathered from this photograph had corresponded to the events that were related to us by Mr Yau, which is the police (circled) and SCDF were present at the incident location.

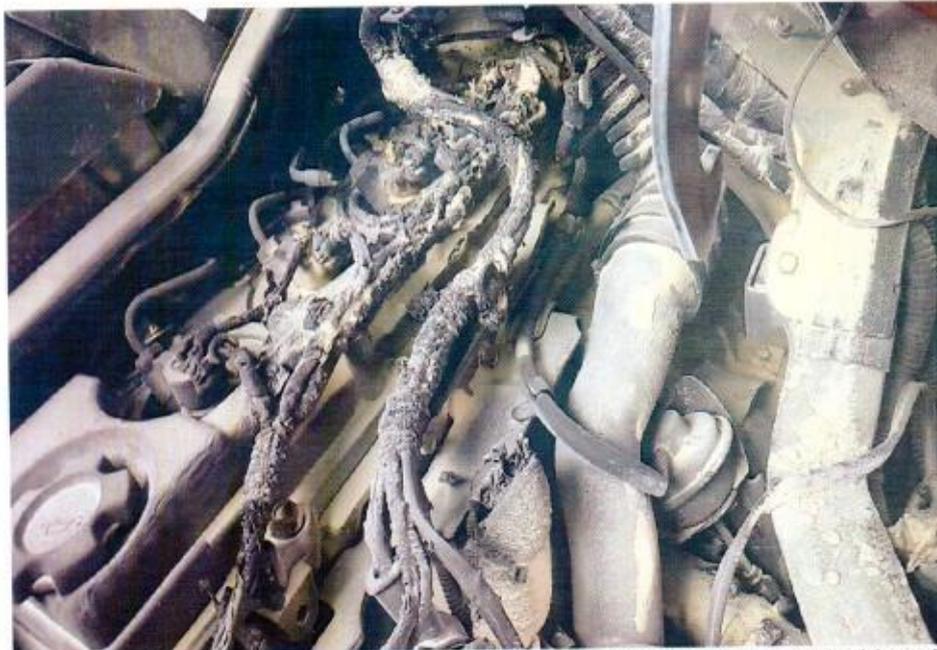
Photo 20 shows the engine compartment of the Insured Vehicle post- incident. In general, the damages sustained to the engine compartment and the fire extinguisher residue found on the burnt stretches of wirings had corresponded to the events that were related to us by Mr Yau, which is the fire had started from the engine compartment.
