Your Ref: TP/IP/43445/2017
Our Ref :CI/TPD18001480/Z

Fatal Accident Investigation Team

Traffic Police Department
Singapore Police Force
10 Ubi Avenue 3
Singapore 408865

**INSPECTION REPORT OF ELECTRIC BICYCLE - PAB (RED) - TRAFFIC
POLICE POUND REPORT NO. 3545/2017**

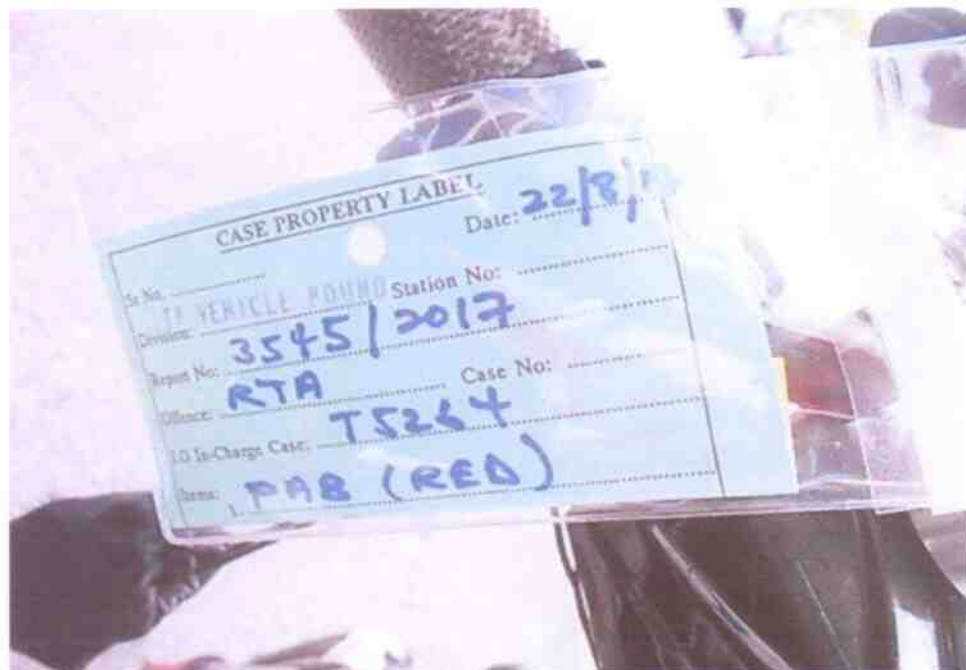
Photo 1 shows the identification of the Electric Bicycle with reference to Traffic Police Pound Report No. 3545/2017.

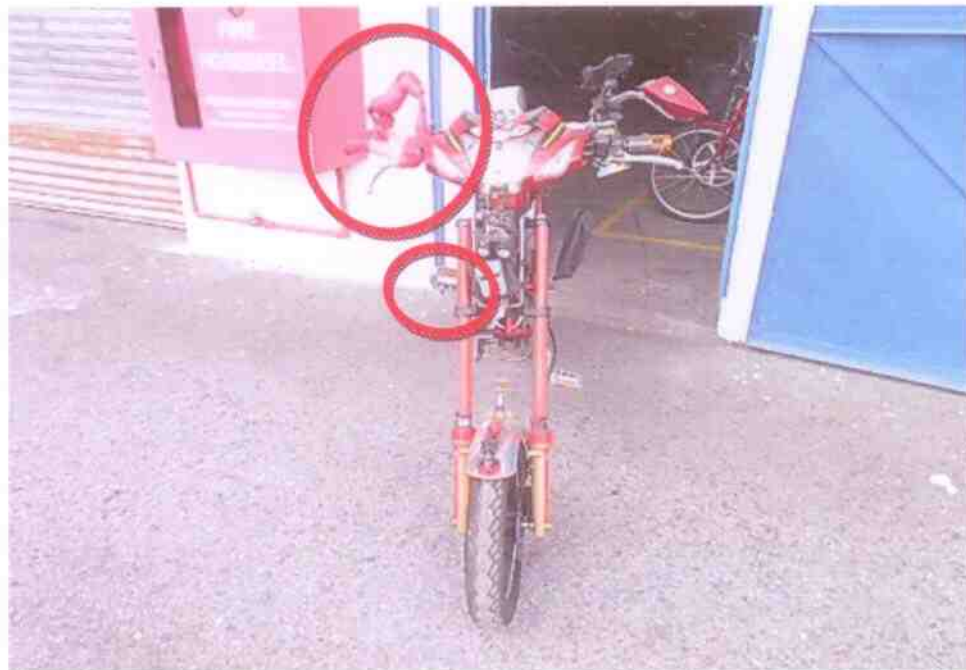
4. The Electric Bicycle was observed to have sustained minor damages at the right portion. The body parts that were found to have been damaged include its right hand handle, right hand foot pedal & brake lever amongst others as a result of the accident.

Photo 2 shows the frontal portion of the Electric Bicycle at time of inspection. Damage on the right hand handle & right hand foot pedal was observed likely due to the accident.

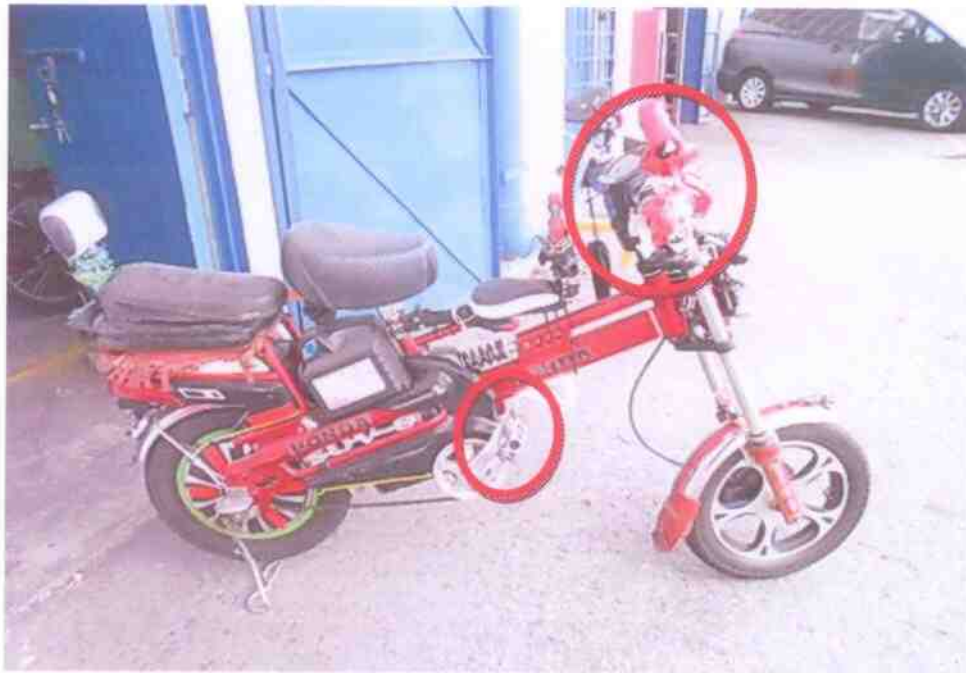
Photo 2 shows the right portion of the Electric Bicycle at time of inspection. Damage on the right hand handle & right hand foot pedal was observed likely due to the accident.

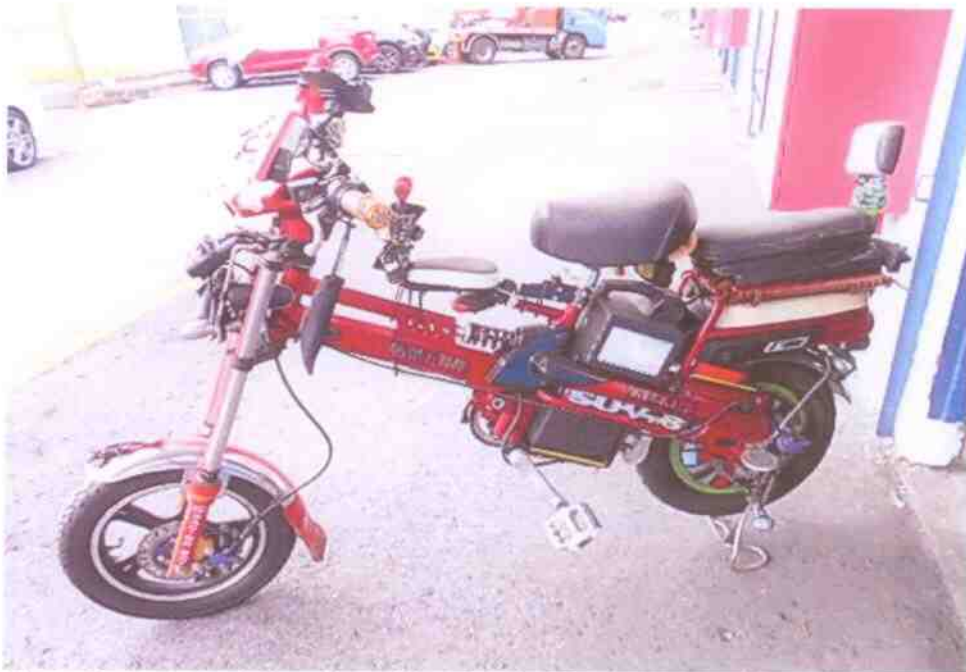
Photo 2 shows the left portion of the Electric Bicycle at time of inspection. It was observed to be in good condition without any damage.

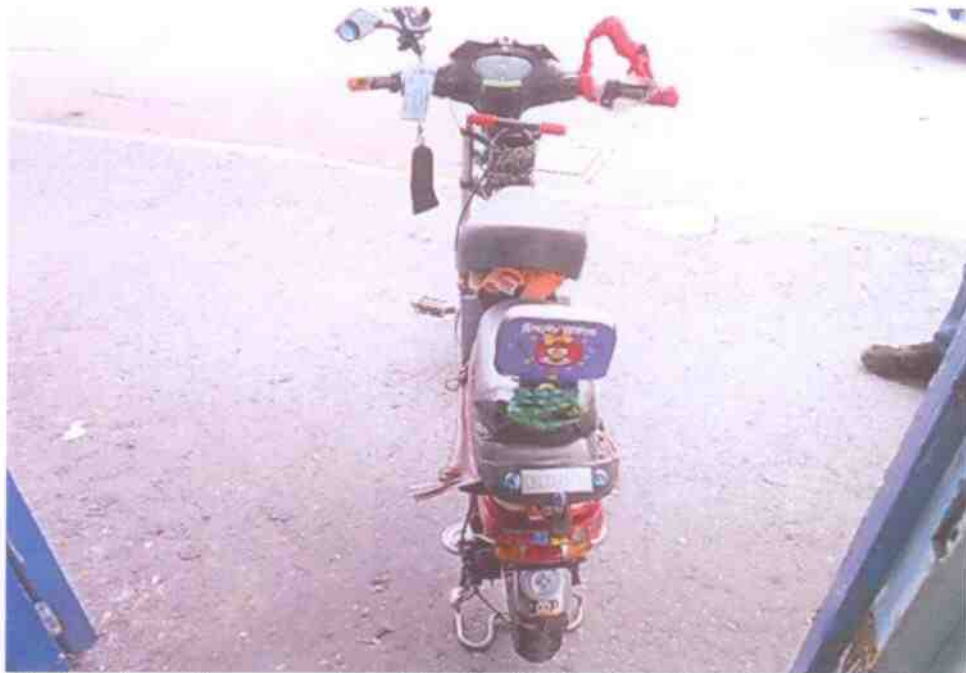
Photo 2 shows the rear portion of the Electric Bicycle at time of inspection. It was observed to be in good condition without any damage.

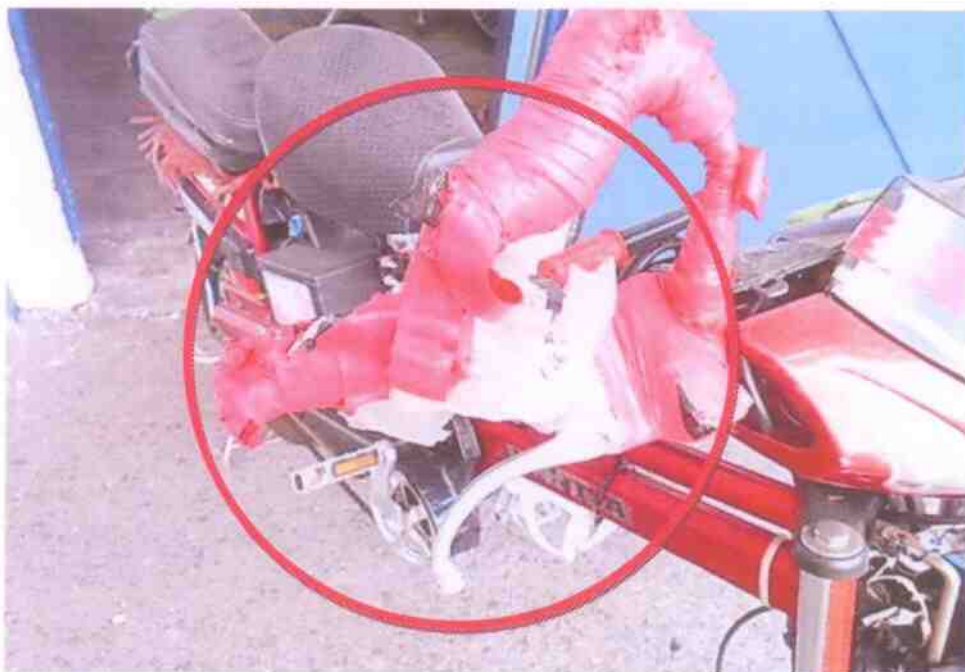
Photo 3 shows the right portion of the Electric Bicycle at time of inspection. Damage on the right hand handle, brake lever & right hand foot pedal was observed likely due to the accident.

11. Further examination revealed that the right hand brake lever for front brake was observed to be bent; it was also found to be stuck likely due to the accidents impact.

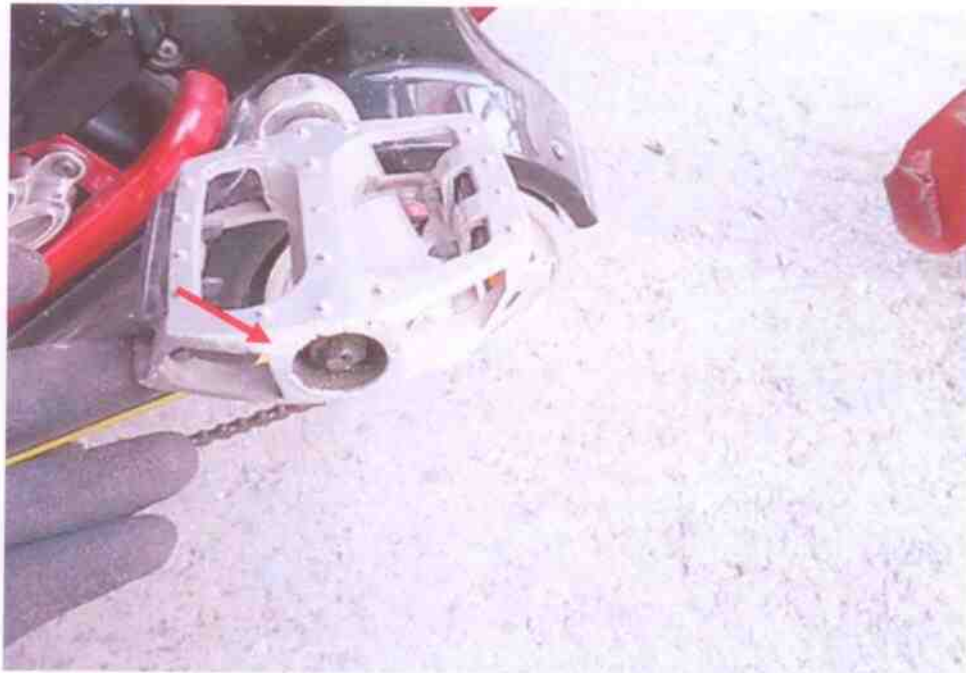
Photo 4 shows the right portion of the Electric Bicycle at time of inspection. Damage on the right hand foot pedal was observed likely due to the accident.

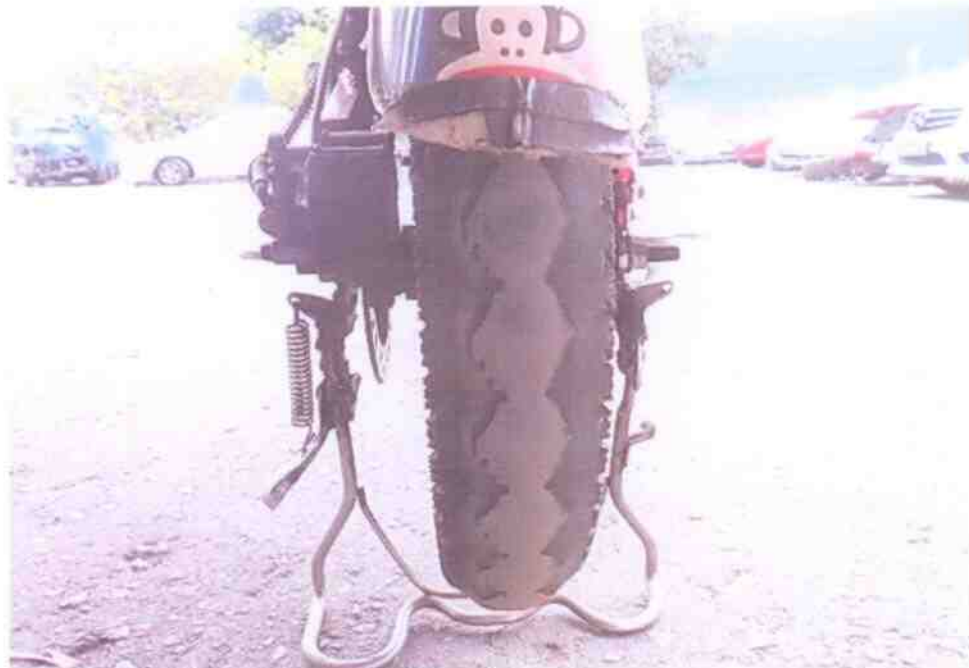
6. The tyres were wrapped around alloy wheel rim that was found to be without any significant damage. See photo 8 & 9 below

Photo 8 shows the rear tyre of the Electric Bicycle at the time of our inspection. The tread pattern of the 2 tyres was clearly visible. We did not observe any tear, burst mark(s) and/or punctured hole(s) on the sidewalls.

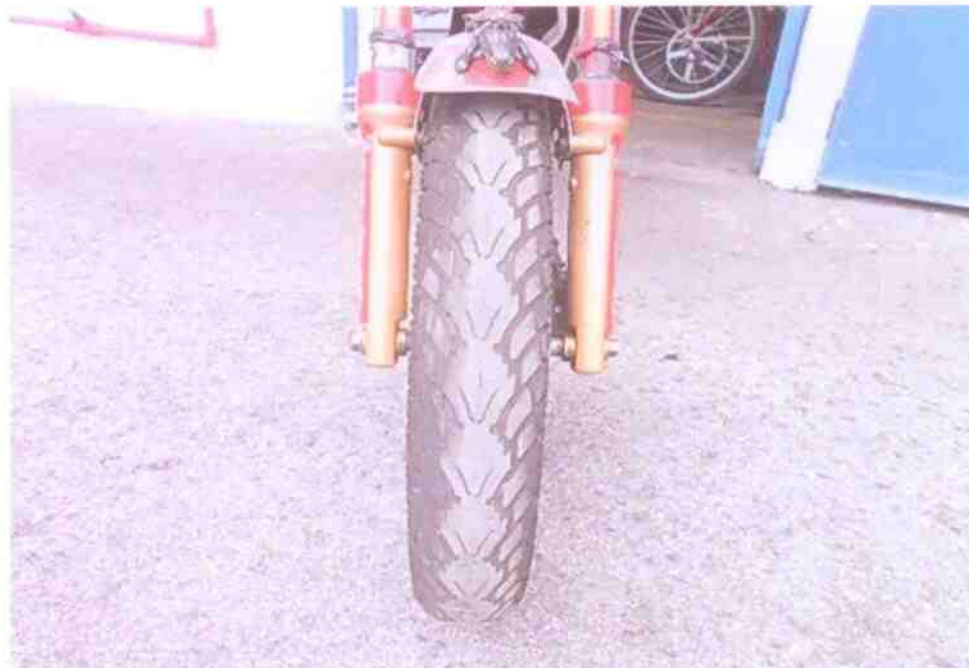
Photo 9 shows the front tyre of the Electric Bicycle at the time of our inspection. The tread pattern of the 2 tyres was clearly visible. We did not observe any tear, burst mark(s) and/or punctured hole(s) on the sidewalls.

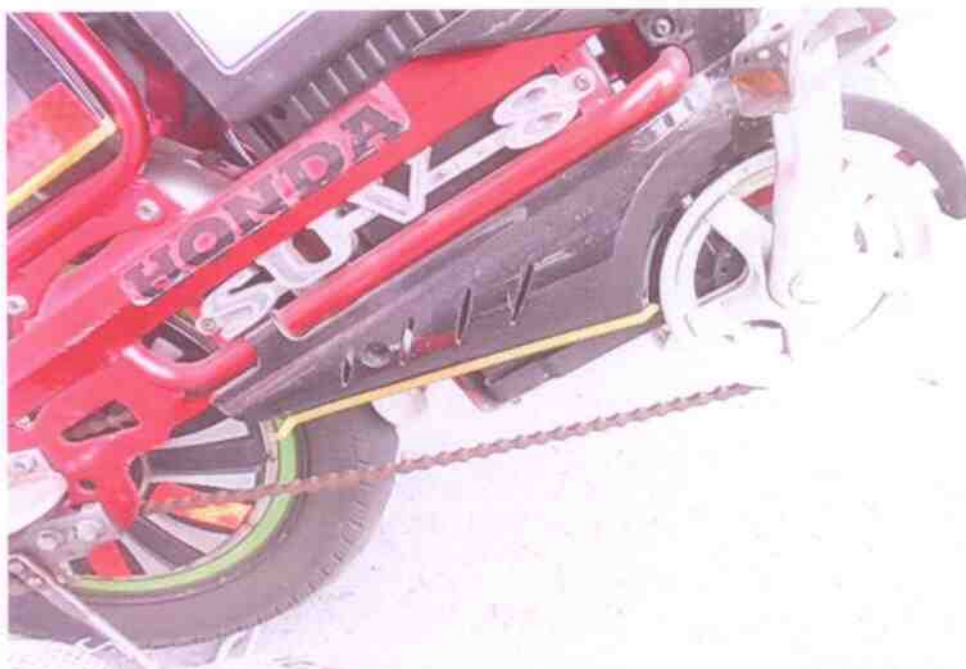
7. The gear chain of the Electric Bicycle was found to be intact without any misalignment. Free play tension test was also conducted & found adequately acceptable. It was also observed to be in operational condition. See photo 10 & 11 below.

Photo 10 shows the general view of the gear train (arrowed) of the Electric Bicycle, which was observed to be intact with no misalignment.

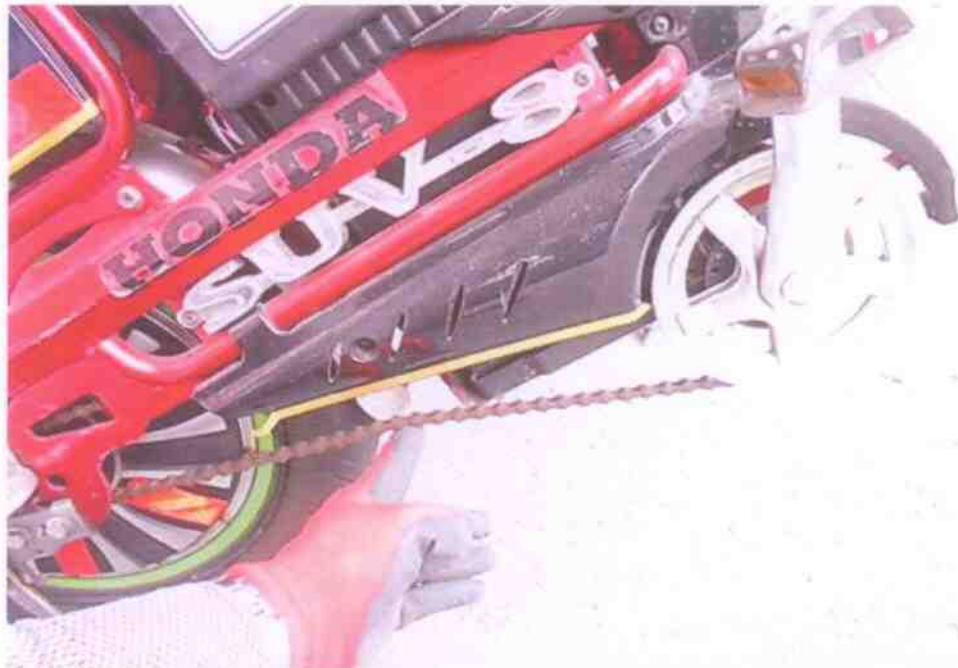
Photo 11 shows a close-up view of the rear chain of the Bicycle at the time of our inspection. Free play tension test was also conducted & found adequately acceptable. It was also observed to be in operational condition.

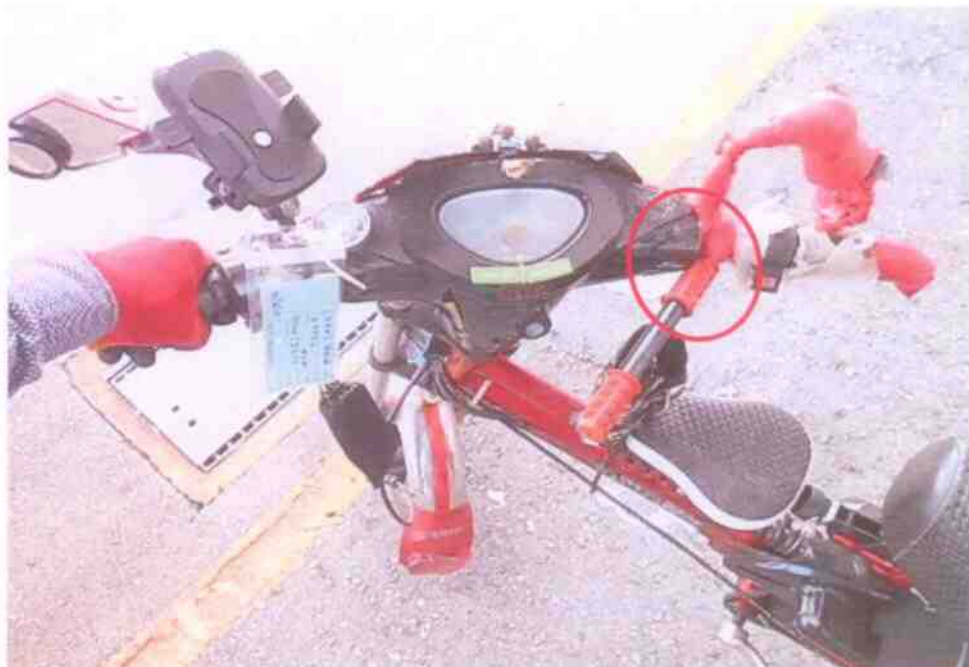
9. However, on further observation we had found an abnormality on the Electric Bicycle's handle bar operational movement. It was found to be hindered by an additional child seat handle bar that was installed in the middle section of the Electric Bicycle's body. Hence, disrupting the normal operating sequence for the Electric Bicycle's steering system. The normal operating sequence for the Electric Bicycle is to be able to turn the handle bar to the fullest left & fullest right without any obstruction from any foreign material.

Photo 13 shows the handle bar of the Electric Bicycle while trying to turn to the fullest right. It was hindered by an additional child seat handle bar that was installed in the middle section of the Electric Bicycle's body. Hence, disrupting the normal operating sequence for the Electric Bicycle's steering system.

16. The steering system was found to be in a serviceable condition. However, our observation had found an abnormality on the Electric Bicycle's handle bar operational movement. It was observed to be hindered by an additional child seat handle bar that was installed in the middle section of the Electric Bicycle's body. Hence, disrupting the normal operating sequence for the Electric Bicycle's steering system. The normal operating sequence for the Electric Bicycle is to be able to turn the handle bar to the fullest left & fullest right without any obstruction from any foreign material. Anyway, looking at the accidents case facts that the Electric Bicycle was travelling on a straight road at the time of accident. This may not likely to cause and/or contributes to the accident.

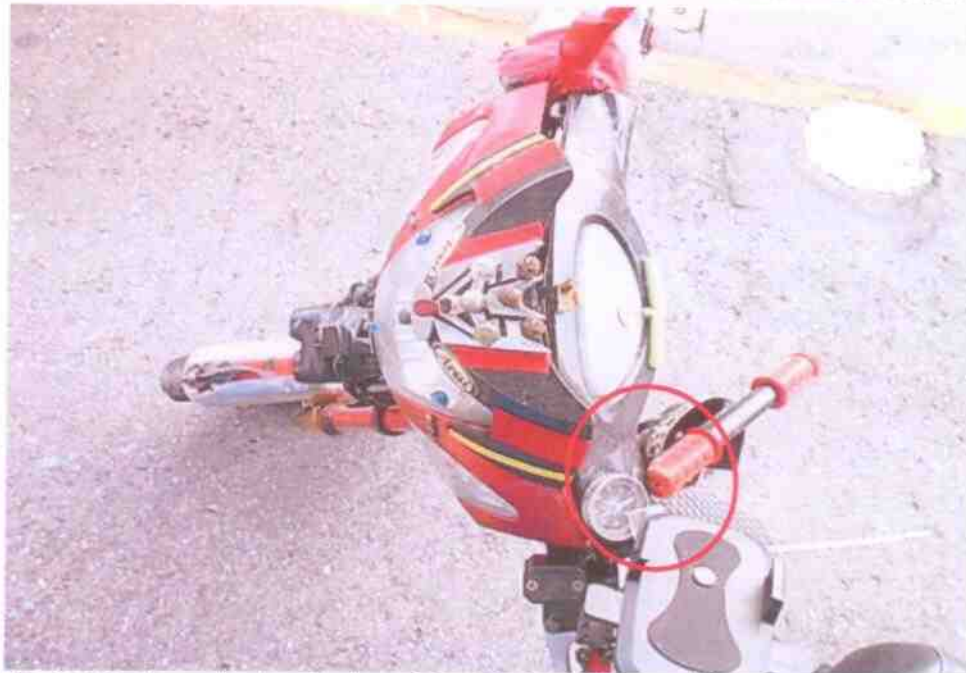
Photo 14 shows the handle bar of the Electric Bicycle while trying to turn to the fullest left. It was hindered by an additional child seat handle bar that was installed in the middle section of the Electric Bicycle's body. Hence, disrupting the normal operating sequence for the Electric Bicycle's steering system.

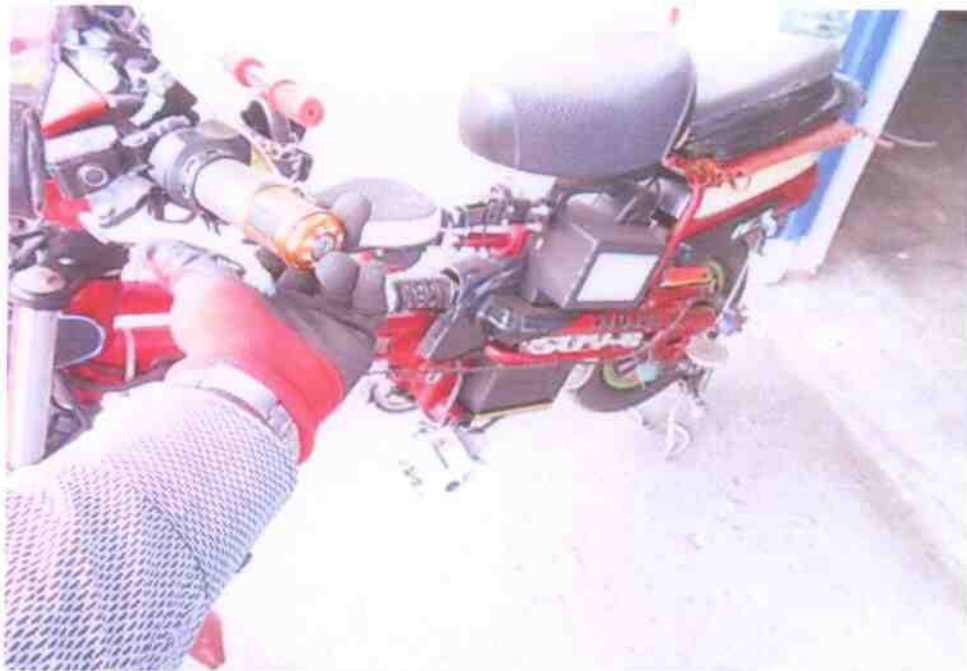
12. A static brake test was conducted only on the Bicycle's rear brake. The test was conducted by lifting the rear tyre above ground & applies a little spinning action to it. The left hand brake lever was then gripped in order to stop the spinning rear tyre. The result was satisfactory. It stopped after gripping the left hand brake to the fullest. It shows that the rear brake calliper was responding to the gripping action. This had appeared to indicate that the rear brake was in a serviceable condition.

Photo 15 shows a static brake test was conducted only on the Bicycle's rear brake. The test was conducted by lifting the rear tyre above ground & applies a little spinning action to it. The hand brake lever was then gripped in order to stop the spinning front tyre. The result was satisfactory. It stopped after gripping the left hand brake to the fullest. It shows that the rear brake clamps was responding to the gripping action. This had appeared to indicate that the rear brake was in a serviceable condition.

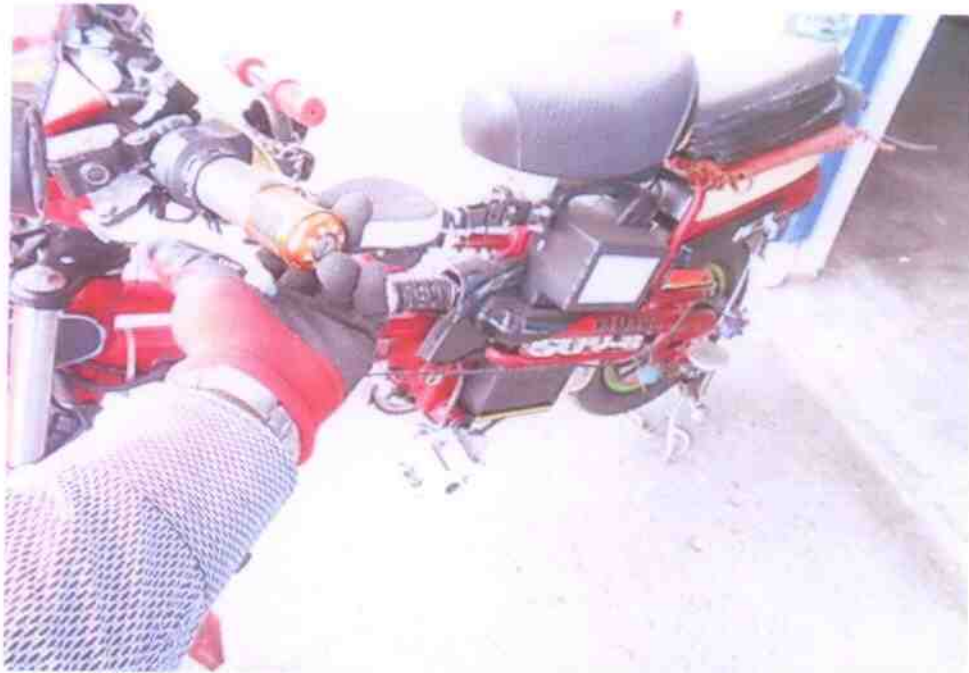
Photo 16 shows a static brake test was conducted only on the Bicycle's front brake. The test was conducted by lifting the front tyre in the air & applies a little spinning action to it. The hand brake lever was then gripped in order to stop the spinning front tyre. The result was unsatisfactory. It didn't stop after gripping the hand brake to the fullest.

15. At the time of our inspection of the Electric Bicycle, its front brake could not be tested (due to damages as a result of the accident). Its rear brake was however found to be in serviceable condition based on the static brake test conducted at time of inspection.
