| Affiliated to Federation Internationale Des Experts En Automobile | | | |
|---|---|---|---|
| FIRST CAPITAL INSURANCE LTD | | Ref : CS/FCI18001486/Kvb | |
| Insured Veh. | SHA 6278B | Veh. Inspected | SKB 8449X |

**INITIAL INSPECTION REPORT OF VEHICLE NO. SKB 8449X**

## ADJUSTMENT ON REPAIR COST FOR VEHICLE NO. SKB 8449X

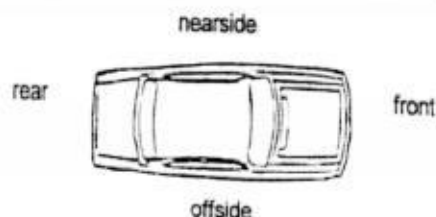
**Description of Damage:**

The vehicle sustained damages at the rear portion

Comments/Present Status:  
Damages Consistent
