Your Ref: TP/IP/66307/2017
Our Ref : CI/TPD18001554/Z

03rd January 2018

MECHANICAL INSPECTION REPORT OF MOTOR CAR SLJ 8352L

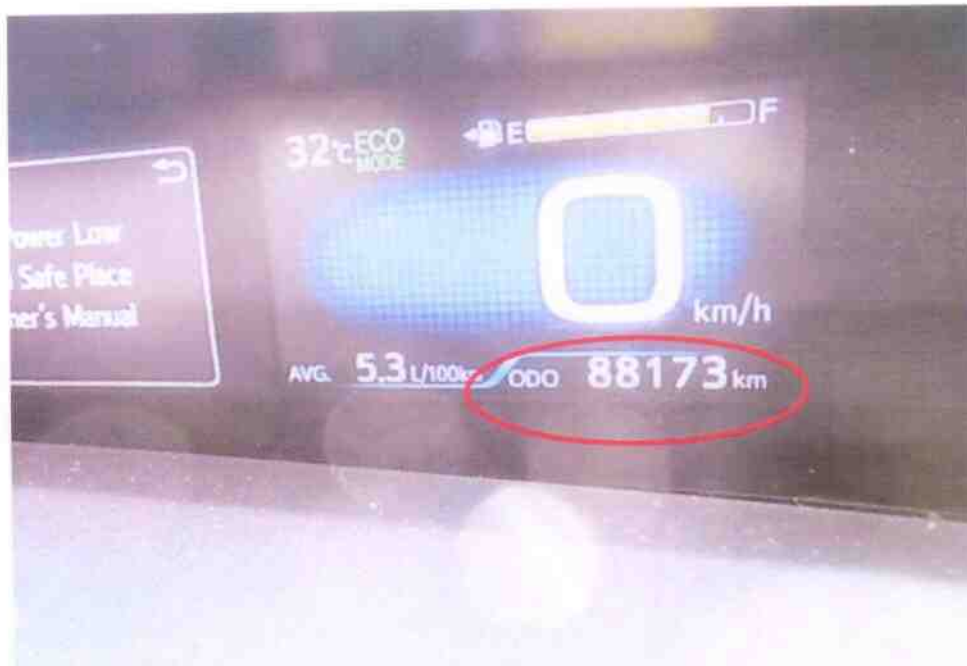
Photo 1 shows the mileage of the Motor Car was recorded to be 88,173km.

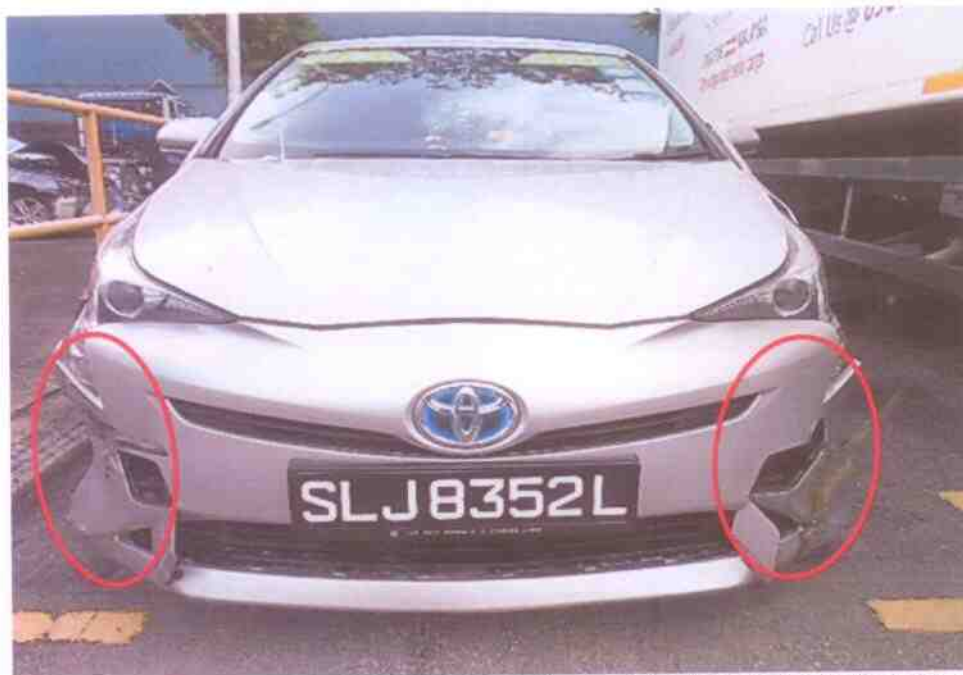
4. The mileage of the Motor Car at the time of our inspection was 88,173km.
5. The Motor Car had sustained relatively extensive impact damages which were noted to its frontal left & frontal right portion. The impact force was relatively significant, causing the various parts and components at the frontal left & frontal right of the engine compartment to be damaged. This has included its front left & right bumper was observed to have been damaged, its left & right headlamp was observed to be cracked & its front left & right tyre was observed to have been deflated due to the accident.

Photo 1 shows a general view of the frontal body of the Motor Car at the time of our inspection. The Motor Car had sustained relatively extensive impact damages which were confined to its frontal left & frontal right portion. The impact force was relatively significant, causing the various parts and components at the front area of the engine compartment to be damaged.

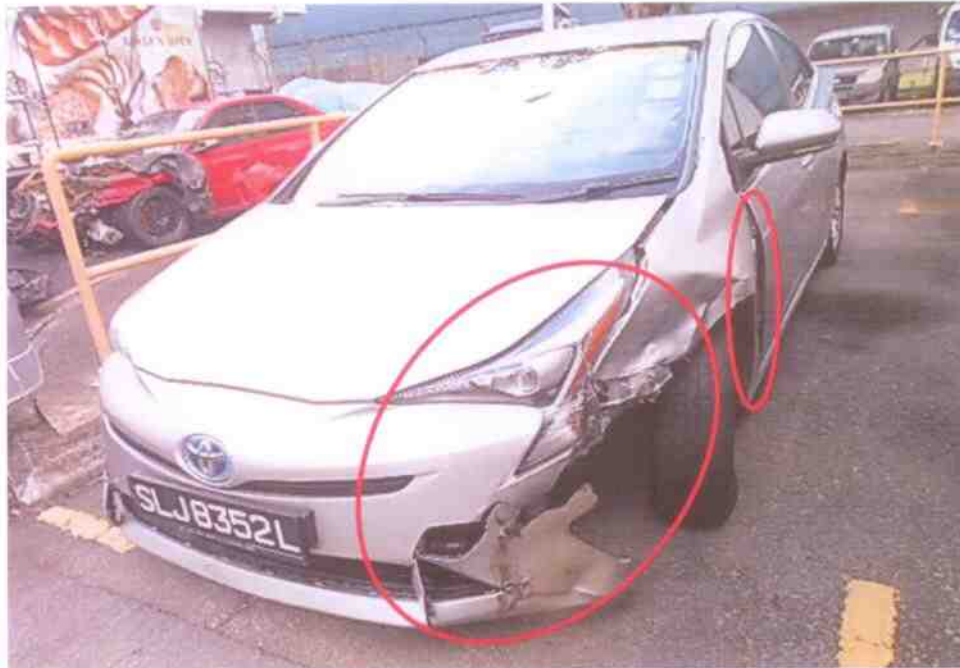
Photo 2 shows a general view of the front left body of the Motor Car at the time of our inspection. The impact force was relatively significant, causing the various parts and components at the front area of the engine compartment to be damaged.

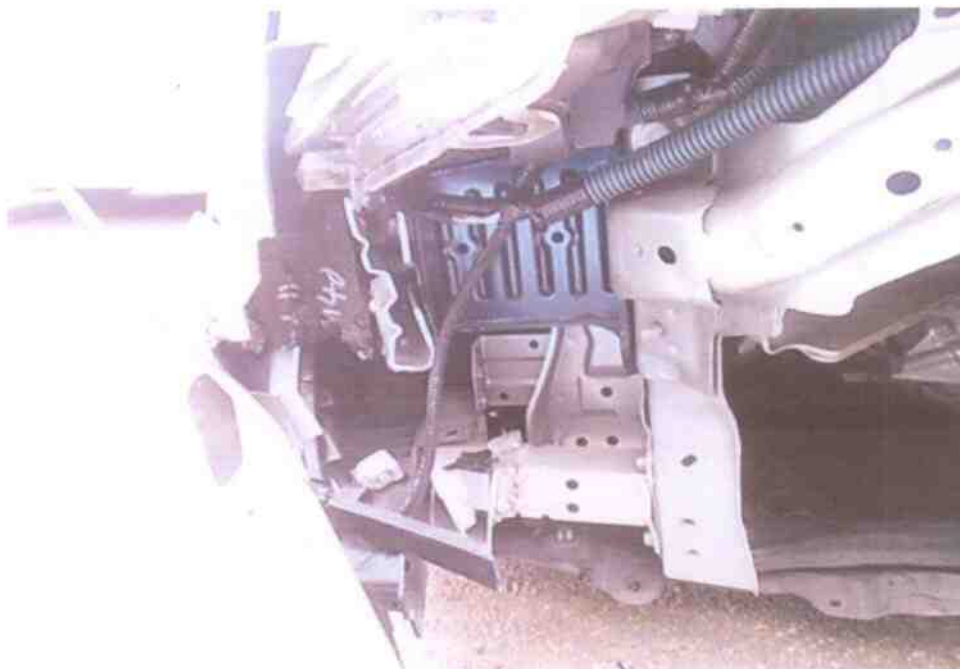
Photo 3 shows a close-up view of the front left body of the Motor Car at the time of our inspection. The impact force was relatively significant, causing the various parts and components at the front left area of the engine compartment to be damaged.

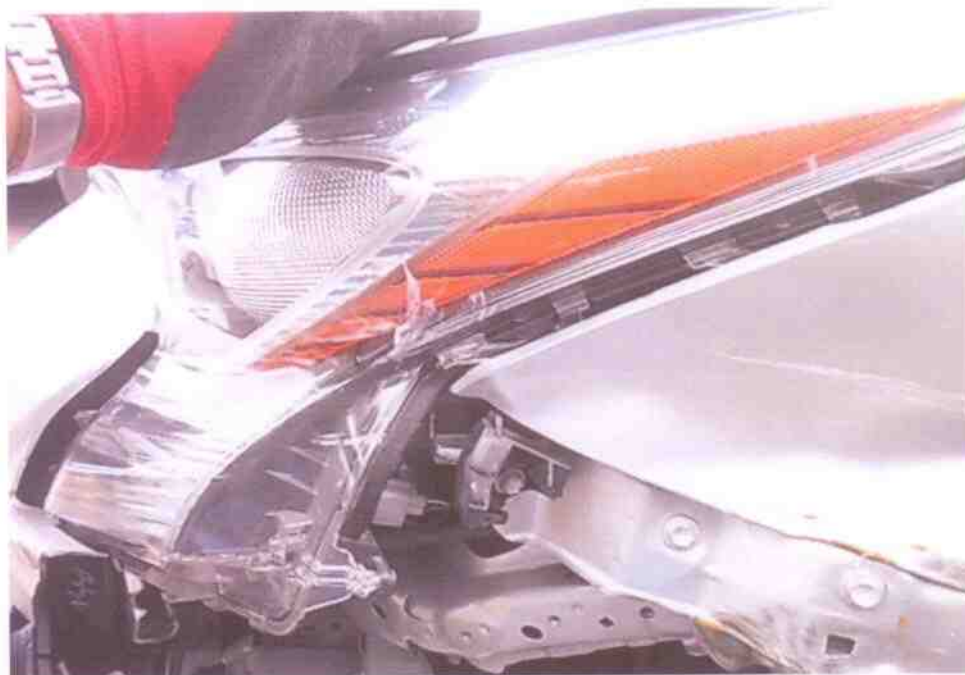
Photo 3 shows a close-up view of the front left body of the Motor Car at the time of our inspection. The impact force was relatively significant, causing the various parts and components at the front area of the engine compartment to be damaged.

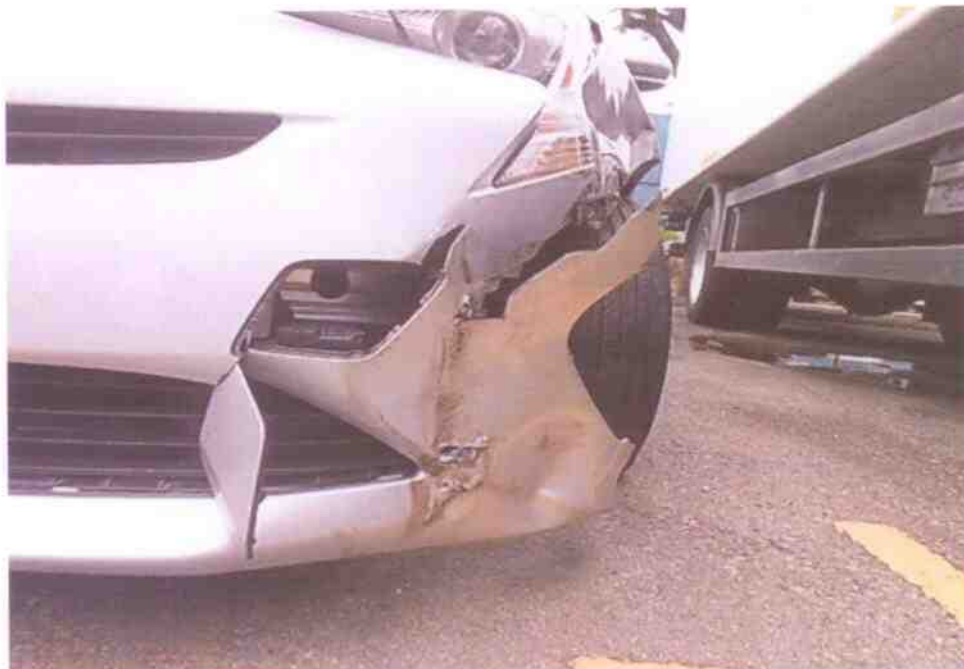
Photo 3 shows a close-up view of the front left body of the Motor Car at the time of our inspection. The impact force was relatively significant, causing the various parts and components at the front area of the engine compartment to be damaged.

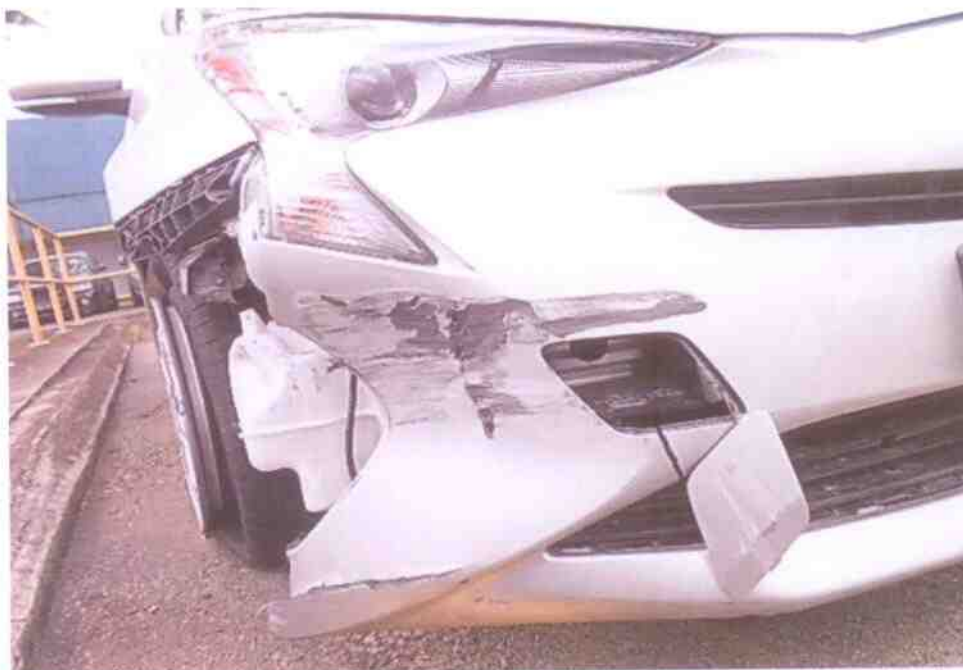
Photo 3 shows a close-up view of the front right body of the Motor Car at the time of our inspection. The impact force was relatively significant, causing the various parts and components at the front area of the engine compartment to be damaged.

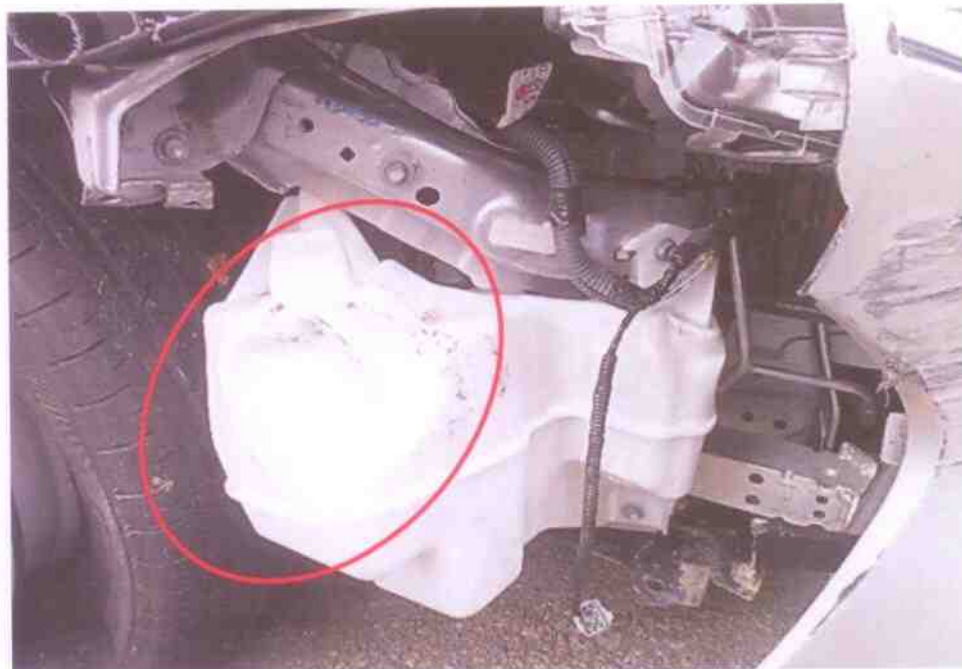
Photo 3 shows a close-up view of the front left body of the Motor Car at the time of our inspection. The impact force was relatively significant, causing the various parts and components at the front area of the engine compartment to be damaged.

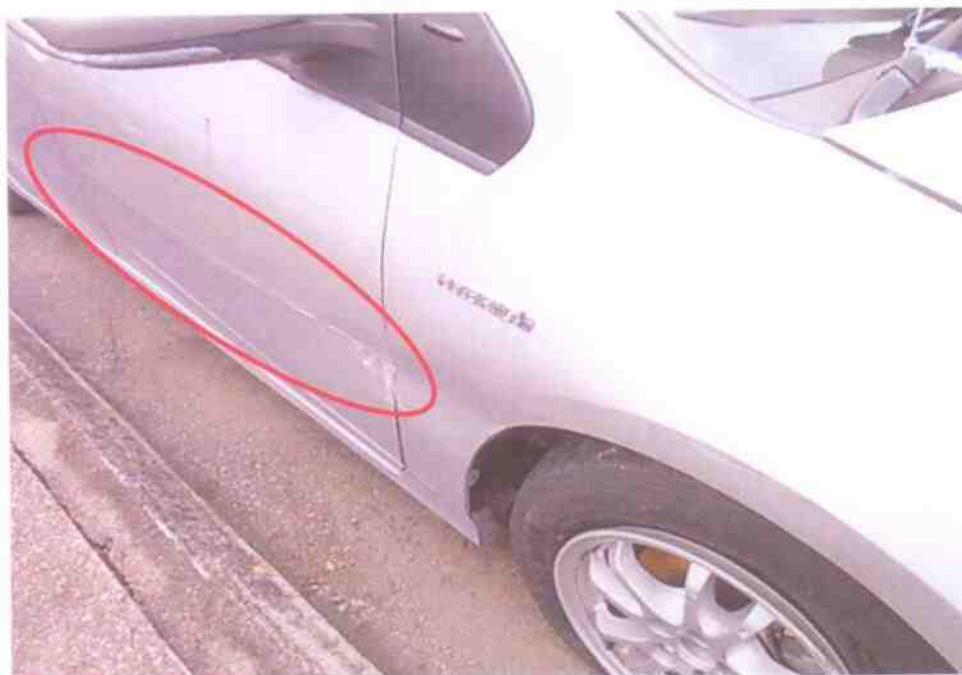
Photo 3 shows a close-up view of the front left body of the Motor Car at the time of our inspection. The impact force was relatively significant, causing the various parts and components at the front area of the engine compartment to be damaged.

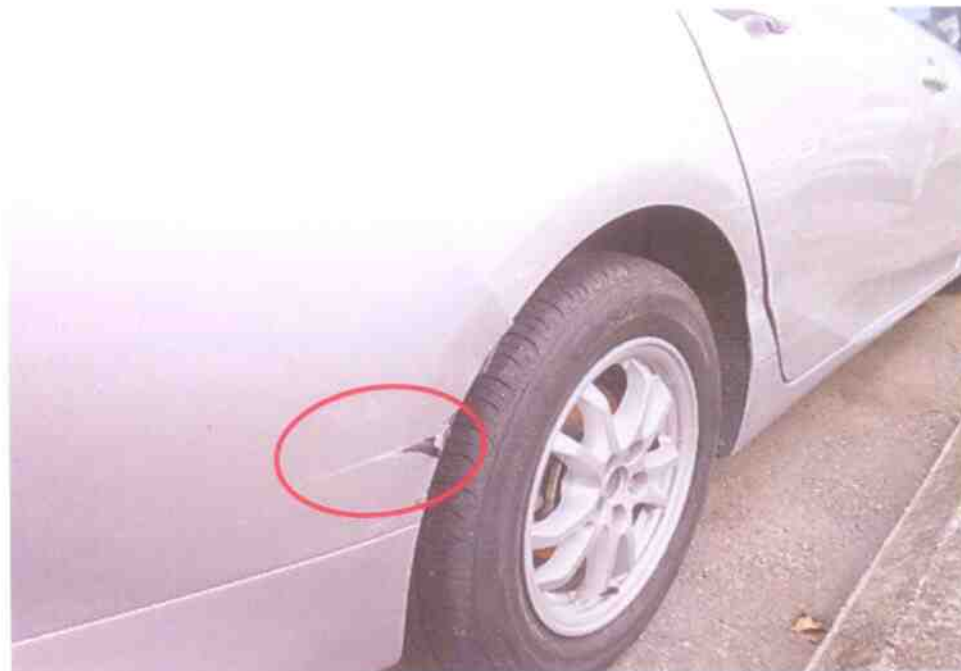
Photo 3 shows a close-up view of the front left body of the Motor Car at the time of our inspection. The impact force was relatively significant, causing the various parts and components at the front area of the engine compartment to be damaged.

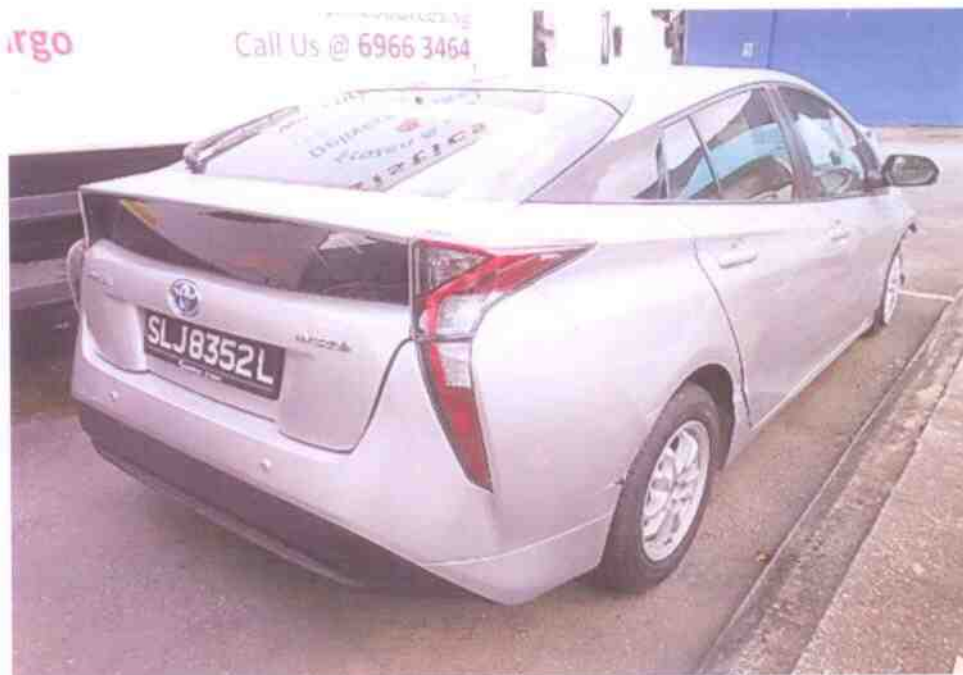
Photo 4 shows a general view of the Motor Car's rear right body at the time of our inspection. There was no damage found to the rear portion of the Motor Car.

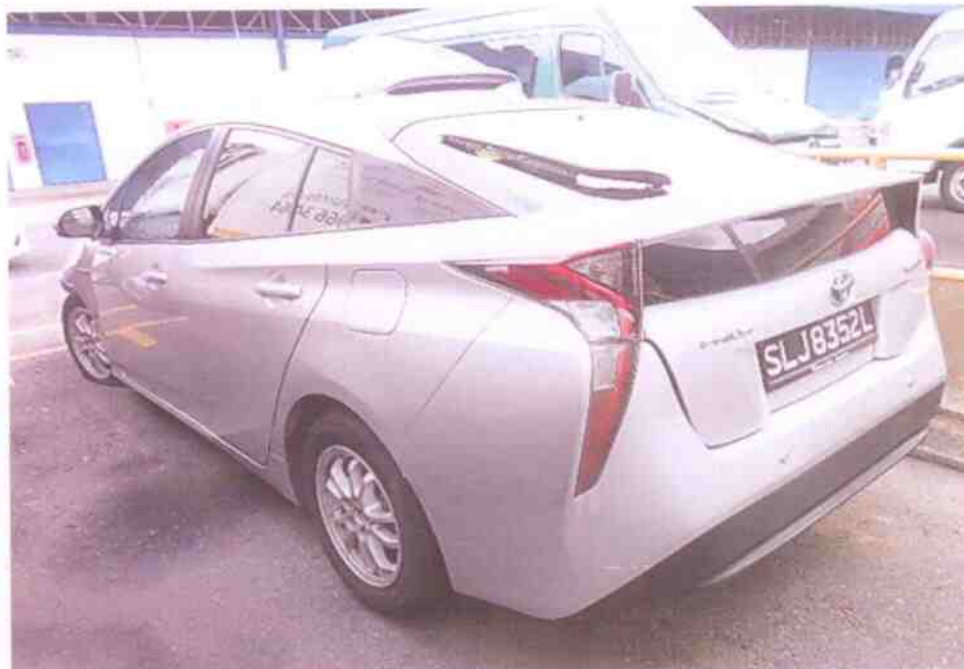
Photo 5 shows a general view of the Motor Car's rear left body at the time of our inspection. There was no damage found to the rear portion of the Motor Car.

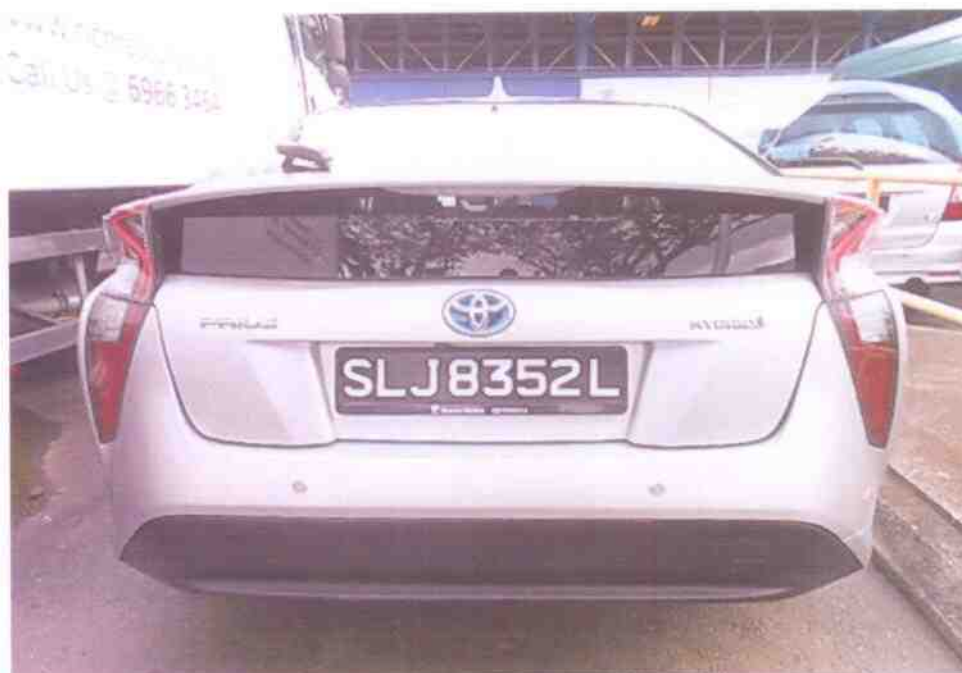
Photo 3 shows a general view of the rear body of the Motor Car. It was observed to be in good condition, no damage was sighted at the time of our inspection.

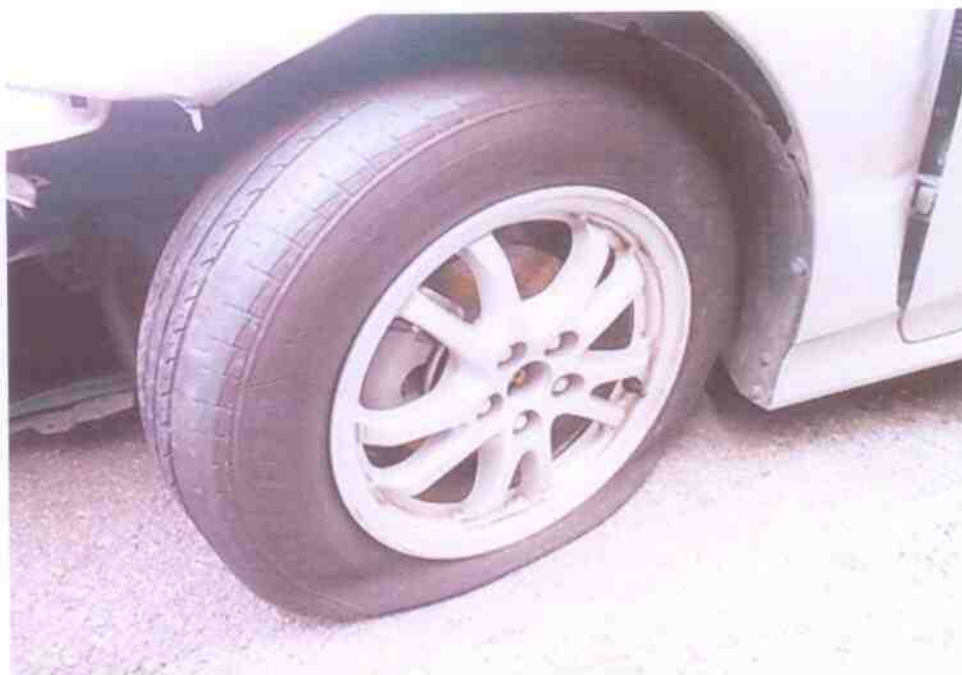
6. The front left & right tyres were observed to be deflated likely due to the accidents impact. The conditions of the Motor Car's 4 tyres were observed to be in serviceable condition despite the front left & right tyres were deflated. The remaining tread depth of the front left tyre was approximately 3mm & the front right tyre was approximately 5mm. We did not find any tear, cut or burst mark(s) on the outer and the inner sidewalls as well as across the tread of the 4 tyres. The 2 rear tyres were also observed to be sufficiently inflated for vehicular operation. The tyre brand, tyre size and remaining tread depth of the 4 tyres were recorded as follows:-

Photo 6 shows the condition of the front left tyre, it was observed to be deflated likely due to the accident's collision impact.

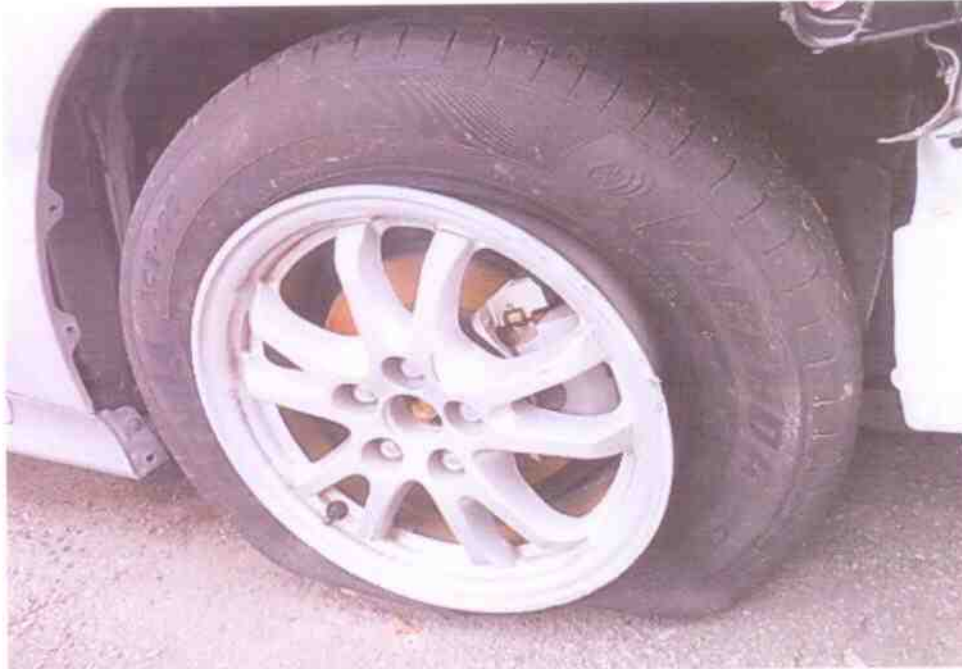
Photo 6 shows the condition of the front right tyre, it was observed to be deflated likely due to the accident's collision impact.

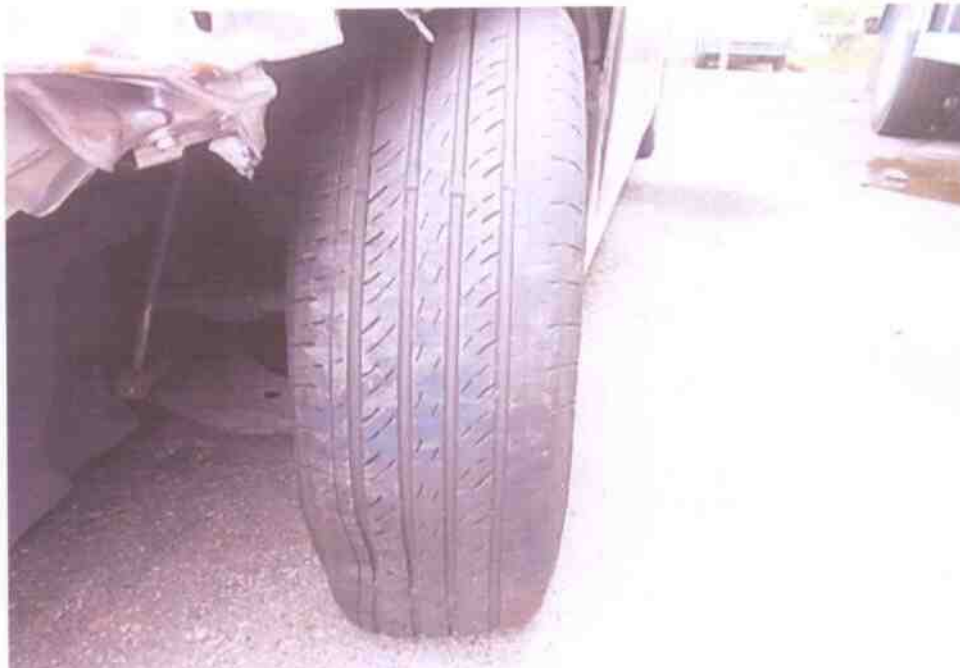
Photo 7 shows the condition of the front left tyre, it was observed to be deflated. The remaining tread depth of the front left tyre was approximately 3mm.

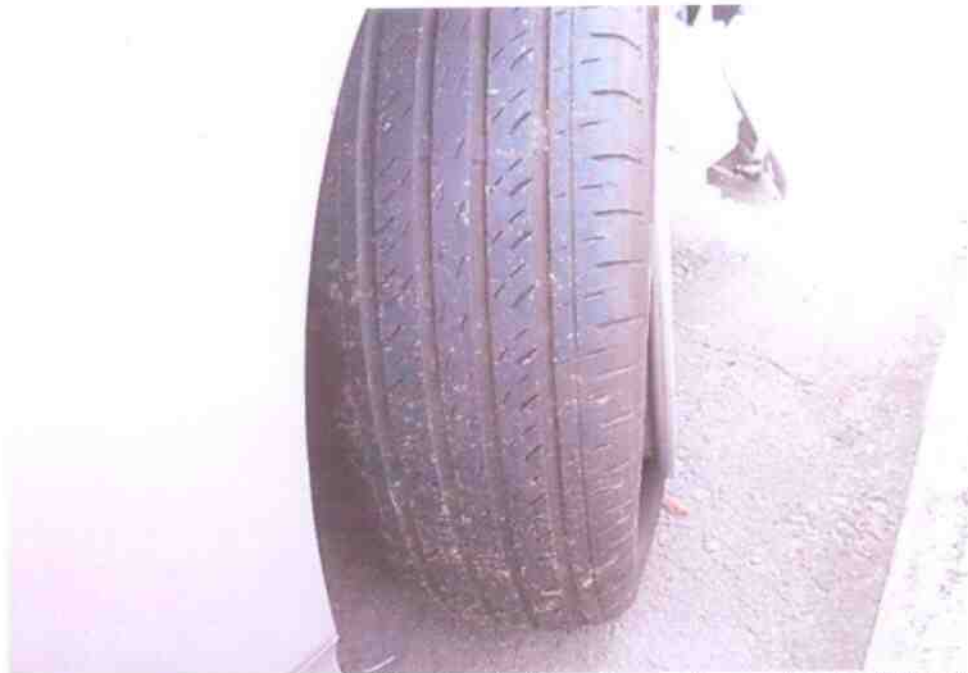
Photo 8 shows the condition of the front left tyre, it was observed to be deflated. The remaining tread depth of the front left tyre was approximately 5mm.

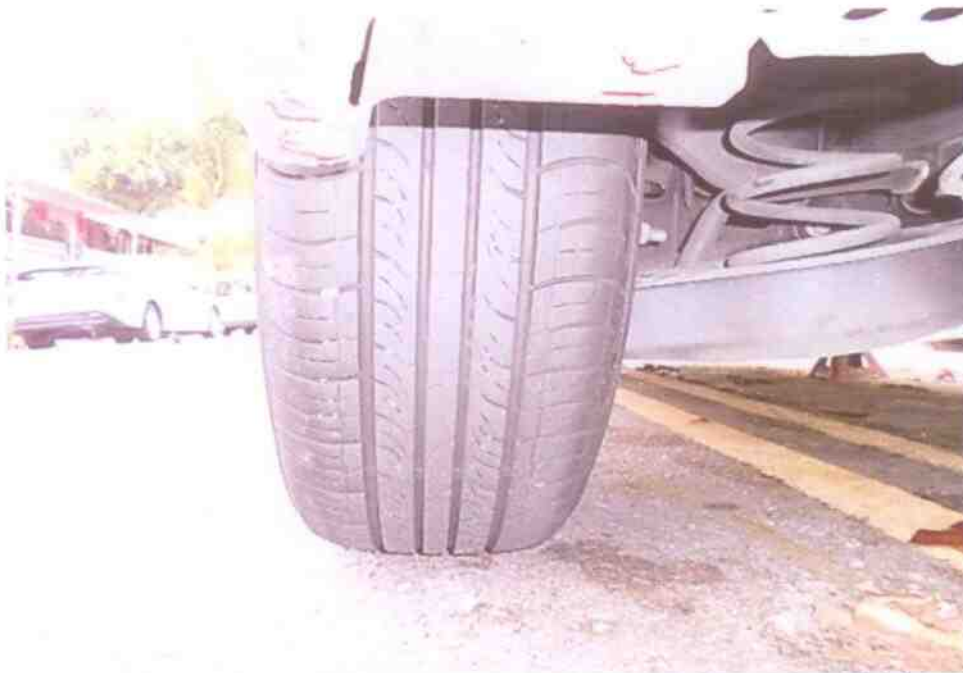
Photo 9 shows the condition of the rear left tyre of the Motor Car, which was observed to be in serviceable condition with remaining tread depth of approximately 5mm. The tyre, which was wrapped around alloy wheel rim, was also observed to be sufficiently inflated for vehicular operation.

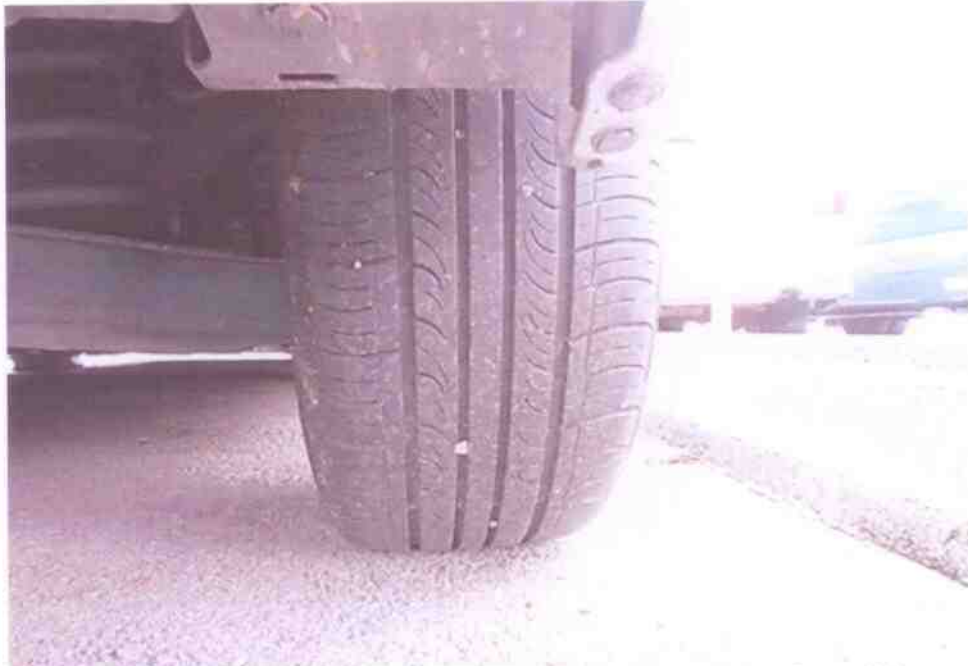
Photo 10 shows the condition of the rear right tyre of the Motor Car, which was observed to be in serviceable condition with remaining tread depth of approximately 6mm. There was also no tear, cut or burst mark(s) on the outer and the inner sidewalls as well as across the tread of the 4 tyres.

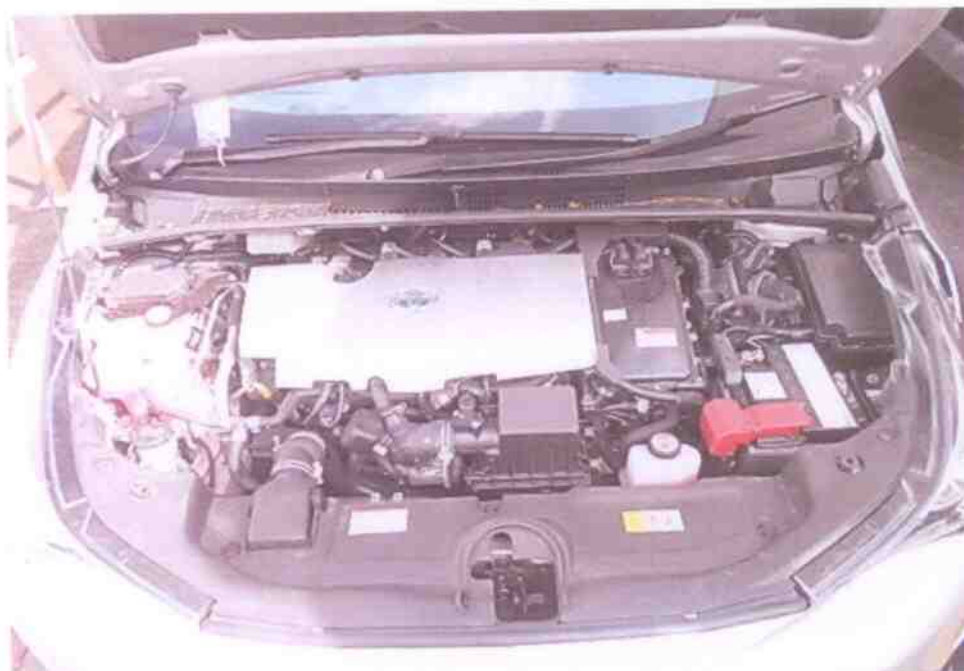
Photo 11 shows a general view of the Motor Car's engine compartment. The various parts and components inside the engine compartment were unaffected by the accident. There was also no sign(s) or indication(s) of fluid leakage and/or fluid stain within the engine compartment.

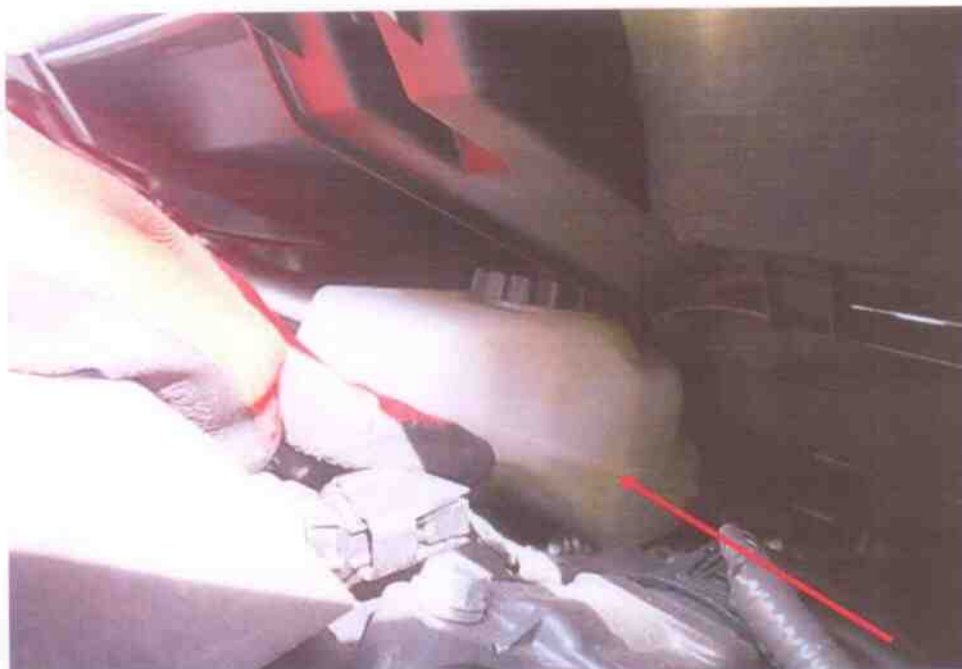
Photo 12 shows the brake fluid reservoir of the Motor Car at the time of our inspection. The brake fluid was observed to be of sufficient level and without any visible contamination (arrowed).

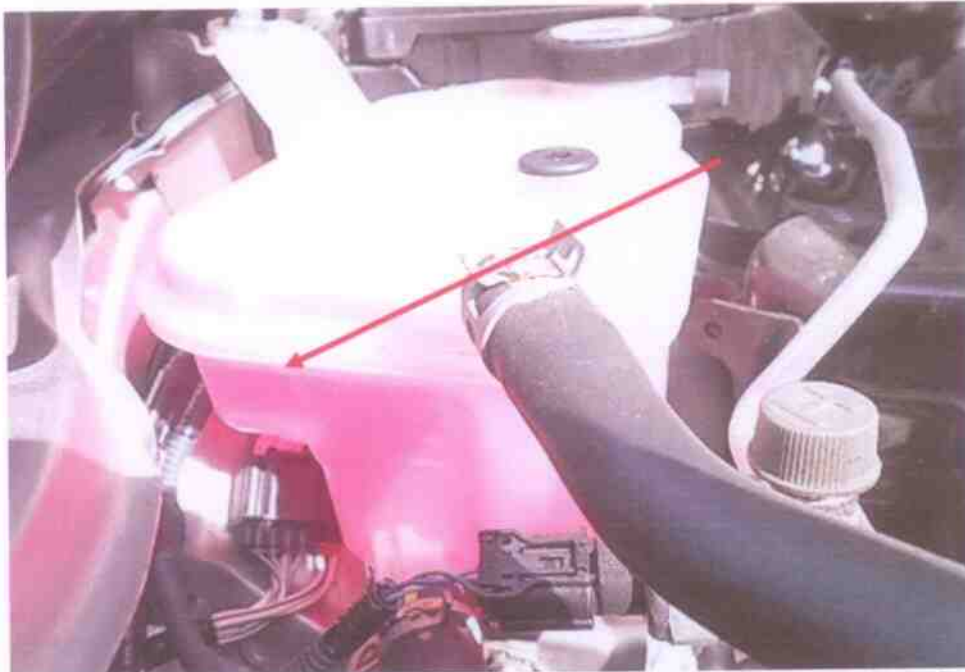
Photo 13 shows checks being carried out to the engine coolant of the Motor Car at the time of our inspection. The engine coolant was observed to be of sufficient level and without any visible contamination upon removal of the radiator cap (arrowed).

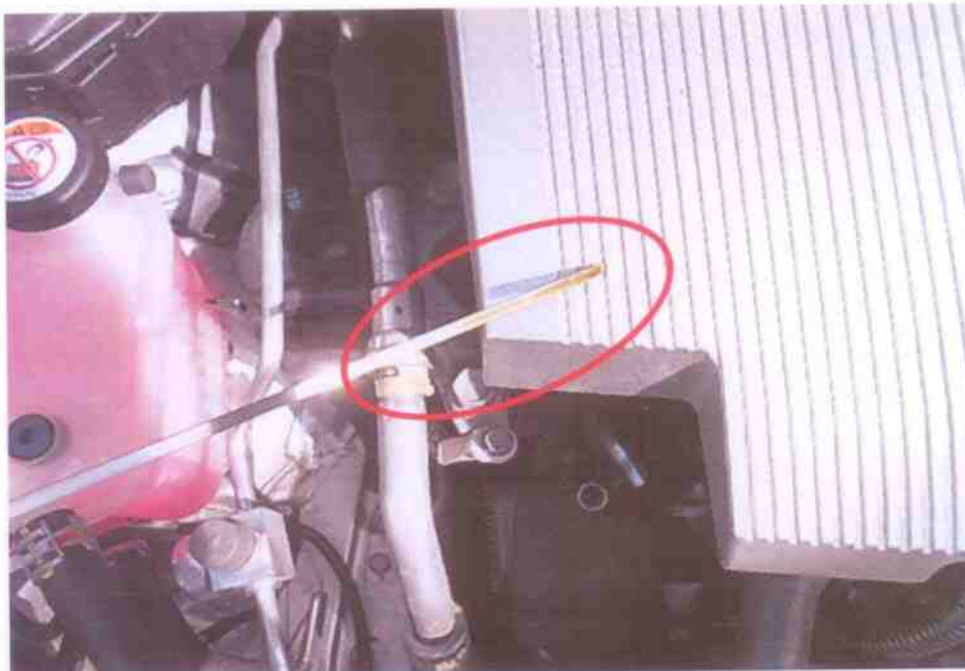
Photo 14 shows the engine oil dip stick of the Motor Car at the time of our inspection. The engine oil was observed to be of sufficient level and without any visible contamination.

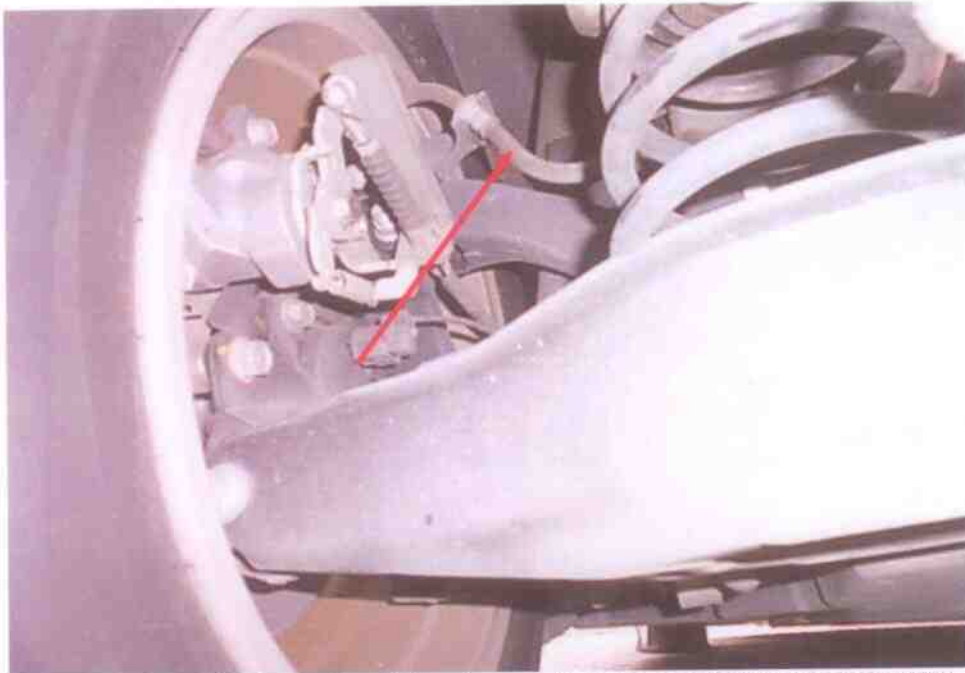
Photo 15 shows the brake hose/pipe (arrowed) at the rear left wheel of the Motor Car. We did not observe any leakage of brake fluid at the time of our inspection of the Motor Car.

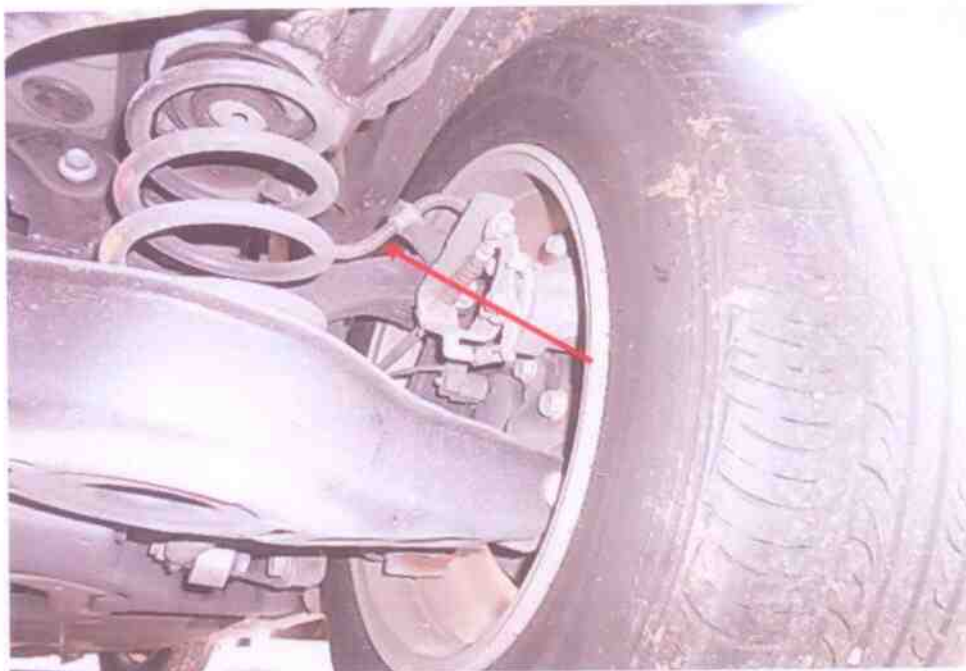
Photo 16 shows the brake hose/pipe (arrowed) at the rear right wheel of the Motor Car. We did not observe any leakage of brake fluid at the time of our inspection of the Motor Car.

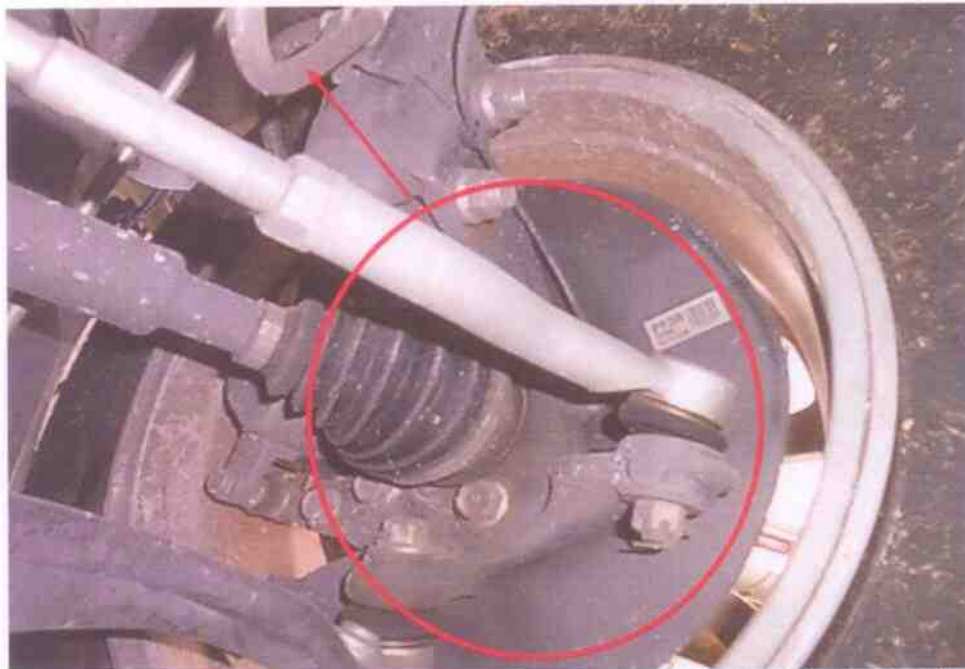
Photo 17 shows the brake hose/pipe (arrowed) at the front right wheel of the Motor Car. We did not observe any leakage of brake fluid at the time of our inspection of the Motor Car. Visual examination of the various components of the braking system like the brake calliper (circled), brake booster, brake pedal etc had revealed all to be intact and without visible damage.

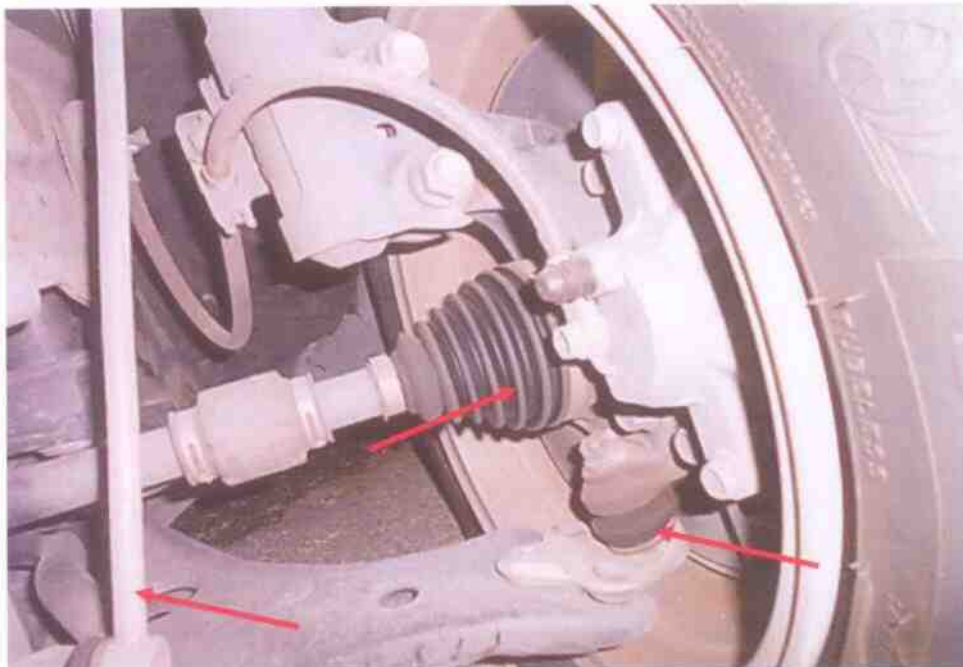
Photo 18 shows the various undercarriage components at the front left wheel of the Motor Car, in particular the steering tie rod & drive shaft (arrowed). The various steering components were all found to be intact, suggesting that the steering system of the Motor Car was likely to be in serviceable condition.

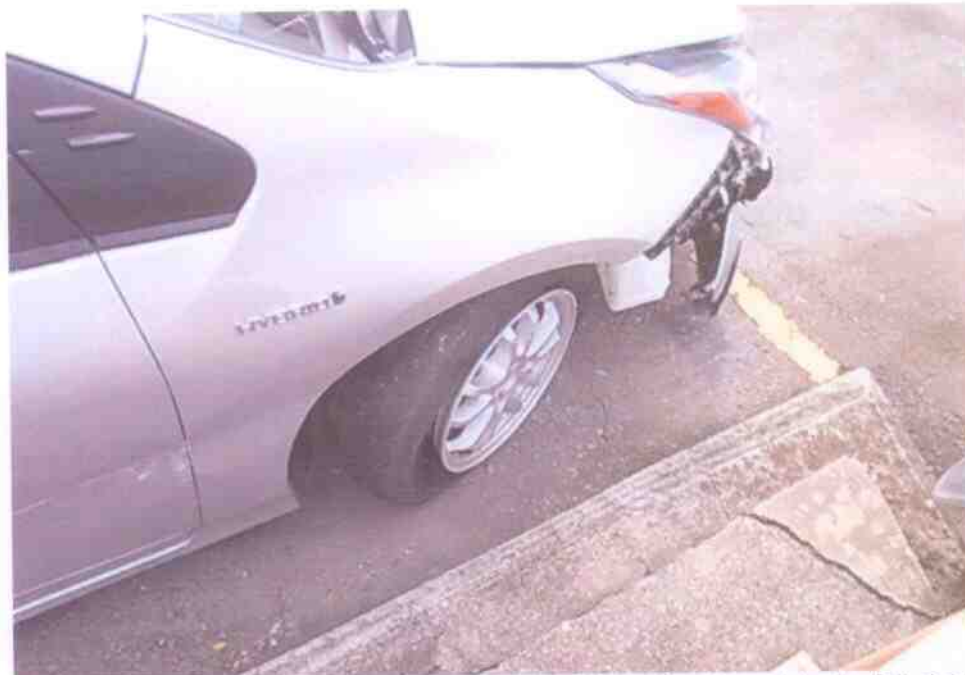
Photo 19 shows the front right wheel of the Motor Car turned to its full right. During our steering system test, we did not experience any abnormal free play and/or resistance when we turned the steering wheel towards the left and right. This would suggest that the steering system of the Motor Car was likely to be in serviceable condition at the material time of accident.

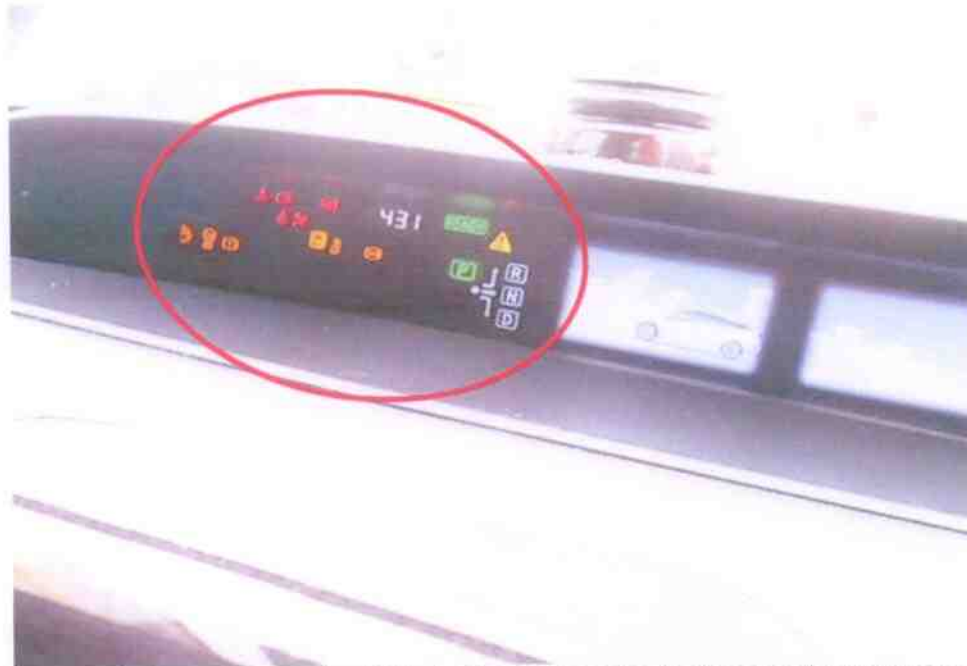
Photo 20 shows the warning lights for the various electronic operating systems of the Motor Car appearing on its instrument panel during the self-test when the engine is cranked, in particular the ABS light and SRS light.

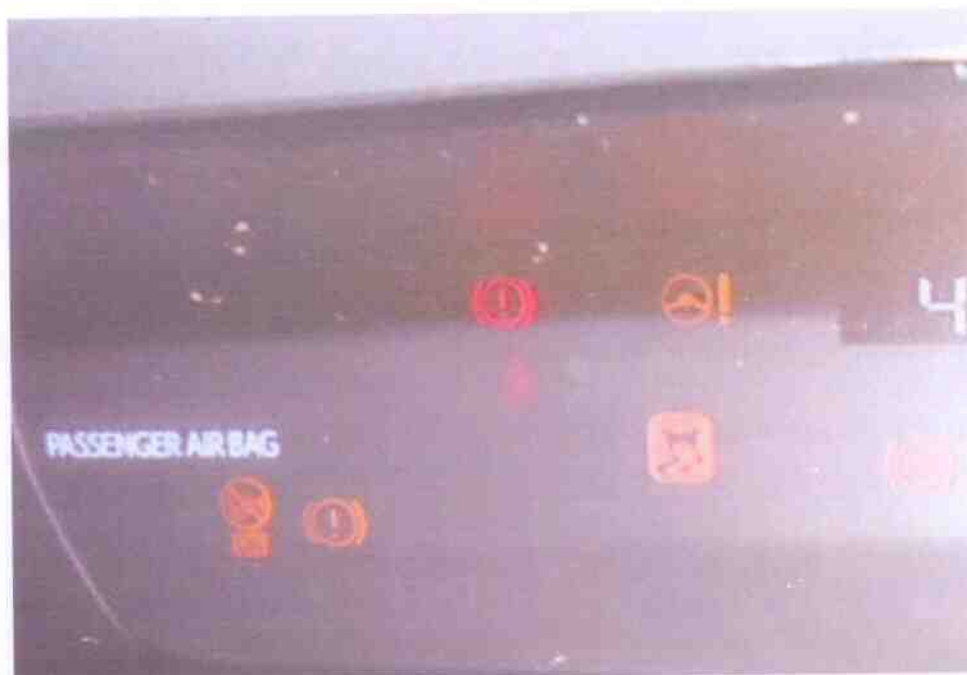
16. Having said that, for this particular case some of the warning lights did not go off after the Motor Car's automatic self-test process. This indicates that some of the sensors failed to initialise during start-up of the engine likely due to accident's impact. However, operational test conducted on the Motor Car reveals that this does not contribute to the accident. (Refer to clause 18 for operational test details) See photo 20 & 21 below.

Photo 21 shows some warning lights illuminated on the instrument panel of the Motor Car after the engine was cranked. This indicates that some of the sensors failed to initialise during start-up of the engine likely due to accidents impact. However, operational test conducted on the Motor Car reveals that this does not contribute to the accident.

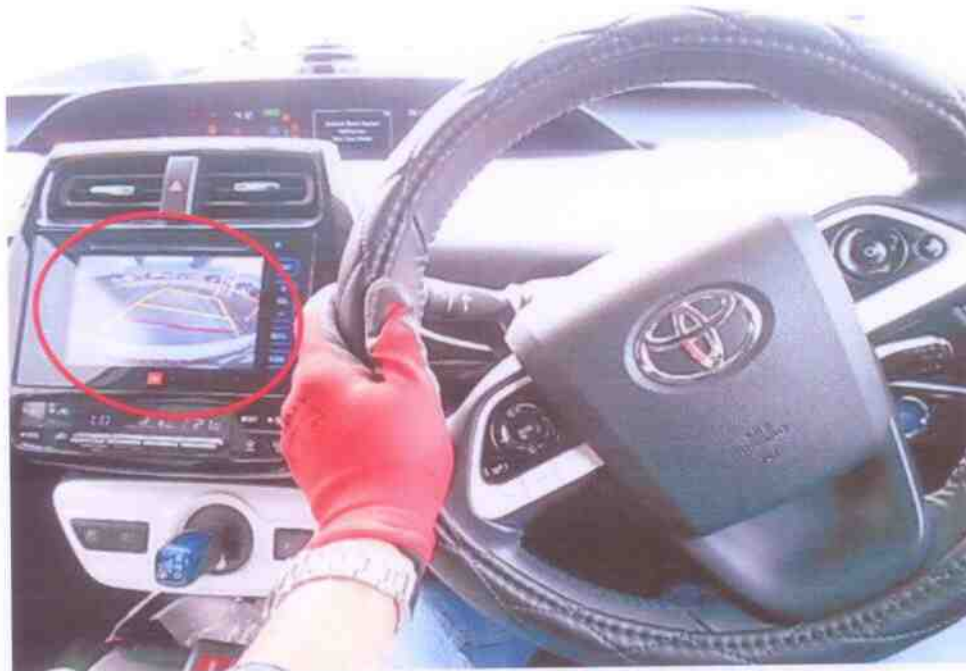
Photo 22 shows during the operational test, the transmission system of the Motor Car was able to be shifted to drive mode and reverse mode without any difficulty.
