Your Ref: 1801164929SG
Our Ref : CI/AIG18001638/N

TECHNICAL INVESTIGATION REPORT OF ENGINE DAMAGE TO THE INSURED VEHICLE SLB 9121Y

Registration Number.	: SLB 9121Y
Make & Model	: MERCEDES BENZ A200 FL STYLE (R17 HLG)
Year of Registration	: April 2016
Chassis Number	: WDD1760432J450276
Speedo Reading	: 40,259km

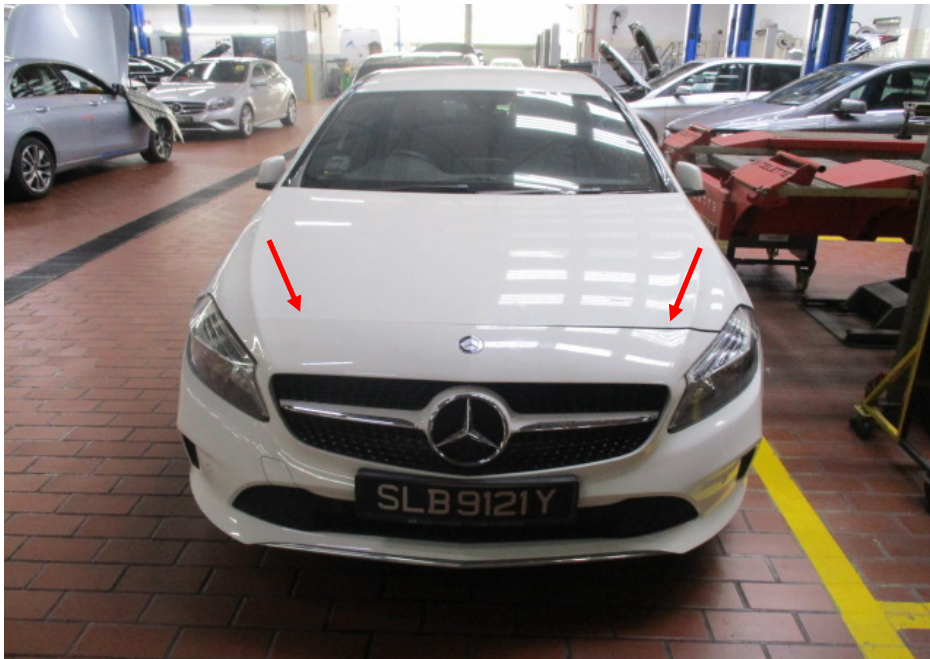
8. The Insured Vehicle was observed to be in good general condition with no visible damage to the exterior body. We did however observe that the fitment of the front bumper and front bonnet was slightly misaligned.
9. Upon examination of the front underside of the Insured Vehicle, we had found graze marks starting from the underside of the front bumper onto the underside of the engine cover, stretching towards the rear of the Insured Vehicle.
10. Upon further examination, we had found a crack and a significantly sized puncture/hole on the underside of the engine oil sump. Engine oil was observed to have leaked from this damaged area. The undercarriage parts and components that were immediately after the punctured engine oil sump were further observed to be covered with engine oil stains.

Photo 1 shows the general view of the Insured Vehicle at the time of our inspection. The Insured Vehicle was observed to be in good general condition with no visible damage to the exterior body. We did however observe that the fitment of the front bumper and front bonnet was slightly misaligned (red arrows).

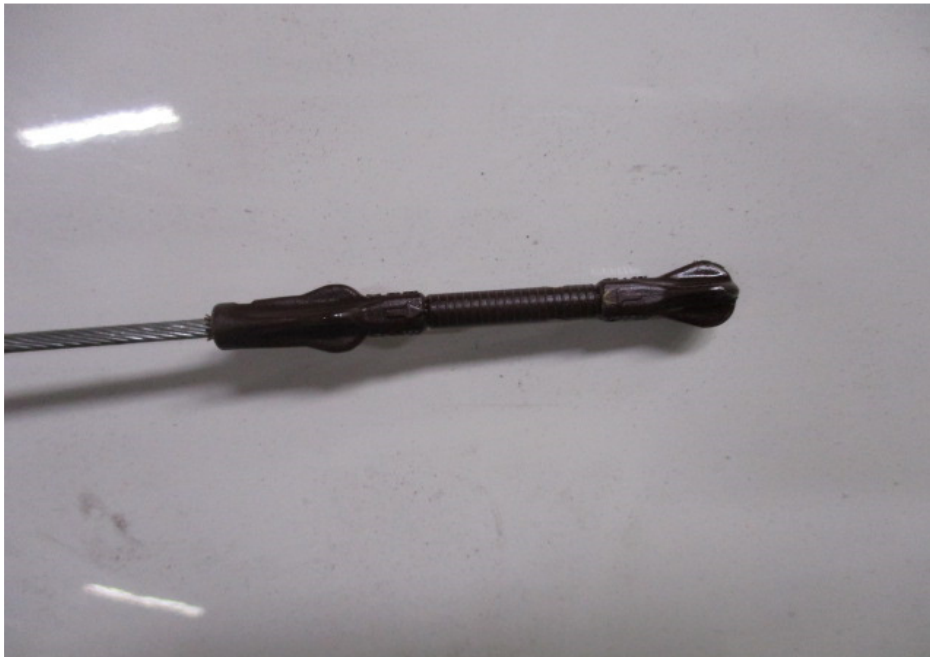
11. There was also insufficient engine oil when we had checked the engine oil dipstick of the Insured Vehicle. When compared with an engine oil dipstick from a similar make and model, we observed that the engine oil dipstick of the Insured Vehicle was slightly discoloured. As a result of insufficient engine oil, the engine of the Insured Vehicle could not be started. See photos 1 – 9 below.

Photo 2 shows the engine oil dipstick of the Insured Vehicle, which had indicated insufficient engine oil. This was due to leakage of engine oil from a puncture/hole that was on the underside of the engine oil sump.

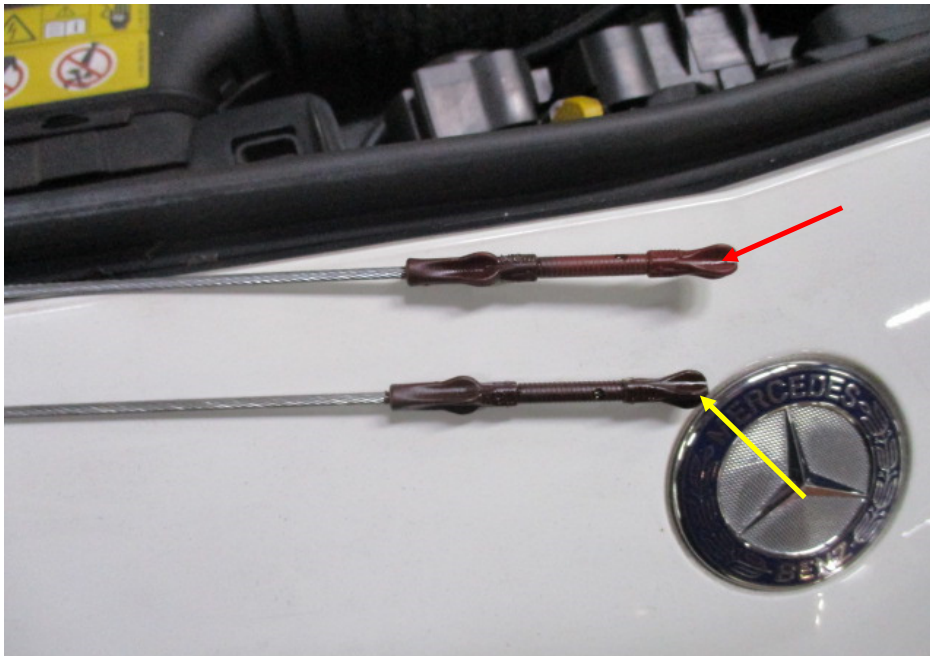
Photo 3 shows when compared with an engine oil dipstick from a similar make and model (red arrow), we observed that the engine oil dipstick of the Insured Vehicle was slightly discoloured (yellow arrow).

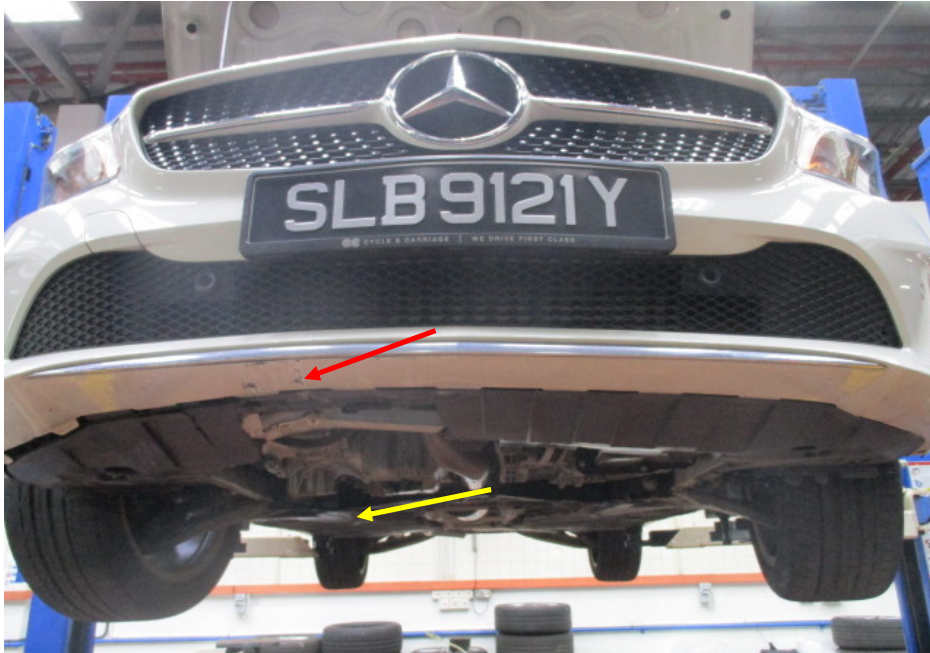
Photo 4 shows the graze marks (red arrow) that were found originating from the underside of the front bumper, onto the underside of the engine cover, stretching towards the rear (yellow arrow) of the Insured Vehicle.

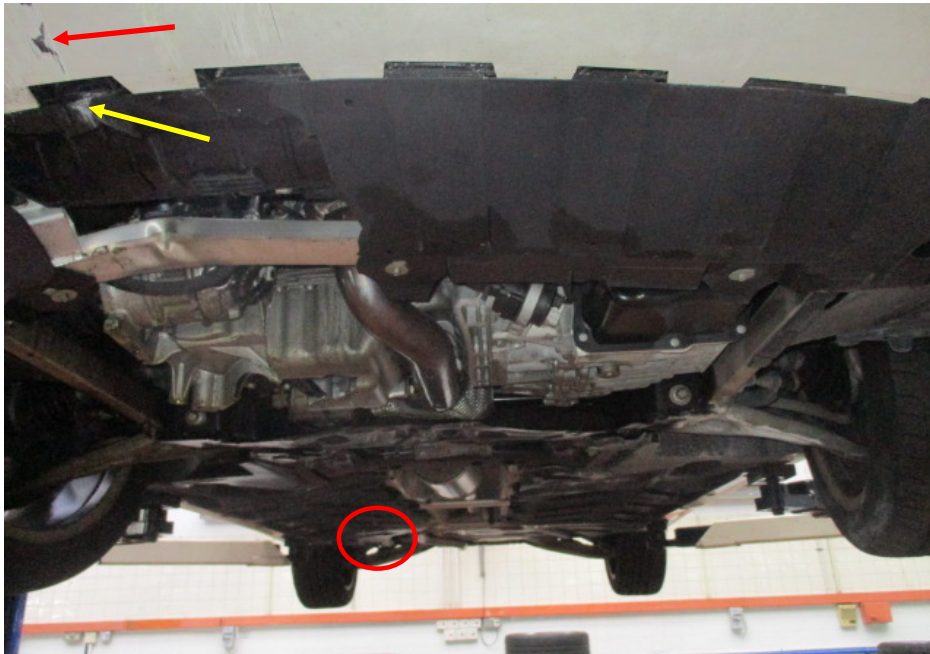
Photo 5 shows a closer view of the graze marks that were found originating from the underside of the front bumper (red arrow), onto the underside of the engine cover (yellow arrow), stretching towards the rear (circled) of the Insured Vehicle.

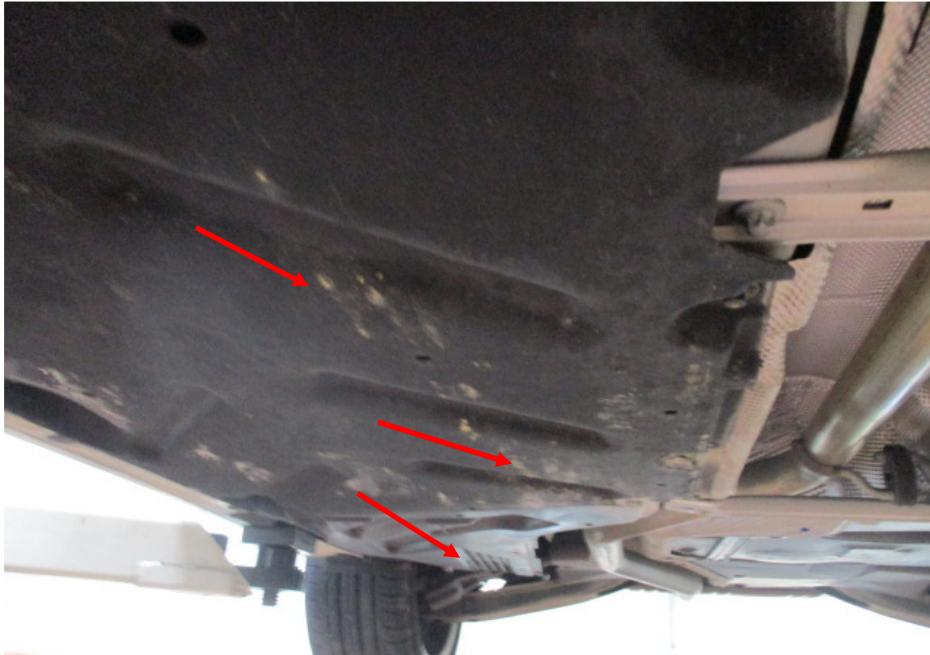
Photo 6 shows a closer view of the graze marks that had stretched towards the rear (red arrows) of the Insured Vehicle.

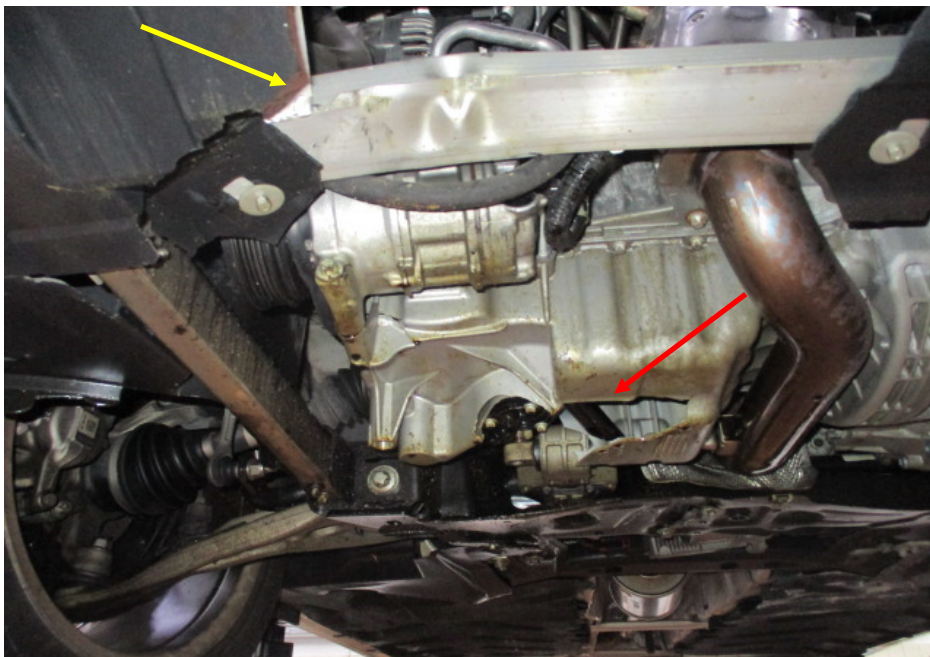
Photo 7 shows the torn front engine undercover (yellow arrow) and broken engine oil sump (red arrow) of the Insured Vehicle.

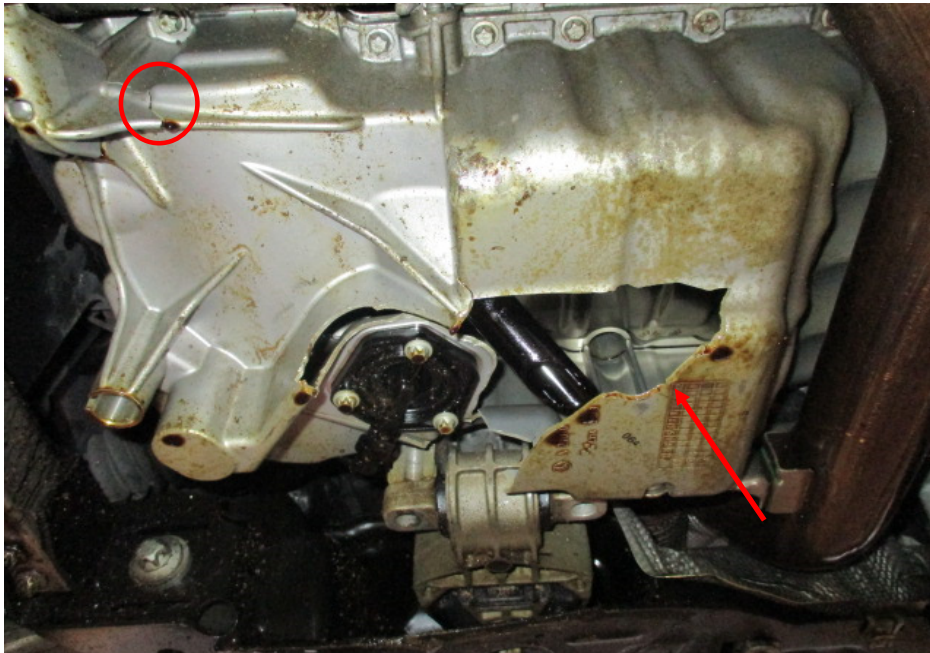
Photo 8 shows a closer view of the crack (circled) and the puncture/hole (red arrow) on the underside of the engine oil sump of the Insured Vehicle. The damage profile of the engine oil sump corresponds to the Insured Vehicle going over an object.

12. For this case, the damage profile of the Insured Vehicle's underside corresponds to the Insured Vehicle going over an object(s), leading to the engine oil sump puncturing. However in such going over object(s) type of incidents, the engine of the vehicle will not be affected by the vehicle going over the object(s), provided that there was no further operation of the engine and/or continued driving after it had gone over the object(s), and also provided that there was no engine oil leakage.

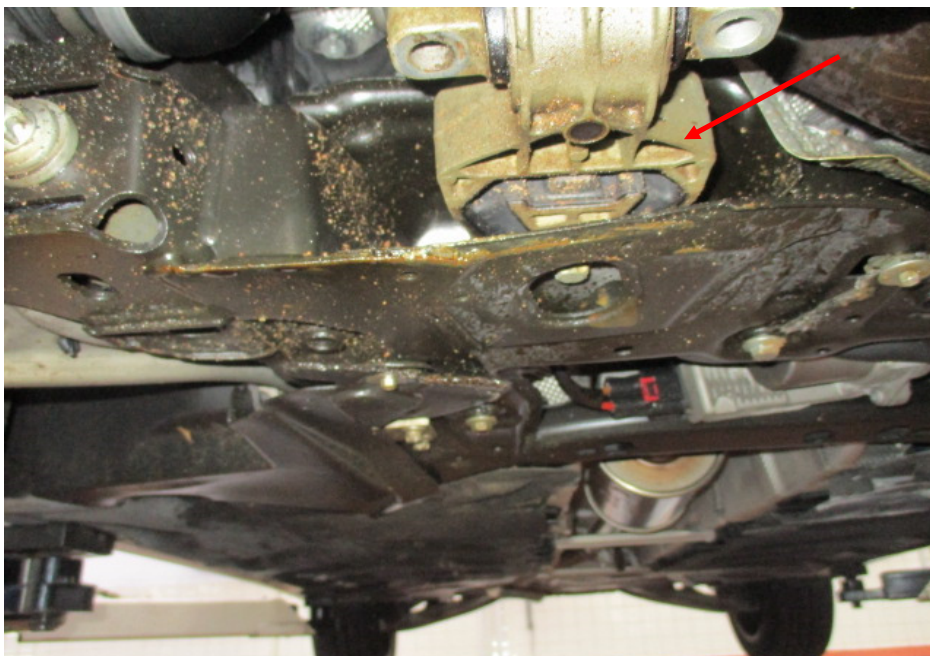
Photo 9 shows the undercarriage parts and components (arrowed) that were immediately after the punctured engine oil sump, covered with engine oil stains.

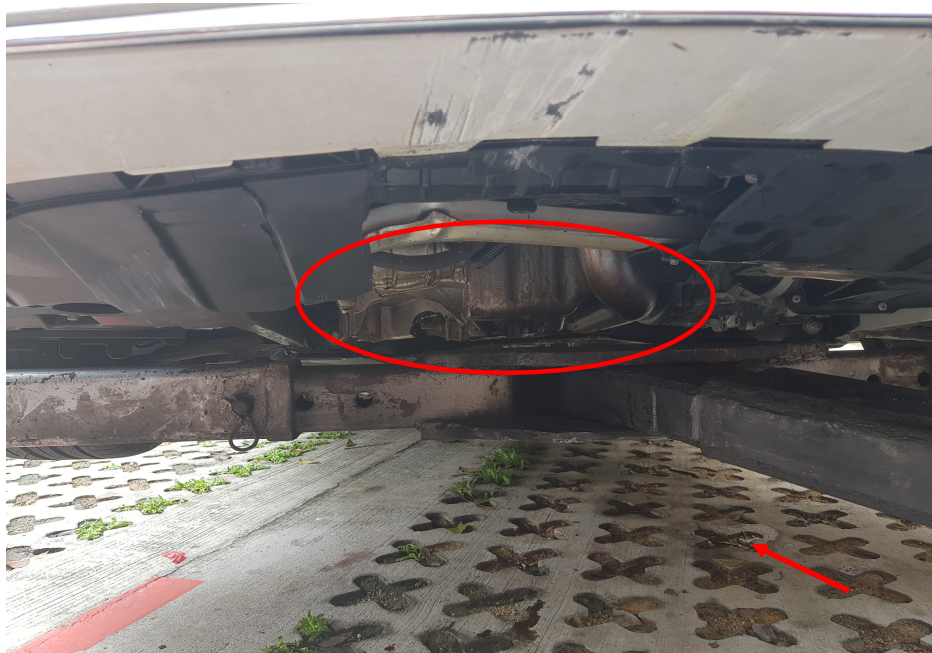
13. For this case, the Insured Vehicle was continued to be driven to a carpark at Tampines Street 91, where it was only towed to C & C the following day after the loud rumbling noise was heard from the engine after the Insured Vehicle was started up. The excessive engine oil leakage was only discovered on the underside of the engine oil sump as well as on the ground only after the front portion of the Insured Vehicle was jacked up by the towing personnel. See photo 10 below.

Photo 10 shows the excessive engine oil leakage was only discovered on the underside of the engine oil sump (circled) as well as on the ground (arrowed) only after the front portion of the Insured Vehicle was jacked up by the towing personnel.

15. Given that there was engine oil leakage from the puncture/hole at the underside of the engine oil sump of the Insured Vehicle as a result of the Insured Vehicle going over an object, the amount of engine oil in the engine would have thus decreased when the Insured Vehicle was being driven to the carpark of Block 930 Tampines Street 91. This would have then led to insufficient engine oil for lubrication and heat removal purposes, ultimately affecting the mechanical parts inside the engine. Hence, resulting in the loud rumbling noise emitting from its engine after the Insured Vehicle was started up the following day.
