Your Ref: 1801164929SG
Our Ref : CI/AIG18001638/N

18 January 2018

**TECHNICAL INVESTIGATION REPORT OF ENGINE DAMAGE TO THE
INSURED VEHICLE SLB 9121Y**

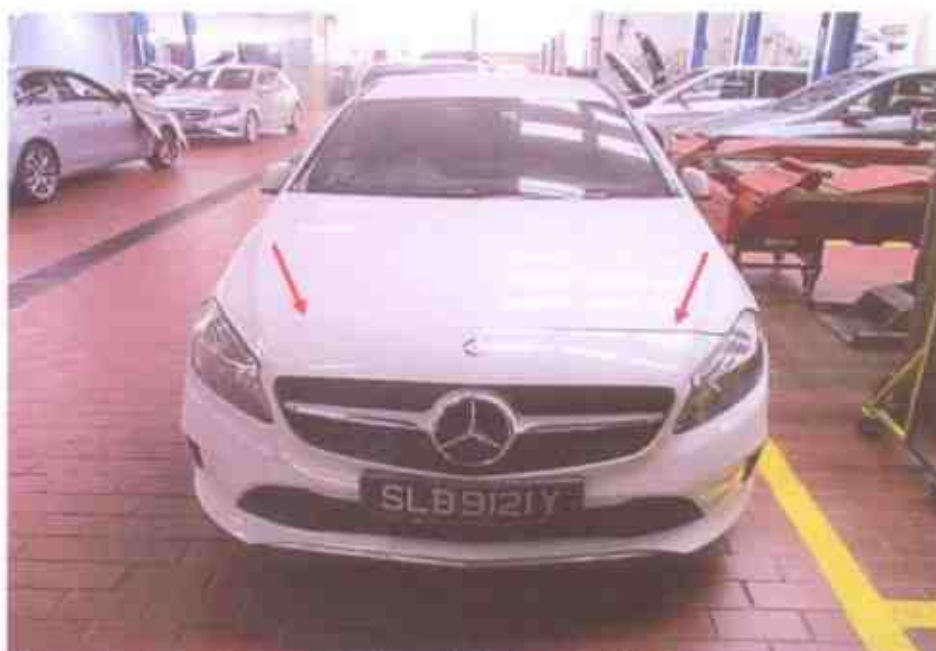
Photo 1 shows the general view of the Insured Vehicle at the time of our inspection. The Insured Vehicle was observed to be in good general condition with no visible damage to the exterior body. We did however observe that the fitment of the front bumper and front bonnet was slightly misaligned (red arrows).

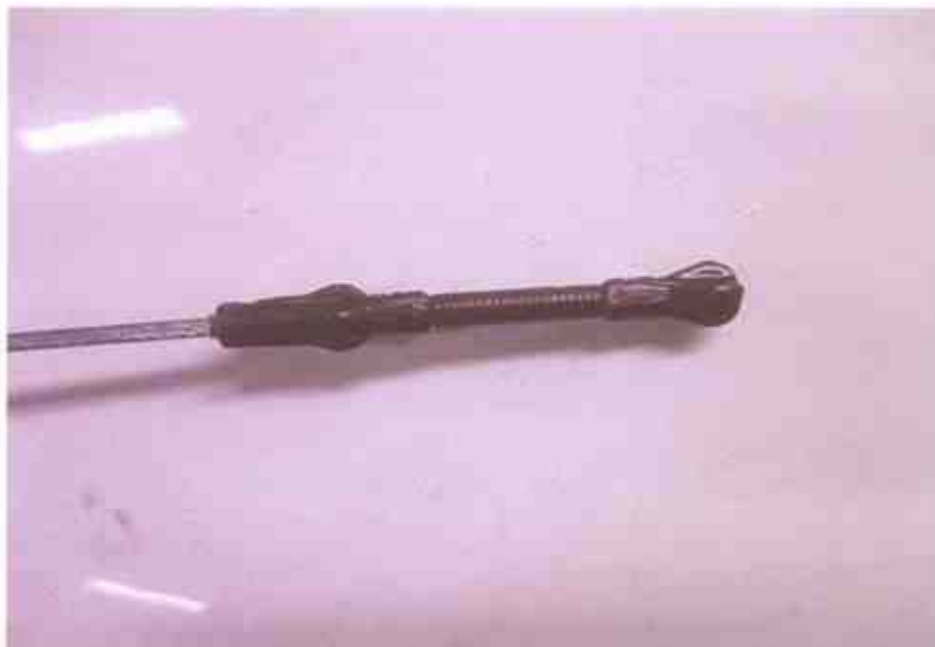
Photo 2 shows the engine oil dipstick of the Insured Vehicle, which had indicated insufficient engine oil. This was due to leakage of engine oil from a puncture/hole that was on the underside of the engine oil sump.

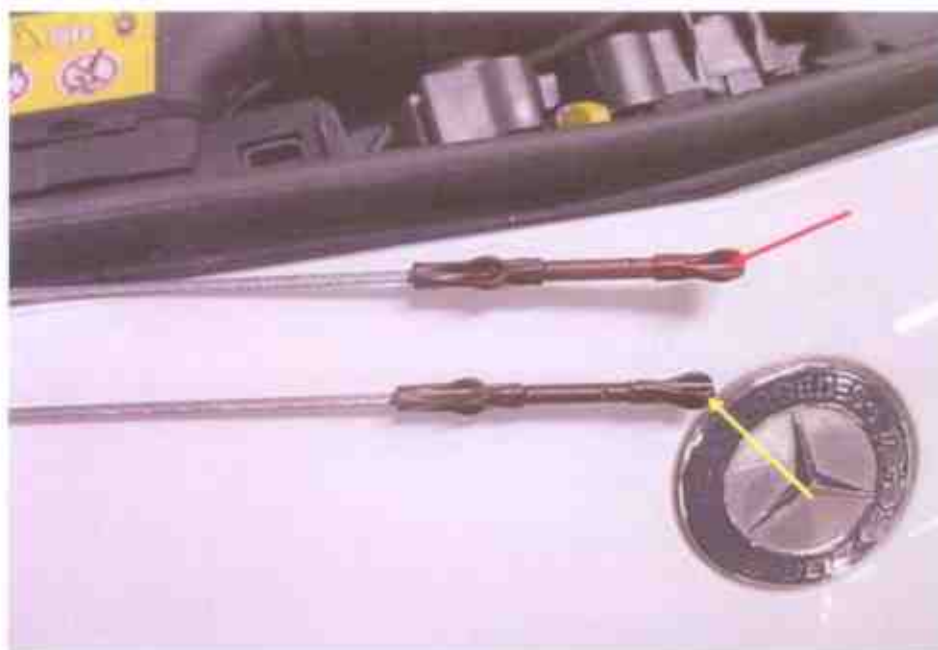
Photo 3 shows when compared with an engine oil dipstick from a similar make and model (red arrow), we observed that the engine oil dipstick of the Insured Vehicle was slightly discoloured (yellow arrow).

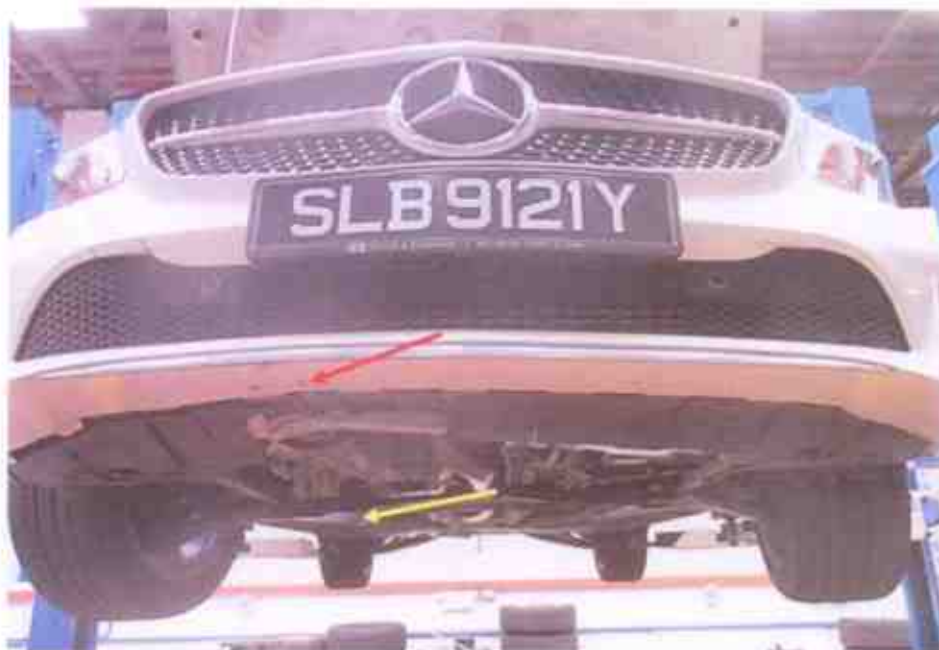
Photo 4 shows the graze marks (red arrow) that were found originating from the underside of the front bumper, onto the underside of the engine cover, stretching towards the rear (yellow arrow) of the Insured Vehicle.

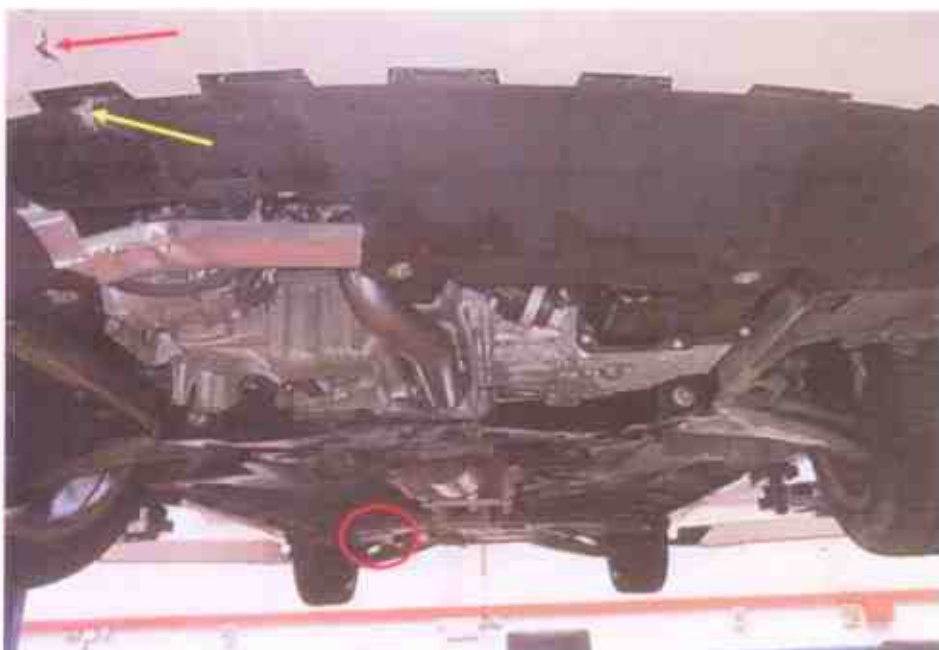
Photo 5 shows a closer view of the graze marks that were found originating from the underside of the front bumper (red arrow), onto the underside of the engine cover (yellow arrow), stretching towards the rear (circled) of the Insured Vehicle.

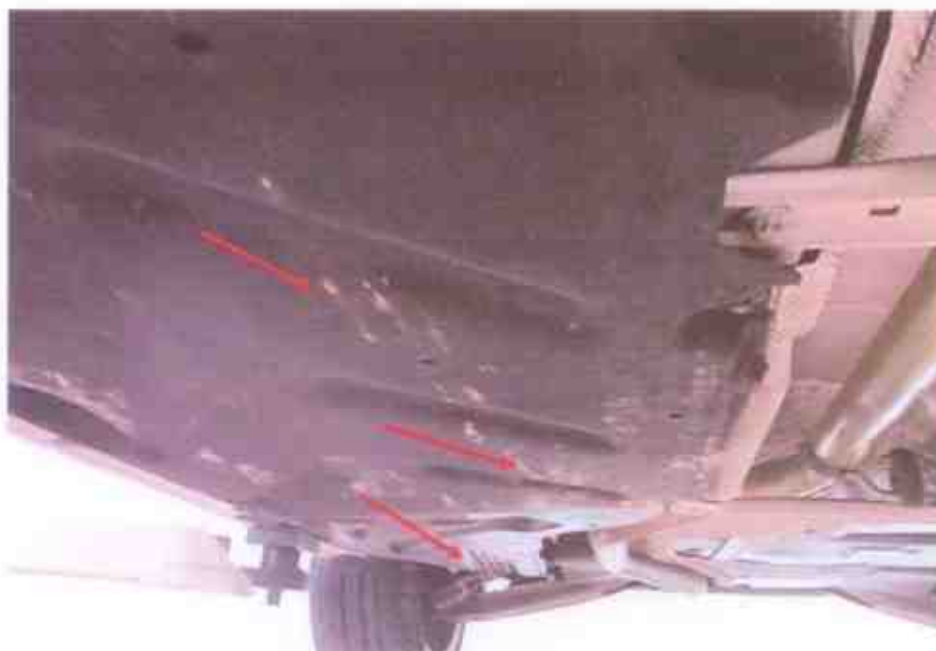
Photo 6 shows a closer view of the graze marks that had stretched towards the rear (red arrows) of the Insured Vehicle.

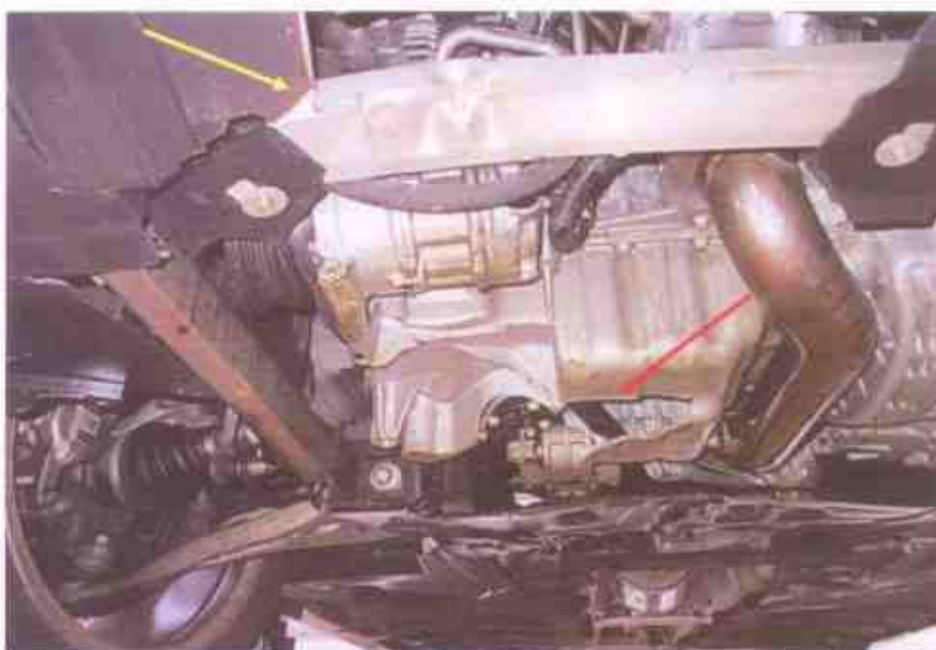
Photo 7 shows the torn front engine undercover (yellow arrow) and broken engine oil sump (red arrow) of the Insured Vehicle.

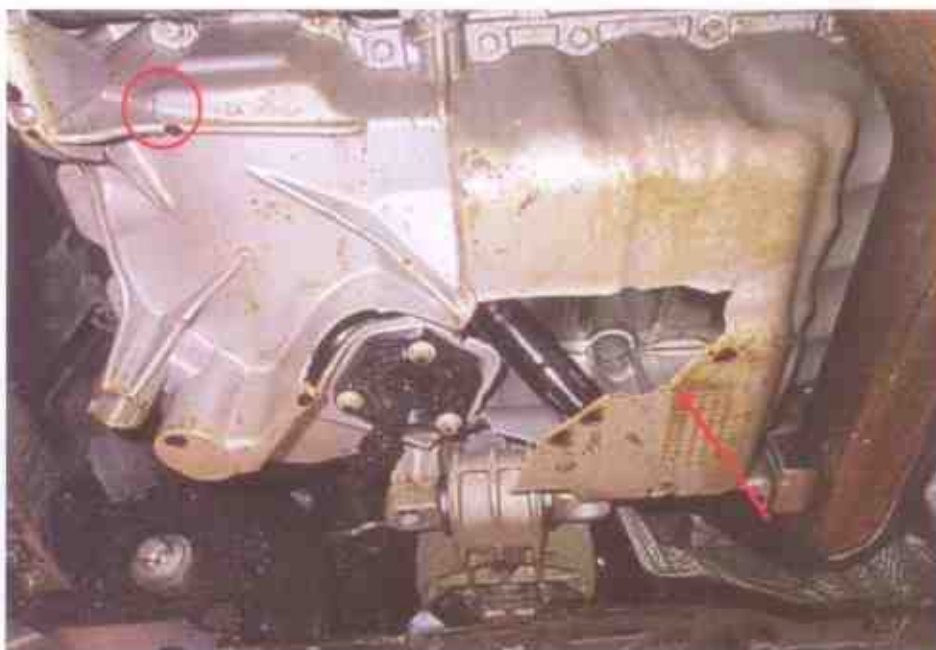
Photo 8 shows a closer view of the crack (circled) and the puncture/hole (red arrow) on the underside of the engine oil sump of the Insured Vehicle. The damage profile of the engine oil sump corresponds to the Insured Vehicle going over an object.

12. For this case, the damage profile of the Insured Vehicle's underside corresponds to the Insured Vehicle going over an object(s), leading to the engine oil sump puncturing. However in such going over object(s) type of incidents, the engine of the vehicle will not be affected by the vehicle going over the object(s), provided that there was no further operation of the engine and/or continued driving after it had gone over the object(s), and also provided that there was no engine oil leakage.

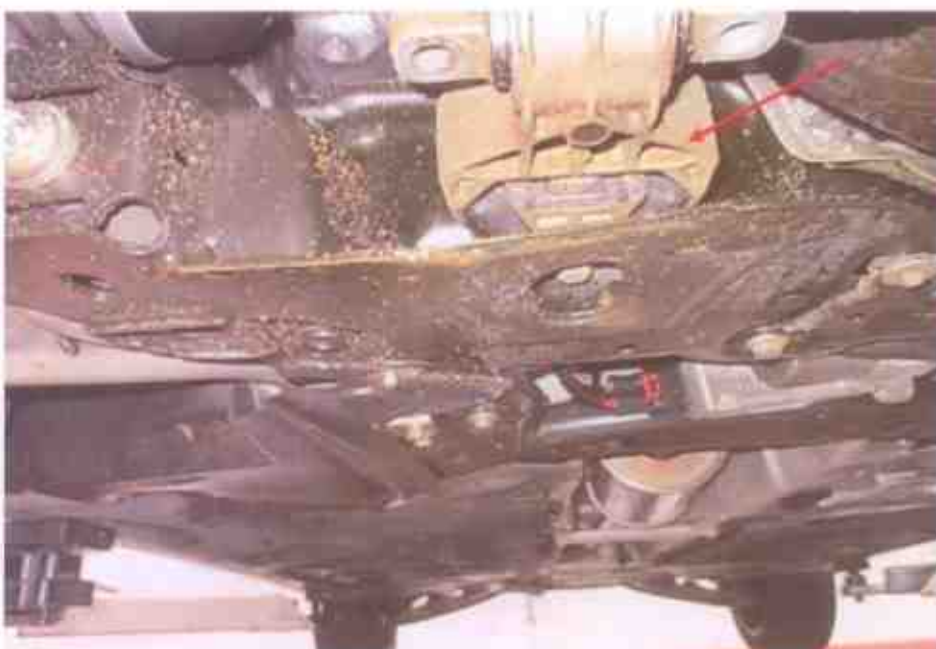
Photo 9 shows the undercarriage parts and components (arrowed) that were immediately after the punctured engine oil sump, covered with engine oil stains.

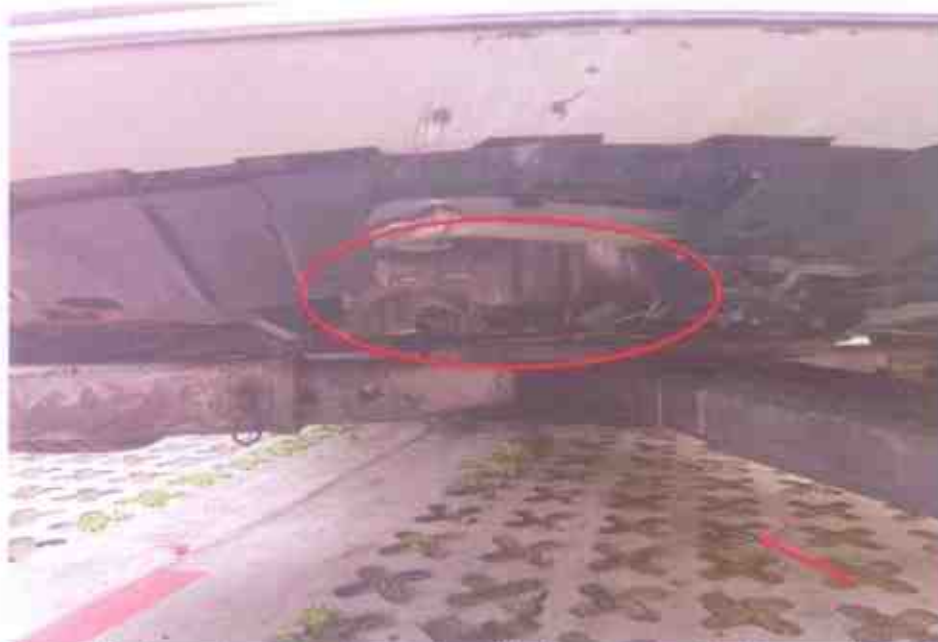
13. For this case, the Insured Vehicle was continued to be driven to a carpark at Tampines Street 91, where it was only towed to C & C the following day after the loud rumbling noise was heard from the engine after the Insured Vehicle was started up. The excessive engine oil leakage was only discovered on the underside of the engine oil sump as well as on the ground only after the front portion of the Insured Vehicle was jacked up by the towing personnel. See photo 10 below.

Photo 10 shows the excessive engine oil leakage was only discovered on the underside of the engine oil sump (circled) as well as on the ground (arrowed) only after the front portion of the Insured Vehicle was jacked up by the towing personnel.
