Your Ref : 542842
Our Ref : CS/MSG18000094/N-1

**AUTOMOBILE TECHNICAL INVESTIGATION REPORT OF ACCIDENT
INVOLVING SHB 7549H AND SKN 6672S ON 27 DECEMBER 2017**

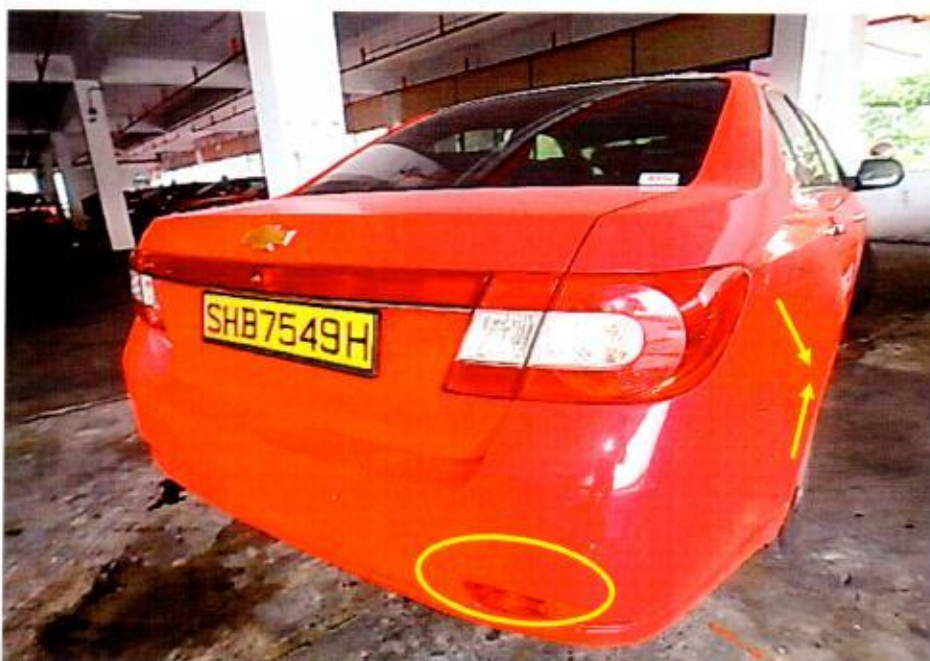
Photo 1 shows a rear view of the Taxi at the time of the Pre- Repair Survey conducted by LKK Auto Consultants Pte. Ltd. which was taken about 7 days after the accident. We observed paint graze marks above and around the rear right bumper reflector of the Taxi (circled). However we also noted that the rear bumper was not misaligned at its right corner edge (yellow arrows).

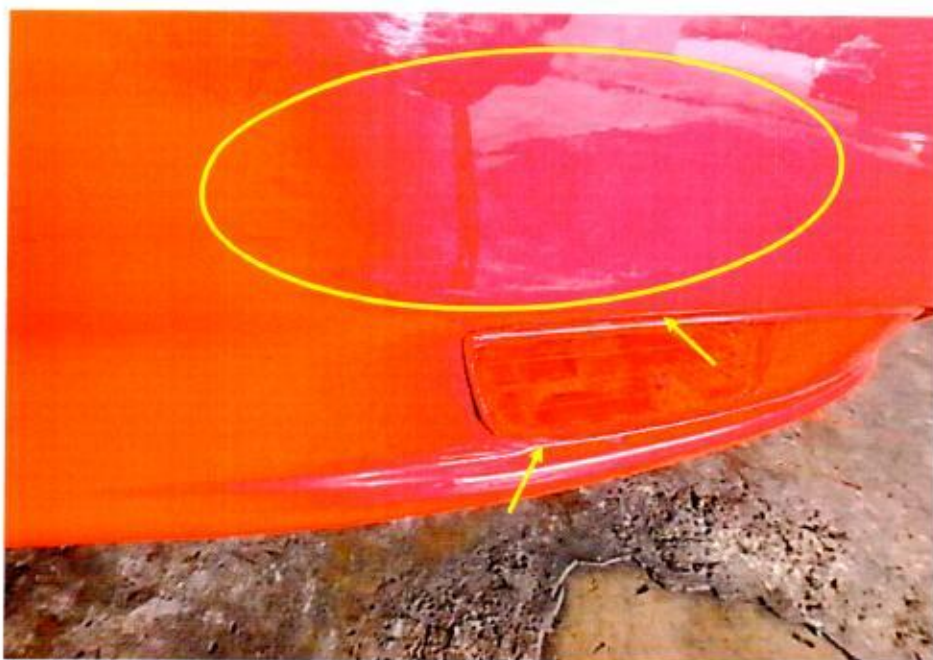
Photo 2 shows a closer view of the lower right portion of the rear bumper of the Taxi. We observed paint graze marks above (circled) and around (yellow arrows) the rear right bumper reflector of the Taxi.

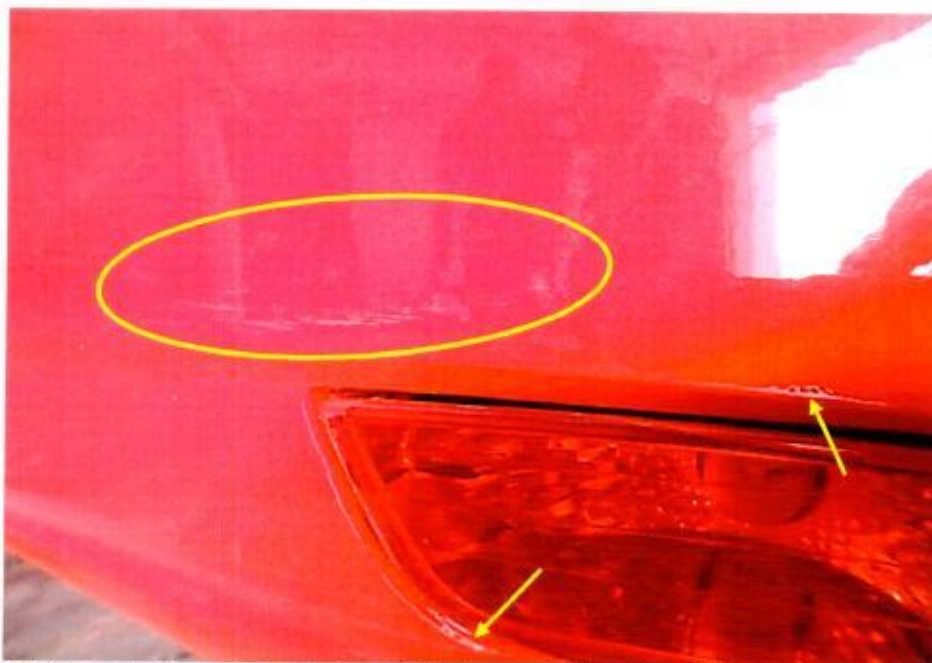
Photo 3 shows a close up view of the lower right portion of the rear bumper of the Taxi. We observed paint graze marks above (circled) and around (yellow arrows) the rear right bumper reflector of the Taxi.

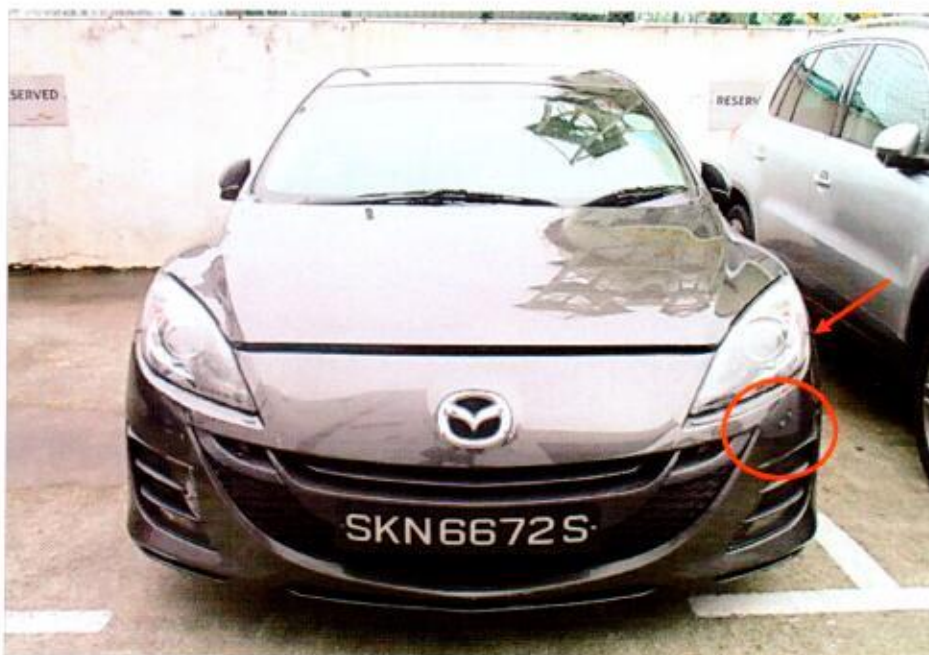
Photo 4 shows the general view of the front portion of the Mazda at the time of inspection. We noted that the Mazda had sustained a slight impact directly onto the left portion of its front bumper. Closer examination had showed faint paint scratch marks above the front left air vent (circled). We also noted that the front bumper was slightly misaligned at its left corner edge (arrowed).

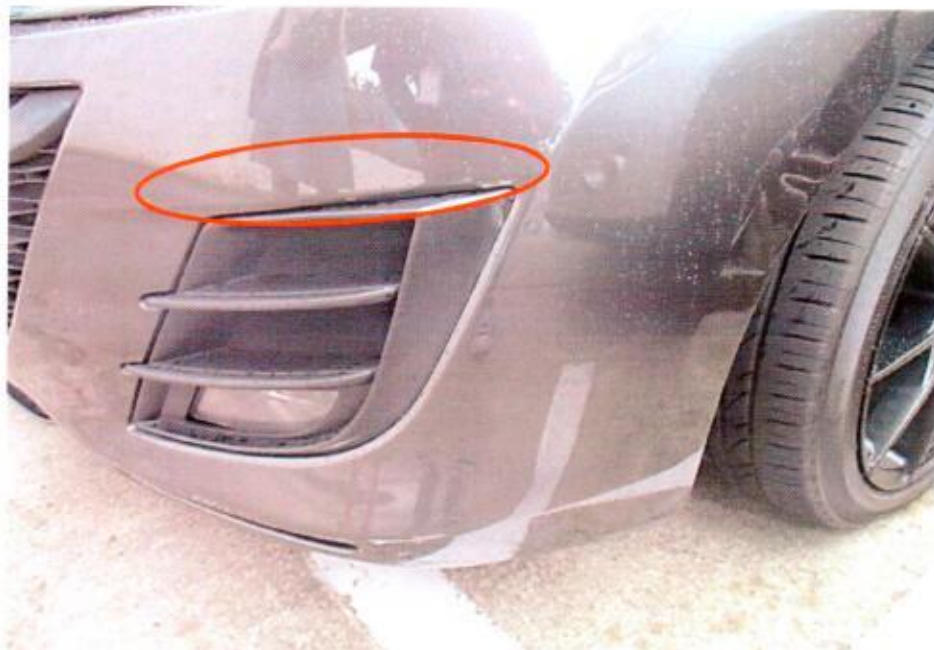
Photo 5 shows a closer view of the left portion of the front bumper of the Mazda at the time of inspection. We observed faint paint scratch marks above the front left air vent (circled).

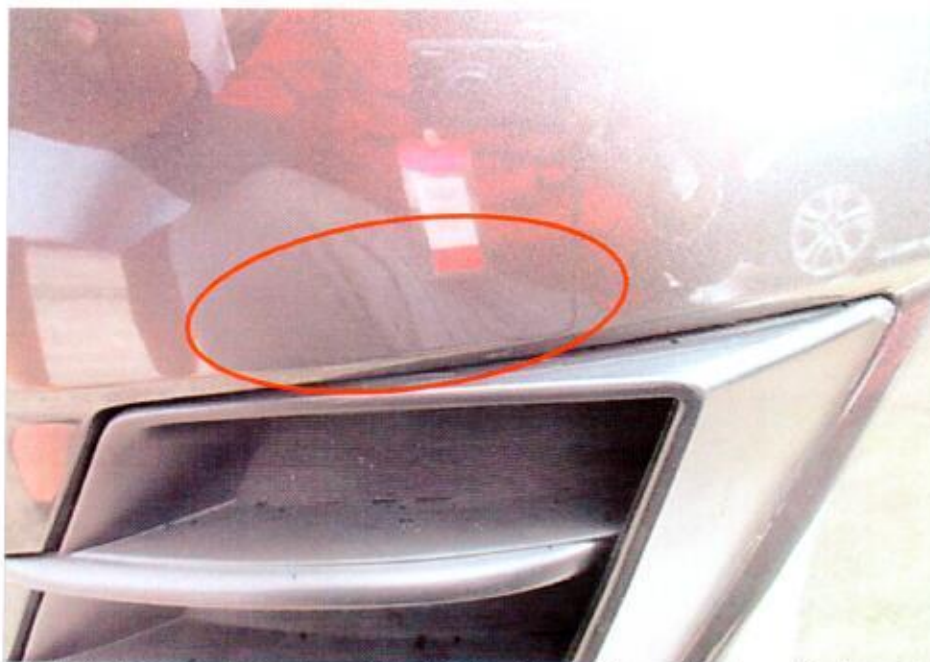
Photo 6 shows a closer view of the faint paint scratch marks above the front left air vent of the Mazda (circled).

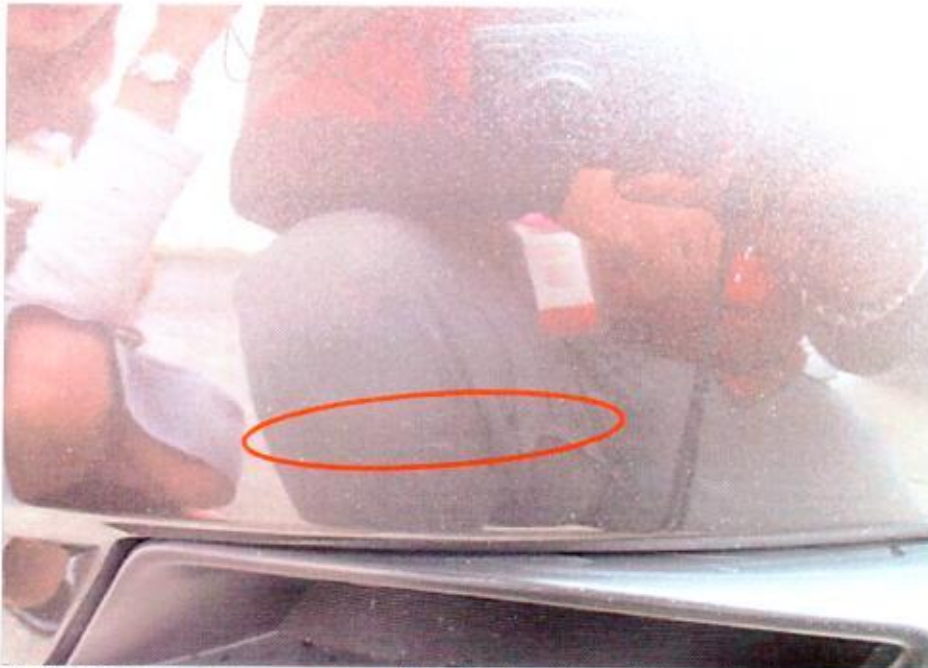
Photo 7 shows a close up view of the faint paint scratch marks above the front left air vent of the Mazda (circled).

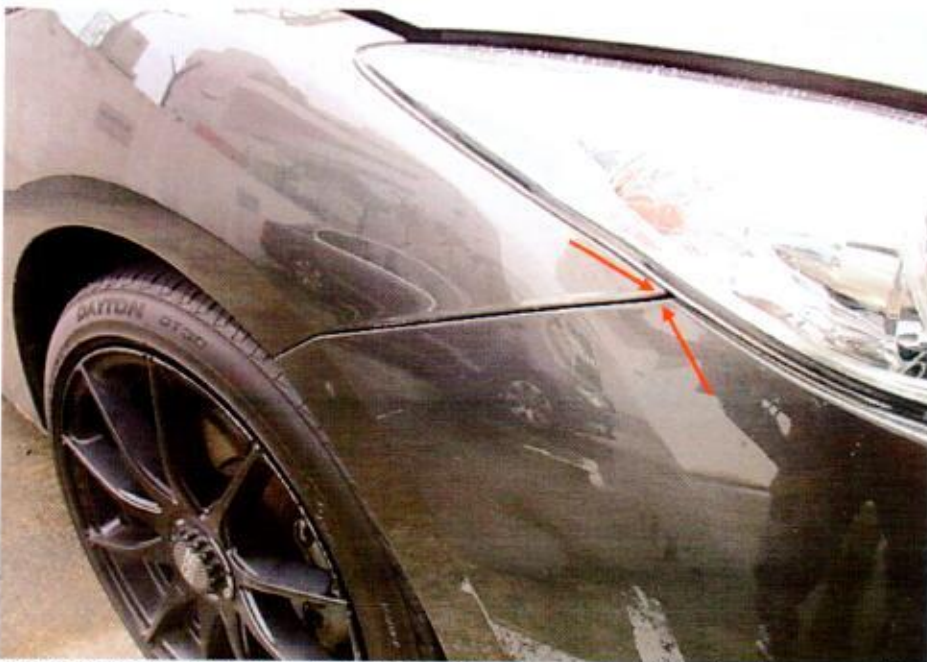
Photo 8 shows a close up view of the right corner edge of the front bumper of the Mazda. We observed that there was no misalignment at the corner edges (red arrows).

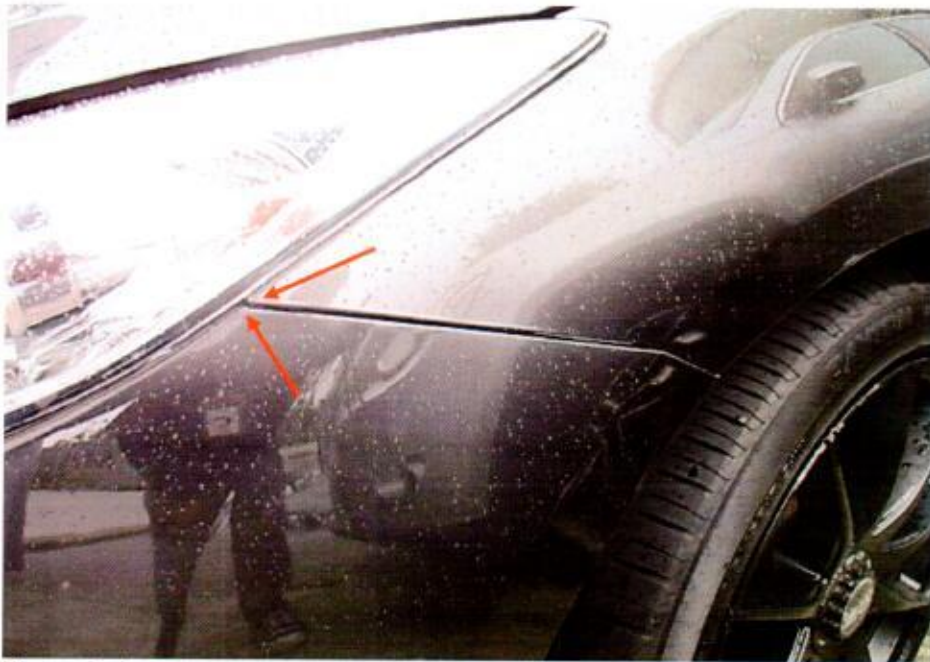
Photo 9 shows a close up view of the left corner edge of the front bumper of the Mazda. We observed that there was a slight misalignment at the left corner edge (red arrows).

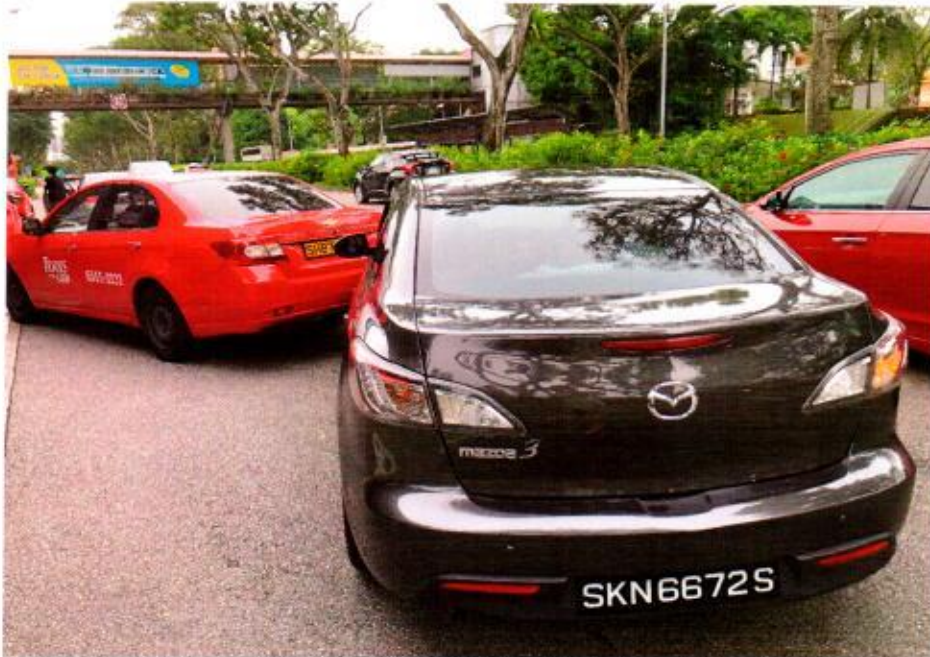
Photo 10 shows a rear view of the final rest position of the Involved Motor Vehicles post- accident which corroborates with Ms Mak's statement how the accident occurred.

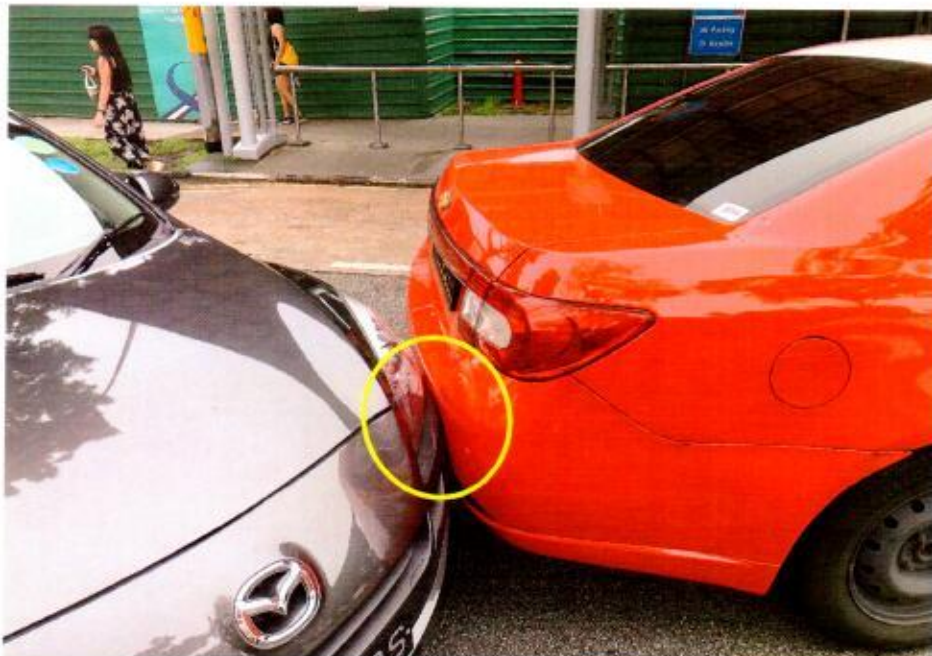
Photo 11 shows a front view of the final rest position of the Involved Motor Vehicles post- accident which corroborates with Ms Mak's statement how the accident occurred. The position of the Involved Motor Vehicles after the accident is consistent to the circumstances of the accident, suggesting that there was contact between them (circled).

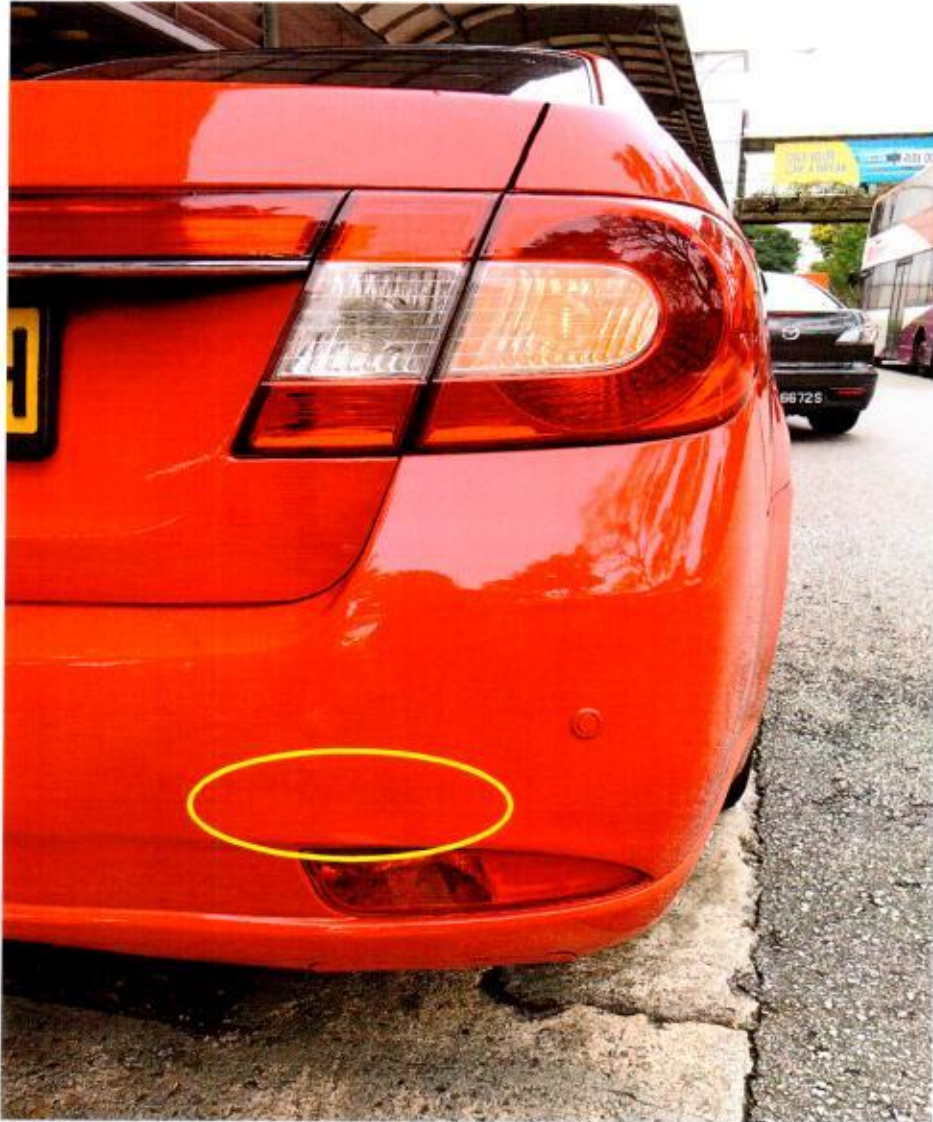
Photo 12 shows a close view of the lower right portion of the rear bumper of the Taxi taken post- accident. We observed the same paint graze marks on the lower right portion of the rear bumper of the Taxi as per the Pre- Repair Survey photographs (circled).

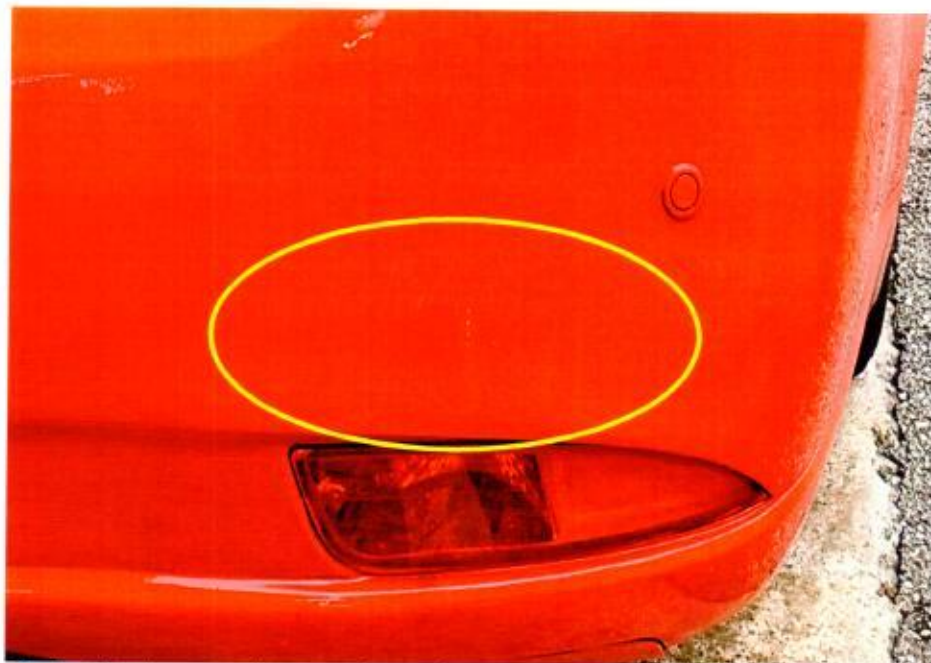
Photo 13 shows a close up view of the paint graze marks on the lower right portion of the rear bumper of the Taxi (circled).

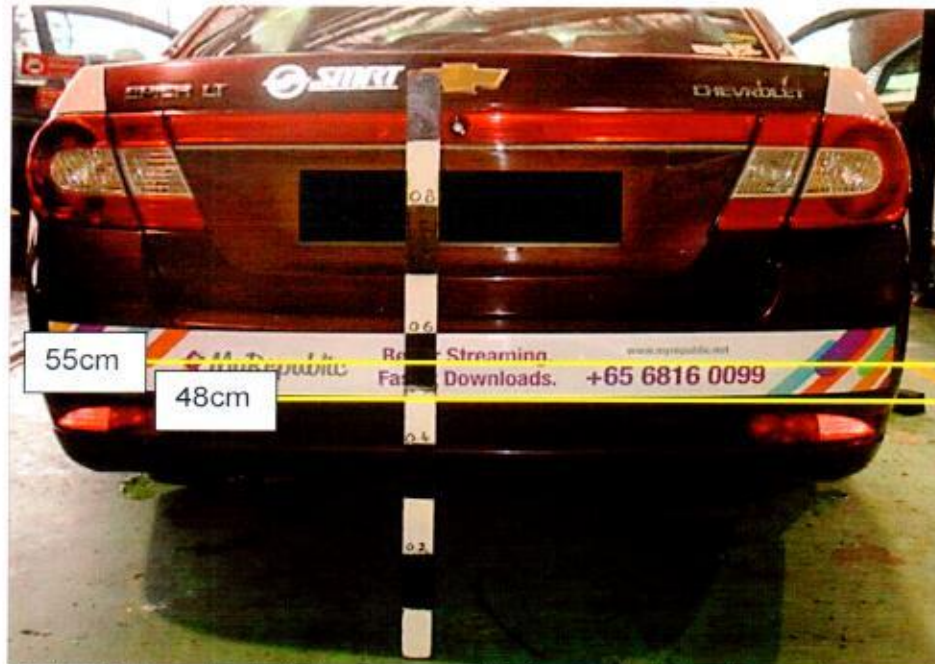
Photo 14 shows the height measurement being conducted on the rear bumper of the Taxi (using a similar make and model). The height above ground level of the lowest paint graze mark found above the rear right bumper reflector was measured to be approximately 48cm. The height above ground level of the highest paint graze mark found above the rear right bumper reflector was measured to be approximately 55cm.

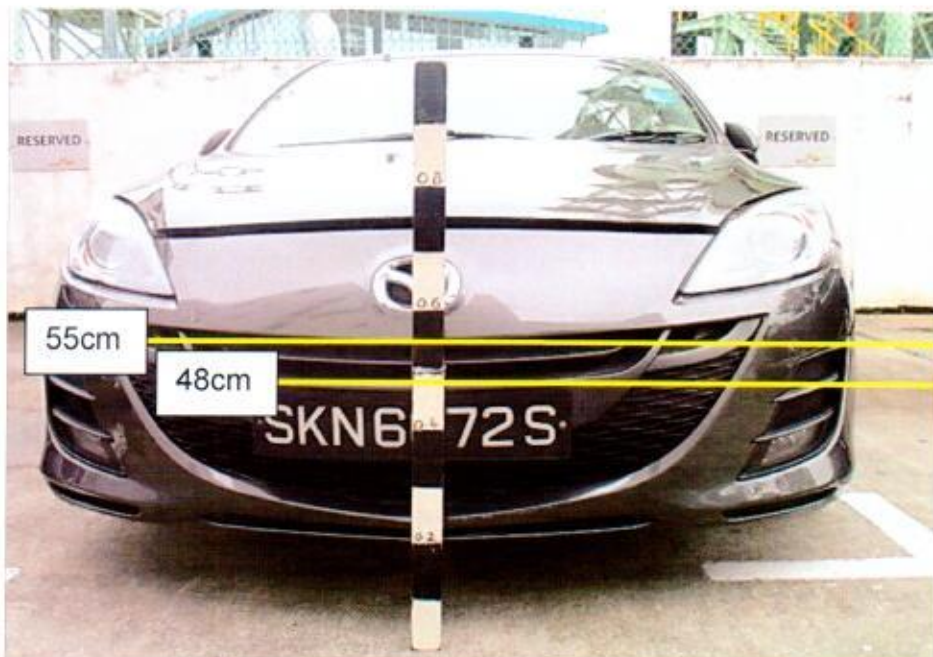
Photo 15 shows the height measurement being conducted on the front bumper of the Mazda. The faint paint scratch marks found on the Mazda are within the 48cm to 55cm range.
