Your Ref : 542842  
Our Ref : CS/MSG18000094/N-1

12 January 2017

**AUTOMOBILE TECHNICAL INVESTIGATION REPORT OF ACCIDENT  
INVOLVING SHB 7549H AND SKN 6672S ON 27 DECEMBER 2017**

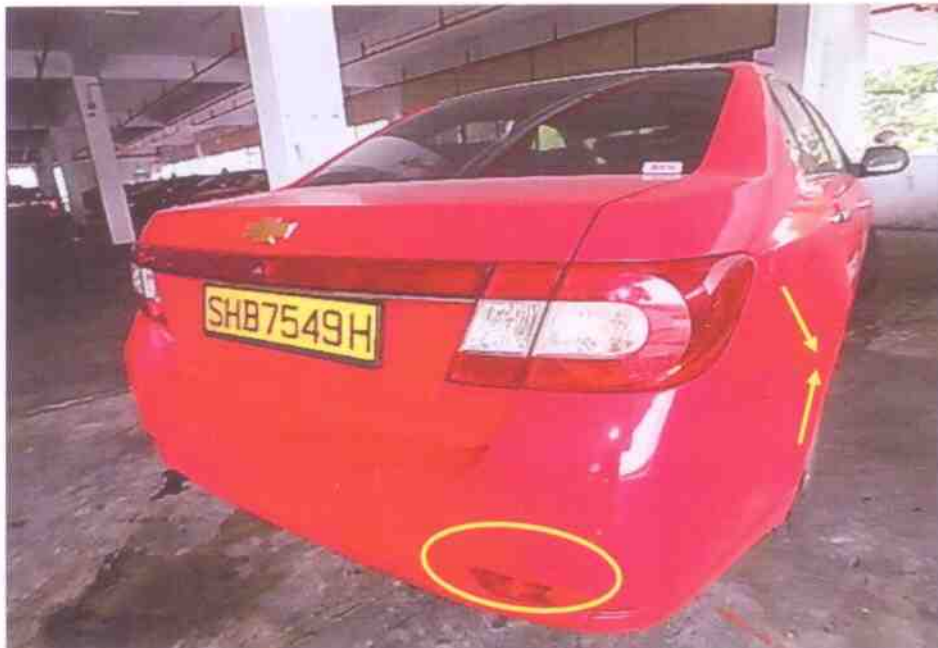
**Photo 1** shows a rear view of the Taxi at the time of the Pre- Repair Survey conducted by LKK Auto Consultants Pte. Ltd. which was taken about 7 days after the accident. We observed paint graze marks above and around the rear right bumper reflector of the Taxi (circled). However we also noted that the rear bumper was not misaligned at its right corner edge (yellow arrows).

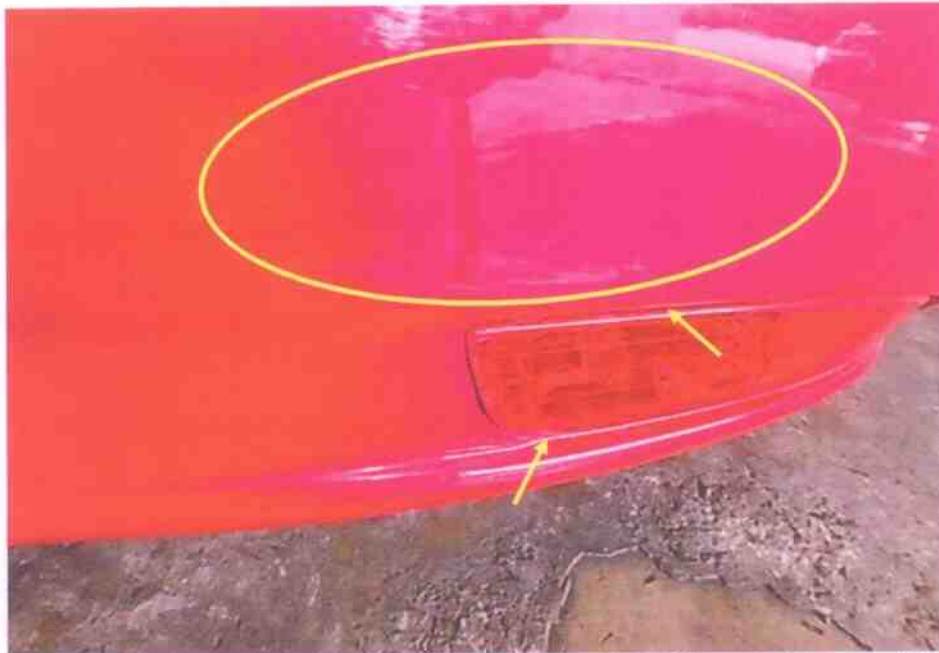
**Photo 2** shows a closer view of the lower right portion of the rear bumper of the Taxi. We observed paint graze marks above (circled) and around (yellow arrows) the rear right bumper reflector of the Taxi.

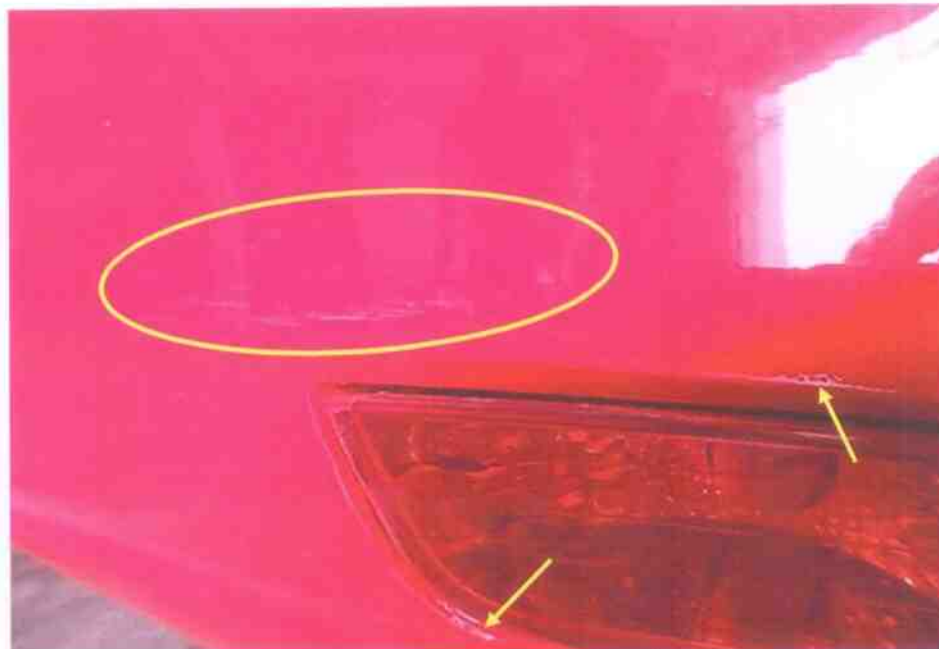
**Photo 3** shows a close up view of the lower right portion of the rear bumper of the Taxi. We observed paint graze marks above (circled) and around (yellow arrows) the rear right bumper reflector of the Taxi.

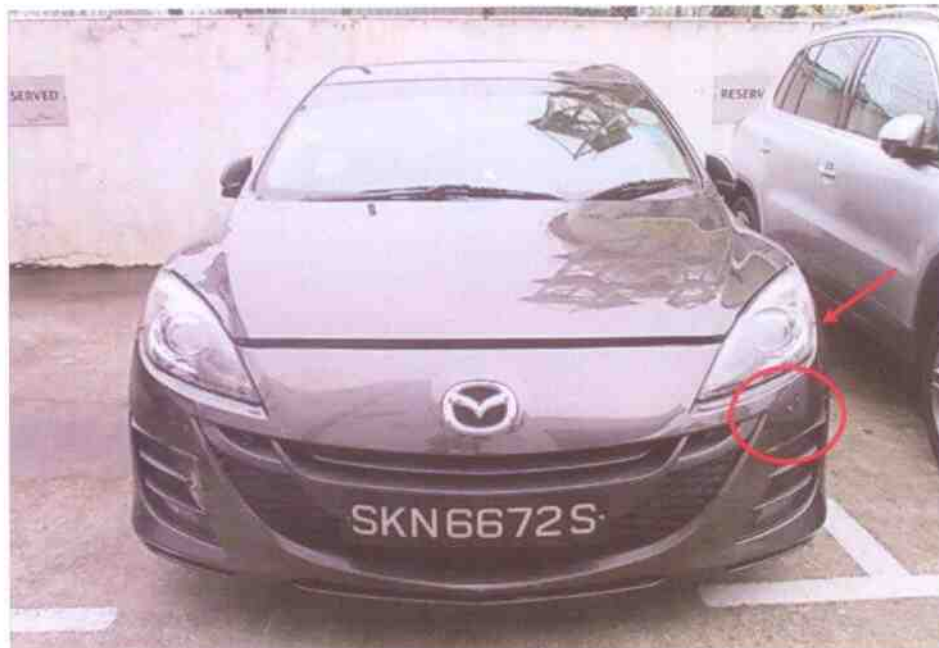
**Photo 4** shows the general view of the front portion of the Mazda at the time of inspection. We noted that the Mazda had sustained a slight impact directly onto the left portion of its front bumper. Closer examination had showed faint paint scratch marks above the front left air vent (circled). We also noted that the front bumper was slightly misaligned at its left corner edge (arrowed).

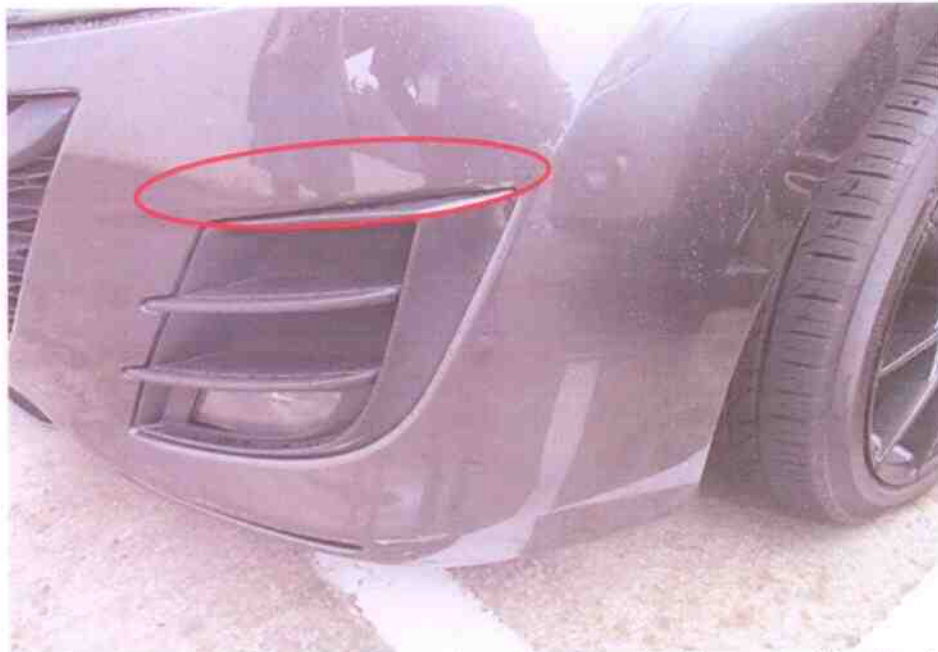
**Photo 5** shows a closer view of the left portion of the front bumper of the Mazda at the time of inspection. We observed faint paint scratch marks above the front left air vent (circled).

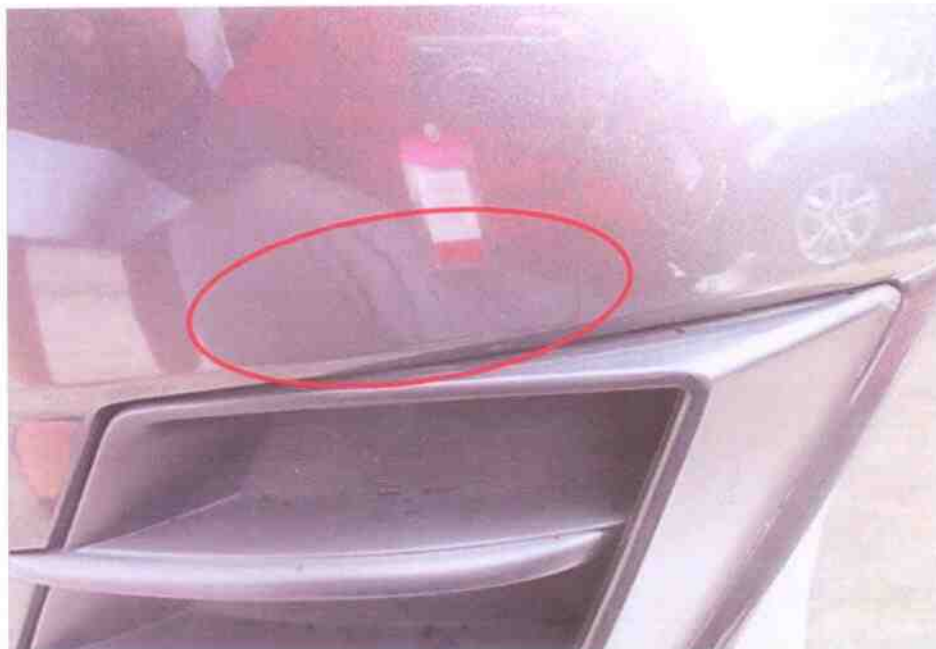
**Photo 6** shows a closer view of the faint paint scratch marks above the front left air vent of the Mazda (circled).

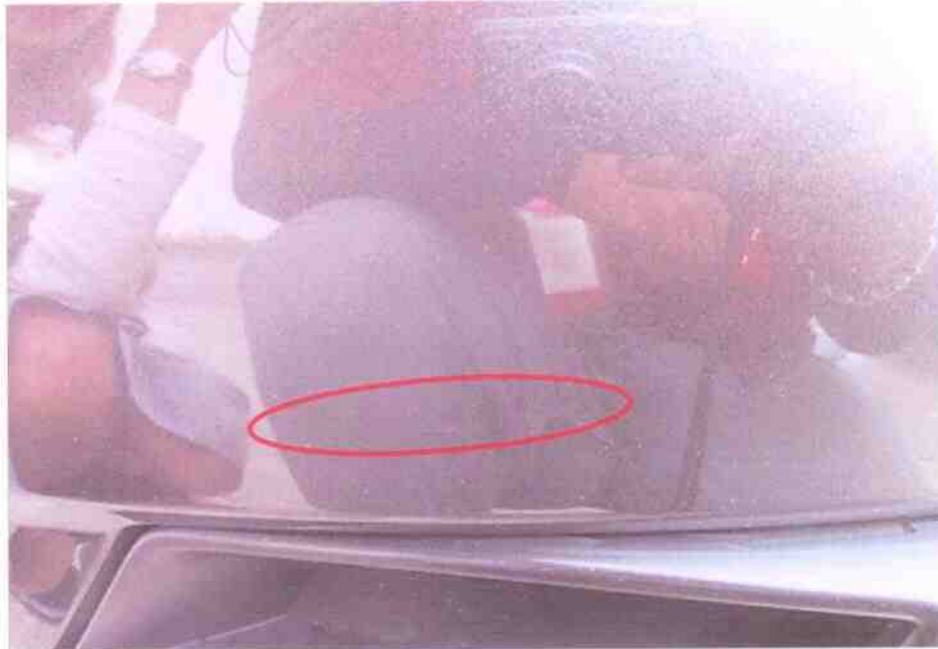
**Photo 7** shows a close up view of the faint paint scratch marks above the front left air vent of the Mazda (circled).

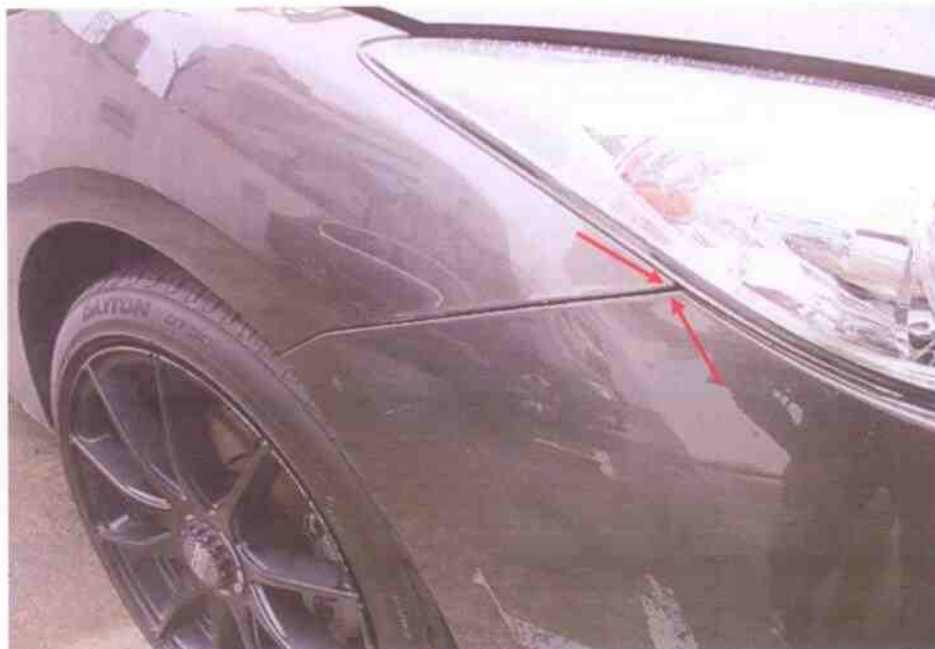
**Photo 8** shows a close up view of the right corner edge of the front bumper of the Mazda. We observed that there was no misalignment at the corner edges (red arrows).

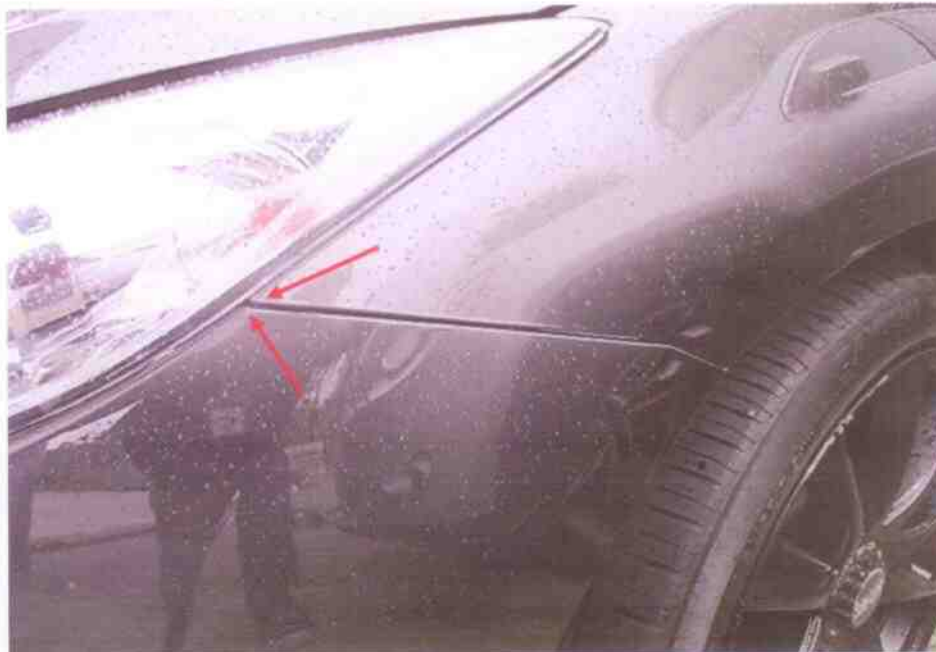
**Photo 9** shows a close up view of the left corner edge of the front bumper of the Mazda. We observed that there was a slight misalignment at the left corner edge (red arrows).

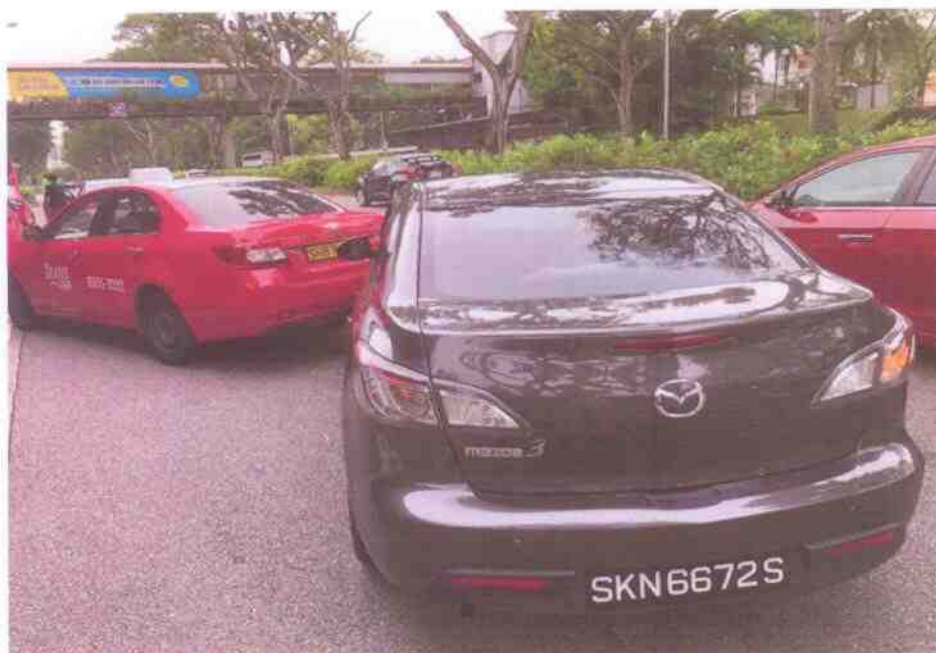
Photo 10 shows a rear view of the final rest position of the Involved Motor Vehicles post- accident which corroborates with Ms Mak's statement how the accident occurred.

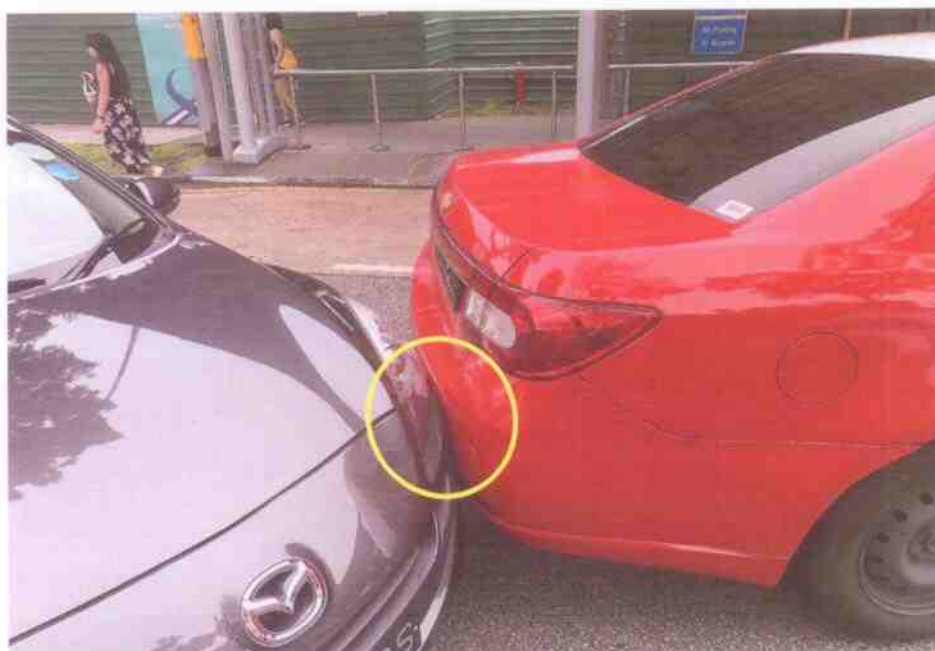
Photo 11 shows a front view of the final rest position of the Involved Motor Vehicles post- accident which corroborates with Ms Mak's statement how the accident occurred. The position of the Involved Motor Vehicles after the accident is consistent to the circumstances of the accident, suggesting that there was contact between them (circled).

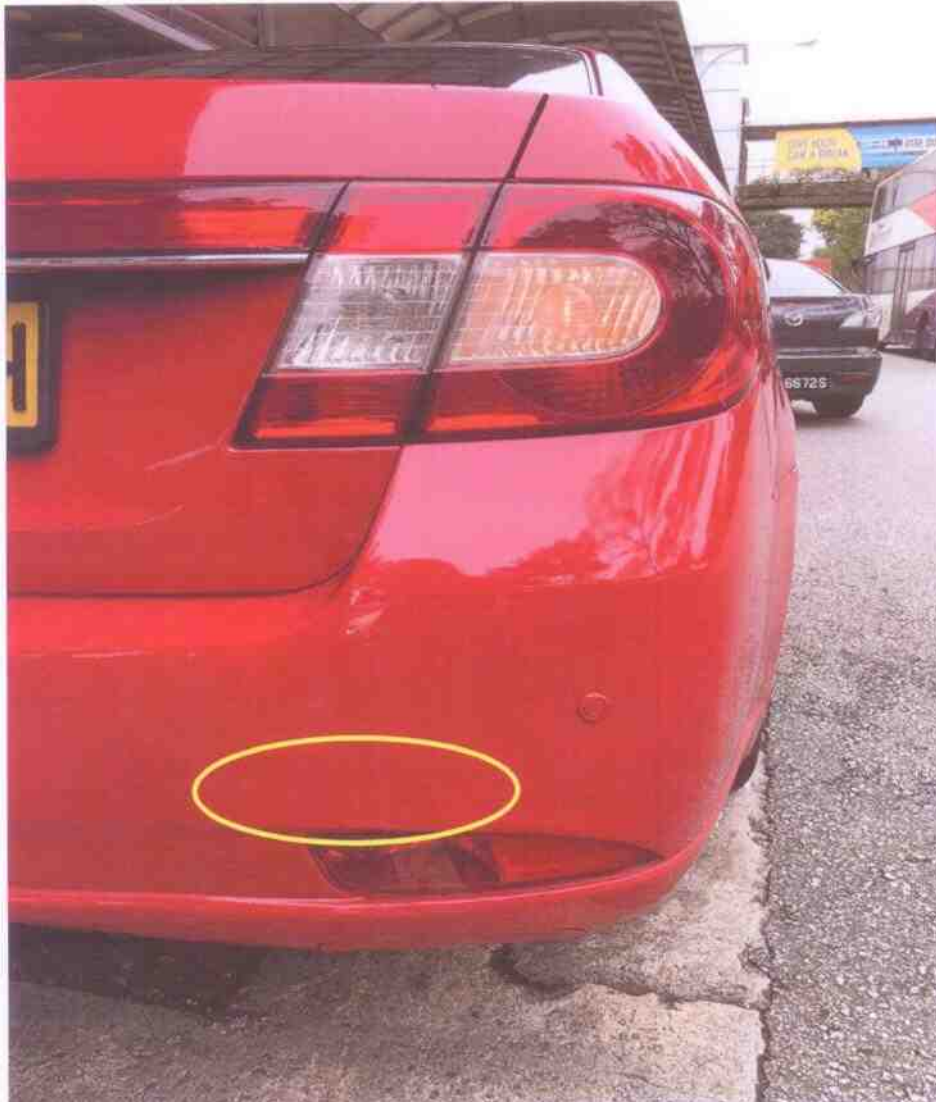
**Photo 12** shows a close view of the lower right portion of the rear bumper of the Taxi taken post- accident. We observed the same paint graze marks on the lower right portion of the rear bumper of the Taxi as per the Pre- Repair Survey photographs (circled).

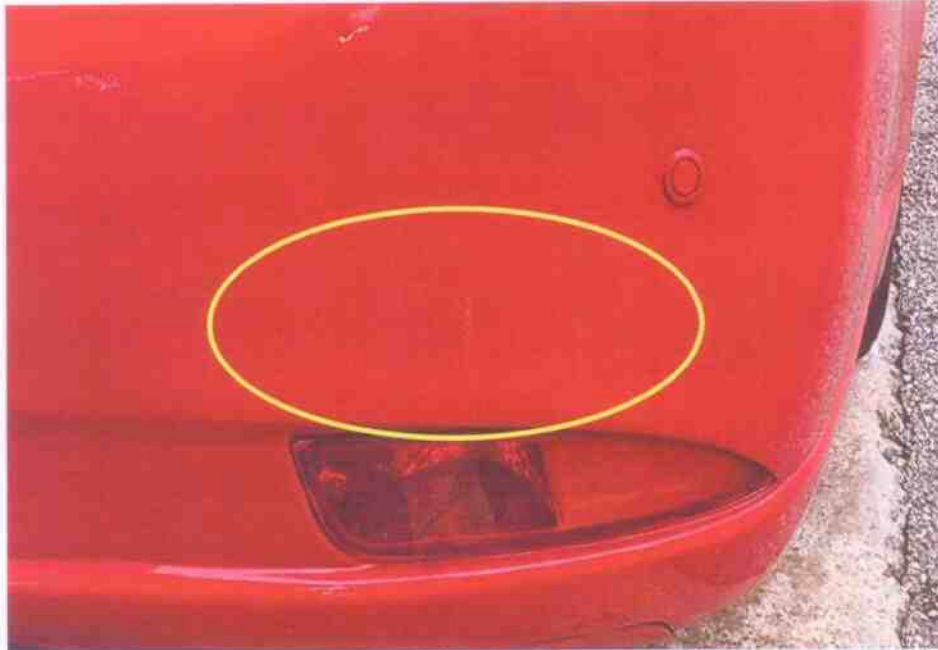
Photo 13 shows a close up view of the paint graze marks on the lower right portion of the rear bumper of the Taxi (circled).

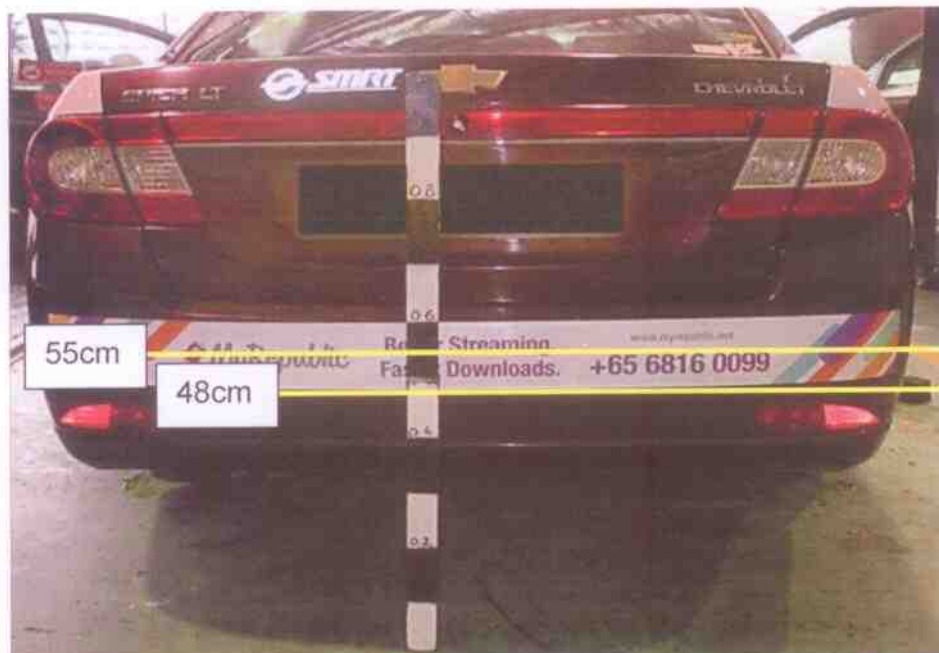
**Photo 14** shows the height measurement being conducted on the rear bumper of the Taxi (using a similar make and model). The height above ground level of the lowest paint graze mark found above the rear right bumper reflector was measured to be approximately 48cm. The height above ground level of the highest paint graze mark found above the rear right bumper reflector was measured to be approximately 55cm.

- a) The height above ground level of the lowest paint graze mark found above the rear right bumper reflector of the Taxi was measured to be approximately 48cm;
- b) the height above ground level of the highest paint graze mark found above the rear right bumper reflector of the Taxi was measured to be approximately 55cm;
- c) the faint paint scratch marks found on the Mazda are within the 48cm to 55cm range;
- d) the height measurements appear to support the findings of possible contact between the front left portion of the Mazda and the rear right portion of the Taxi. The damage observed on the front left portion of the Mazda was a result of this contact and corresponds to the damage observed on the rear right portion of the Taxi;
- e) Our findings are further supported by the accident scene photographs which had showed contact between the Involved Motor Vehicles.

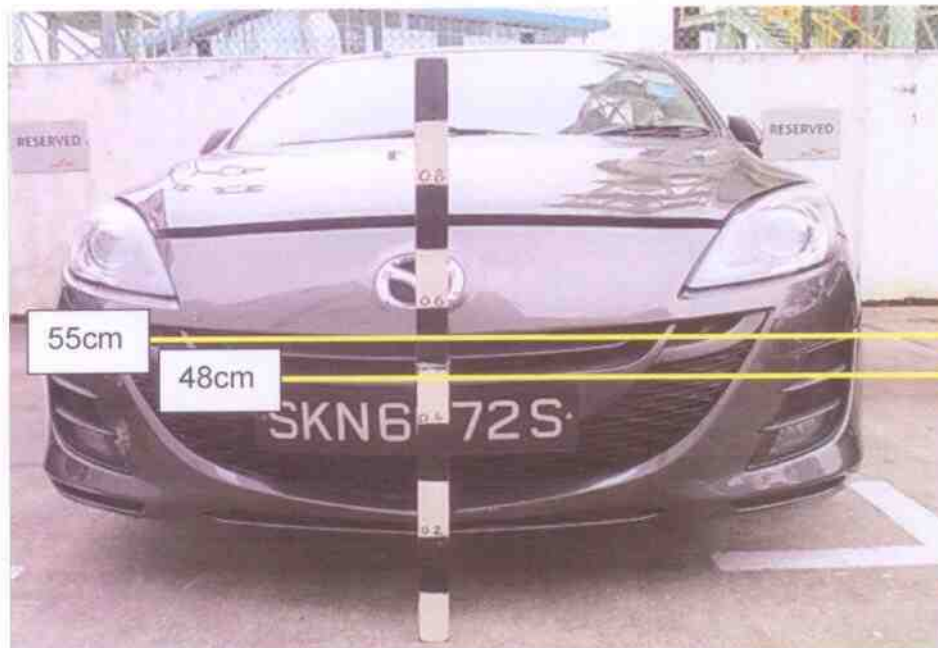
**Photo 15** shows the height measurement being conducted on the front bumper of the Mazda. The faint paint scratch marks found on the Mazda are within the 48cm to 55cm range.
