Auto
Consultants
Pte Ltd

INVESTIGATION REPORT:

Our Ref : CC3/AIG18001712/N

Insured : SLN 8005T

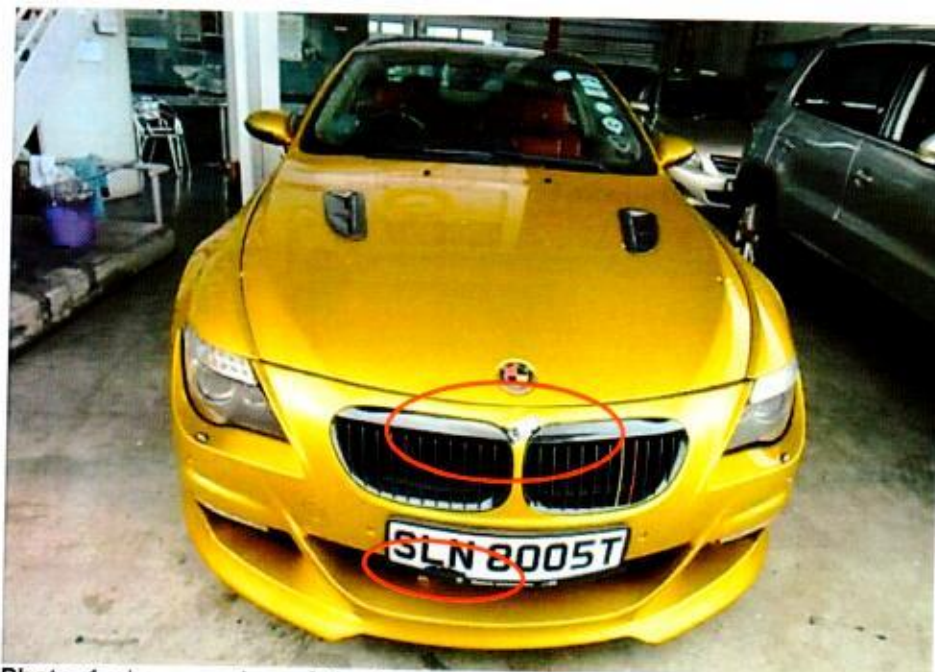
Photo 1 shows a view of the front portion of the Insured Vehicle during the accident reporting. The front bumper and front number plate of the Insured Vehicle had sustained damages as a result of the accident (circled).

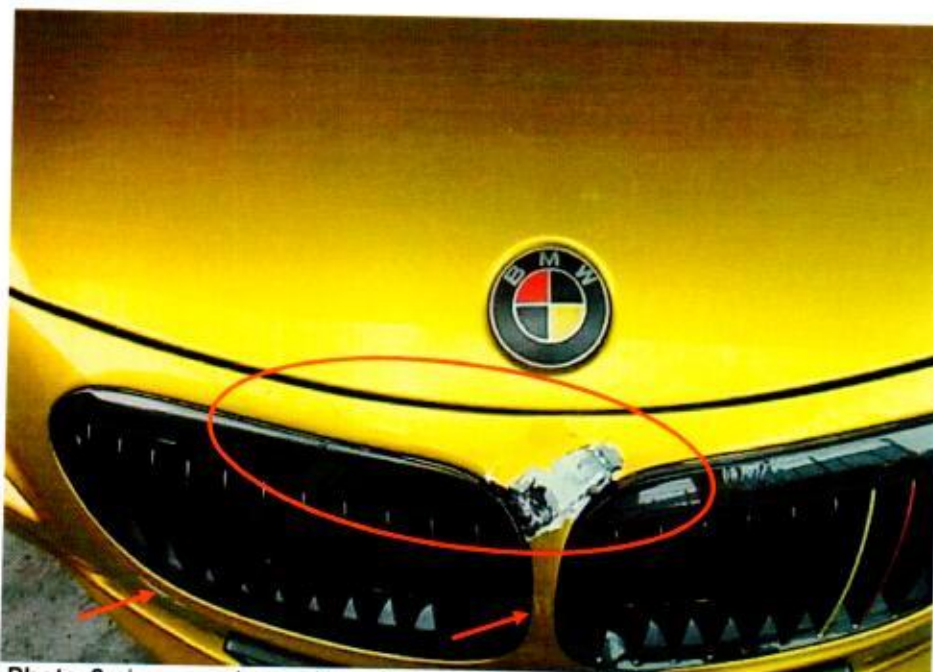
Photo 2 shows a closer view of the front bumper of the Insured Vehicle during the accident reporting. The front bumper had sustained a dent at the centre portion, resulting in paint chip marks in between the front grilles and paint crack marks above the front grilles (circled). Whitish marks were also observed on and around the front grilles (arrowed). This correlates with Mr Boo's statement of the Insured Vehicle rear- ending the Toyota.

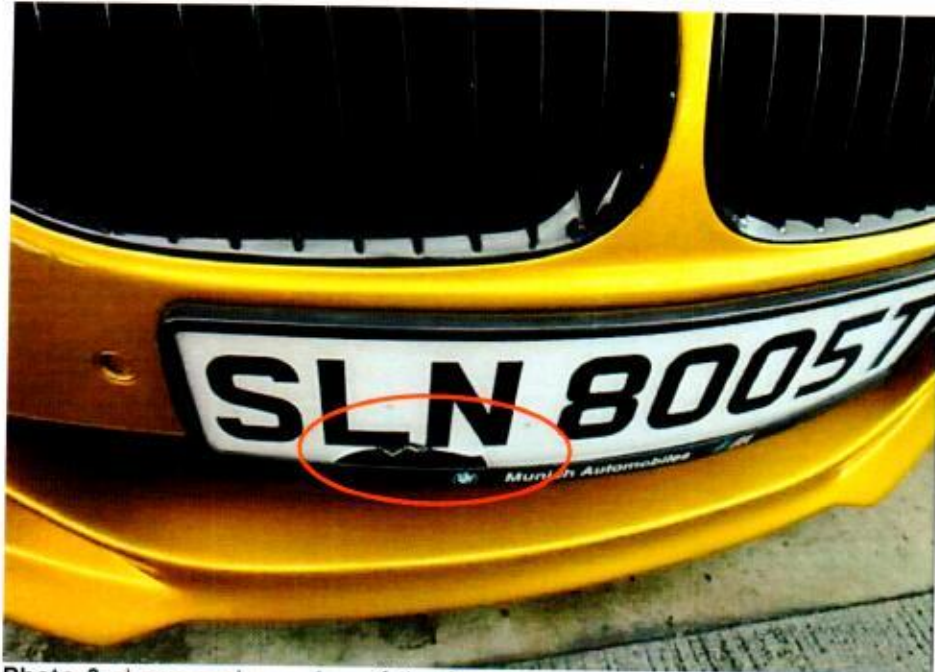
Photo 3 shows a closer view of the front number plate of the Insured Vehicle during the accident reporting. The front number plate had cracked and was missing a piece as a result of the accident (circled). This correlates with Mr Boo's statement of the Insured Vehicle rear- ending the Toyota.

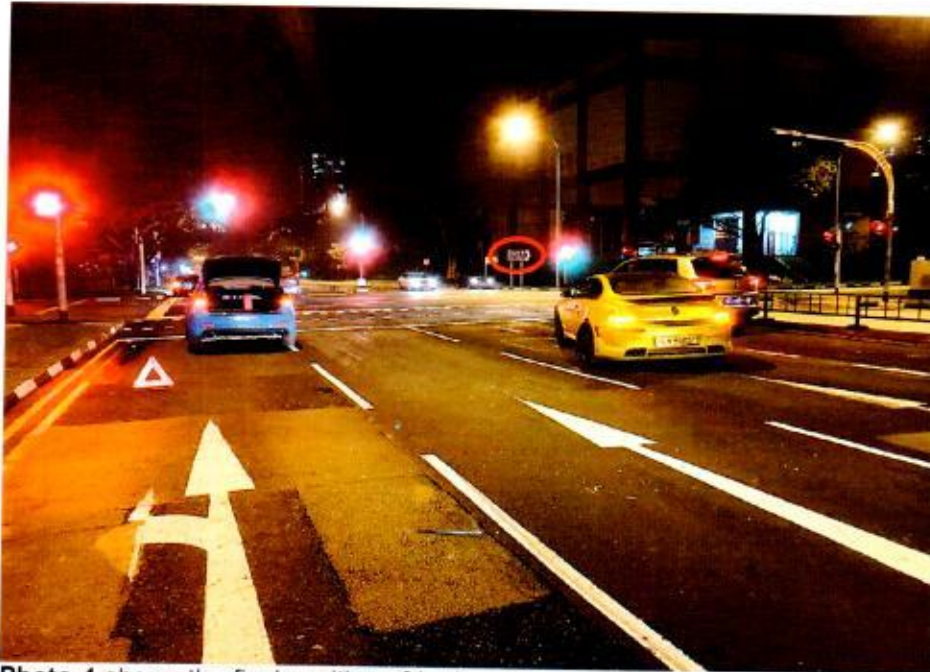
Photo 4 shows the final position of both vehicles post- accident which seems to correlate with Mr Boo's statement that the accident had occurred before the traffic junction of Ang Mo Kio Avenue 5 and Ang Mo Kio Street 53 (circled).

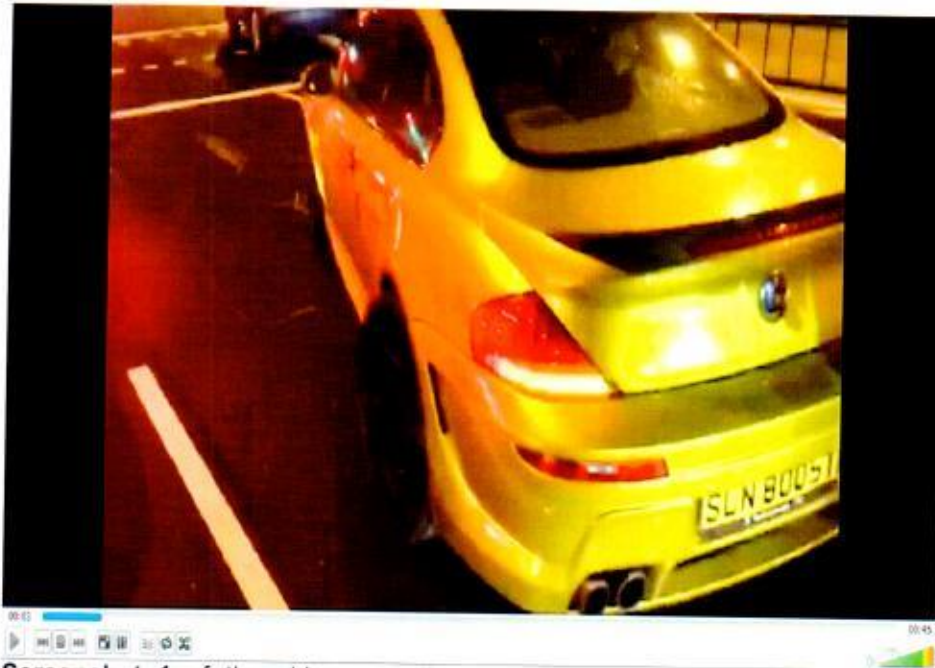
Screenshot 1 of the video recording taken from Mr Boos' mobile phone showing the final position of the Insured Vehicle after the accident.

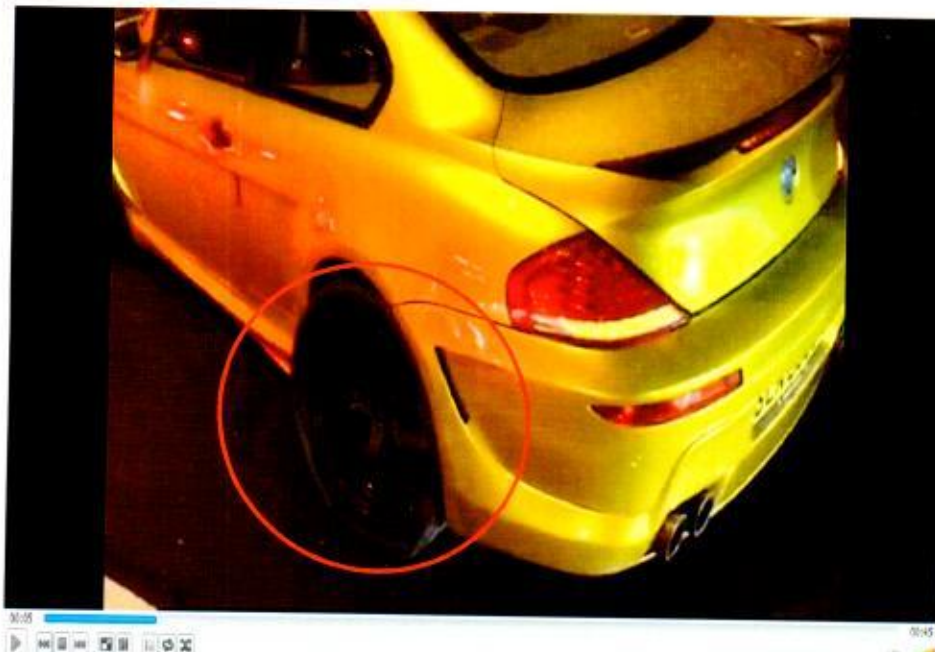
Screenshot 2 of the video recording taken from Mr Boos' mobile phone showing the damages sustained to the left rear wheel rim and tyre of the Insured Vehicle as a result of the accident (circled).

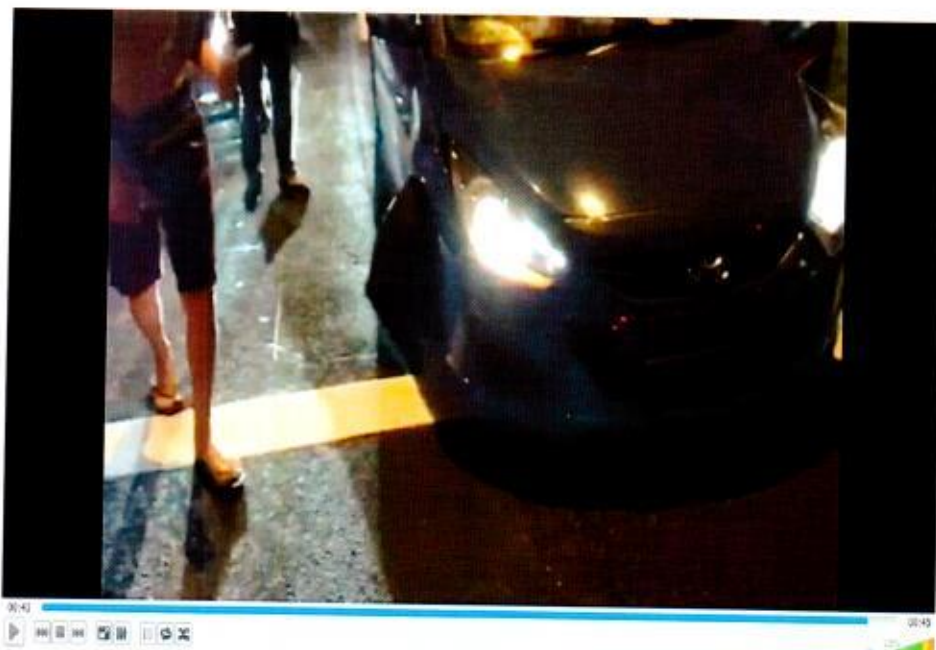
Screenshot 3 of the video recording taken from Mr Boos' mobile phone showing the final position of the Taxi after the accident.

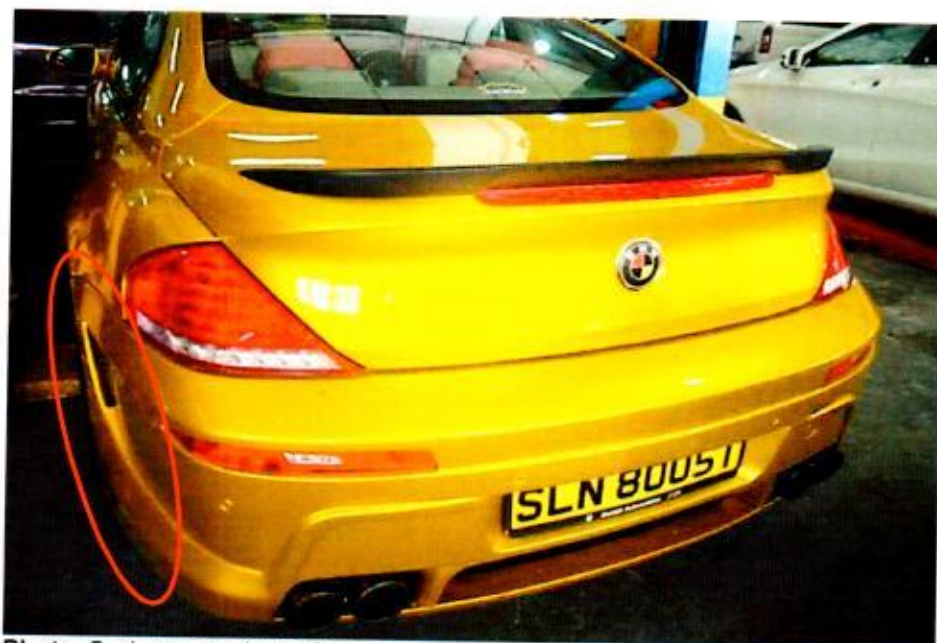
Photo 5 shows a view of the rear portion of the Insured Vehicle during the accident reporting. The left rear portion of the Insured Vehicle had sustained damages as a result of the accident (circled).

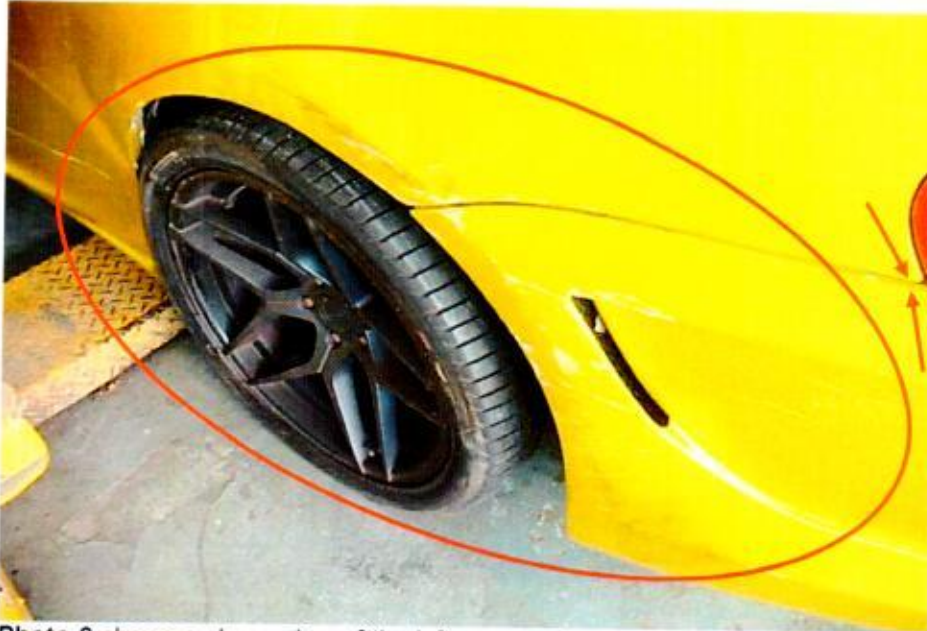
Photo 6 shows a closer view of the left rear portion of the Insured Vehicle during the accident reporting. The left rear wheel fender and rear bumper had sustained a dent and paint graze marks. The left rear wheel had also sustained similar marks of grazing nature and was punctured as a result of the accident (circled). There was a slight misalignment of the left side of the rear bumper at its corner edges (arrowed). This correlates with Mr Boo's statement that the Insured Vehicle was hit on its left rear portion by the Taxi.

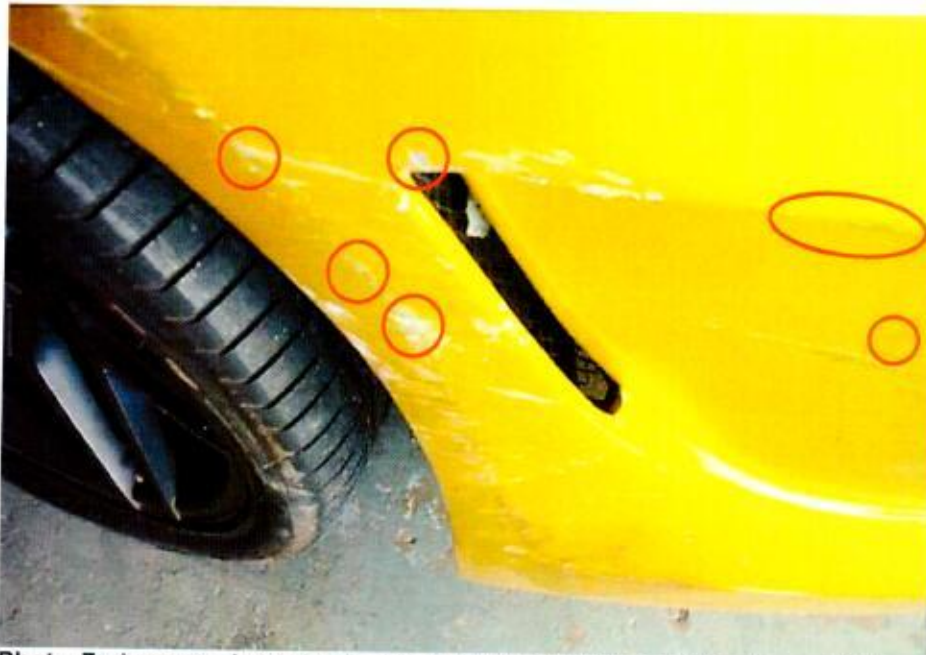
Photo 7 shows a close up view of the left rear portion of the Insured Vehicle during the accident reporting. We observed bluish paint transfer marks at the left rear portion of the Insured Vehicle (circled). This correlates with Mr Boo's statement that the Insured Vehicle was hit on its left rear portion by the Taxi.

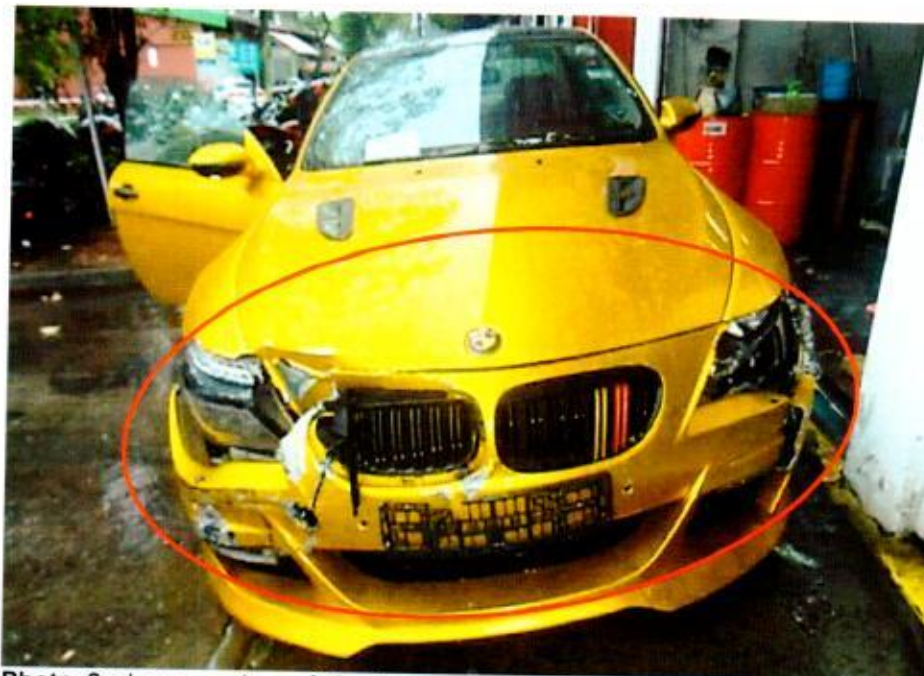
Photo 8 shows a view of the front portion of the Insured Vehicle during the accident reporting. The front portion sustained extensive damages as a result of the accident with both vehicles (circled).

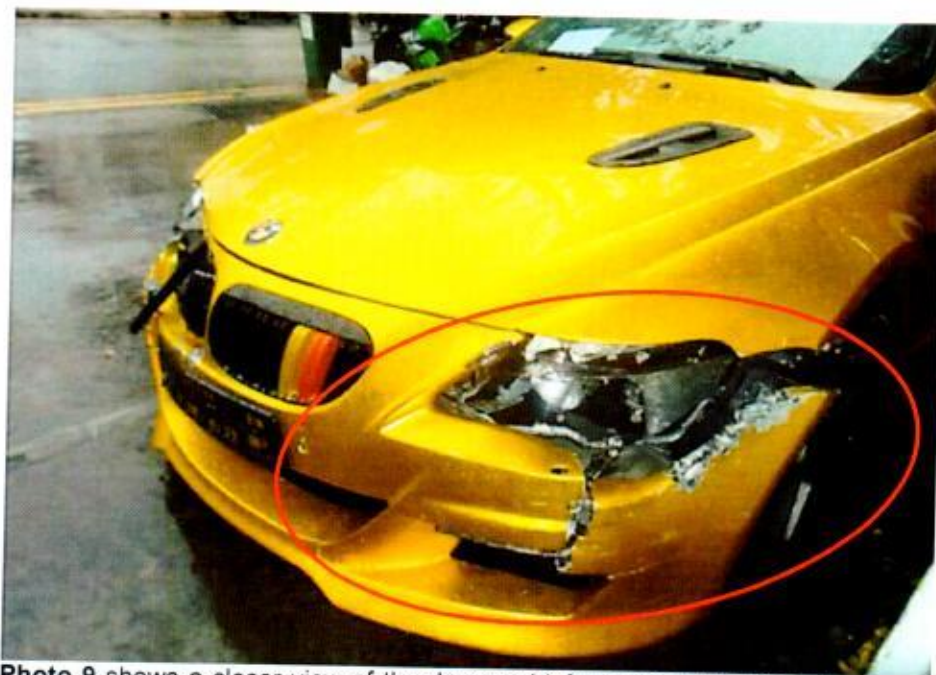
Photo 9 shows a closer view of the damaged left portion of the front bumper of the Insured Vehicle during the accident reporting (circled). The extensive damages sustained seem to corroborate with Mr Boo's statement that he had hit the right front portion of the Honda at the material time of accident.

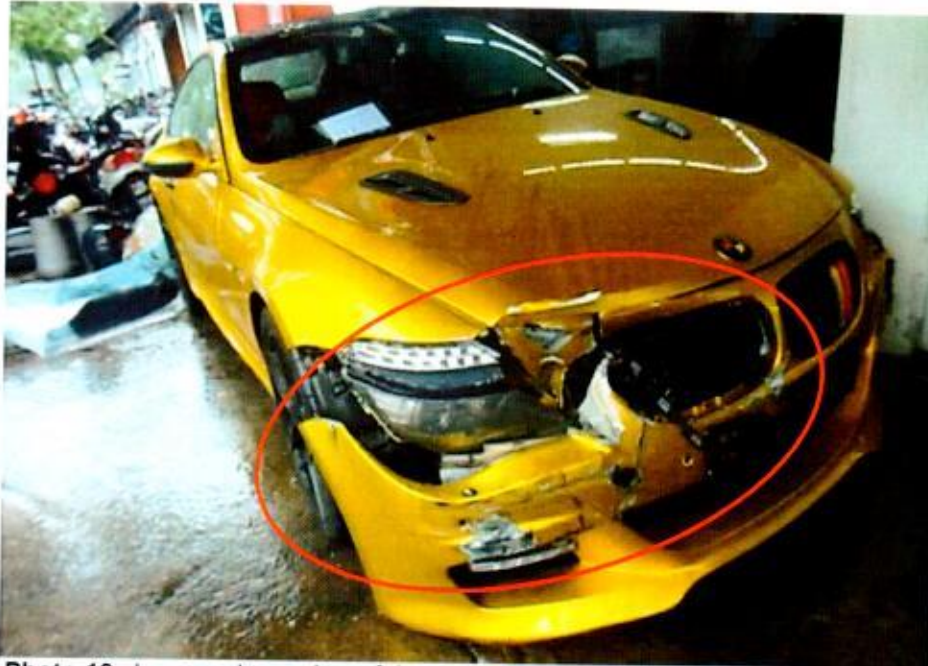
Photo 10 shows a closer view of the damaged right portion of the front bumper of the Insured Vehicle during the accident reporting (circled). The extensive damages sustained seem to corroborate with Mr Boo's statement that he had hit the right rear portion of the Taxi at the material time of accident.

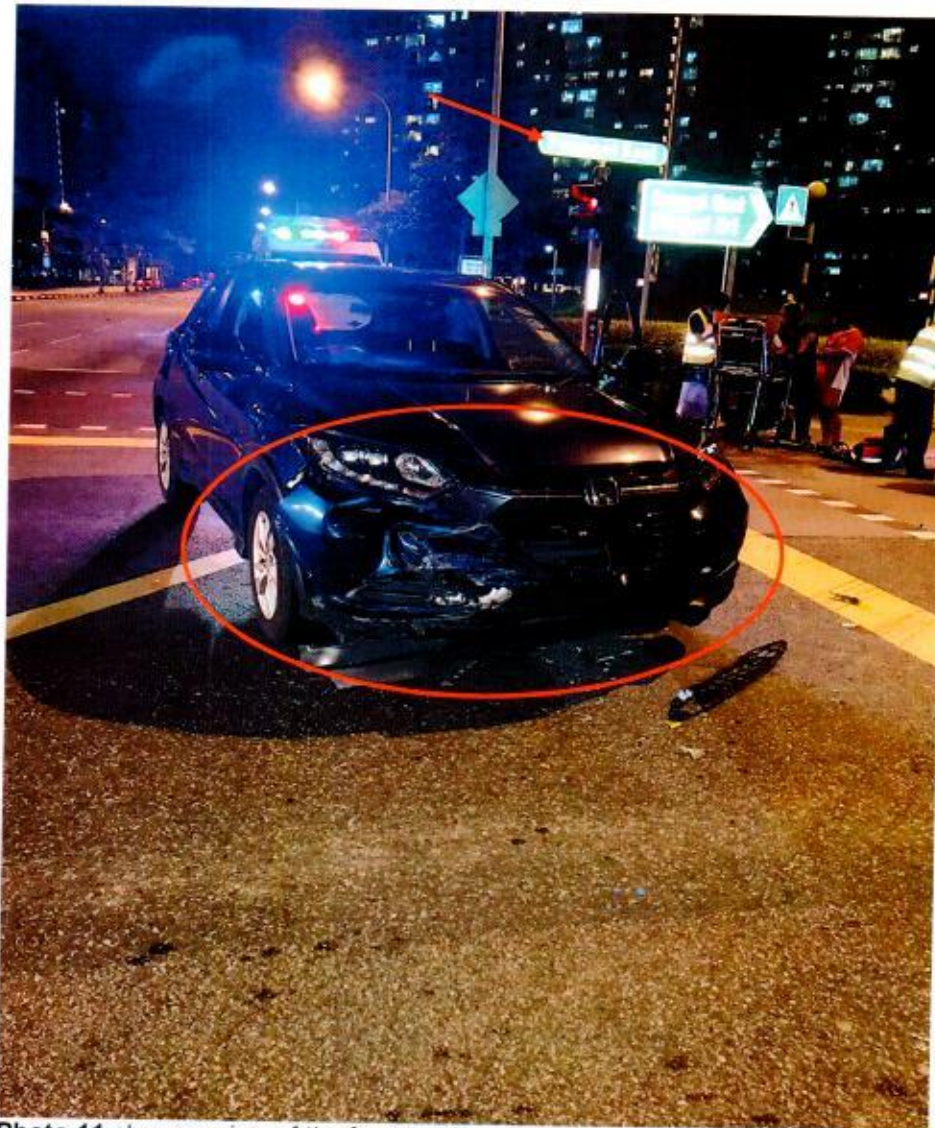
Photo 11 shows a view of the front portion of the Honda post- accident. The right front portion sustained damages and the front number plate broke off upon impact with the Insured Vehicle (circled). This correlates with Ms Serene's statement that the accident had occurred when she was waiting behind the Taxi at the right turn pocket of the T- junction of Punggol Central and Punggol East (arrowed).

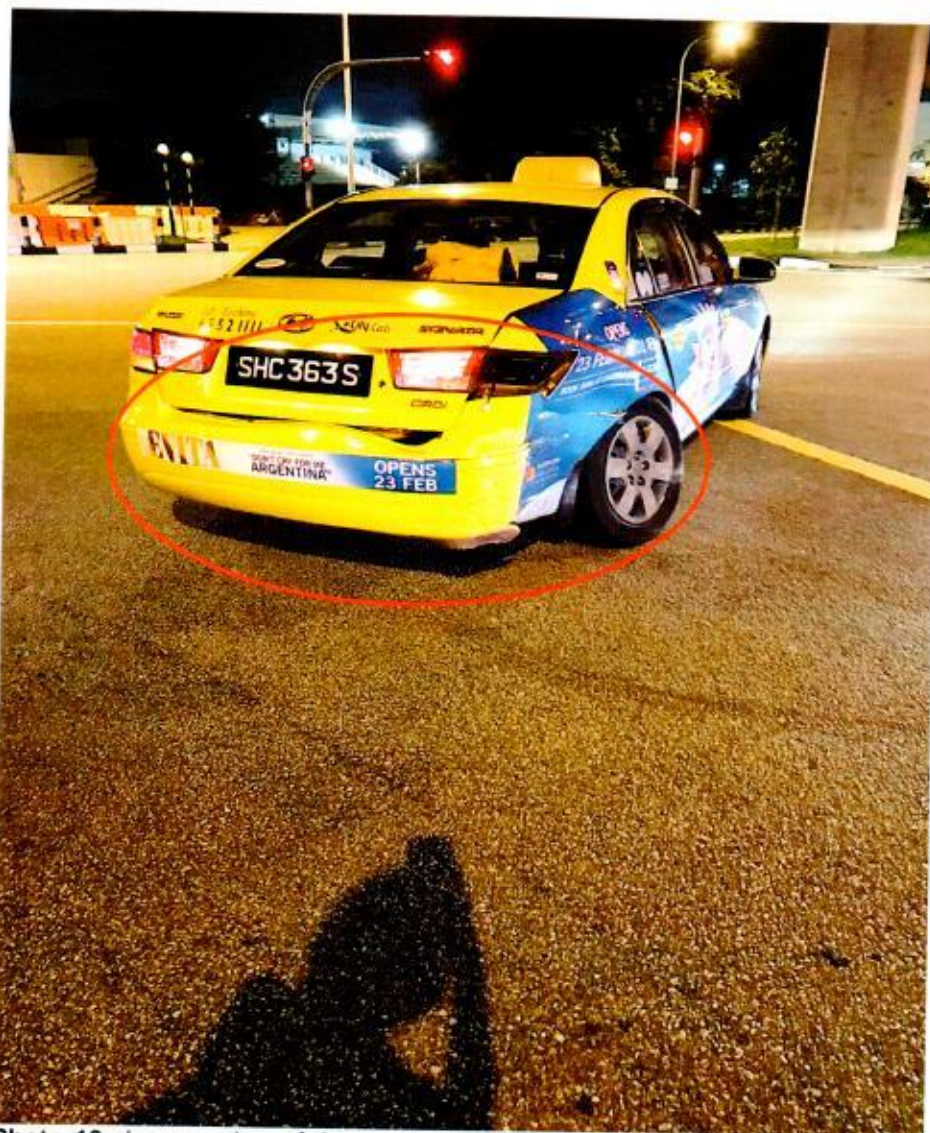
Photo 12 shows a view of the rear portion of the Taxi post- accident. The right rear portion sustained damages a result of the accident with the Insured Vehicle (circled). This correlates with Ms Serene's statement that the accident had occurred when she was waiting behind the Taxi at the right turn pocket of the T-junction of Punggol Central and Punggol East.

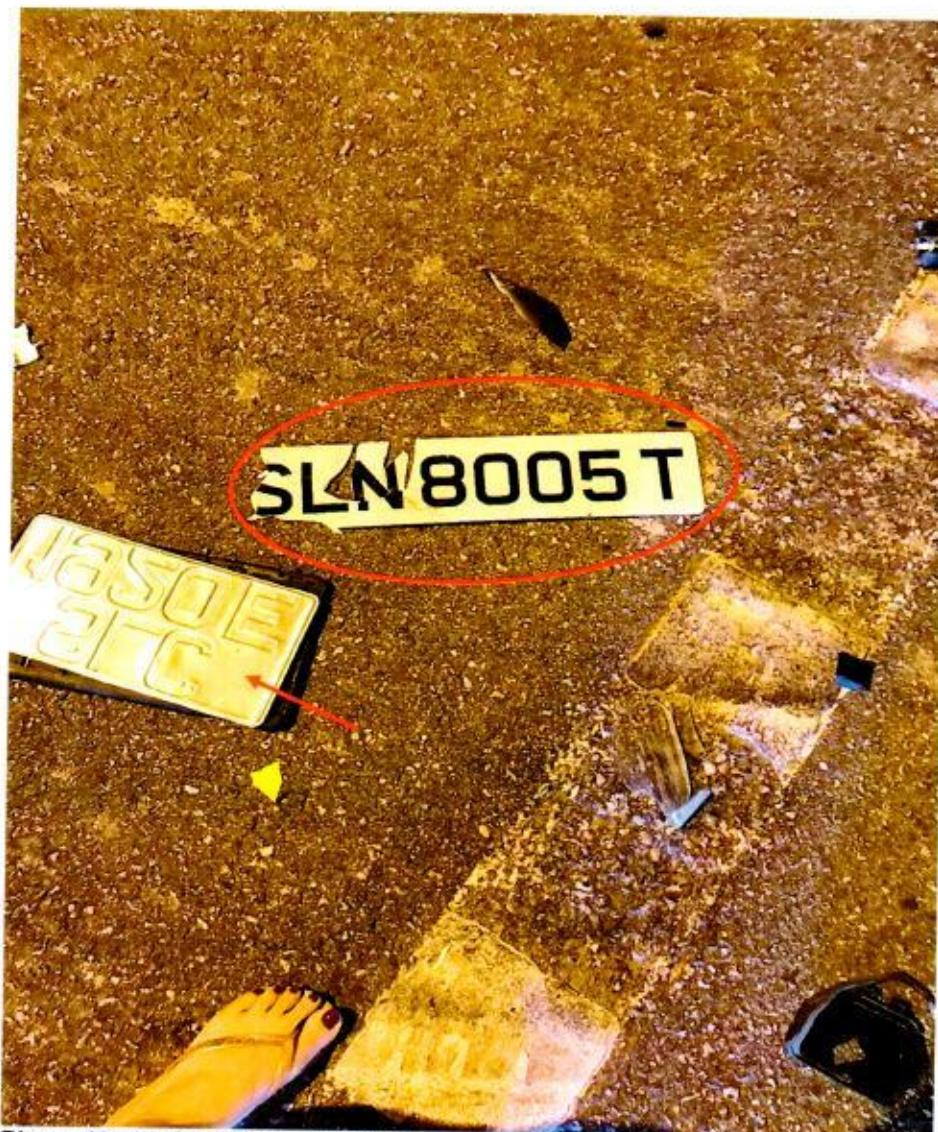
Photo 13 shows a view of the front number plates of both the Honda (arrowed) and the Insured Vehicle (circled) which had broken off upon impact.

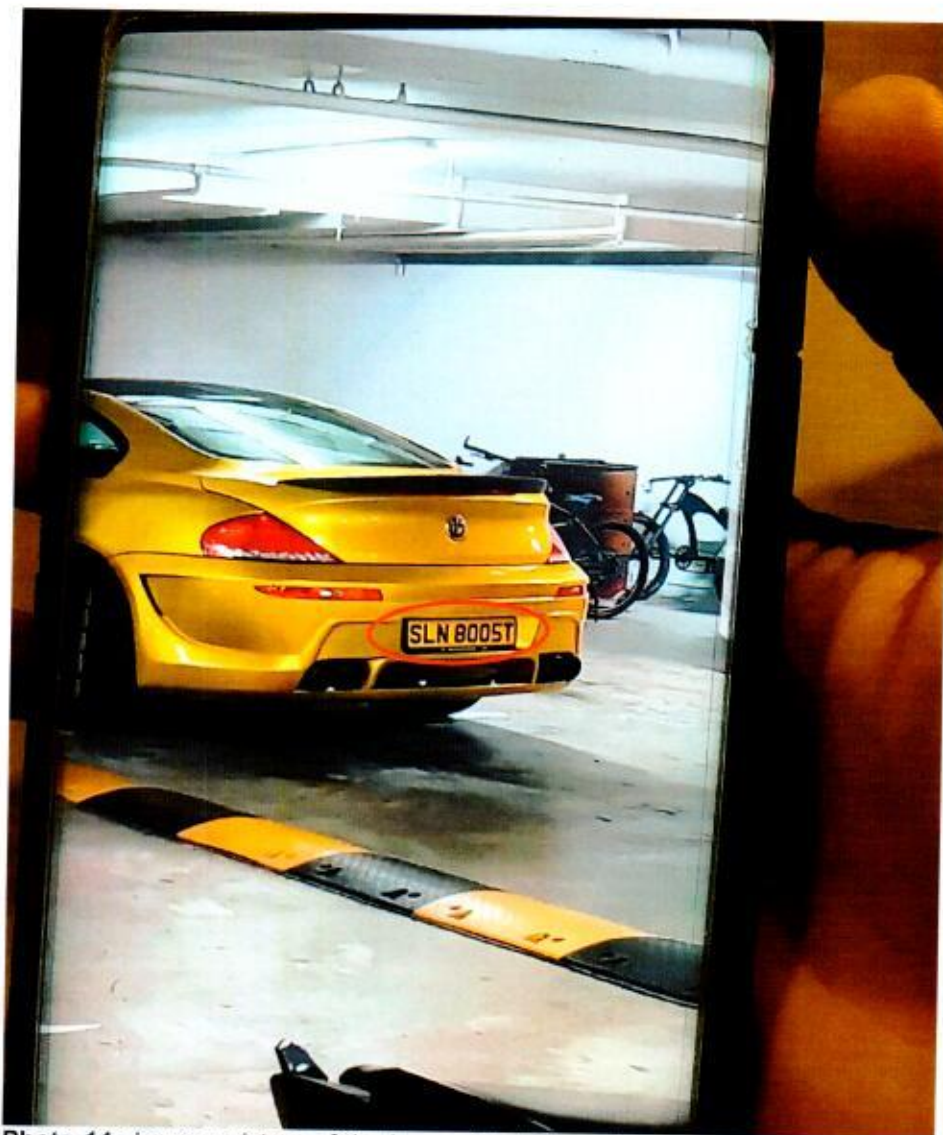
Photo 14 shows a picture of the Insured Vehicle at the basement carpark of the condo residence (circled) which Ms Serene had received from the elderly woman at about 2200 hours after the accident had occurred. This corroborates with the elderly woman's statement that the driver of the Insured Vehicle is 1 of her neighbours.
