Your Ref: TP/IP/55631/2017  
Our Ref :CI/TPD17022589/Z-1

29<sup>th</sup> January 2018

**INSPECTION REPORT OF ELECTRIC SCOOTER - TRAFFIC POLICE POUND  
REPORT NO. 7581/17.**

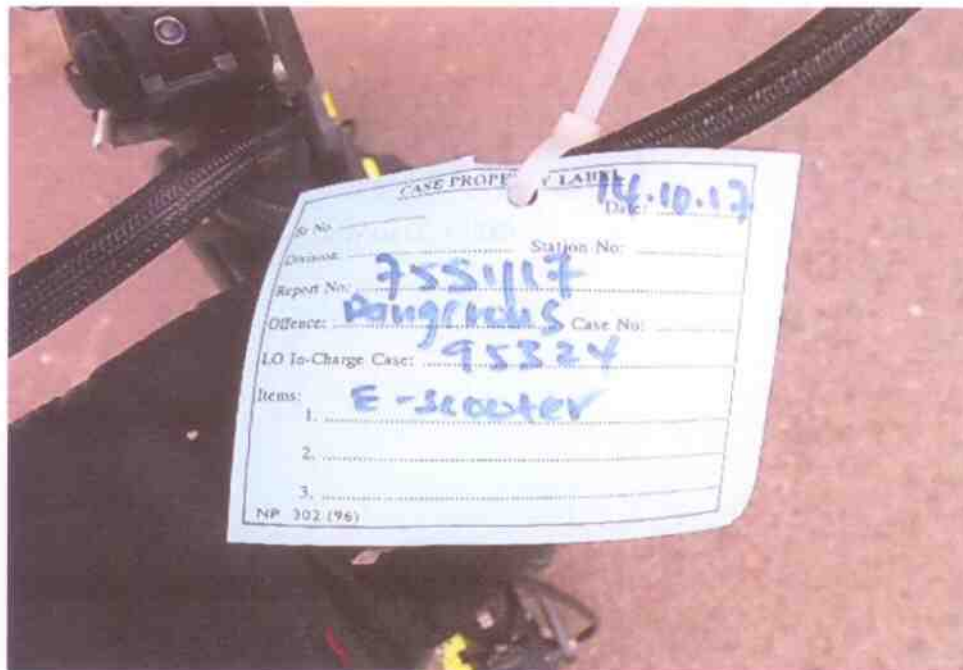
**Photo 1** shows the identification of the Electric Scooter with reference to Traffic Police Pound Report No. 7581/17.

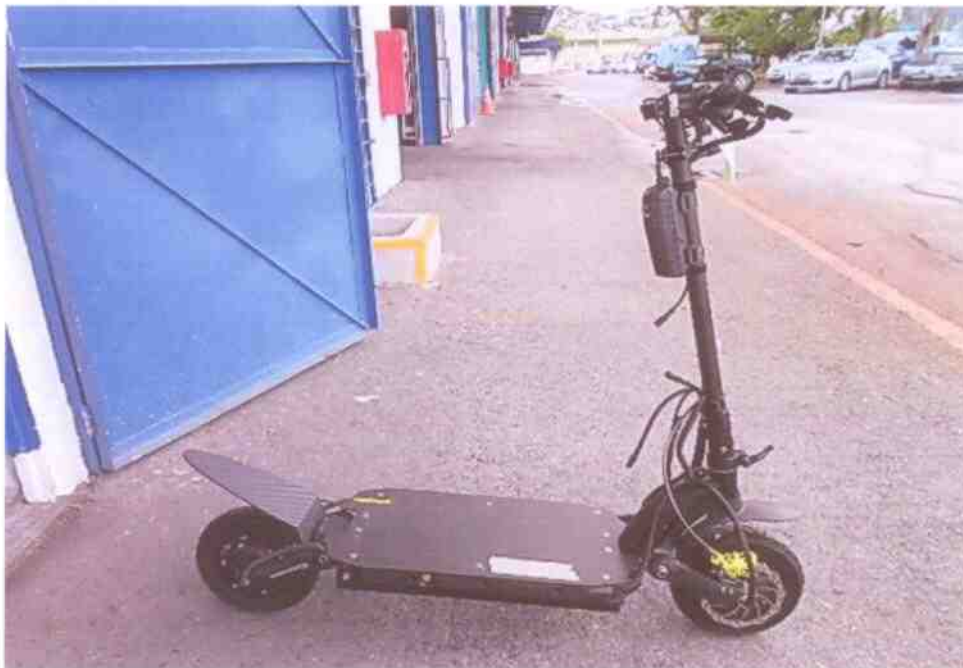
**Photo 2** shows the right portion of the Electric Scooter at time of inspection. A detailed inspection revealed that the Electric Scooter were in a good condition. No damages were noted on the Electric Scooter at the time of our inspection.

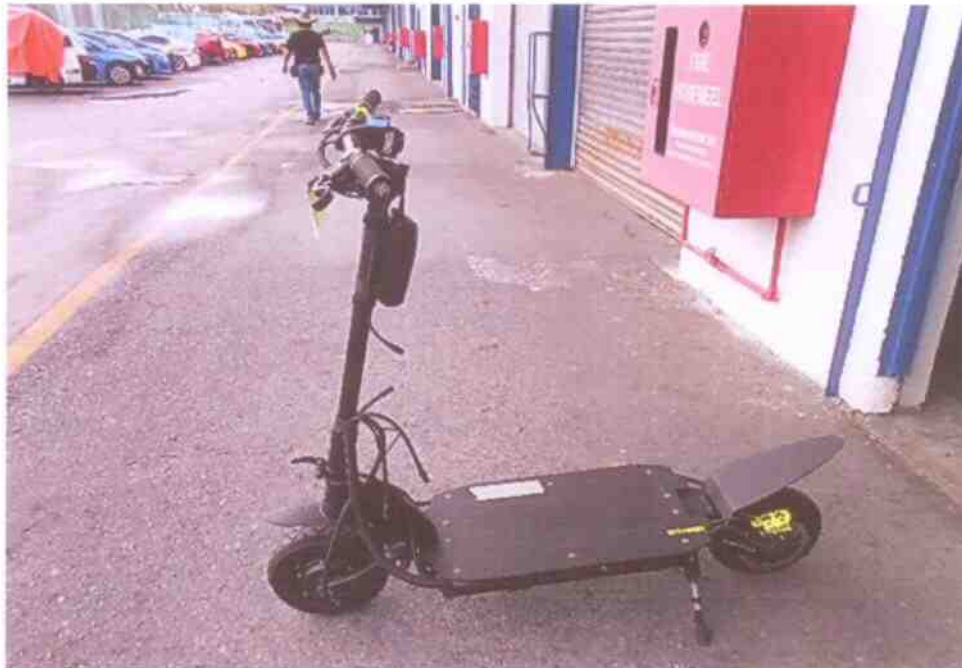
**Photo 3** shows the left portion of the Electric Scooter at time of inspection. A detailed inspection revealed that the Electric Scooter were in a good condition. No damages were noted on the Electric Scooter at the time of our inspection.

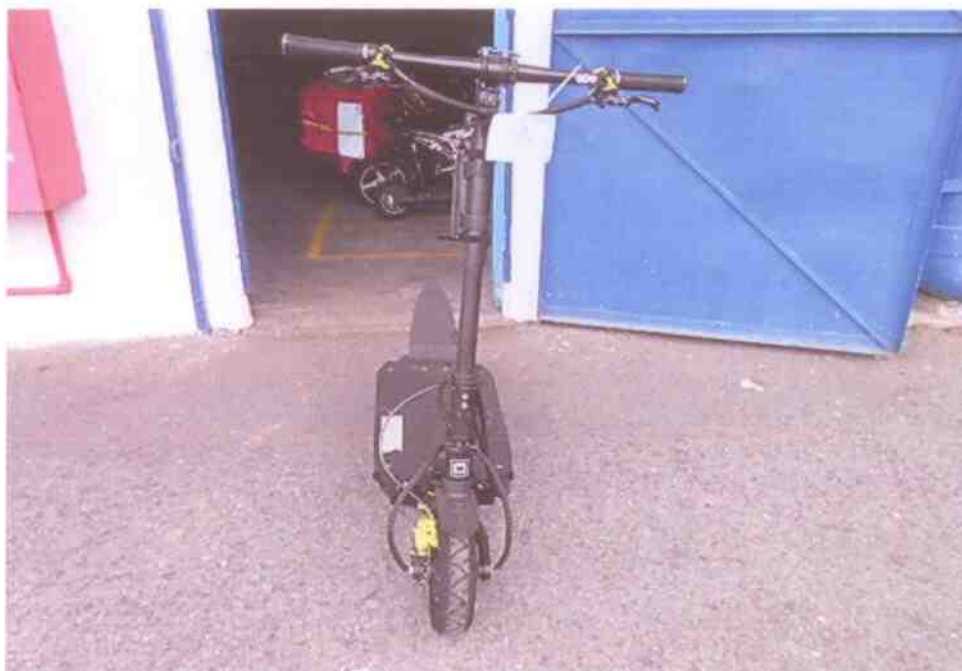
**Photo 4** shows the front portion of the Electric Scooter at time of inspection. A detailed inspection revealed that the Electric Scooter were in a good condition. No damages were noted on the Electric Scooter at the time of our inspection.

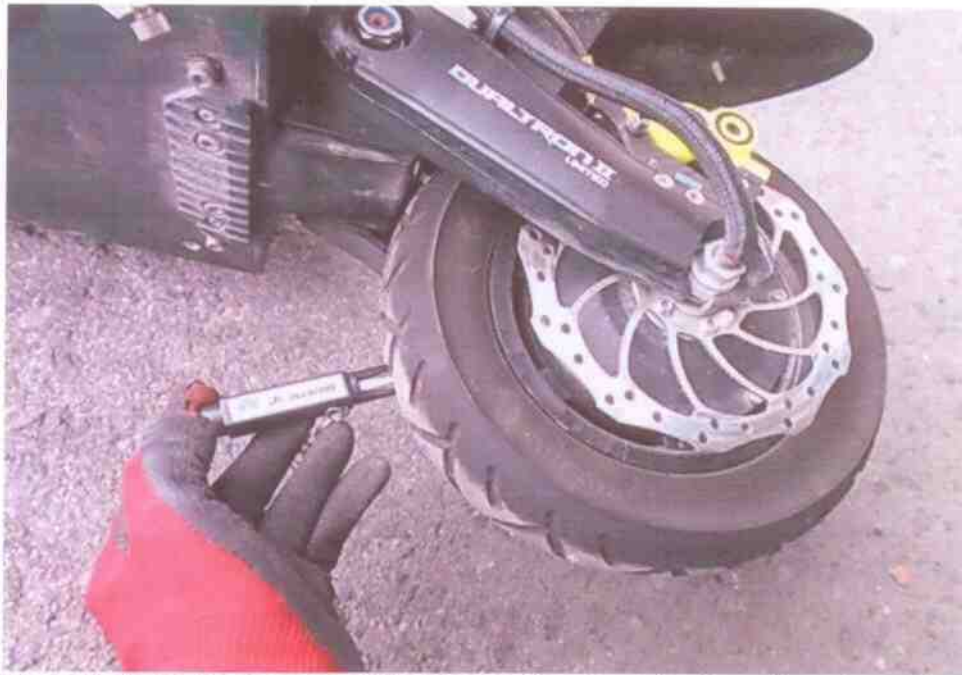
6. The tyres were wrapped around alloy wheel rim that was found to be without any significant damage. See photo 5 & 6 below

**Photo 5** shows the rear tyre of the Electric Scooter at the time of our inspection. The tread pattern of the 2 tyres was clearly visible. We did not observe any tear, burst mark(s) and/or punctured hole(s) on the sidewalls.

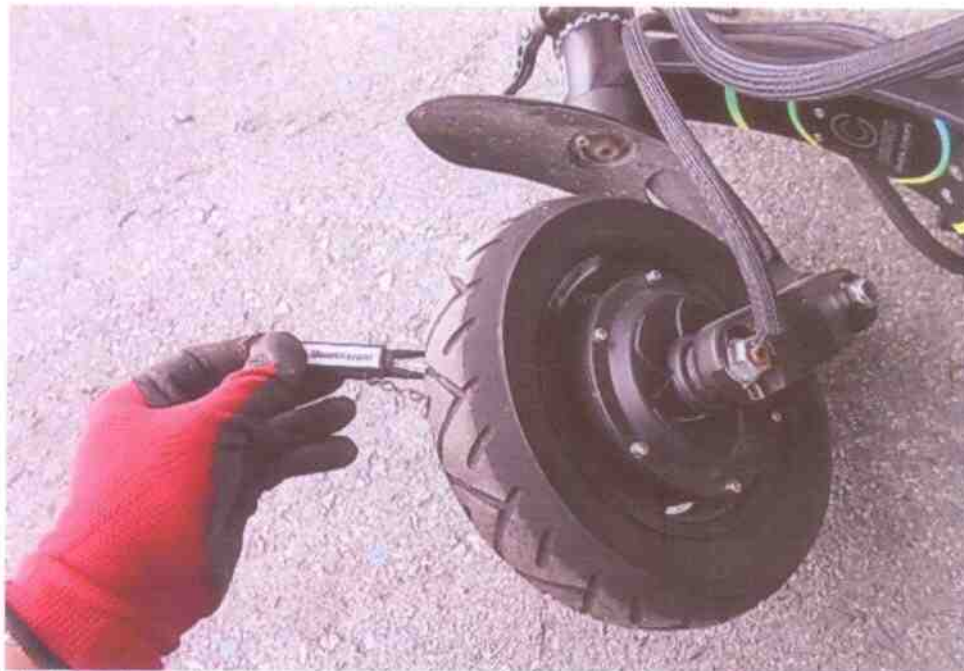
**Photo 6** shows the front tyre of the Electric Scooter at the time of our inspection. The tread pattern of the 2 tyres was clearly visible. We did not observe any tear, burst mark(s) and/or punctured hole(s) on the sidewalls.

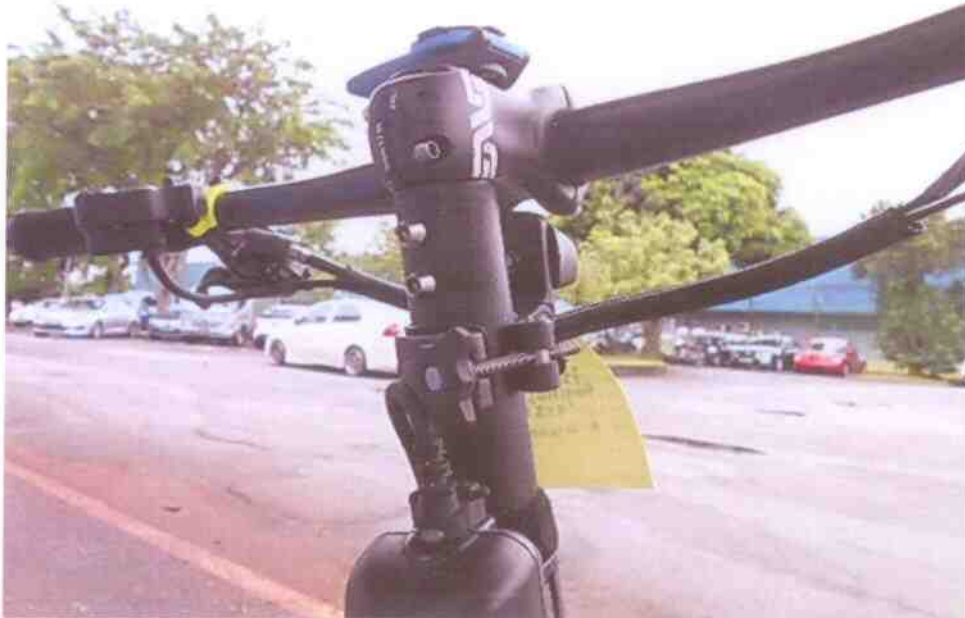
7. Our checks on the steering components of the Electric Scooter had revealed that its steering system was in serviceable condition & its front fork was found to be intact and undamaged. It was observed to be able to turn to full left & full right.

**Photo 7** shows steering components of the Electric Scooter had revealed that its steering system was in serviceable condition & its front fork was found to be intact and undamaged. It was observed to be able to turn to full left & full right.

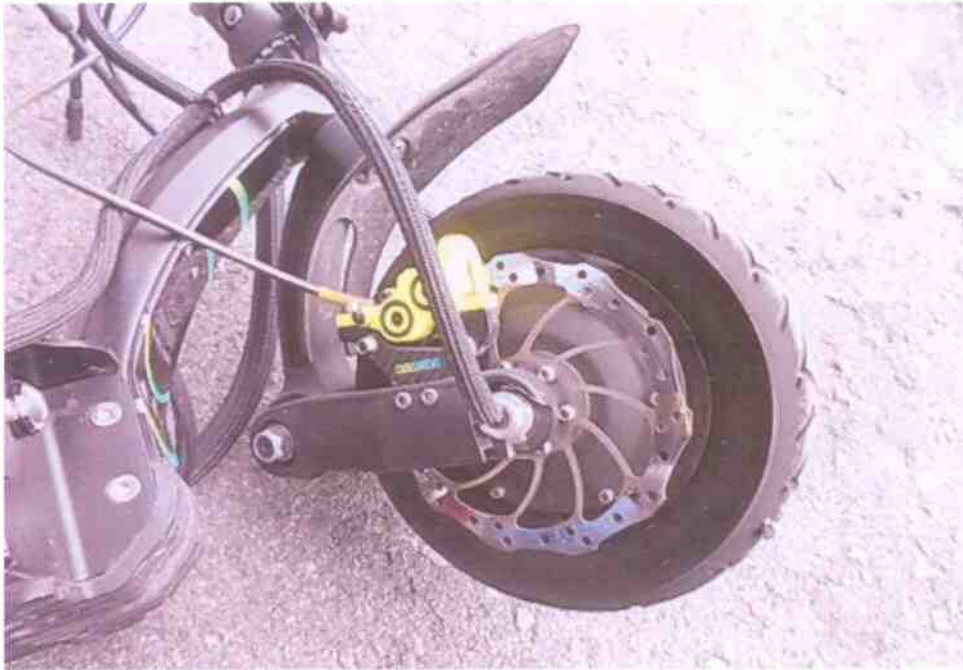
**Photo 8** shows steering components of the Electric Scooter had revealed that its steering system was in serviceable condition & its front fork was found to be intact and undamaged. It was observed to be able to turn to full left & full right.

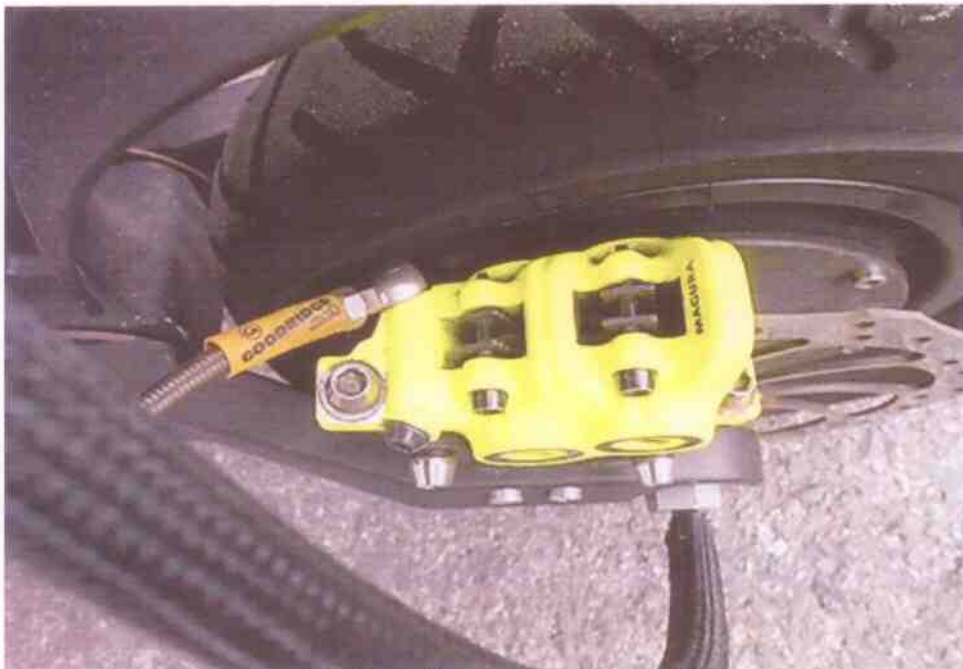
8. The braking system of the Electric Scooter was controlled by mechanical means (cables, callipers and springs). Our visual examination of the various components in the brake system, like the hand brake lever (left & right), brake callipers (front & rear), revealed that it was in a serviceable condition.

9. A static brake test was conducted on the Electric Scooter's front & rear brake. The test was conducted by lifting the tyre above ground & applies a little spinning action to it. The hand brake lever was then gripped in order to the stop the spinning tyre. The result was satisfactory. It stopped after gripping the hand brake to the fullest. It shows that the front & rear brake calliper was responding to the gripping action. This had appeared to indicate that both front & rear brake was in a serviceable condition.

**Photo 9** shows the front brake callipers, revealed that it was in a serviceable condition.

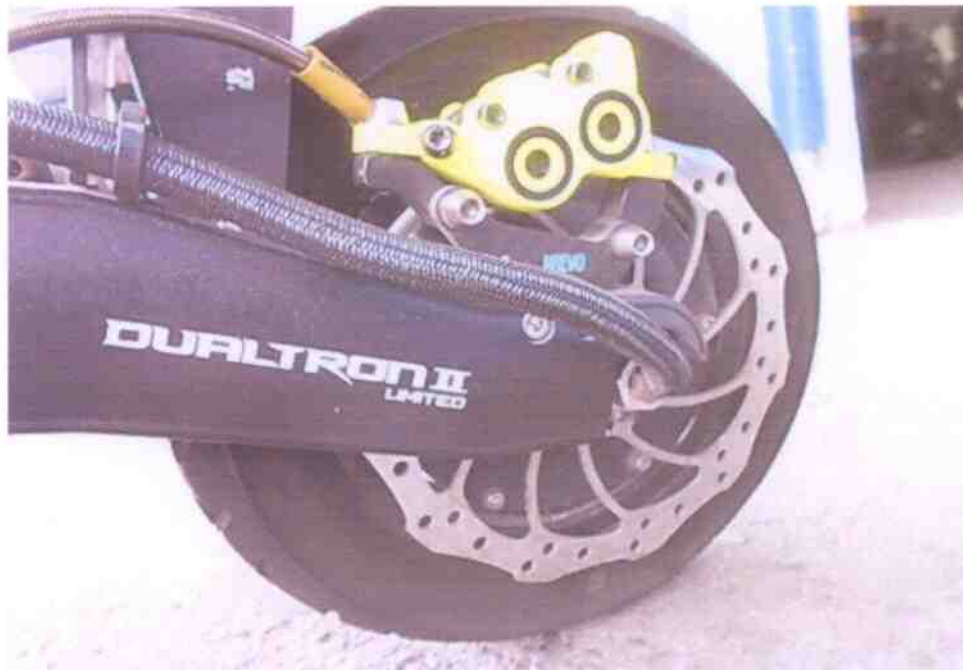
**Photo 10** shows the rear brake callipers, revealed that it was in a serviceable condition.
