Your Ref: TP/IP/38311/2017
Our Ref : CI/TPD18001912/D

01 February 2018

MECHANICAL INSPECTION REPORT OF MOTOR TAXI SHB 9616J

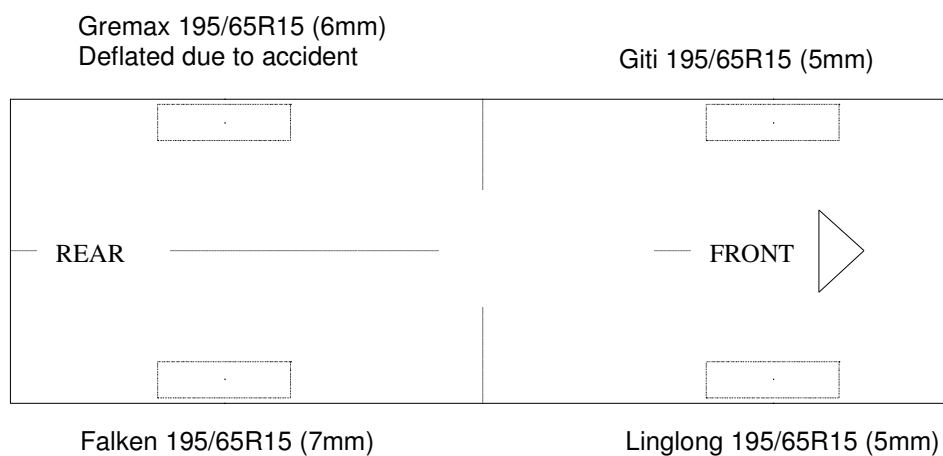
7. The condition of the Motor Taxi's 4 tyres was observed to be in serviceable condition. I did not find any tear, cut or burst mark(s) on the outer and the inner sidewalls as well as across the tread of the 4 tyres. The 4 tyres were also sufficiently inflated for vehicular operation except for the rear left tyre, which was observed to be deflated as a result of the accident. The tyre brand, tyre size and remaining tread depth of the 4 tyres were recorded as follows:-

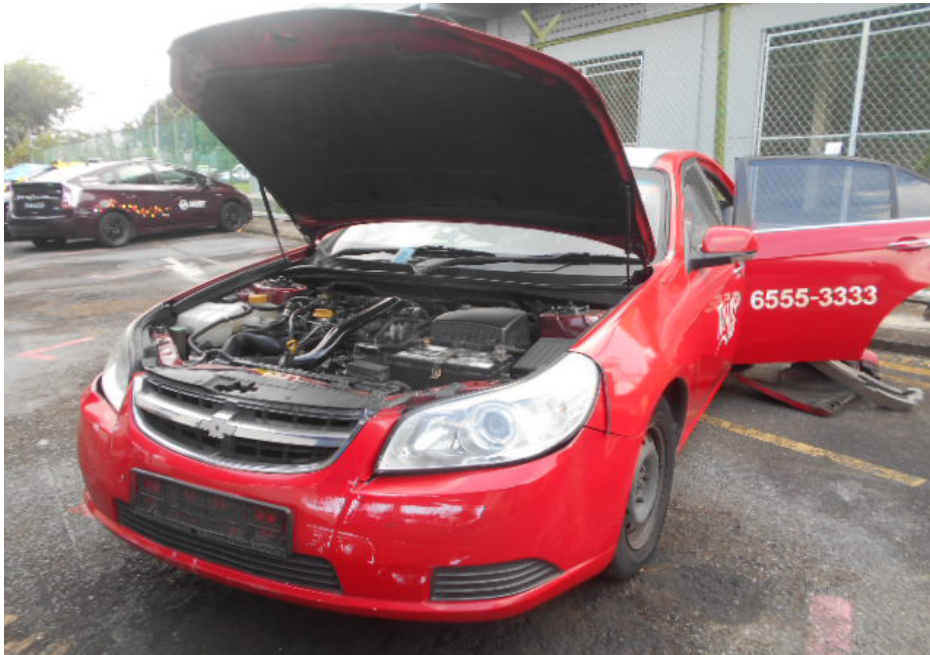
Photo 1 shows a general view of the front left body of the Motor Taxi at the time of my first inspection. The Motor Taxi was observed to have sustained damages at its frontal portion and rear portion. The front number plate, front bonnet, front grille, front bumper reinforcement and front support panel were amongst the body parts at the frontal portion that were damaged. The mileage of the Motor Taxi was recorded to be 739,101km.

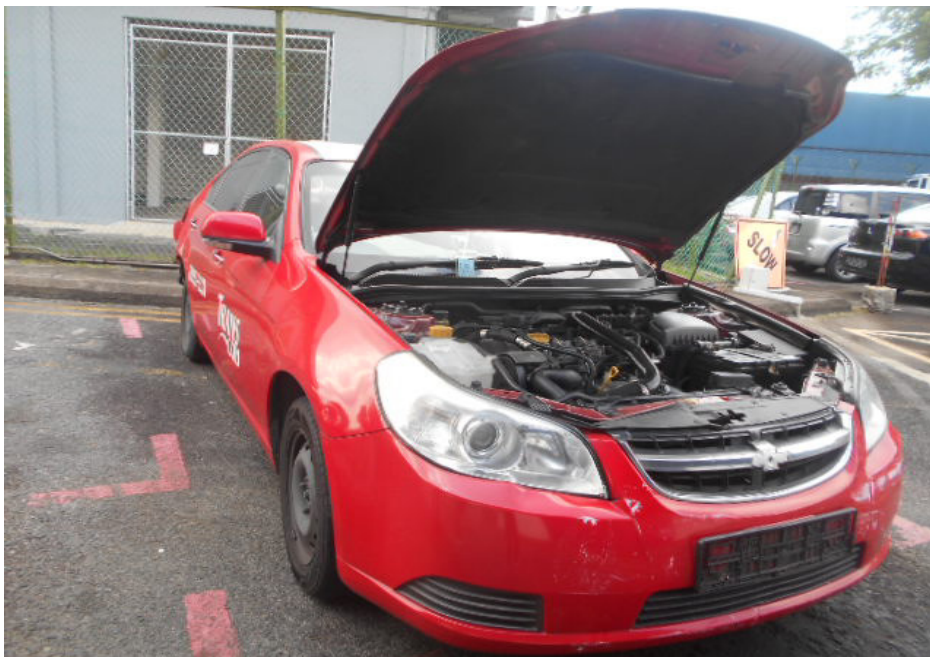
Photo 2 shows a general view of the front right body of the Motor Taxi at the time of my inspection. The Motor Taxi was observed to have sustained damages at its frontal portion and rear portion.

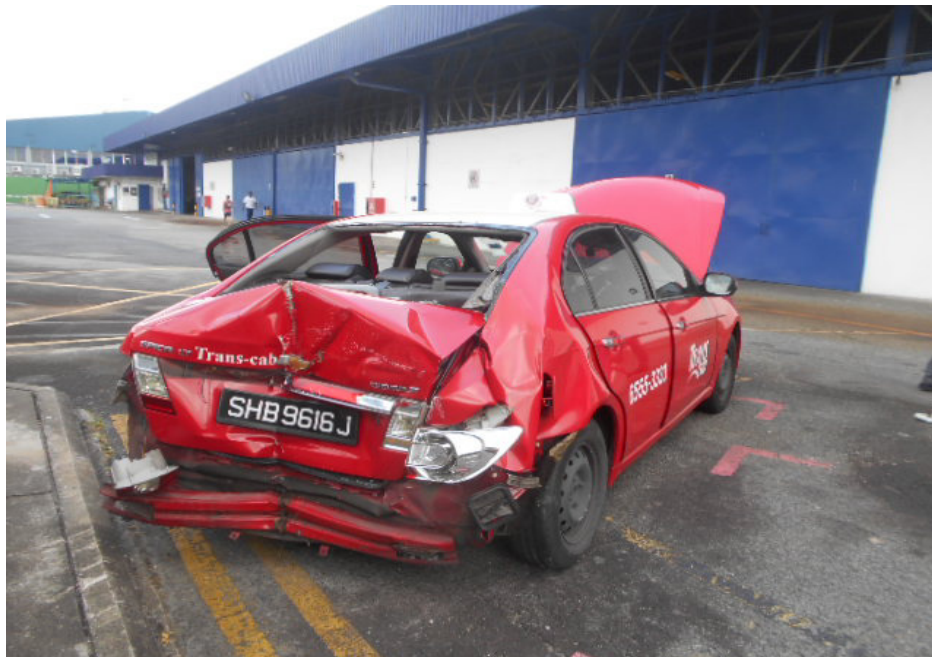
Photo 3 shows a general view of the Motor Taxi's rear right body at the time of my inspection. The rear bumper, rear bootlid, rear taillamps, rear right fender, rear bootlid lamps and rear windscreen were amongst the body parts at the rear portion of the Motor Taxi that were observed to have been damaged as a result of the accident.

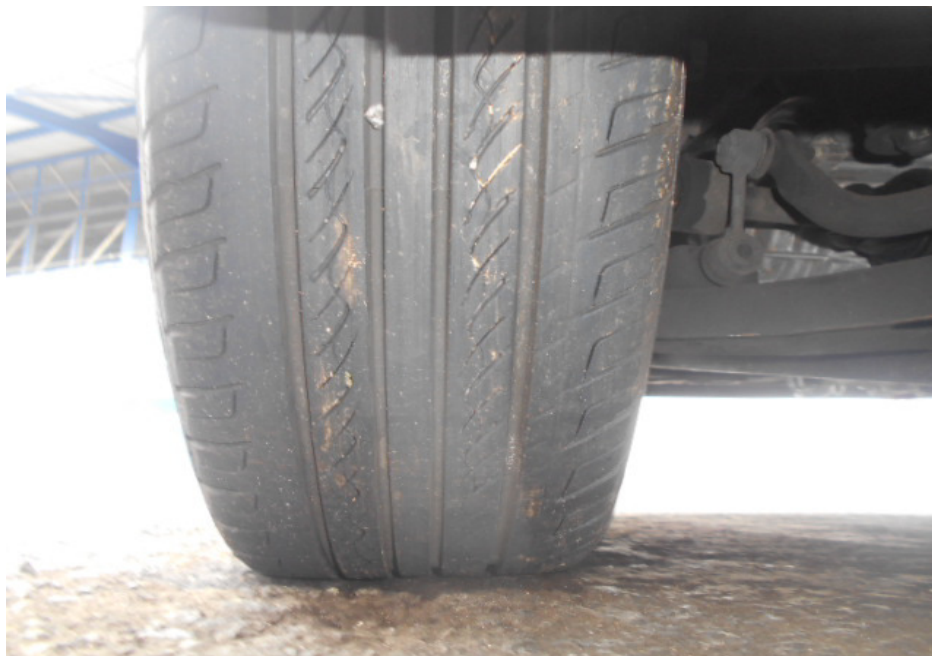
Photo 4 shows the condition of the front left tyre of the Motor Taxi, which was observed to be in serviceable condition with remaining tread depth of approximately 5mm. The tyre, which was wrapped around standard wheel rim, was also observed to be sufficiently inflated for vehicular operation. There was no tear, cut or burst mark(s) on the outer and the inner sidewalls as well as across the tread of the tyre.

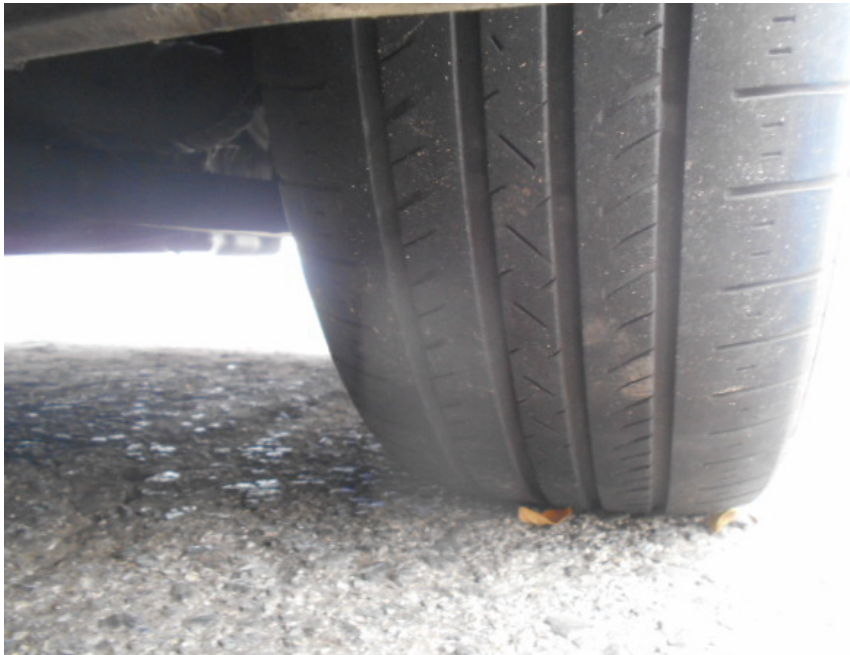
Photo 5 shows the condition of the front right tyre of the Motor Taxi, which was observed to be in serviceable condition with remaining tread depth of approximately 5mm. The tyre, which was wrapped around standard wheel rim, was also observed to be sufficiently inflated for vehicular operation. A slight dent was observed on the front right wheel rim as a result of the accident.

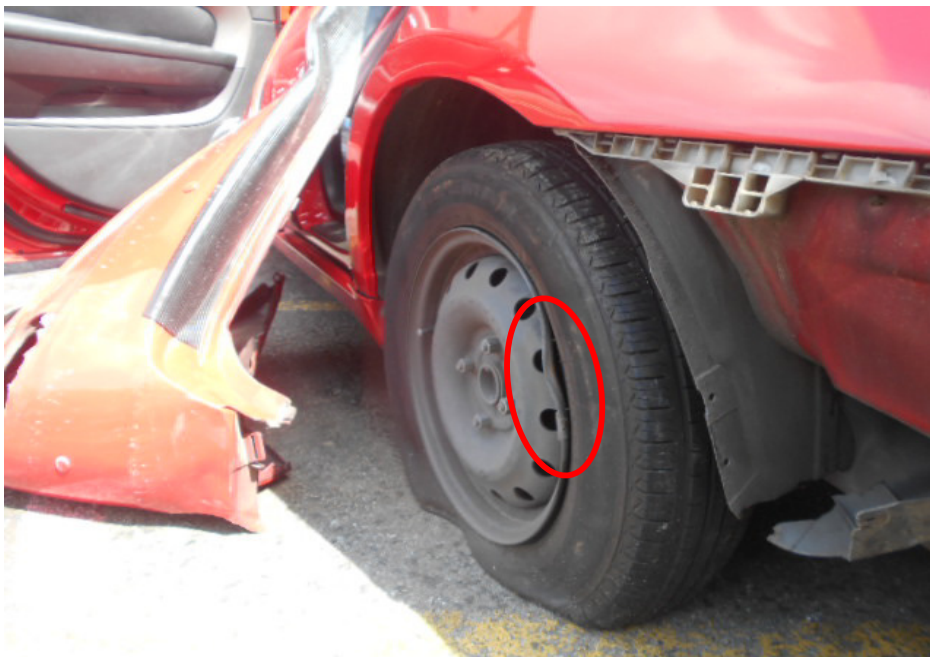
Photo 6 shows a general view of the rear left wheel rim and rear left tyre of the Motor Taxi. The rear left wheel rim was observed to be dented (circled) while the rear left tyre was observed to be deflated. Both were a result of the accident.

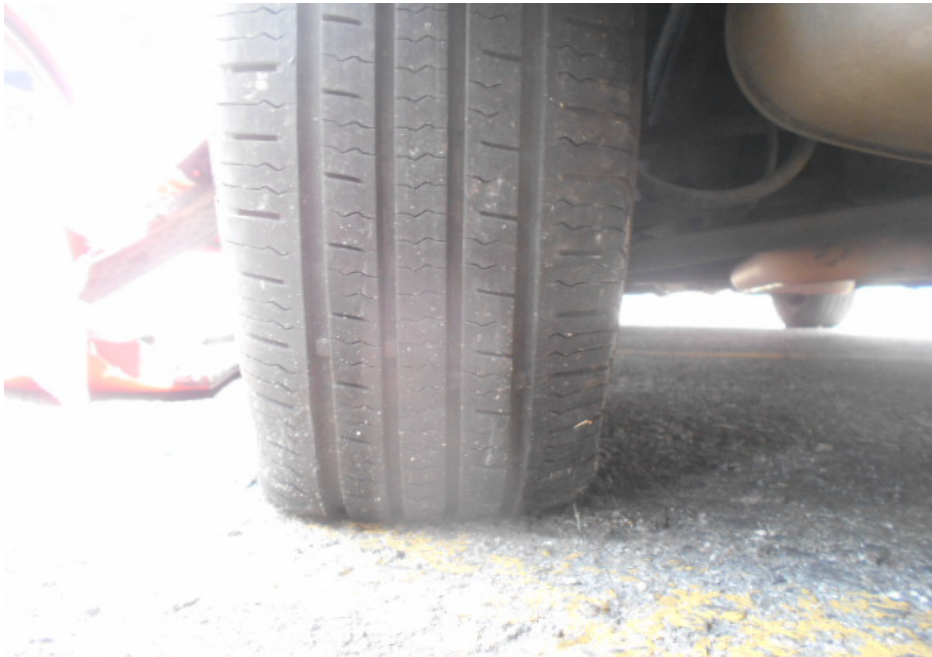
Photo 7 shows the condition of the rear left tyre of the Motor Taxi, which was observed to be in serviceable condition with remaining tread depth of approximately 6mm. The tyre was observed to be deflated as a result of the accident.

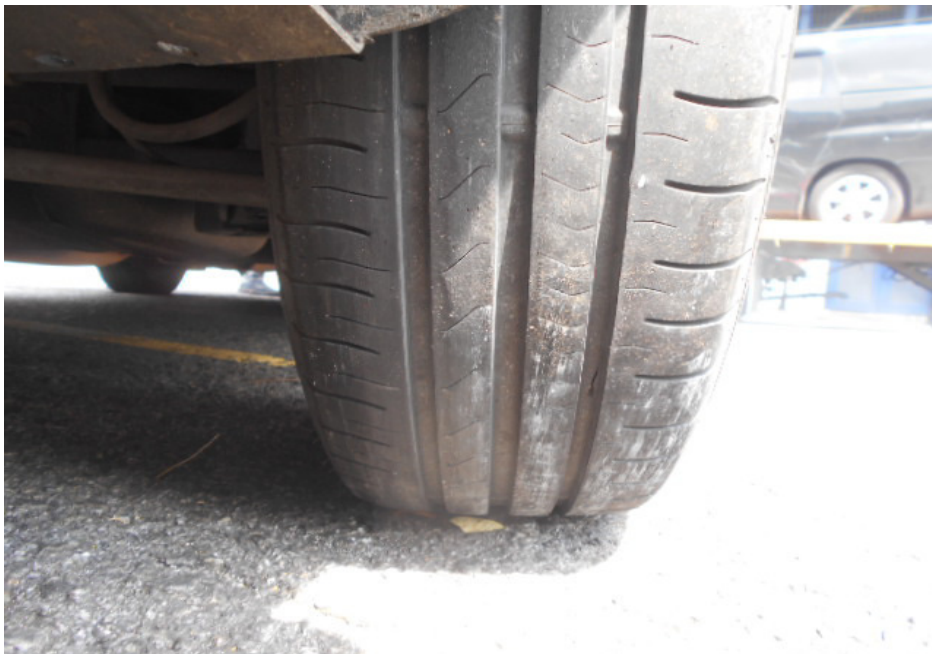
Photo 8 shows the condition of the rear right tyre of the Motor Taxi, which was observed to be in serviceable condition with remaining tread depth of approximately 7mm. The tyre, which was wrapped around standard wheel rim, was also observed to be sufficiently inflated for vehicular operation.

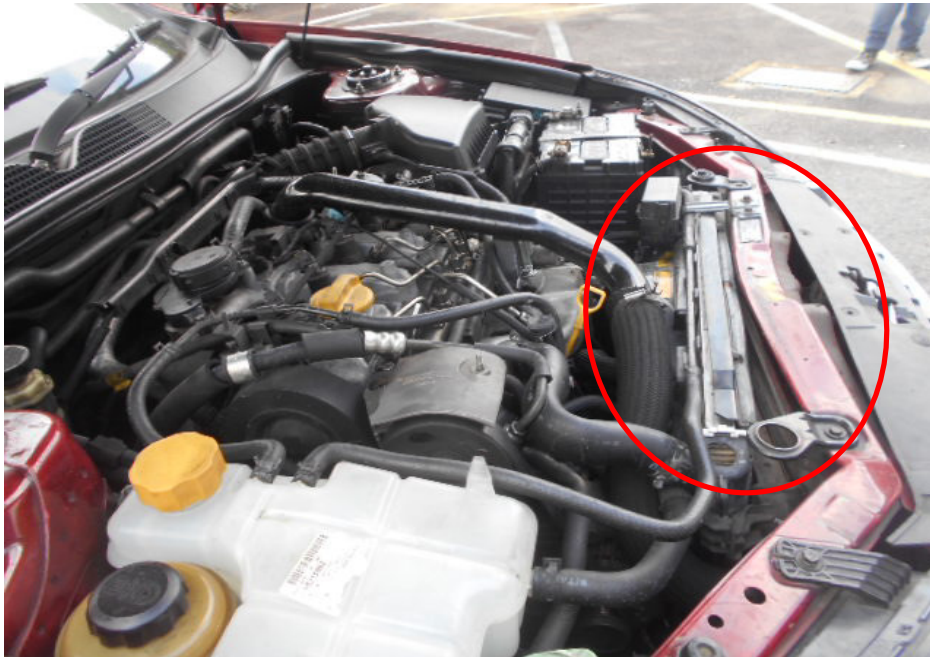
9. Upon examination of the Motor Taxi's engine compartment, I had observed parts that were mainly towards the front of the engine compartment pushed inwards as a result of the impact force onto the frontal body of the Motor Taxi. Parts like the front support panel, air condenser and radiator were affected.

Photo 9 shows a general view of the Motor Taxi's engine compartment. The parts that were mainly towards the front of the engine compartment (circled) were pushed inwards as a result of the impact force onto the front body of the Motor Taxi. Parts like the front support panel, air condenser and radiator were affected.

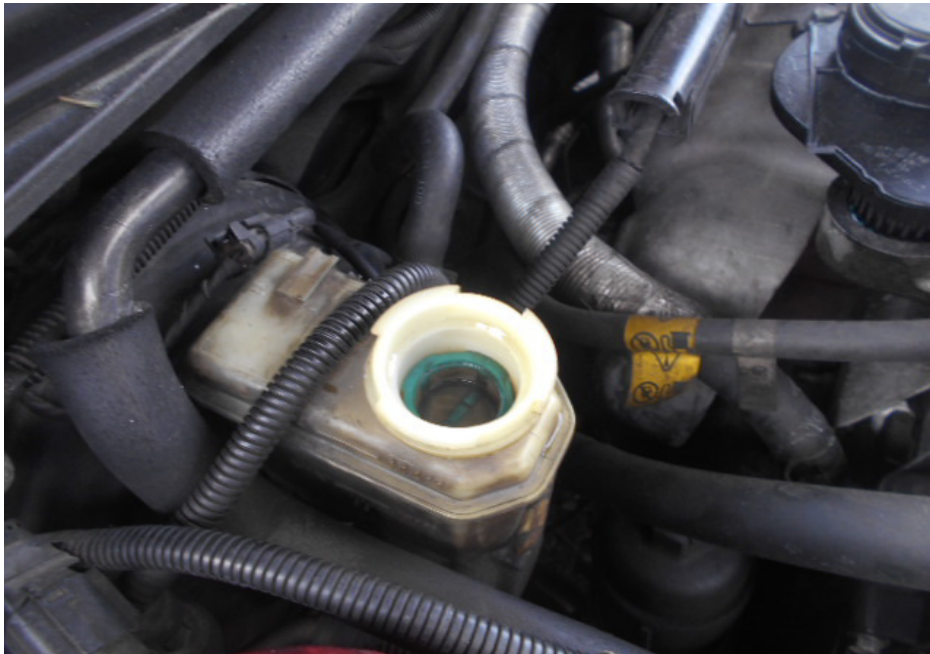
Photo 10 shows the brake fluid reservoir of the Motor Taxi at the time of my inspection. The brake fluid was observed to be of sufficient level and without any visible contamination.

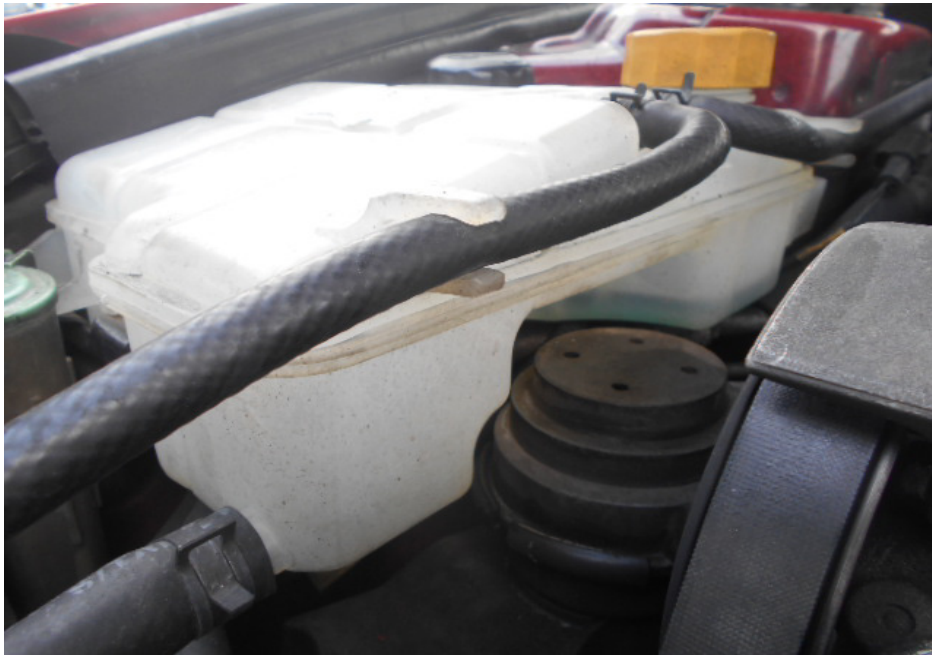
10. The brake fluid, power steering fluid and engine oil were all found to be of sufficient level for operating purposes. Visually, there was also no contamination found to these fluids. The engine coolant was however observed to have leaked from the Motor Taxi's radiator, which was damaged due to the accident.

Photo 11 shows the engine coolant reservoir tank of the Motor Taxi at the time of my inspection. The engine coolant was observed to be of insufficient level. This was due to leakage of engine coolant from the Motor Taxi's damaged radiator.

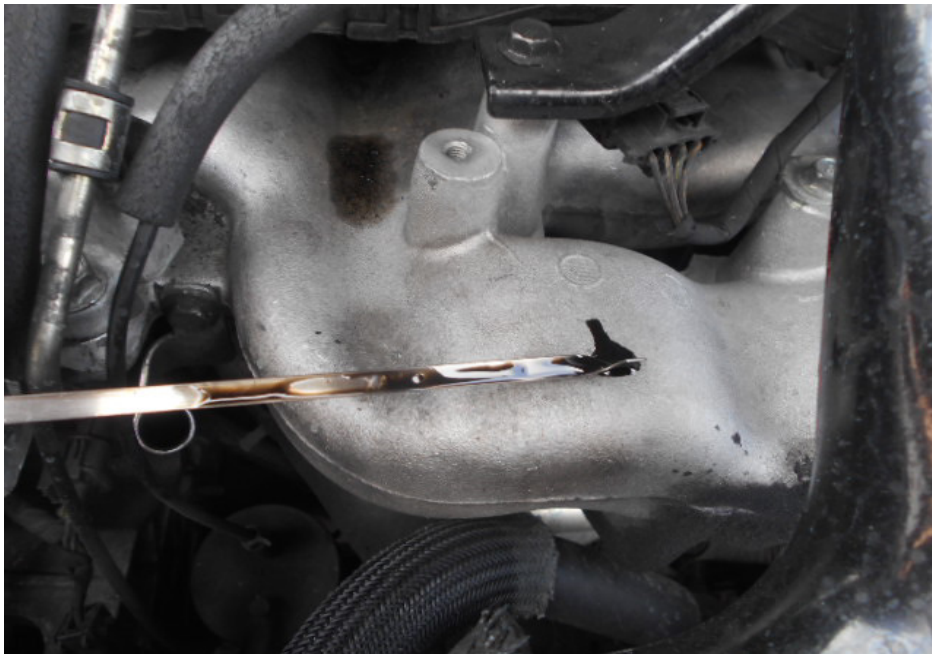
Photo 12 shows the engine oil dip stick of the Motor Taxi at the time of my inspection. The engine oil was observed to be of sufficient level and without any visible contamination.

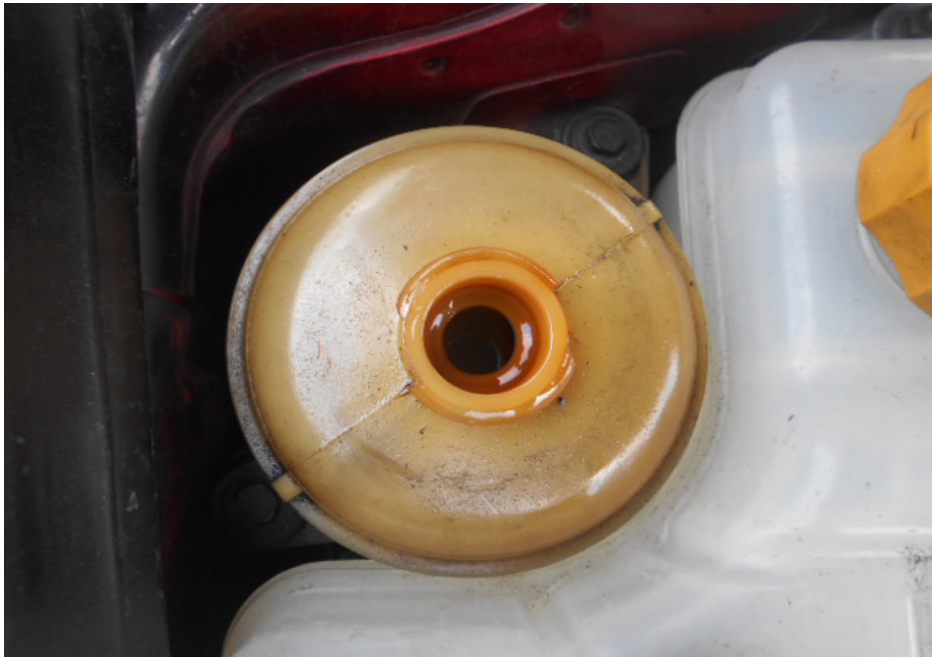
Photo 13 shows the power steering fluid reservoir tank of the Motor Taxi at the time of my inspection. The power steering fluid was observed to be of sufficient level and without any visible contamination.

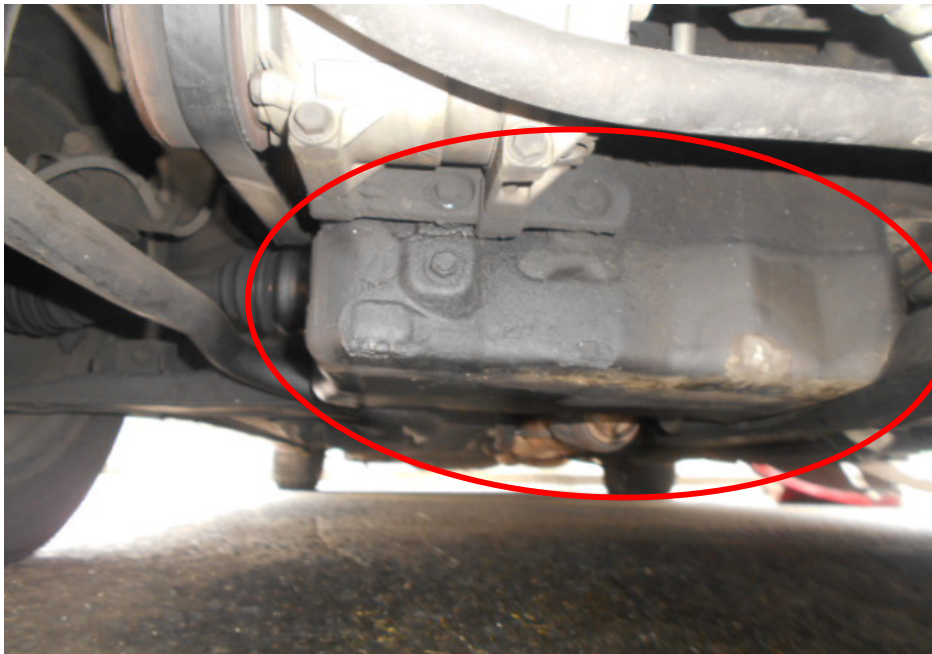
11. My checks on the underside of the Motor Taxi revealed fluid stains on the engine oil sump and some undercarriage components of the Motor Taxi. This was due to the leakage of engine fluid. I also note the presence of dirt and dust particles accumulated around the fluid stain areas, indicating that the fluid leak was pre-existing for a period of time and not a result of the accident.

Photo 14 shows the underside of the Motor Taxi. Fluid stains were observed on the engine oil sump (circled) and some undercarriage components of the Motor Taxi. This was due to the leakage of engine fluid. I also note the presence of dirt and dust particles accumulated around the fluid stain areas, indicating that the fluid leak was pre-existing for a period of time and not a result of the accident.

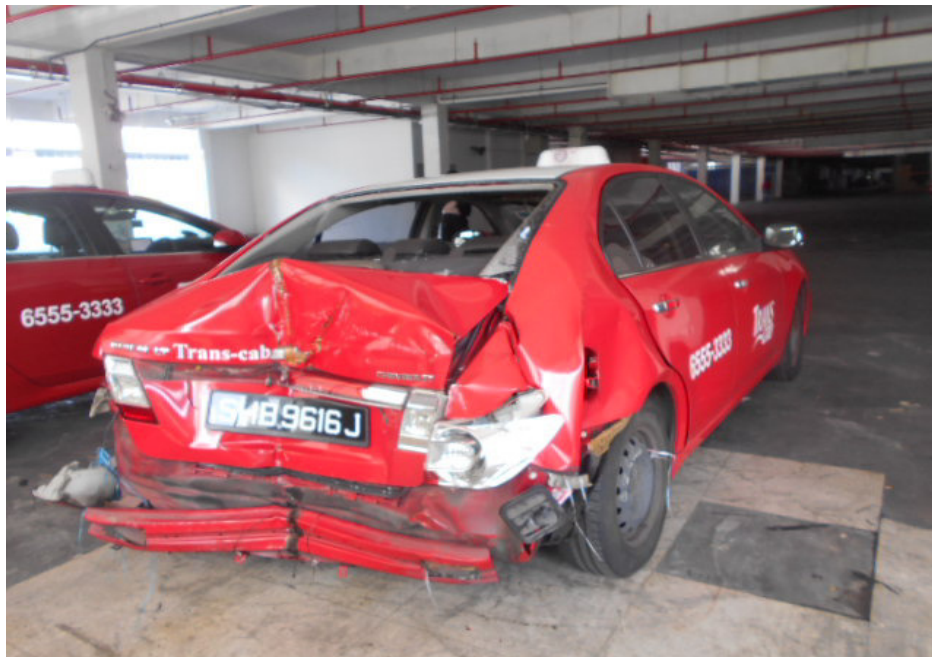
Photo 15 shows a general view of the Motor Taxi during the second inspection on 22 December 2017 at the premises of Transcab Auto Services Pte Ltd.

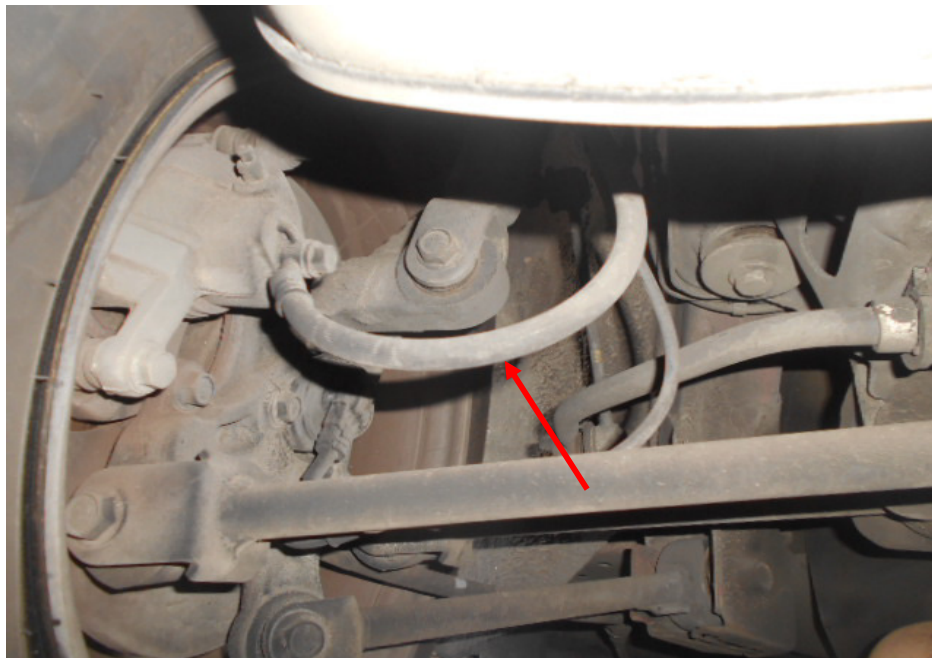
15. Static brake tests conducted on the Motor Taxi revealed no abnormality. The brake booster had responded well to the various tests conducted. There was also no abnormal movement of the brake pedal when it was depressed. In general, the static brake tests had suggested that there was no internal leakage of pressure/vacuum in the braking system of the Motor Taxi. The braking system of the Motor Taxi was likely to be in serviceable condition at the material time. This was taking into consideration that the brake fluid was of sufficient level, and also that there was no sign(s) of brake fluid leakage along the brake hoses and brake pipes.

Photo 16 shows the brake hose/pipe (arrowed) at the rear left wheel of the Motor Taxi. There was no brake fluid leak observed. Static tests of the Motor Taxi's braking system had indicated that there was no internal leakage of pressure/vacuum. Hence the braking system was likely to be in serviceable condition at the material time of accident. The undercarriage components of the Motor Taxi were also all found to be intact and without any visible damage.

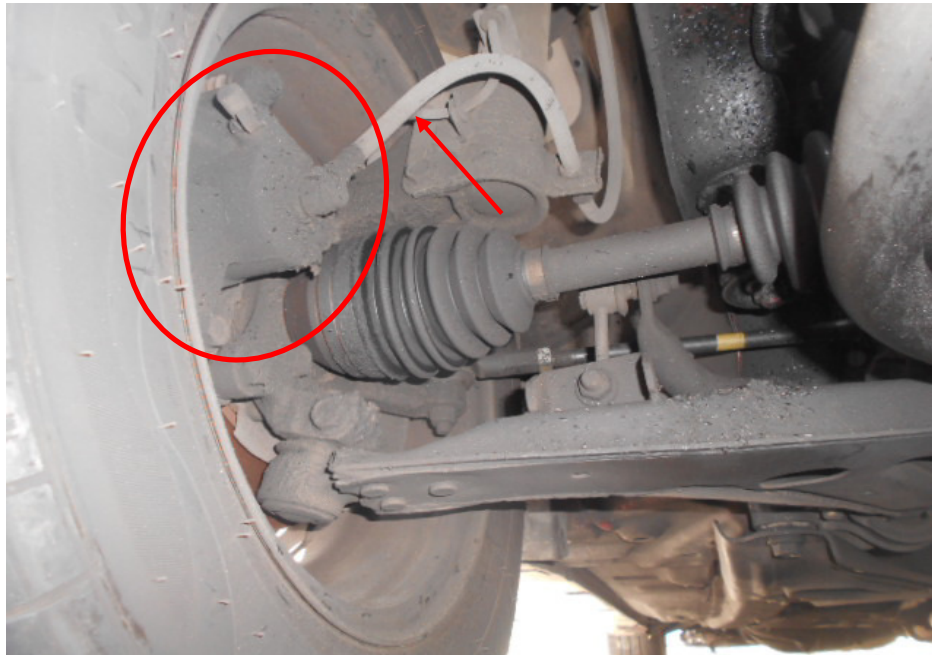
Photo 17 shows the brake hose/pipe (arrowed) at the front right wheel of the Motor Taxi. There was no brake fluid leak observed. Visual examination of the various components of the braking system like the brake caliper (circled), brake booster, brake pedal etc had revealed all to be intact and without visible damage.

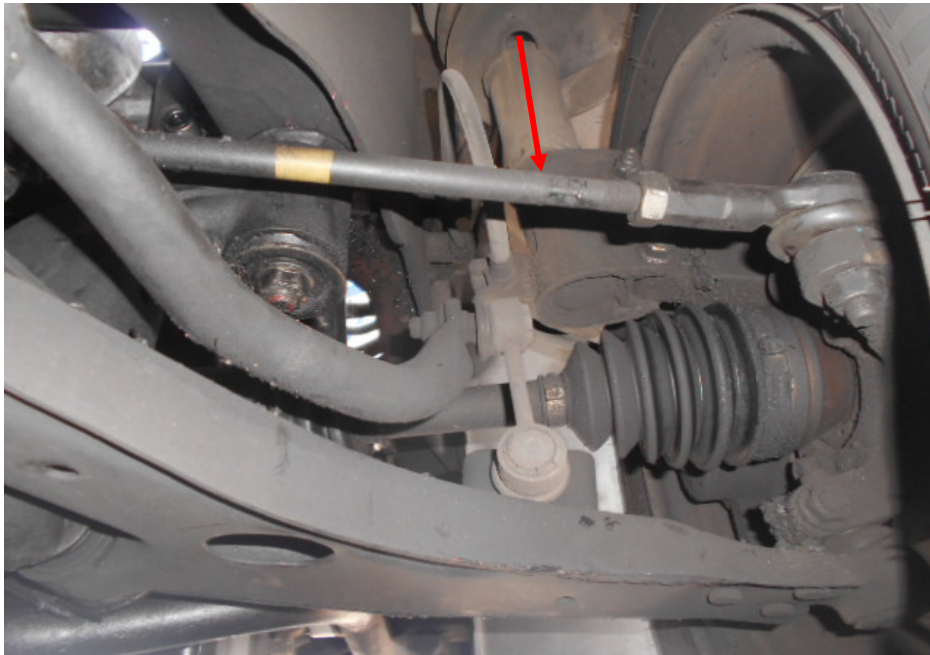
Photo 19 shows the various undercarriage components at the front right wheel of the Motor Taxi, in particular the steering tie rod (arrowed). The various steering components were all found to be intact, suggesting that the steering system of the Motor Taxi was likely to be in serviceable condition at the material time of accident.

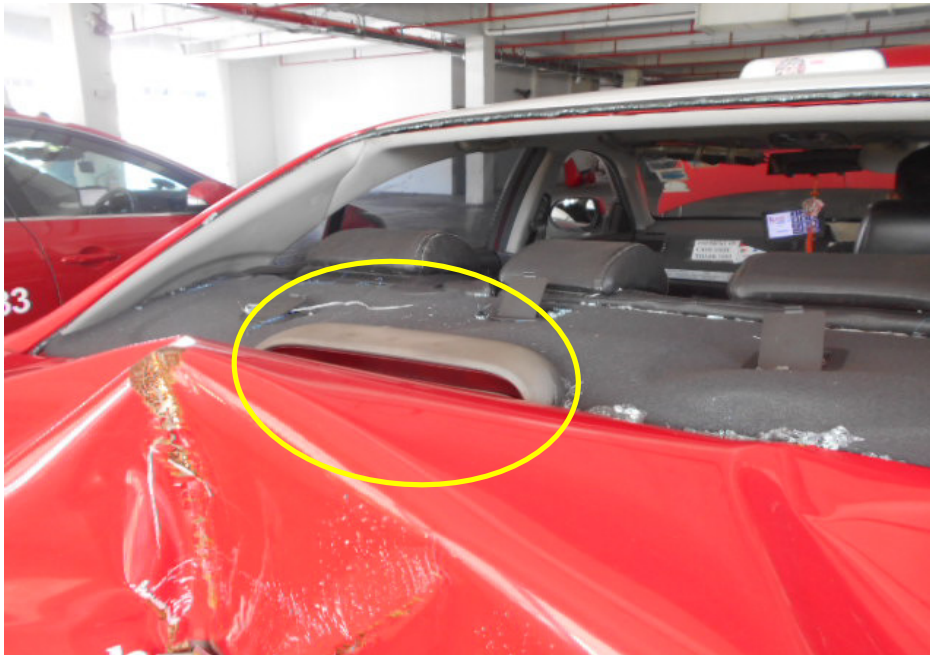
24. During my inspection of the Motor Taxi, I had observed that the bulbs of the Motor Taxi's brake lights were in working condition. The brake lights at the rear left taillamp, rear right taillamp and the third brake light illuminated when the brake pedal of the Motor Taxi was depressed. Co-relating this observations with the observations from the video recording, it would appear that the brake pedal of the Motor Taxi was not depressed by the driver at the material time of accident. See photo 20 & 21.

Photo 20 shows the third brake light (circled) of the Motor Taxi. The bulbs of the Motor Taxi's brake lights were observed to be in working condition at the time of my inspection. The brake lights at the rear left taillamp, rear right taillamp and the third brake light illuminated when the brake pedal of the Motor Taxi was depressed.

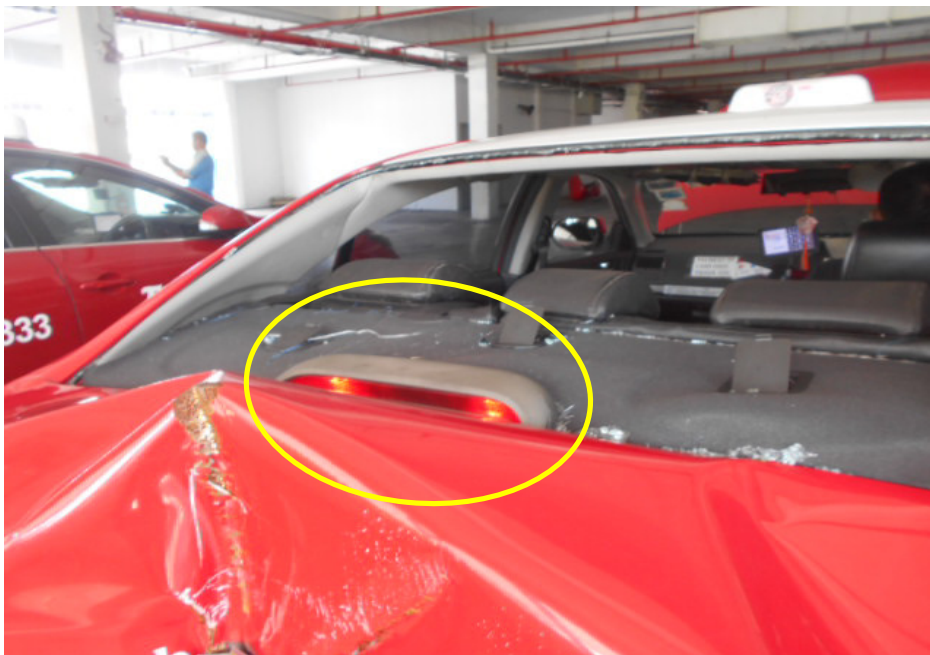
Photo 21 shows the brake light (circled) for the Motor Taxi's third brake lamp illuminated upon stepping on the brake pedal.
