Your Ref: TP/IP/38311/2017  
Our Ref : CI/TPD18001912/D

01 February 2018

**MECHANICAL INSPECTION REPORT OF MOTOR TAXI SHB 9616J**

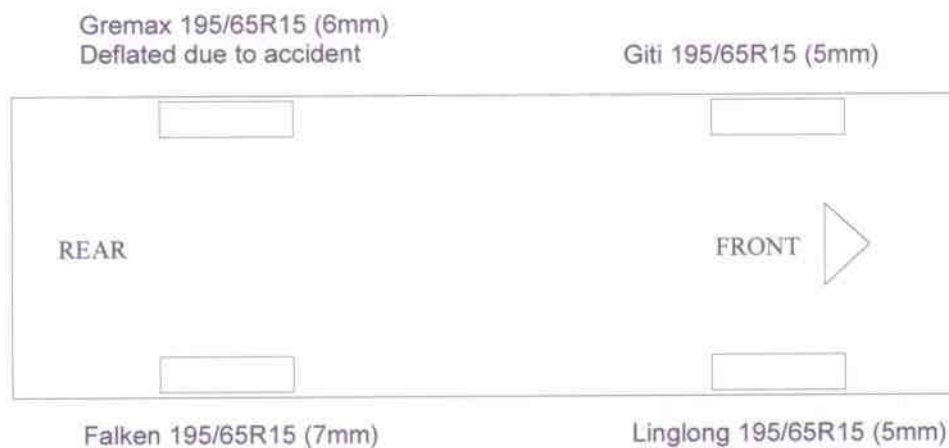
7. The condition of the Motor Taxi's 4 tyres was observed to be in serviceable condition. I did not find any tear, cut or burst mark(s) on the outer and the inner sidewalls as well as across the tread of the 4 tyres. The 4 tyres were also sufficiently inflated for vehicular operation except for the rear left tyre, which was observed to be deflated as a result of the accident. The tyre brand, tyre size and remaining tread depth of the 4 tyres were recorded as follows:-

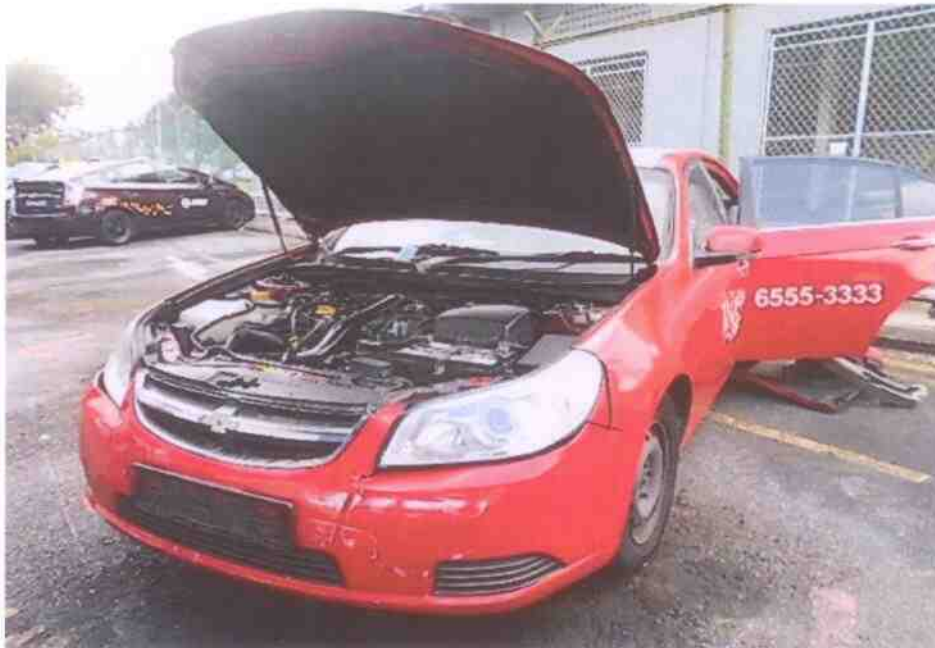
5. The mileage of the Motor Taxi was recorded to be 739,101km at the time of the 2 inspections.
6. The Motor Taxi had sustained impact damage at its frontal portion and rear portion. Its front bumper, front bonnet, front grille, front bumper reinforcement and front support panel were amongst the body parts at the frontal portion that were damaged. Its rear bumper, rear bootlid, rear taillamps, rear end panel, rear right fender and rear windscreen were amongst the body parts at the rear portion that were damaged as a result of the accident.

**Photo 1** shows a general view of the front left body of the Motor Taxi at the time of my first inspection. The Motor Taxi was observed to have sustained damages at its frontal portion and rear portion. The front number plate, front bonnet, front grille, front bumper reinforcement and front support panel were amongst the body parts at the frontal portion that were damaged. The mileage of the Motor Taxi was recorded to be 739,101km.

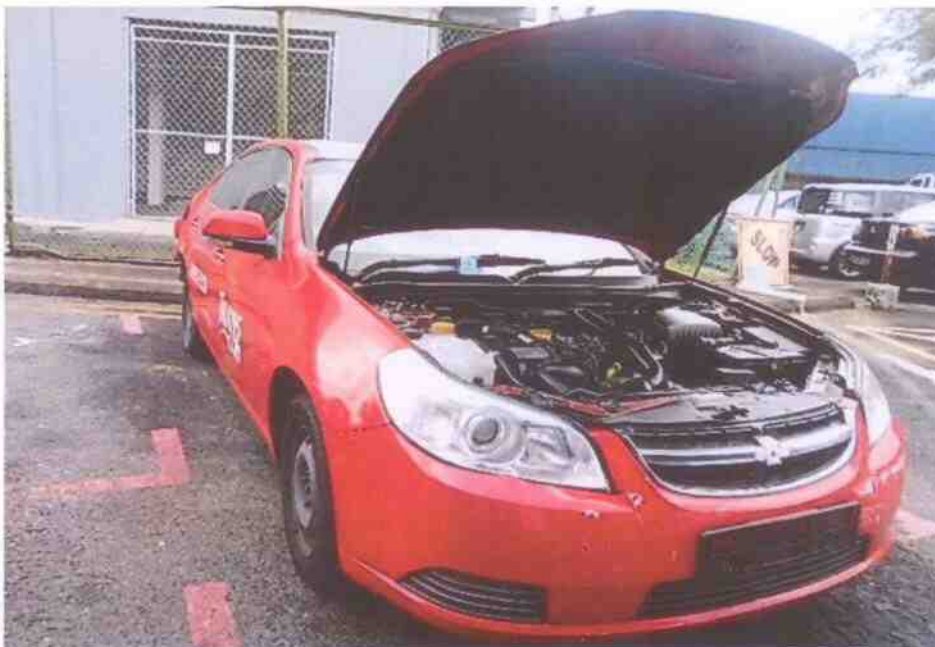
**Photo 2** shows a general view of the front right body of the Motor Taxi at the time of my inspection. The Motor Taxi was observed to have sustained damages at its frontal portion and rear portion.

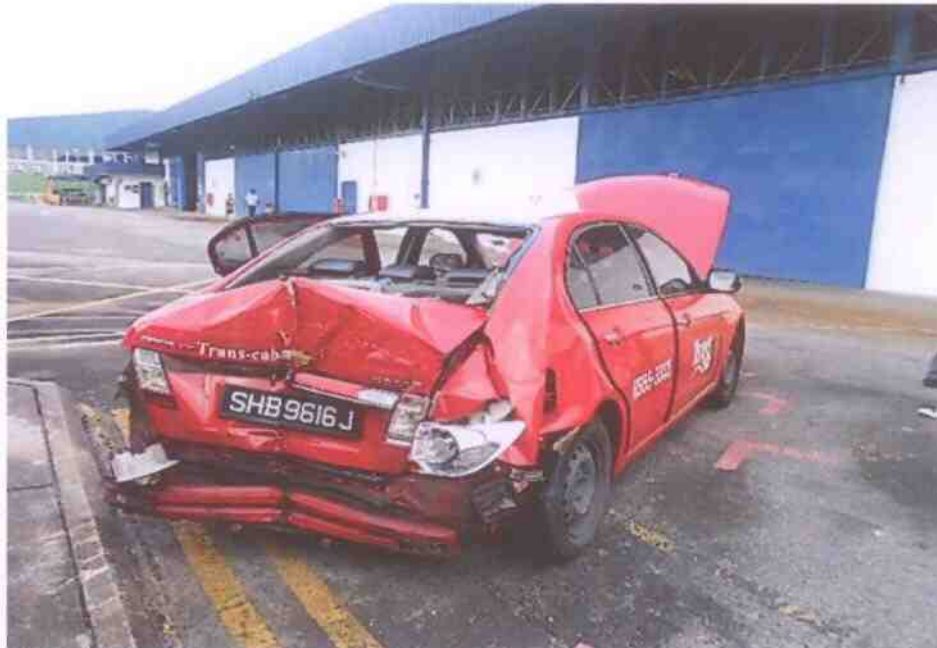
**Photo 3** shows a general view of the Motor Taxi's rear right body at the time of my inspection. The rear bumper, rear bootlid, rear taillamps, rear right fender, rear bootlid lamps and rear windscreen were amongst the body parts at the rear portion of the Motor Taxi that were observed to have been damaged as a result of the accident.

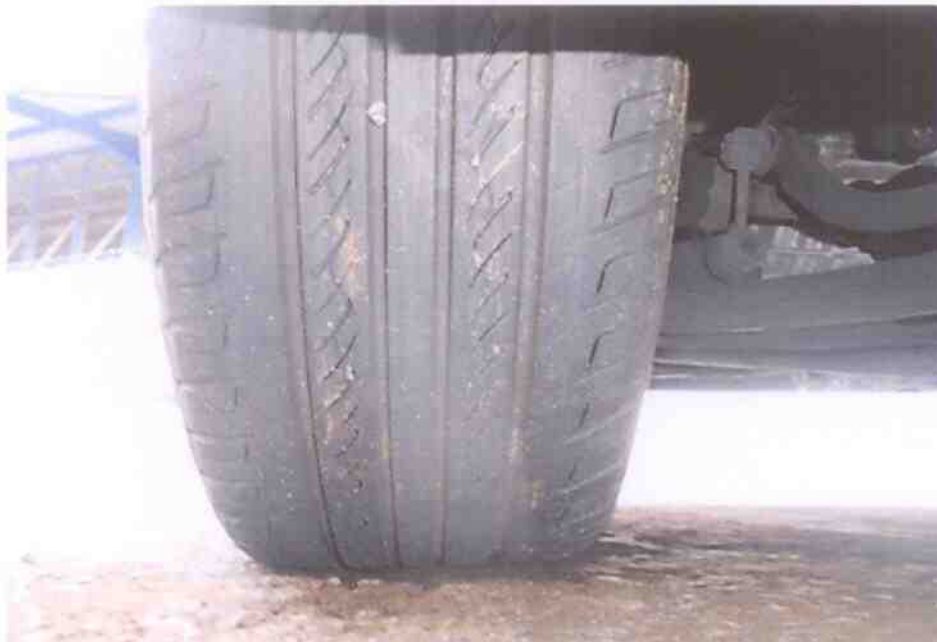
**Photo 4** shows the condition of the front left tyre of the Motor Taxi, which was observed to be in serviceable condition with remaining tread depth of approximately 5mm. The tyre, which was wrapped around standard wheel rim, was also observed to be sufficiently inflated for vehicular operation. There was no tear, cut or burst mark(s) on the outer and the inner sidewalls as well as across the tread of the tyre.

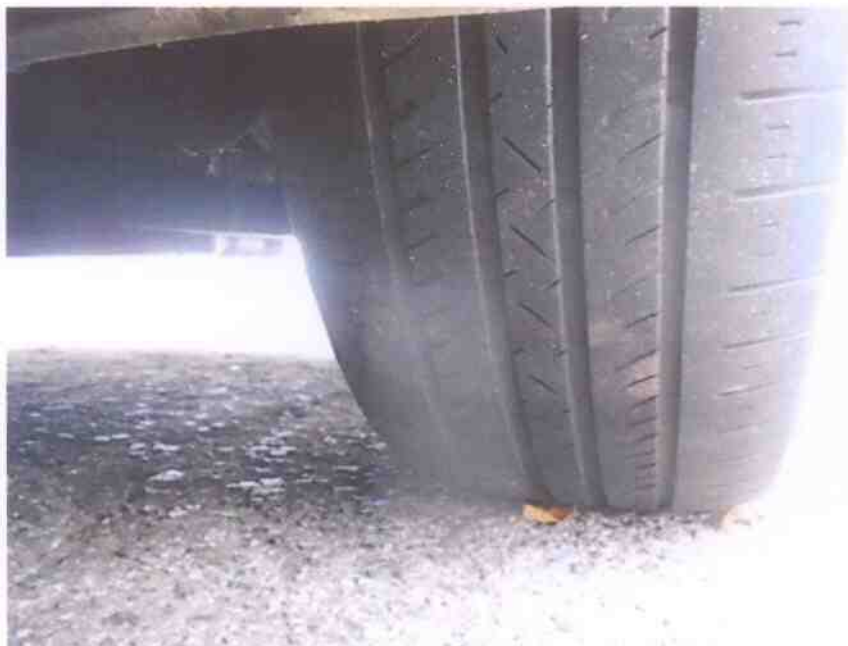
**Photo 5** shows the condition of the front right tyre of the Motor Taxi, which was observed to be in serviceable condition with remaining tread depth of approximately 5mm. The tyre, which was wrapped around standard wheel rim, was also observed to be sufficiently inflated for vehicular operation. A slight dent was observed on the front right wheel rim as a result of the accident.

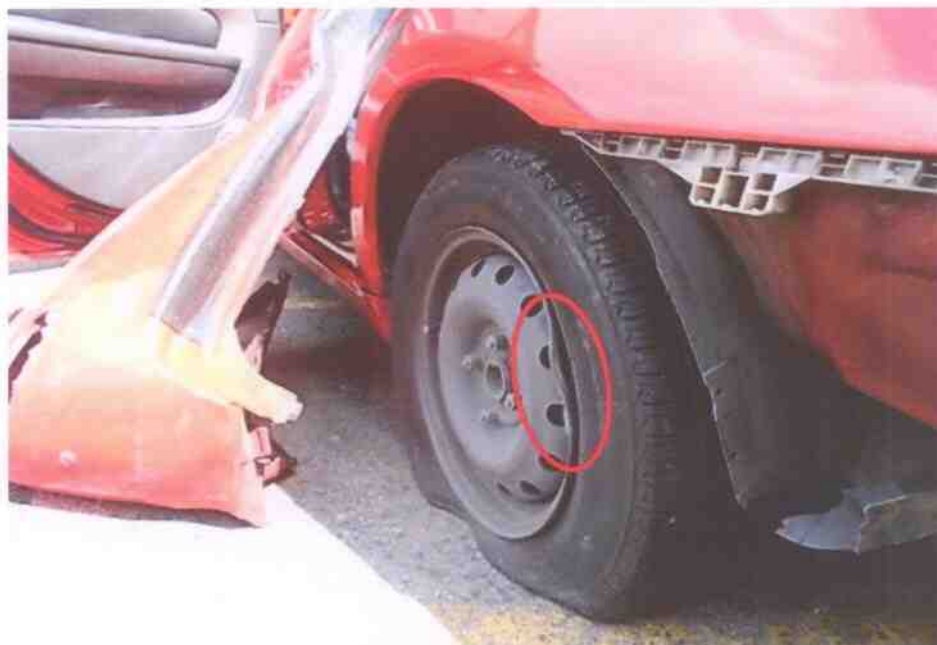
8. The 4 tyres were observed to be wrapped around standard wheel rims. The rear left wheel rim and front right wheel rim were observed to be dented while the rear right wheel rim and front left wheel rim were observed to be without any significant damage. See photo 1 – 8 below.

**Photo 6** shows a general view of the rear left wheel rim and rear left tyre of the Motor Taxi. The rear left wheel rim was observed to be dented (circled) while the rear left tyre was observed to be deflated. Both were a result of the accident.

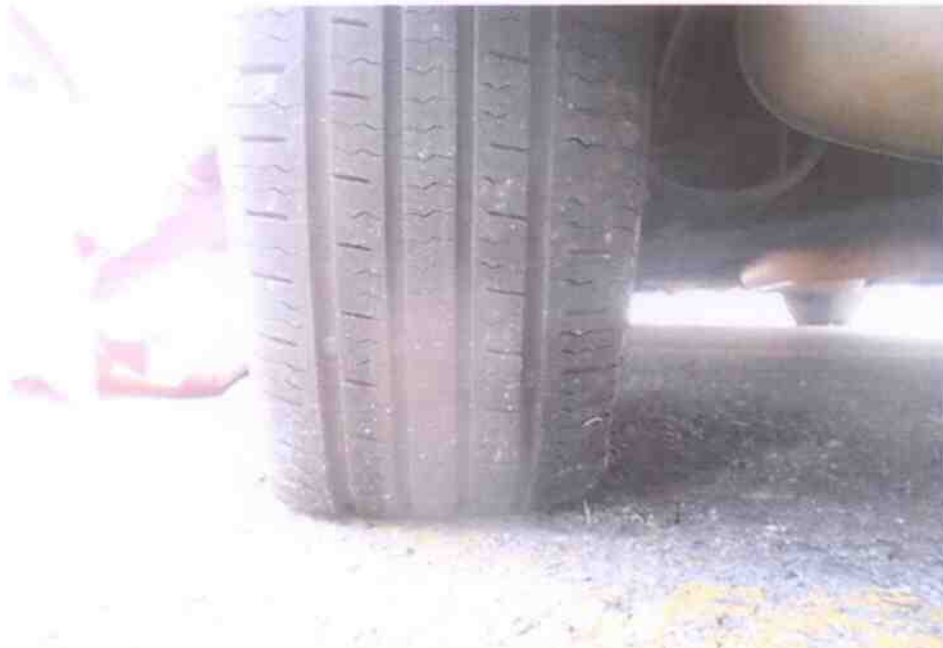
**Photo 7** shows the condition of the rear left tyre of the Motor Taxi, which was observed to be in serviceable condition with remaining tread depth of approximately 6mm. The tyre was observed to be deflated as a result of the accident.

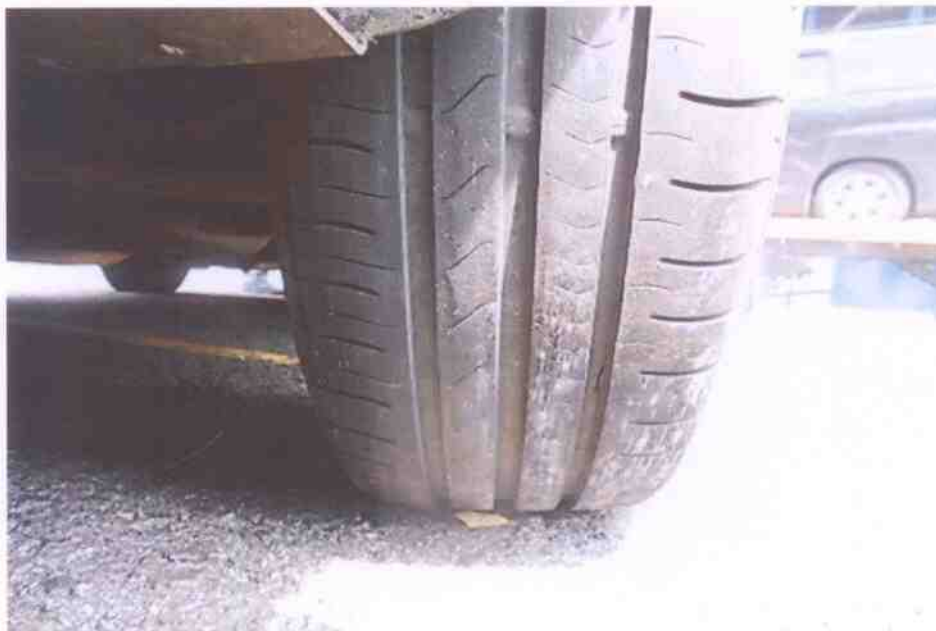
**Photo 8** shows the condition of the rear right tyre of the Motor Taxi, which was observed to be in serviceable condition with remaining tread depth of approximately 7mm. The tyre, which was wrapped around standard wheel rim, was also observed to be sufficiently inflated for vehicular operation.

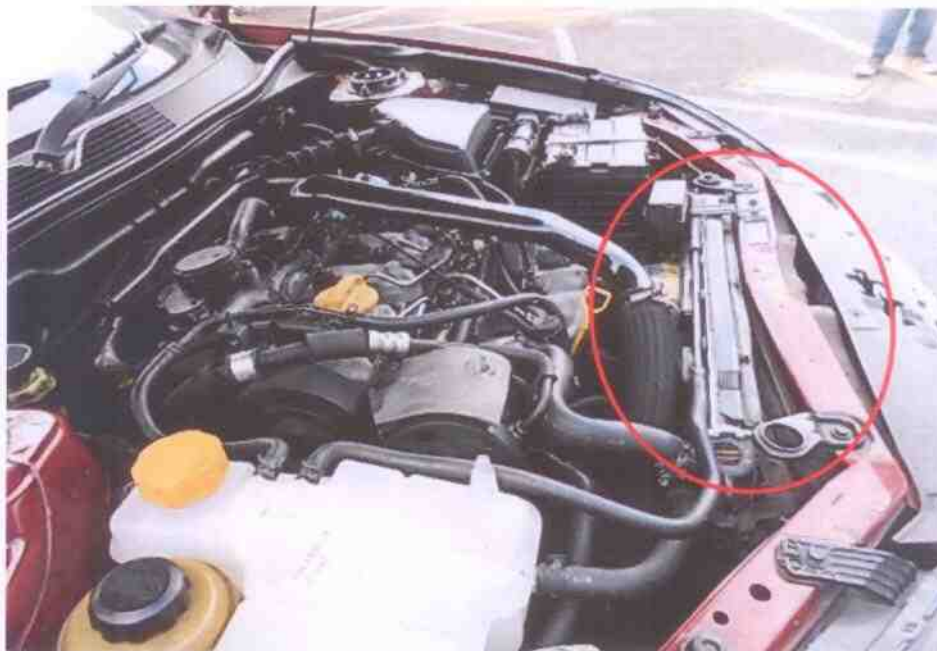
9. Upon examination of the Motor Taxi's engine compartment, I had observed parts that were mainly towards the front of the engine compartment pushed inwards as a result of the impact force onto the frontal body of the Motor Taxi. Parts like the front support panel, air condenser and radiator were affected.

**Photo 9** shows a general view of the Motor Taxi's engine compartment. The parts that were mainly towards the front of the engine compartment (circled) were pushed inwards as a result of the impact force onto the front body of the Motor Taxi. Parts like the front support panel, air condenser and radiator were affected.

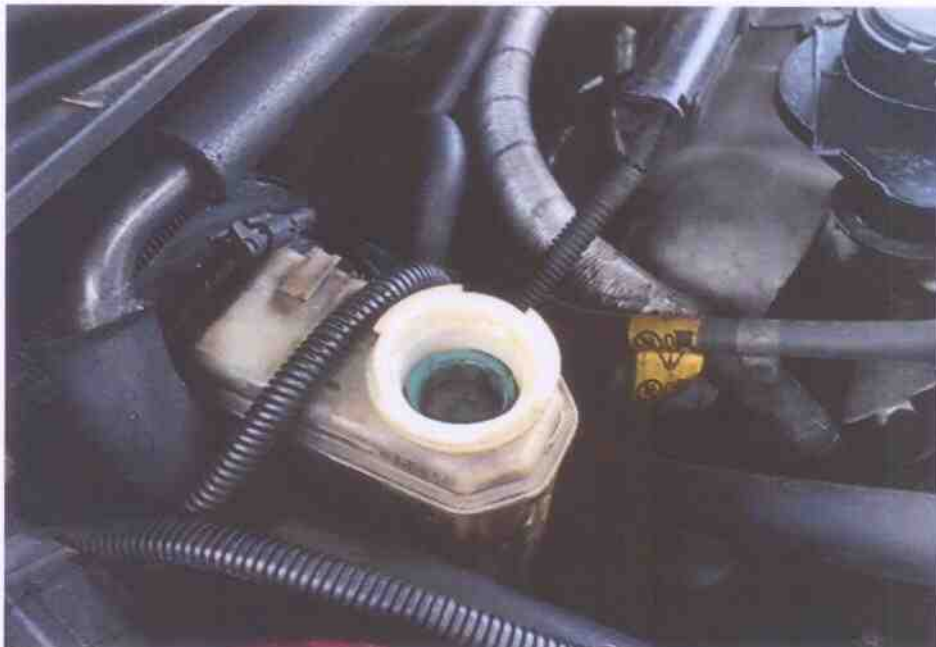
**Photo 10** shows the brake fluid reservoir of the Motor Taxi at the time of my inspection. The brake fluid was observed to be of sufficient level and without any visible contamination.

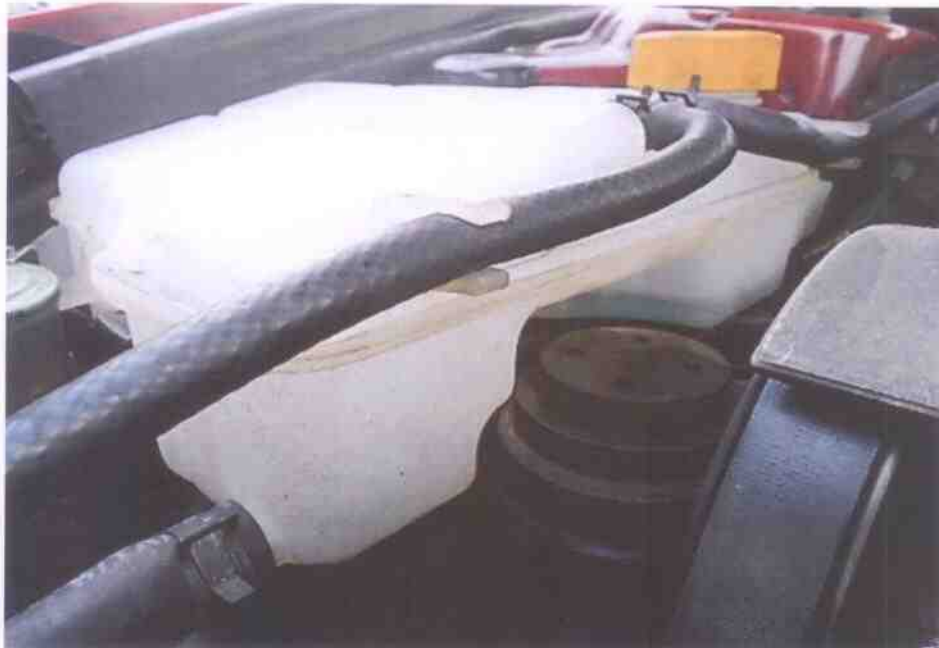
10. The brake fluid, power steering fluid and engine oil were all found to be of sufficient level for operating purposes. Visually, there was also no contamination found to these fluids. The engine coolant was however observed to have leaked from the Motor Taxi's radiator, which was damaged due to the accident.

**Photo 11** shows the engine coolant reservoir tank of the Motor Taxi at the time of my inspection. The engine coolant was observed to be of insufficient level. This was due to leakage of engine coolant from the Motor Taxi's damaged radiator.

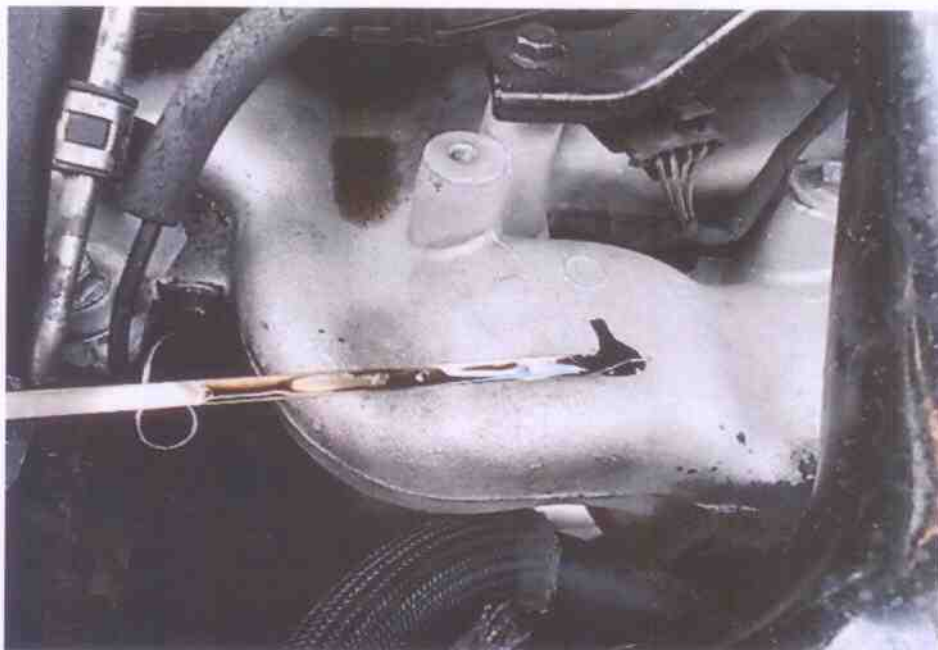
**Photo 12** shows the engine oil dip stick of the Motor Taxi at the time of my inspection. The engine oil was observed to be of sufficient level and without any visible contamination.

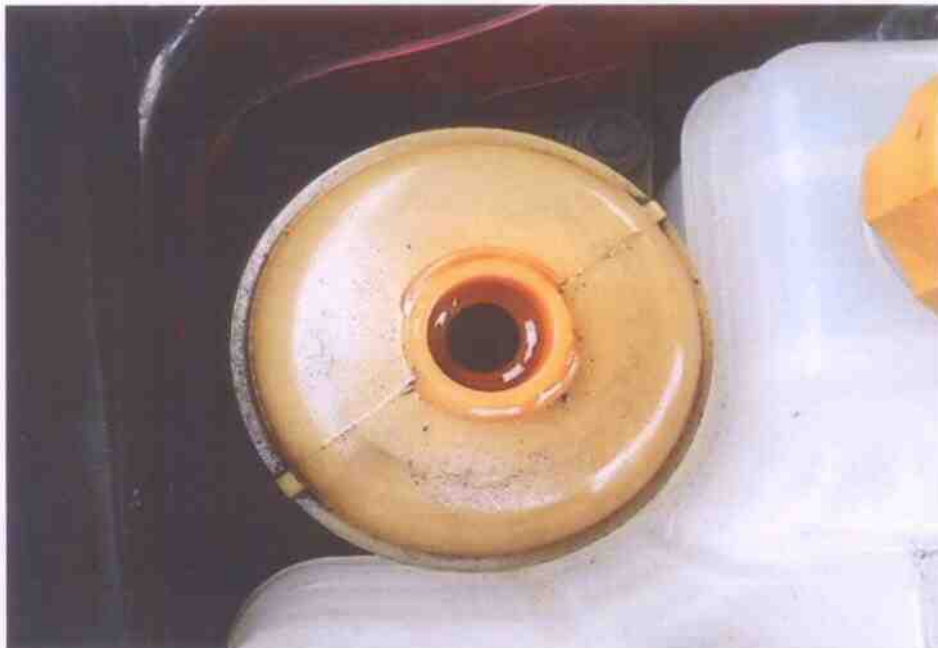
**Photo 13** shows the power steering fluid reservoir tank of the Motor Taxi at the time of my inspection. The power steering fluid was observed to be of sufficient level and without any visible contamination.

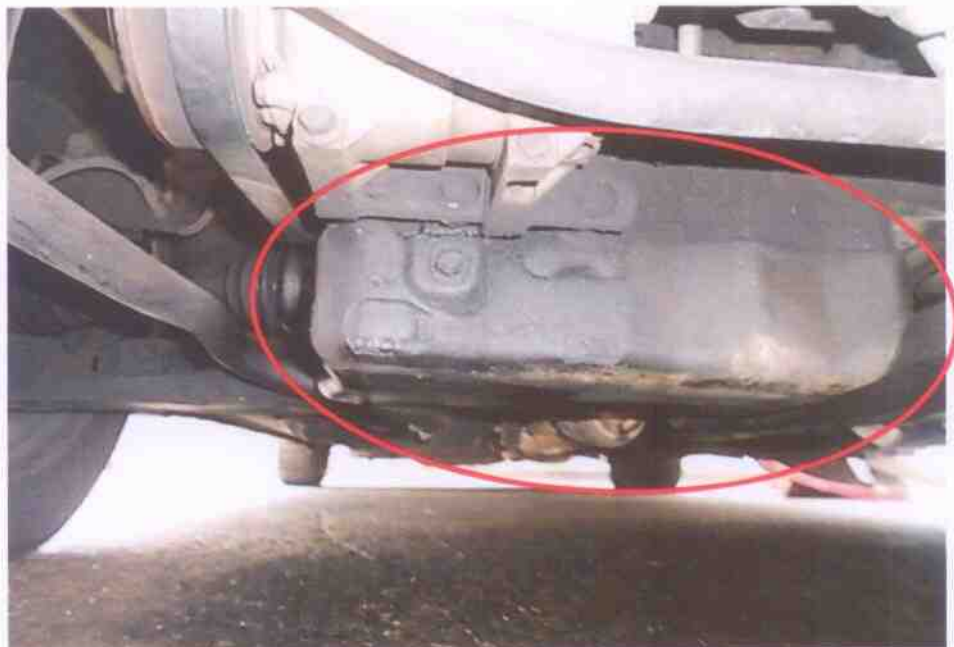
11. My checks on the underside of the Motor Taxi revealed fluid stains on the engine oil sump and some undercarriage components of the Motor Taxi. This was due to the leakage of engine fluid. I also note the presence of dirt and dust particles accumulated around the fluid stain areas, indicating that the fluid leak was pre-existing for a period of time and not a result of the accident.

**Photo 14** shows the underside of the Motor Taxi. Fluid stains were observed on the engine oil sump (circled) and some undercarriage components of the Motor Taxi. This was due to the leakage of engine fluid. I also note the presence of dirt and dust particles accumulated around the fluid stain areas, indicating that the fluid leak was pre-existing for a period of time and not a result of the accident.

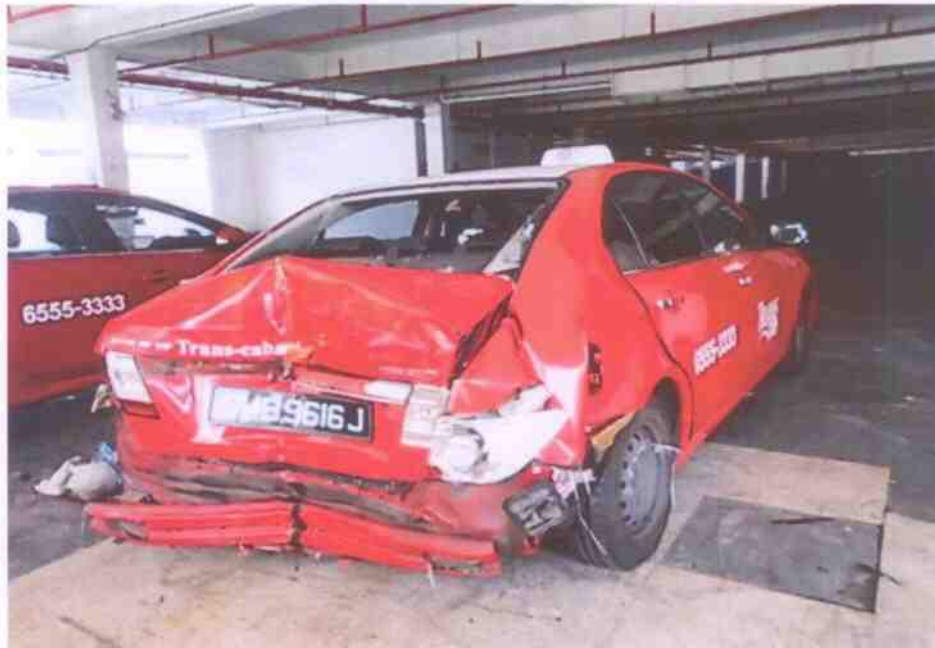
**Photo 15** shows a general view of the Motor Taxi during the second inspection on 22 December 2017 at the premises of Transcab Auto Services Pte Ltd.

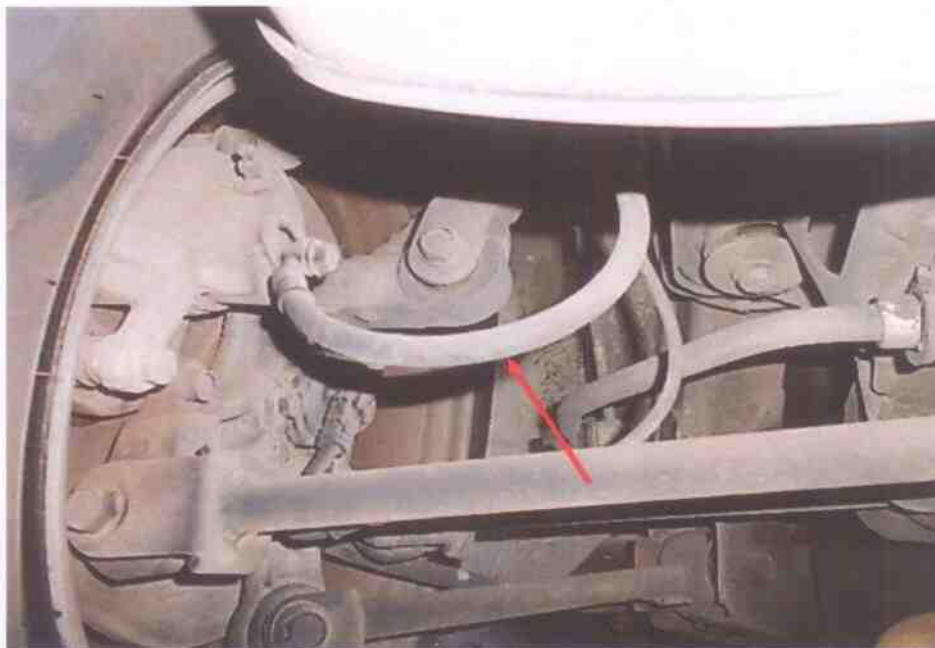
15. Static brake tests conducted on the Motor Taxi revealed no abnormality. The brake booster had responded well to the various tests conducted. There was also no abnormal movement of the brake pedal when it was depressed. In general, the static brake tests had suggested that there was no internal leakage of pressure/vacuum in the braking system of the Motor Taxi. The braking system of the Motor Taxi was likely to be in serviceable condition at the material time. This was taking into consideration that the brake fluid was of sufficient level, and also that there was no sign(s) of brake fluid leakage along the brake hoses and brake pipes.

**Photo 16** shows the brake hose/pipe (arrowed) at the rear left wheel of the Motor Taxi. There was no brake fluid leak observed. Static tests of the Motor Taxi's braking system had indicated that there was no internal leakage of pressure/vacuum. Hence the braking system was likely to be in serviceable condition at the material time of accident. The undercarriage components of the Motor Taxi were also all found to be intact and without any visible damage.

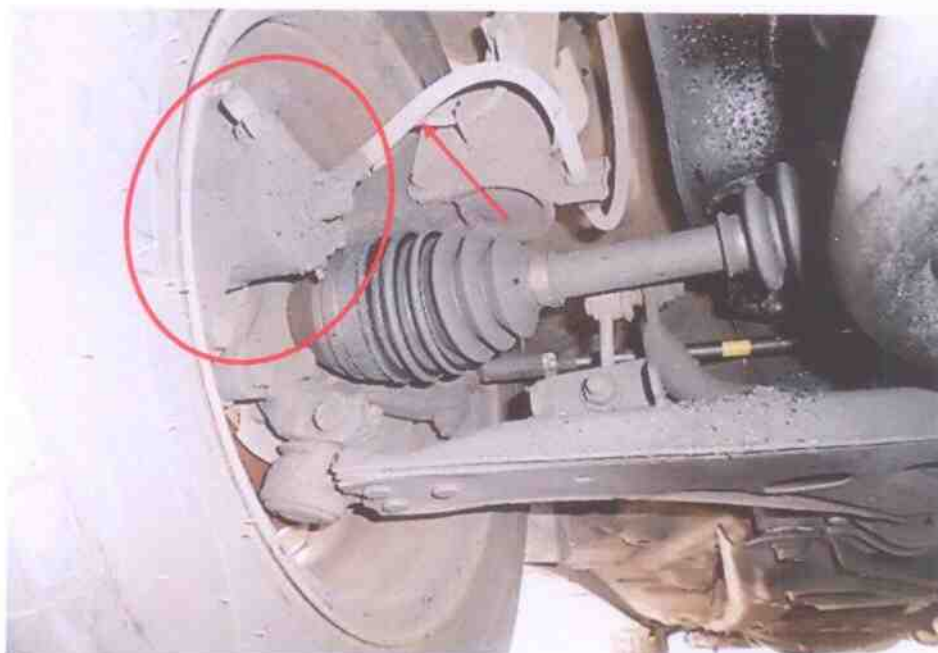
**Photo 17** shows the brake hose/pipe (arrowed) at the front right wheel of the Motor Taxi. There was no brake fluid leak observed. Visual examination of the various components of the braking system like the brake caliper (circled), brake booster, brake pedal etc had revealed all to be intact and without visible damage.

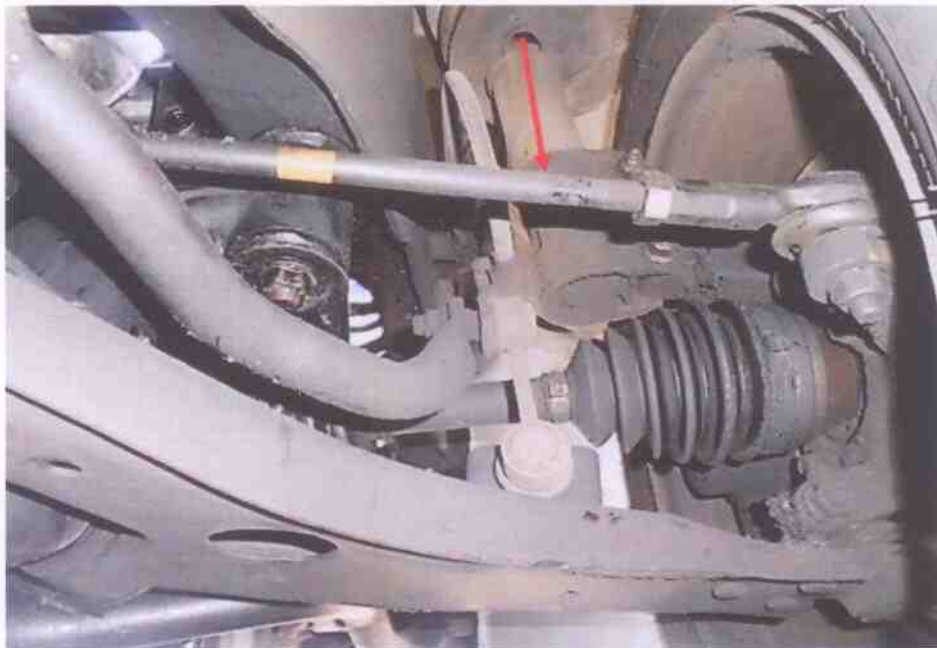
**Photo 19** shows the various undercarriage components at the front right wheel of the Motor Taxi, in particular the steering tie rod (arrowed). The various steering components were all found to be intact, suggesting that the steering system of the Motor Taxi was likely to be in serviceable condition at the material time of accident.

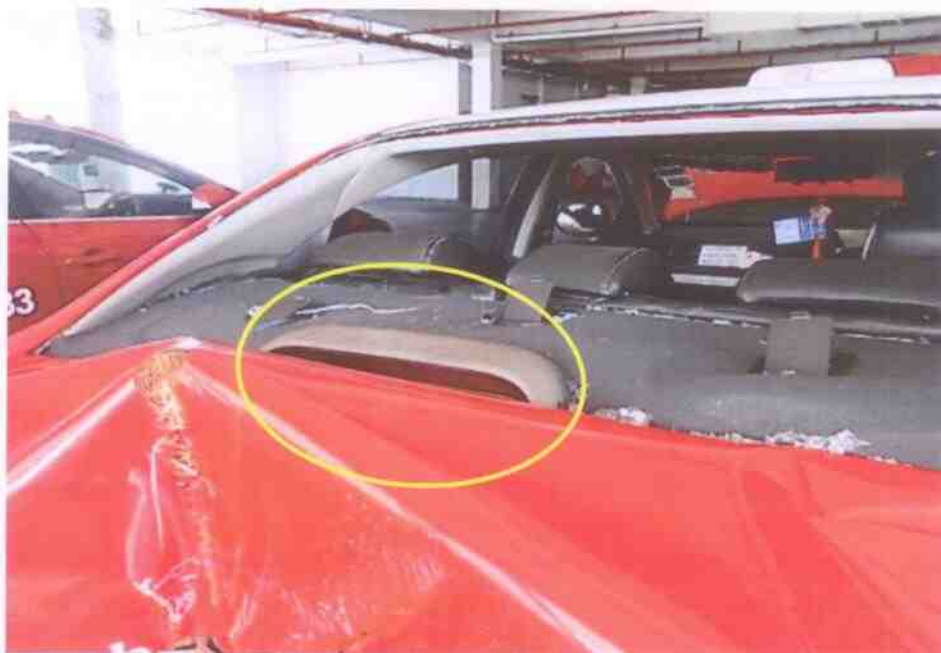
24. During my inspection of the Motor Taxi, I had observed that the bulbs of the Motor Taxi's brake lights were in working condition. The brake lights at the rear left taillamp, rear right taillamp and the third brake light illuminated when the brake pedal of the Motor Taxi was depressed. Co-relating this observations with the observations from the video recording, it would appear that the brake pedal of the Motor Taxi was not depressed by the driver at the material time of accident. See photo 20 & 21.

**Photo 20** shows the third brake light (circled) of the Motor Taxi. The bulbs of the Motor Taxi's brake lights were observed to be in working condition at the time of my inspection. The brake lights at the rear left taillamp, rear right taillamp and the third brake light illuminated when the brake pedal of the Motor Taxi was depressed.

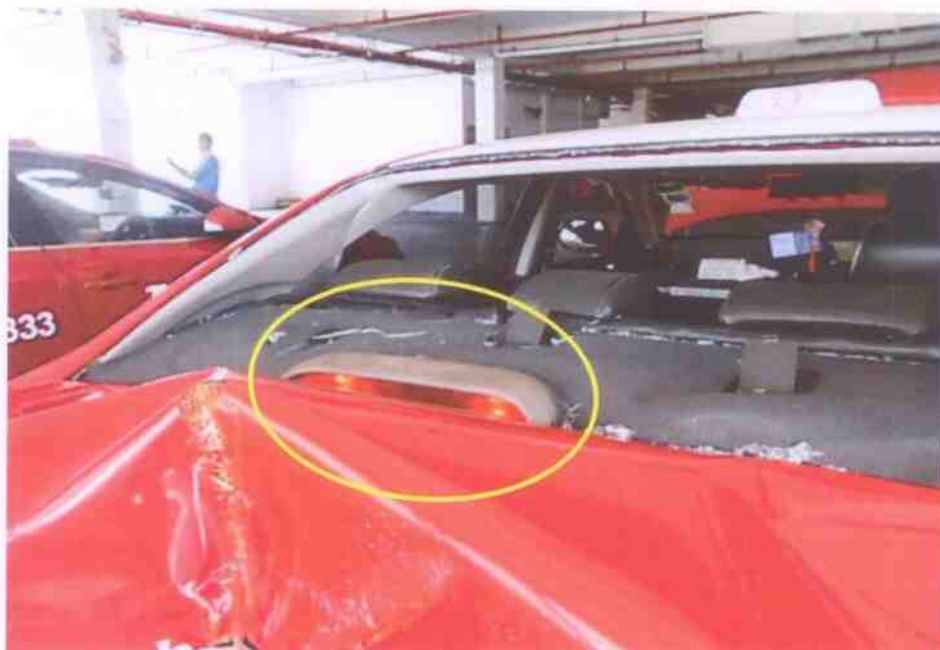
**Photo 21** shows the brake light (circled) for the Motor Taxi's third brake lamp illuminated upon stepping on the brake pedal.
