Your Ref: TP/IP/65389/2017
Our Ref : CI/TPD18001916/D

01 February 2018

MECHANICAL INSPECTION REPORT OF MOTOR TAXI SHD 9684B

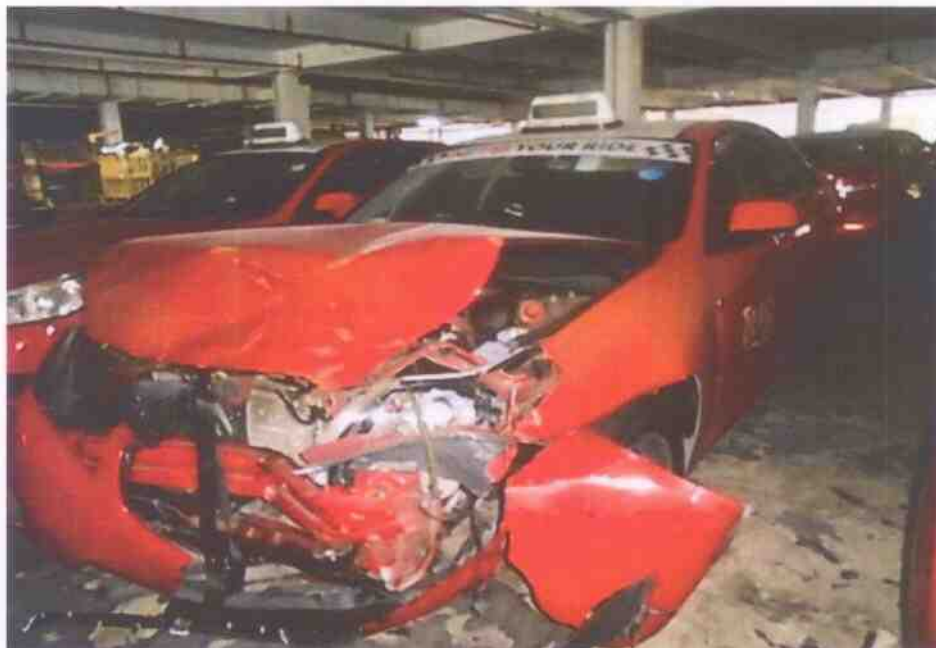
Photo 1 shows a general view of the front left body of the Motor Taxi at the time of my inspection. The Motor Taxi was observed to have sustained impact damage that was confined to its frontal body. Its front bumper, front bonnet, front left headlamp and front left fender were amongst the body parts that were damaged as a result of the accident. The mileage of the Motor Taxi was not recorded due to the extent of damage, which had affected the ignition system of the Motor Taxi.

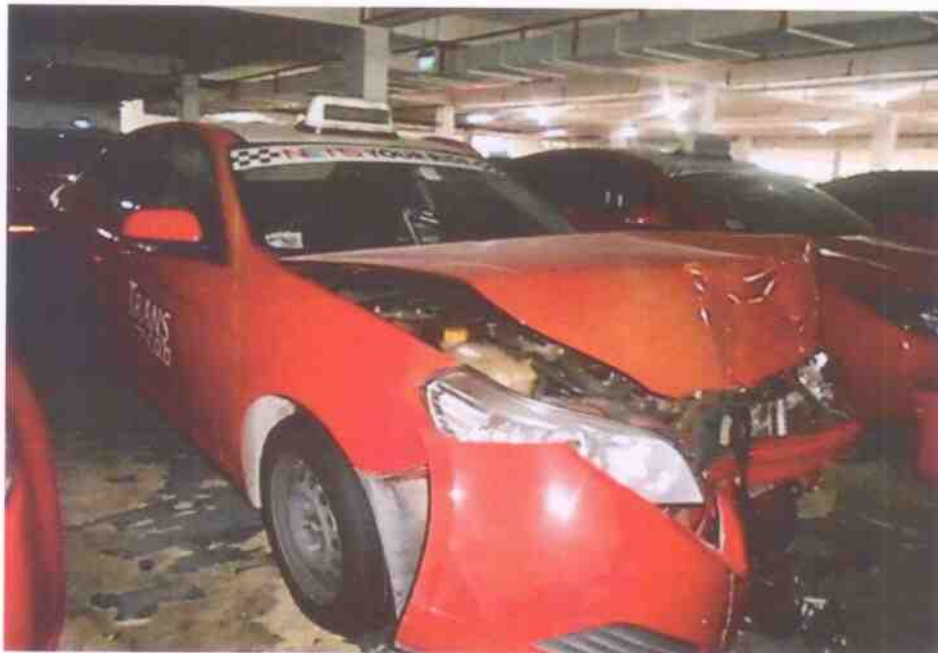
Photo 2 shows a general view of the front right body of the Motor Taxi at the time of my inspection. The Motor Taxi was observed to have sustained impact damage that was confined to its frontal body. Its front bumper, front bonnet and front right headlamp were amongst the body parts that were damaged as a result of the accident. The mileage of the Motor Taxi was not recorded due to the extent of damage, which had affected the ignition system of the Motor Taxi.

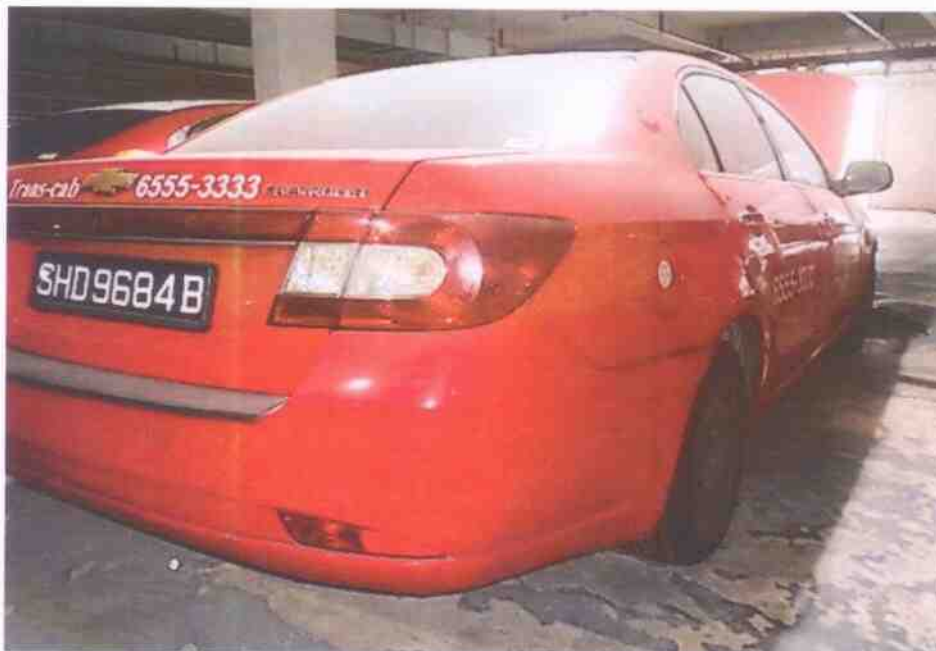
Photo 3 shows a general view of the Motor Taxi's rear right body at the time of my inspection. The rear body of the Motor Taxi was observed to be unaffected.

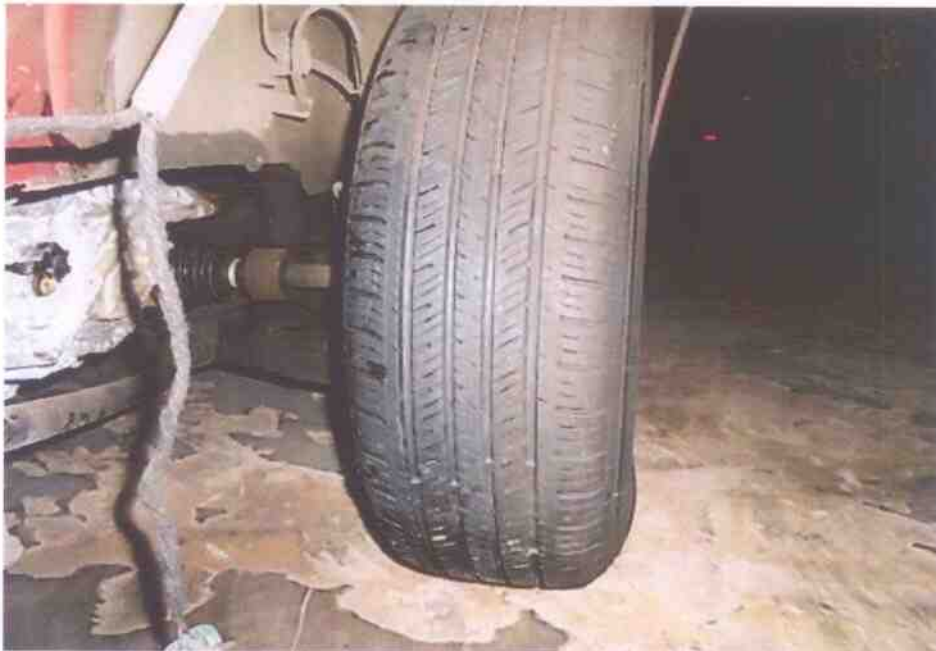
Photo 4 shows the condition of the front left tyre of the Motor Taxi, which was observed to be in serviceable condition with remaining tread depth of approximately 6mm. The tyre, which was wrapped around standard wheel rim, was also observed to be sufficiently inflated for vehicular operation. There was no tear, cut or burst mark(s) on the outer and the inner sidewalls as well as across the tread of the tyre.

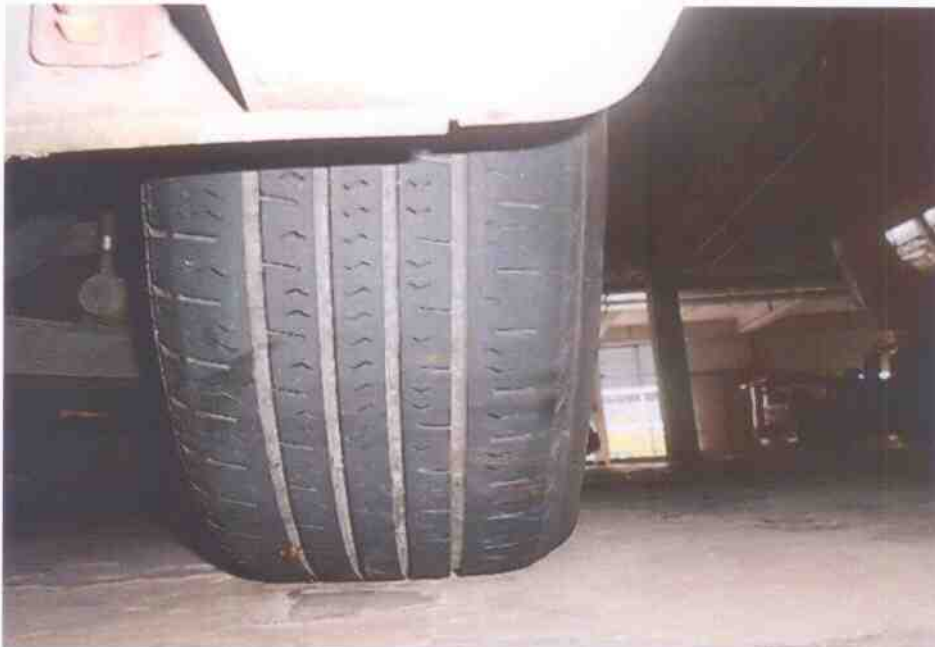
Photo 5 shows the condition of the front right tyre of the Motor Taxi, which was observed to be in serviceable condition with remaining tread depth of approximately 6mm. The tyre, which was wrapped around standard wheel rim, was also observed to be sufficiently inflated for vehicular operation.

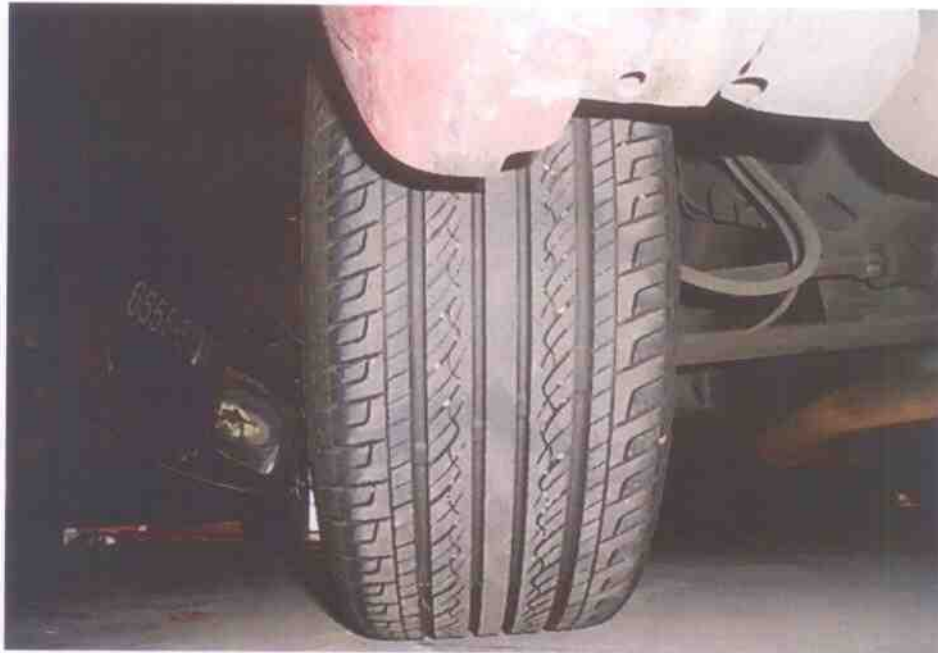
Photo 6 shows the condition of the rear left tyre of the Motor Taxi, which was observed to be in serviceable condition with remaining tread depth of approximately 6mm. The tyre, which was wrapped around standard wheel rim, was also observed to be sufficiently inflated for vehicular operation. The 4 tyres of the Motor Taxi were wrapped around standard wheel rims that were without any damage.

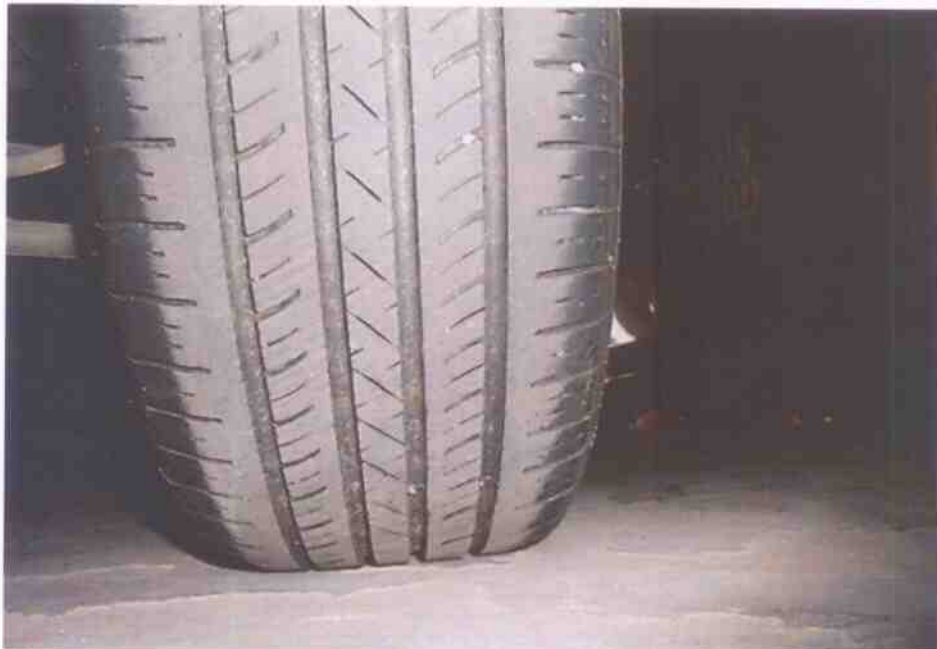
Photo 7 shows the condition of the rear right tyre of the Motor Taxi, which was observed to be in serviceable condition with remaining tread depth of approximately 6mm. There was no tear, cut or burst mark(s) on the outer and the inner sidewalls as well as across the tread of the tyre.

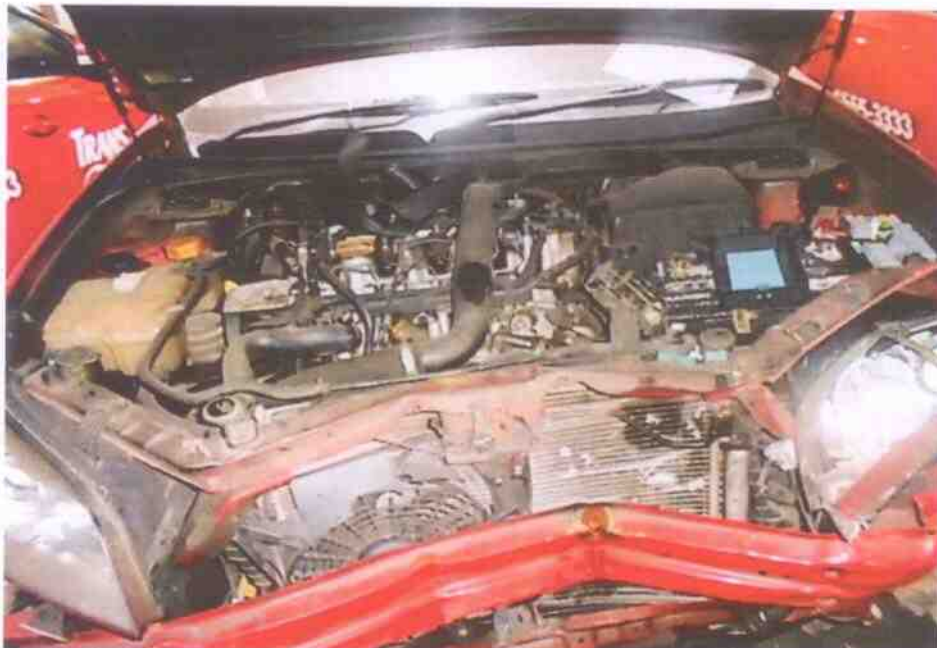
Photo 8 shows a general view of the Motor Taxi's engine compartment. Parts that were mainly towards the front of the engine compartment were pushed inwards as a result of the impact force onto the frontal body of the Motor Taxi. The front support panel, front bumper reinforcement, cooling fan, air condenser and radiator were all observed to have been damaged.

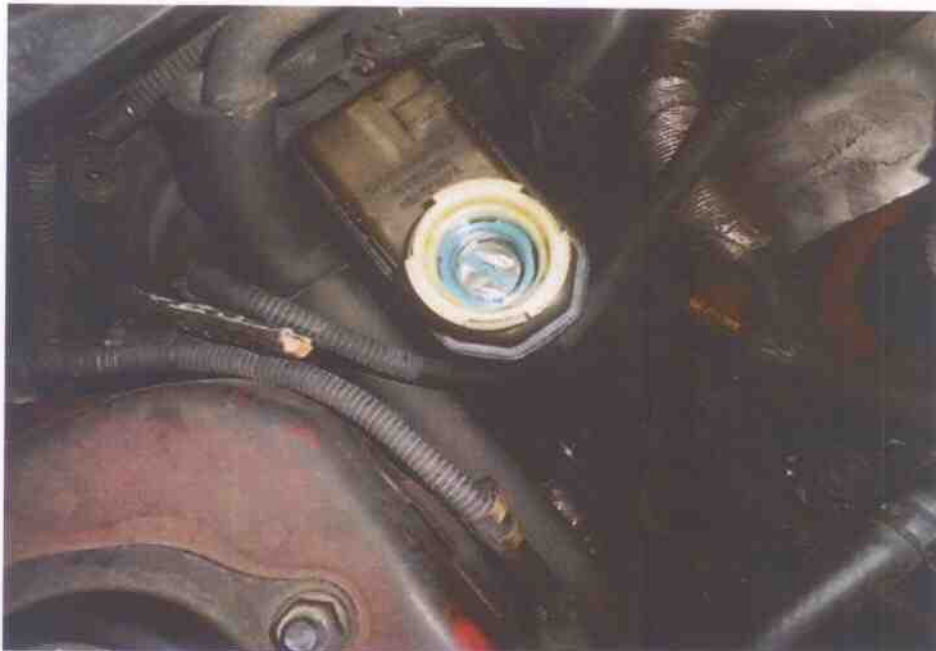
Photo 9 shows the brake fluid reservoir of the Motor Taxi at the time of my inspection. I had found the brake fluid to be of sufficient level for operating purposes, and without any visible contamination.

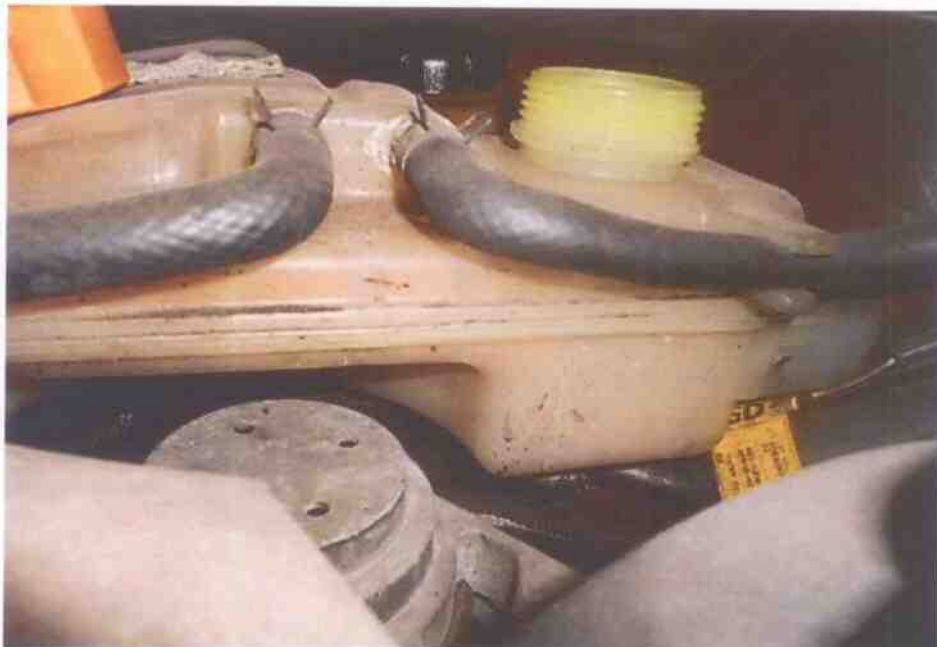
Photo 10 shows the engine coolant reservoir tank of the Motor Taxi at the time of my inspection. The engine coolant was observed to be of insufficient level for operating purposes. This was due to engine coolant leakage from a damaged radiator.

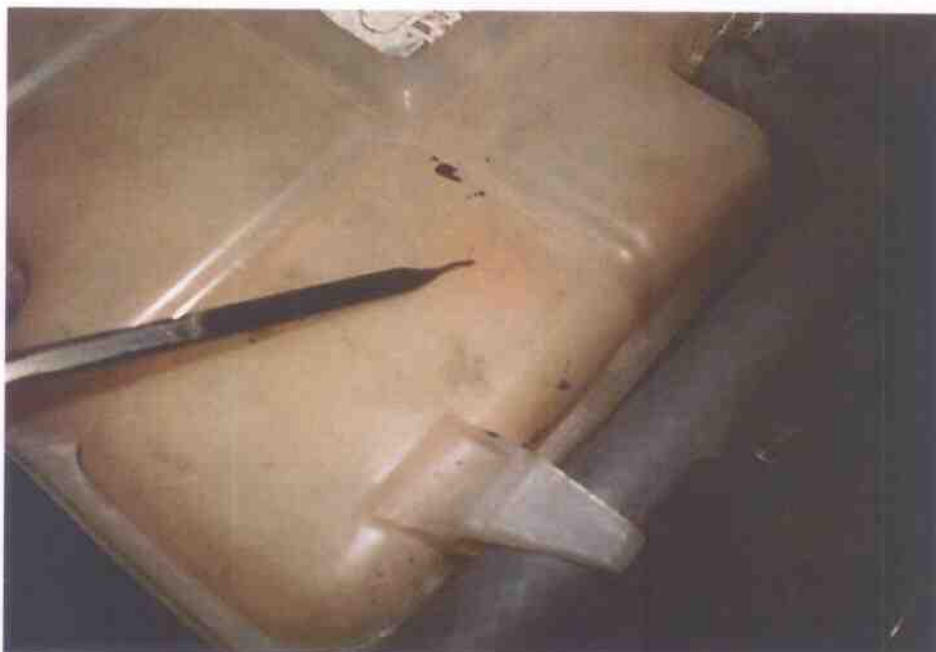
Photo 11 shows the engine oil dip stick of the Motor Taxi at the time of my inspection. The engine oil was observed to be of sufficient level and without any visible contamination.

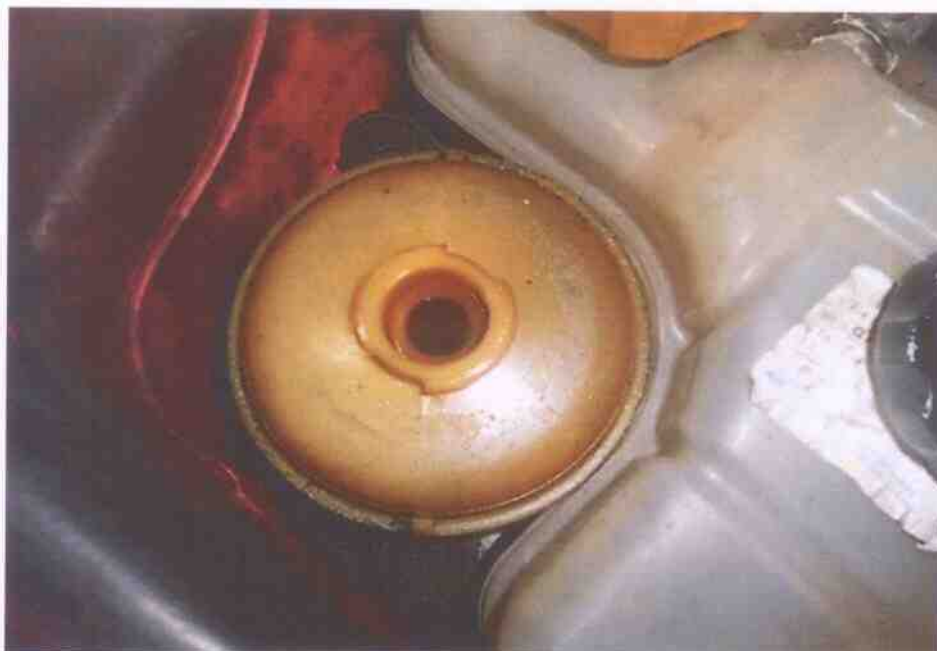
Photo 12 shows the power steering fluid reservoir of the Motor Taxi at the time of my inspection. The power steering fluid was observed to be of insufficient level for operating purposes. This was due to leakage from a damaged hose/pipe as a result of the accident.

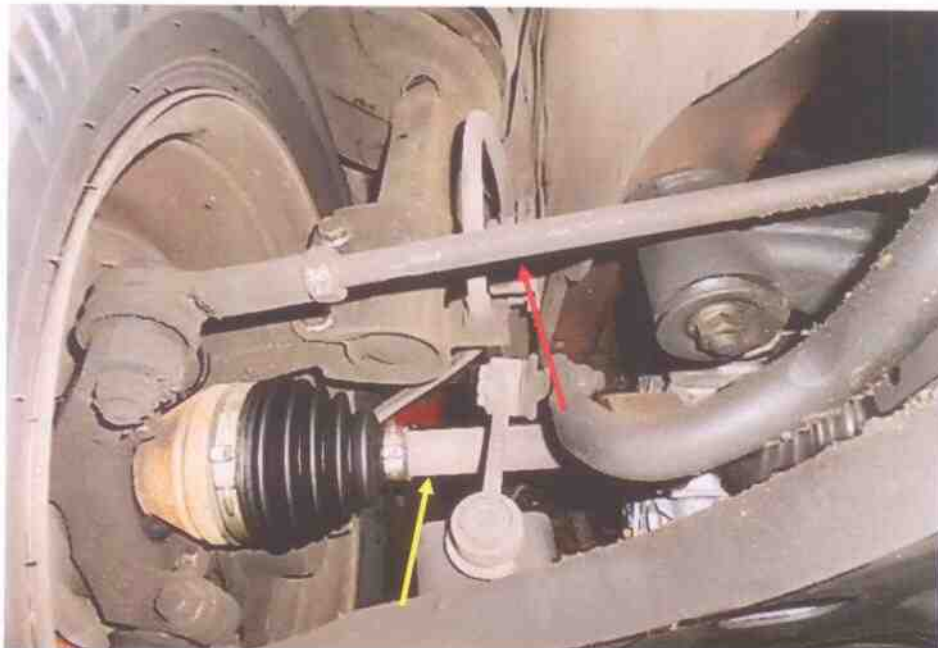
Photo 13 shows the various undercarriage components at the front left wheel of the Motor Taxi, in particular the steering tie rod (red arrow) and front left drive shaft (yellow arrow). The various steering components were all found to be intact, suggesting that the steering system of the Motor Taxi was likely to be in serviceable condition at the material time of accident.

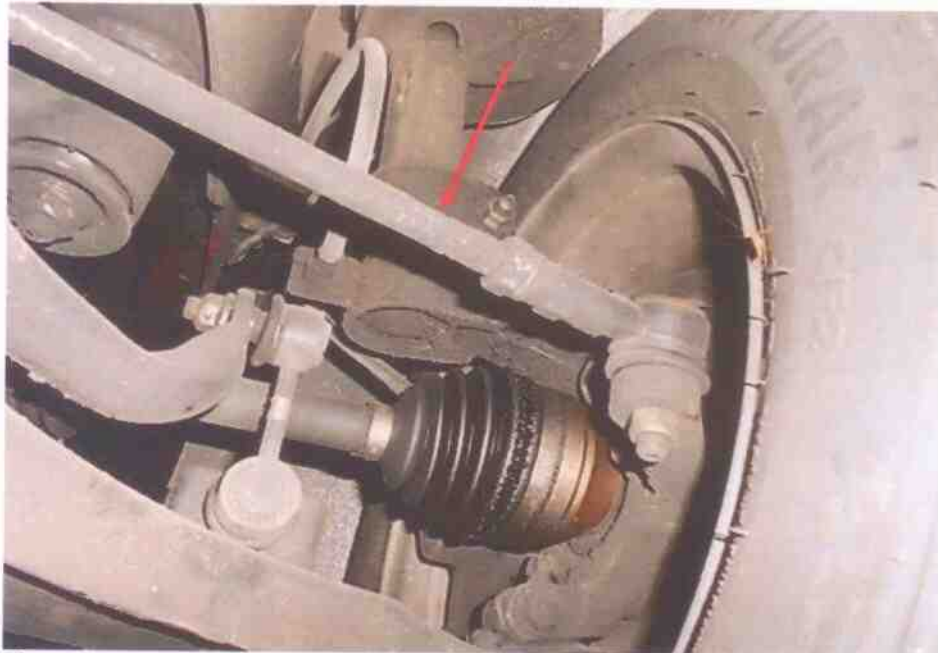
Photo 14 shows the various undercarriage components at the front right wheel of the Motor Taxi, in particular the steering tie rod (arrowed). The various steering components were all found to be intact, suggesting that the steering system of the Motor Taxi was likely to be in serviceable condition at the material time of accident.

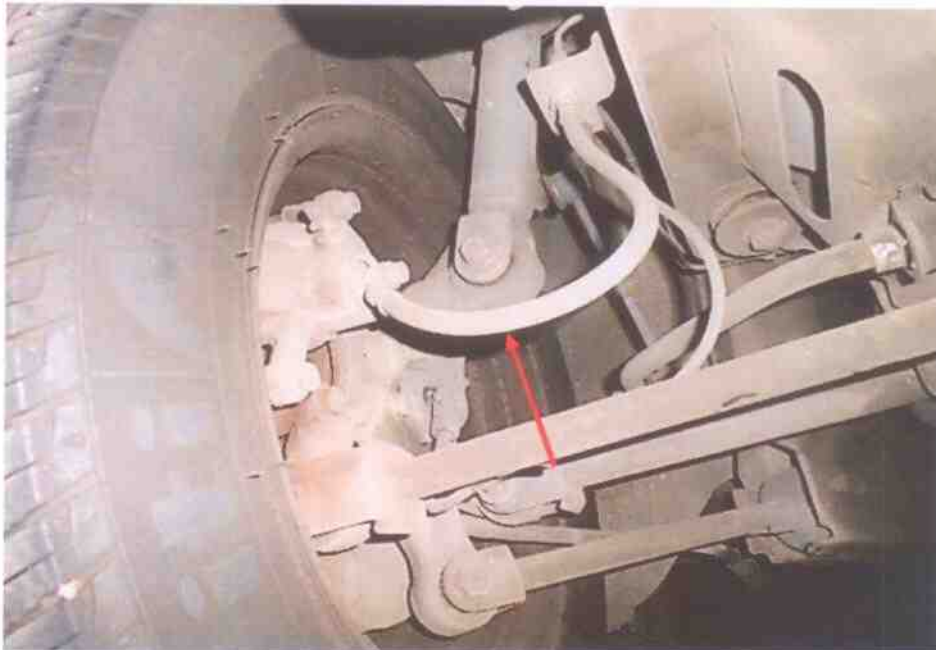
Photo 15 shows the various undercarriage components at the rear left wheel of the Motor Taxi, in particular the brake hose (arrowed). I did not observe any leakage of brake fluid at the 4 wheels of the Motor Taxi. My visual inspection of the various mechanical components of the Motor Taxi's braking system revealed all to be intact and without visible damage, indicating that the braking system was likely to be in serviceable condition at the material time of accident.

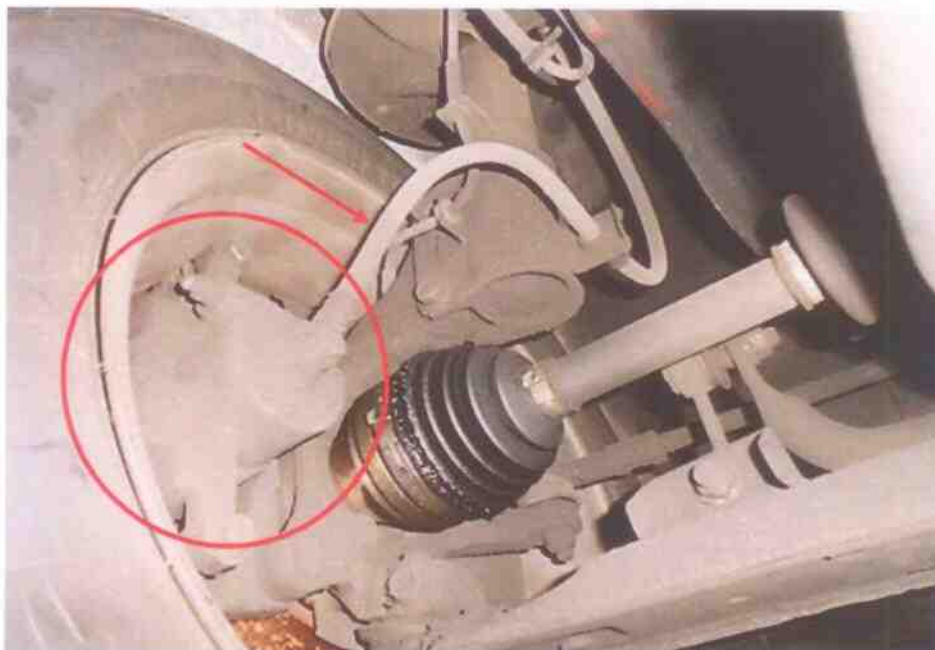
Photo 16 shows the brake hose/pipe (arrowed) at the front right wheel of the Motor Taxi. There was no brake fluid leak observed. Visual examination of the various components of the braking system like the brake caliper (circled), brake booster, brake pedal etc had revealed all to be intact and without visible damage.
