Your Ref: TP/IP/41385/2017
Our Ref : CI/TPD18001920/D

03 February 2018

MECHANICAL INSPECTION REPORT OF MOTOR CAR SLF 2021C

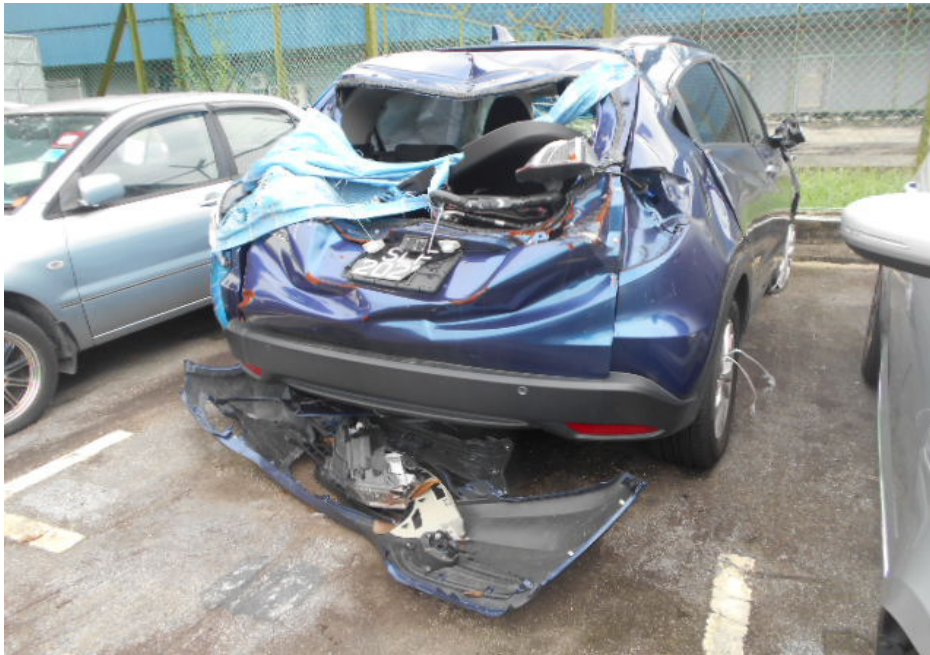
Photo 1 shows a general view of the rear portion of the Motor Car at the time of my inspection. Its rear tailgate, rear windscreen, rear right fender and roof panel were amongst the body parts that were severely damaged as a result of the accident.

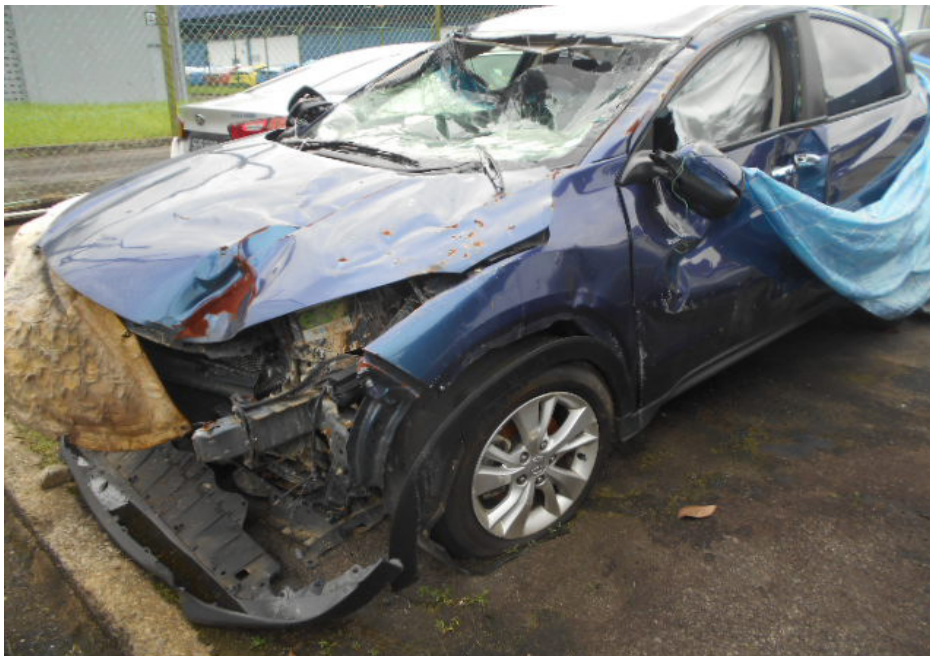
Photo 2 shows a general view of the front left portion of the Motor Car at the time of my inspection. The Motor Car was also observed to have sustained extensive impact damage at its frontal portion and left portion. Its front bumper, front bonnet, front left fender, front windscreen, left front door and roof panel were amongst the body parts that were observed to have been damaged as a result of the accident.

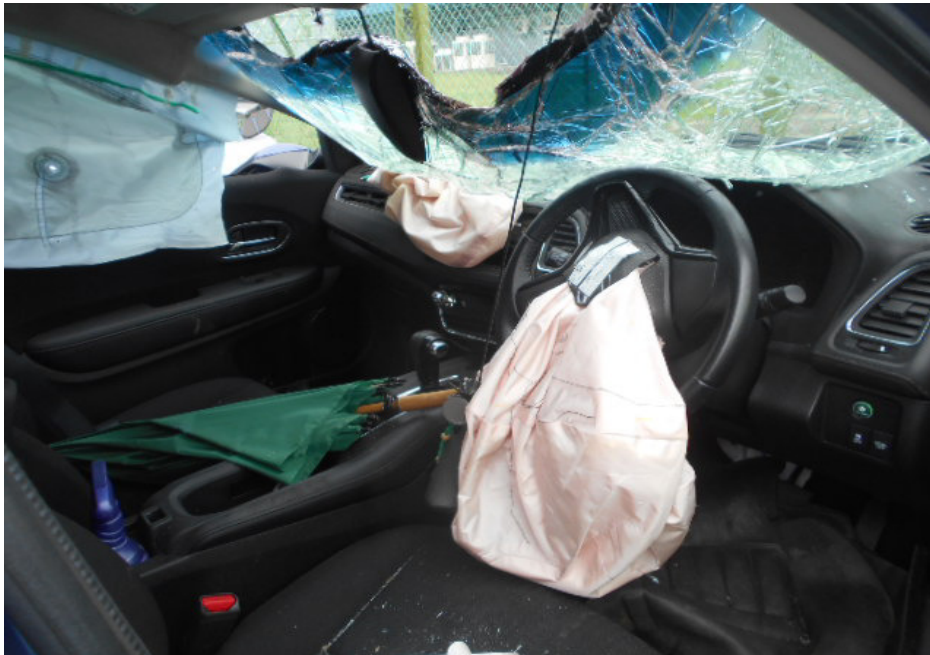
Photo 3 shows a general view of the Motor Car's interior compartment. Several parts and components inside the interior compartment were observed to have been damaged. This had included the front dashboard, trims and seats. The driver's air bag, front left passenger air bag and left curtain air bag were also deployed as a result of the accident.

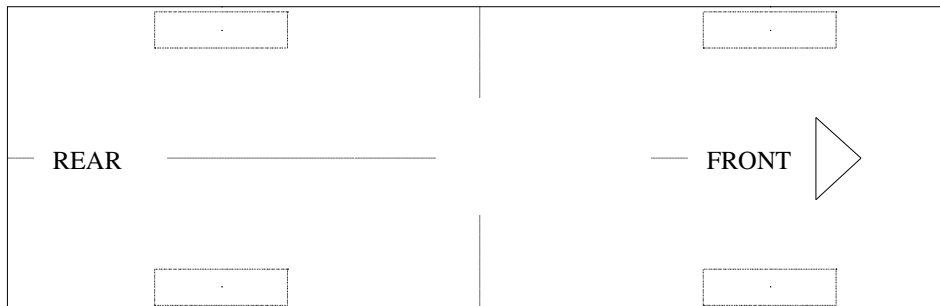
Yokohama 215/60R16 (7mm)

Dunlop 215/60R16 (6mm)
Deflated from accident

Achilles 215/60R16 (7mm)

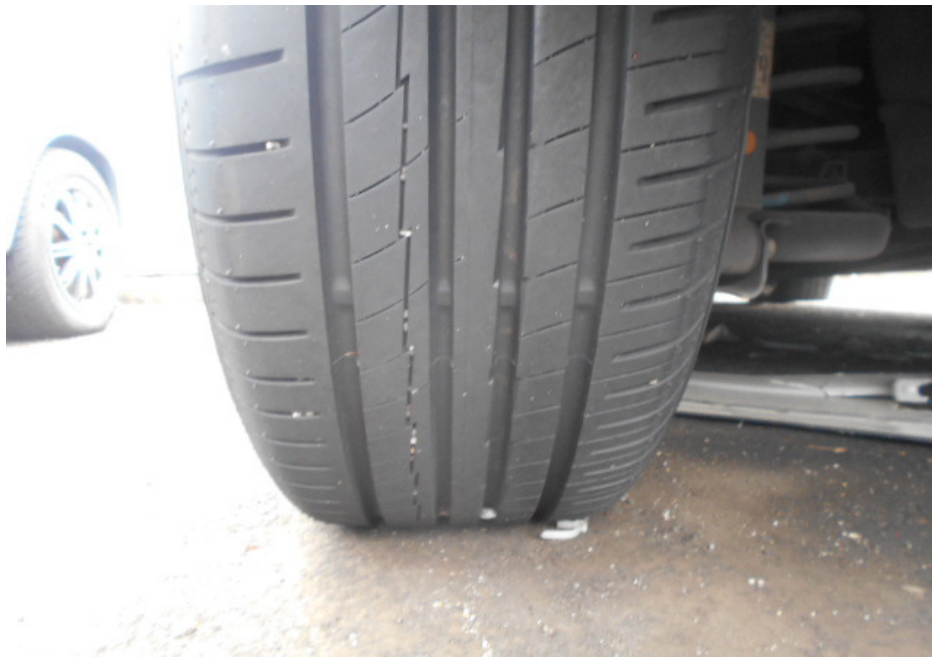
Photo 4 shows the condition of the rear left tyre of the Motor Car, which was observed to be in serviceable condition with remaining tread depth of approximately 7mm. There was no tear, cut or burst mark(s) on the outer and the inner sidewalls as well as across the tread of this tyre. The tyre, which was wrapped around alloy wheel rim, was also observed to be sufficiently inflated for vehicular operation.

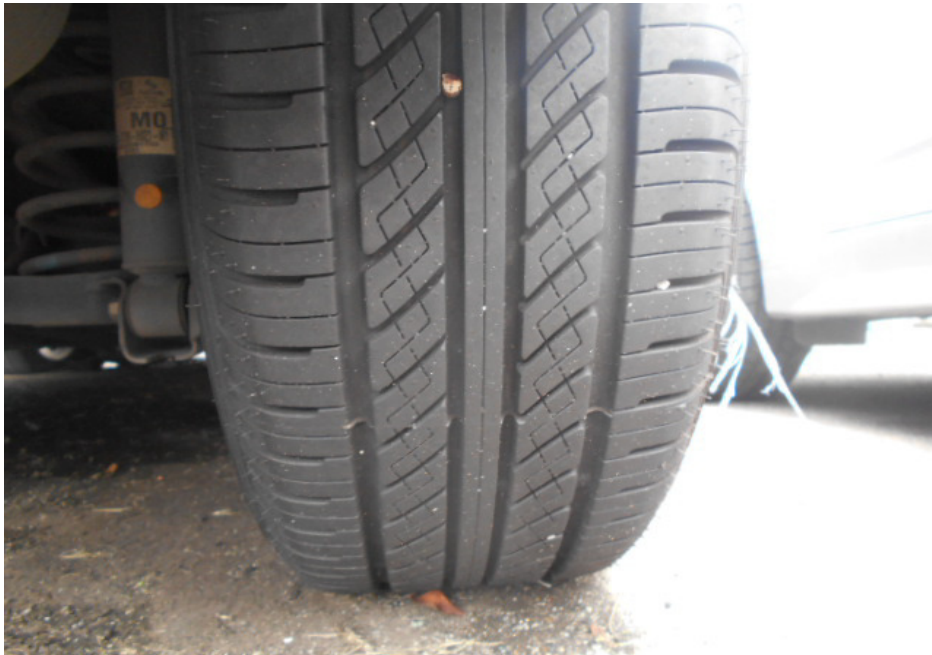
Photo 5 shows the condition of the rear right tyre of the Motor Car, which was observed to be in serviceable condition with remaining tread depth of approximately 7mm. There was no tear, cut or burst mark(s) on the outer and the inner sidewalls as well as across the tread of this tyre. The tyre, which was wrapped around alloy wheel rim, was also observed to be sufficiently inflated for vehicular operation.

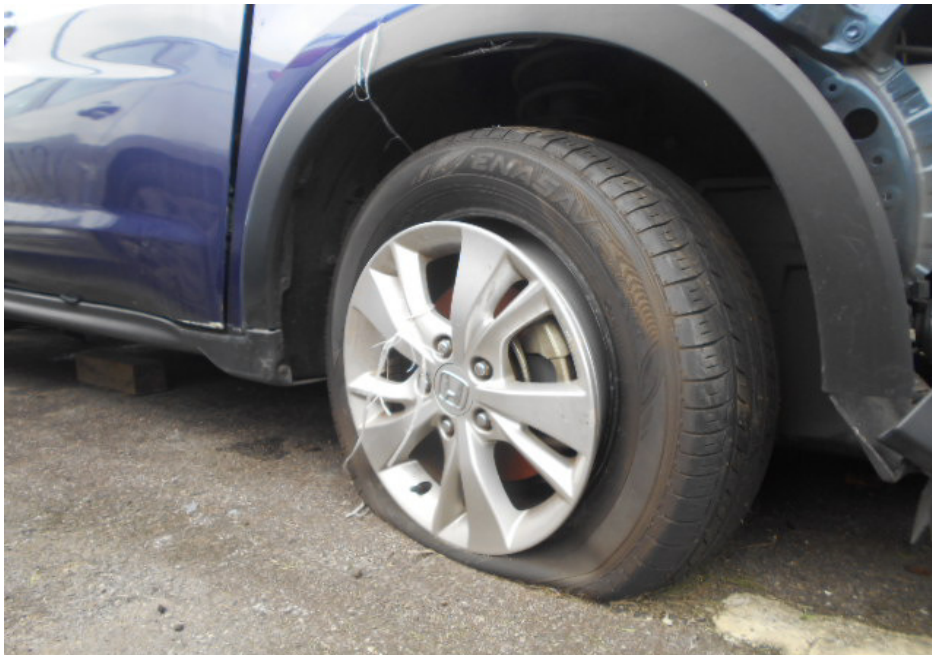
Photo 6 shows a general view of the front right wheel rim and tyre of the Motor Car. The front right tyre was observed to be deflated and loosely wrapped around the front right wheel rim as a result of the accident.

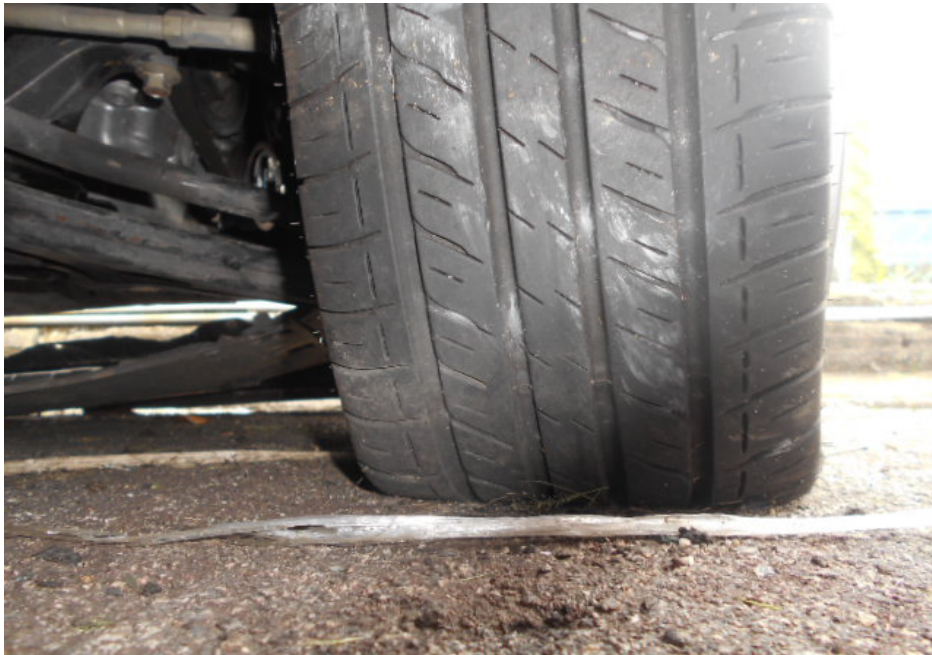
Photo 7 shows the condition of the front right tyre of the Motor Car, which was observed to be in serviceable condition with remaining tread depth of approximately 6mm. The tyre was observed to be deflated and loosely wrapped around the front right wheel rim as a result of the accident.

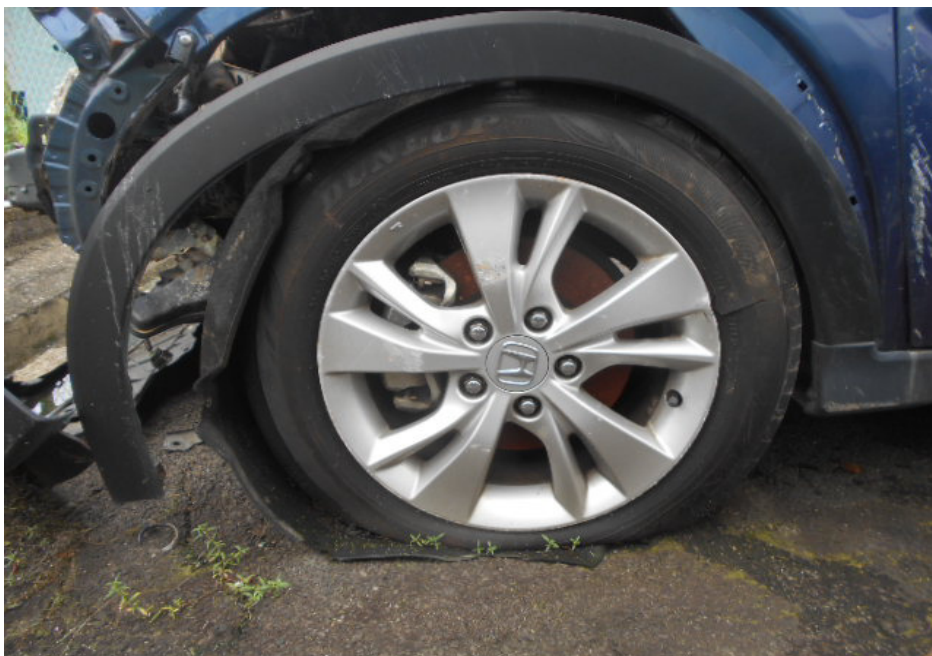
Photo 8 shows a general view of the front left wheel rim and tyre of the Motor Car. The front left tyre was observed to be deflated with a cut on its outer sidewall. The front left wheel rim was also observed to be dented as a result of the accident.

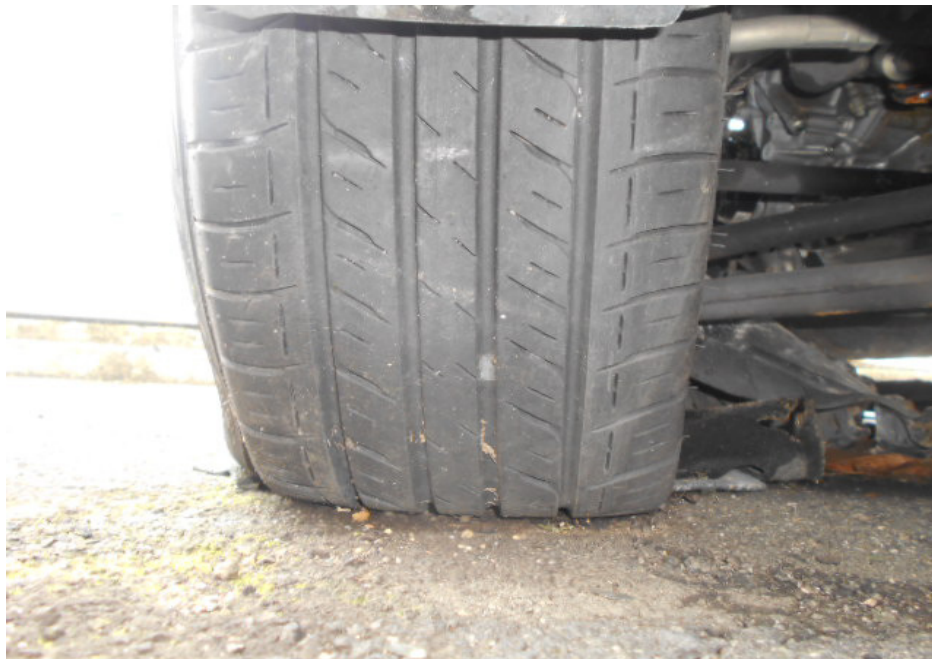
Photo 9 shows the condition of the front left tyre of the Motor Car, which was observed to be in serviceable condition with remaining tread depth of approximately 6mm. The tyre was observed to be deflated and cut as a result of the accident.

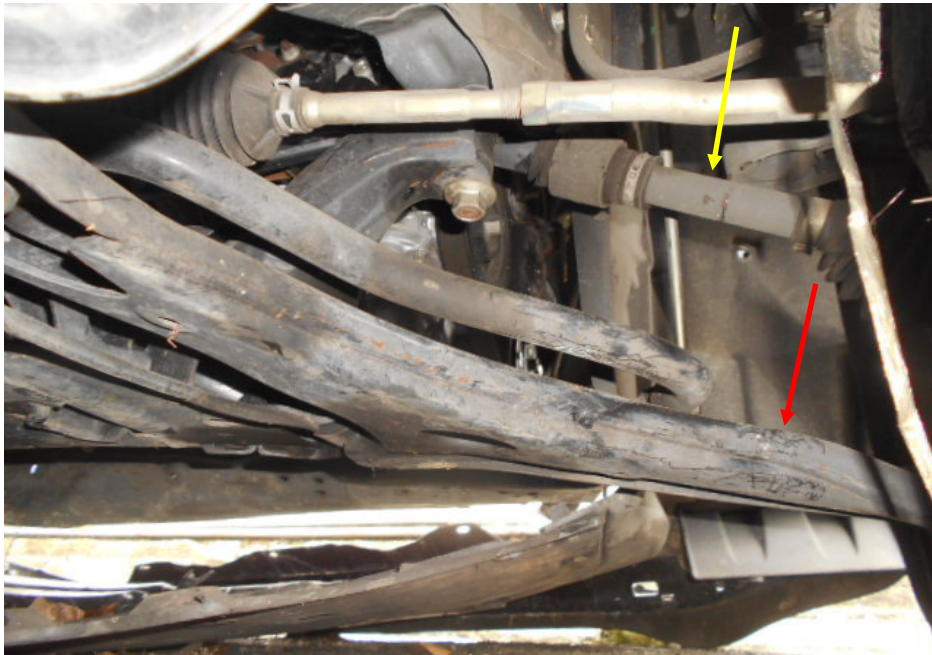
Photo 10 shows the undercarriage components at the front right wheel of the Motor Car. My checks on the underside of the Motor Car revealed damage to the various undercarriage components at the front right wheel and front left wheel of the Motor Car. Components like the front right lower arm (red arrow), front right drive shaft (yellow arrow) and front right steering tie rod were all found to be have been damaged.

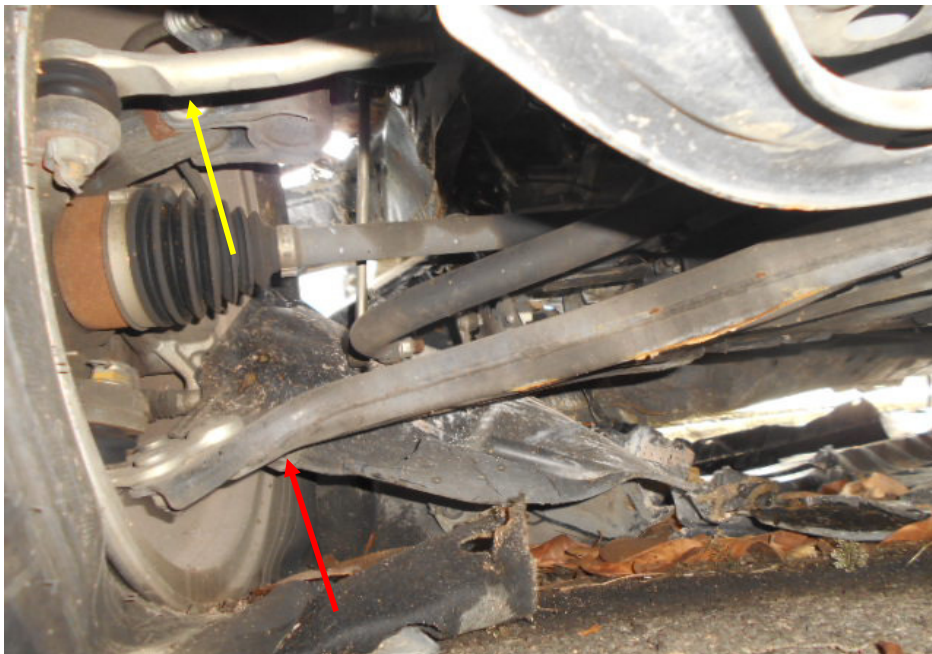
Photo 11 shows the undercarriage components at the front left wheel of the Motor Car. My checks on the underside of the Motor Car revealed damage to the various undercarriage components at the front right wheel and front left wheel of the Motor Car. Components like the front left lower arm (red arrow) and front left steering tie rod (yellow arrow) were damaged.

12. For this inspection, I was not able to conduct any tests on the steering system of the Motor Car due to damage to several mechanical components of the steering system like the steering tie rod (refer to photograph 11 above).
13. With regard to the braking system, although I was also not able to carry out any tests given that the Motor Car's engine could not be started due to damage to its ignition system as a result of the accident, my visual inspection of the various mechanical components of the braking system had however appear to suggest that the braking system was in serviceable condition. Parts like the brake master pump, brake booster, brake calipers and brake hoses amongst others were all observed to be intact and undamaged. There was also no sign(s) or indication(s) of brake fluid leak observed at the 4 wheels of the Motor Car. See photo 12 & 13 below.

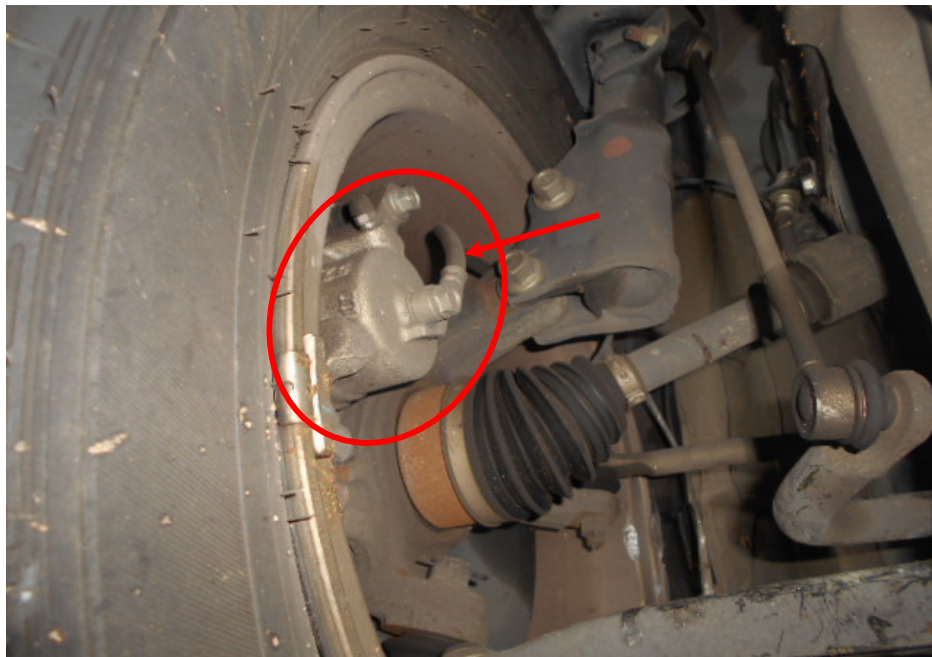
Photo 12 shows the brake hose (arrowed) at the front right wheel of the Motor Car. I did not observe any leakage of brake fluid at the 4 wheels of the Motor Car. My visual inspection of the various mechanical components of the Motor Car's braking system, including its brake caliper (circled), revealed all to be intact and without visible damage, indicating that the braking system was likely to be in serviceable condition at the material time of accident.

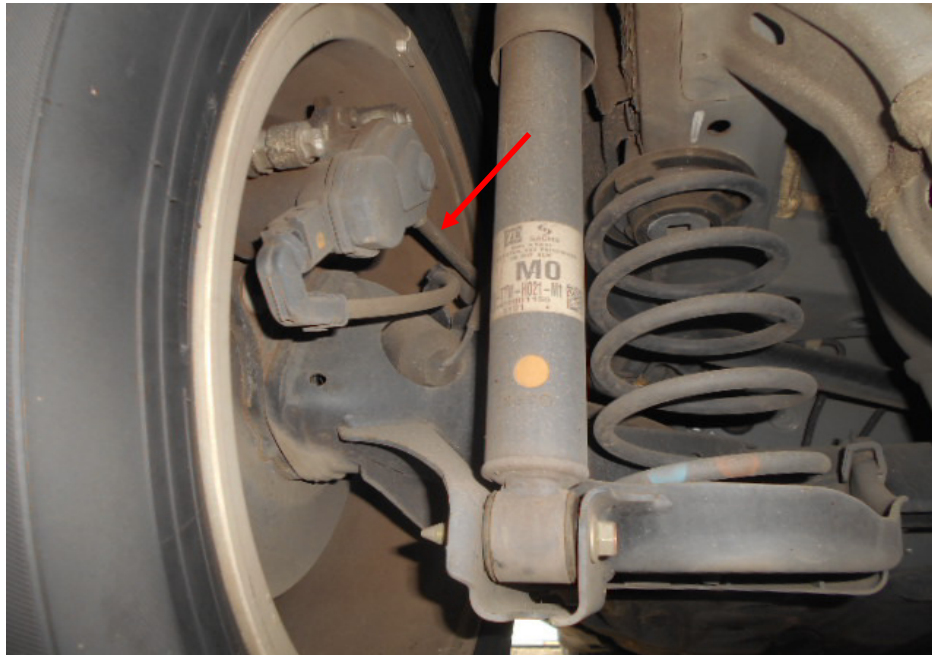
Photo 13 shows the various undercarriage components at the rear left wheel of the Motor Car, in particular the brake hose (arrowed). I did not observe any leakage of brake fluid at the 4 wheels of the Motor Car. My visual inspection of the various mechanical components of the Motor Car's braking system revealed all to be intact and without visible damage, indicating that the braking system was likely to be in serviceable condition at the material time of accident.
