Your Ref: TP/IP/41385/2017  
Our Ref : CI/TPD18001920/D

03 February 2018

**Fatal Accident Investigation Team**

**MECHANICAL INSPECTION REPORT OF MOTOR CAR SLF 2021C**

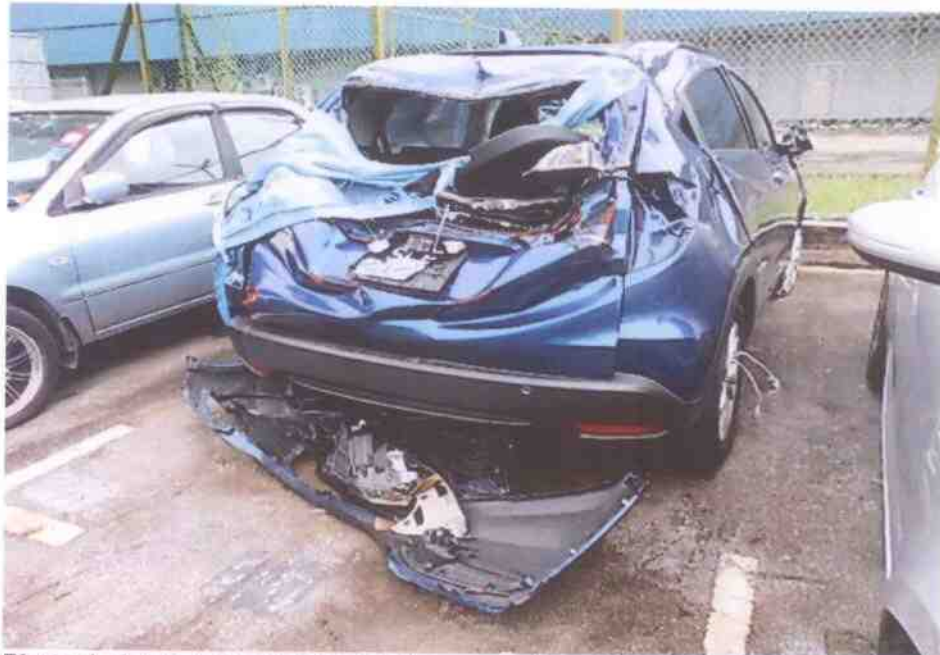
**Photo 1** shows a general view of the rear portion of the Motor Car at the time of my inspection. Its rear tailgate, rear windscreen, rear right fender and roof panel were amongst the body parts that were severely damaged as a result of the accident.

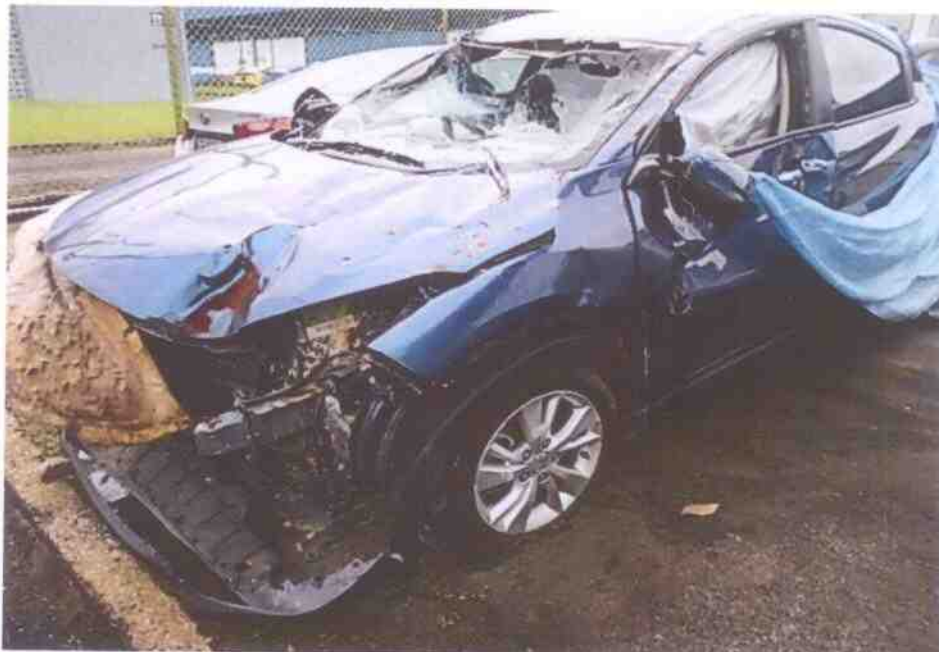
**Photo 2** shows a general view of the front left portion of the Motor Car at the time of my inspection. The Motor Car was also observed to have sustained extensive impact damage at its frontal portion and left portion. Its front bumper, front bonnet, front left fender, front windscreen, left front door and roof panel were amongst the body parts that were observed to have been damaged as a result of the accident.

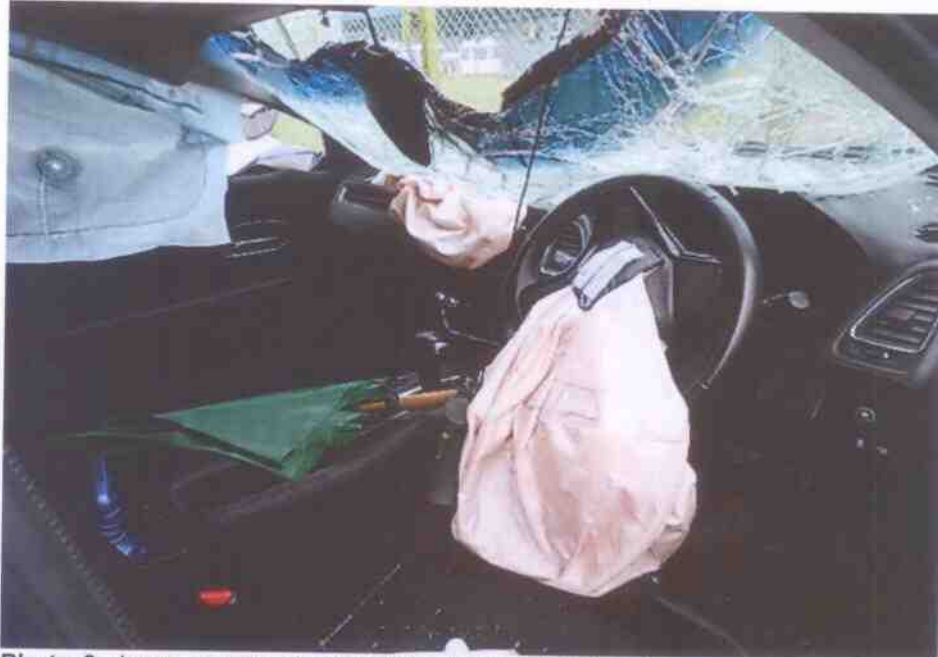
Photo 3 shows a general view of the Motor Car's interior compartment. Several parts and components inside the interior compartment were observed to have been damaged. This had included the front dashboard, trims and seats. The driver's air bag, front left passenger air bag and left curtain air bag were also deployed as a result of the accident.

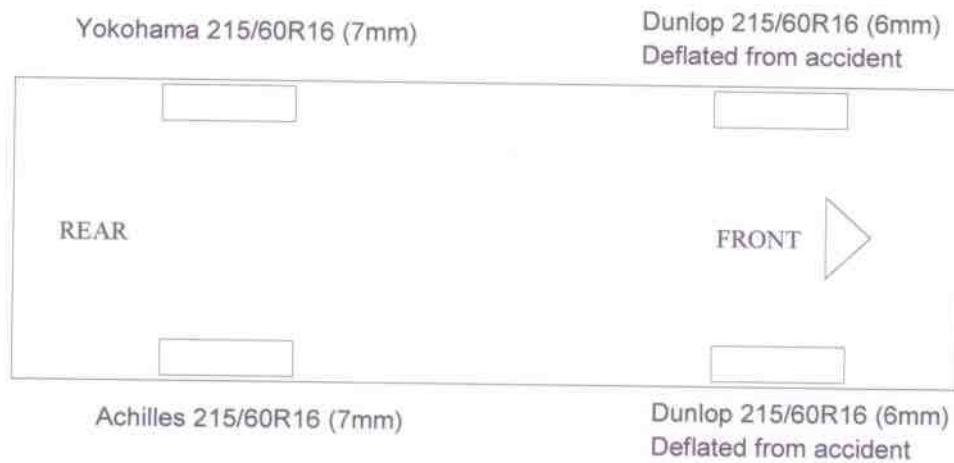
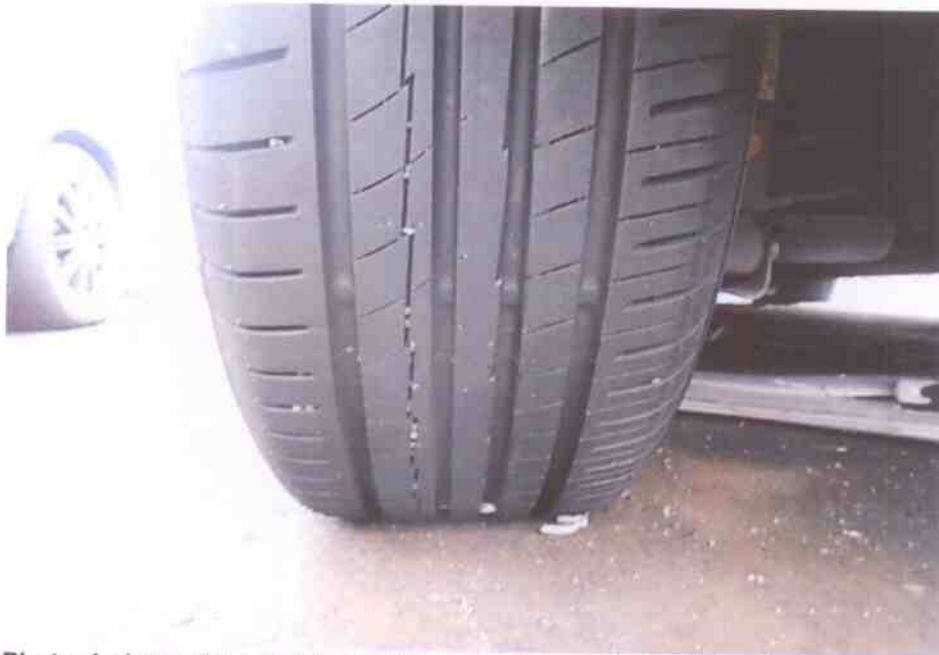
**Photo 4** shows the condition of the rear left tyre of the Motor Car, which was observed to be in serviceable condition with remaining tread depth of approximately 7mm. There was no tear, cut or burst mark(s) on the outer and the inner sidewalls as well as across the tread of this tyre. The tyre, which was wrapped around alloy wheel rim, was also observed to be sufficiently inflated for vehicular operation.

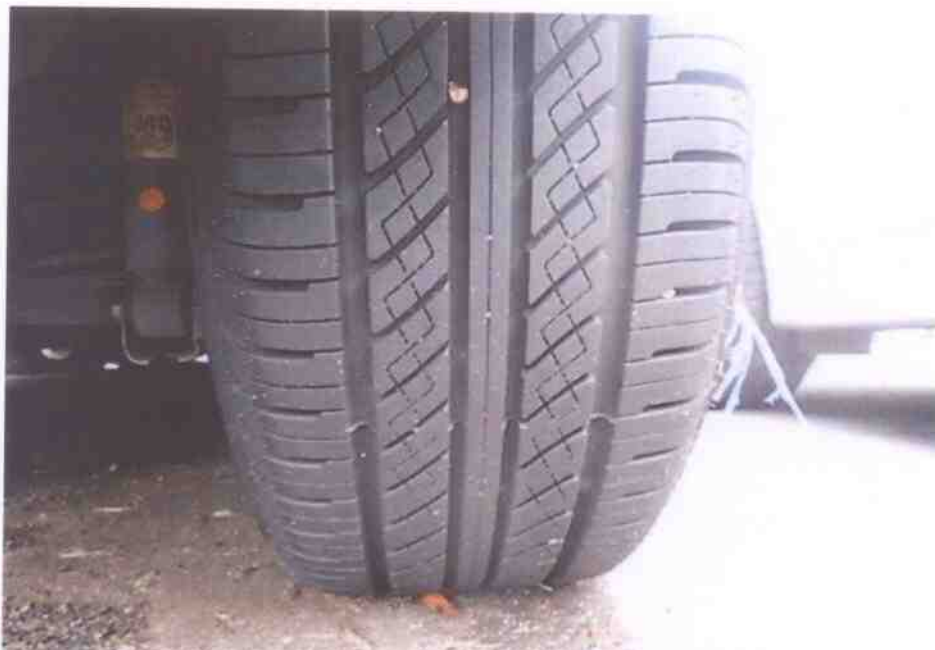
**Photo 5** shows the condition of the rear right tyre of the Motor Car, which was observed to be in serviceable condition with remaining tread depth of approximately 7mm. There was no tear, cut or burst mark(s) on the outer and the inner sidewalls as well as across the tread of this tyre. The tyre, which was wrapped around alloy wheel rim, was also observed to be sufficiently inflated for vehicular operation.

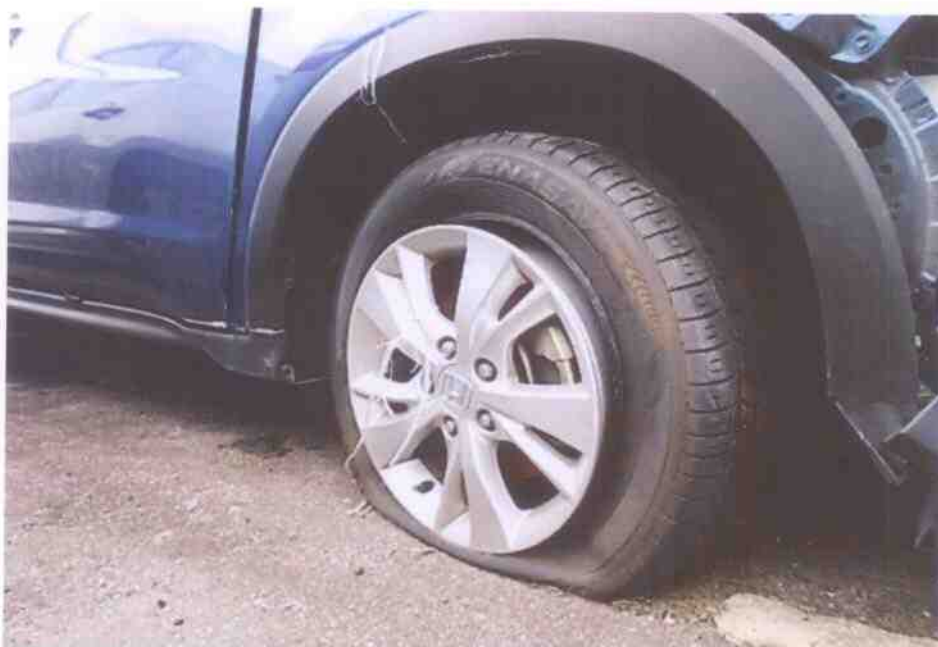
**Photo 6** shows a general view of the front right wheel rim and tyre of the Motor Car. The front right tyre was observed to be deflated and loosely wrapped around the front right wheel rim as a result of the accident.

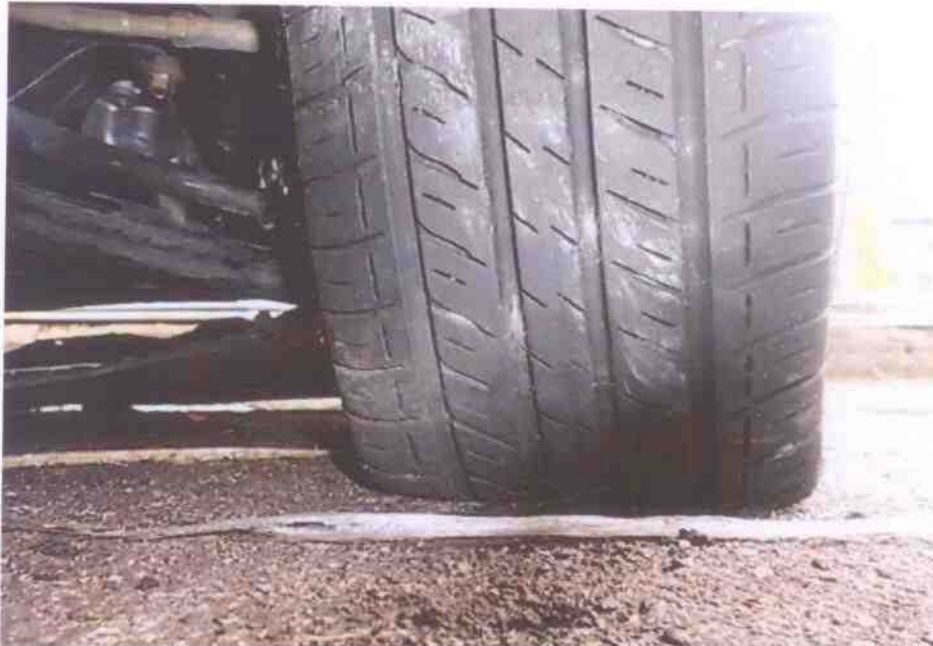
**Photo 7** shows the condition of the front right tyre of the Motor Car, which was observed to be in serviceable condition with remaining tread depth of approximately 6mm. The tyre was observed to be deflated and loosely wrapped around the front right wheel rim as a result of the accident.

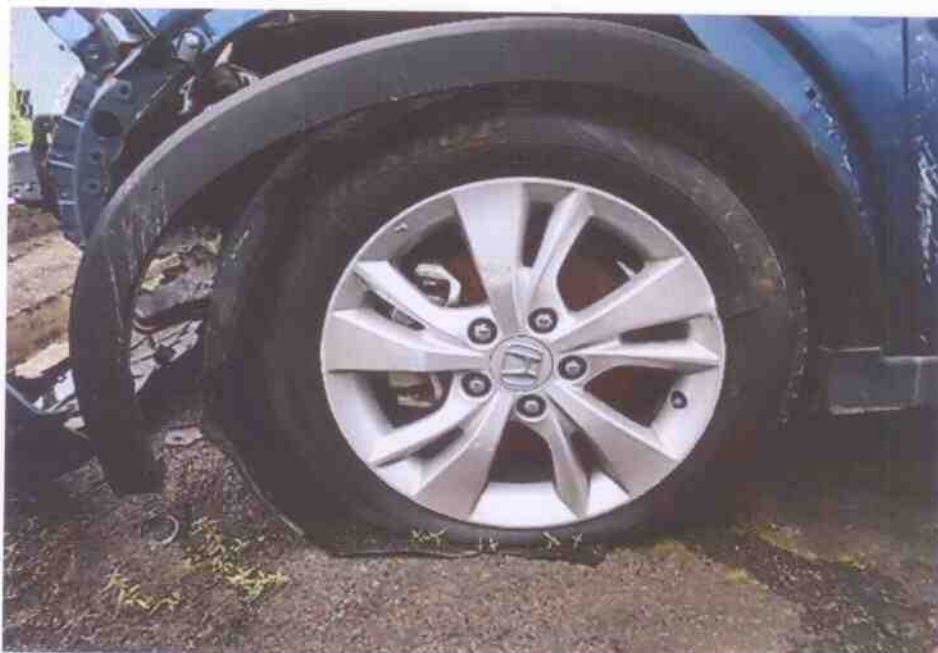
**Photo 8** shows a general view of the front left wheel rim and tyre of the Motor Car. The front left tyre was observed to be deflated with a cut on its outer sidewall. The front left wheel rim was also observed to be dented as a result of the accident.

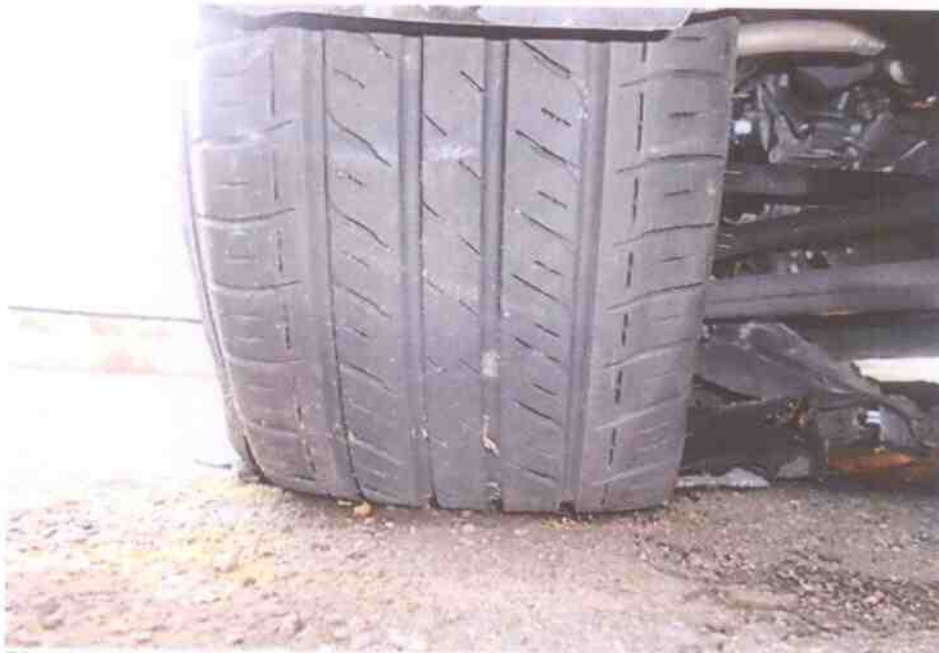
**Photo 9** shows the condition of the front left tyre of the Motor Car, which was observed to be in serviceable condition with remaining tread depth of approximately 6mm. The tyre was observed to be deflated and cut as a result of the accident.

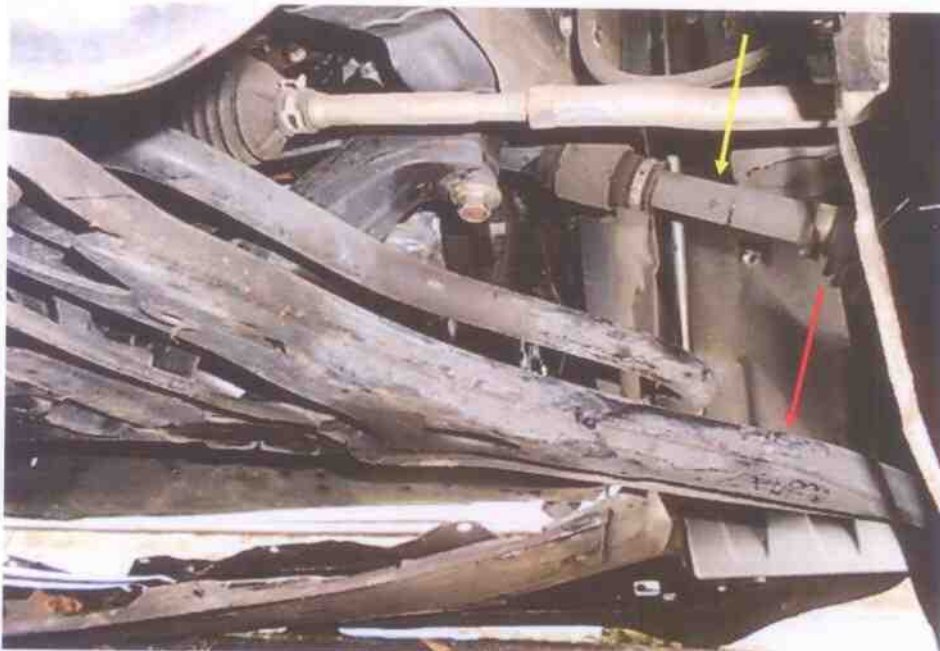
**Photo 10** shows the undercarriage components at the front right wheel of the Motor Car. My checks on the underside of the Motor Car revealed damage to the various undercarriage components at the front right wheel and front left wheel of the Motor Car. Components like the front right lower arm (red arrow), front right drive shaft (yellow arrow) and front right steering tie rod were all found to be have been damaged.

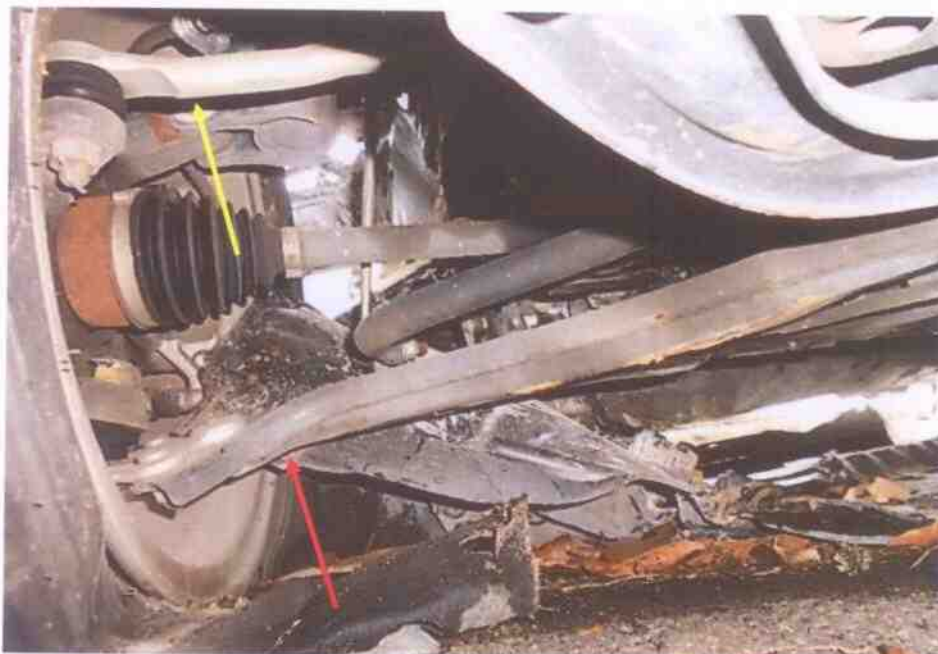
**Photo 11** shows the undercarriage components at the front left wheel of the Motor Car. My checks on the underside of the Motor Car revealed damage to the various undercarriage components at the front right wheel and front left wheel of the Motor Car. Components like the front left lower arm (red arrow) and front left steering tie rod (yellow arrow) were damaged.

12. For this inspection, I was not able to conduct any tests on the steering system of the Motor Car due to damage to several mechanical components of the steering system like the steering tie rod (refer to photograph 11 above).
13. With regard to the braking system, although I was also not able to carry out any tests given that the Motor Car's engine could not be started due to damage to its ignition system as a result of the accident, my visual inspection of the various mechanical components of the braking system had however appear to suggest that the braking system was in serviceable condition. Parts like the brake master pump, brake booster, brake calipers and brake hoses amongst others were all observed to be intact and undamaged. There was also no sign(s) or indication(s) of brake fluid leak observed at the 4 wheels of the Motor Car. See photo 12 & 13 below.

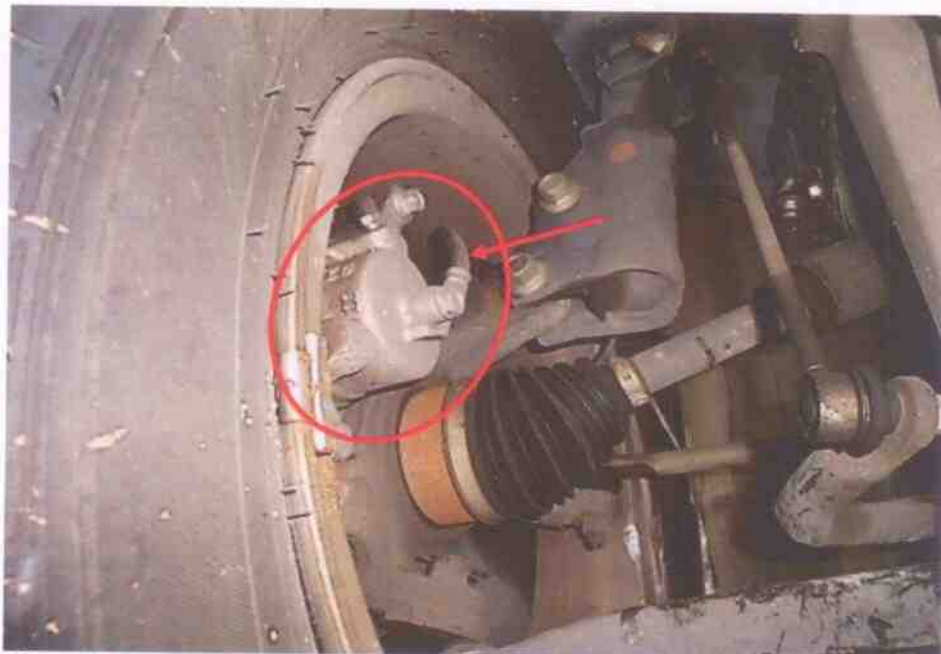
**Photo 12** shows the brake hose (arrowed) at the front right wheel of the Motor Car. I did not observe any leakage of brake fluid at the 4 wheels of the Motor Car. My visual inspection of the various mechanical components of the Motor Car's braking system, including its brake caliper (circled), revealed all to be intact and without visible damage, indicating that the braking system was likely to be in serviceable condition at the material time of accident.

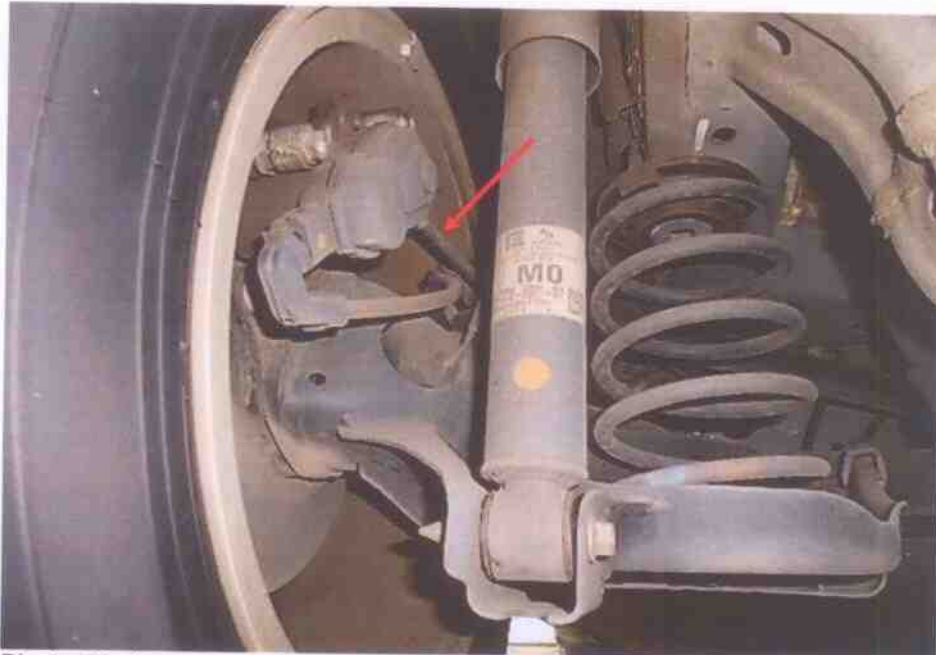
**Photo 13** shows the various undercarriage components at the rear left wheel of the Motor Car, in particular the brake hose (arrowed). I did not observe any leakage of brake fluid at the 4 wheels of the Motor Car. My visual inspection of the various mechanical components of the Motor Car's braking system revealed all to be intact and without visible damage, indicating that the braking system was likely to be in serviceable condition at the material time of accident.
