Your Ref : 4222949323SG
Our Ref : CC6/AIG18001934/N

11 March 2019

**AUTOMOBILE TECHNICAL INVESTIGATION REPORT OF ACCIDENT
INVOLVING SLS 7527J AND SKA 8399L ON 17 JANUARY 2018**

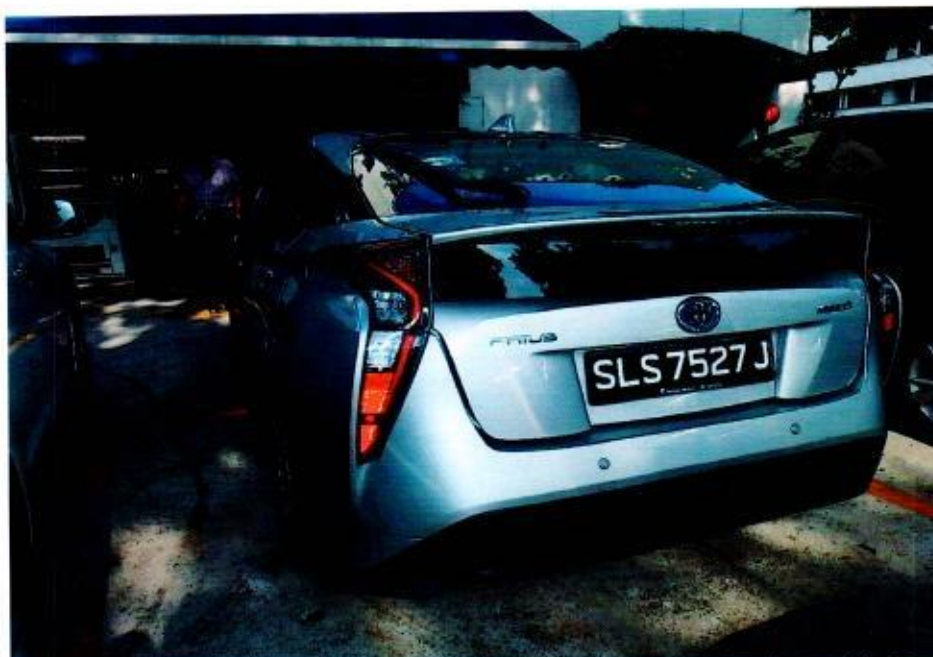
Photo 1 shows the general view of the rear of the Toyota at the time of the Pre-Repair Survey conducted by LKK Auto Consultants Pte. Ltd. which was taken about 2 weeks after the accident. The damage to the Toyota was observed to be confined to its rear portion, at the rear bumper.

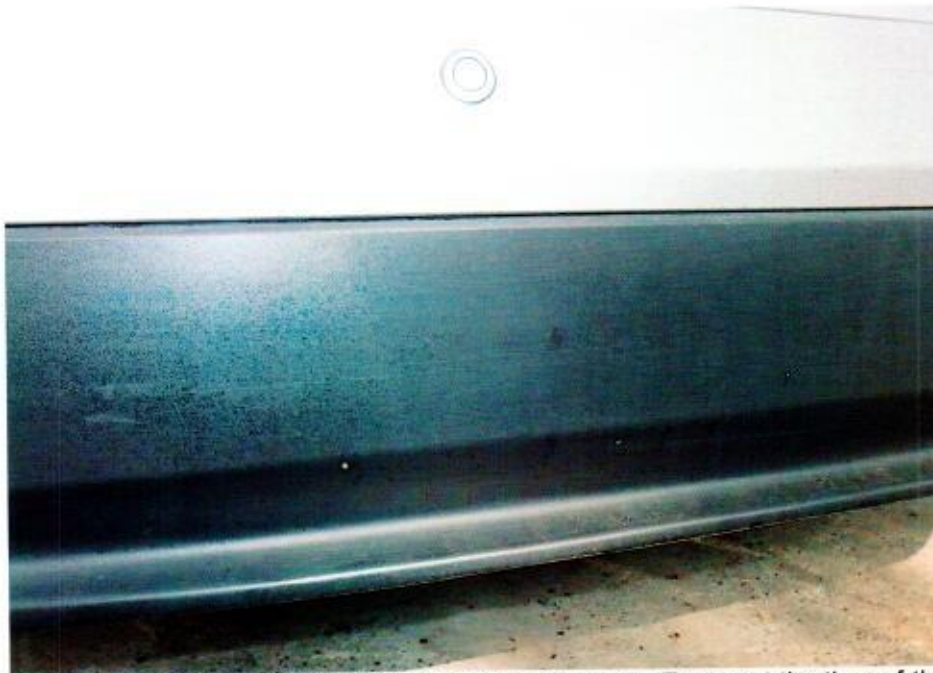
7. We had observed horizontal whitish marks on the left portion of the lower rear bumper. We also noted that the rear bumper was not misaligned at its corner edges. See photos 1 - 5 below.

Photo 2 shows a closer view of the rear bumper of the Toyota at the time of the Pre- Repair Survey conducted by LKK Auto Consultants Pte. Ltd. which was taken about 2 weeks after the accident. Horizontal whitish marks were observed on the left portion of the lower rear bumper (arrowed).

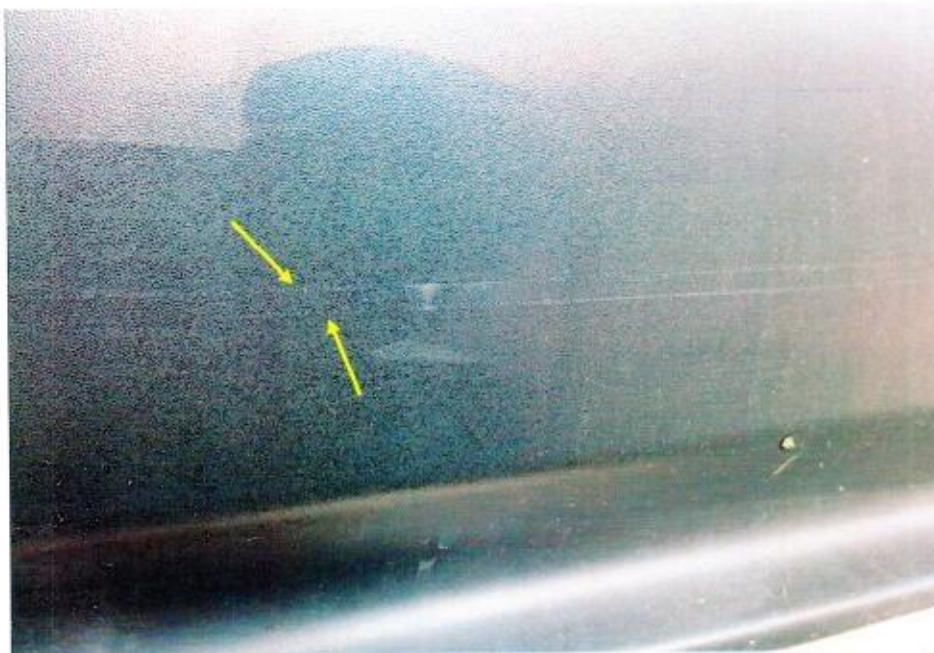
Photo 3 shows a close up view of the horizontal whitish marks observed on the left portion of the Toyota's lower rear bumper (arrowed).

14. Firstly, the horizontal whitish marks on the centre portion of the Toyota's lower rear bumper were caused by an object that is of a similar horizontal shape, pressing onto the rear portion of the Toyota. If one was to consider the shape of the Mercedes's front number plate frame, it would then appear that these horizontal whitish marks were caused by the top portion of the Mercedes's front number plate frame.

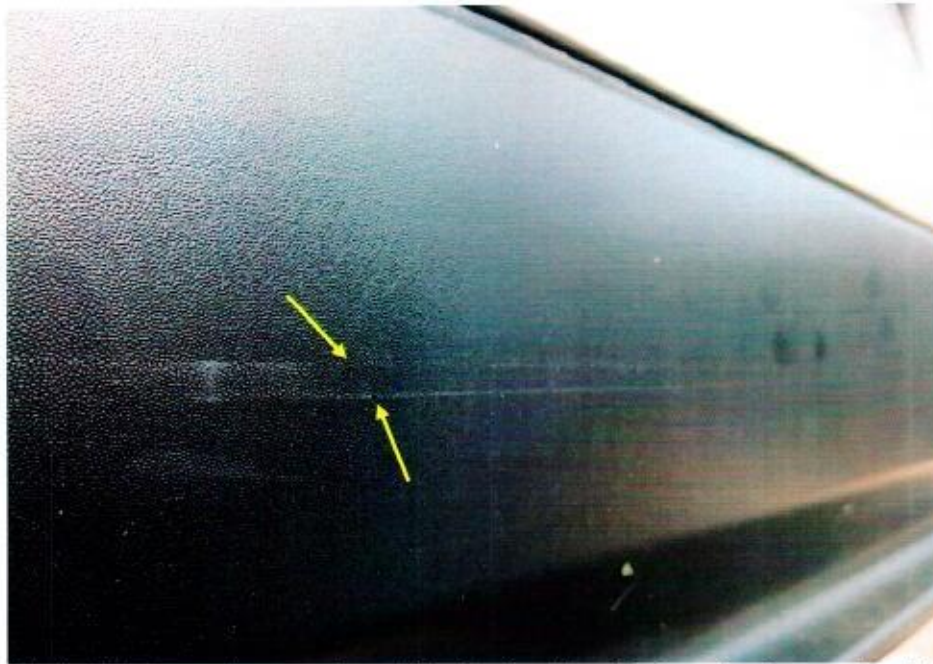
Photo 4 shows a close up view of the horizontal whitish marks observed on the left portion of the Toyota's lower rear bumper (arrowed).

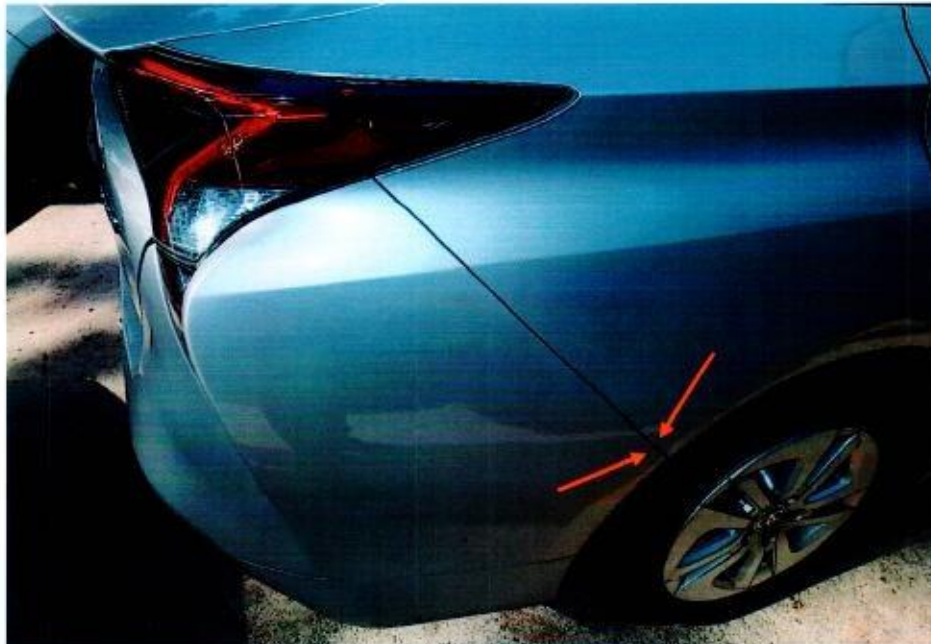
Photo 5 shows a close up view of the right corner edge of the rear bumper of the Toyota. We observed that there was no misalignment at the corner edges (red arrows).

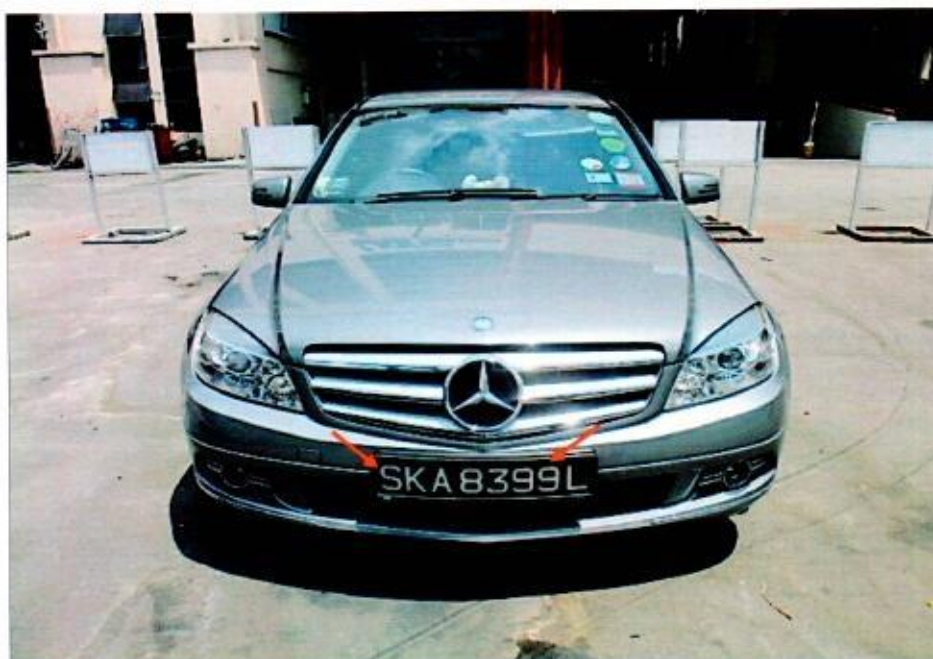
Photo 6 shows the general view of the front portion of the Mercedes at the time of our inspection. The only body part shape on the front of the Mercedes that could possibly correspond to the horizontal whitish marks found on the lower rear bumper of the Toyota was the top portion (arrowed) of its rectangular shaped front number plate frame.

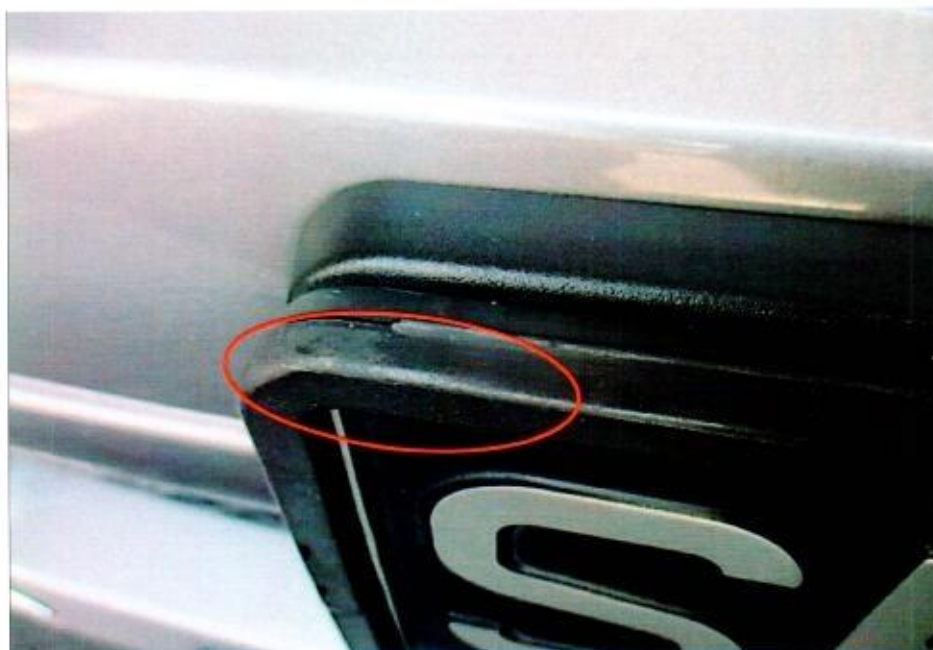
11. Our visual examination of the Mercedes's front number plate frame revealed that its top portion was slightly distorted. However the frame was not broken and/or cracked. It would then appear that the front number plate frame of the Mercedes had sustained an impact that was relatively light as there was no obvious crack or break on the front number plate frame. We observed blackish horizontal marks on some of the alpha-numeric letterings of the Mercedes's front number plate. It was also noted that the front bumper was not misaligned at its corner edges. See photos 6 - 13 below.

Photo 7 shows a close up view of the top right portion of the Mercedes's front number plate frame. The frame was observed to be slightly distorted (circled). However there was no obvious crack or break on the front number plate frame.

15. Although there was no obvious crack or break on the front number plate frame of the Mercedes at the time of our inspection, it could be due to the impact force arising from the contact being not significant enough to have stretched past the material strength of the front number plate frame. In this aspect, one would have to consider the material stiffness of the number plate frame, which is constructed of hard plastic, against the thermoplastic (soft plastic) material of the rear bumper.

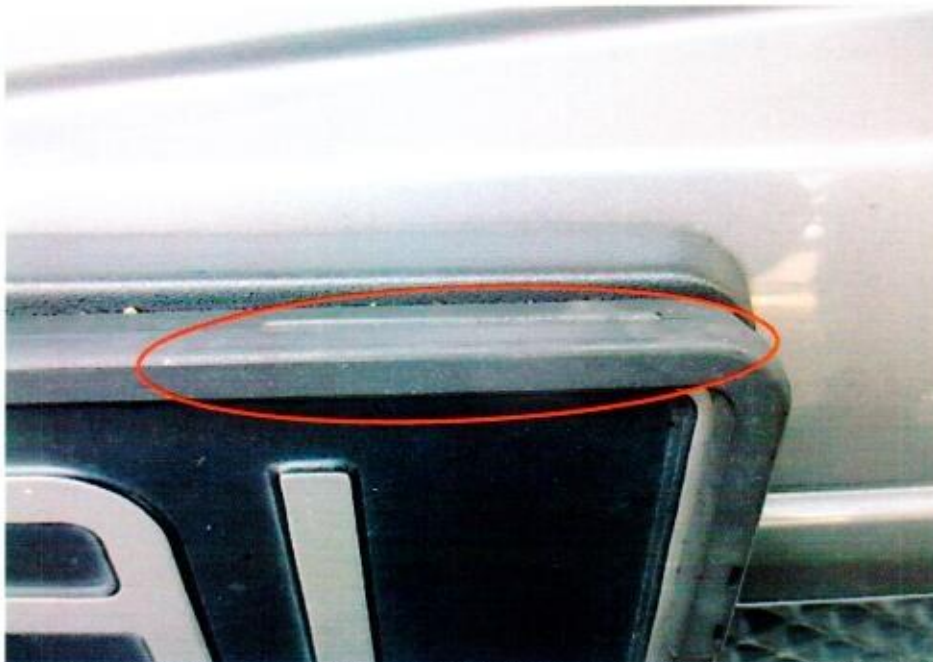
Photo 8 shows a close up view of the top left portion of the Mercedes's front number plate frame. The frame was observed to be slightly distorted (circled). However there was no obvious crack or break on the front number plate frame.

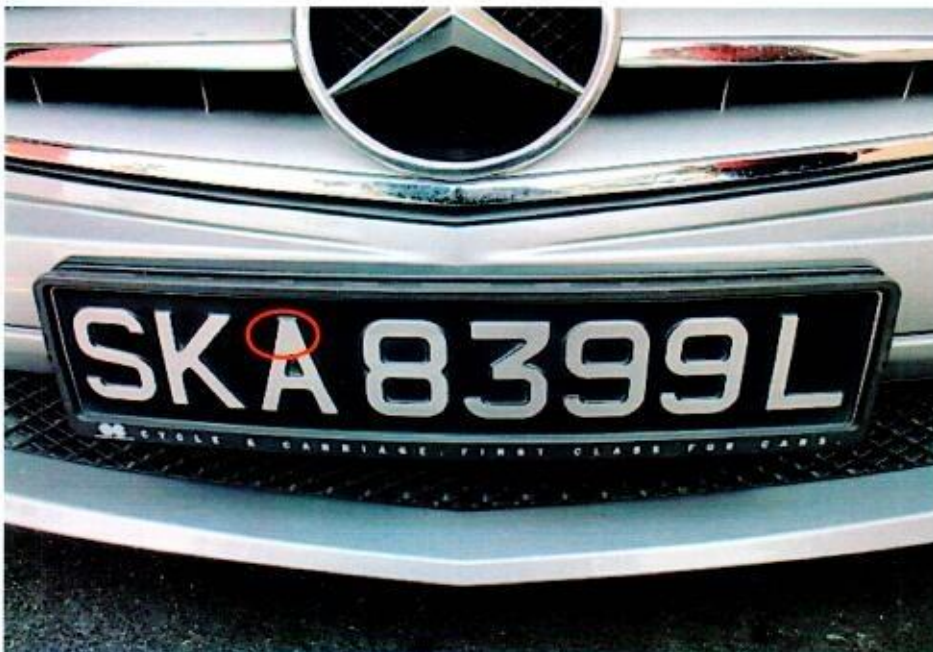
Photo 9 shows the front number plate of the Mercedes. We observed horizontal blackish marks on some of the alpha-numeric letterings of the Mercedes front number plate (circled).

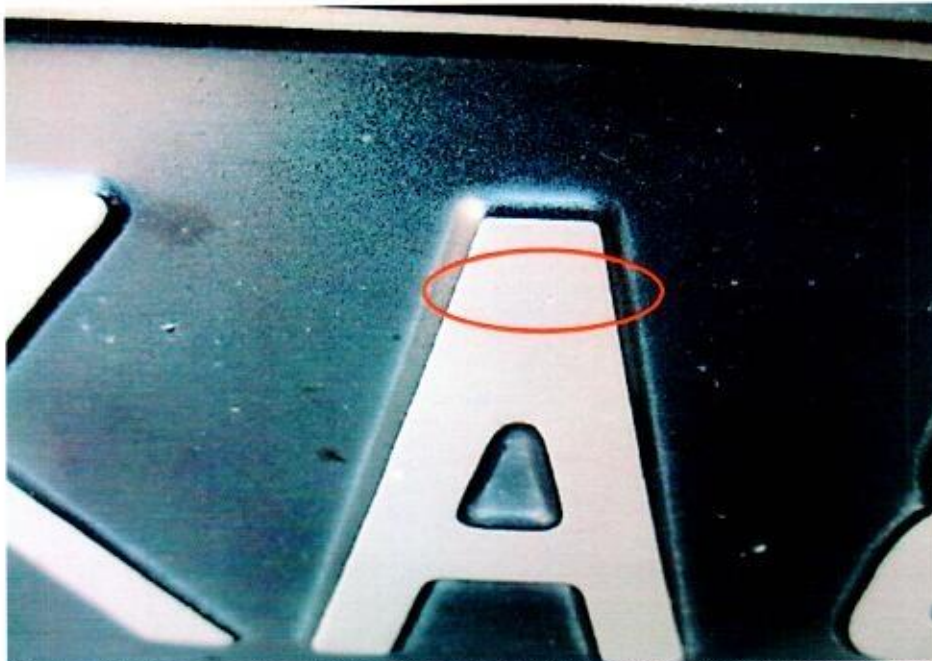
Photo 10 shows a closer view of the horizontal blackish marks on some of the alpha-numeric letterings of the Mercedes front number plate (circled).

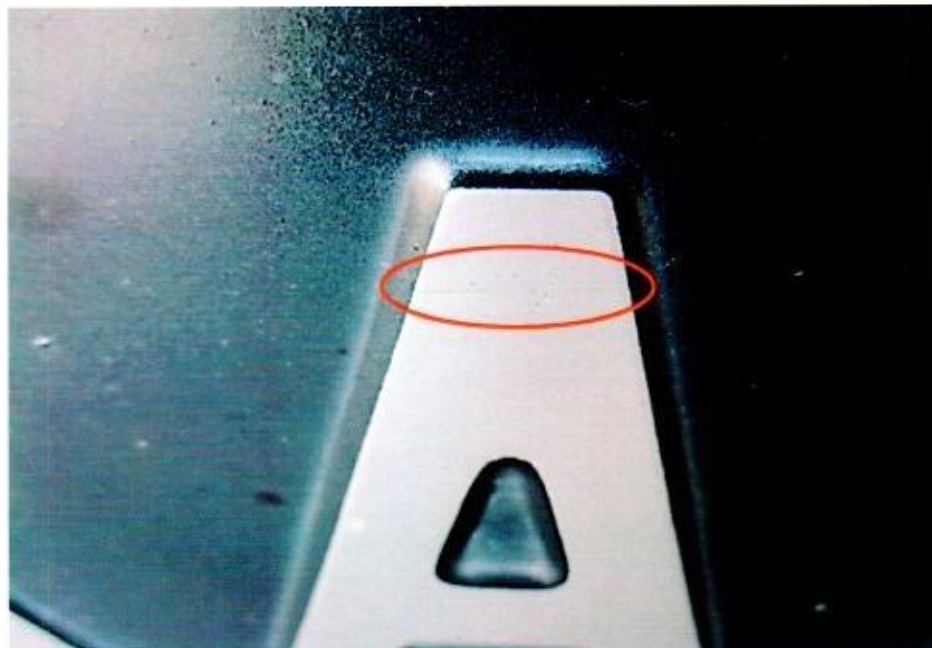
Photo 11 shows a close up view of the horizontal blackish marks on some of the alpha-numeric letterings of the Mercedes front number plate (circled).

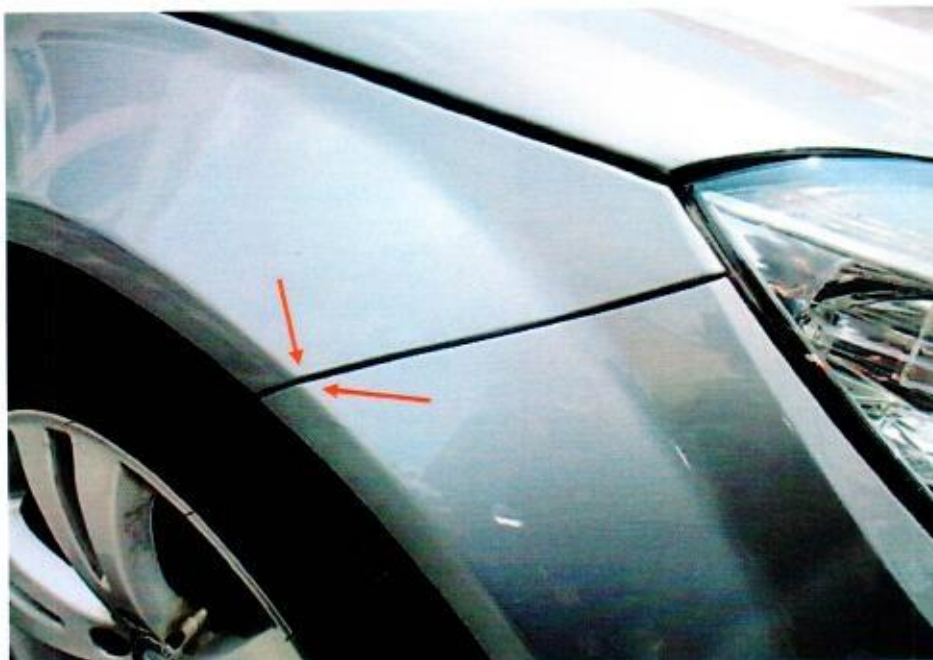
Photo 12 shows a close up view of the right corner edge of the front bumper of the Mercedes. We observed that there was no misalignment at the corner edges (red arrows).

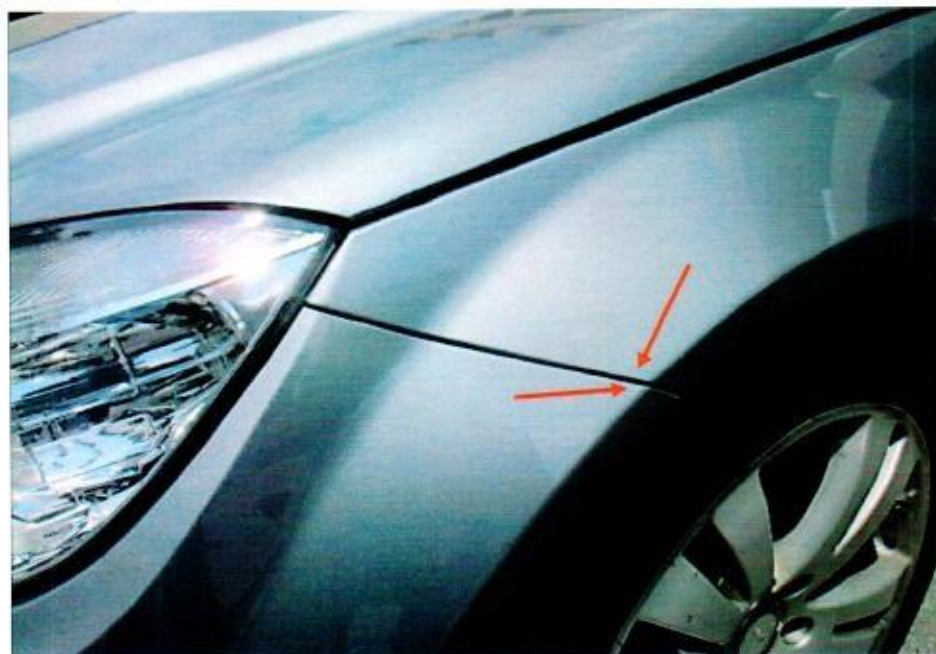
Photo 13 shows a close up view of the left corner edge of the front bumper of the Mercedes. We observed that there was no misalignment at the corner edges (red arrows).

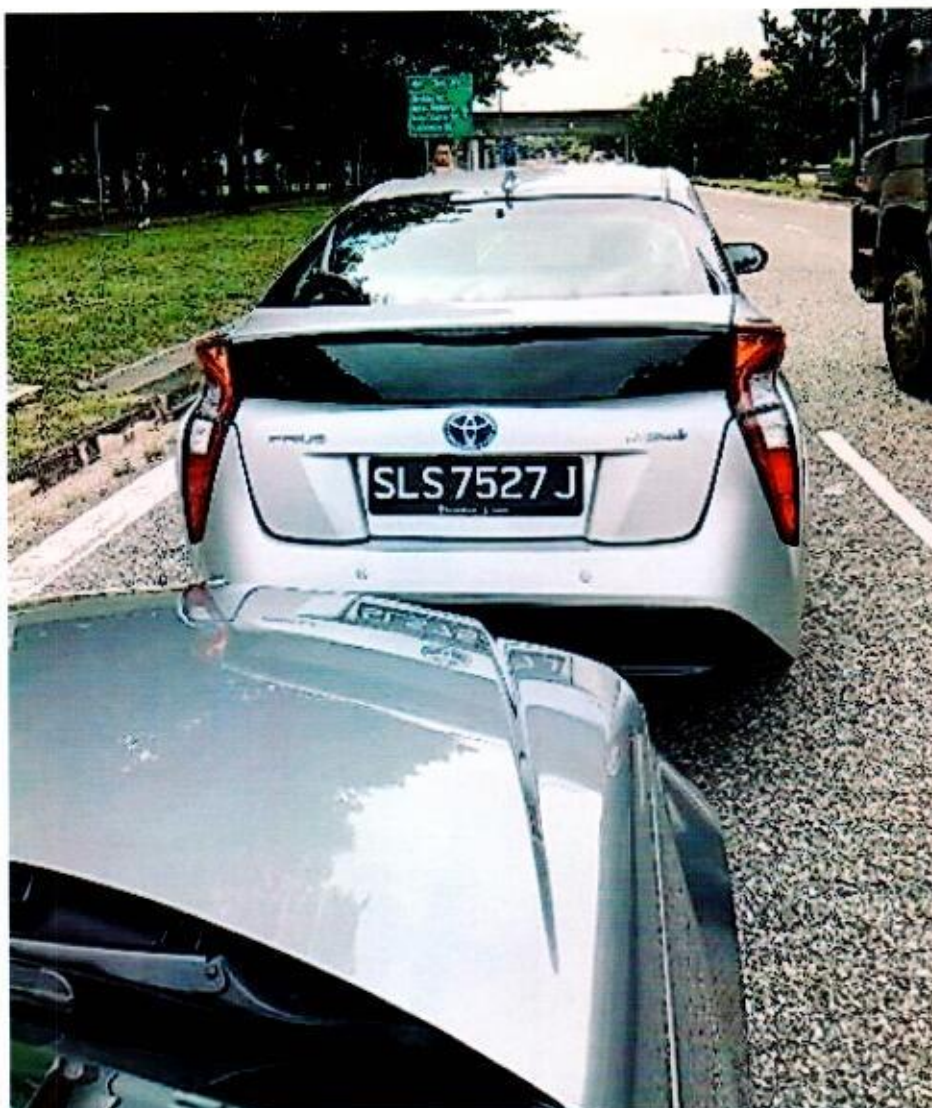
12. Our review of the available accident scene photographs showing the final position of the Involved Motor Cars provided to us by Ms Kwok had showed the Mercedes behind the Toyota. The position of the Mercedes appeared to be slightly towards the left from the rear of the Toyota. No other information could be obtained from these photographs. See photo 14 below.

Photo 14 shows the final position of the Involved Motor Cars post- accident, with the Mercedes behind the Toyota. The position of the Mercedes appeared to be slightly towards the left from the rear of the Toyota. No other information could be obtained from this photograph.

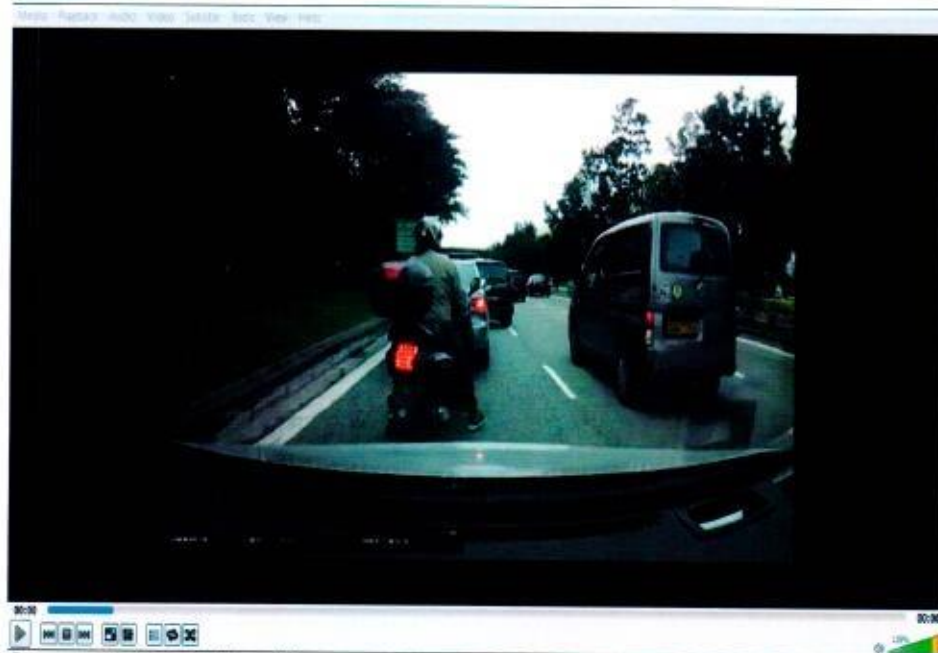
Screenshot 1 of the video recording from the video recording device that was mounted onto the front windscreen of the Toyota showing the Toyota inching forward and braking along the 3rd lane.

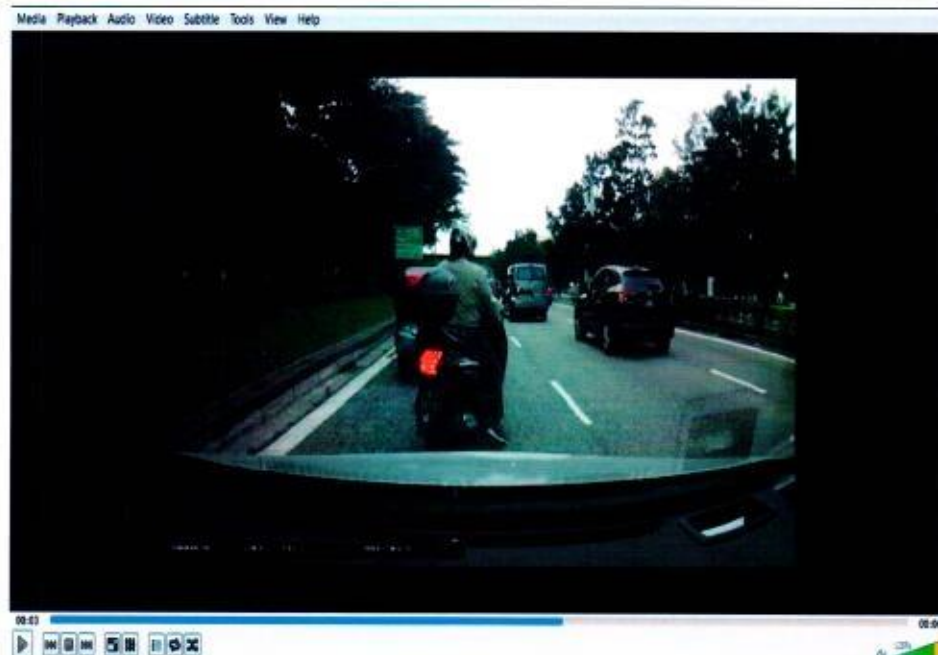
17. The Toyota can be seen inching forward and braking along the 3rd lane at the start of the video. Between the 2nd and 3rd second mark of the video recording, we had noted a slight movement (forward like movement) of the Toyota whilst braking. This was after the Mercedes had rear-ended the Toyota. The capturing of this slight movement by the video recording device that was mounted on the front windscreen of the Toyota is a sign that there was a jerk-like movement to the Toyota itself. Ultimately, indicating that there was contact between the front portion of the Mercedes and the rear portion of the Toyota.

Screenshot 2 of the video recording from the video recording device that was mounted onto the front windscreen of the Toyota. Between the 2nd and 3rd second mark of the video recording, we had noted a slight movement (forward like movement) of the Toyota whilst braking. This was after the Mercedes had rear- ended the Toyota. The capturing of this slight movement by the video recording device that was mounted on the front windscreen of the Toyota is a sign that there was a jerk- like movement to the Toyota itself. Ultimately, indicating that there was contact between the front portion of the Mercedes and the rear portion of the Toyota.

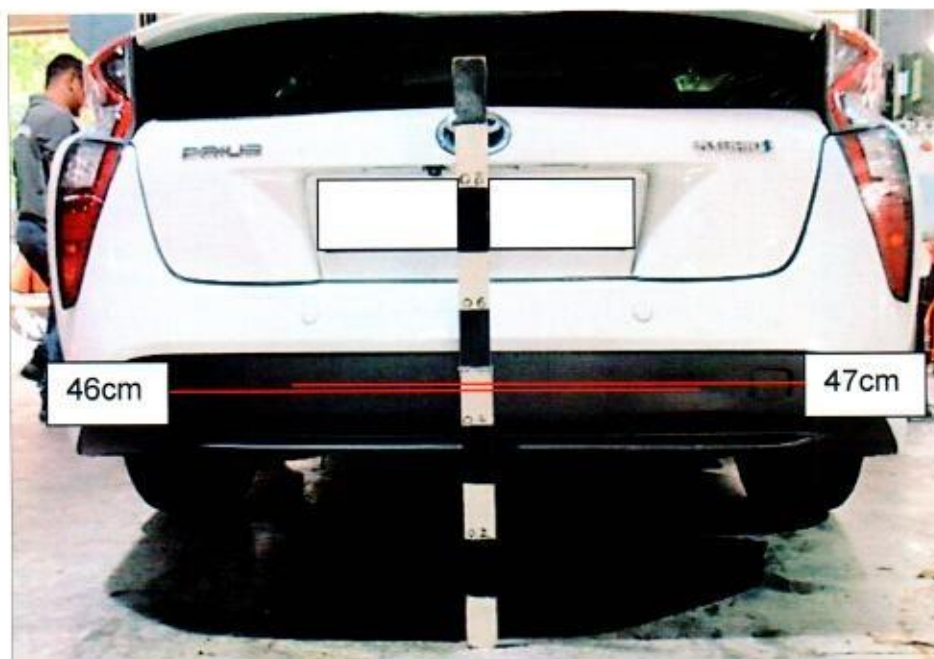
Photo 15 shows the height measurement being conducted on the rear portion of the Toyota (using a similar make and model). The height range above ground level of the lower rear bumper of the Toyota, at the area where the horizontal whitish marks were found was measured to be approximately between 46cm to 47cm.

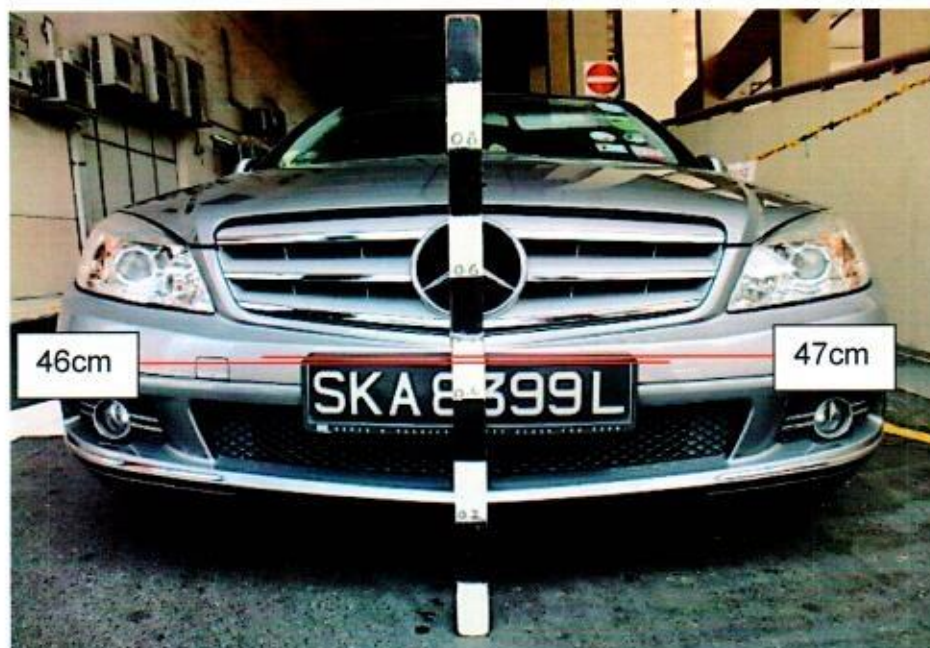
Photo 16 shows the height measurement being conducted on the front portion of the Mercedes. The body part at the height range of between 46cm to 47m above ground level was the top portion of the front number plate frame.

- a) the height range above ground level of the lower rear bumper of the Toyota, at the area where the horizontal whitish marks were found was measured to be approximately between 46cm to 47cm;
- b) the body part at the height range of between 46cm to 47m above ground level was the top portion of the Mercedes's front number plate fame;
- c) the height measurements appear to support the findings of possible contact between the rear portion of the Toyota and the front portion of the Mercedes. The damage observed on the rear bumper of the Toyota was a result of this contact and corresponds to the damage observed on the front number plate frame of the Mercedes.
