Your Ref : 4222949323SG
Our Ref : CC6/AIG18001934/N

11 March 2019

**AUTOMOBILE TECHNICAL INVESTIGATION REPORT OF ACCIDENT
INVOLVING SLS 7527J AND SKA 8399L ON 17 JANUARY 2018**

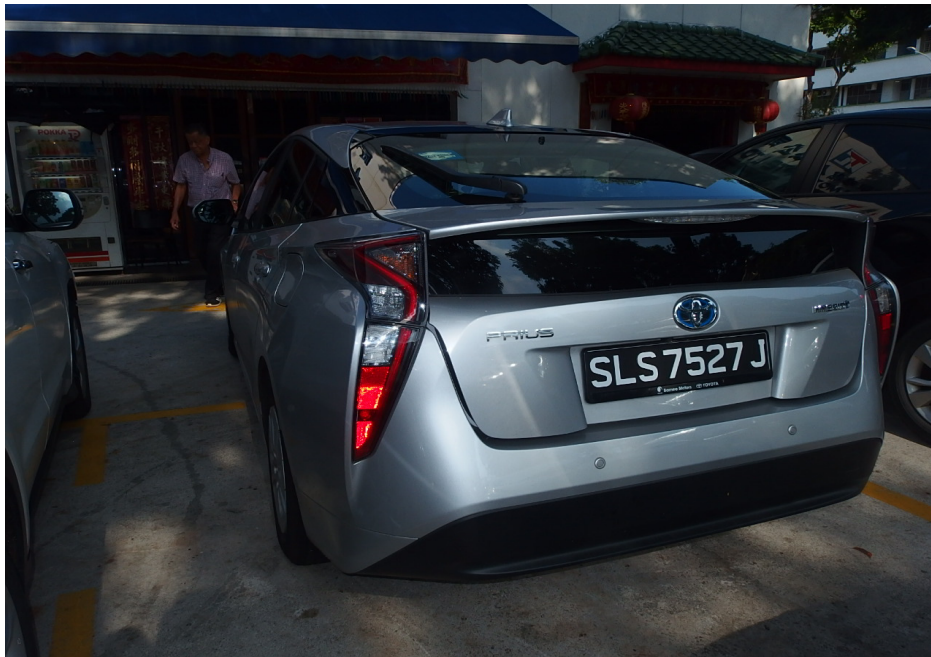
Photo 1 shows the general view of the rear of the Toyota at the time of the Pre-Repair Survey conducted by LKK Auto Consultants Pte. Ltd. which was taken about 2 weeks after the accident. The damage to the Toyota was observed to be confined to its rear portion, at the rear bumper.

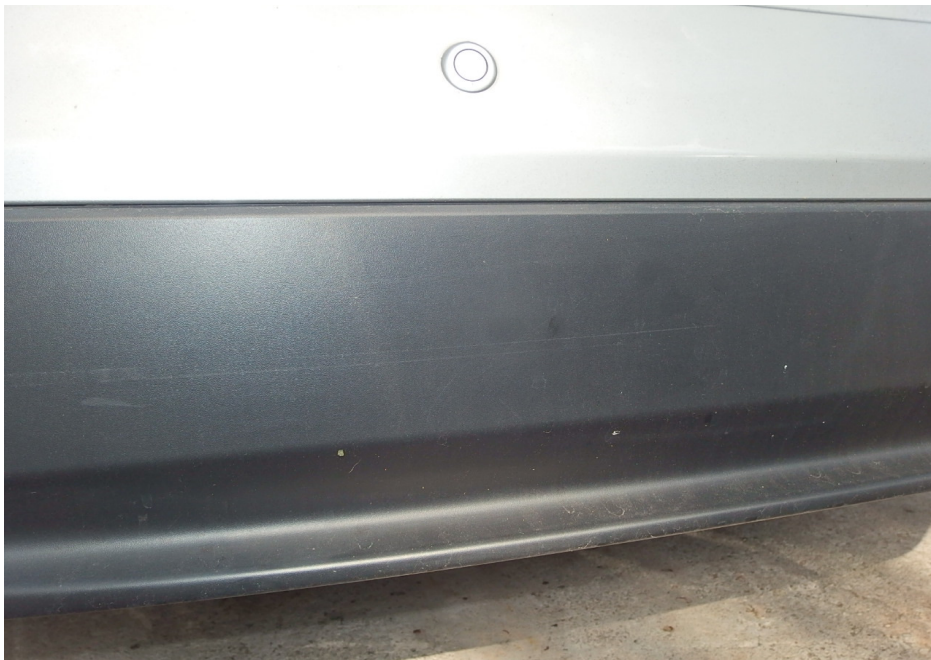
Photo 2 shows a closer view of the rear bumper of the Toyota at the time of the Pre- Repair Survey conducted by LKK Auto Consultants Pte. Ltd. which was taken about 2 weeks after the accident. Horizontal whitish marks were observed on the left portion of the lower rear bumper (arrowed).

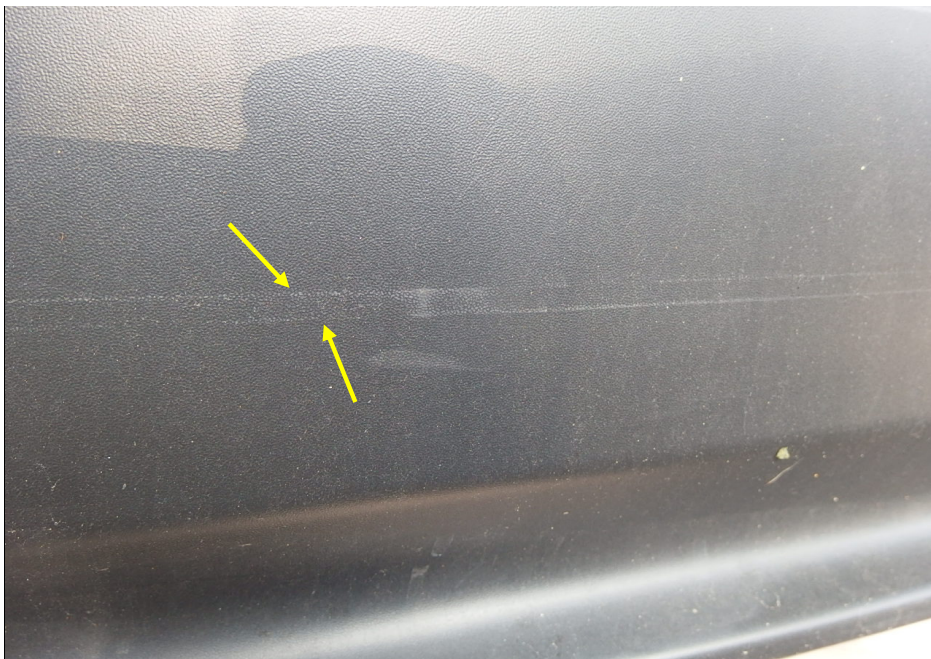
Photo 3 shows a close up view of the horizontal whitish marks observed on the left portion of the Toyota's lower rear bumper (arrowed).

14. Firstly, the horizontal whitish marks on the centre portion of the Toyota's lower rear bumper were caused by an object that is of a similar horizontal shape, pressing onto the rear portion of the Toyota. If one was to consider the shape of the Mercedes's front number plate frame, it would then appear that these horizontal whitish marks were caused by the top portion of the Mercedes's front number plate frame.

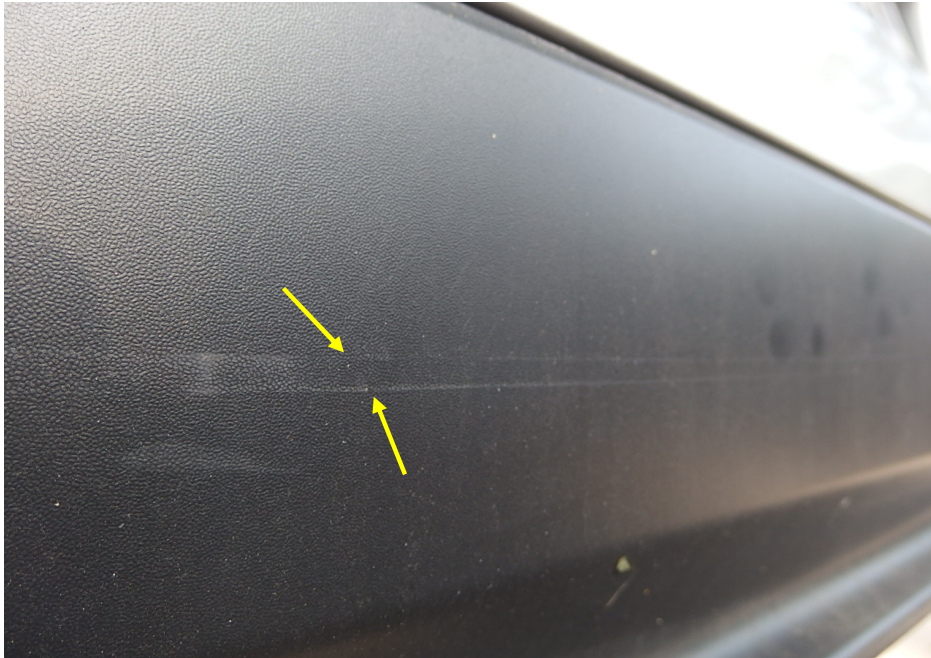
Photo 4 shows a close up view of the horizontal whitish marks observed on the left portion of the Toyota's lower rear bumper (arrowed).

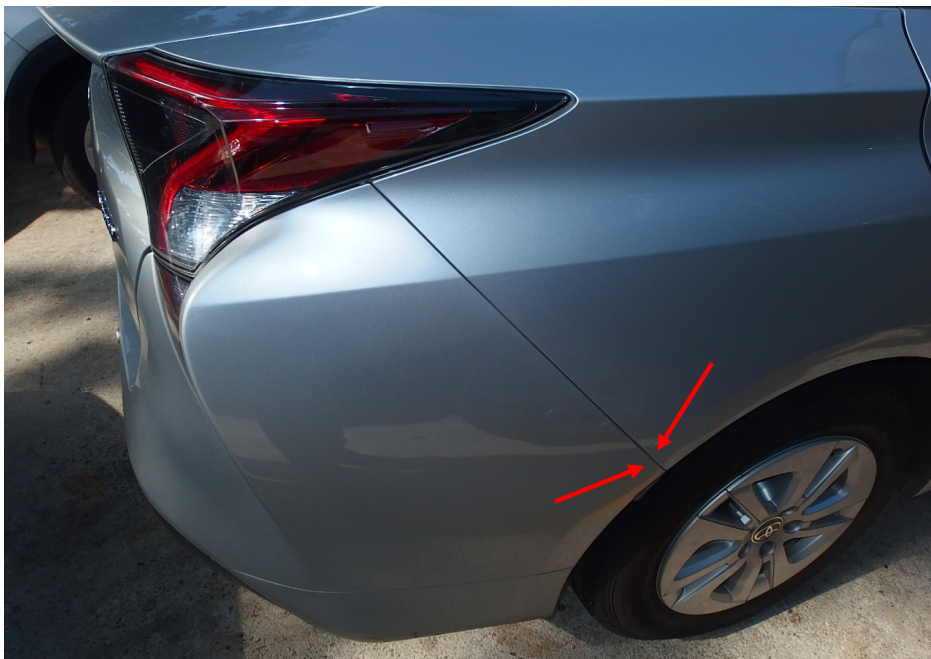
Photo 5 shows a close up view of the right corner edge of the rear bumper of the Toyota. We observed that there was no misalignment at the corner edges (red arrows).

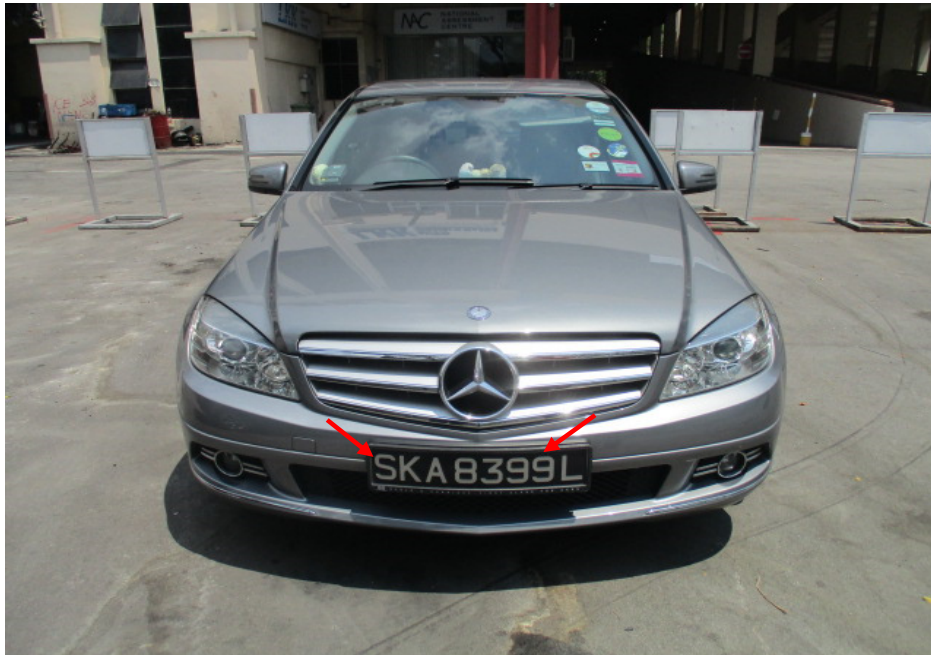
Photo 6 shows the general view of the front portion of the Mercedes at the time of our inspection. The only body part shape on the front of the Mercedes that could possibly correspond to the horizontal whitish marks found on the lower rear bumper of the Toyota was the top portion (arrowed) of its rectangular shaped front number plate frame.

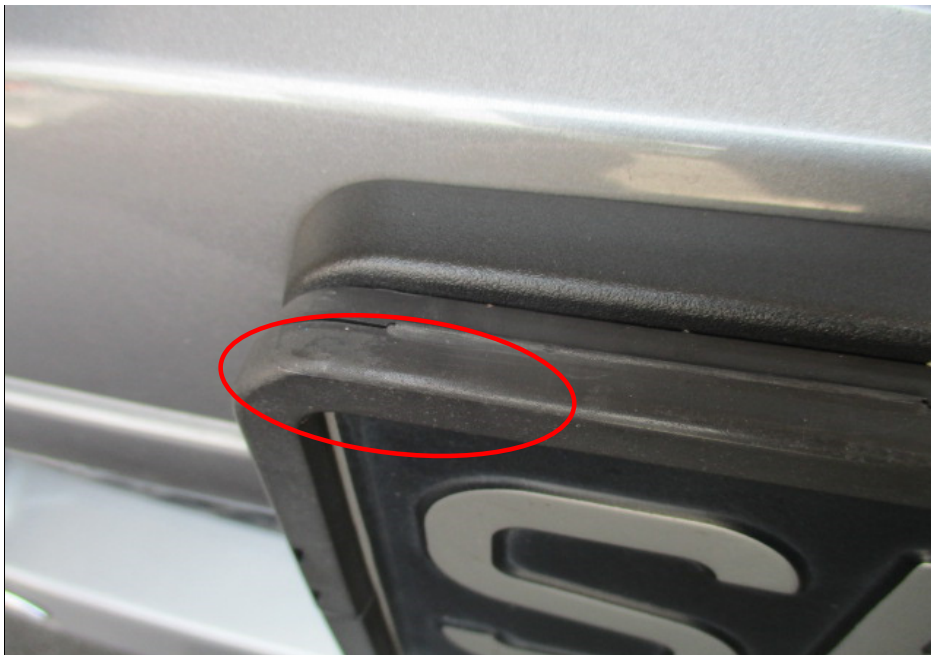
Photo 7 shows a close up view of the top right portion of the Mercedes's front number plate frame. The frame was observed to be slightly distorted (circled). However there was no obvious crack or break on the front number plate frame.

15. Although there was no obvious crack or break on the front number plate frame of the Mercedes at the time of our inspection, it could be due to the impact force arising from the contact being not significant enough to have stretched pass the material strength of the front number plate frame. In this aspect, one would have to consider the material stiffness of the number plate frame, which is constructed of hard plastic, against the thermoplastic (soft plastic) material of the rear bumper.

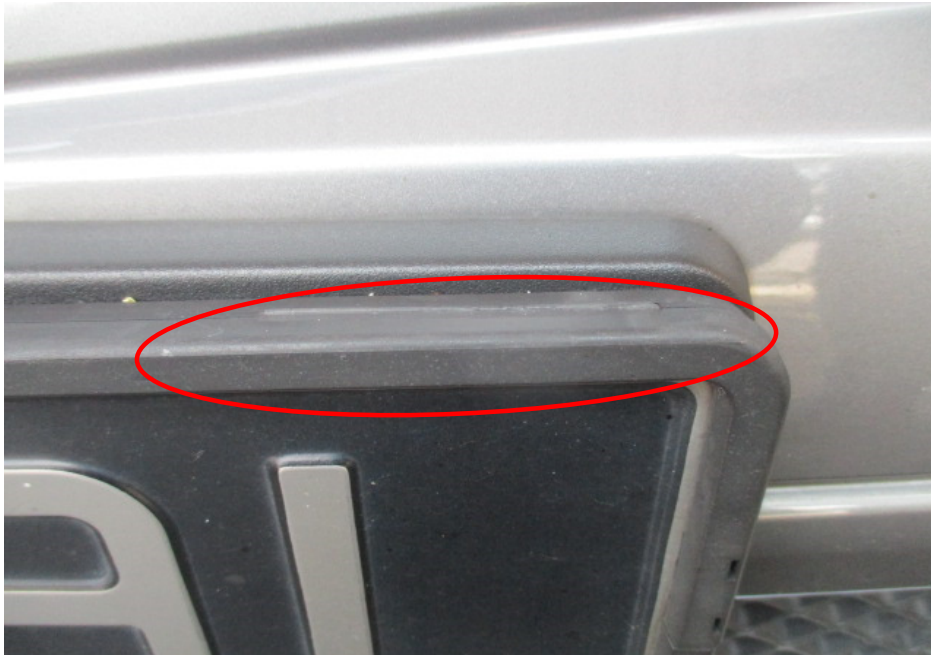
Photo 8 shows a close up view of the top left portion of the Mercedes's front number plate frame. The frame was observed to be slightly distorted (circled). However there was no obvious crack or break on the front number plate frame.

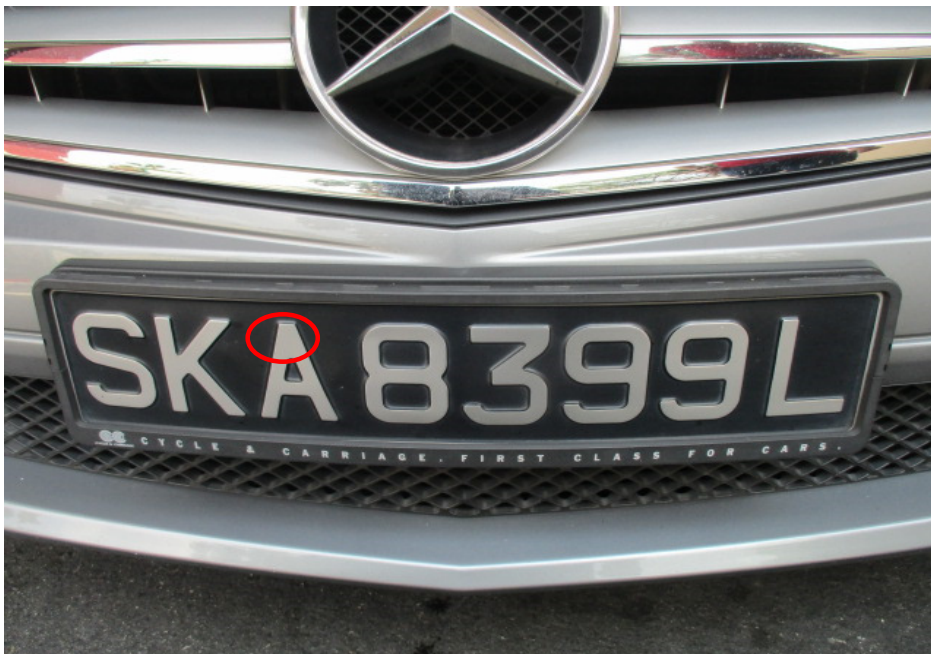
Photo 9 shows the front number plate of the Mercedes. We observed horizontal blackish marks on some of the alpha-numeric letterings of the Mercedes front number plate (circled).

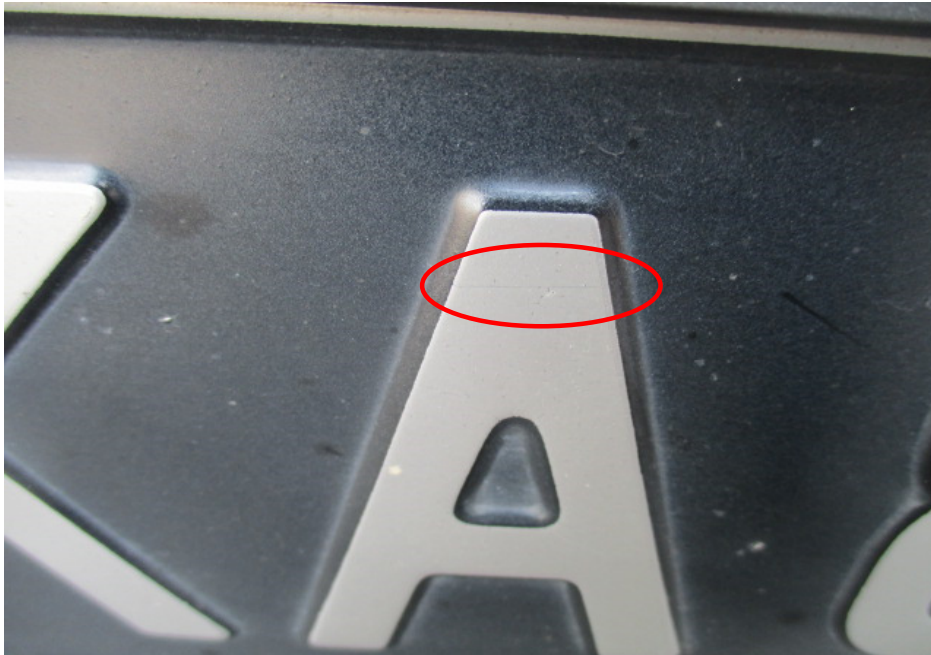
Photo 10 shows a closer view of the horizontal blackish marks on some of the alpha-numeric letterings of the Mercedes front number plate (circled).

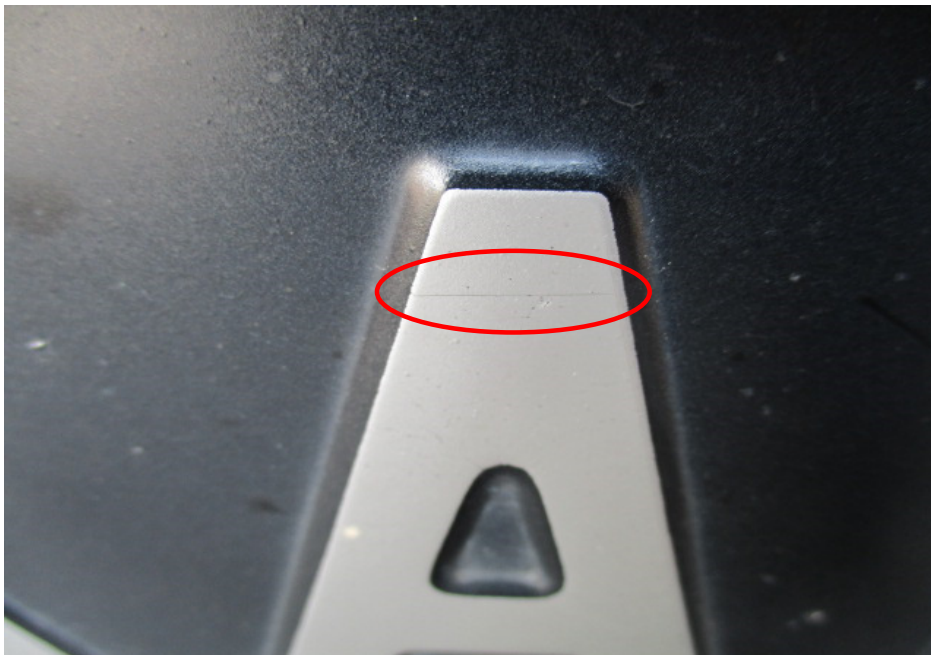
Photo 11 shows a close up view of the horizontal blackish marks on some of the alpha-numeric letterings of the Mercedes front number plate (circled).

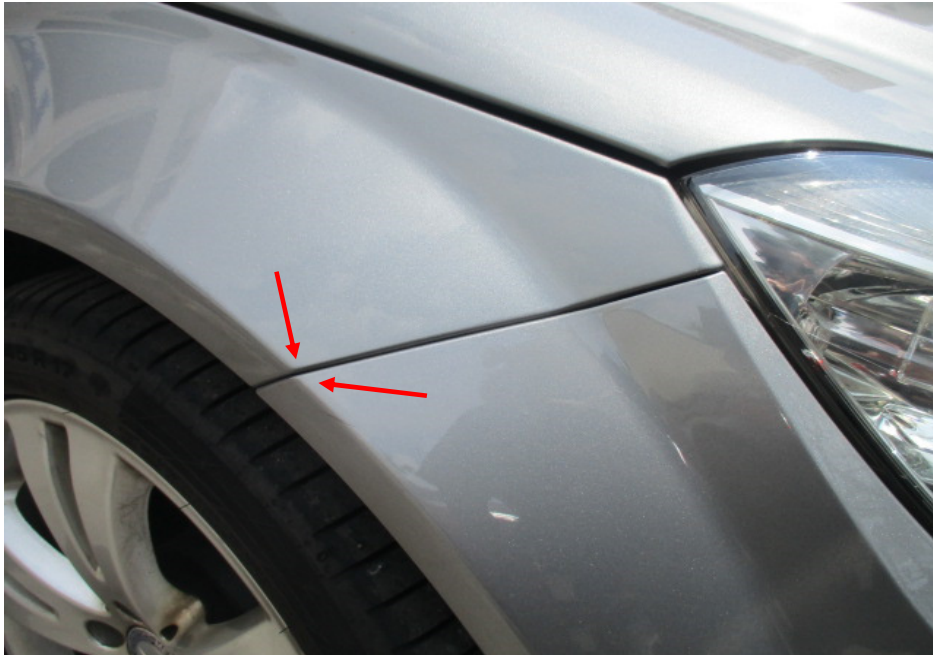
Photo 12 shows a close up view of the right corner edge of the front bumper of the Mercedes. We observed that there was no misalignment at the corner edges (red arrows).

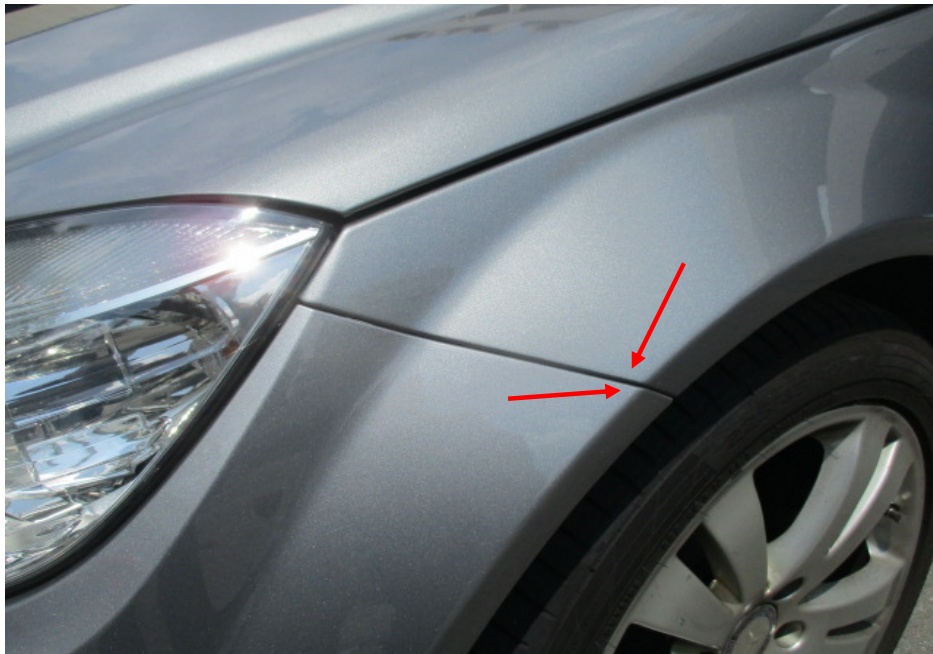
Photo 13 shows a close up view of the left corner edge of the front bumper of the Mercedes. We observed that there was no misalignment at the corner edges (red arrows).

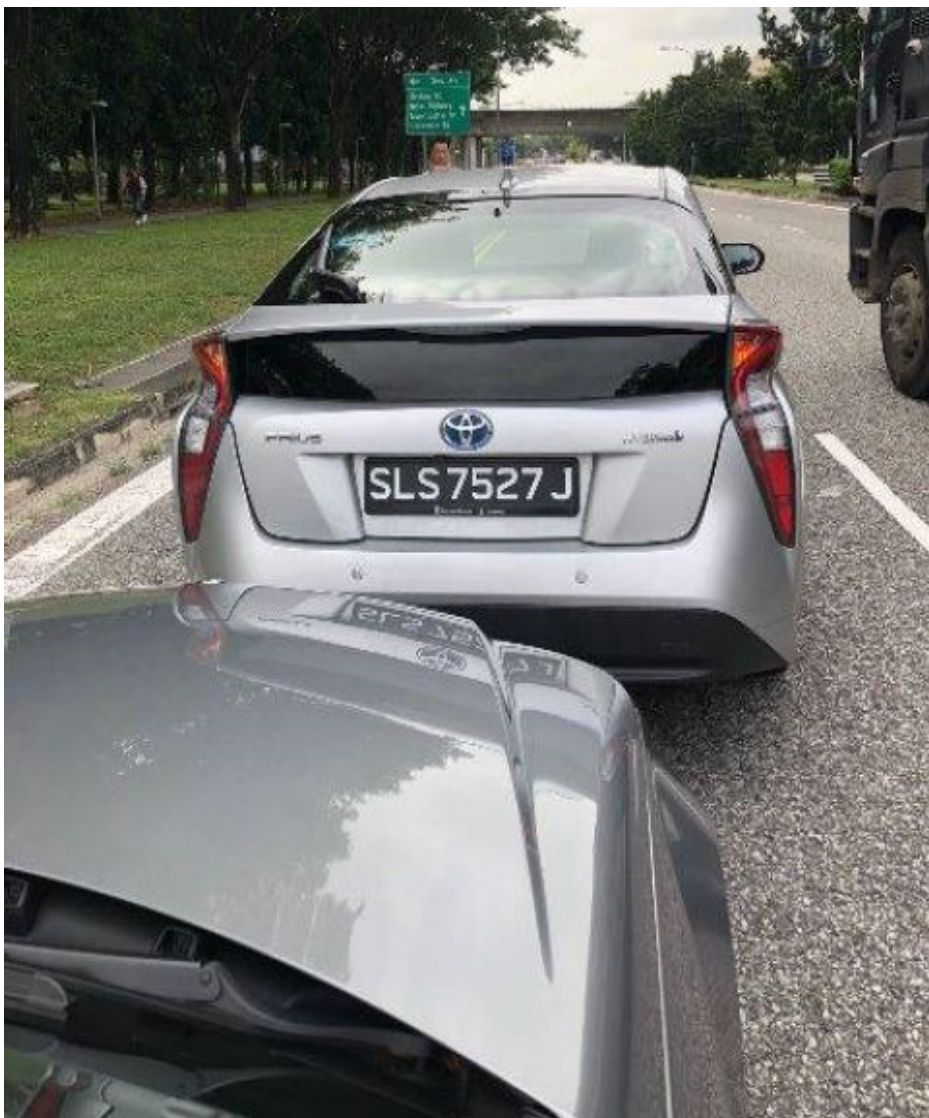
Photo 14 shows the final position of the Involved Motor Cars post- accident, with the Mercedes behind the Toyota. The position of the Mercedes appeared to be slightly towards the left from the rear of the Toyota. No other information could be obtained from this photograph.

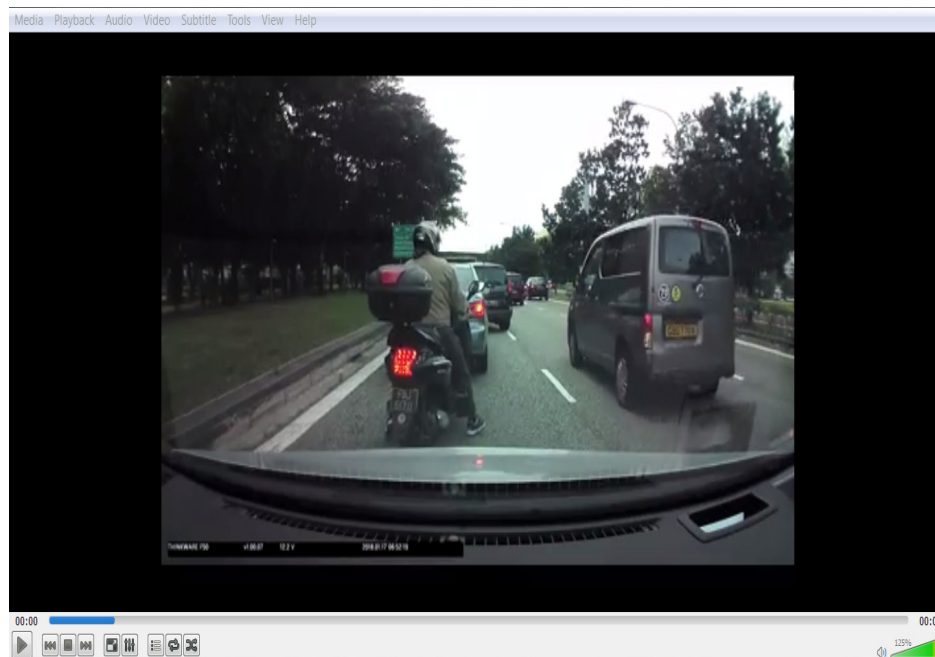
Screenshot 1 of the video recording from the video recording device that was mounted onto the front windscreen of the Toyota showing the Toyota inching forward and braking along the 3rd lane.

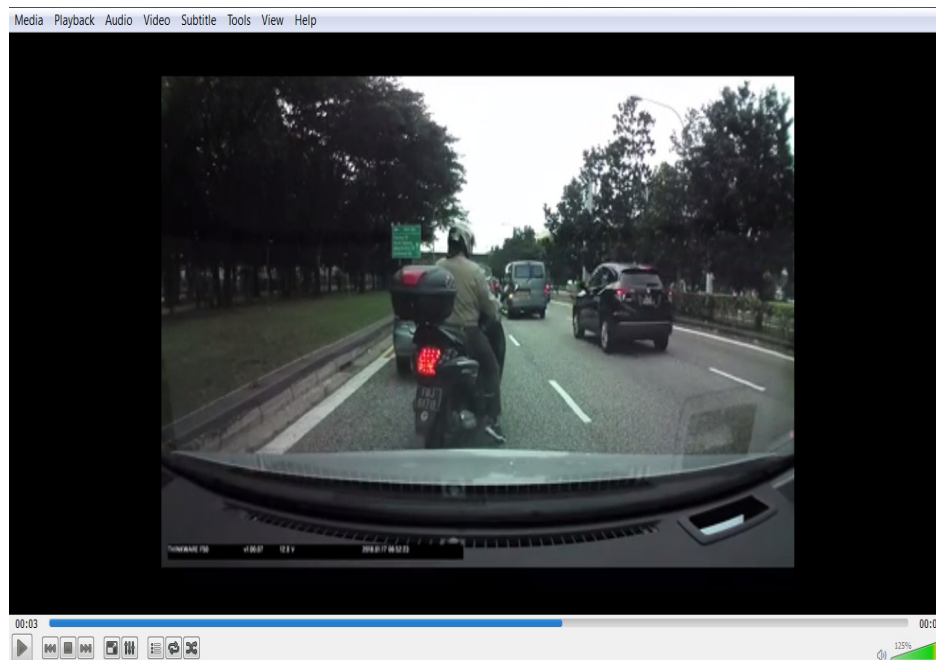
Screenshot 2 of the video recording from the video recording device that was mounted onto the front windscreen of the Toyota. Between the 2nd and 3rd second mark of the video recording, we had noted a slight movement (forward like movement) of the Toyota whilst braking. This was after the Mercedes had rear-ended the Toyota. The capturing of this slight movement by the video recording device that was mounted on the front windscreen of the Toyota is a sign that there was a jerk-like movement to the Toyota itself. Ultimately, indicating that there was contact between the front portion of the Mercedes and the rear portion of the Toyota.

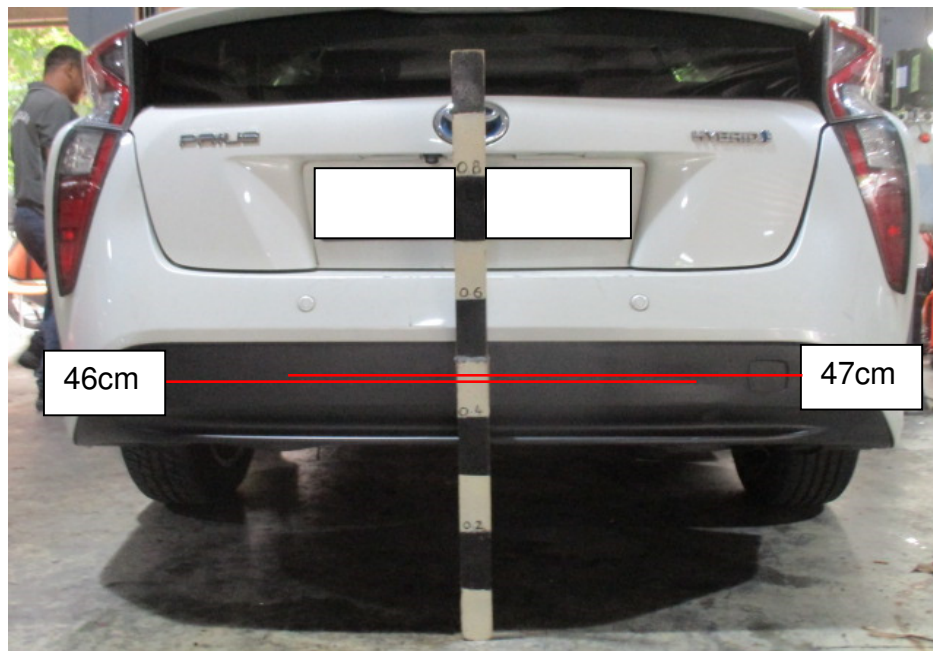
Photo 15 shows the height measurement being conducted on the rear portion of the Toyota (using a similar make and model). The height range above ground level of the lower rear bumper of the Toyota, at the area where the horizontal whitish marks were found was measured to be approximately between 46cm to 47cm.

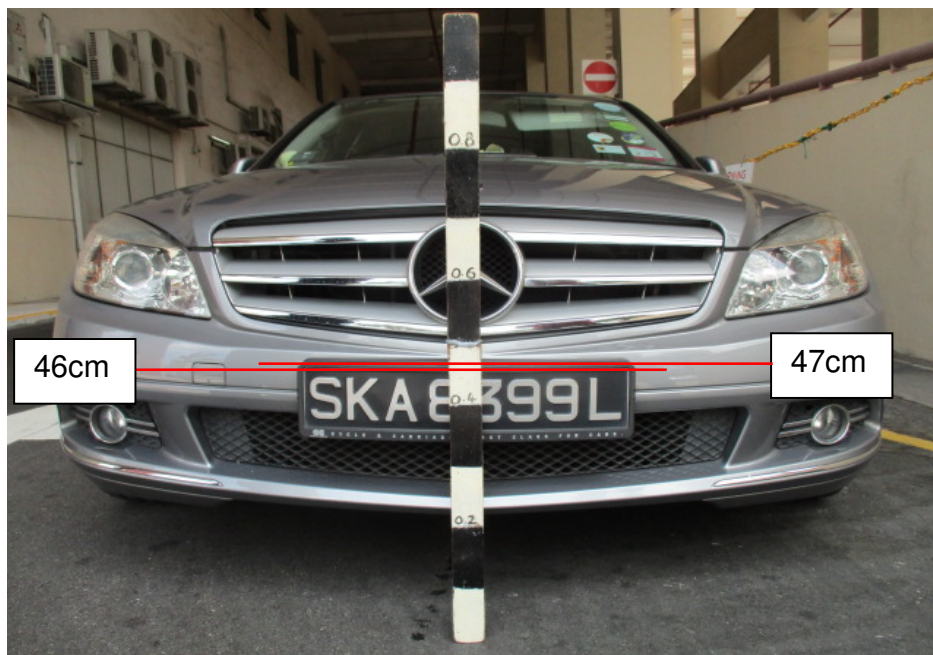
Photo 16 shows the height measurement being conducted on the front portion of the Mercedes. The body part at the height range of between 46cm to 47m above ground level was the top portion of the front number plate frame.

- a) the height range above ground level of the lower rear bumper of the Toyota, at the area where the horizontal whitish marks were found was measured to be approximately between 46cm to 47cm;
- b) the body part at the height range of between 46cm to 47m above ground level was the top portion of the Mercedes's front number plate fame;
- c) the height measurements appear to support the findings of possible contact between the rear portion of the Toyota and the front portion of the Mercedes. The damage observed on the rear bumper of the Toyota was a result of this contact and corresponds to the damage observed on the front number plate frame of the Mercedes.
