Your Ref: TP/IP/60337/2017
Our Ref : CI/TPD18001963/Z

Fatal Accident Investigation Team

MECHANICAL INSPECTION REPORT OF MOTOR BUS SBS 3802J

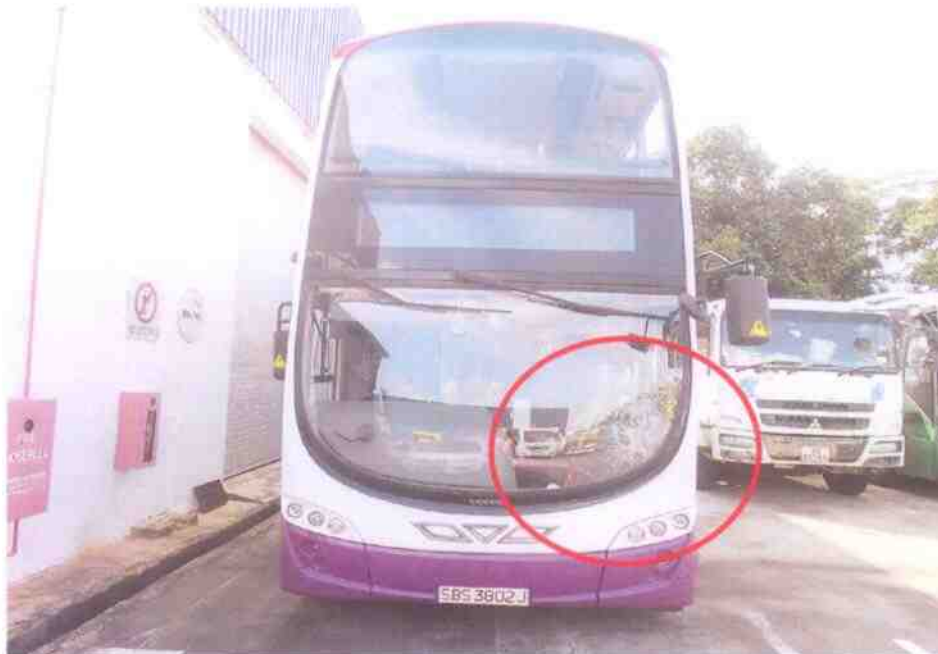
4. The mileage of the Motor Bus at the time of our inspection was not recorded due to a flat battery.
5. The Motor Bus was observed to have sustained relatively minor impact damage at its front left body. Its front left windshield was observed to be cracked; its front left lower bumper was observed to be misaligned likely due to the accident's impact.
6. The damages were consistent with the accidents case fact that the Motor Bus collided with a pedestrian onto its frontal portion hence sustained with such damages mentioned above. See photo 1 to 6 below.

Photo 1 shows a general view of the front body of the Motor Bus at the time of our inspection. The Motor Bus was observed to have sustained relatively minor damage at its front body. Its windshield was observed to be cracked.

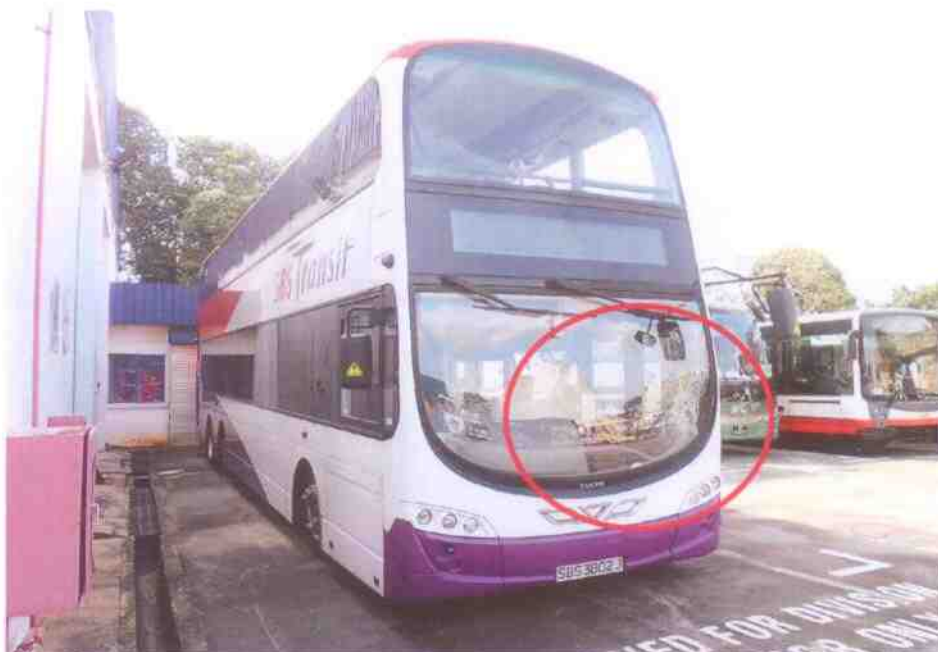
Photo 2 shows a general view of the front right body of the Motor Bus at the time of our inspection. The Motor Bus was observed to have sustained relatively minor damage at its front body. Its windshield was observed to be cracked.

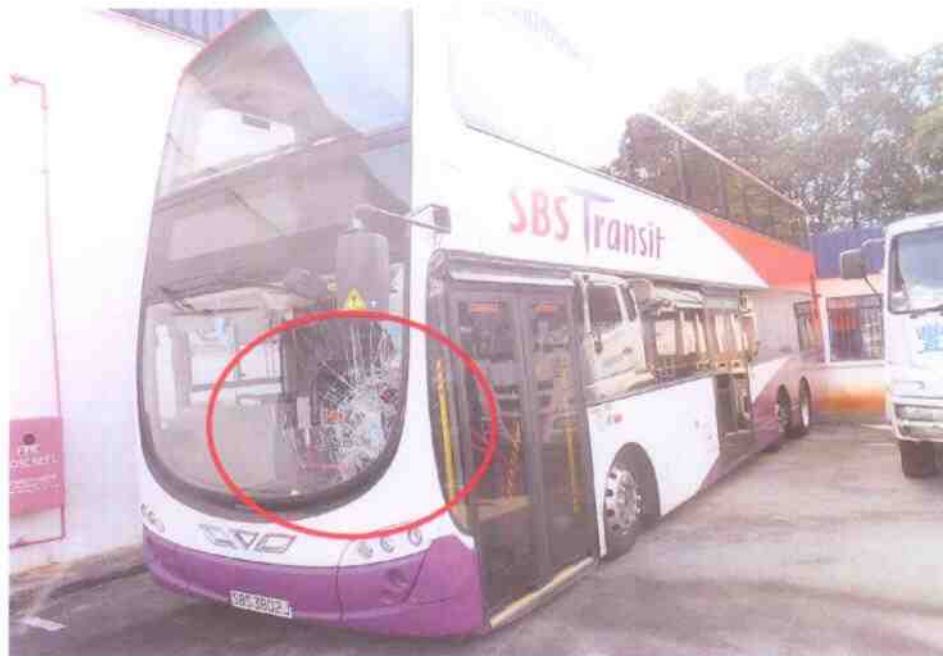
Photo 3 shows a general view of the front left body of the Motor Bus at the time of our inspection. The Motor Bus was observed to have sustained relatively minor damage at its front body. Its windshield was observed to be cracked.

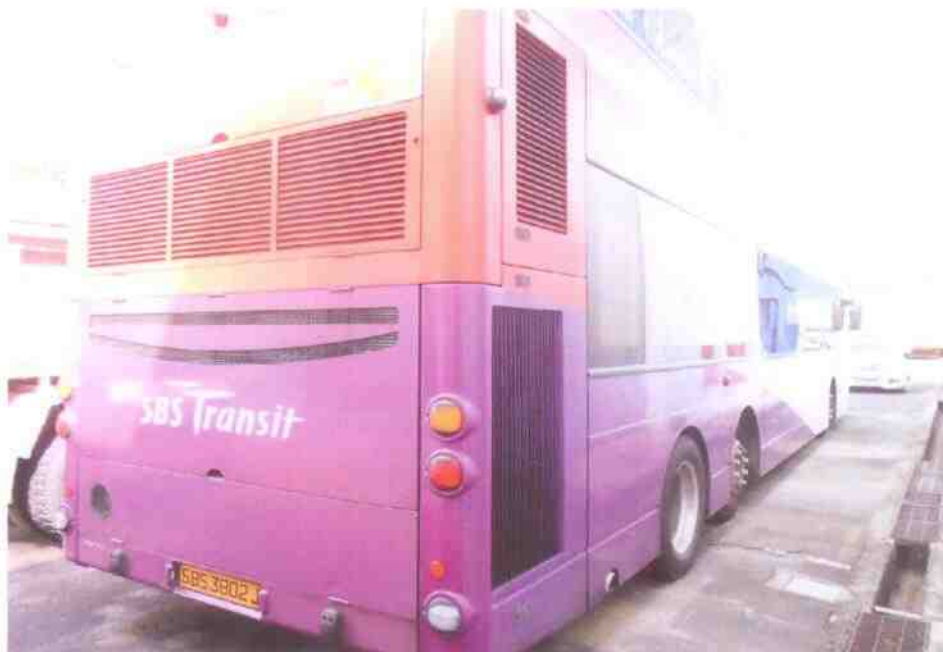
Photo 4 shows a general view of the Motor Bus's rear right body at the time of our inspection. There was no impact damage found at the rear portion of the Motor Bus.

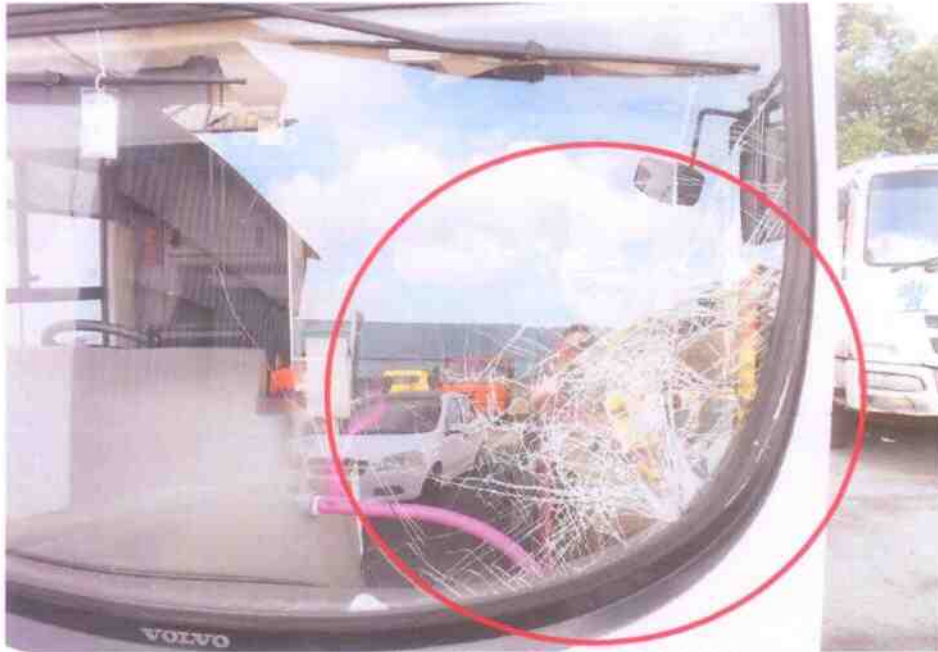
Photo 5 shows a close-up view of the Motor Bus's windshield. It was observed to be cracked likely due to the accident's impact.

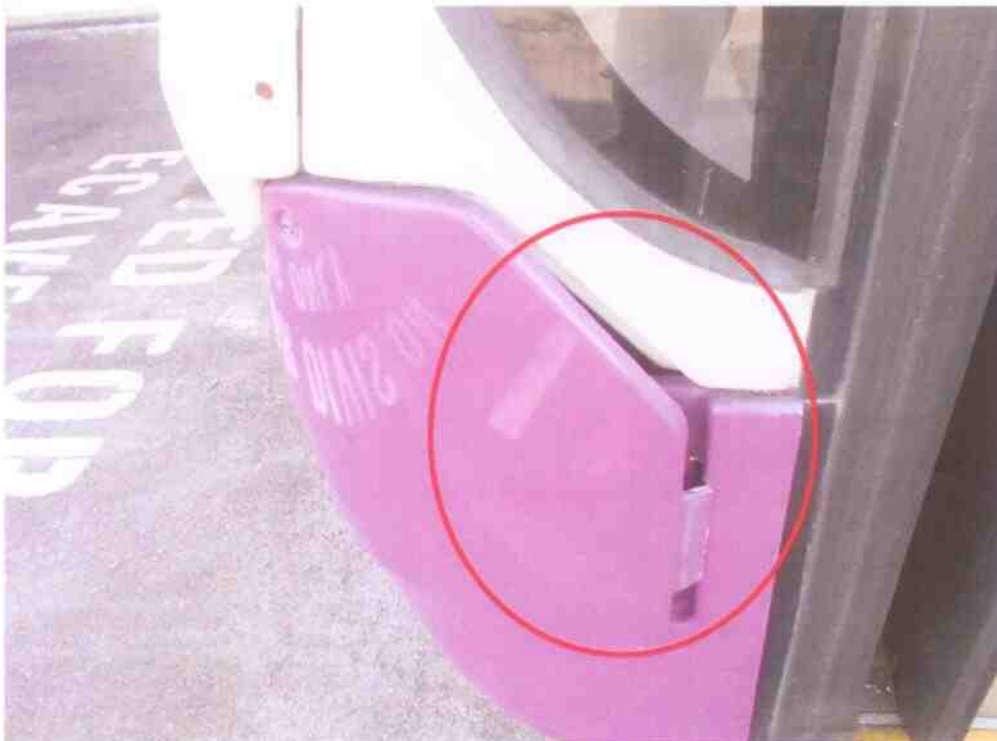
Photo 6 shows a close-up view of the Motor Bus's left hand lower bumper. It was observed to be misaligned likely due to the accident's impact.

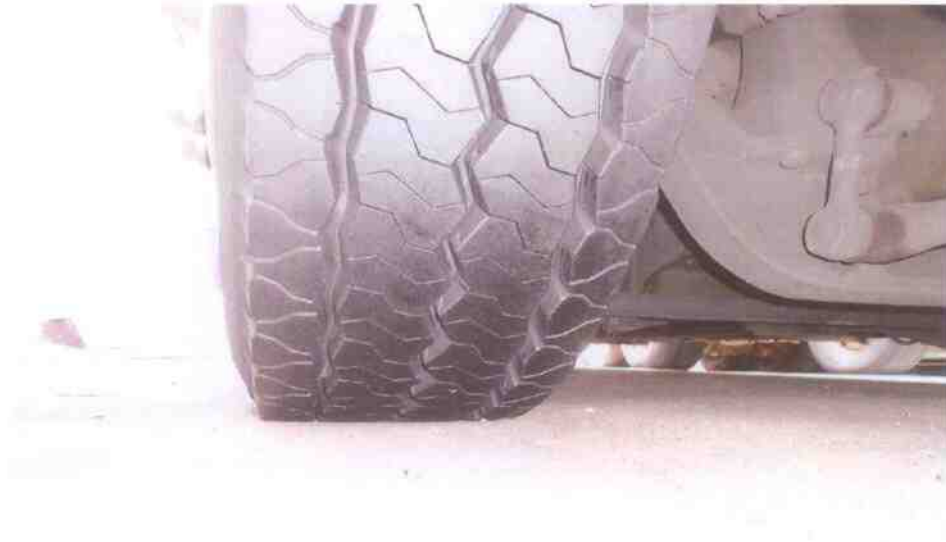
Photo 7 shows the condition of the front right tyre of the Motor Bus, which was observed to be in serviceable condition with remaining tread depth of approximately 13mm.

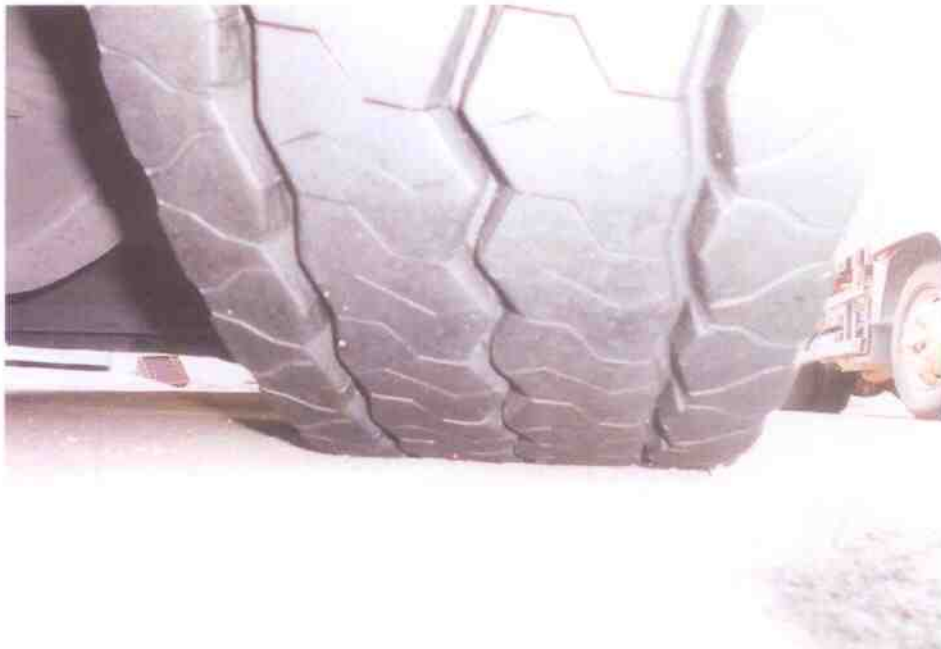
Photo 8 shows the condition of the front left tyre of the Motor Bus, which was observed to be in serviceable condition with remaining tread depth of approximately 18mm.

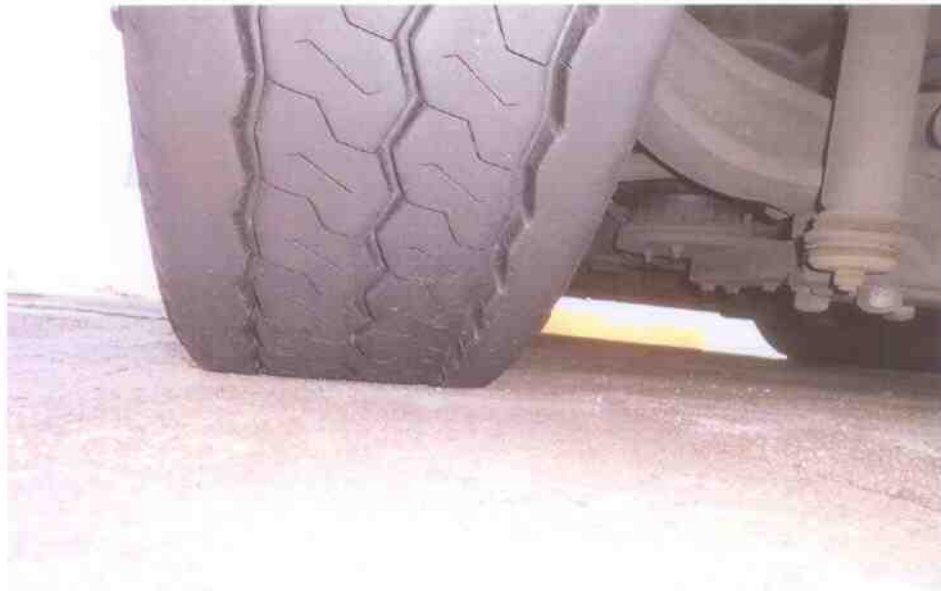
Photo 9 shows the condition of the rear right tyres (centre axle) of the Motor Bus, which were observed to be in serviceable condition with remaining tread depth of approximately 13mm.

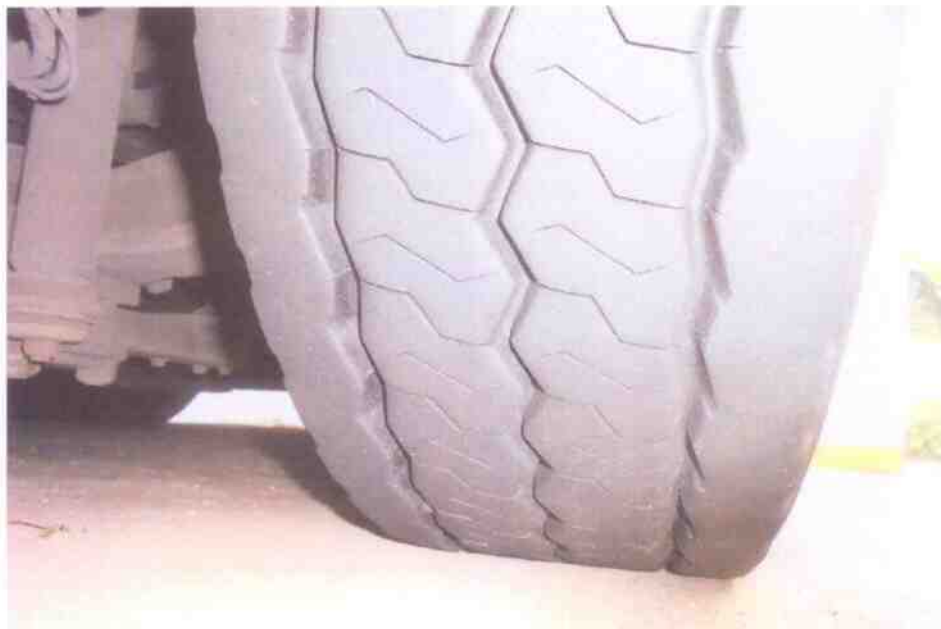
Photo 10 shows the condition of the rear left tyres (centre axle) of the Motor Bus, which were observed to be in serviceable condition with remaining tread depth of approximately 15mm. The tyres, which were wrapped around standard alloy wheel rims, were also observed to be sufficiently inflated for vehicular operation.

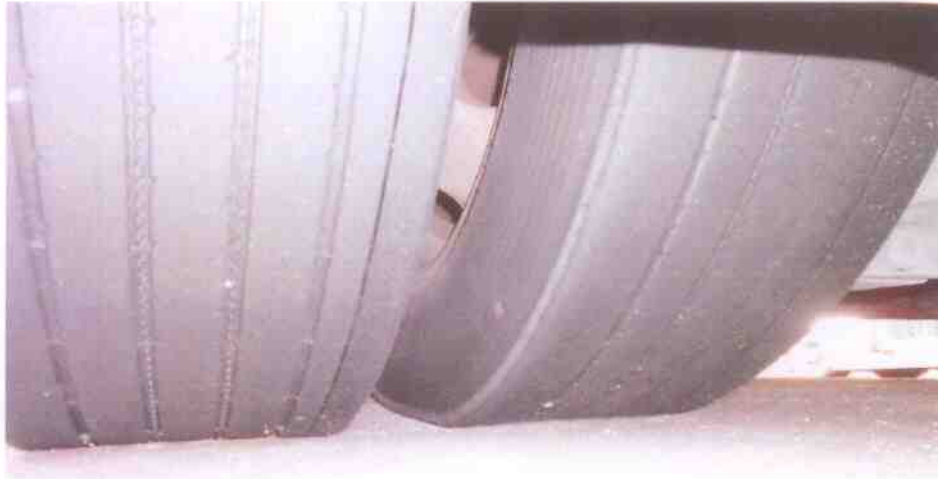
Photo 11 shows the condition of the rear right tyres of the Motor Bus, which were observed to be in serviceable condition with remaining tread depth of approximately 3mm. The tyres, which were wrapped around standard alloy wheels rims, were also observed to be sufficiently inflated for vehicular operation.

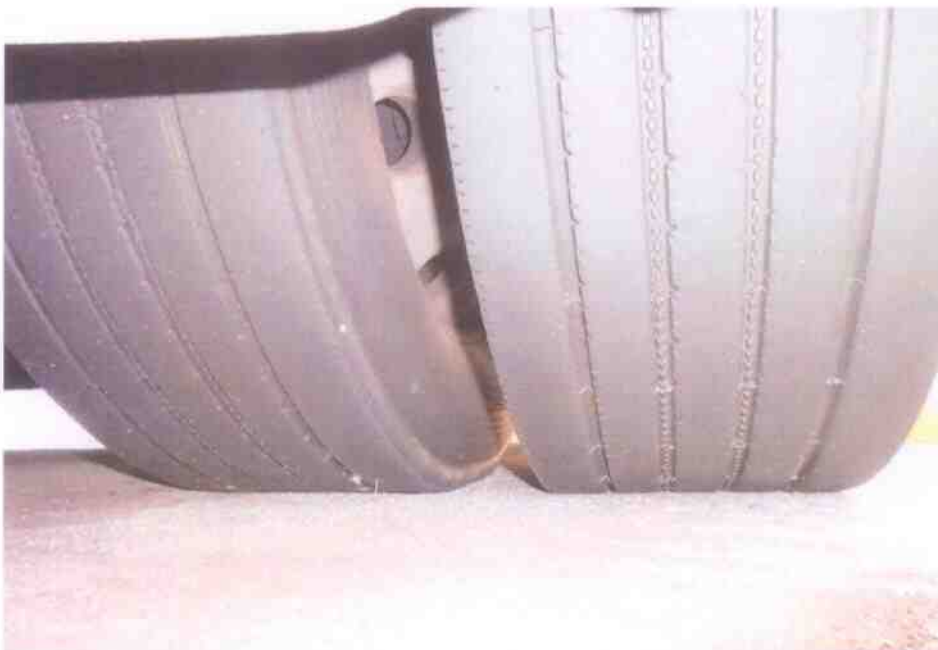
Photo 12 shows the condition of the rear left tyres (centre axle) of the Motor Bus, which were observed to be in serviceable condition with remaining tread depth of approximately 4mm. The tyres, which were wrapped around standard alloy wheel rims, were also observed to be sufficiently inflated for vehicular operation.

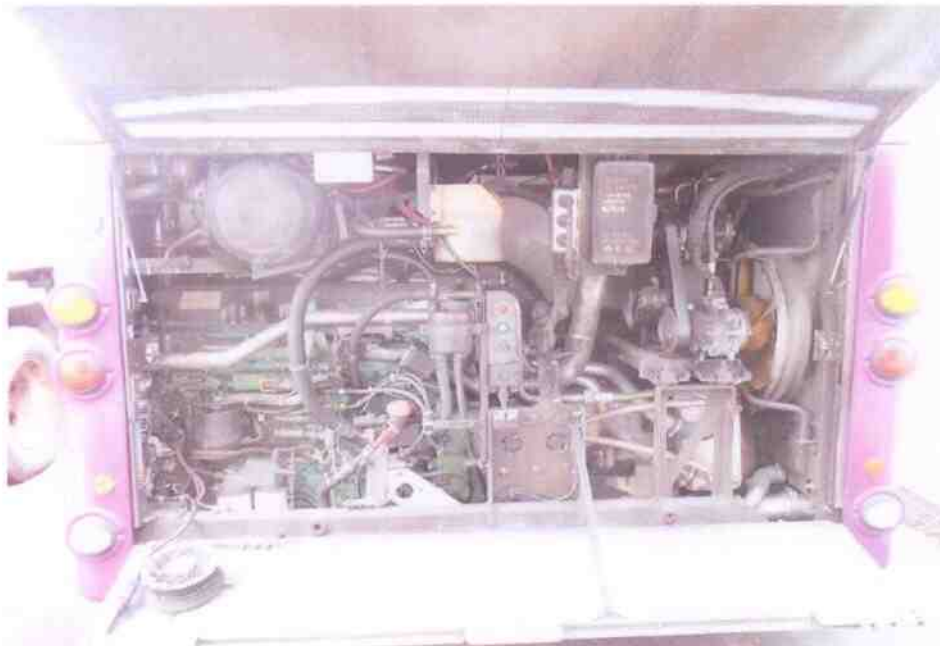
Photo 13 shows the engine compartment of the Motor Bus was located at the rear of the Motor Bus.

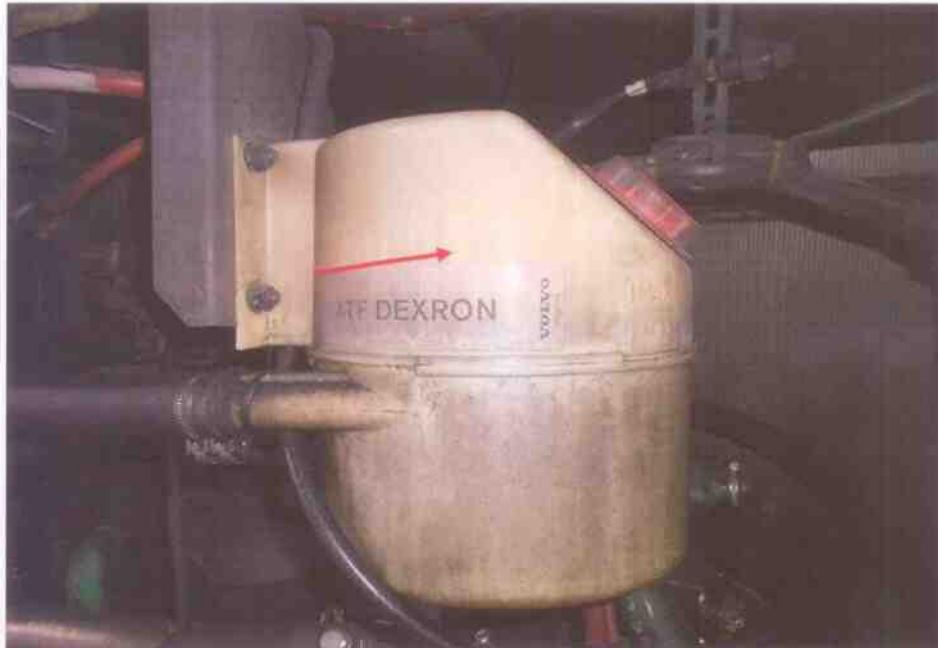
Photo 14 shows the Auto Transmission fluid of the Motor Bus. It was observed to be of sufficient level without any contamination at time of our inspection.

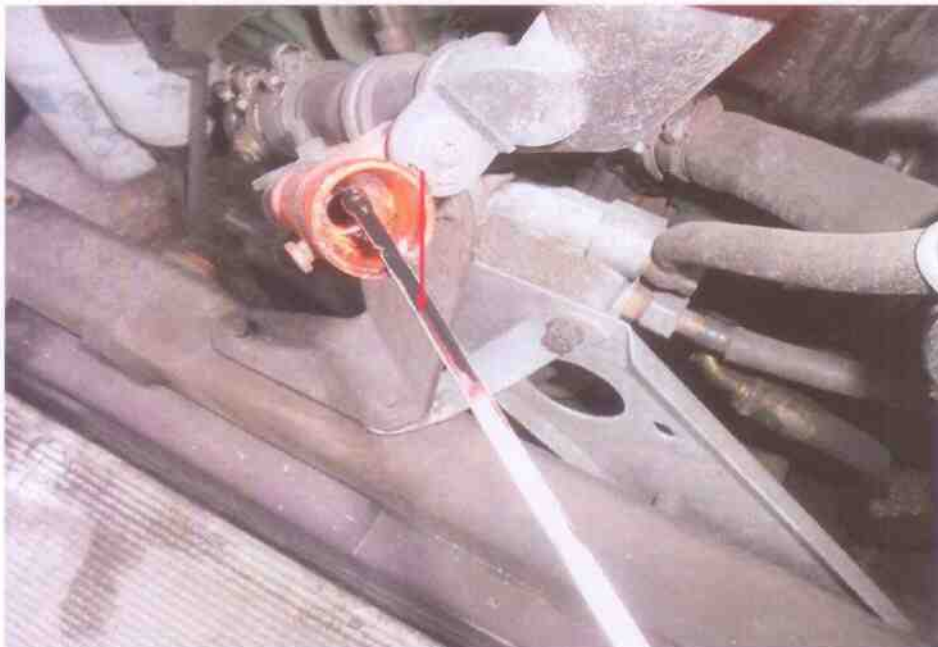
Photo 15 shows the engine fluid of the Motor Bus. It was observed to be of sufficient level without any contamination at time of our inspection.

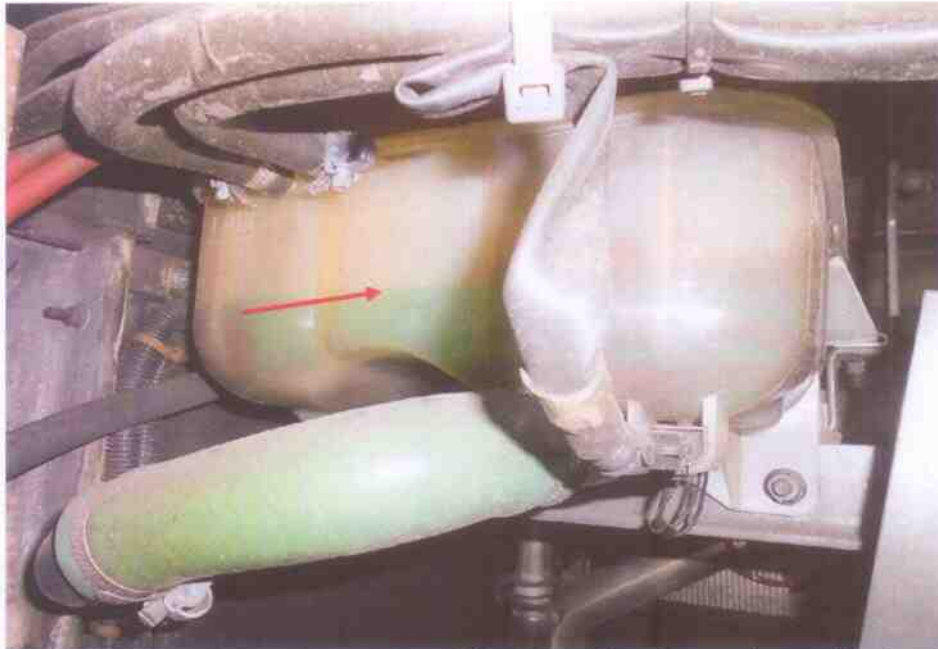
Photo 16 shows the engine coolant of the Motor Bus. It was observed to be of sufficient level without any contamination at time of our inspection.

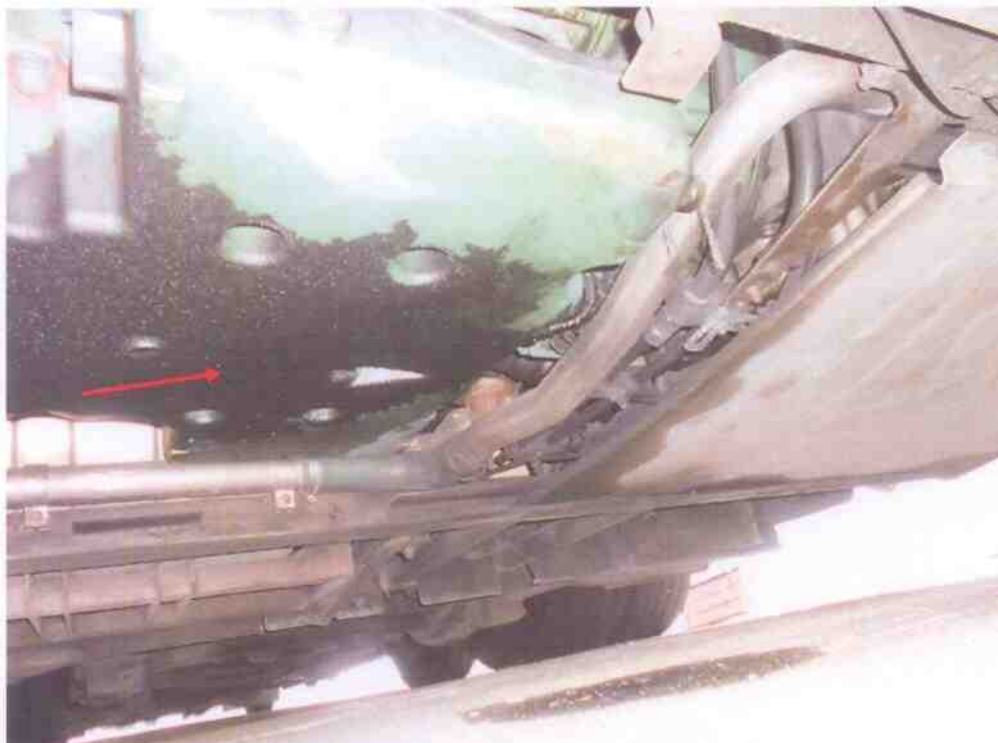
11. Our subsequent checks on the underside of the Motor Bus reveals some fluid stain sighted under the engine compartment. Further investigation found that the fluid stain was a pre-existed prior the accident & not a fresh fluid. This was due to some dirt observed associated with the fluid stain. Conclusively, it is not likely to be related to the accident. Visually, the various undercarriage components of the Motor Bus were observed to be intact and without any visible damage except for the damages caused by the accident. See photo 13 – 18 below.

Photo 17 shows the engine underside of the Motor Bus. It was observed to be sighted with fluid leakage. However it was noted to be a pre-existed fluid leakage due to the dust stain that associated with it.

21. Although our subsequent checks on the underside of the Motor Bus reveals that some fluid stain sighted under the engine compartment. Further investigation found that the fluid stain was a pre-existed prior the accident & not a fresh fluid. This was due to some dirt observed associated with the fluid stain. Conclusively, it is not likely to be related to the accident. Visually, the various undercarriage components of the Motor Bus were observed to be intact and without any visible damage except for the damages caused by the accident

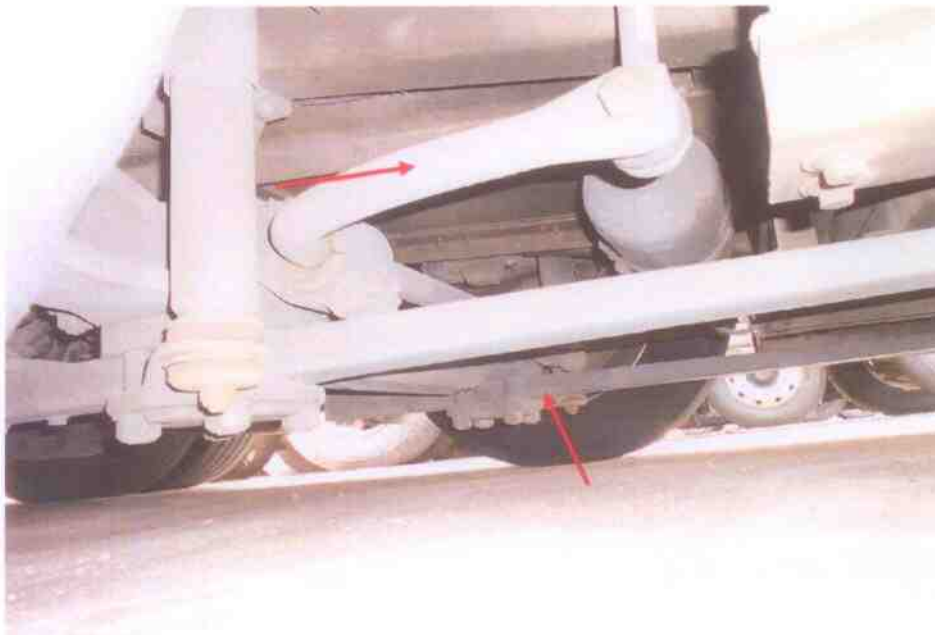
Photo 18 shows some of the mechanical components (arrowed) of the Motor Bus's steering system. Our visual checks on the various mechanical components of the steering system revealed all to be intact and in good condition. The steering system of the Motor Bus is hence likely to be in serviceable condition at the time of accident.

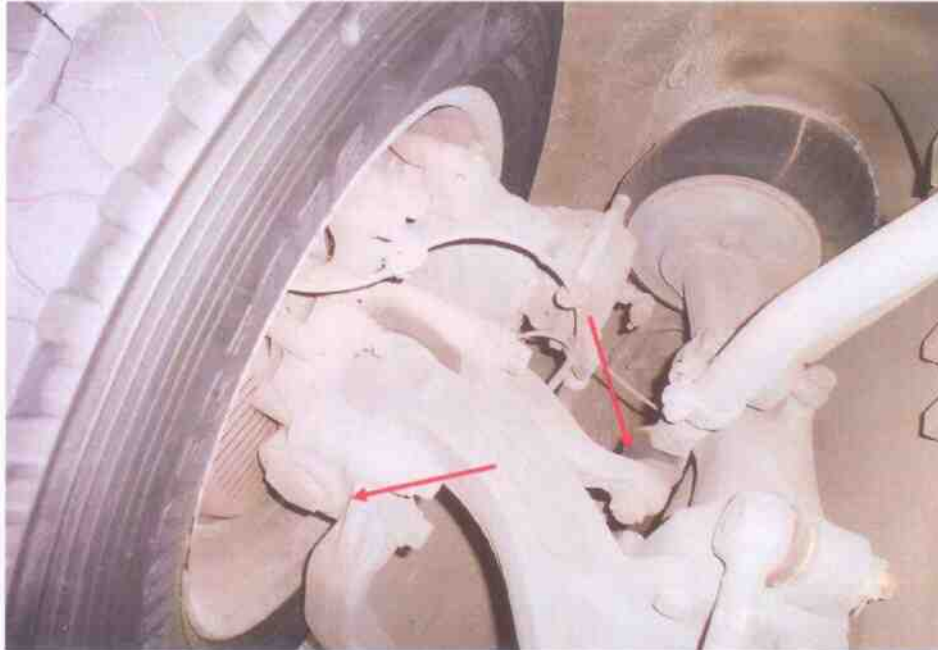
Photo 19 shows the undercarriage components at the front right wheel of the Motor Bus. The various undercarriage components of the Motor Bus were all observed to be intact and without any visible damage. This had included the steering rack and steering ball joints (arrowed) of the Motor Bus.

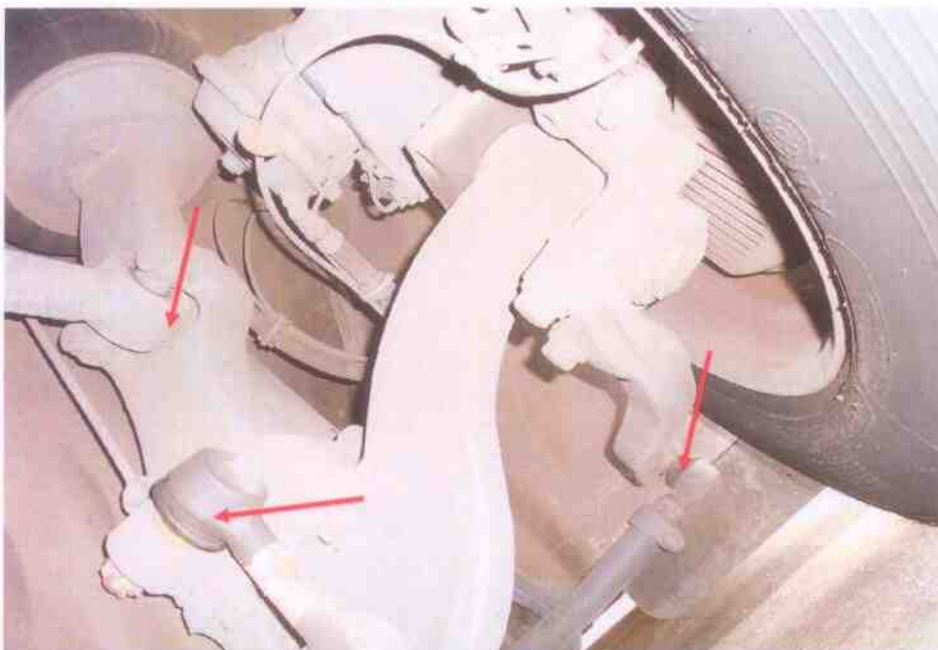
Photo 20 shows the undercarriage components at the front left wheel of the Motor Bus. The various undercarriage components of the Motor Bus were all observed to be intact and without any visible damage. This had included the steering rack and steering ball joints (arrowed) of the Motor Bus, which were observed to be securely attached to the front left wheel and front right wheel.

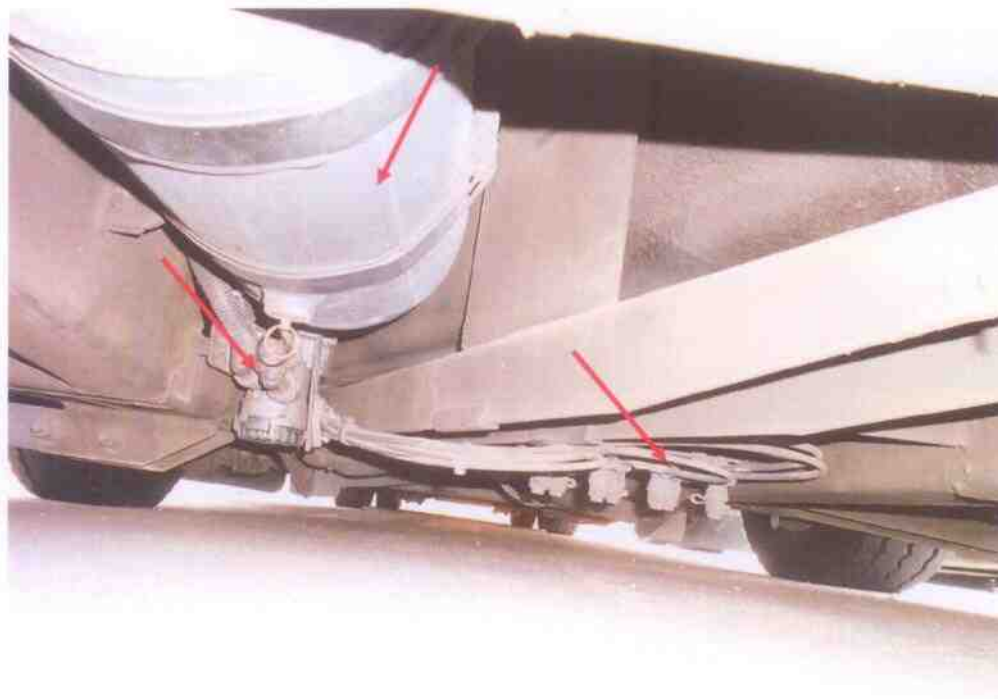
15. Since the engine of the Motor Bus could not be started, we were hence not able to carry out test(s) on whether there was any leakage of compressed air that could have affected the braking efficiency of the Motor Bus. However the air pipes, air tanks and connecting valves had all appear to be in good general condition and securely fitted upon our visual examination of these parts.

16. In general, our visual inspection of the mechanical components of the Motor Bus's braking system appear to suggest that its braking system was in serviceable condition at the material time of accident. See photo 21 below.

Photo 21 shows a general view of the air tank, valves, pipes and hoses, which are some of the components for the air-assisted braking system of the Motor Bus. This was at the underside of the Motor Bus's front body. We were however not able to carry out any operational test(s) to the braking system of the Motor Bus as its engine was unable to be started.

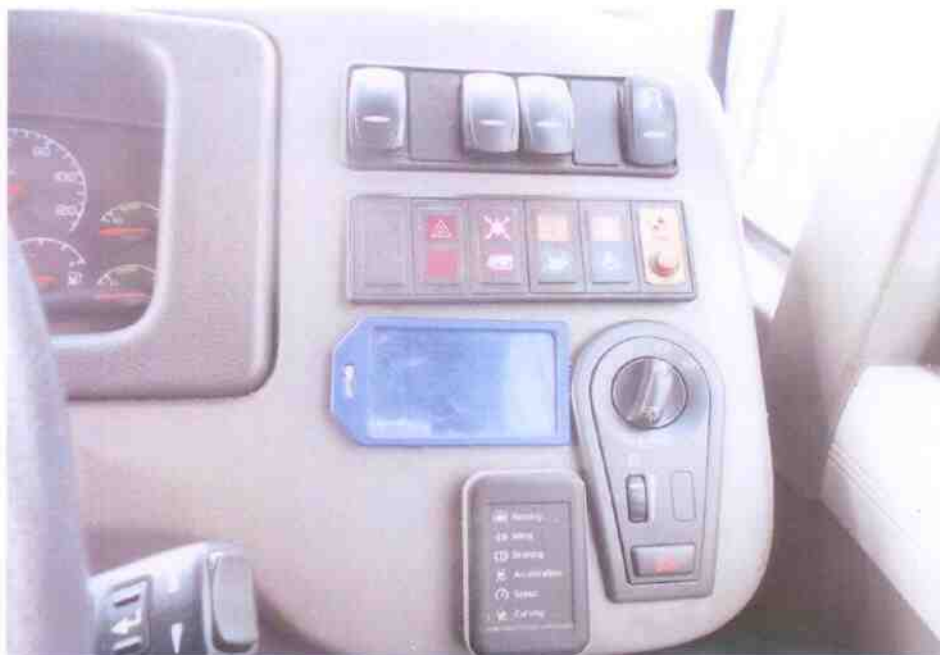
Photo 22 shows the indicators at the driver's seat. Other operational indicators were unable to be initialized due to the flat battery. Hence, no test was carried out to the Motor Bus additional devices.

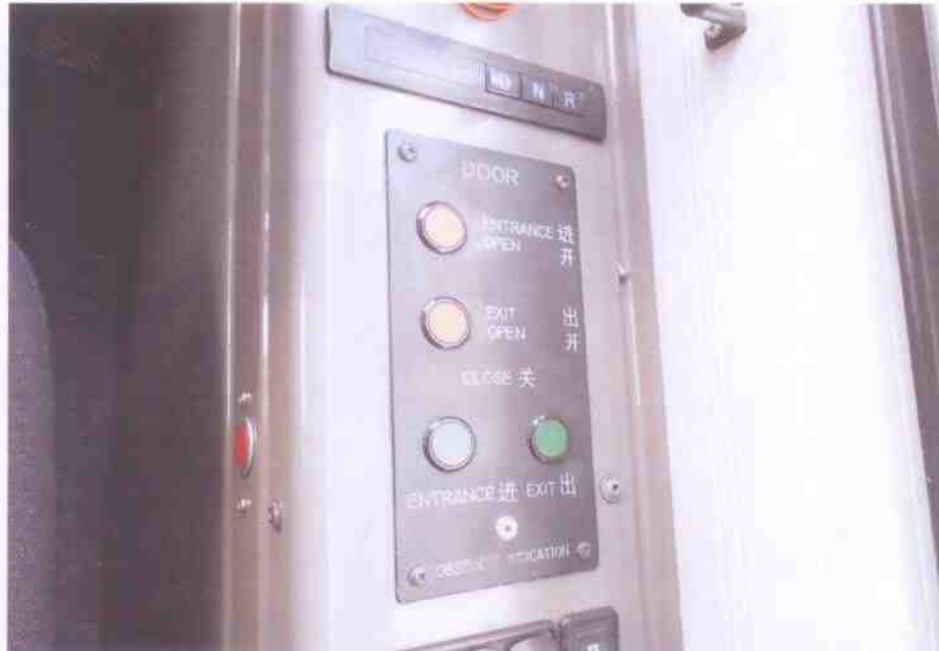
Photo 23 shows the indicators at the driver's seat. Other operational indicators were unable to be initialized due to the flat battery. Hence, no test was carried out to the Motor Bus additional devices.
