Your Ref: TP/IP/60899/2017
Our Ref : CI/TPD18001965/Z

Fatal Accident Investigation Team

MECHANICAL INSPECTION REPORT OF MOTOR LORRY YN 3671Z

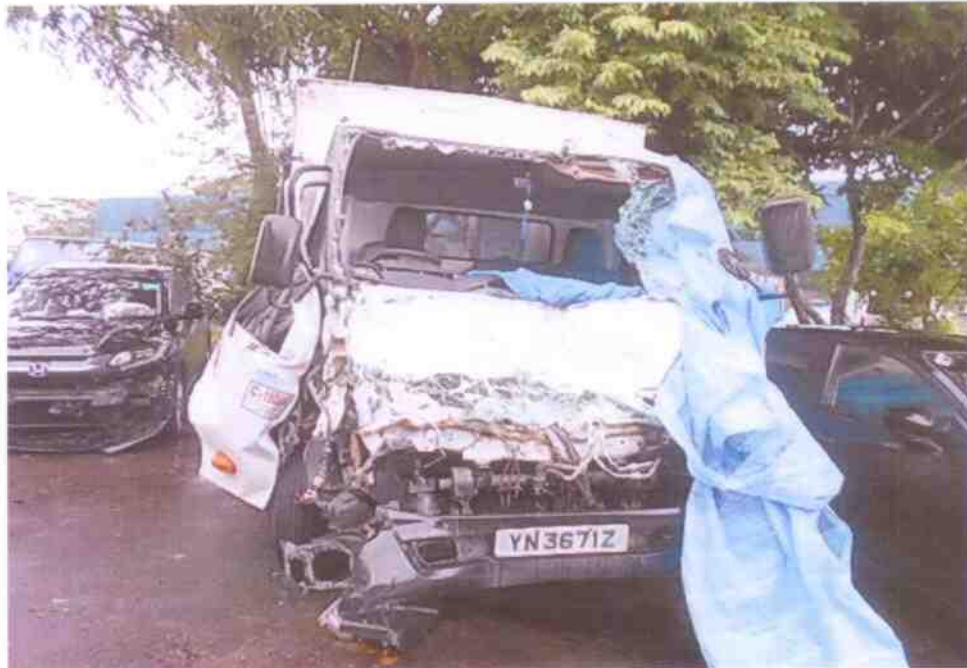
Photo 1 shows a general view of the frontal portion of the Motor Lorry at the time of our inspection. The Motor Lorry was observed to have sustained extensive impact damage at its frontal portion. The impact force was relatively significant, causing its entire front cabin to be buckled and crumpled.

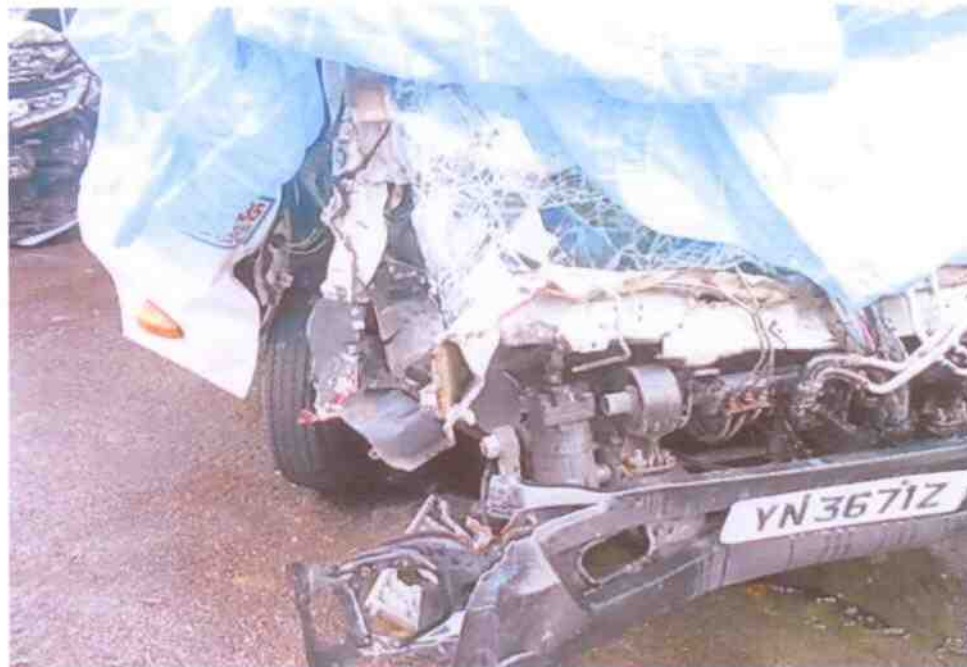
Photo 2 shows a closer view of the frontal portion of the Motor Lorry at the time of our inspection. A number of mechanical parts and components at the frontal portion were also severely damaged as a result of the accident.

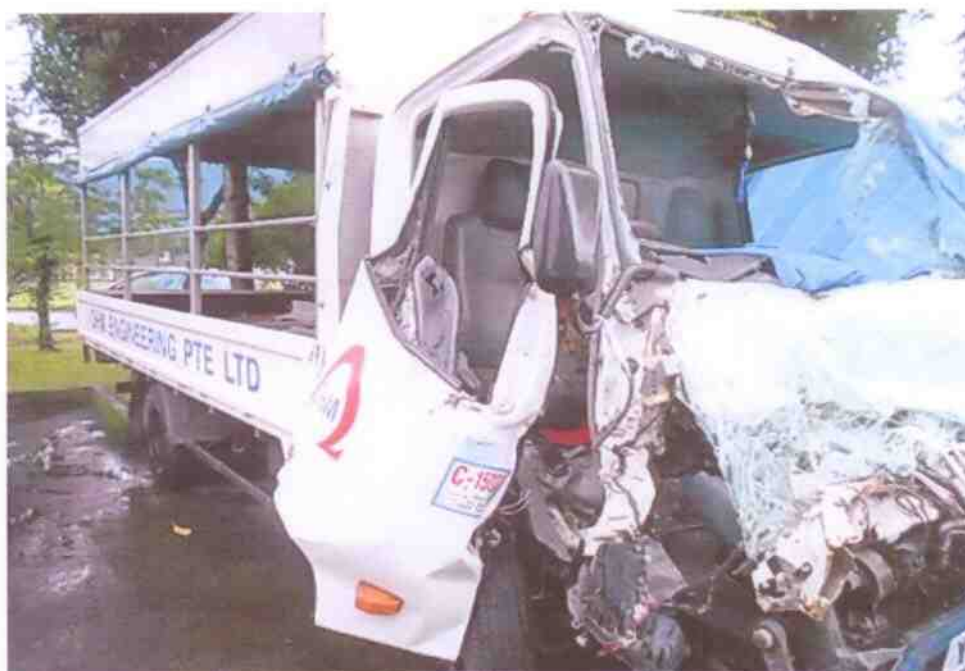
Photo 3 shows a general view of the front left portion of the Motor Lorry at the time of our inspection. The Motor Lorry was observed to have sustained extensive impact damage at its front left portion. The impact force was relatively significant, causing its entire front cabin to be buckled and crumpled.

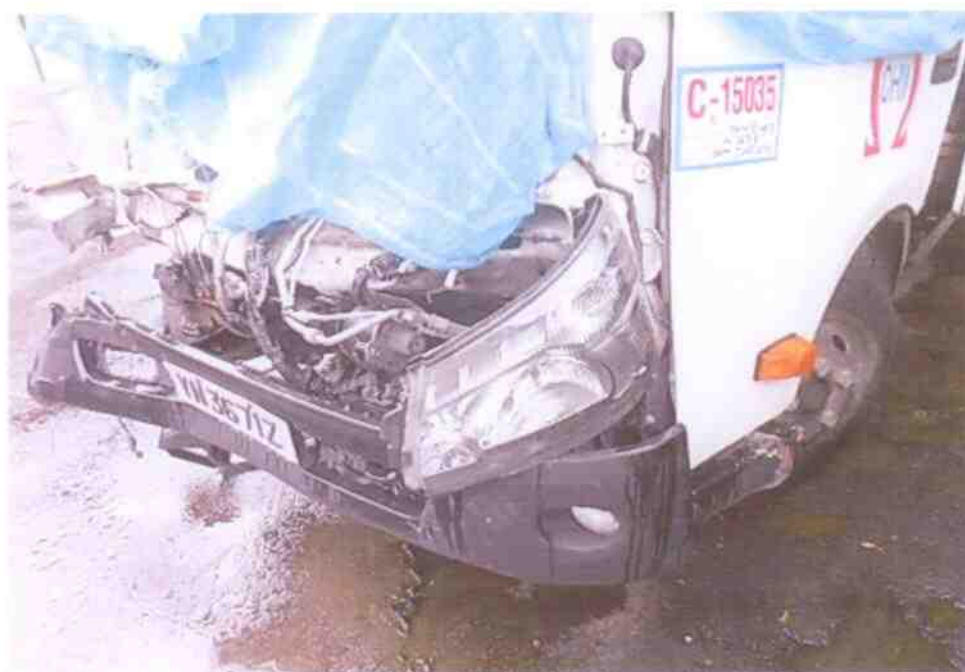
Photo 4 shows a general view of the front right portion of the Motor Lorry at the time of our inspection. The Motor Lorry was observed to have sustained extensive impact damage at its front left portion. The impact force was relatively significant, causing its entire front cabin to be buckled and crumpled.

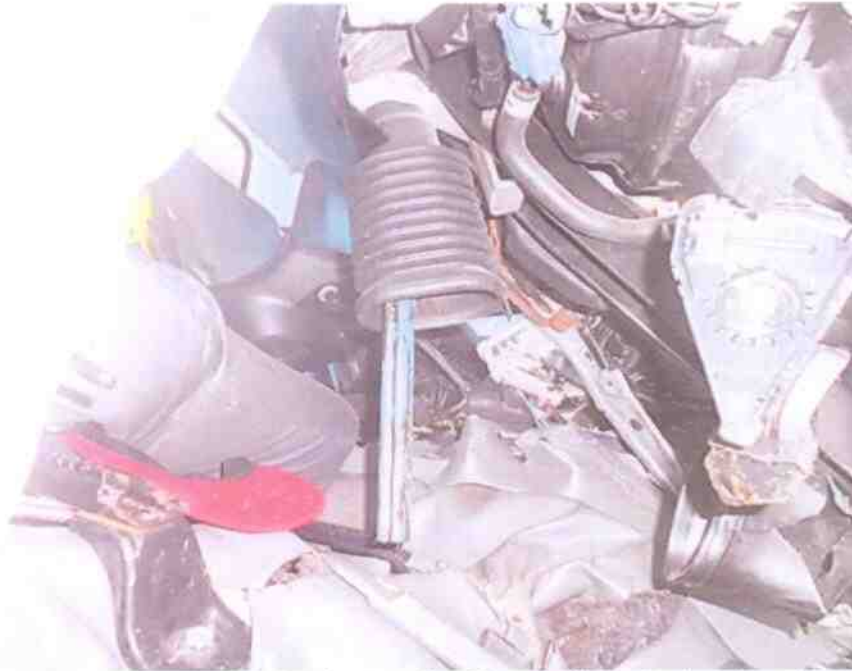
Photo 5 shows the interior of the front cabin. The dashboard, steering wheel, seats, floor panel and roof panel inside the front cabin were all observed to be pushed/buckled inwards, towards the rear of the Motor Lorry. This is consistent to the nature of this accident where the direction of impact onto the Motor Lorry was from the front to rear direction.

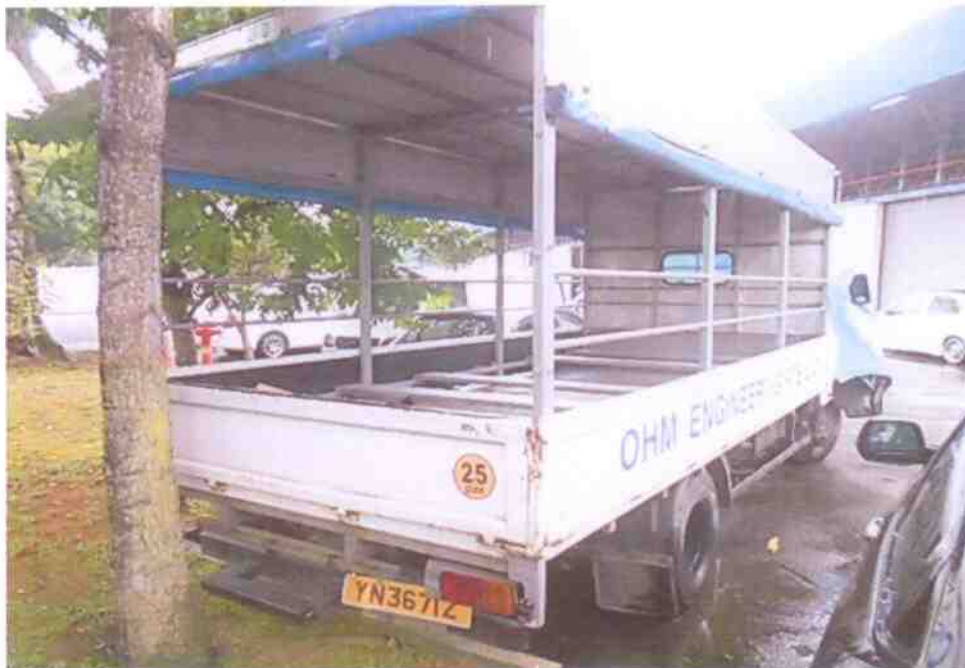
Photo 6 shows a general view of the rear right portion of the Motor Lorry at the time of our inspection. The rear portion was observed to be relatively unaffected by the accident.

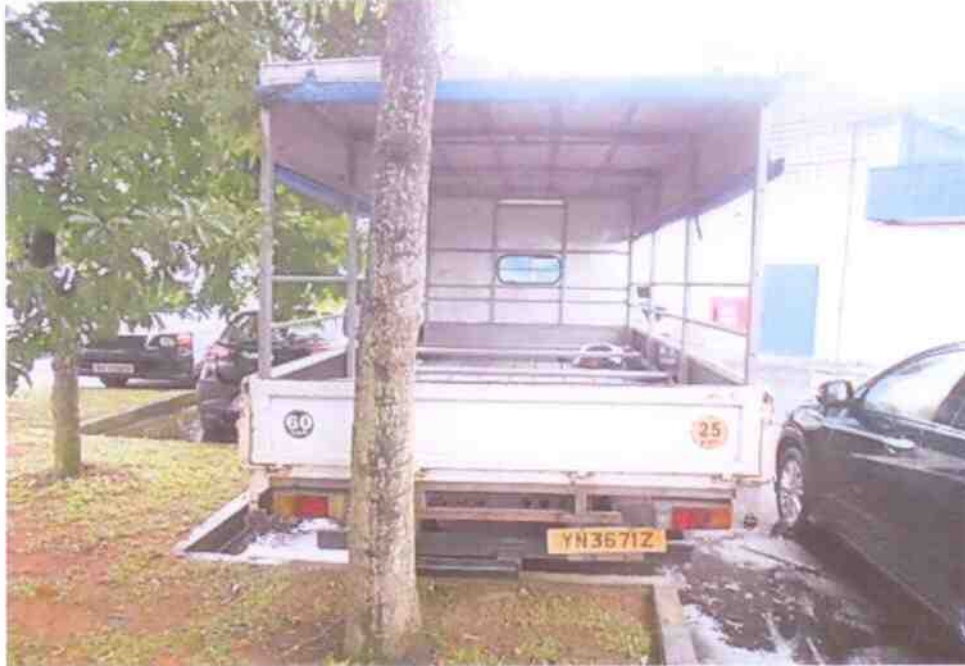
Photo 7 shows a general view of the rear portion of the Motor Lorry at the time of my inspection. The rear portion was observed to be relatively unaffected by the accident.

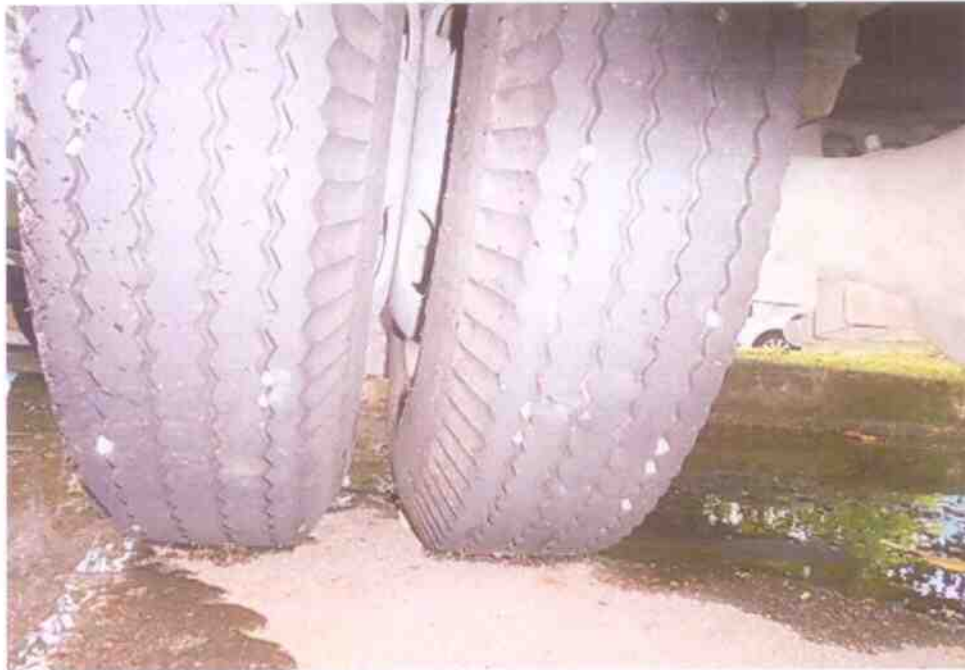
Photo 8 shows the condition of the rear right tyres of the Motor Lorry, which was observed to be in serviceable condition with remaining tread depth of approximately 5mm. There was no tear, cut or burst mark(s) on the outer and the inner sidewalls as well as across the tread of this 2 tyres. The tyres, which was wrapped around alloy wheel rim, was also observed to be sufficiently inflated for vehicular operation.

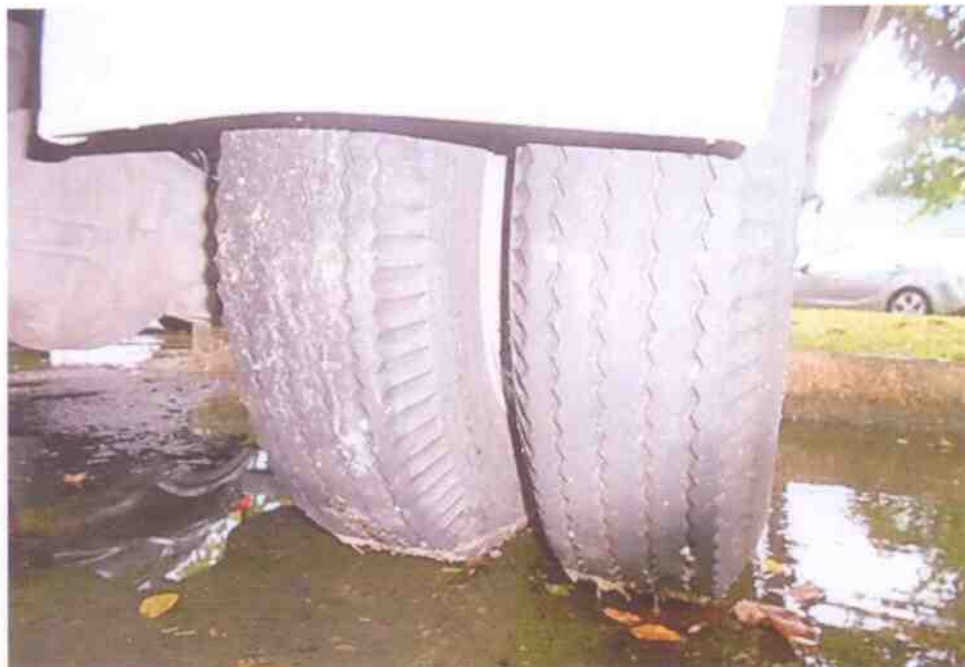
Photo 9 shows the condition of the rear left tyres of the Motor Lorry, which was observed to be in serviceable condition with remaining tread depth of approximately 5mm. There was no tear, cut or burst mark(s) on the outer and the inner sidewalls as well as across the tread of these 2 tyres, which were also observed to be sufficiently inflated for vehicular operation.

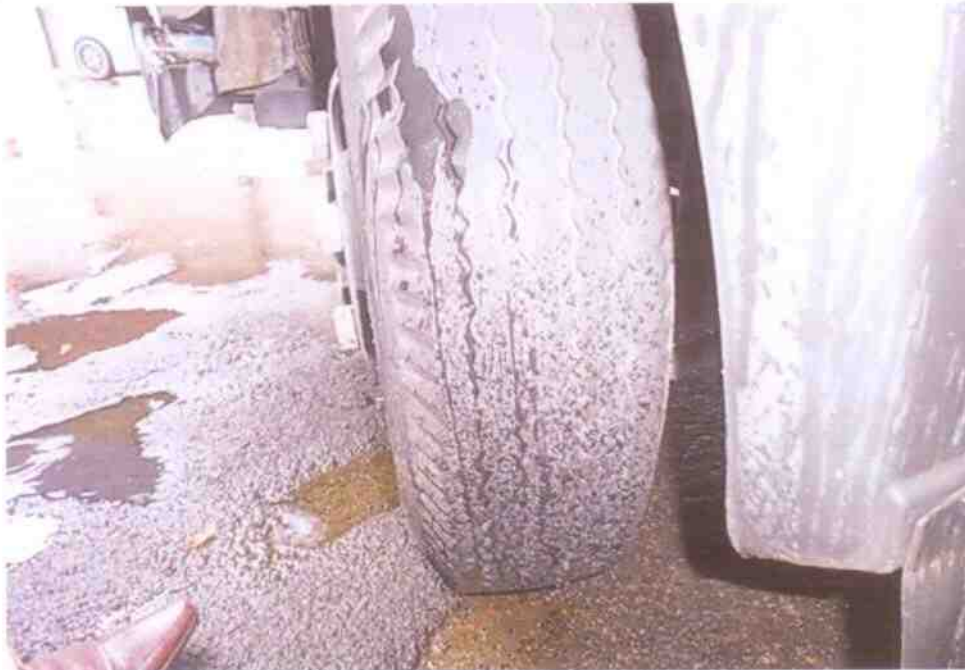
Photo 10 shows the condition of the front left tyre of the Motor Lorry, which was observed to be in serviceable condition with remaining tread depth of approximately 5mm. There was also no tear, cut or burst mark(s) on the outer and the inner sidewalls as well as across the tread of this tyre.

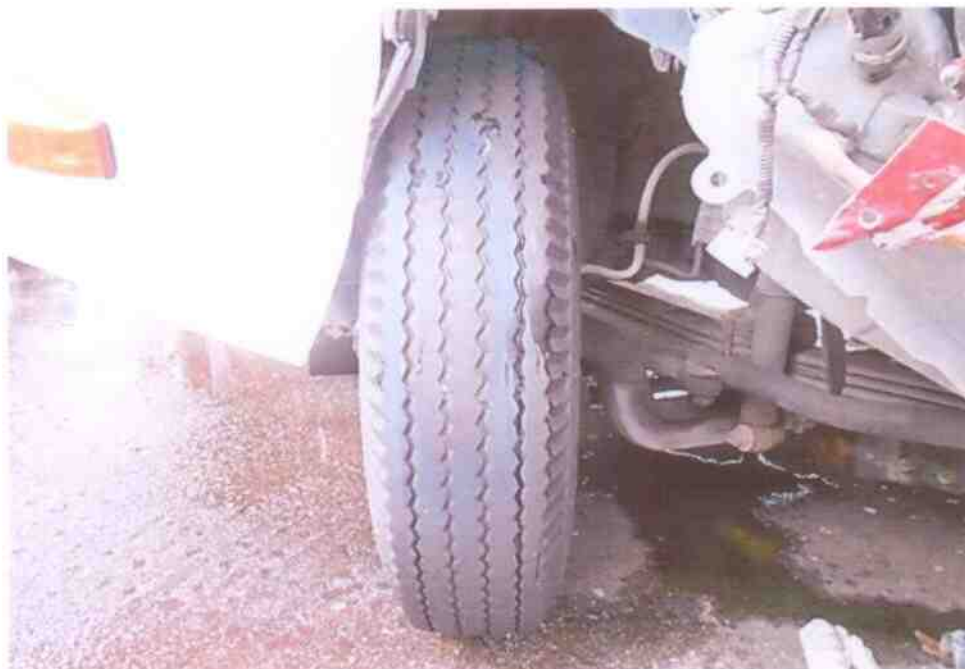
Photo 11 shows the condition of the front right tyre of the Motor Lorry. The front right tyre was observed to be in serviceable condition with remaining tread depth of approximately 5mm. There was also no tear, cut or burst mark(s) on the outer and the inner sidewalls as well as across the tread of this tyre.

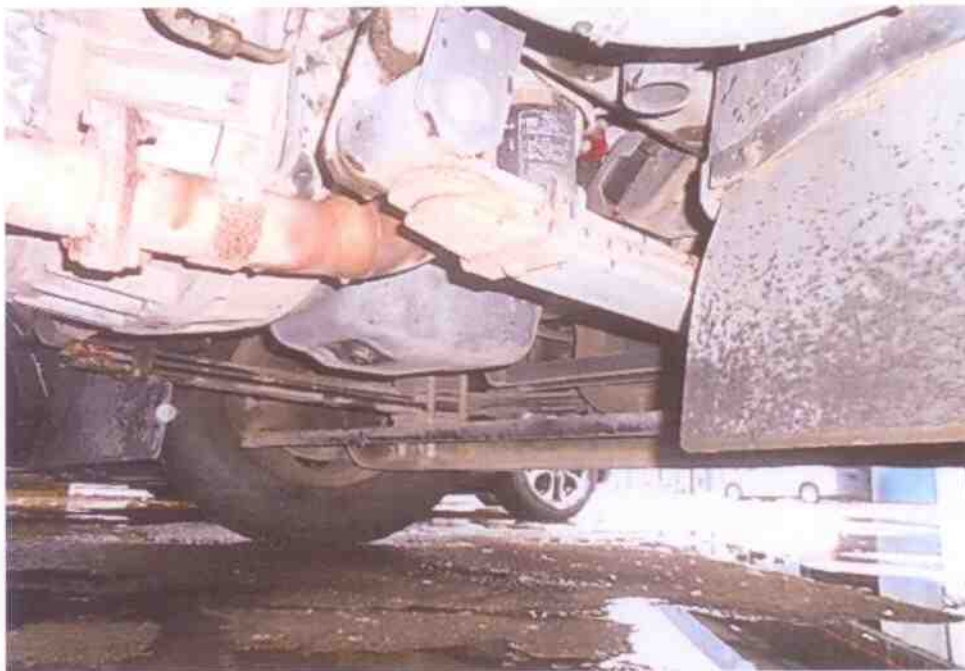
Photo 12 shows the underside of the Motor Lorry, at the area where the engine is located. We were not able to closely inspect the engine compartment of the Motor Lorry due to the extensive damage to its front cabin. Our visual checks from the underside had however appear to indicate that the engine assembly and transmission assembly were both intact and unaffected by the collision.

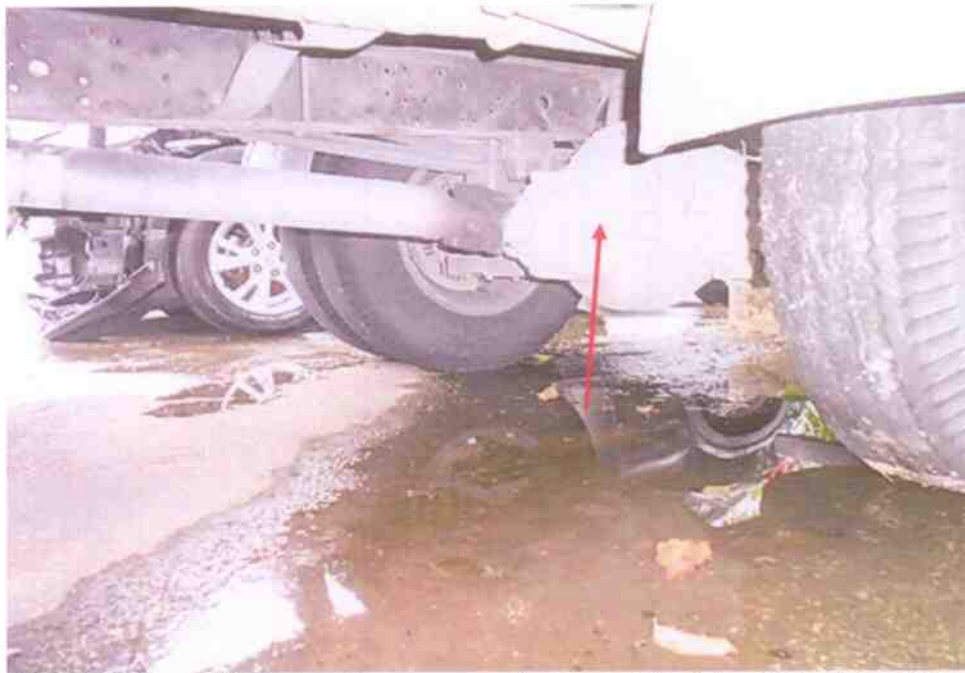
Photo 13 shows the transmission assembly (arrowed) of the Motor Lorry intact and unaffected by the collision.

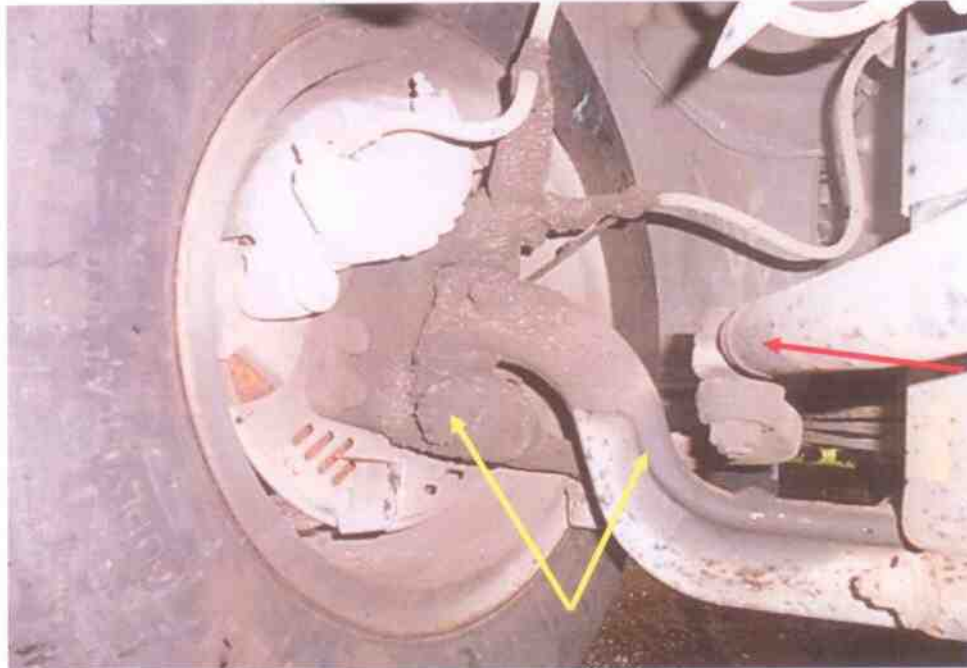
Photo 14 shows the undamaged steering shaft (red arrow) of the Motor Lorry. The steering shaft and steering rack (yellow arrow) of the Motor Lorry were however observed to be intact and securely attached to the front right wheel and front right wheel. The steering ball joints were also observed to be in a serviceable condition.

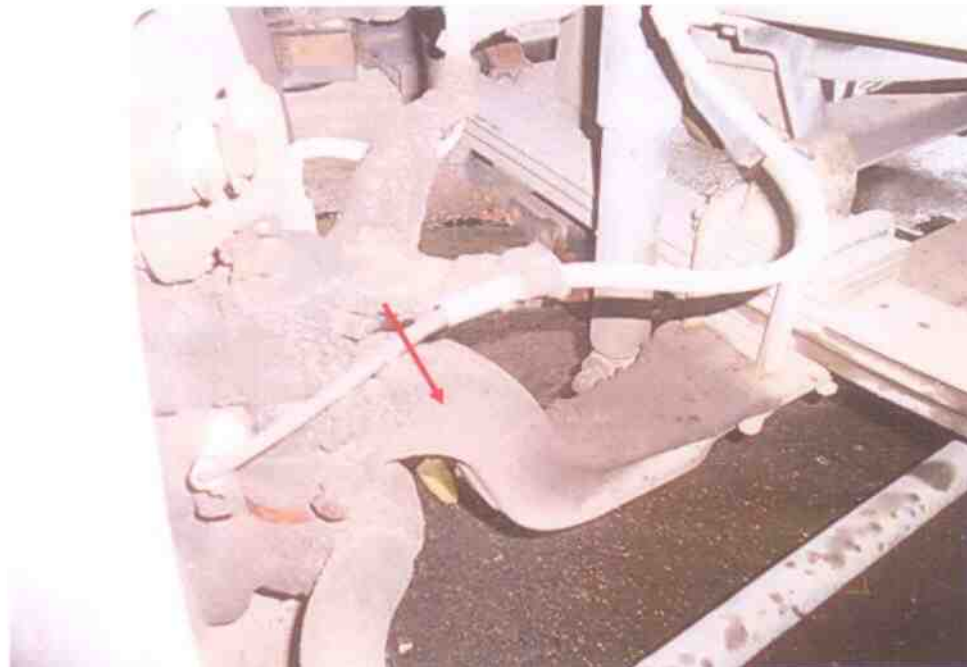
Photo 15 shows the undercarriage components at the front left wheel of the Motor Lorry. The various undercarriage components of the Motor Lorry were all observed to be intact and without any visible damage. This had included the steering rack (arrowed) of the Motor Lorry.

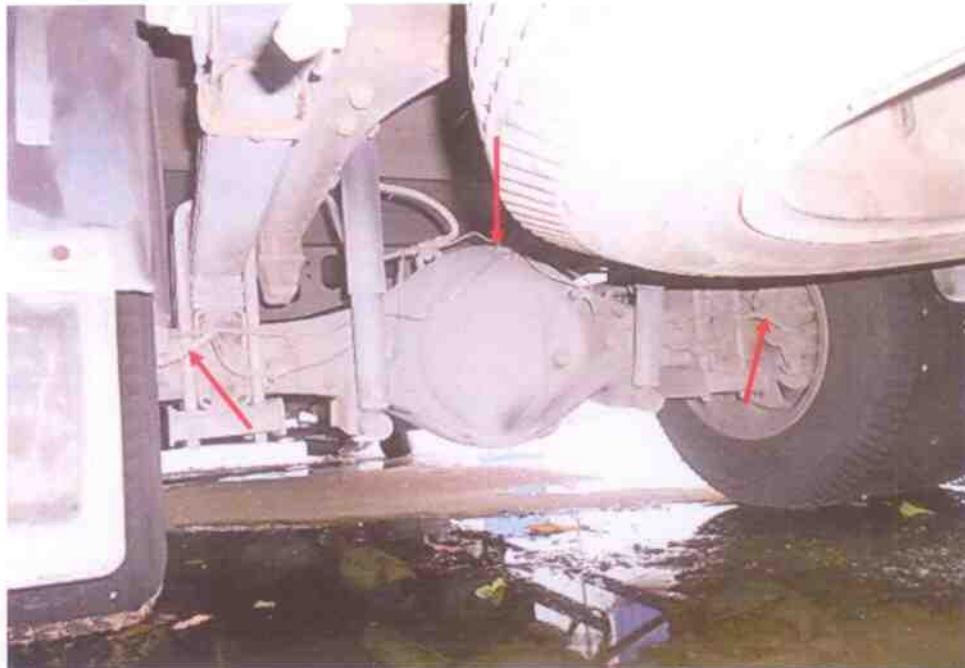
Photo 16 shows the brake hose (arrowed) at the rear right wheel of the Motor Lorry. At the time of our inspection, we did not find any sign(s) of brake fluid leakage along the brake hoses and brake pipes.

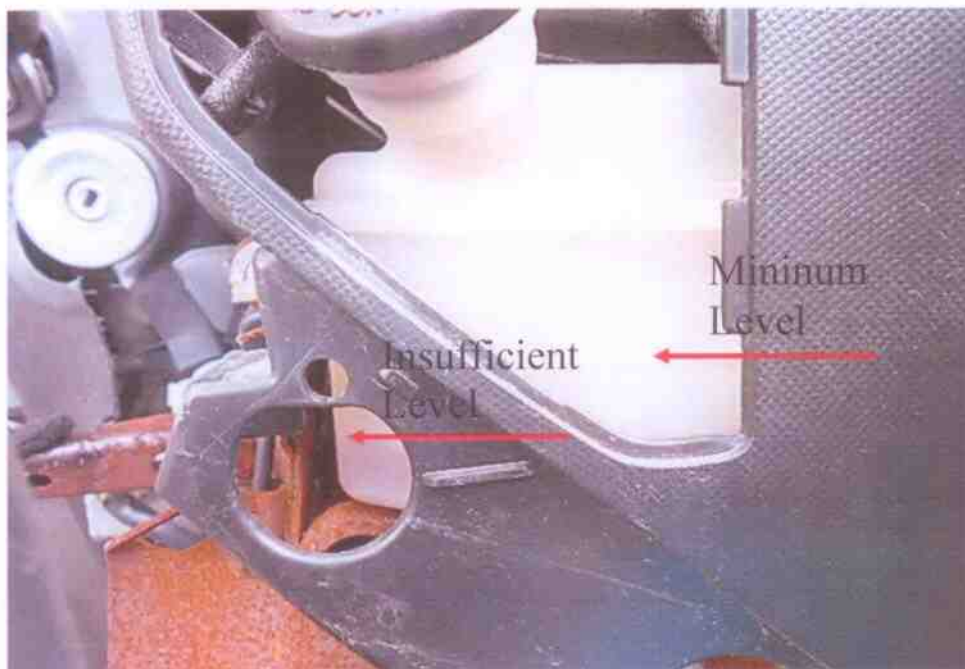
13. We were not able to conduct any tests on the steering system and braking system of the Motor Lorry. This was mainly due to the extensive damage of the Motor Lorry's front cabin, which had affected several mechanical components of the steering system and braking system like the steering wheel, steering box, brake booster and brake pedal amongst others. Brake fluids were observed to be insufficient likely due to the damages to the brake reservoir as a result of the accident.

Photo 17 shows the insufficient brake fluid likely due to the damages on the braking system as a result of the accident.

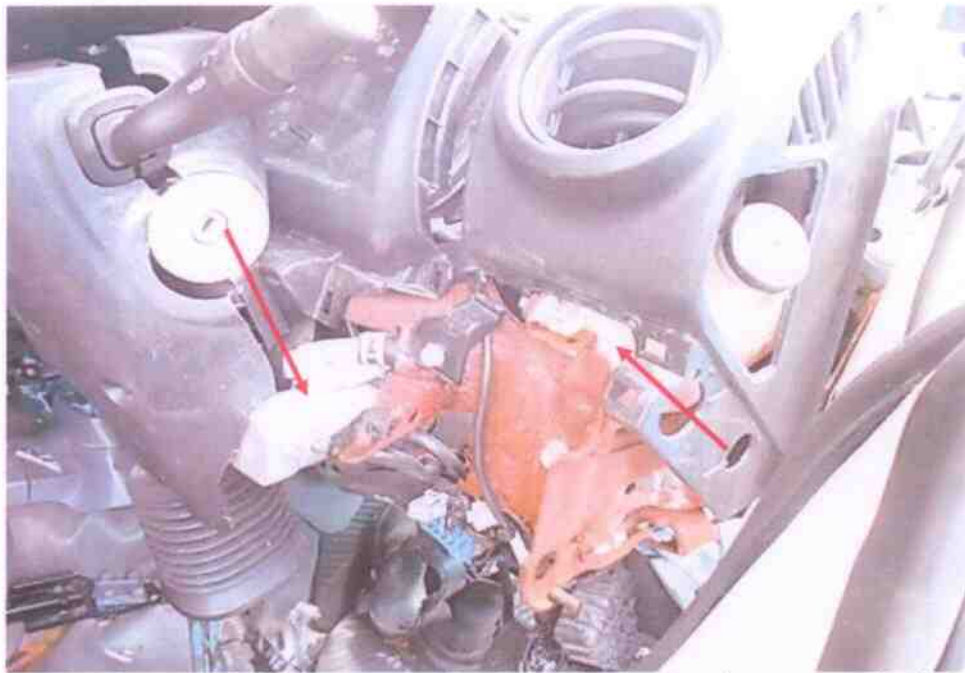
Photo 18 shows the damages on the brake fluid reservoir as a result of the accident.
