MECHANICAL INSPECTION REPORT OF MOTOR CAR SLB 1038H

1. We refer to your request on 09th January 2018 to conduct a physical inspection of a motor car bearing registration number SLB 1038H (herein referred to as "**Motor Car**"), which was involved in a fatal road traffic accident on 16th December 2017.
2. The purpose of this inspection is to primarily determine if there was any possible mechanical failure to the Motor Car that may have contributed to the accident.
3. Following the request, we carried out a physical inspection of the Motor Car on 01st February 2018 at the premises of Traffic Police vehicle pound, 517 Airport Road Singapore 539942. We now set out below our observations and comments with respect to this inspection.

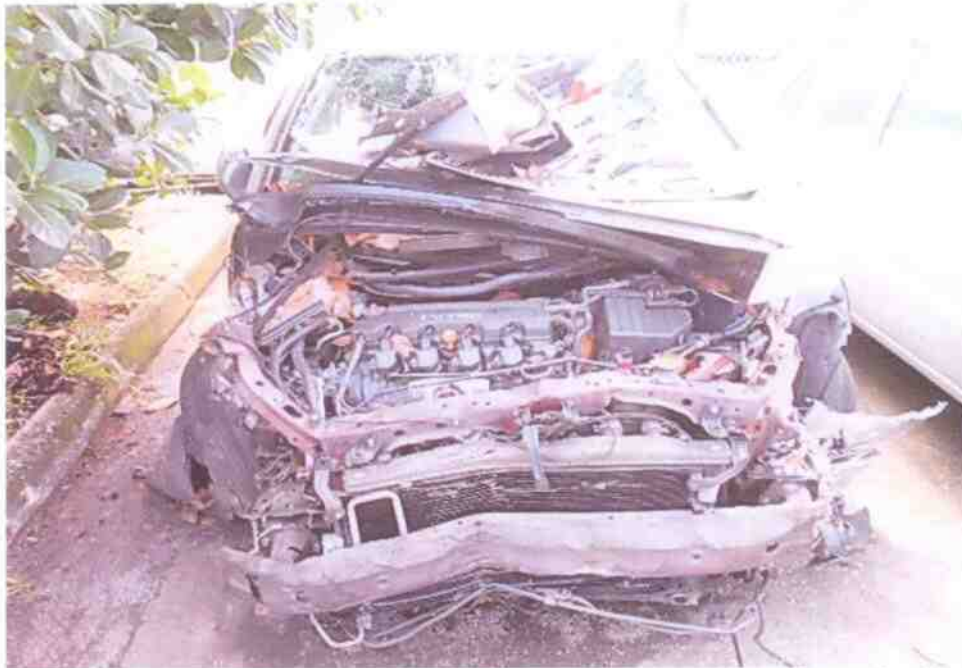
Photo 1 shows a general view of the frontal portion of the Motor Car at the time of our inspection. The Motor Car was observed to have sustained extensive impact damage at its frontal portion. The impact force was significant, causing the various parts and components inside the engine compartment to be damaged.

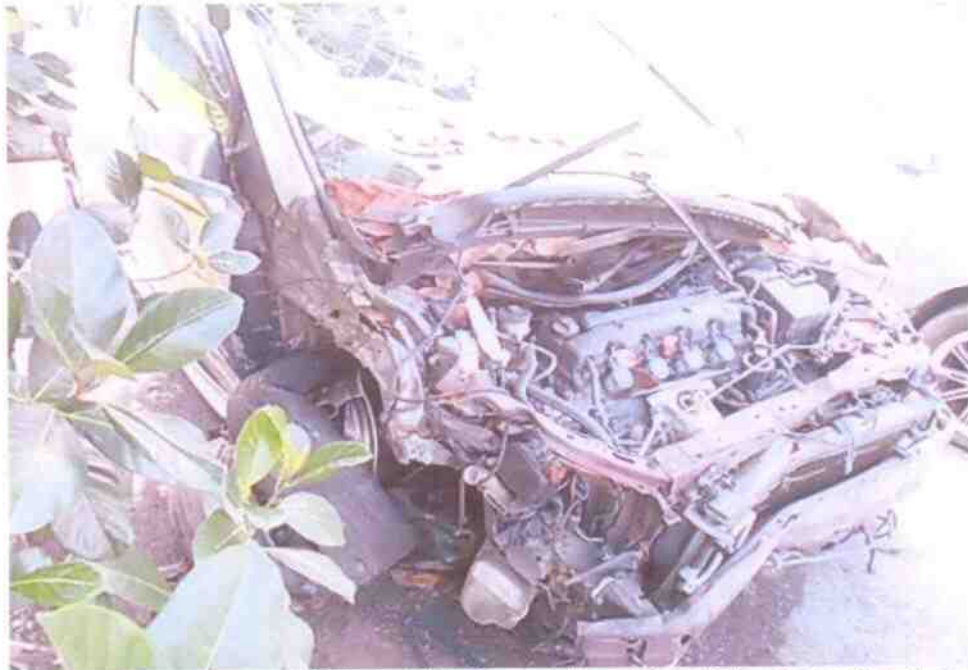
Photo 2 shows a general view of the front right portion of the Motor Car at the time of our inspection. The Motor Car was observed to have sustained extensive impact damage at its frontal portion.

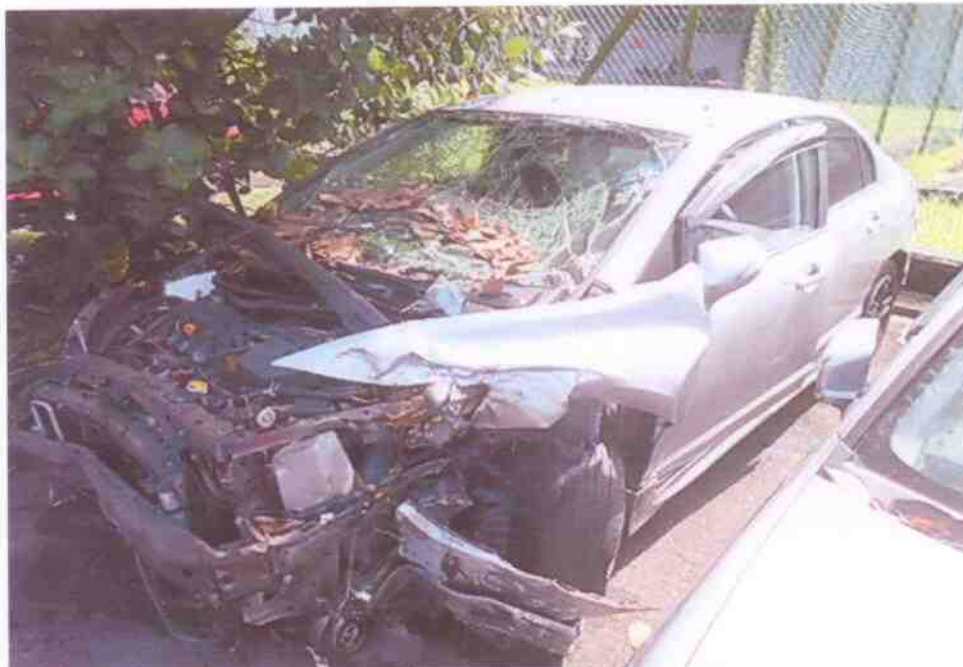
Photo 3 shows a general view of the front left portion of the Motor Car at the time of our inspection. The Motor Car was observed to have sustained with extensive impact damage at its frontal portion.

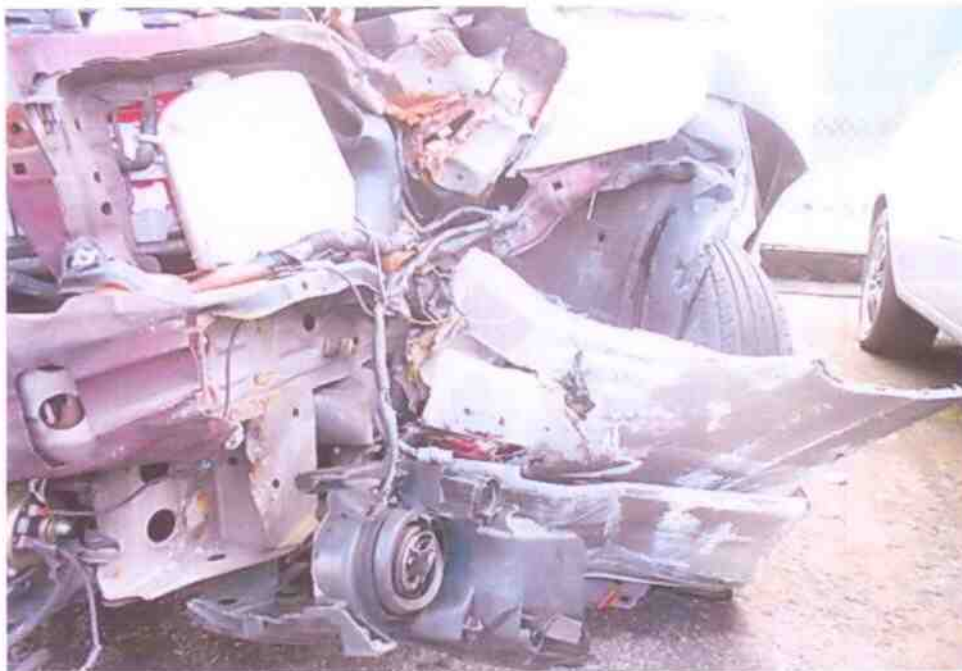
Photo 4 shows a closer view of the damage at the frontal portion of the Motor Car's engine. The impact force was significant, causing the various parts and components inside the engine compartment to be pushed inwards, towards the rear of the Motor Car.

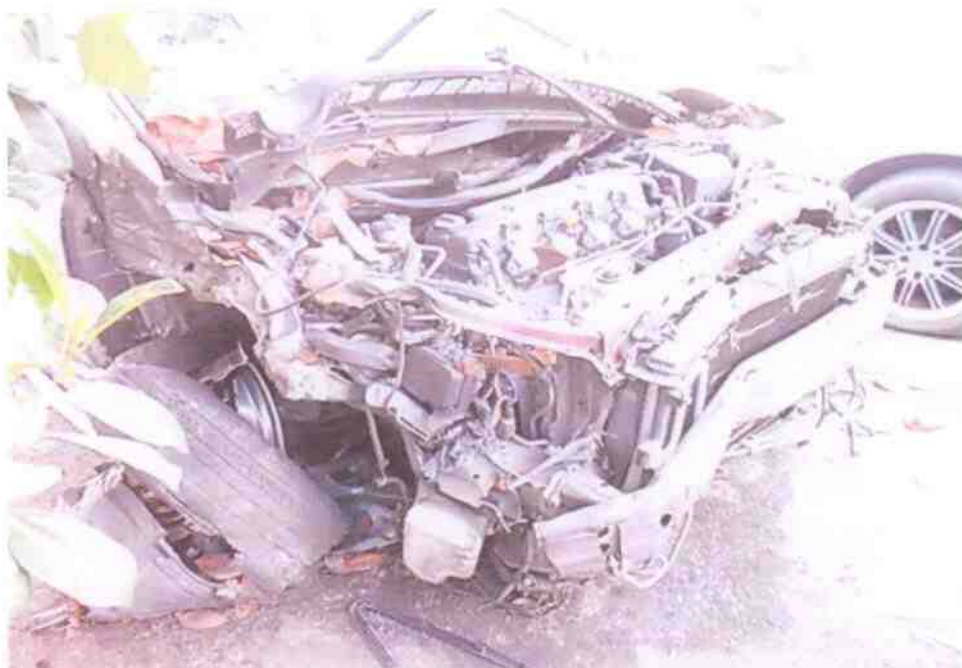
Photo 5 shows a closer view of the damage at the frontal right portion of the Motor Car. The impact force was significant, causing the various parts and components inside the engine compartment to be pushed inwards, towards the rear of the Motor Car.

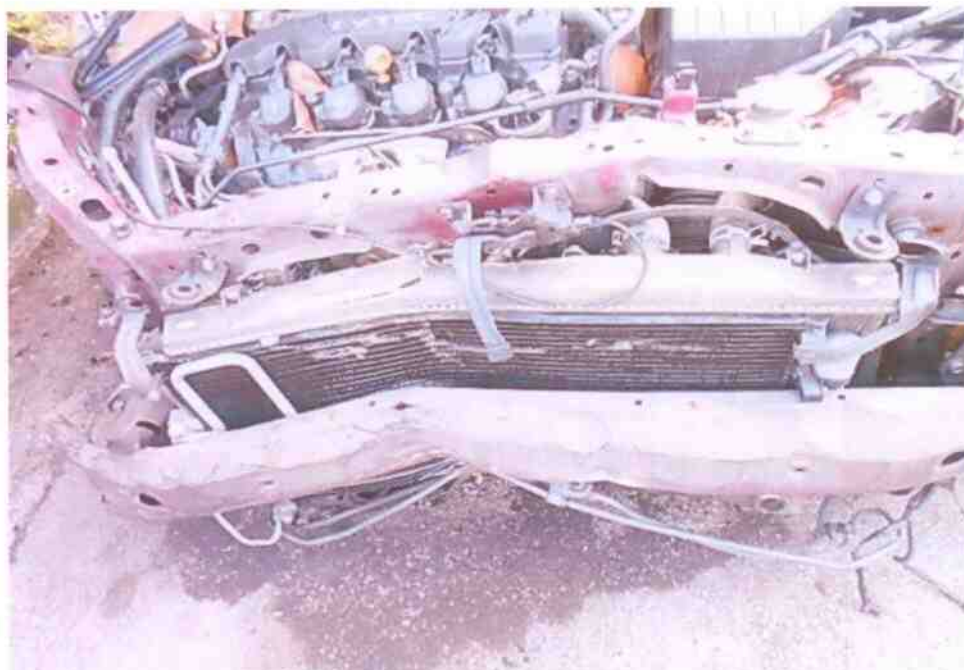
Photo 6 shows a closer view of the damage at the frontal portion of the Motor Car. The impact force was significant, causing the various parts and components inside the engine compartment to be pushed inwards, towards the rear of the Motor Car.

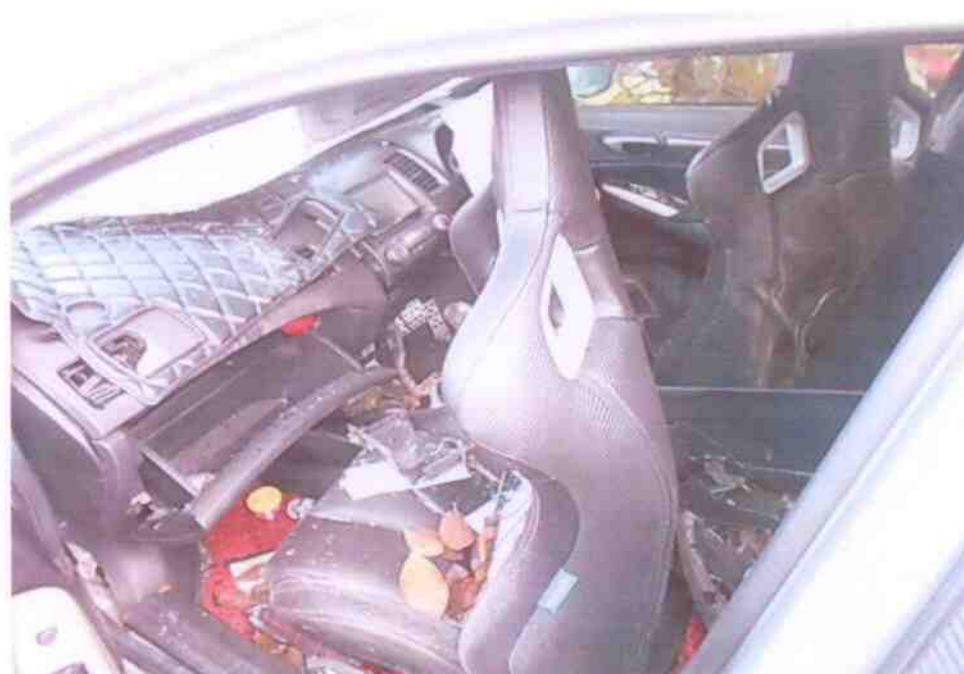
Photo 7 shows a closer view of the left front passenger seat of the Motor Car. The impact force was significant, causing the components such as driver & passenger's seat, glove compartment, gear knob assembly amongst others to be damaged likely due to the accident's impact collision.

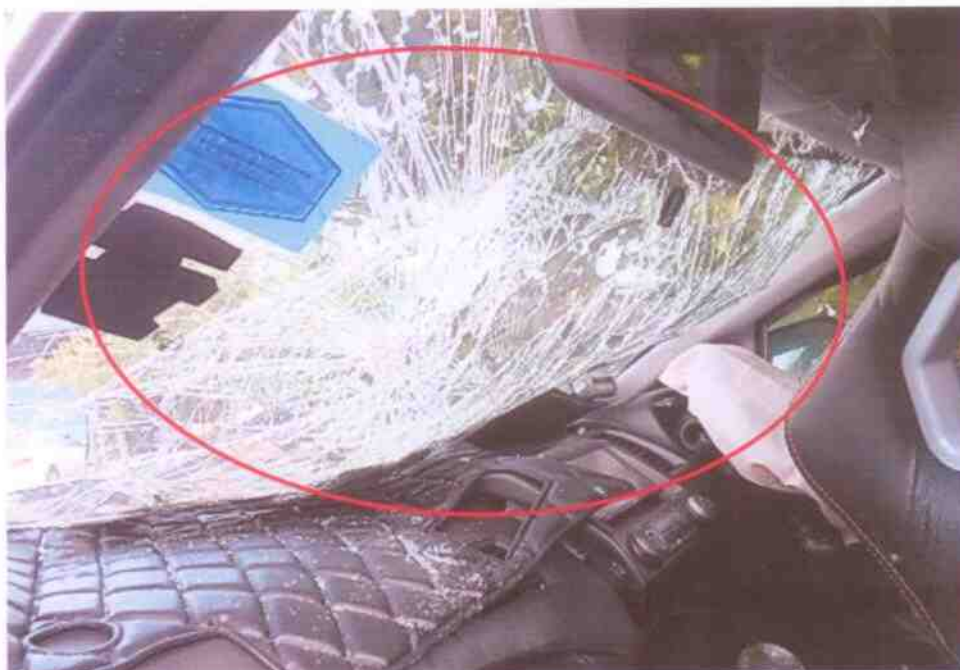
Photo 8 shows a closer view of the damage at the windscreen area of the Motor Car. The impact force was significant, causing the windscreen to sustain a shattering cracked.

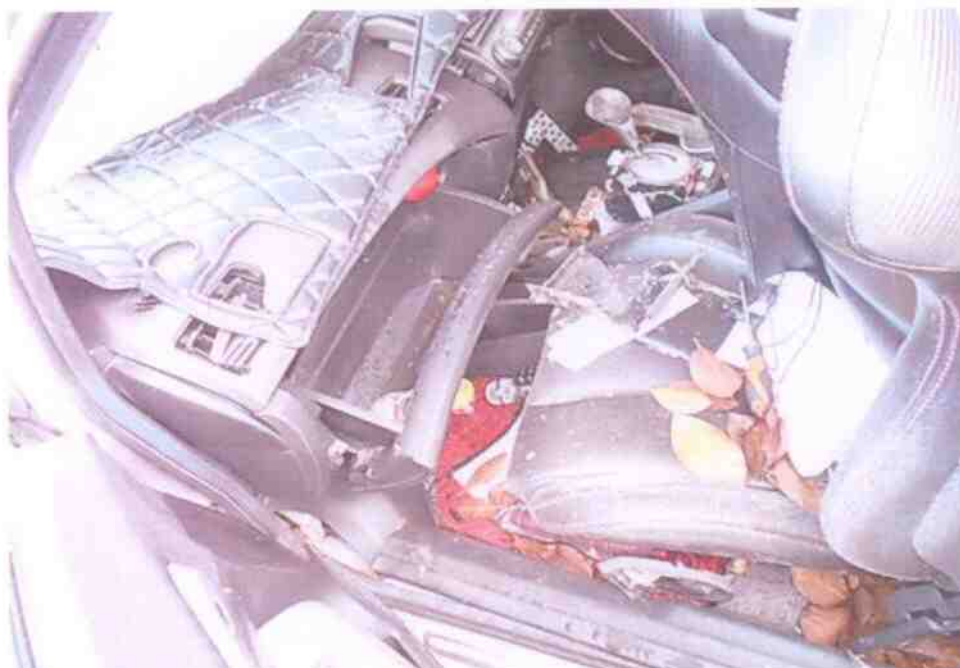
Photo 9 shows a closer view of the left front passenger seat of the Motor Car. The impact force was significant, causing the components such as driver & passenger's seat, glove compartment, gear knob assembly amongst others to be damaged likely due to the accident's impact collision.

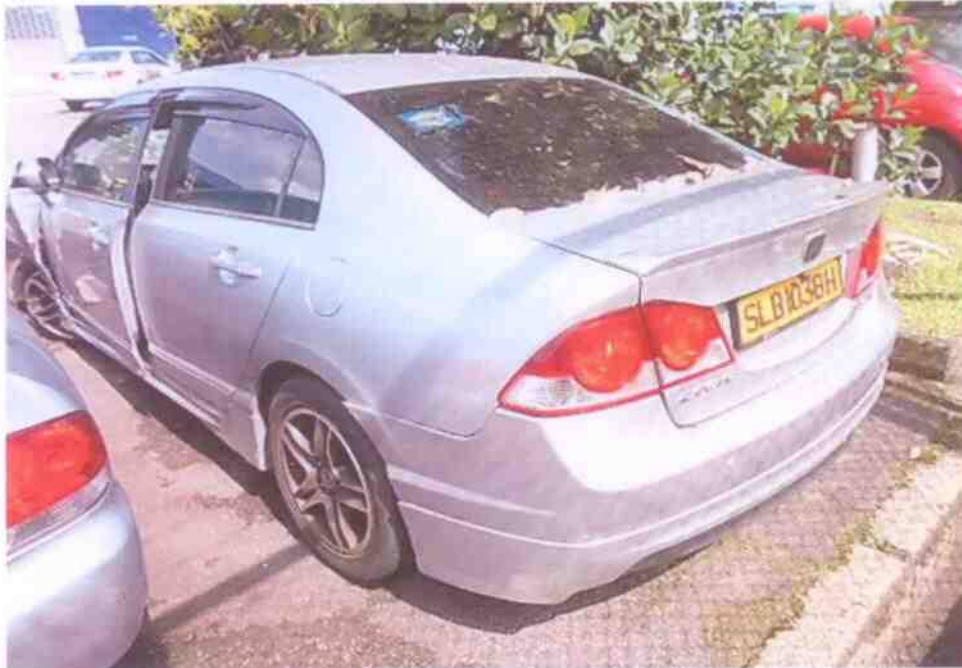
Photo 10 shows a general view of the rear left portion of the Motor Car. The rear portion was observed to be in good condition, no damages found at time of our inspection.

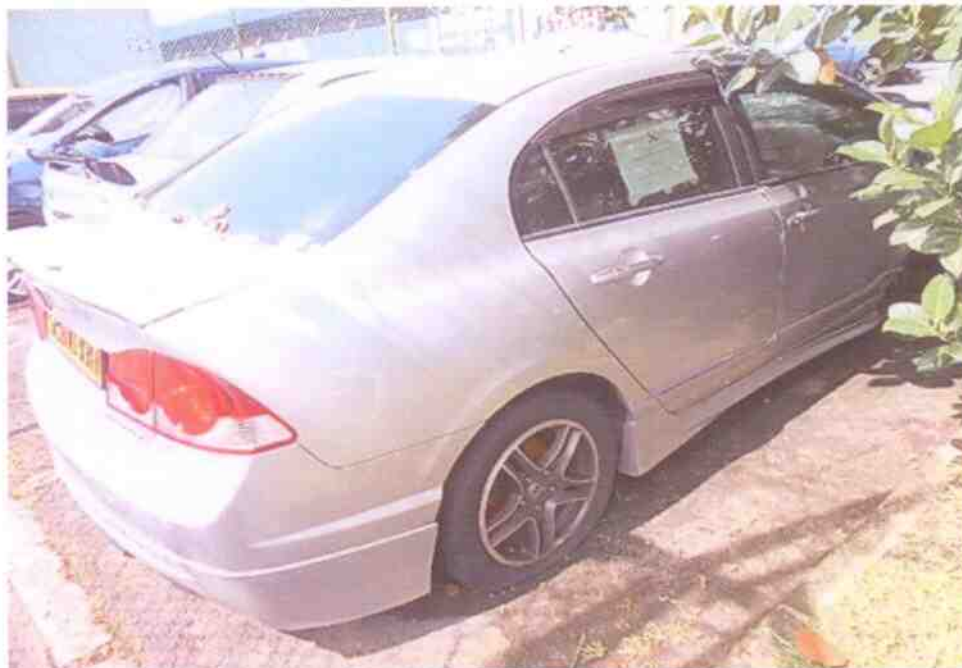
Photo 11 shows a general view of the rear right portion of the Motor Car. The rear portion was observed to be in good condition, no damages found on the Motor Car's body at time of our inspection. However, we found that the rear right tyre was deflated due to the accident.

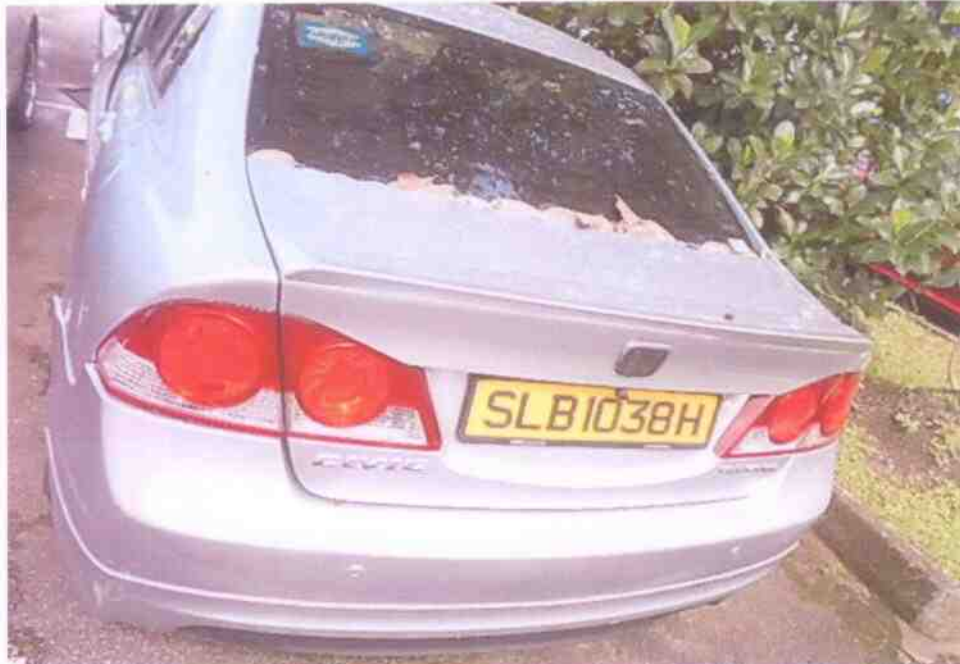
Photo 12 shows a general view of the rear left portion of the Motor Car. The rear portion was observed to be in good condition, no damages found at time of our inspection.

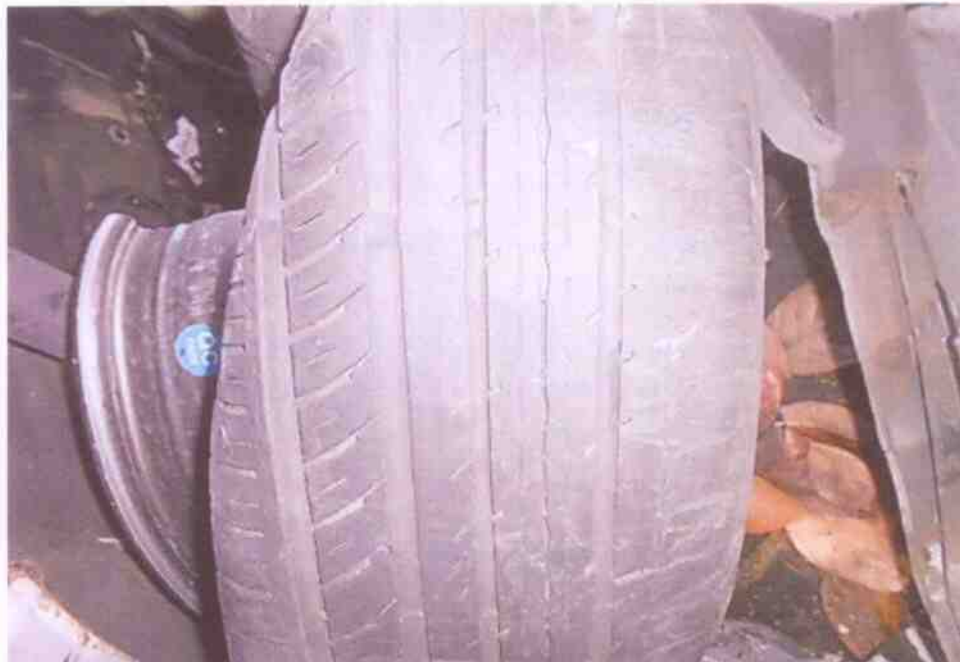
Photo 13 shows the condition of the front right tyre of the Motor Car. The tread patterns were obvious visually. The remaining tread depth of the front left tyre was approximately 3mm.

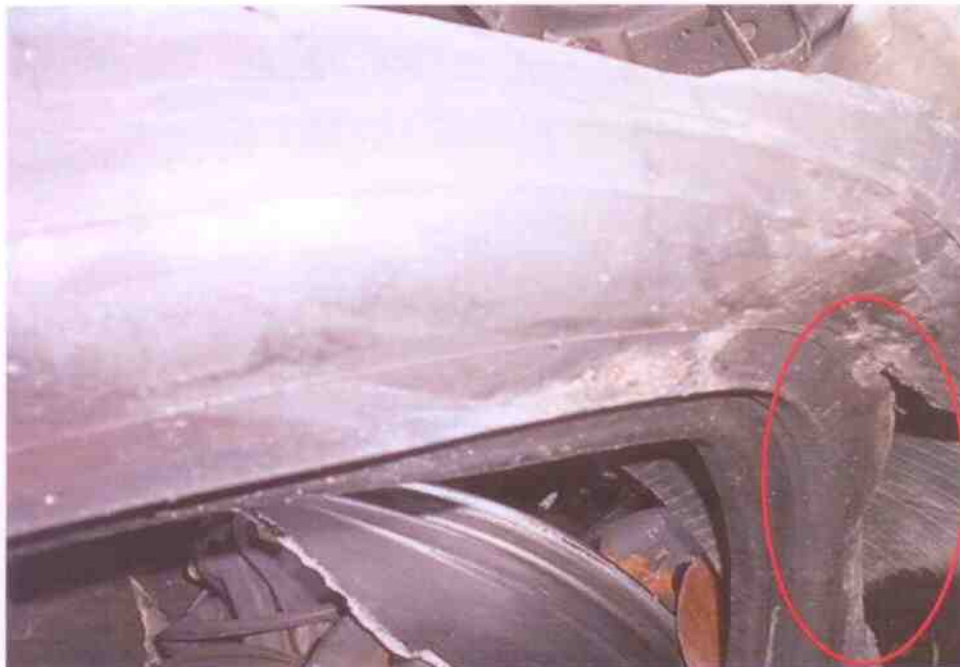
Photo 14 shows the condition of the front right tyre of the Motor Car, which was observed to be torn due to the accident's impact.

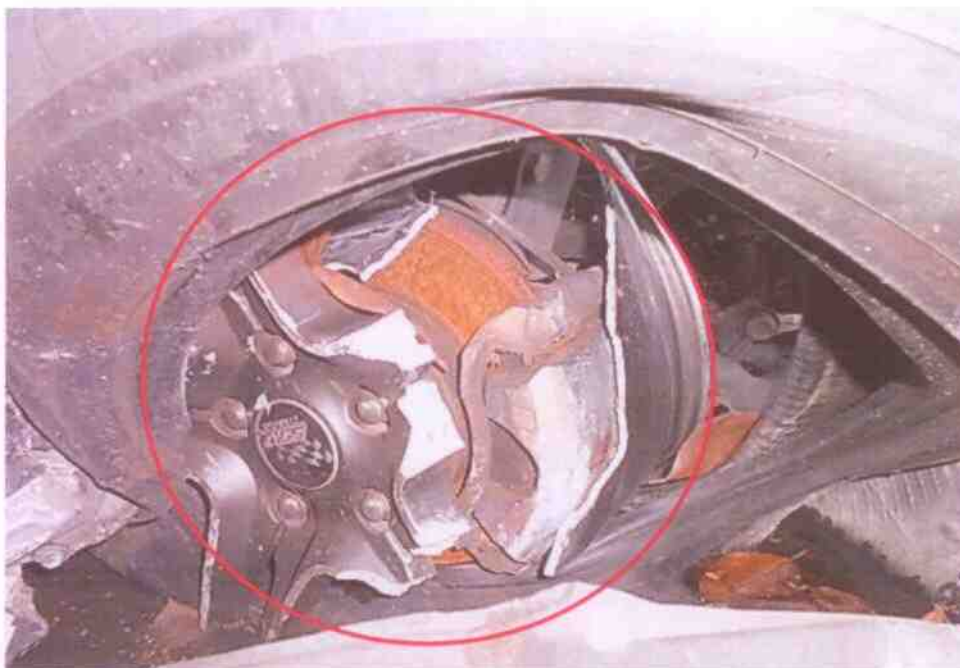
Photo 15 shows the condition of the front right wheel rim of the Motor Car, which was observed to be damaged due to the accident's impact.

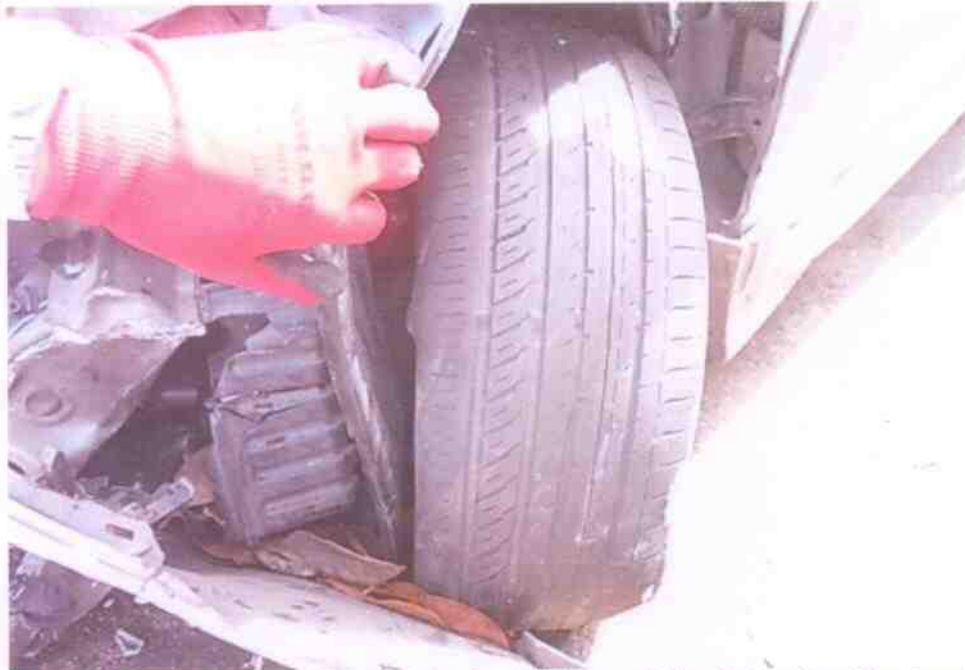
Photo 16 shows the condition of the front left tyre of the Motor Car. The tread patterns were obvious visually. The remaining tread depth of the front left tyre was approximately 3mm.

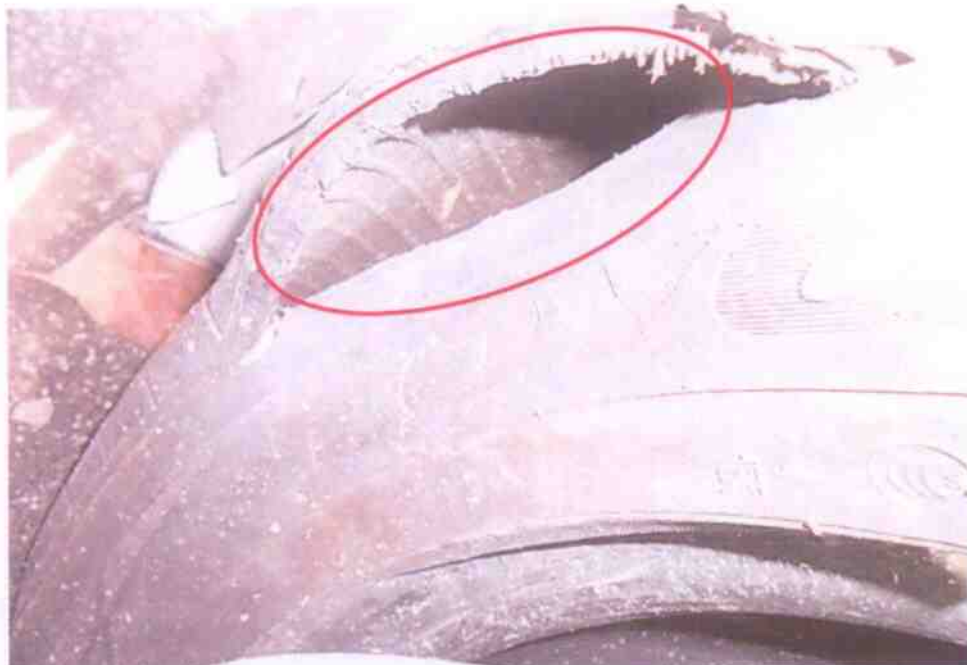
Photo 17 shows the condition of the front left tyre of the Motor Car, which was observed to be torn due to the accident's impact.

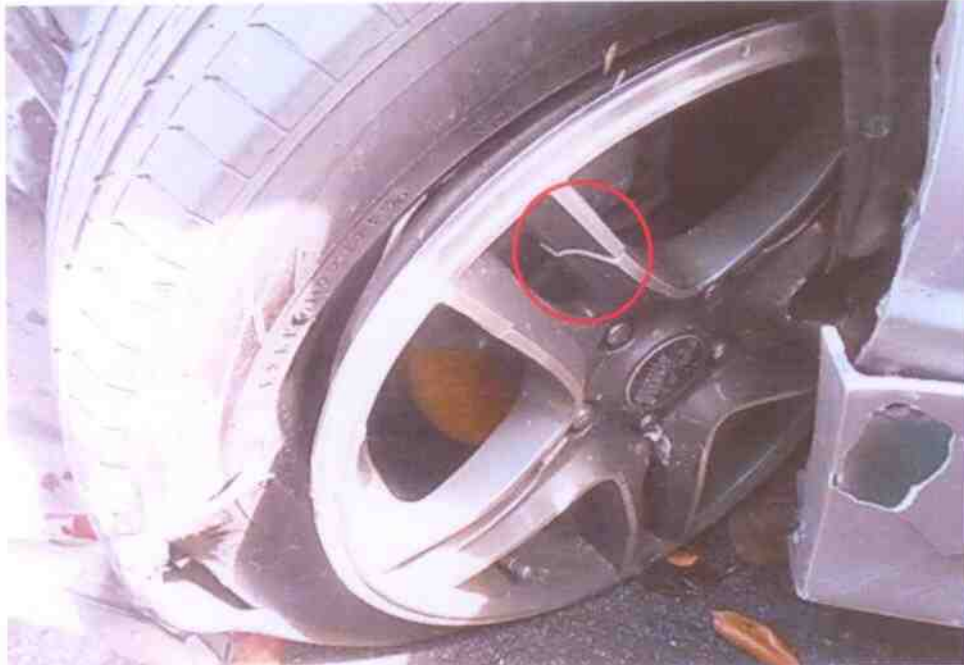
Photo 18 shows the condition of the front left wheel rim of the Motor Car, which was observed to be damaged due to the accident's impact.

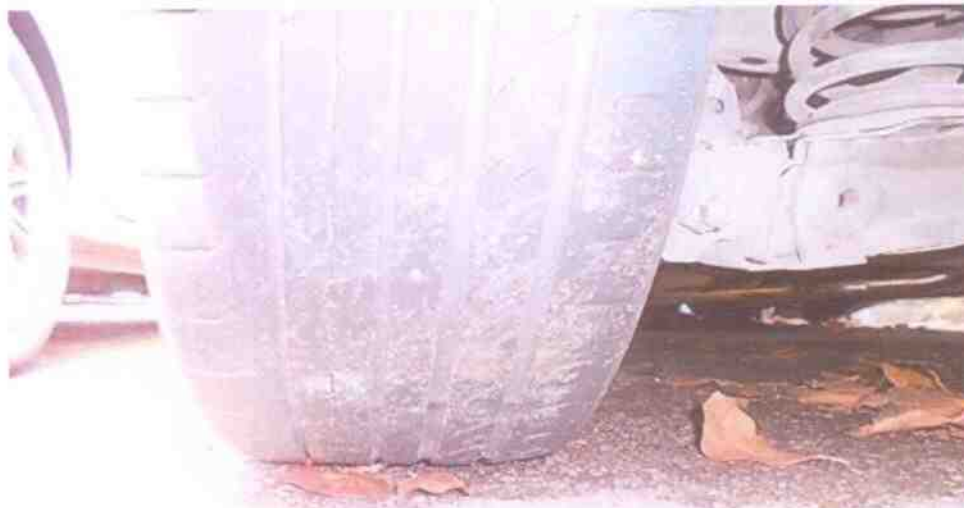
9. The rear left tyre was observed to be in serviceable condition. We did not find any tear, cut or burst mark(s) on the outer and the inner sidewalls as well as across the tread of the tyre. It was also observed to be sufficiently inflated for vehicular operation. The remaining tread depth of the rear left tyre was approximately 3mm.

Photo 19 shows the condition of the rear left tyre of the Motor Car, which was observed to be in serviceable condition. The tyre was also observed to be sufficiently inflated for vehicular operation.

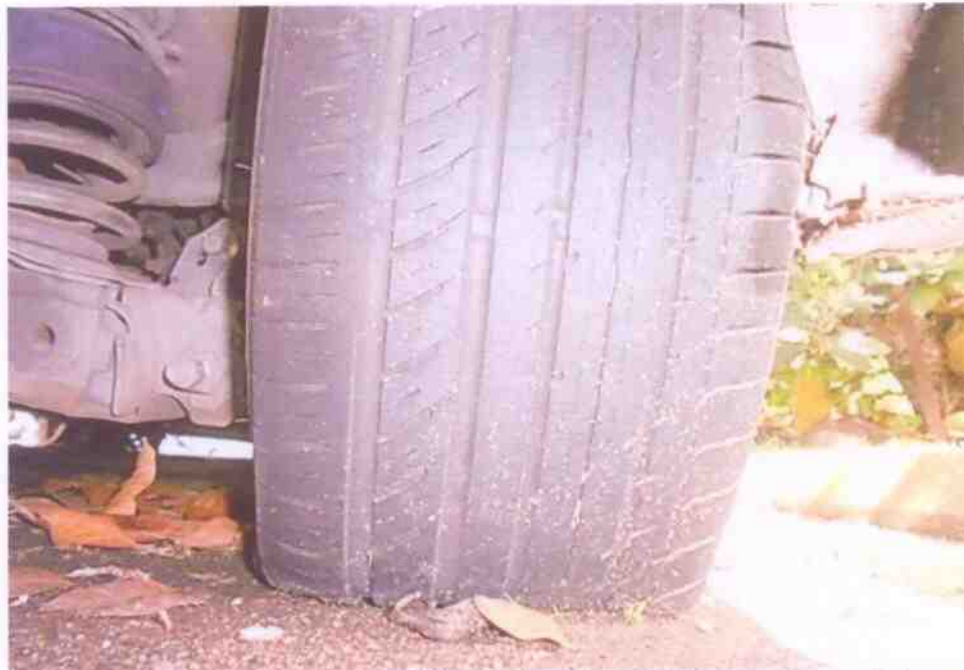
Photo 20 shows the condition of the rear right tyre of the Motor Car, which was observed to be deflated likely due to the accident's collision impact.

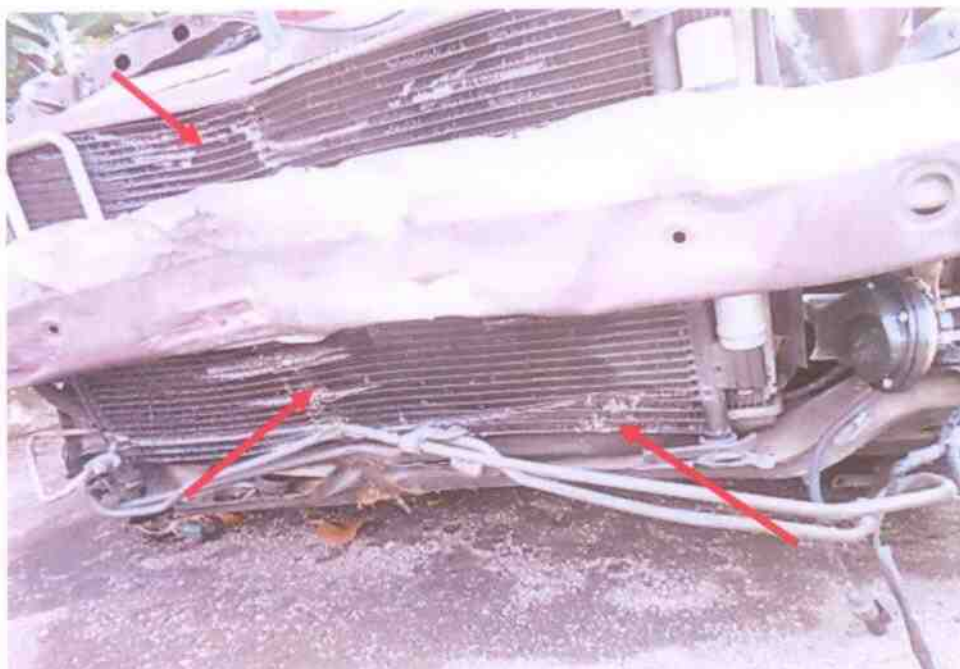
Photo 21 shows the close up view of the radiator's tank that was observed to be damaged likely due to the accident impact.

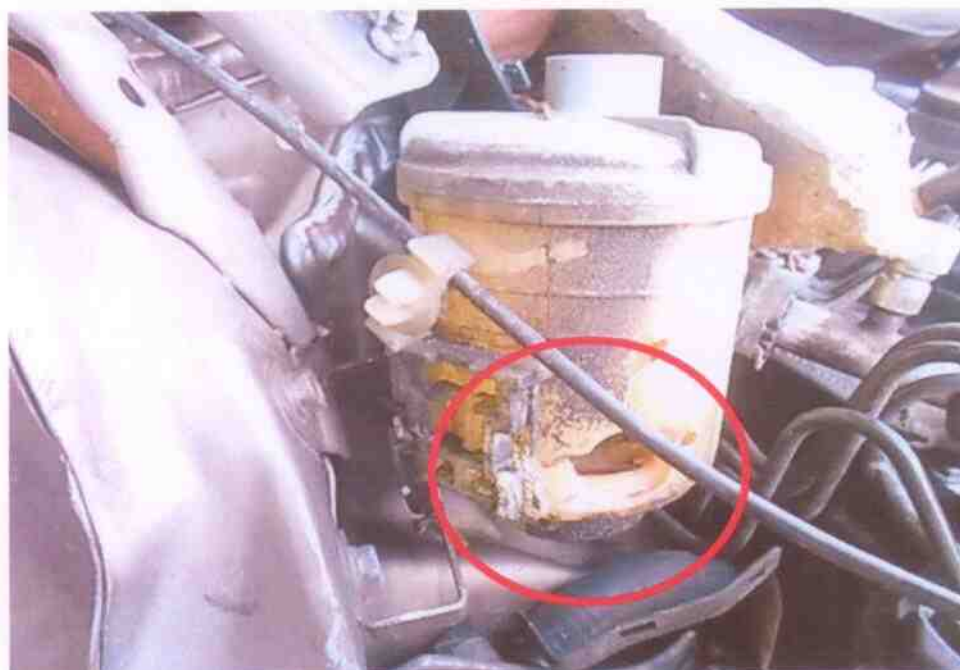
Photo 22 shows the close up view of the steering fluid reservoir that was broken likely due to the accident impact.

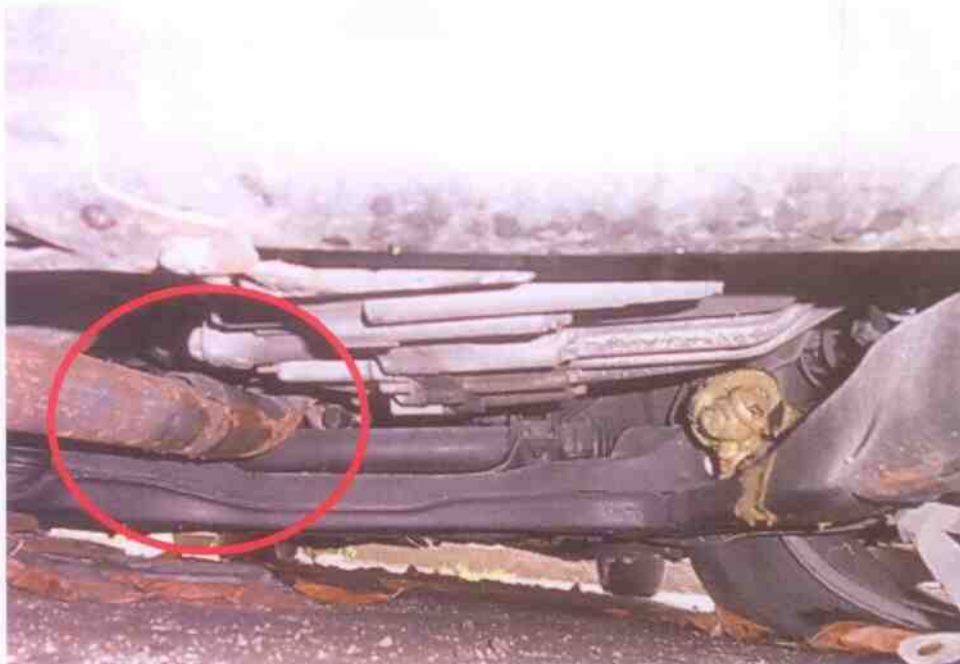
Photo 23 shows the close up view of the fluid leakage at the undercarriage area likely due to the accident impact.

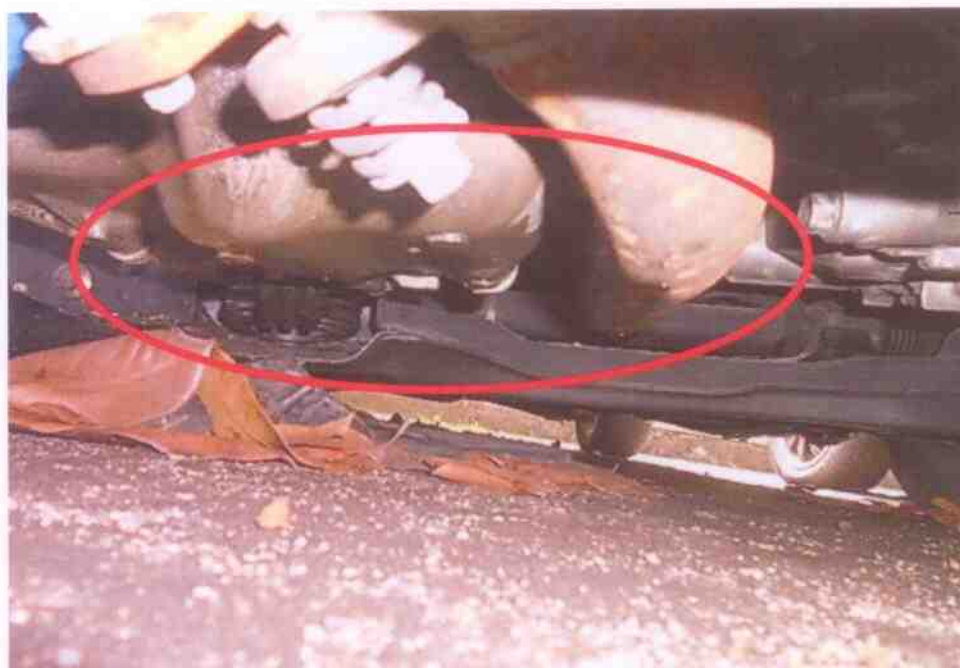
Photo 24 shows the close up view of the fluid leakage at the undercarriage area likely due to the accident impact.

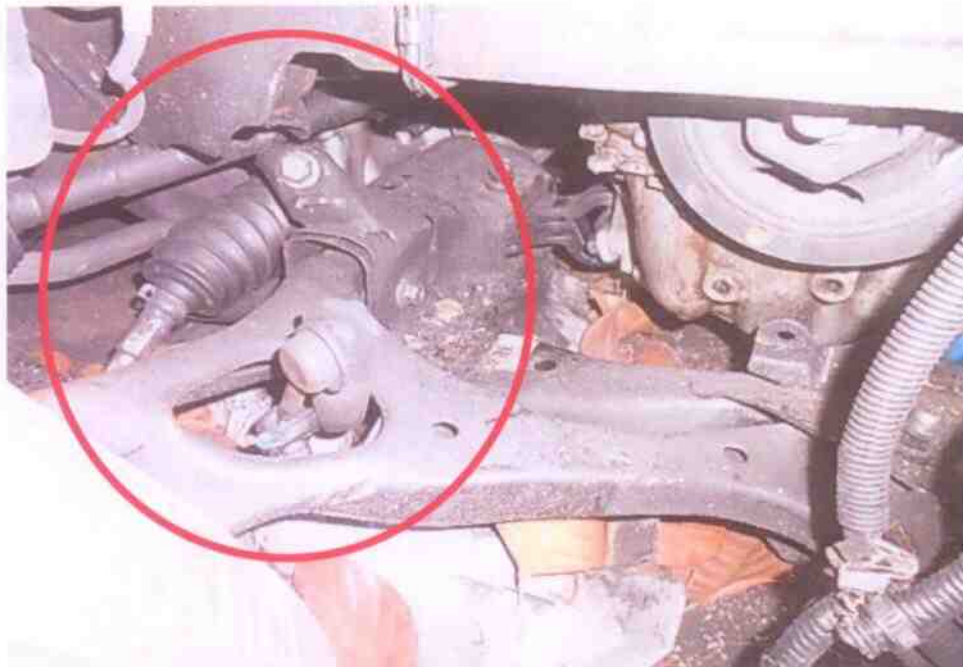
Photo 25 shows a close up view on the front right drive shaft of the Motor Car. We were not able to conduct any tests on the steering system of the Motor Car due to the damage to this components, as well as leakage of power steering fluid.

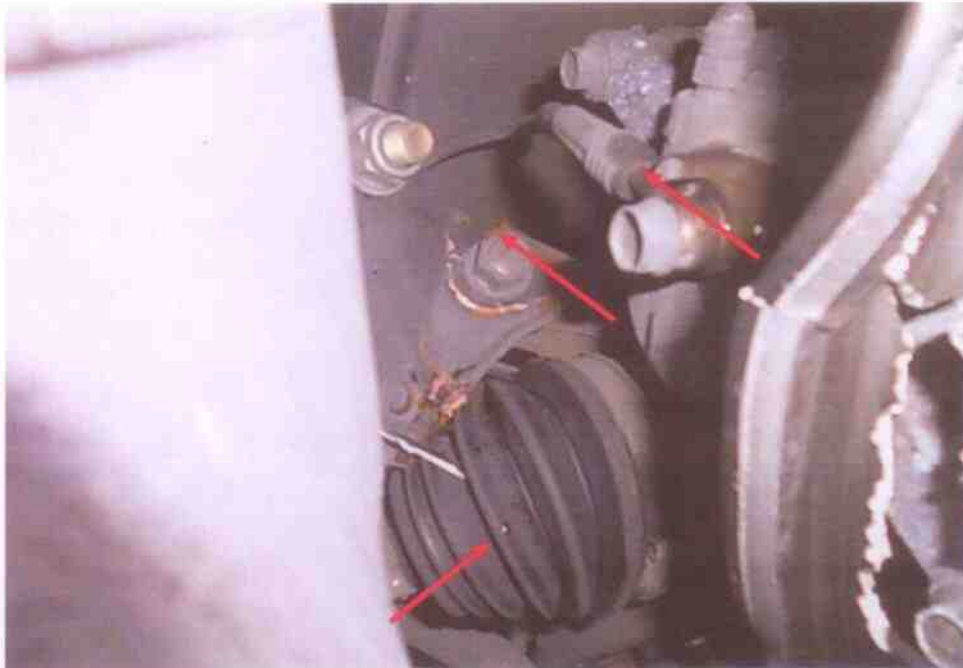
Photo 26 shows the damaged on the front left drive shaft of the Motor Car. We were not able to conduct any tests on the steering system of the Motor Car due to the damage to this components, as well as leakage of fluids.

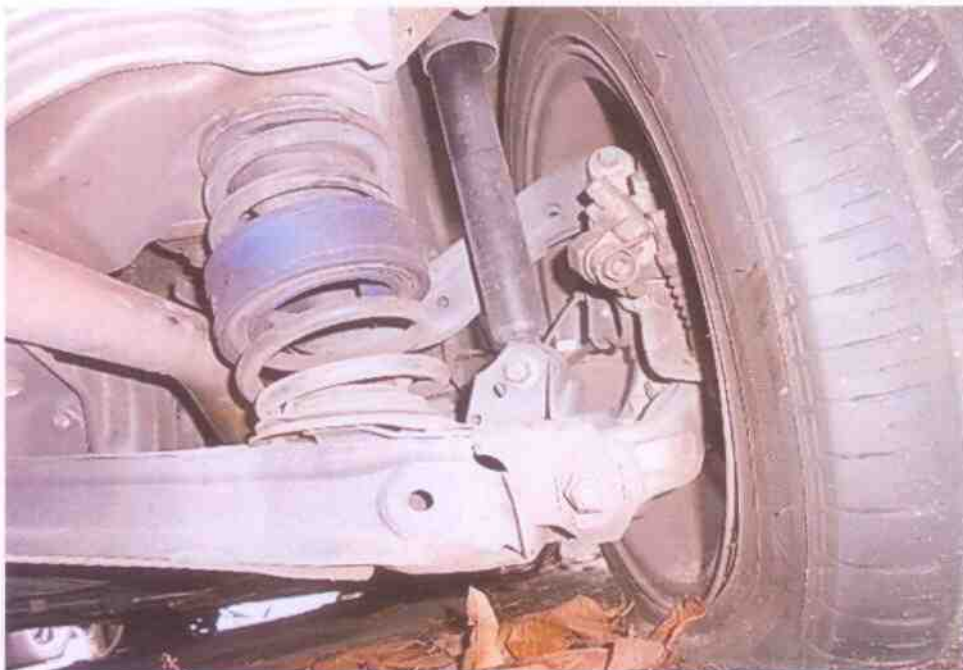
Photo 27 shows the braking & steering components at the rear right wheel of the Motor Car. We did not observe any leakage of brake fluid at the time of our inspection of the Motor Car.

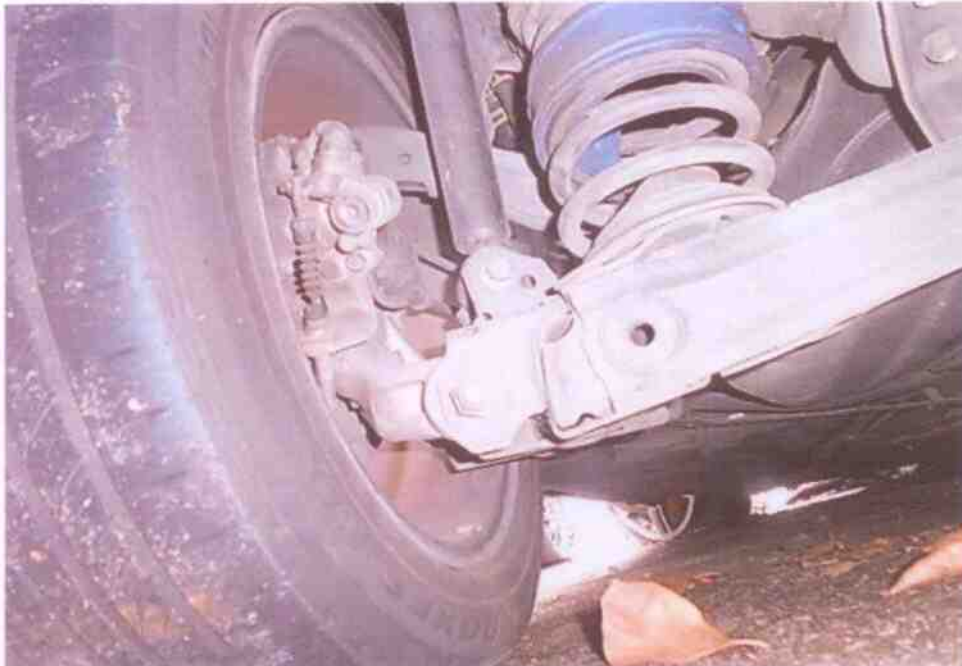
Photo 28 shows the braking & steering components at the left right wheel of the Motor Car. We did not observe any leakage of brake fluid at the time of our inspection of the Motor Car.

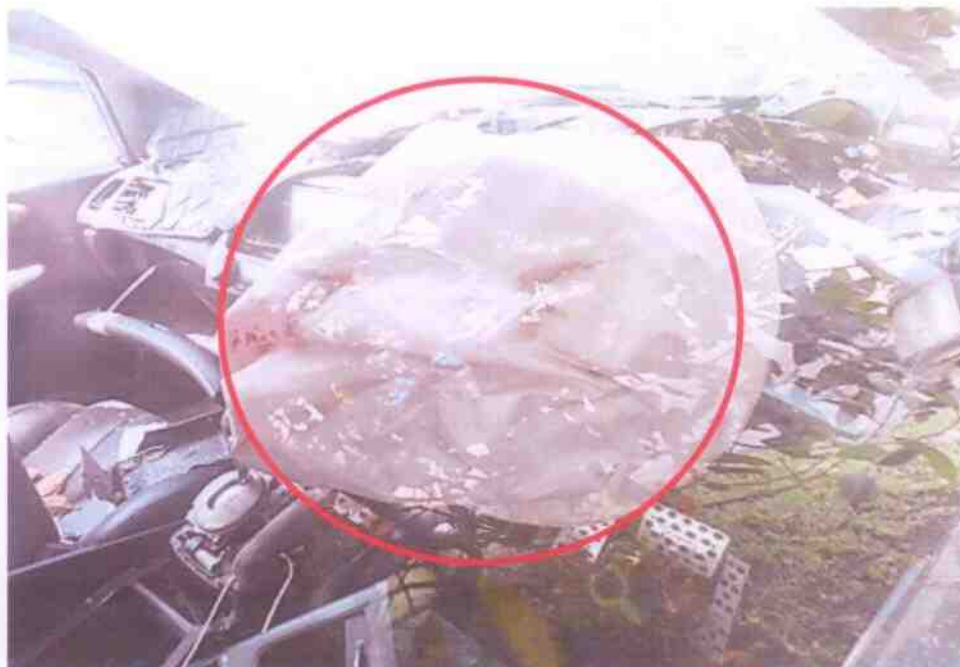
Photo 29 shows the Supplemental Restraint System (SRS) of the Motor Car was however likely to be in normal operating condition at the material time of the accident. The evidence of the deployed driver's airbag indicates that the impact sensors and control module of the Motor Car's SRS were all in serviceable condition at the material time of accident.
