Your Ref: TP/IP/65603/2017  
Our Ref : CI/TPD18001967/Z

**Fatal Accident Investigation Team**

**MECHANICAL INSPECTION REPORT OF MOTOR CAR SJR 4331E**

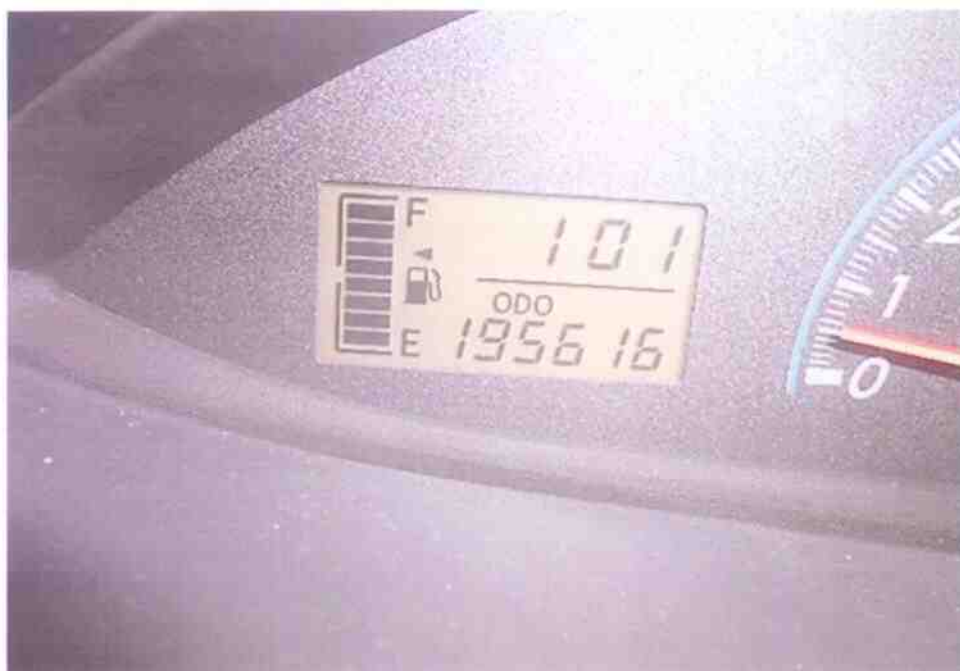
**Photo 1** shows the mileage of the Motor Car was 195,616 km.

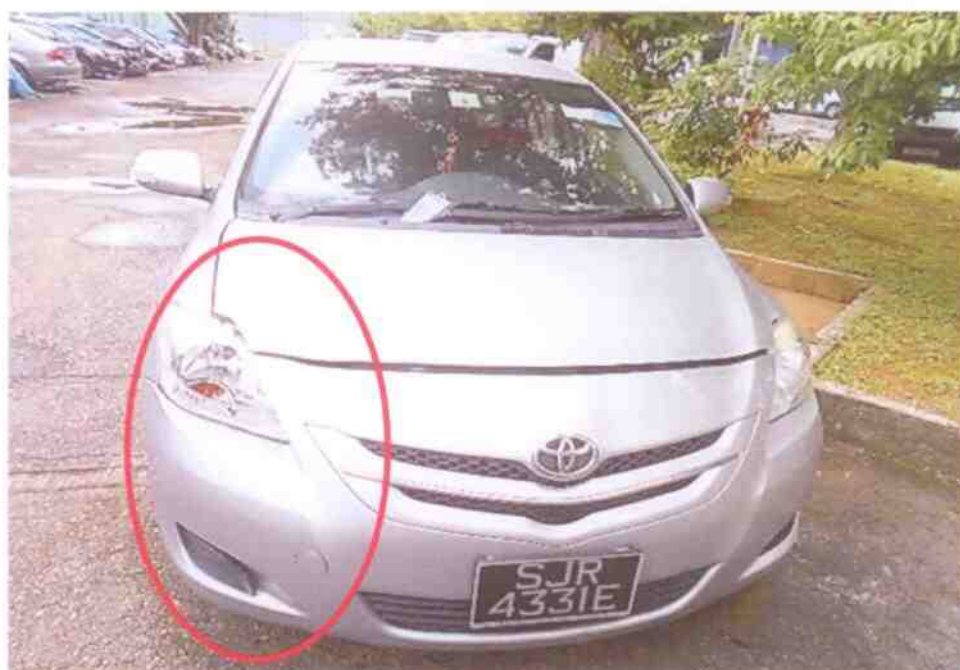
**Photo 2** shows a general view of the front body of the Motor Car at the time of our inspection. The Motor Car was observed to have sustained for a minor damages at the frontal portion.

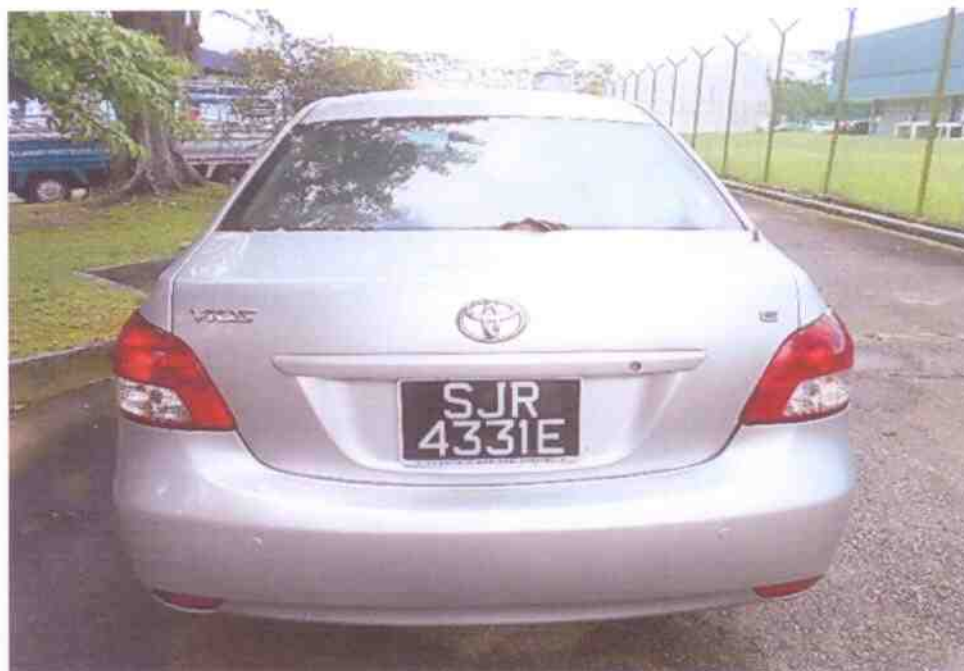
**Photo 3** shows a general view of the rear body of the Motor Car at the time of our inspection. The Motor Car was observed to be in good general condition.

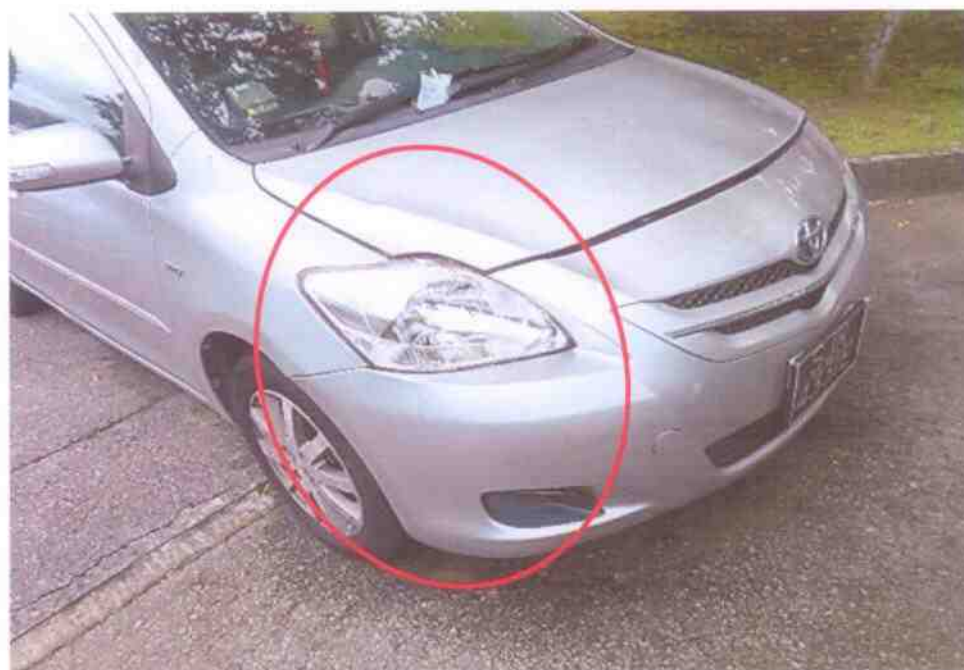
**Photo 4** shows a semi close up view of the front left of the Motor Car at the time of our inspection. The Motor Car had sustained relatively minor impact at the front left of the Motor Car.

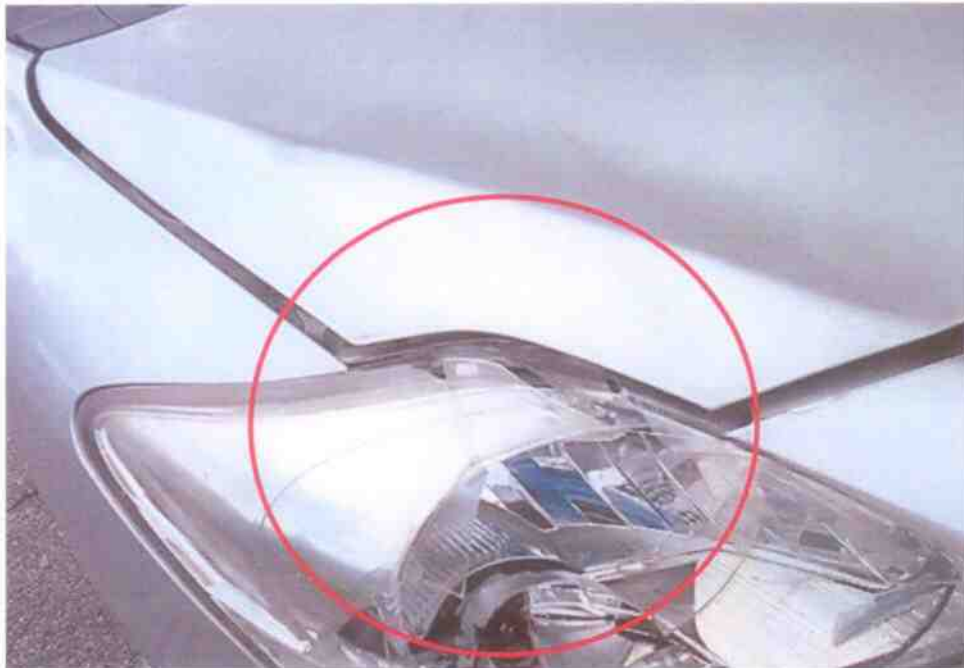
**Photo 5** shows a close up view of the headlamp & front bonnet of the Motor Car at the time of our inspection. It was observed to have sustained with damages consistent to the accident's case fact.

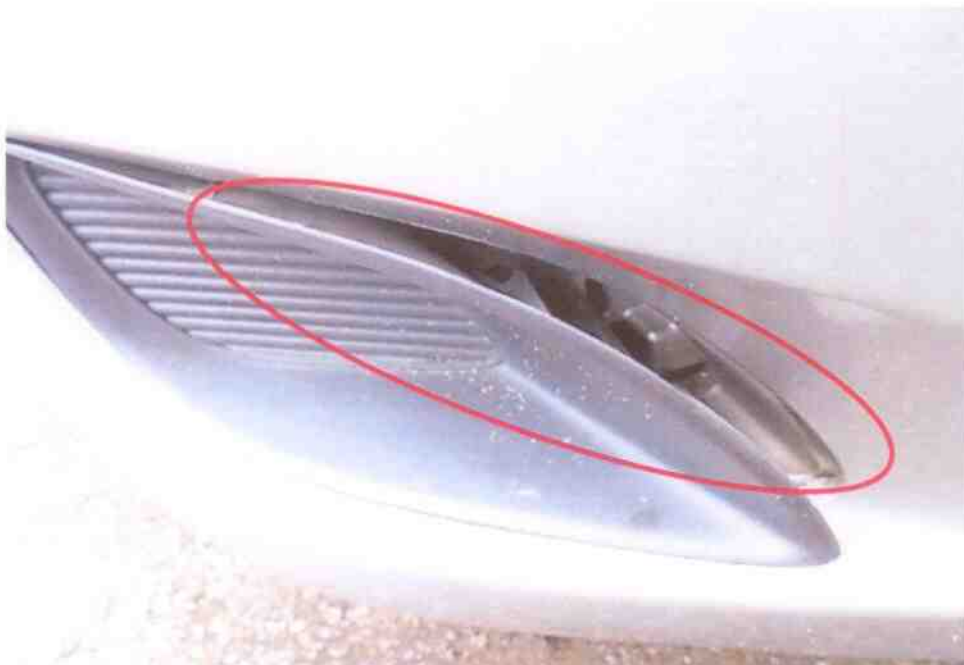
**Photo 6** shows a close up view of the spot light garnish of the Motor Car at the time of our inspection. It was observed to be dislodged from its original installation.

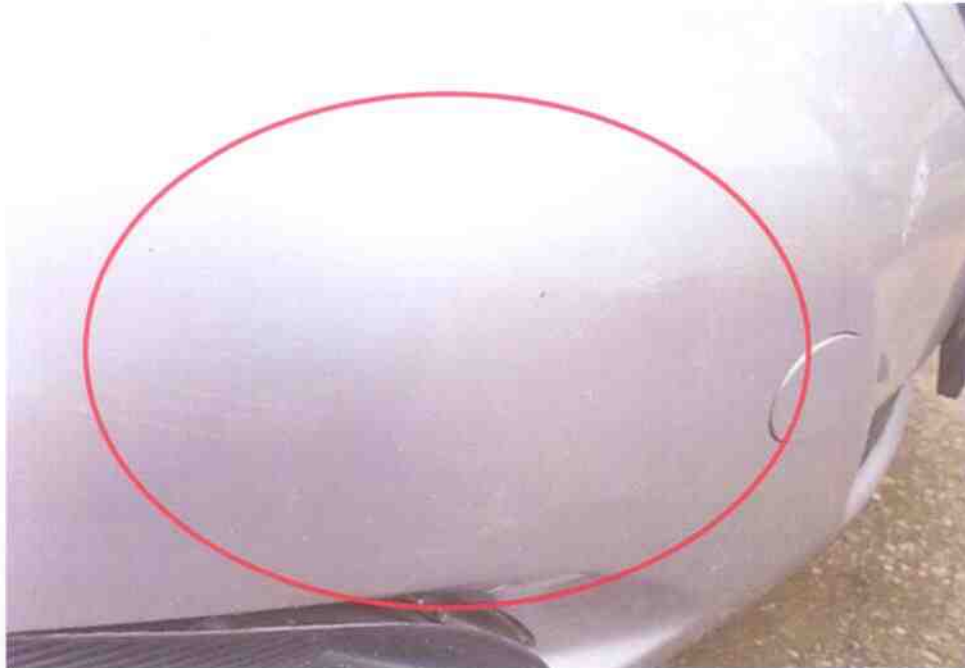
**Photo 7** shows a close up view of the front bumper of the Motor Car at the time of our inspection. It was observed to be with deformation marks.

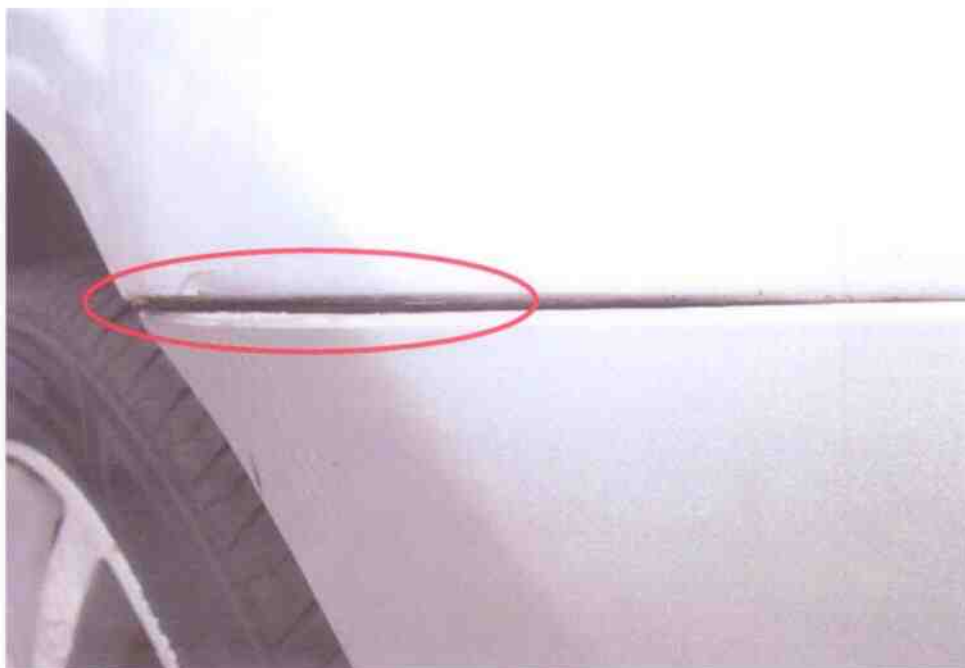
**Photo 8** shows a close up view of the front bumper of the Motor Car at the time of our inspection. It was observed to be misaligned.

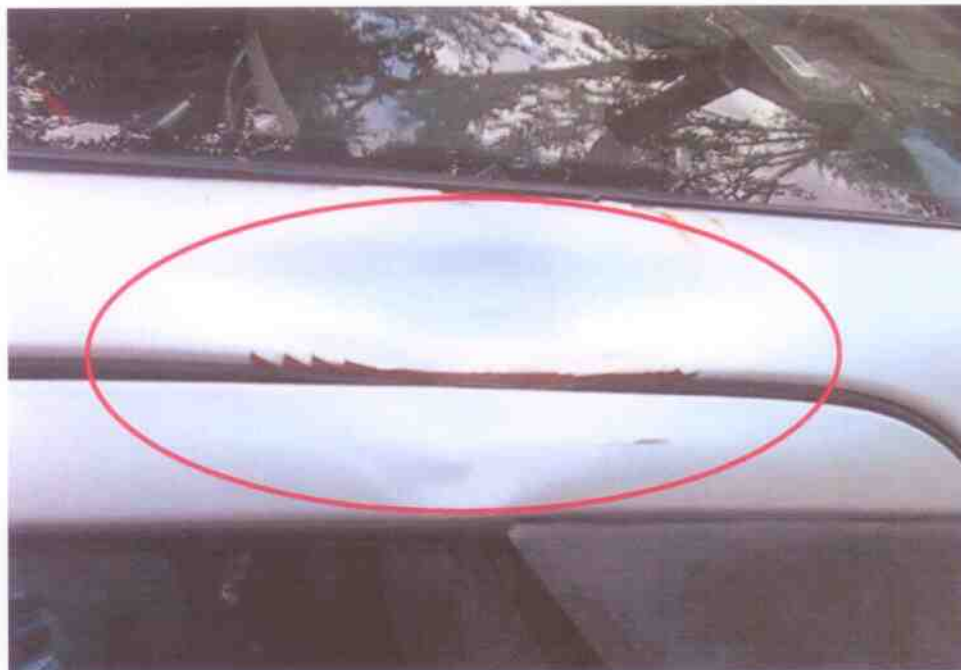
**Photo 9** shows a close up view of the front right door of the Motor Car at the time of our inspection. It was observed to be dented likely due to the accident.

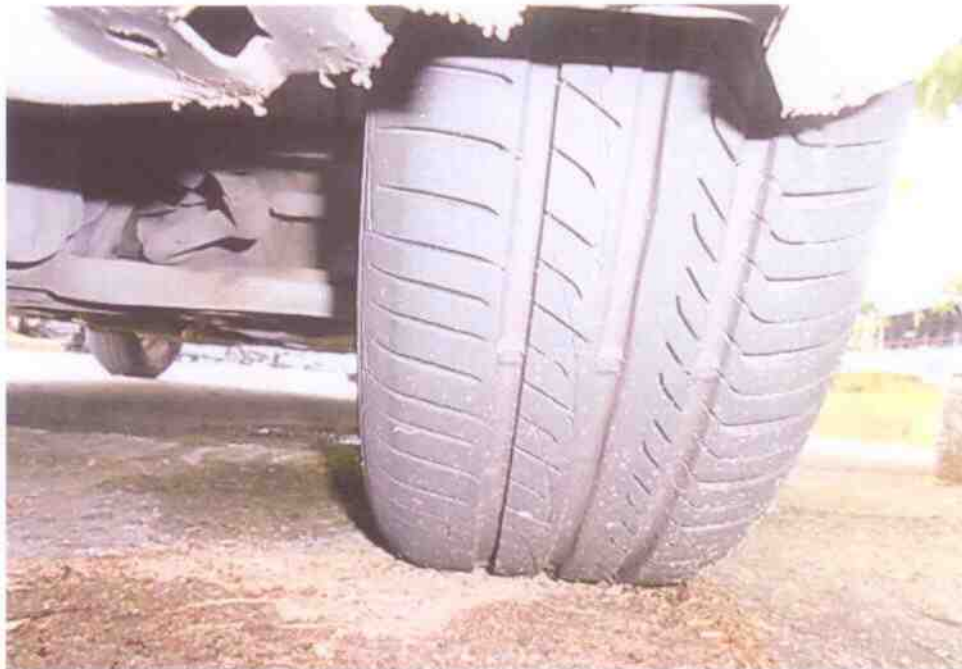
**Photo 10** shows the condition of the front left tyre of the Motor Car, which was observed to be in serviceable condition with remaining tread depth of approximately 7mm. The tyre, which was wrapped around alloy wheel rim, was also observed to be sufficiently inflated for vehicular operation. There was no tear, cut or burst mark(s) on the outer and the inner sidewalls as well as across the tread of the 4 tyres.

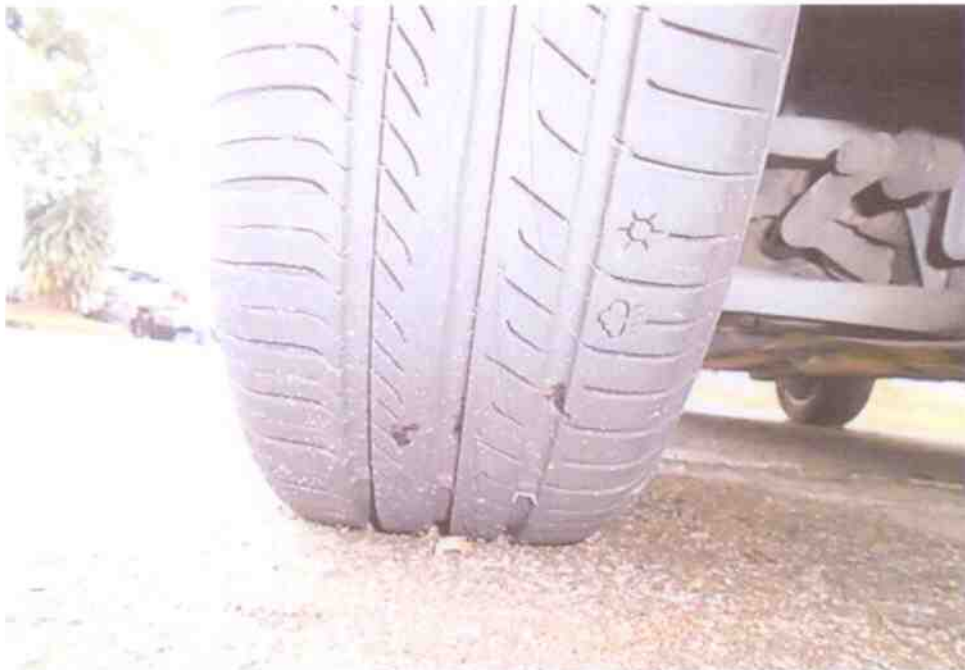
**Photo 11** shows the condition of the front right tyre of the Motor Car, which was observed to be in serviceable condition with remaining tread depth of approximately 7mm. The tyre, which was wrapped around alloy wheel rim, was also observed to be sufficiently inflated for vehicular operation.

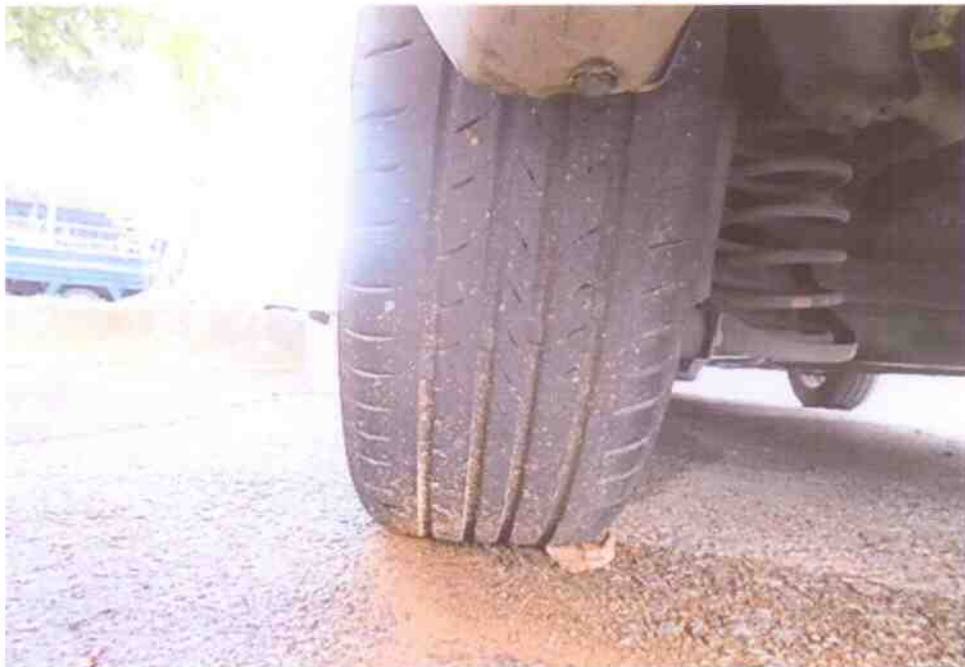
**Photo 12** shows the condition of the rear left tyre of the Motor Car, which was observed to be in serviceable condition with remaining tread depth of approximately 6mm. The tyre, which was wrapped around alloy wheel rim, was also observed to be sufficiently inflated for vehicular operation.

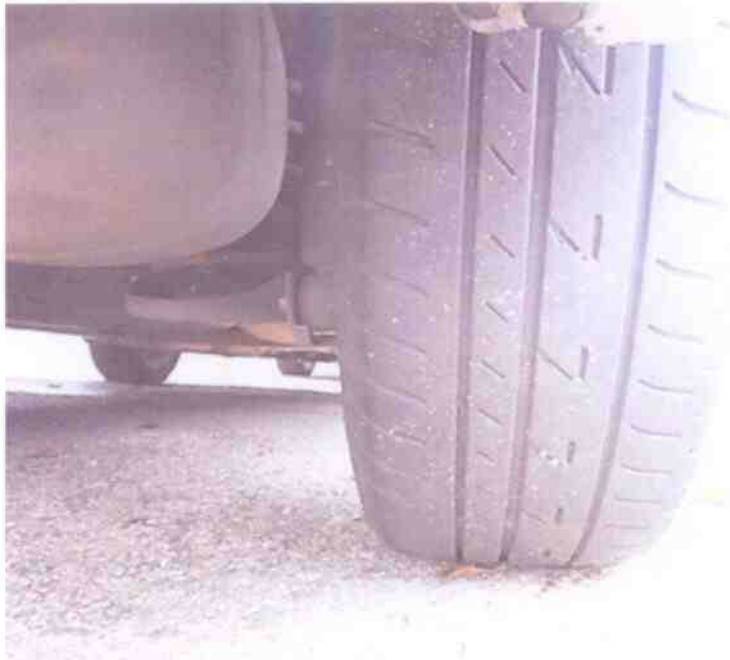
**Photo 13** shows the condition of the rear right tyre of the Motor Car, which was observed to be in serviceable condition with remaining tread depth of approximately 6mm. There was also no tear, cut or burst mark(s) on the outer and the inner sidewalls as well as across the tread of the 4 tyres.

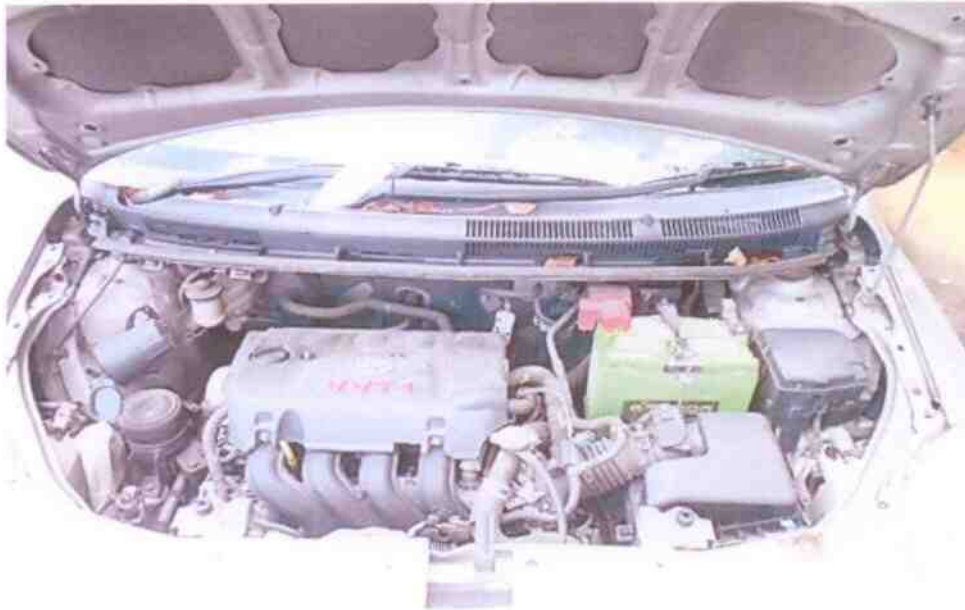
**Photo 14** shows a general view of the Motor Car's engine compartment. The various parts and components inside the engine compartment were unaffected by the accident. There was also no sign(s) or indication(s) of fluid leakage and/or fluid stain within the engine compartment.

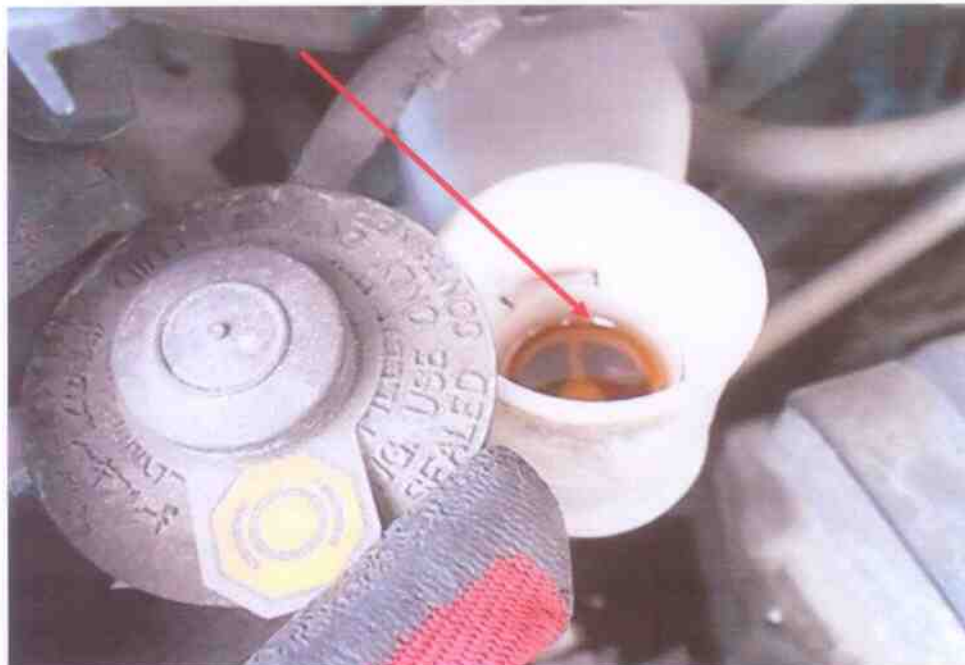
**Photo 15** shows the brake fluid reservoir of the Motor Car at the time of our inspection. The brake fluid was observed to be of sufficient level (arrowed) and without any visible contamination.

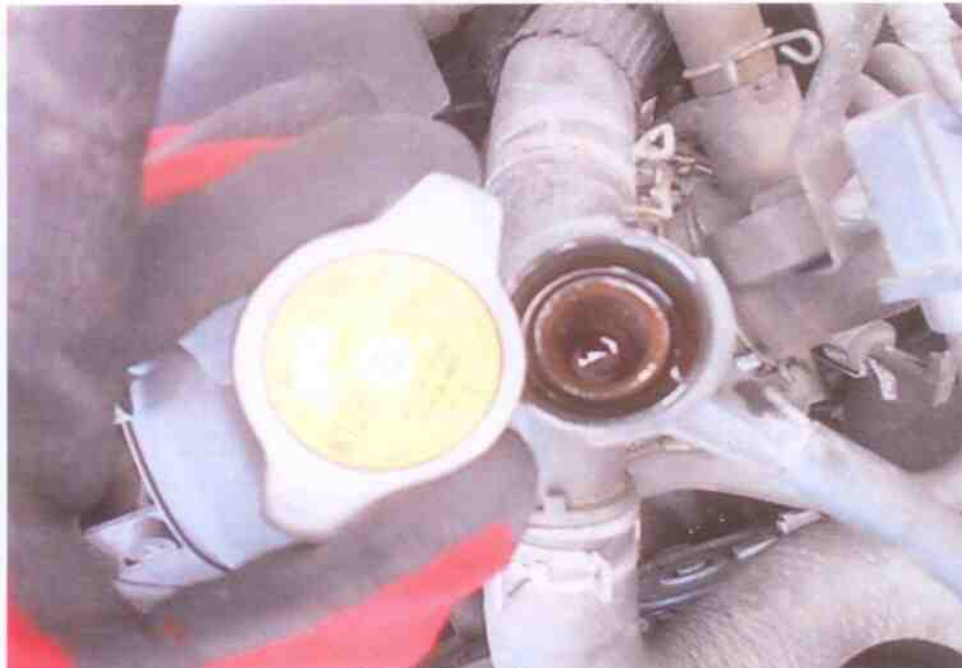
**Photo 16** shows the coolant fluid in the radiator tank of the Motor Car at the time of our inspection. The coolant fluid was observed to be of sufficient level and without any visible contamination.

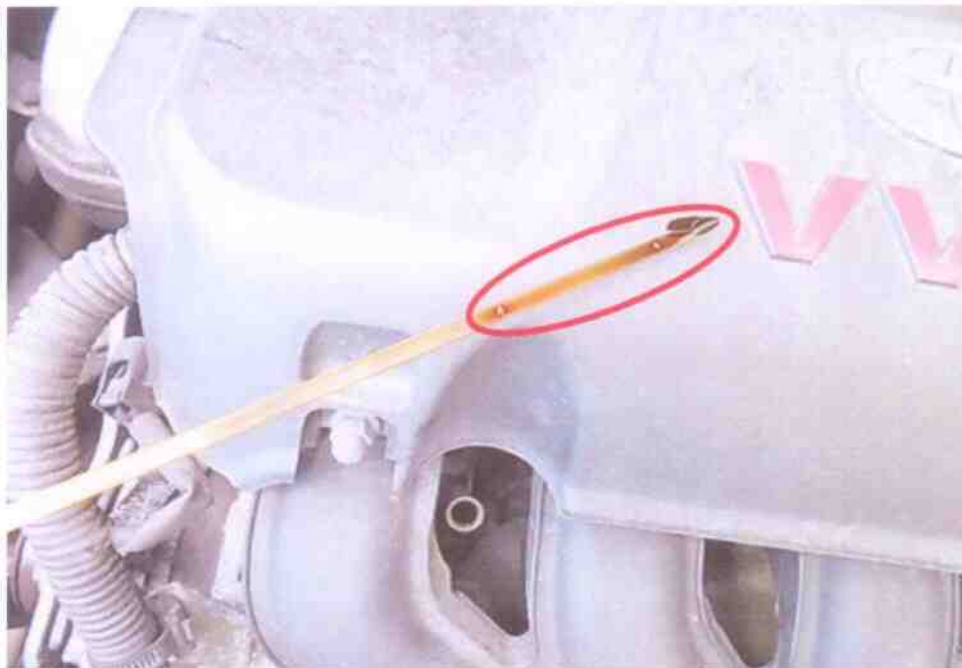
**Photo 17** shows the engine oil dip stick of the Motor Car at the time of our inspection. The engine oil was observed to be of sufficient level and without any visible contamination.

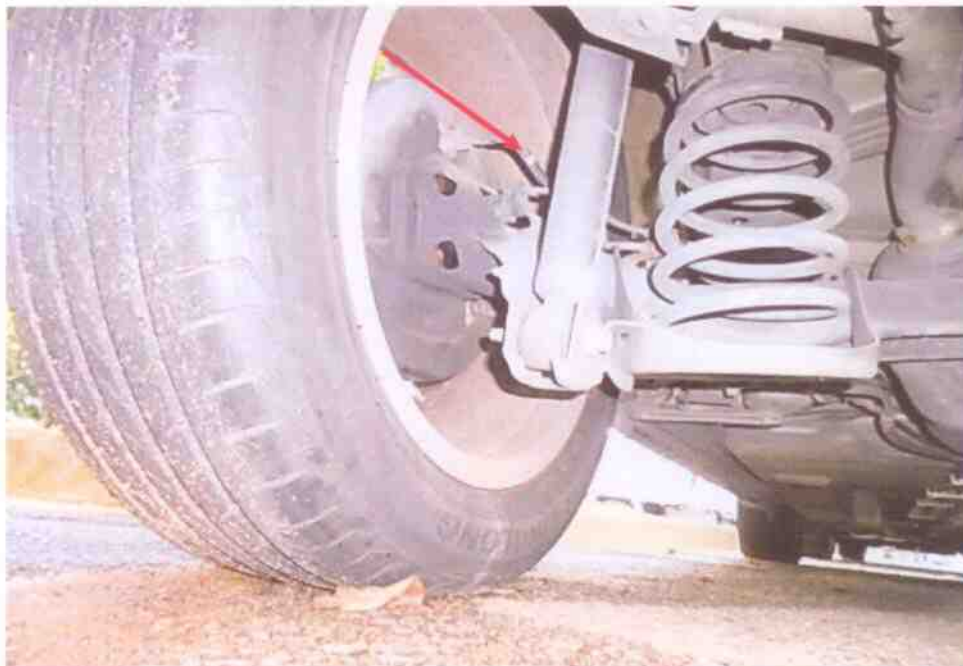
**Photo 18** shows the brake hose (arrowed) at the rear left wheel of the Motor Car. We did not observe any leakage of brake fluid at the time of our inspection of the Motor Car. Our visual inspection of the various mechanical components of the Motor Car's braking system revealed all to be intact and without visible damage, indicating that the braking system was likely to be in serviceable condition at the material time of accident.

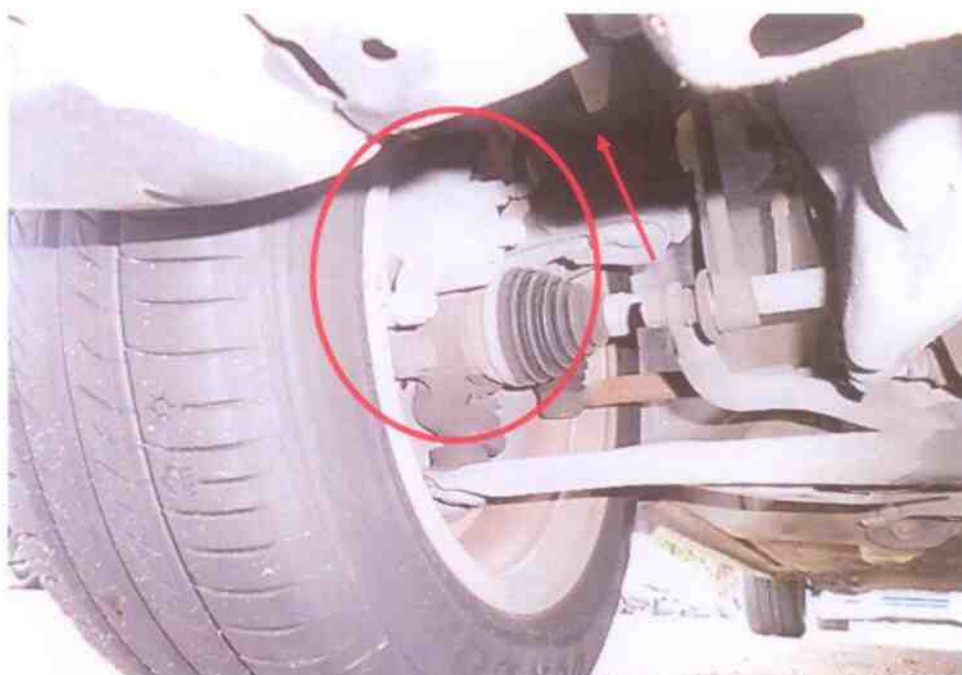
**Photo 19** shows the brake hose (arrowed) at the front right wheel of the Motor Car. We did not observe any leakage of brake fluid at the time of our inspection of the Motor Car. Our visual inspection of the various mechanical components of the Motor Car's braking system, including its brake calliper (circled), revealed all to be intact and without visible damage, indicating that the braking system was likely to be in serviceable condition at the material time of accident.

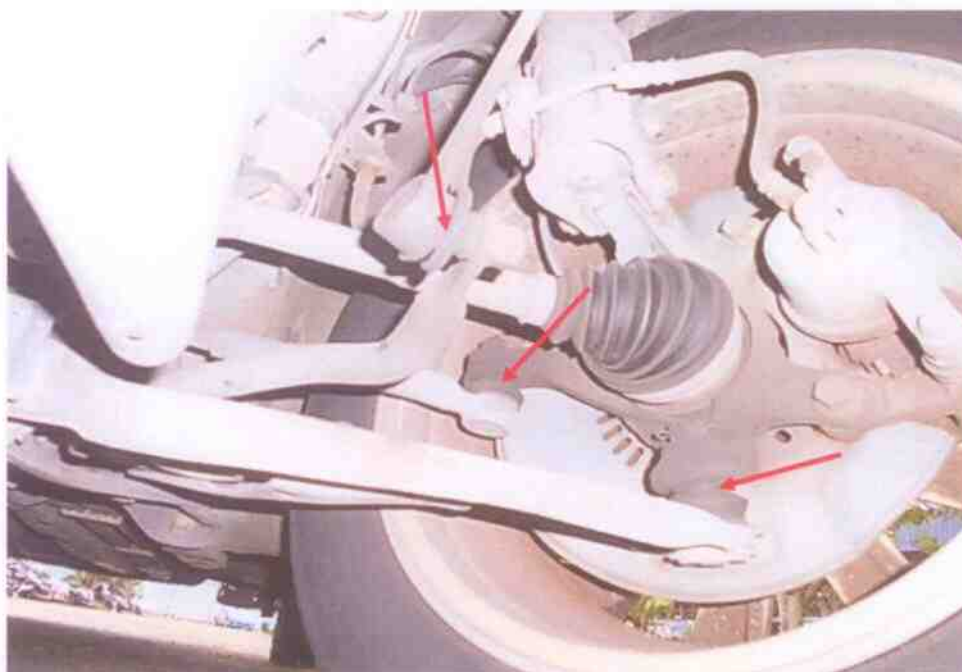
**Photo 20** shows the various undercarriage components at the front left wheel of the Motor Car, in particular the steering tie rod (arrowed). The various steering components were all found to be intact, suggesting that the steering system of the Motor Car was likely to be in serviceable condition.

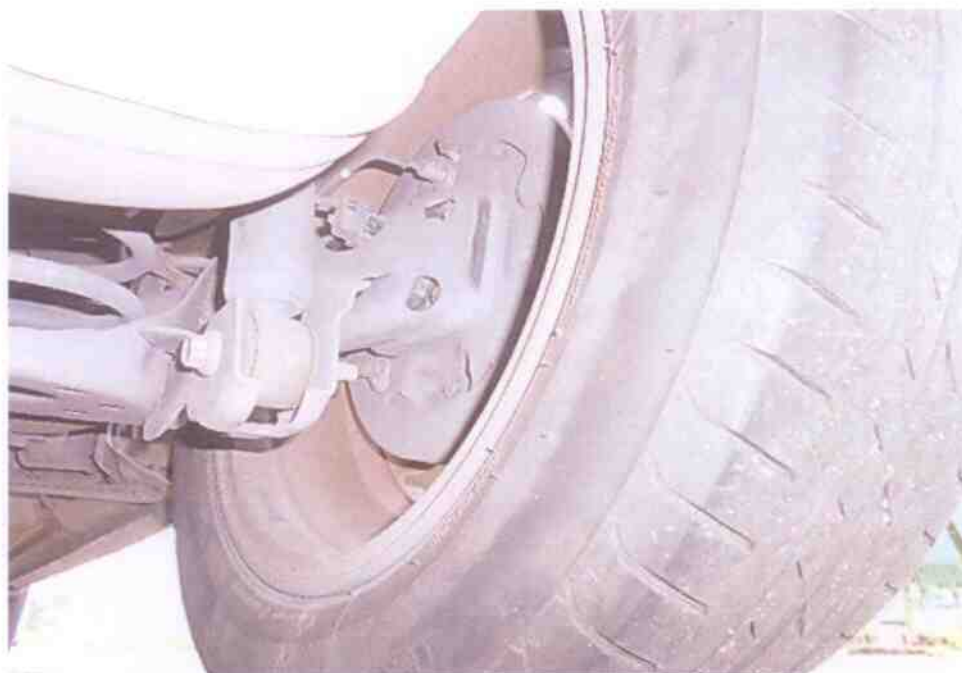
**Photo 21** shows the various undercarriage components at the rear right wheel of the Motor Car. We did not observe any leakage of brake fluid at the time of our inspection of the Motor Car. Our visual inspection of the various mechanical components of the Motor Car's braking system revealed all to be intact and without visible damage, indicating that the braking system was likely to be in serviceable condition at the material time of accident.

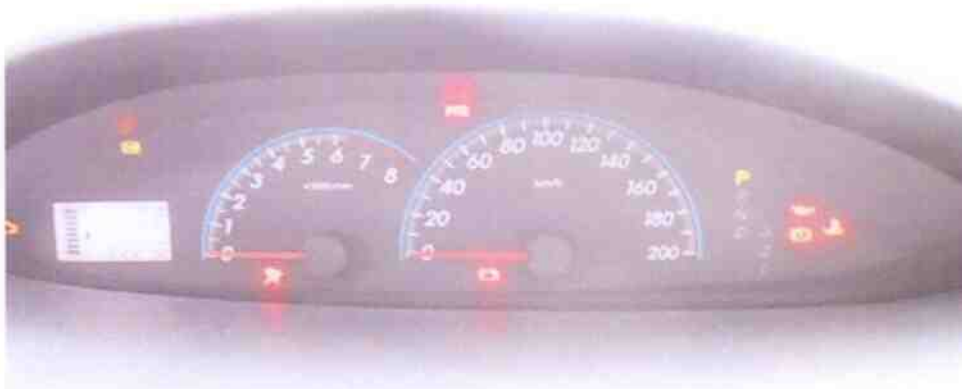
**Photo 22** shows the warning lights for the various electronic operating systems of the Motor Car appearing on its instrument panel during the self-test when the engine is cranked, in particular the ABS light and SRS light.

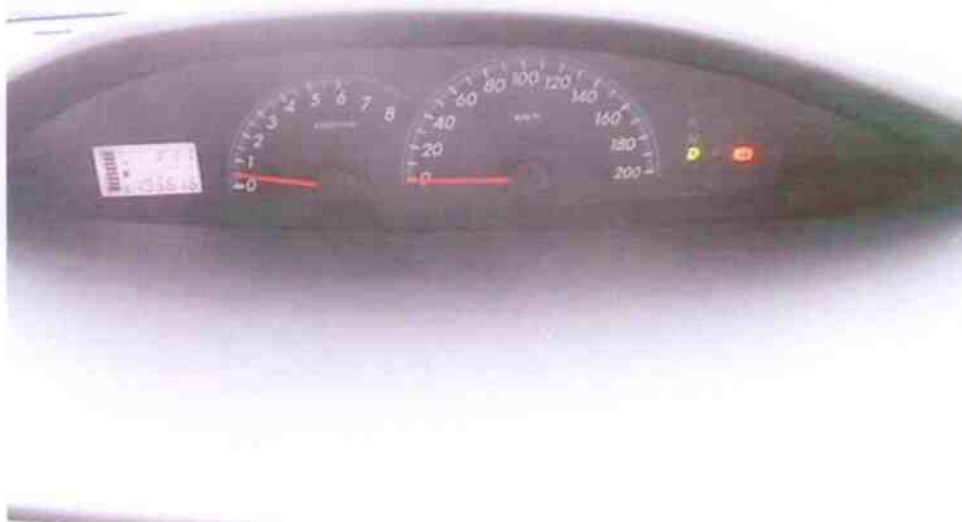
**Photo 23** shows no warning lights illuminated on the instrument panel of the Motor Car after the engine was cranked. This would suggest that there was no abnormality to the various electronic operating systems of the Motor Car, like the ABS and SRS.
