REF: CS3/MSG17023035/WNB-1

Affiliated to Federation Internationale Des Experts En Automobile			
MSIG INSURANCE (SINGAPORE) PTE LTD		Ref : CS3/MSG17023035/Wrb-1	
16 RAFFLES QUAY #24-01 HONG LEONG BLDG SINGAPORE 048581		Date : 01-02-2018	 
		Code : MSG

1. Policy Particulars :- THIRD PARTY CLAIM			
Insured Veh.	SLG 1431D	Veh. Inspected	SJW 5337G
Policy No.	29002101MCX	Coverage (\$)	0.00
Claim No.		Excess (\$)	0.00
Assign From	MERIMEN (LIONEL TAN)	Assign Date	01/02/2018

VEHICLE DAMAGE INSPECTION REPORT

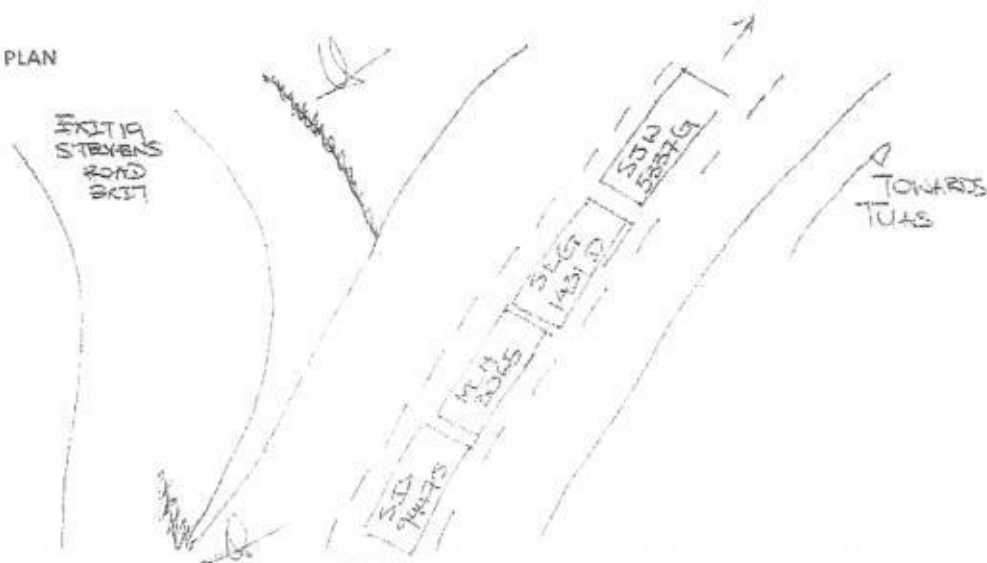
Sketch Plan #2 Pg. 1

DESCRIBE CIRCUMSTANCES OF THE ACCIDENT

I was driving along Rte towards Tux on the middle of 2 lanes, after Stephens Road Exit. When the car ^{in front} of me, SJS 5337 G, suddenly jammed brake, I followed suite, and managed to brake in time but the car behind me, MCN 3065 did not stop in time and collided with my vehicle (SLG 1431 D) which caused my vehicle to surge forward, leading to my car, colliding with SJS 5337 G. The car, SJS 9447 S that was behind MCN 3065 had collided with MCN 3065 causing MCN 3065 to hit us a 2nd time.
