Your Ref: TP/IP/64573/2017  
Our Ref : CI/TPD18002088/Z

**Fatal Accident Investigation Team**  
Traffic Police Department  
Singapore Police Force  
10 Ubi Avenue 3  
Singapore 408865

**INSPECTION REPORT OF ELECTRIC SCOOTER - TRAFFIC POLICE POUND  
REPORT NO. 4996/17**

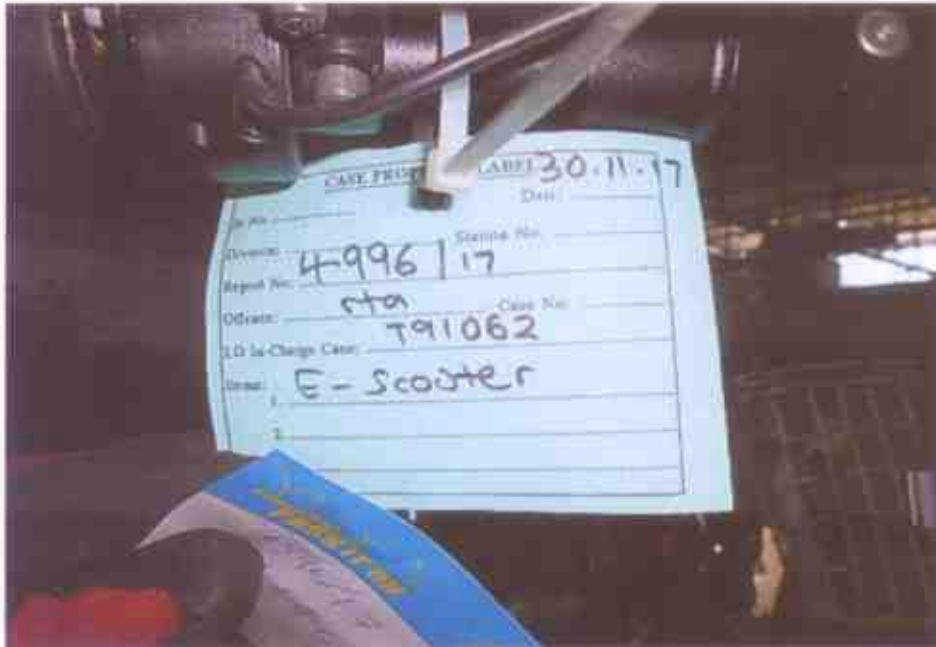
Photo 1 shows the identification of the Electric Scooter with reference to Traffic Police Pound Report No. 4996/17.

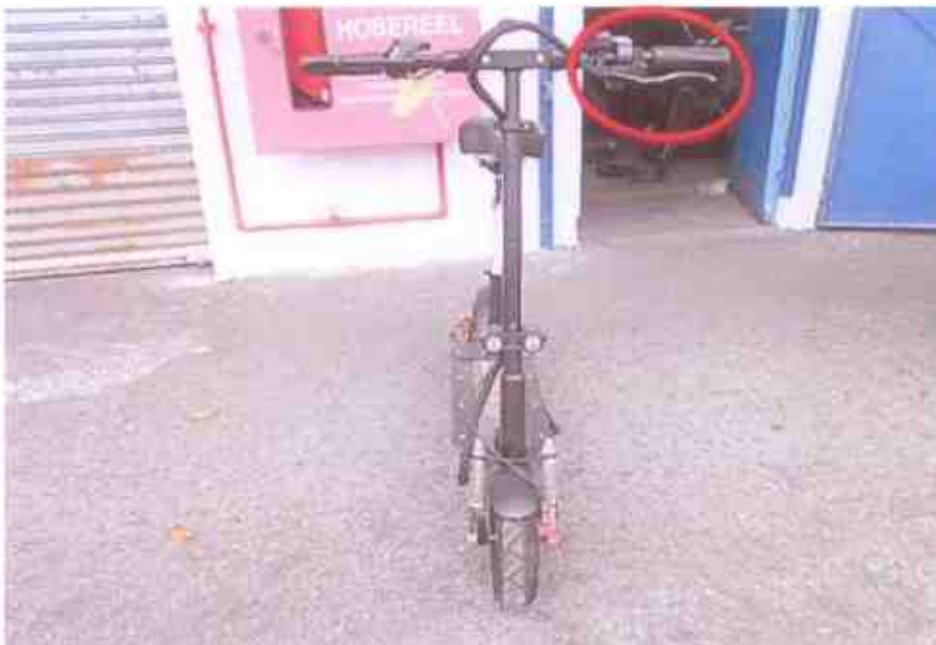
4. The Electric Scooter was observed to have sustained minor damages at the left portion. The body parts that were found to have been damaged include its left hand handle, left hand portion of the seat & left hand brake lever amongst others as a result of the accident. See photo 1 to 7 below.

Photo 2 shows the frontal portion of the Electric Scooter at time of inspection. Damage on the left hand handle, left hand portion of the seat & right hand brake lever was observed likely due to the accident.

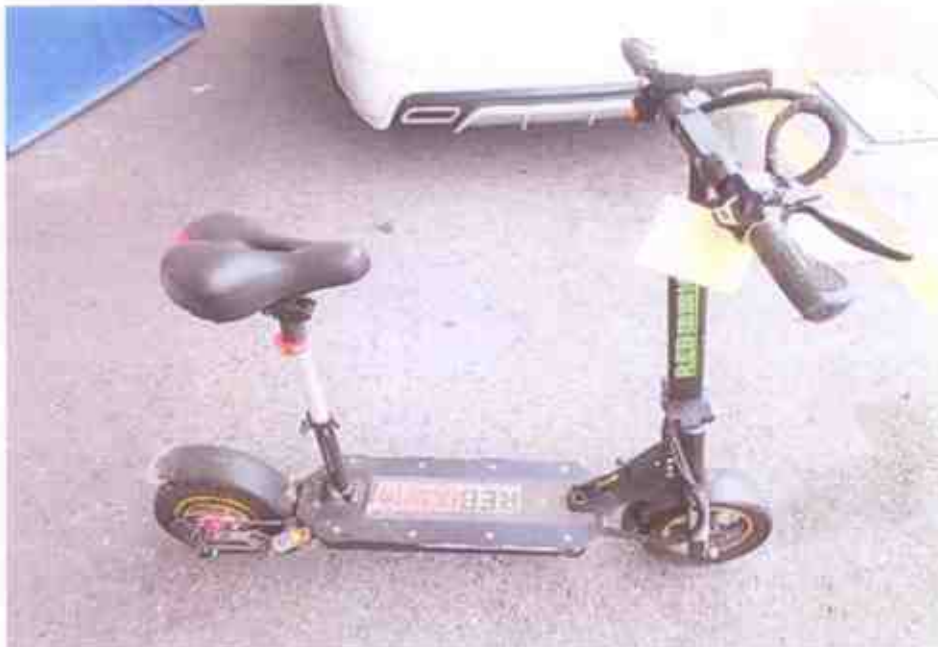
**Photo 3** shows the right portion of the Electric Scooter at time of inspection. It was observed to be in good condition.

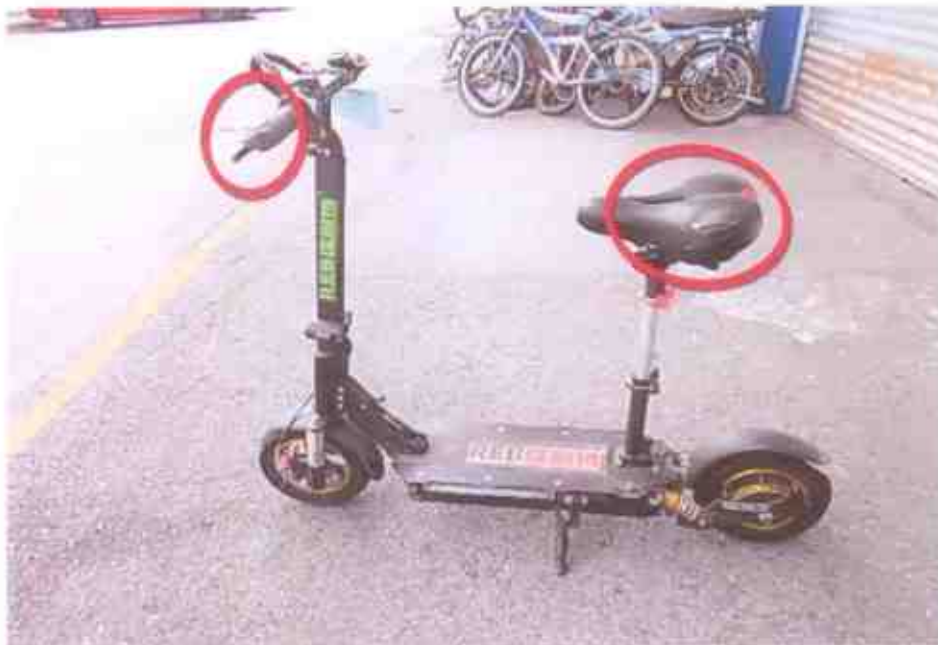
**Photo 4** shows the left portion of the Electric Scooter at time of inspection. Damage on the left hand handle, left hand portion of the seat & right hand brake lever was observed likely due to the accident.

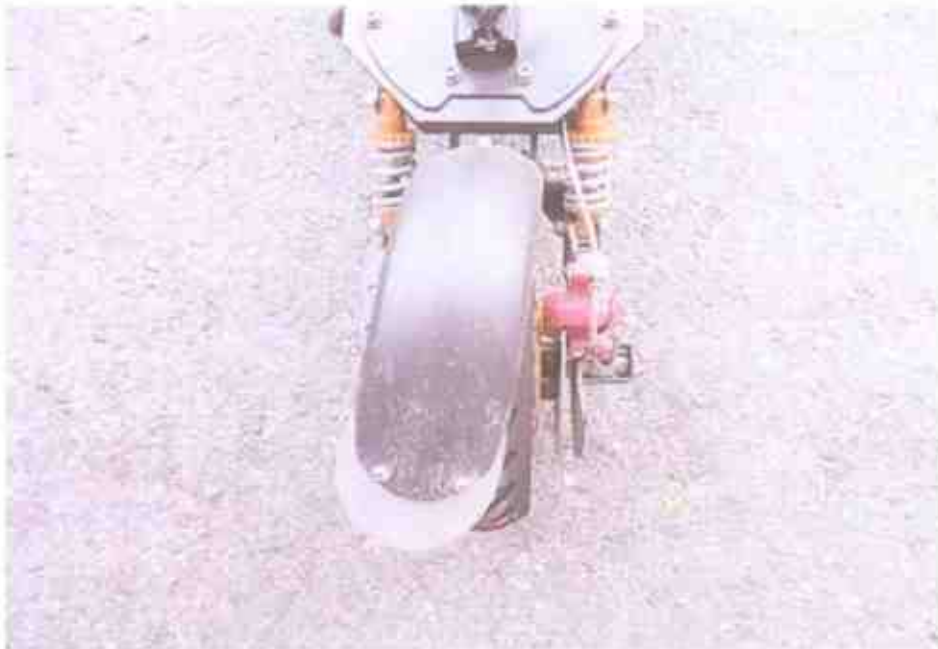
**Photo 5** shows the rear portion of the Electric Scooter at time of inspection. It was observed to be in good condition.

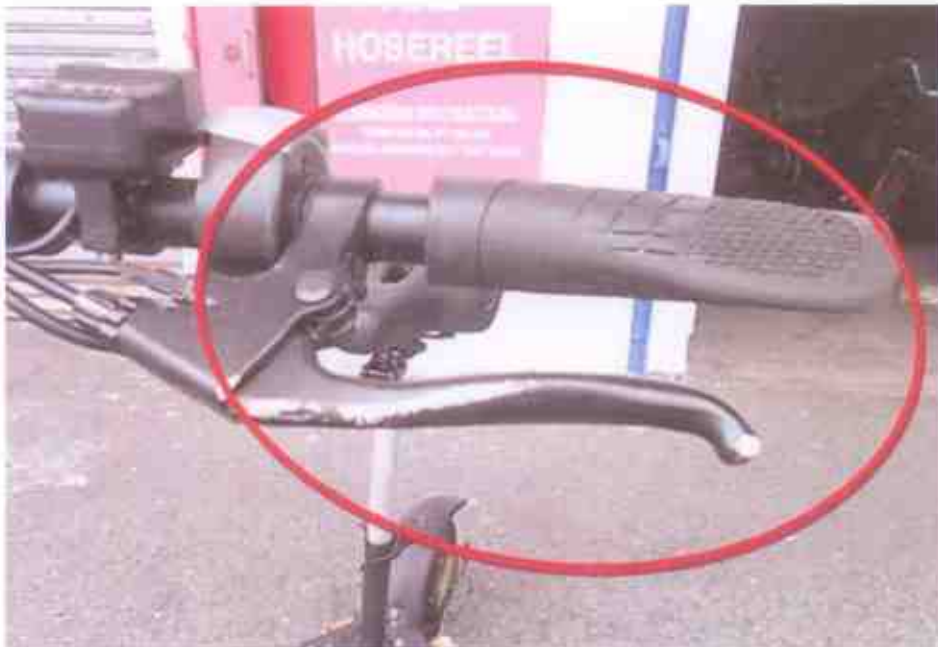
**Photo 6** shows the left portion of the Electric Scooter at time of inspection. Damage on the left hand handle & brake lever was observed likely due to the accident.

10. Further examination revealed that the left hand brake lever for rear brake was observed to be bent; it was also found to be stuck likely due to the accidents impact.
11. A static brake test was conducted only on the Electric Scooter's front brake. The test was conducted by lifting the rear tyre above ground & applies a little spinning action to it. The right hand brake lever was then gripped in order to stop the spinning rear tyre. The result was satisfactory. It stopped after gripping the right hand brake to the fullest. It shows that the front brake calliper was responding to the gripping action. This had appeared to indicate that the front brake was in a serviceable condition. See photo 11 & 12 below.

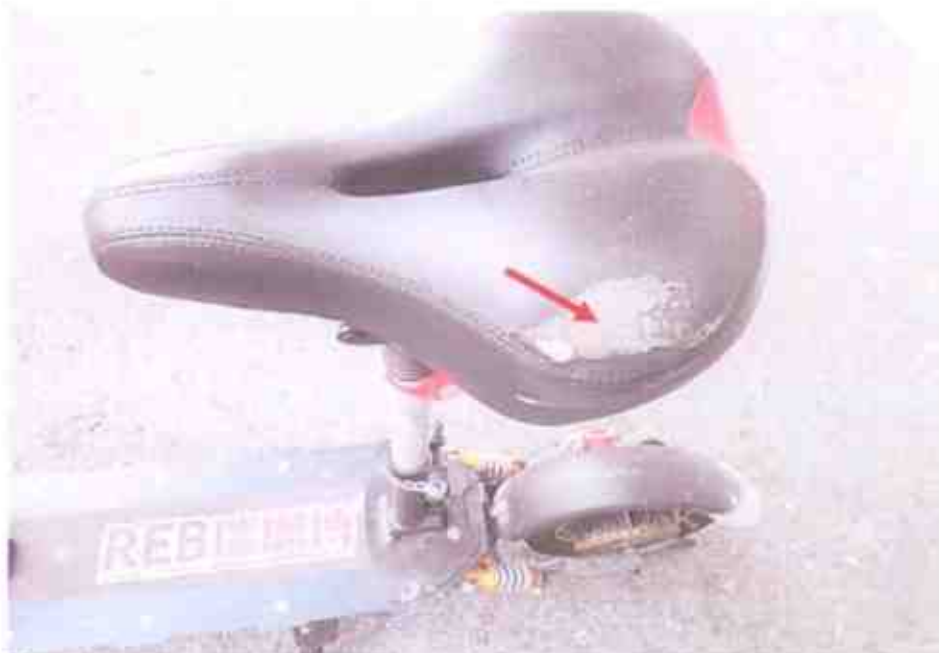
Photo 7 shows the seat of the Electric Scooter at time of inspection. Damage on the right portion of the seat was observed likely due to the accident.

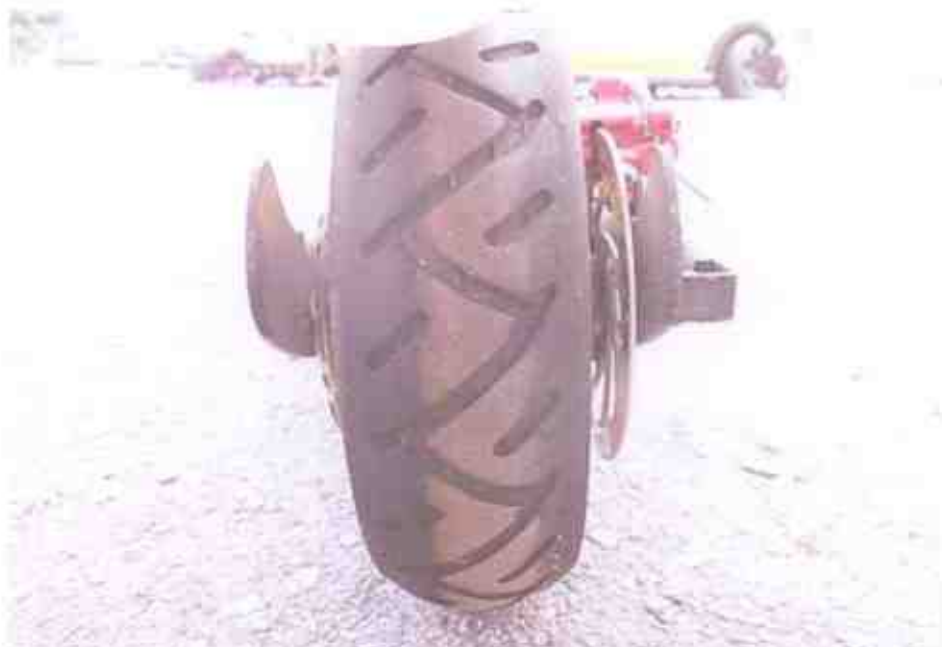
6. The tyres were wrapped around alloy wheel rim that was found to be without any significant damage. See photo 8 & 9 below

**Photo 8** shows the rear tyre of the Electric Scooter at the time of our inspection. The tread pattern of the 2 tyres was clearly visible. We did not observe any tear, burst mark(s) and/or punctured hole(s) on the sidewalls.

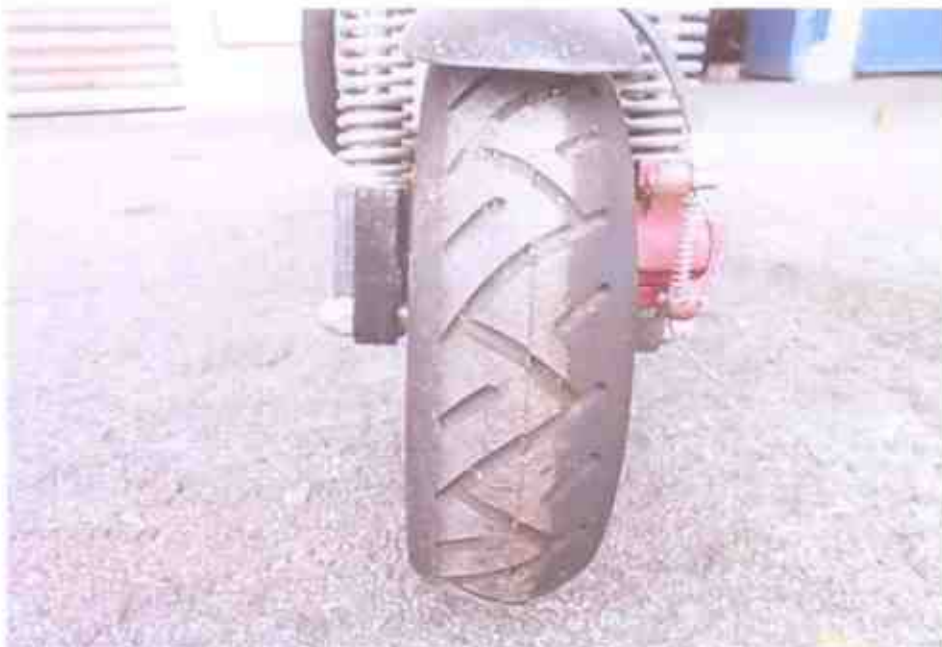
**Photo 9** shows the front tyre of the Electric Scooter at the time of our inspection. The tread pattern of the 2 tyres was clearly visible. We did not observe any tear, burst mark(s) and/or punctured hole(s) on the sidewalls.

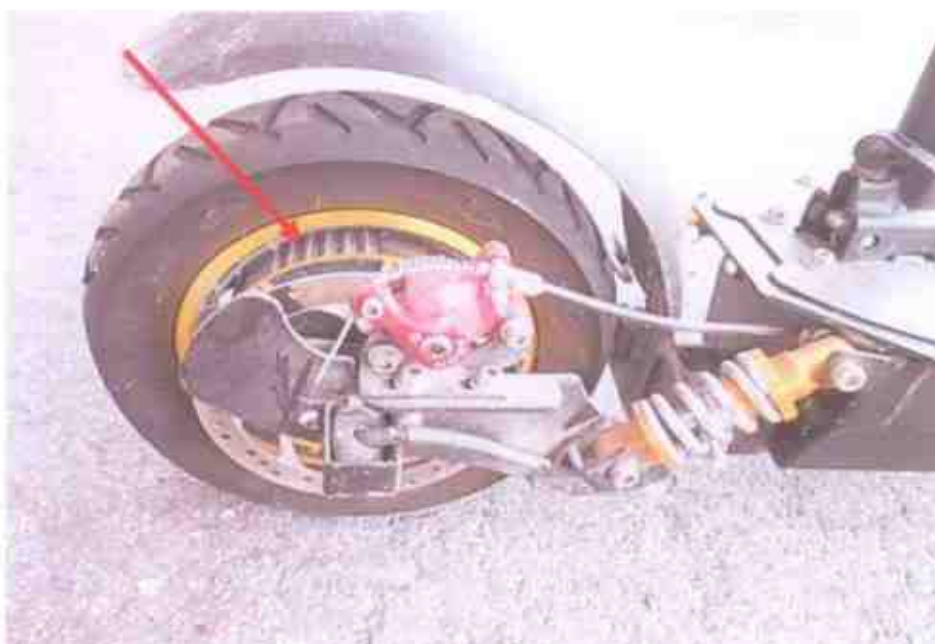
7. The Electric Scooter was controlled by a motor to drive the rear tyre. The motor was originally installed on the rear portion at the rear tyre & found adequately acceptable. The motor of the Electric Scooter was found to be intact without any misalignment or damages. It was also observed to be in operational condition. See photo 10 below.

Photo 10 shows the general view of the drive motor (arrowed) of the Electric Scooter, which was observed to be intact with no misalignment.

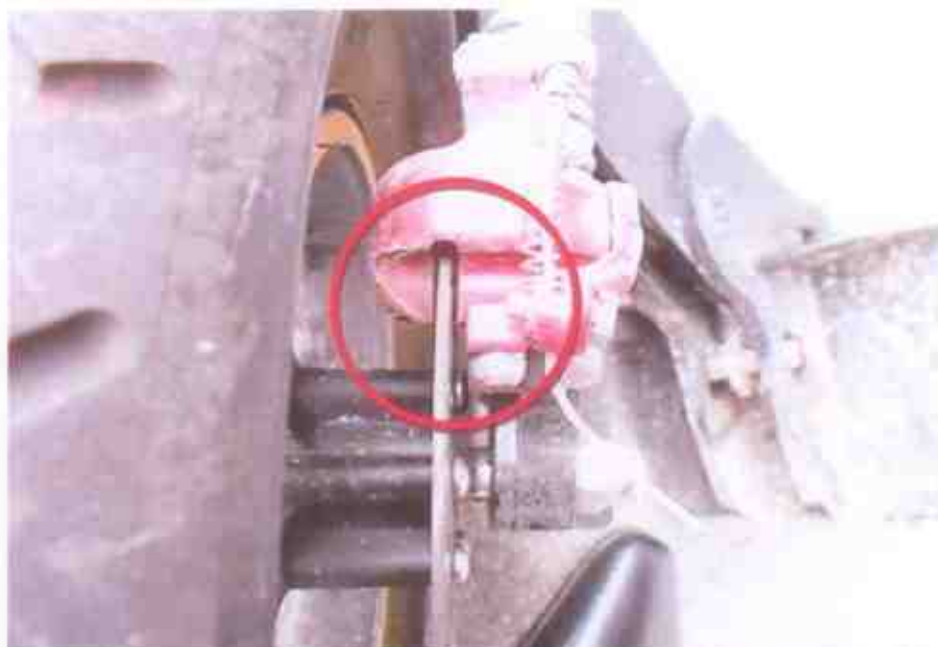
**Photo 11** shows the close-up view of the front brake calliper (circled) of the Electric Scooter, which was observed to be intact with no damages.

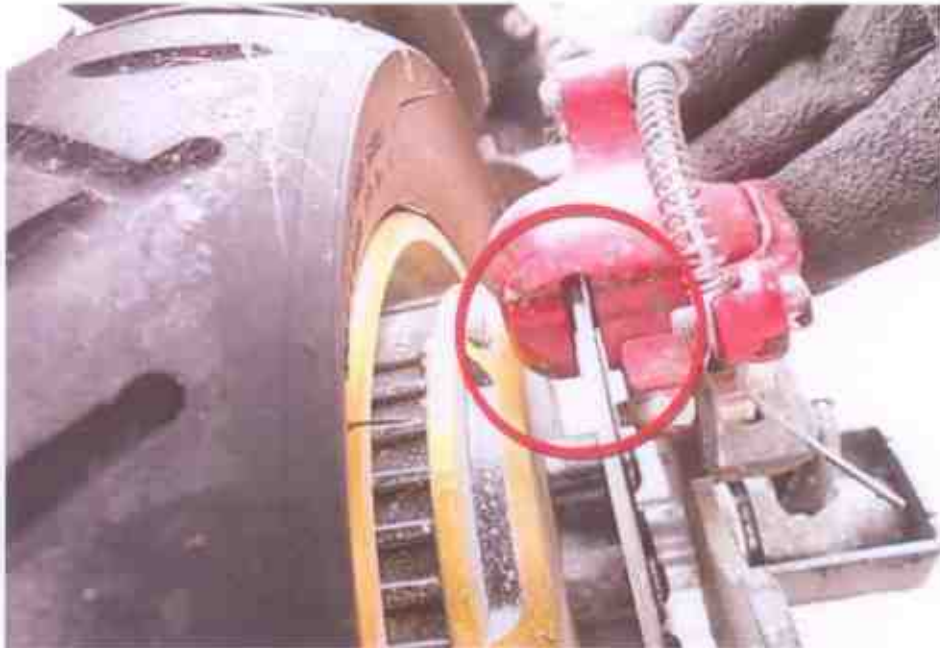
**Photo 12** shows the close-up view of the rear brake calliper (circled) of the Electric Scooter, which was observed to be intact with no damages.

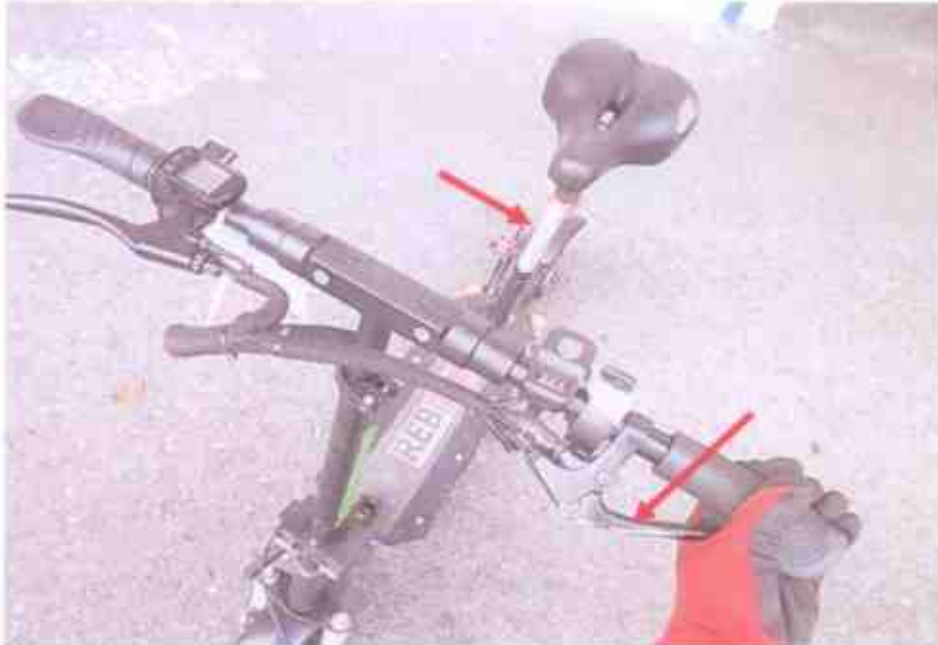
**Photo 13** shows a static brake test was conducted only on the Bicycle's rear brake. The test was conducted by lifting the rear tyre above ground & applies a little spinning action to it. The hand brake lever was then gripped in order to stop the spinning front tyre. The result was unsatisfactory. It didn't stop after gripping the left hand brake to the fullest. It shows that the rear brake clamps was not responding to the gripping action. This had appeared to indicate that the rear brake was not in a serviceable condition.

13. At the time of our inspection of the Electric Scooter, its rear brake could not be tested (due to damages as a result of the accident). Its front brake was however found to be in serviceable condition based on the static brake test conducted at time of inspection.

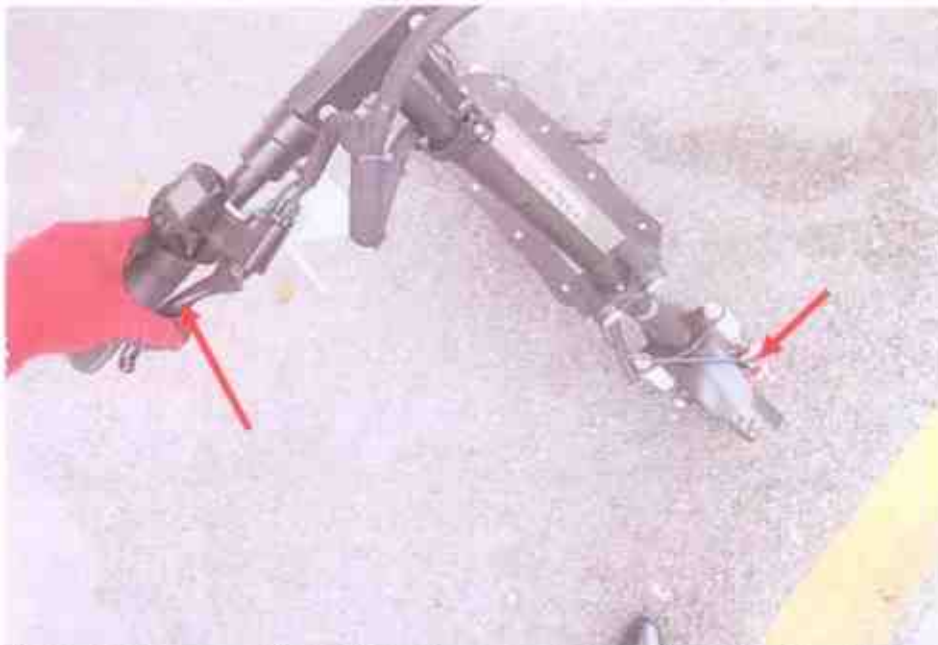
**Photo 14** shows a static brake test was conducted only on the Bicycle's front brake. The test was conducted by lifting the front tyre in the air & applies a little spinning action to it. The hand brake lever was then gripped in order to stop the spinning front tyre. The result was satisfactory. It stops after gripping the hand brake to the fullest.
