Your Ref: TP/IP/64573/2017
Our Ref : CI/TPD18002091/Z

06th February 2018

MECHANICAL INSPECTION REPORT OF MOTOR BUS SBS 7559K

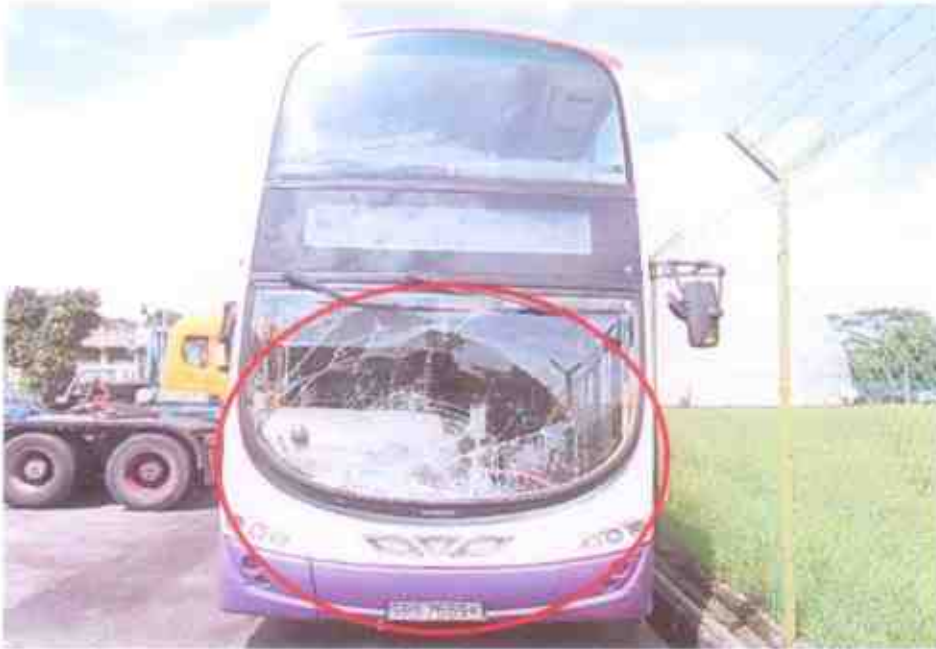
4. The mileage of the Motor Bus at the time of our inspection was not recorded due to a flat battery.
5. The Motor Bus was observed to have sustained relatively minor impact damage at its front body. Its front windshield was observed to be cracked; its front undercarriage re-enforcement structure bar, windshield garnish, lower bumper & number plate was observed to have sustained minor scratches.
6. The damages were consistent with the accidents case fact that the Motor Bus collided with an E-Scooter & the rider onto its frontal portion hence sustained with such damages mentioned above. See photo 1 to 9 below.

Photo 1 shows a general view of the front body of the Motor Bus at the time of our inspection. The Motor Bus was observed to have sustained relatively minor damage at its front body. Its windshield was observed to be cracked.

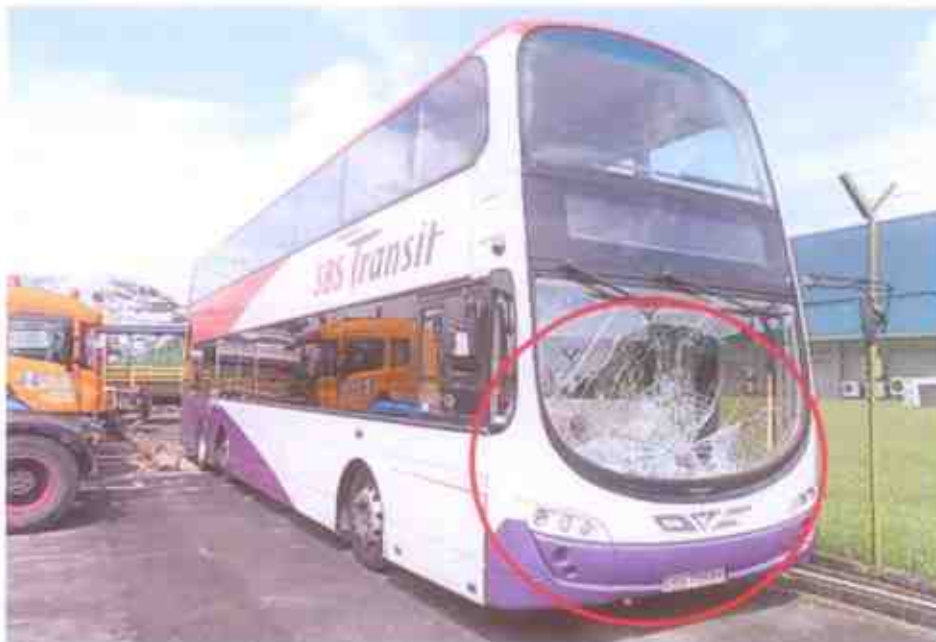
Photo 2 shows a general view of the front right body of the Motor Bus at the time of our inspection. The Motor Bus was observed to have sustained relatively minor damage at its front body. Its windshield was observed to be cracked.

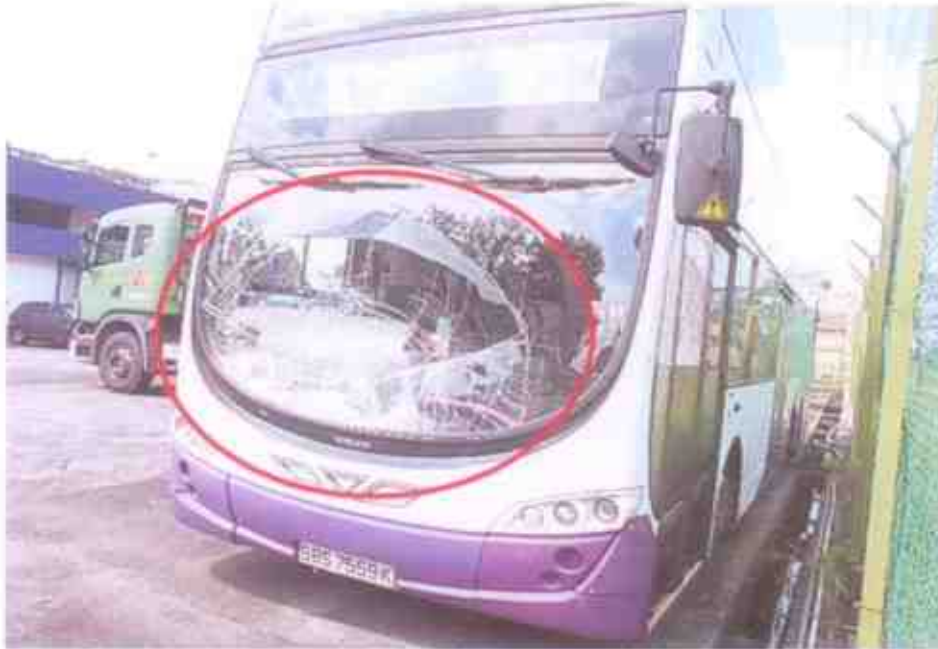
Photo 3 shows a general view of the front left body of the Motor Bus at the time of our inspection. The Motor Bus was observed to have sustained relatively minor damage at its front body. Its windshield was observed to be cracked.

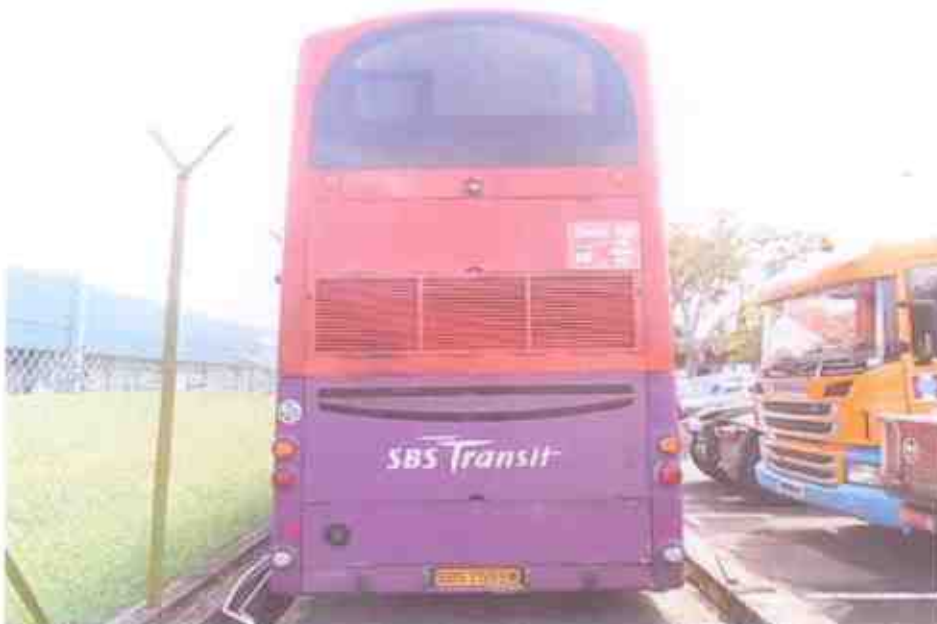
Photo 4 shows a general view of the Motor Bus's rear left body at the time of our inspection. There was no impact damage found at the rear portion of the Motor Bus.

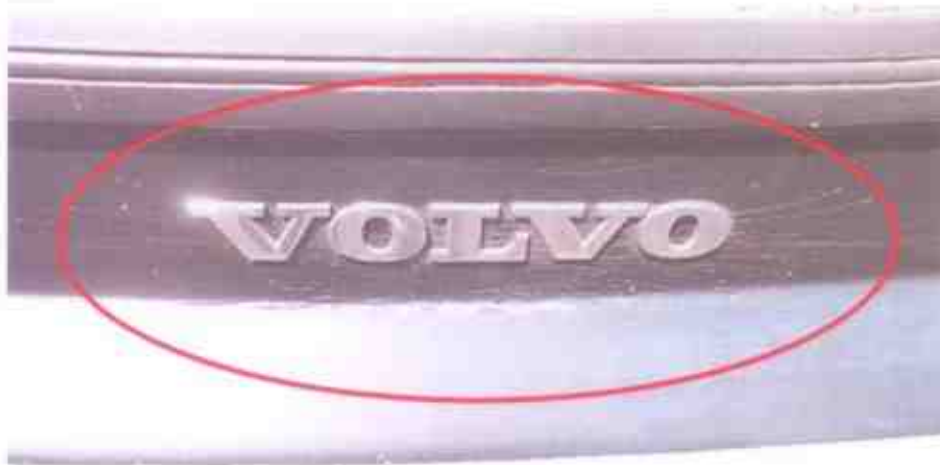
Photo 5 shows a close-up view of the Motor Bus's around the emblem's area. It was observed to have sustained minor deformation likely due to the accident's impact.

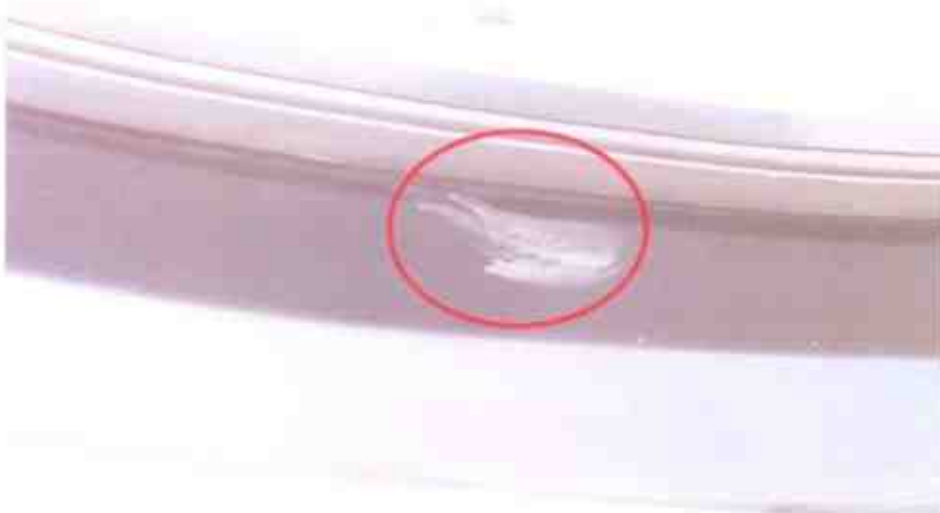
Photo 6 shows a close-up view of the Motor Bus's windshield garnish. It was observed to have sustained minor scratches likely due to the accident's impact.

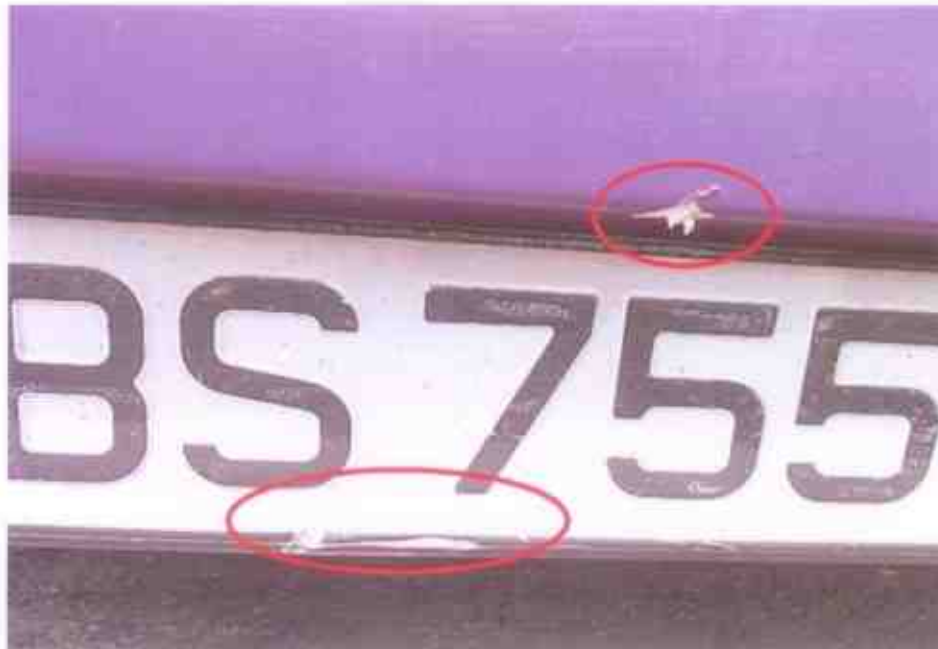
Photo 7 shows a close-up view of the Motor Bus's number plate area. It was observed to have sustained with minor scratches likely due to the accident's impact.

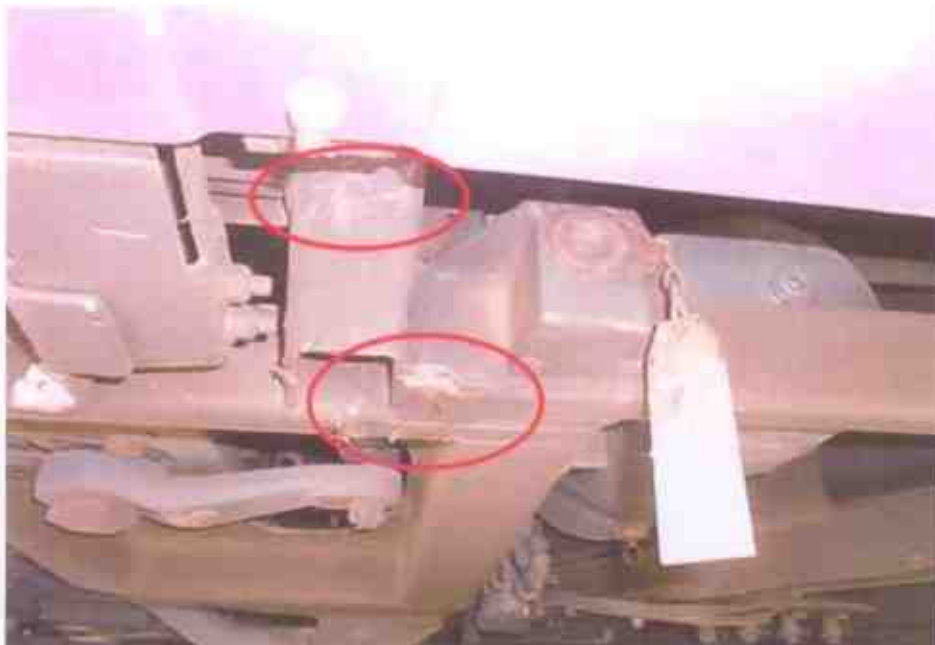
Photo 8 shows a close-up view of the Motor Bus's front undercarriage area. It was observed to have sustained with minor scratches likely due to the accident's impact.

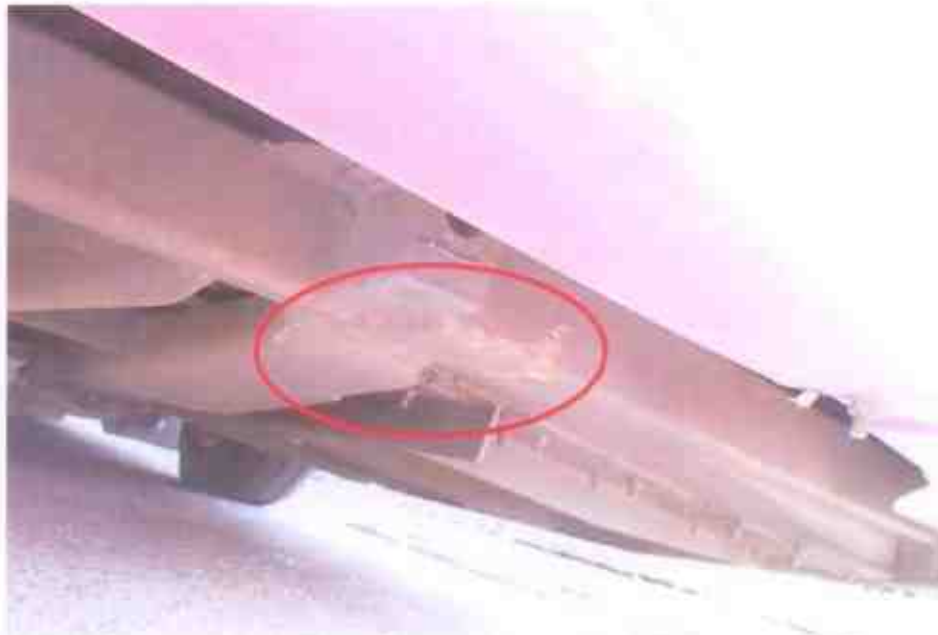
Photo 9 shows a close-up view of the Motor Bus's front undercarriage area. It was observed to have sustained with minor scratches likely due to the accident's impact

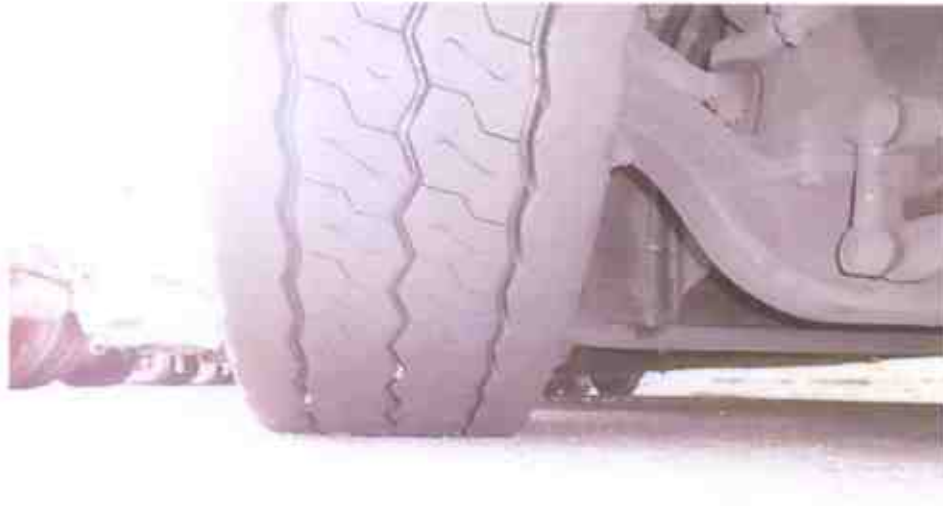
Photo 10 shows the condition of the front right tyre of the Motor Bus, which was observed to be in serviceable condition with remaining tread depth of approximately 12mm.

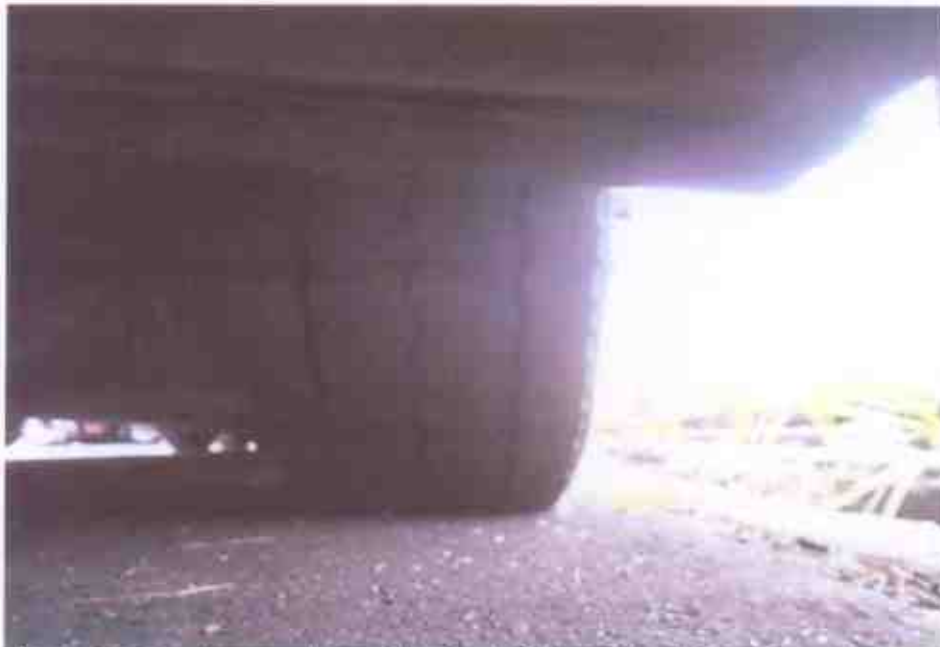
Photo 11 shows the condition of the front left tyre of the Motor Bus, which was observed to be in serviceable condition with remaining tread depth of approximately 10mm.

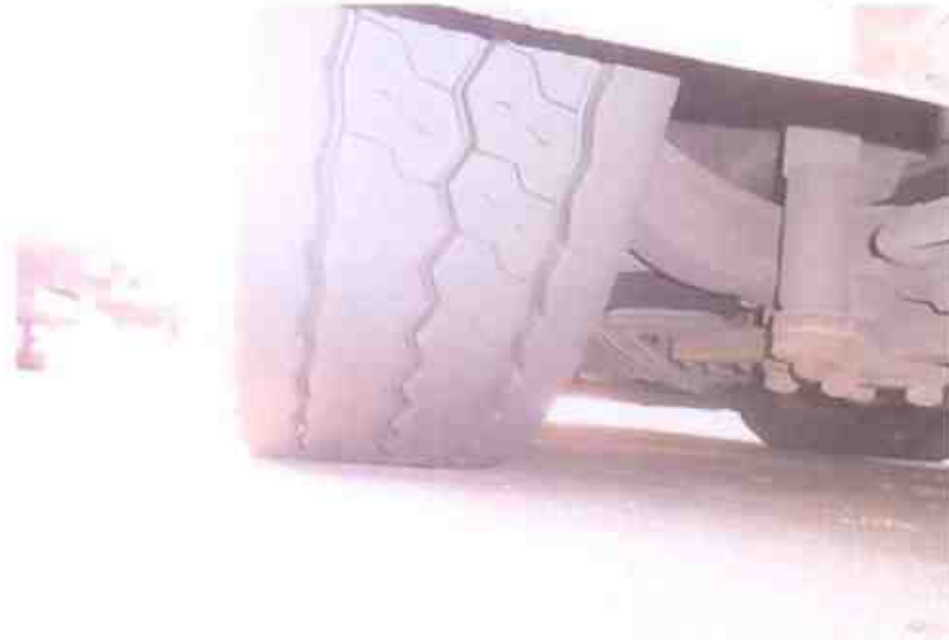
Photo 12 shows the condition of the rear right tyres (centre axle) of the Motor Bus, which were observed to be in serviceable condition with remaining tread depth of approximately 13mm.

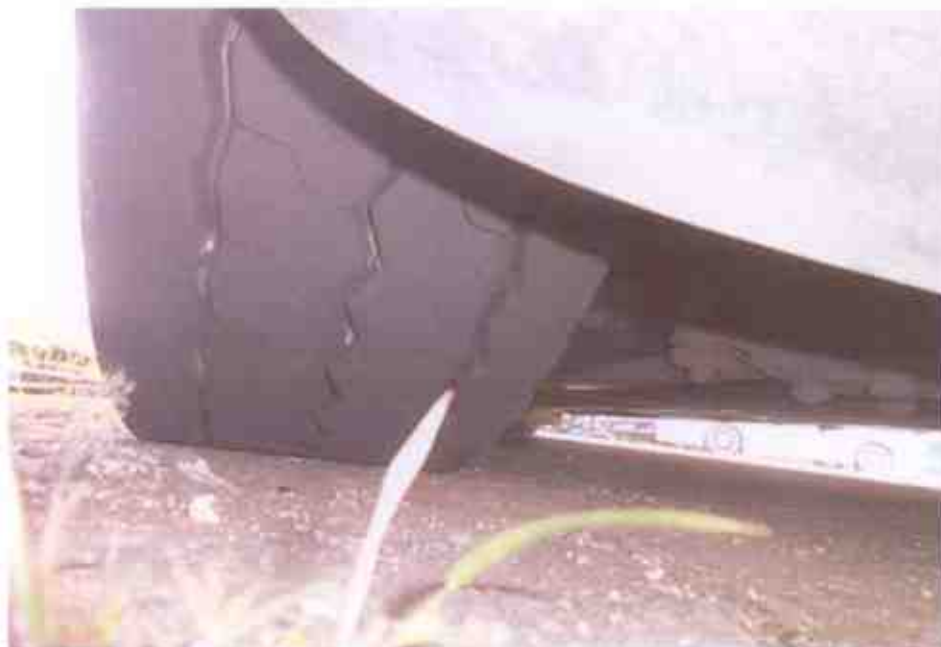
Photo 13 shows the condition of the rear left tyres (centre axle) of the Motor Bus, which were observed to be in serviceable condition with remaining tread depth of approximately 10mm. The tyres, which were wrapped around standard alloy wheel rims, were also observed to be sufficiently inflated for vehicular operation.

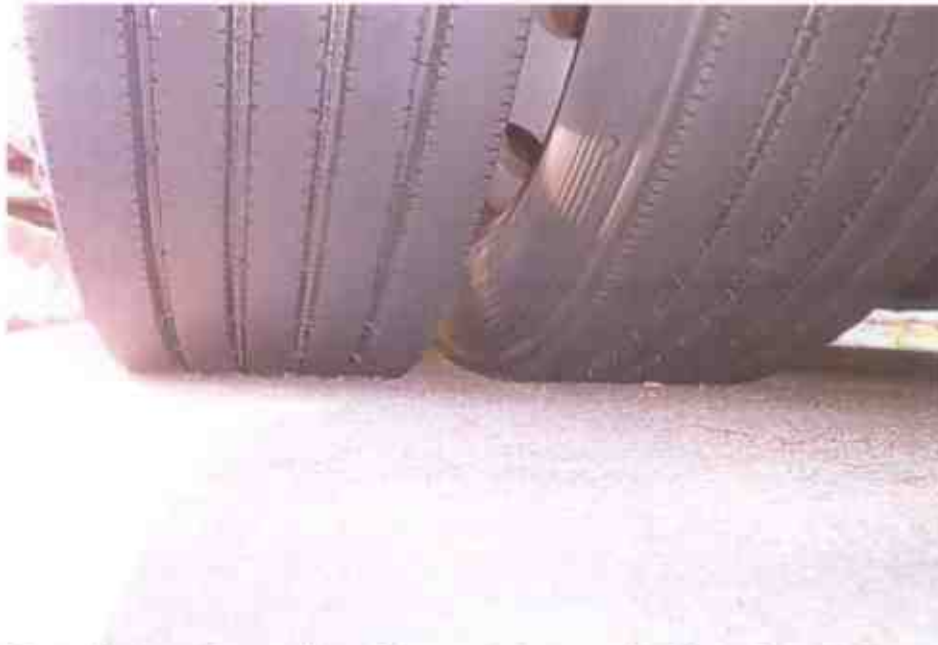
Photo 14 shows the condition of the rear right tyres of the Motor Bus, which were observed to be in serviceable condition with remaining tread depth of approximately 11mm. The tyres, which were wrapped around standard alloy wheels rims, were also observed to be sufficiently inflated for vehicular operation.

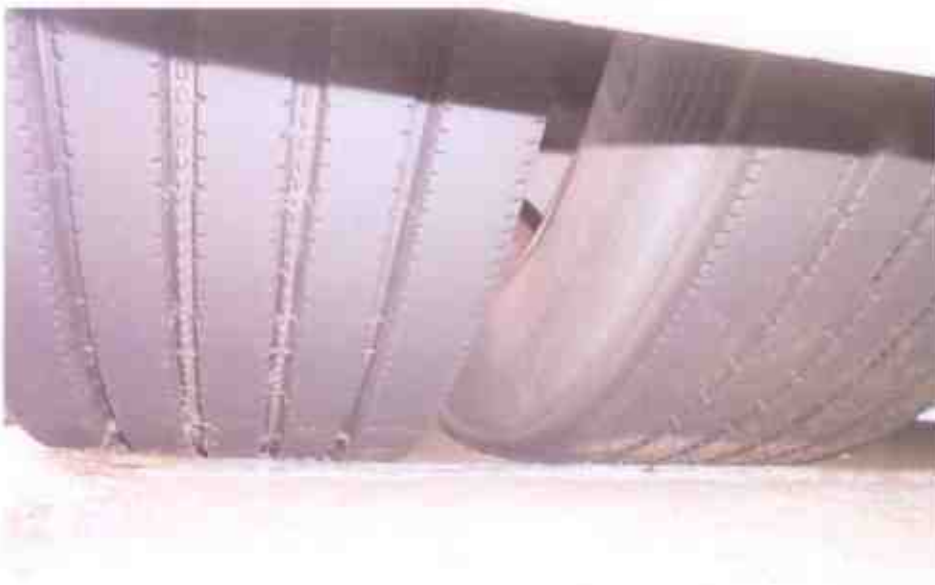
Photo 15 shows the condition of the rear left tyres (centre axle) of the Motor Bus, which were observed to be in serviceable condition with remaining tread depth of approximately 12mm. The tyres, which were wrapped around standard alloy wheel rims, were also observed to be sufficiently inflated for vehicular operation.

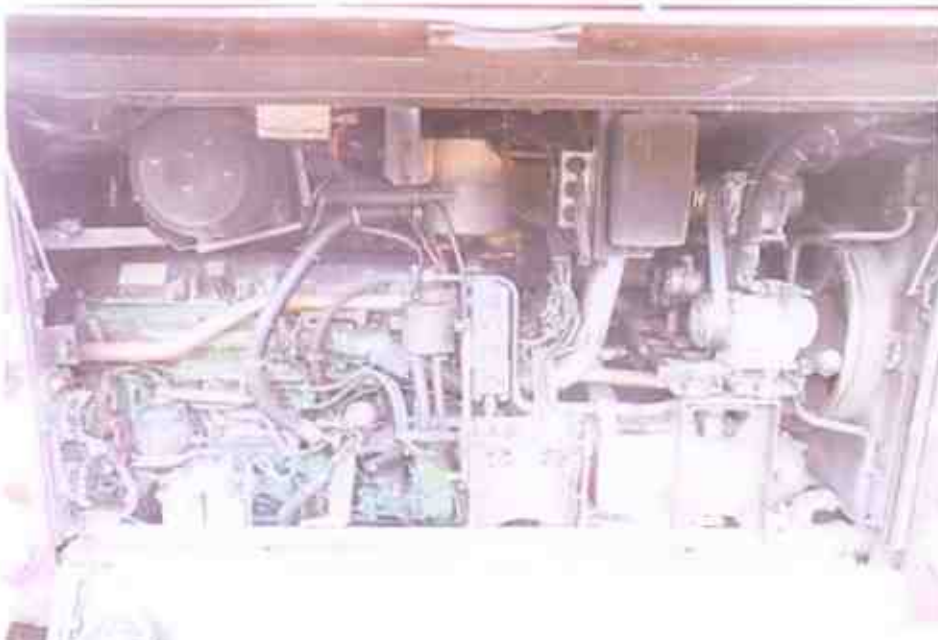
Photo 16 shows the engine compartment of the Motor Bus was located at the rear of the Motor Bus.

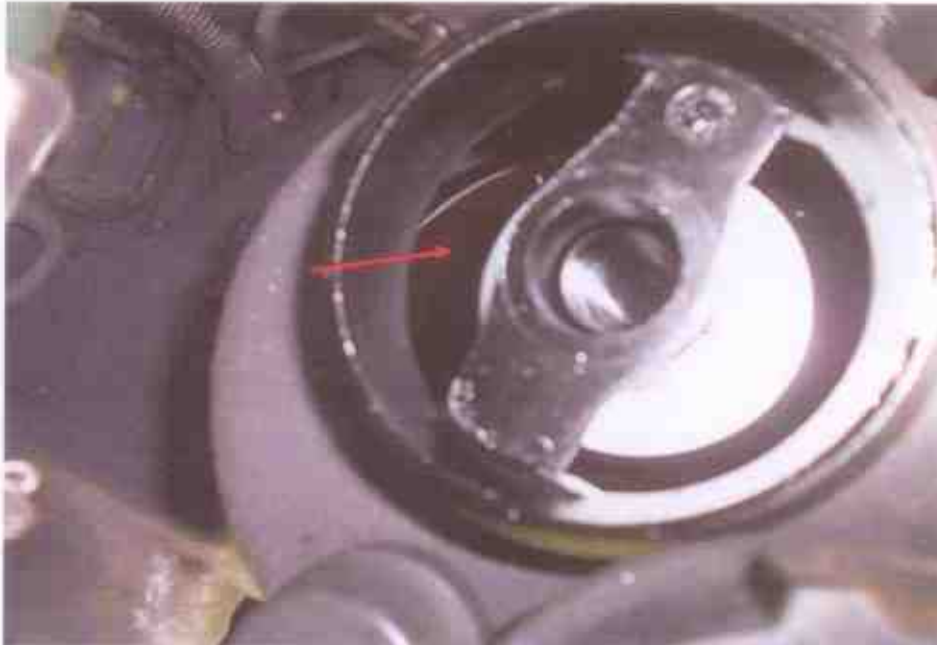
Photo 17 shows the steering fluid of the Motor Bus. It was observed to be of sufficient level without any contamination at time of our inspection.

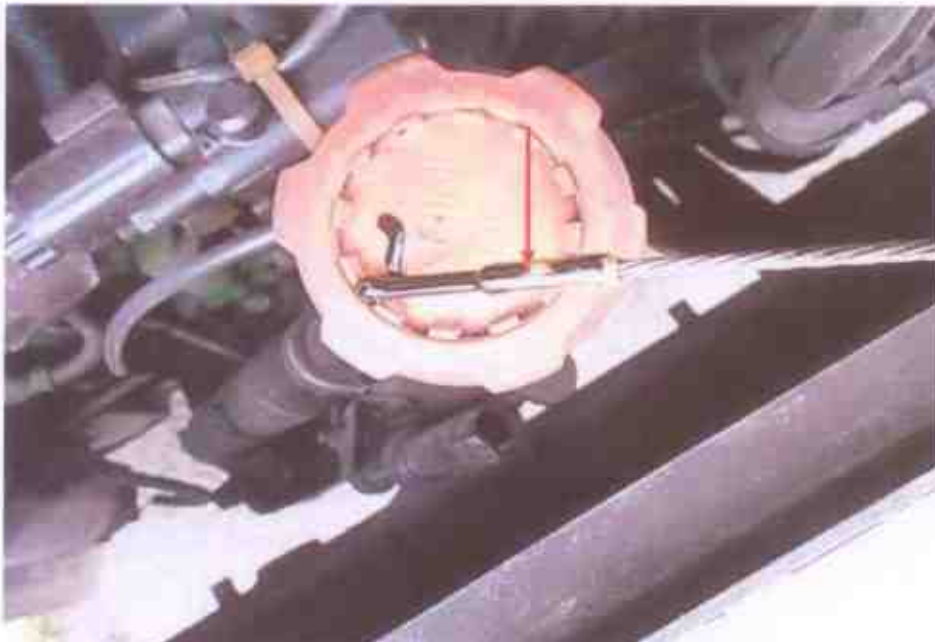
Photo 18 shows the engine fluid of the Motor Bus. It was observed to be of sufficient level without any contamination at time of our inspection.

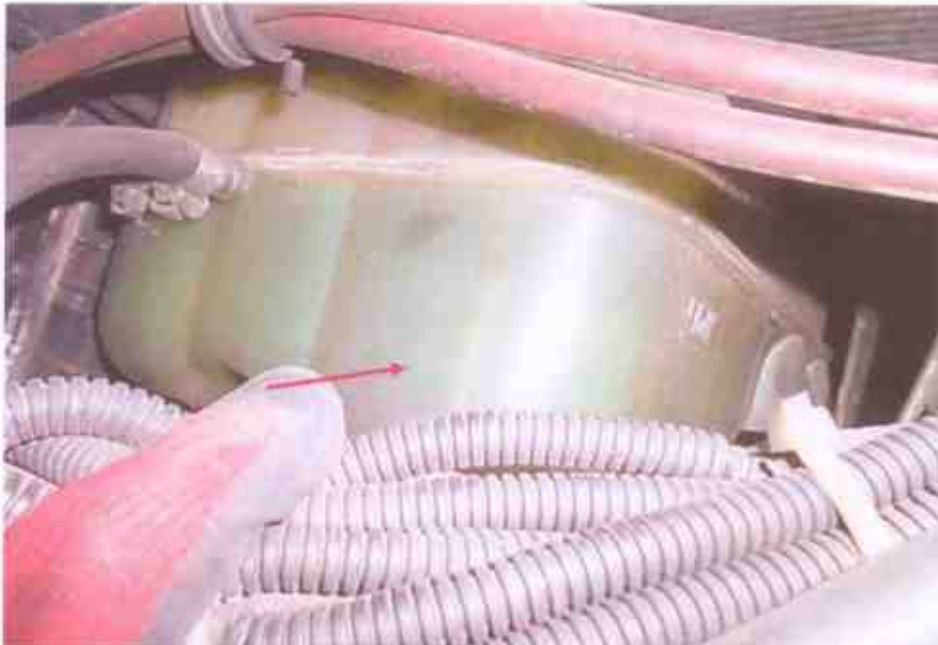
Photo 19 shows the engine coolant of the Motor Bus. It was observed to be of sufficient level without any contamination at time of our inspection.

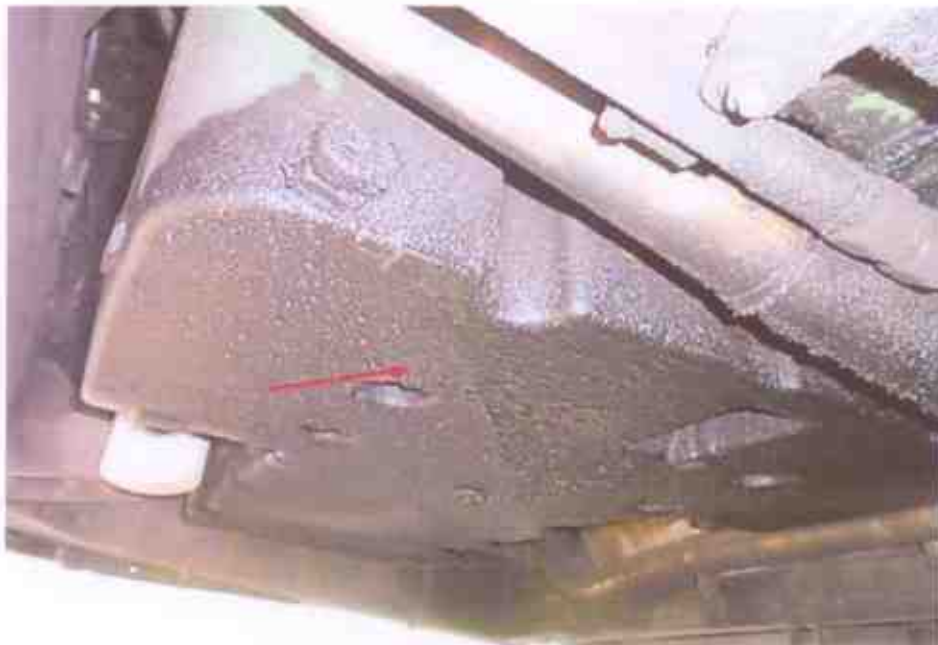
11. Our subsequent checks on the underside of the Motor Bus reveals some fluid stain sighted under the engine compartment. Further investigation found that the fluid stain was a pre-existed prior the accident & not a fresh fluid. This was due to some dirt observed associated with the fluid stain. Conclusively, it is not likely to be related to the accident. Visually, the various undercarriage components of the Motor Bus were observed to be intact and without any visible damage except for the damages caused by the accident. See photo 16 – 20 below.

Photo 20 shows the engine underside of the Motor Bus. It was observed to be sighted with fluid leakage. However it was noted to be a pre-existed fluid leakage due to the dust stain that associated with it.

21. Although our subsequent checks on the underside of the Motor Bus reveals that some fluid stain sighted under the engine compartment. Further investigation found that the fluid stain was a pre-existed prior the accident & not a fresh fluid. This was due to some dirt observed associated with the fluid stain. Conclusively, it is not likely to be related to the accident. Visually, the various undercarriage components of the Motor Bus were observed to be intact and without any visible damage except for the damages caused by the accident

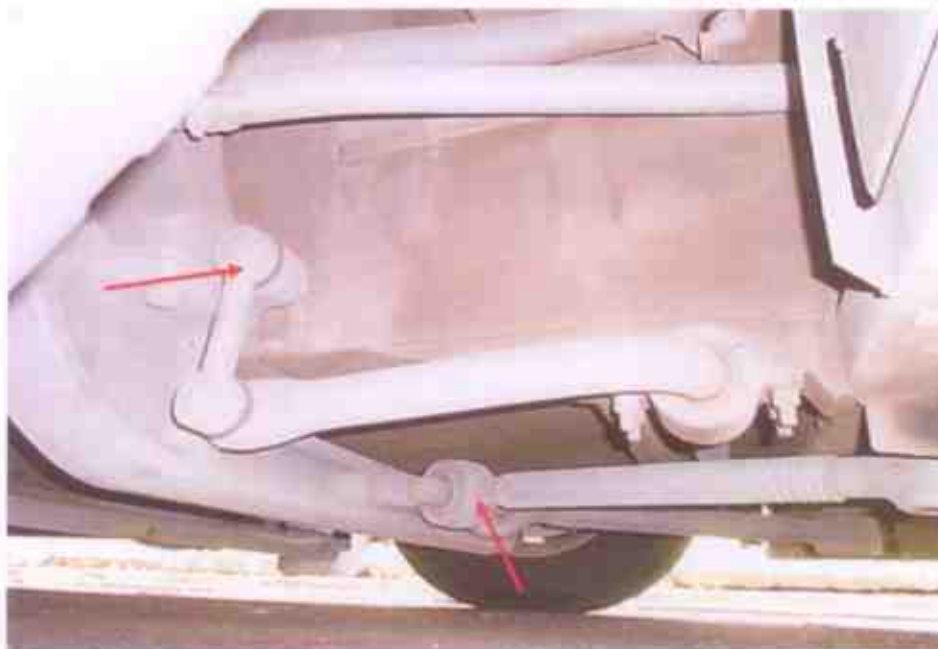
Photo 21 shows some of the mechanical components (arrowed) of the Motor Bus's steering system. Our visual checks on the various mechanical components of the steering system revealed all to be intact and in good condition. The steering system of the Motor Bus is hence likely to be in serviceable condition at the time of accident.

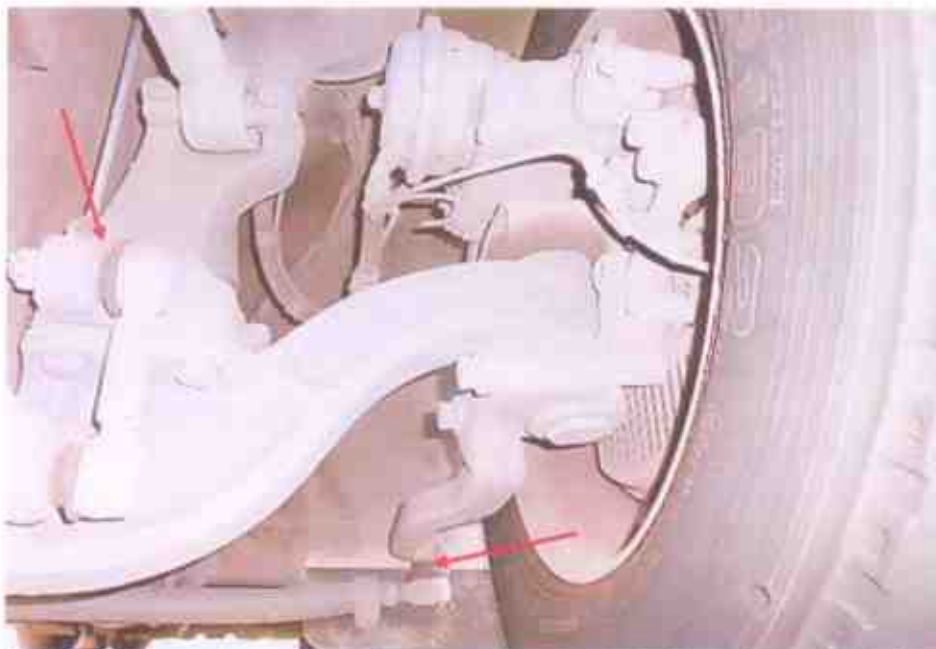
Photo 22 shows the undercarriage components at the front right wheel of the Motor Bus. The various undercarriage components of the Motor Bus were all observed to be intact and without any visible damage. This had included the steering rack and steering ball joints (arrowed) of the Motor Bus.

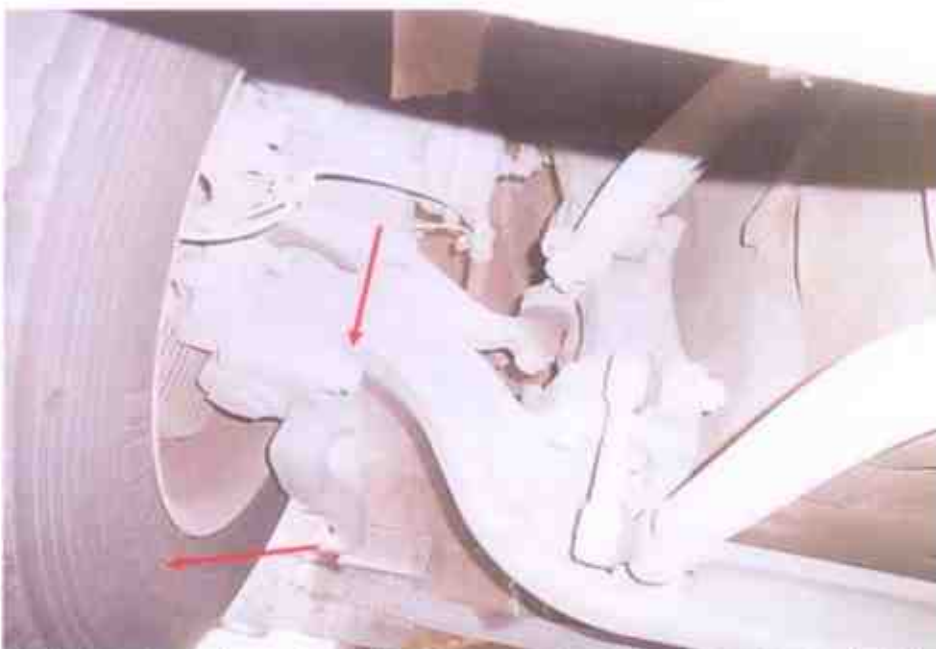
Photo 23 shows the undercarriage components at the front left wheel of the Motor Bus. The various undercarriage components of the Motor Bus were all observed to be intact and without any visible damage. This had included the steering rack and steering ball joints (arrowed) of the Motor Bus, which were observed to be securely attached to the front left wheel and front right wheel.

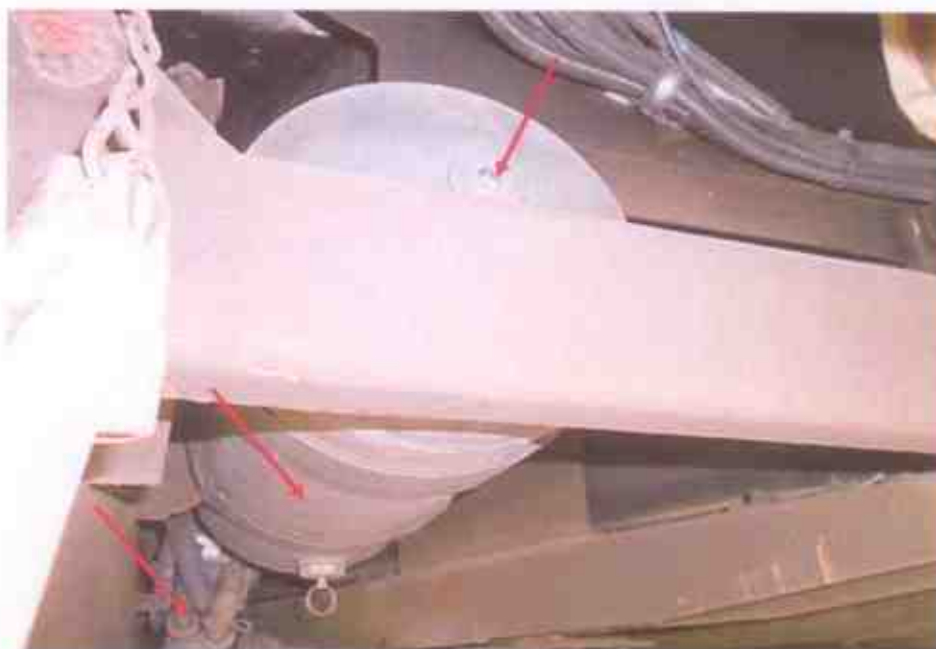
15. Since the engine of the Motor Bus could not be started, we were hence not able to carry out test(s) on whether there was any leakage of compressed air that could have affected the braking efficiency of the Motor Bus. However the air pipes, air tanks and connecting valves had all appear to be in good general condition and securely fitted upon our visual examination of these parts.

16. In general, our visual inspection of the mechanical components of the Motor Bus's braking system appear to suggest that its braking system was in serviceable condition at the material time of accident. See photo 24 below.

Photo 24 shows a general view of the air tank, valves, pipes and hoses, which are some of the components for the air-assisted braking system of the Motor Bus. This was at the underside of the Motor Bus's front right body. We were however not able to carry out any operational test(s) to the braking system of the Motor Bus as its engine was unable to be started.

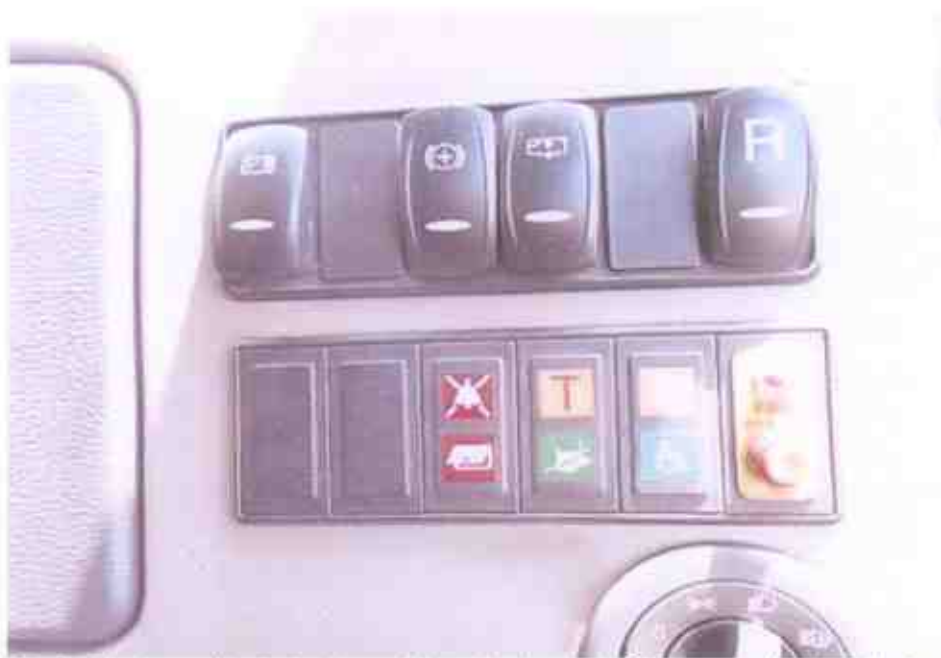
Photo 25 shows the indicators at the driver's seat. Other operational indicators were unable to be initialized due to the flat battery. Hence, no test was carried out to the Motor Bus additional devices.

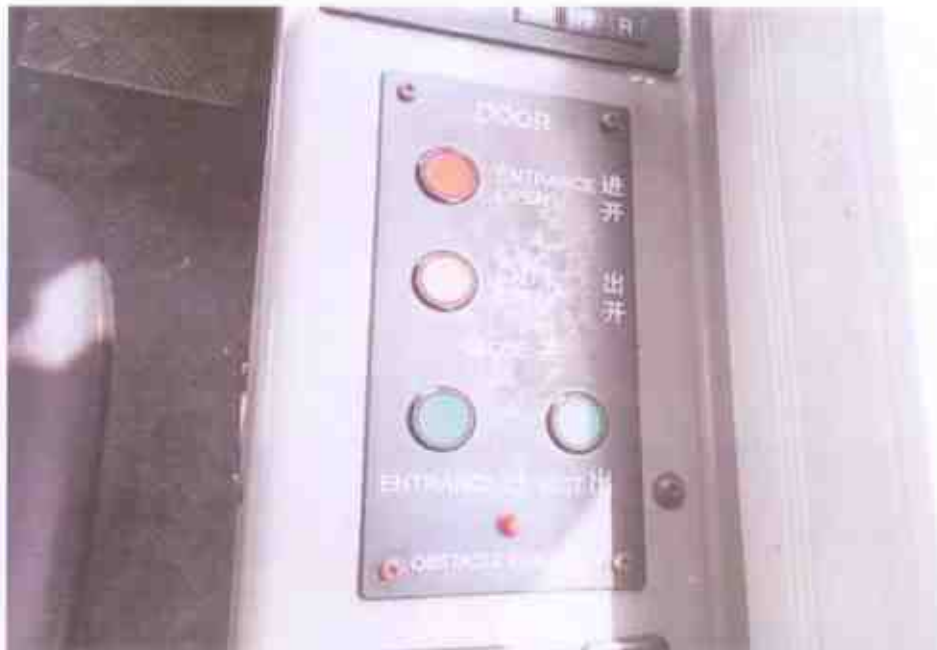
Photo 26 shows the indicators at the driver's seat. Other operational indicators were unable to be initialized due to the flat battery. Hence, no test was carried out to the Motor Bus additional devices.
