Your Ref: TP/IP/65761/2017
Our Ref : CI/TPD18002141/N

Fatal Accident Investigation Team

MECHANICAL INSPECTION REPORT OF MOTOR CAR SGN 6422U

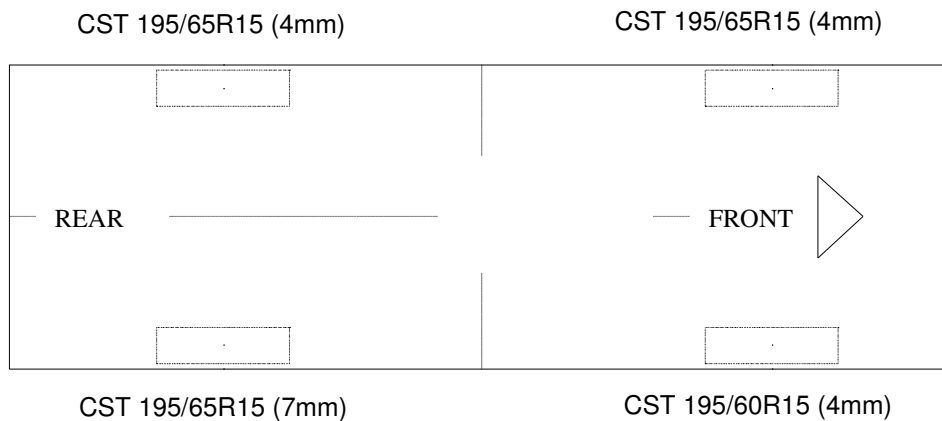
7. The 4 tyres were also observed to be sufficiently inflated for vehicular operation. The tyre brand, tyre size and remaining tread depth of the 4 tyres were recorded as follows:-

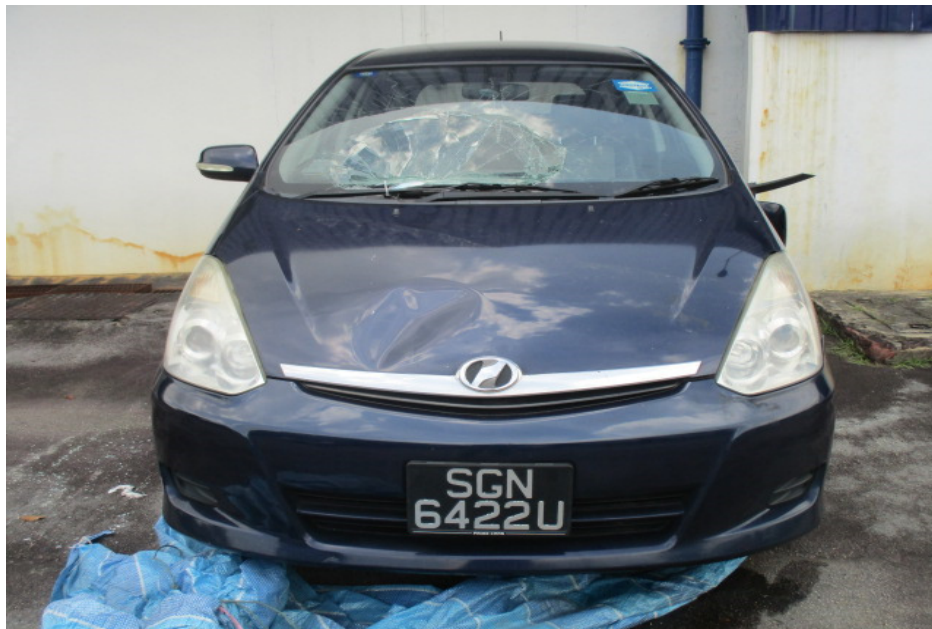
4. The mileage of the Motor Car at the time of our inspection was not recorded as its engine could not be started due to a flat battery.
5. The Motor Car had sustained relatively minor impact at the right side of its front bumper, which had caused the front bonnet to be dented and the front windscreen to be cracked. The right side of the front bumper of the Motor Car was observed to be scratched. The left side mirror of the Motor Car was also dislodged.

Photo 1 shows a general view of the front body of the Motor Car at the time of our inspection. The Motor Car was observed to be in good general condition except for some relatively minor impact damage at its front body and right front body. The left side mirror was also dislodged. The mileage of the Motor Car was not recorded as its engine could not be started due to a flat battery.

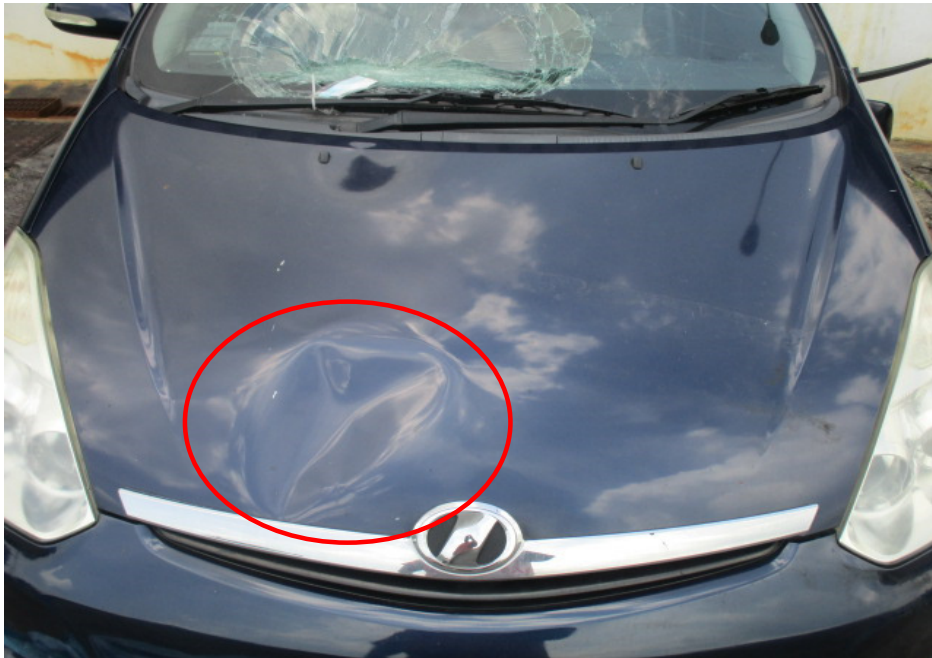
Photo 2 shows a general view of the front bonnet of the Motor Car at the time of our inspection. The Motor Car was observed to be in good general condition. Its front bonnet was however observed to be dented at the right side (circled).

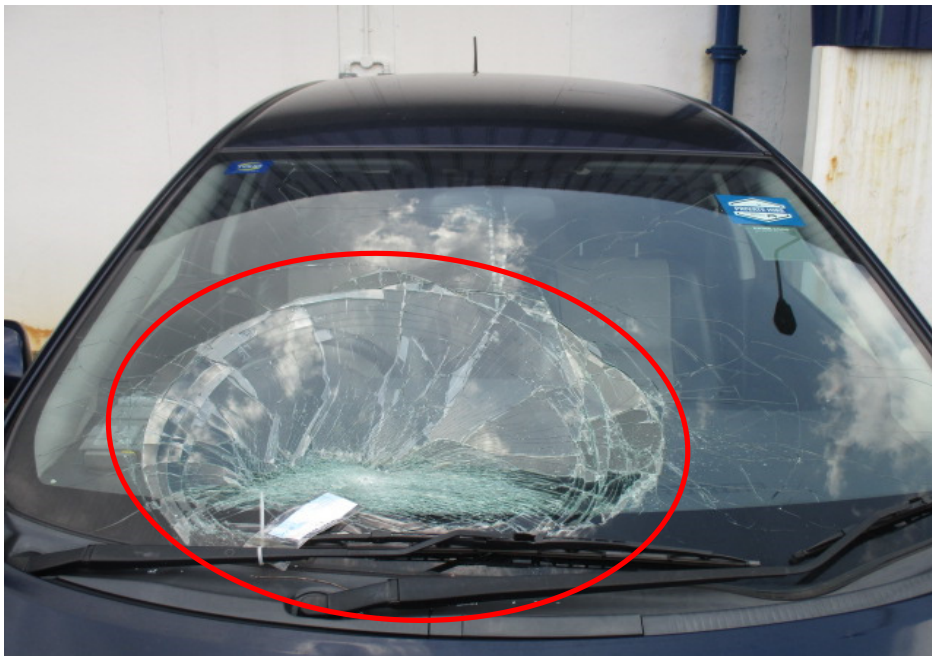
Photo 3 shows a general view of the Motor Car's front windscreen at the time of our inspection. The right side of the front windscreen of the Motor Car was observed to be cracked (circled).

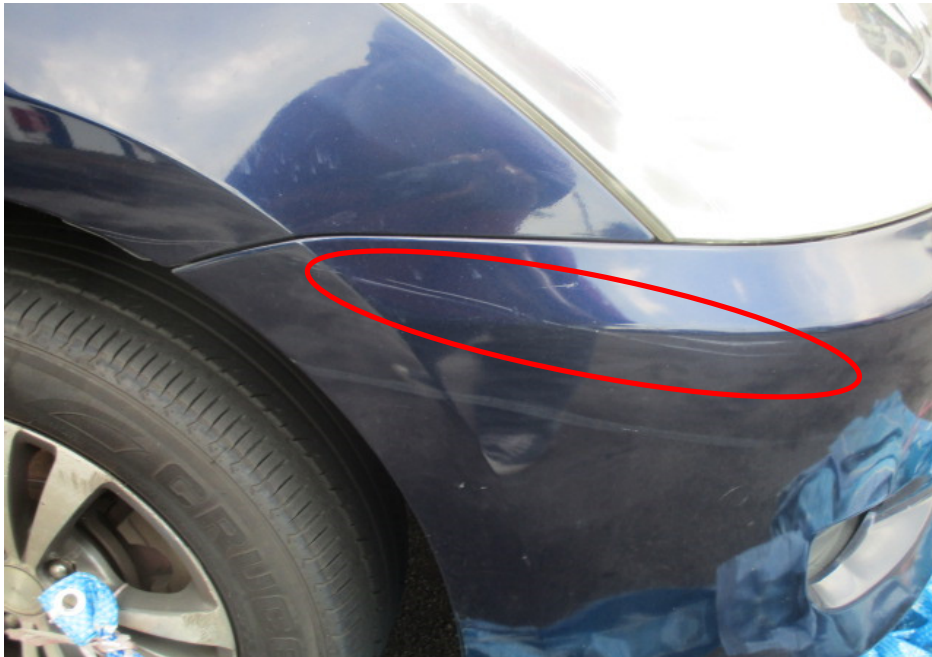
Photo 4 shows a general view of the Motor Car's right front body at the time of our inspection. The Motor Car was observed to be in good general condition. Its front bumper was however observed to be scratched at the right side (circled).

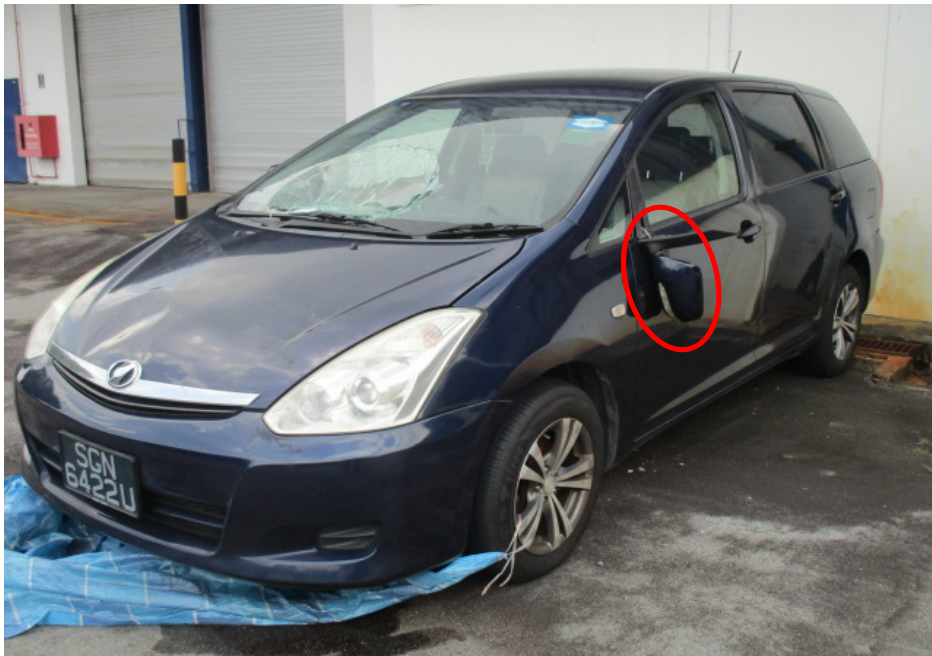
Photo 5 shows a general view of the Motor Car's left front body at the time of our inspection. The Motor Car was observed to be in good general condition. Its left side mirror was however observed to be dislodged (circled).

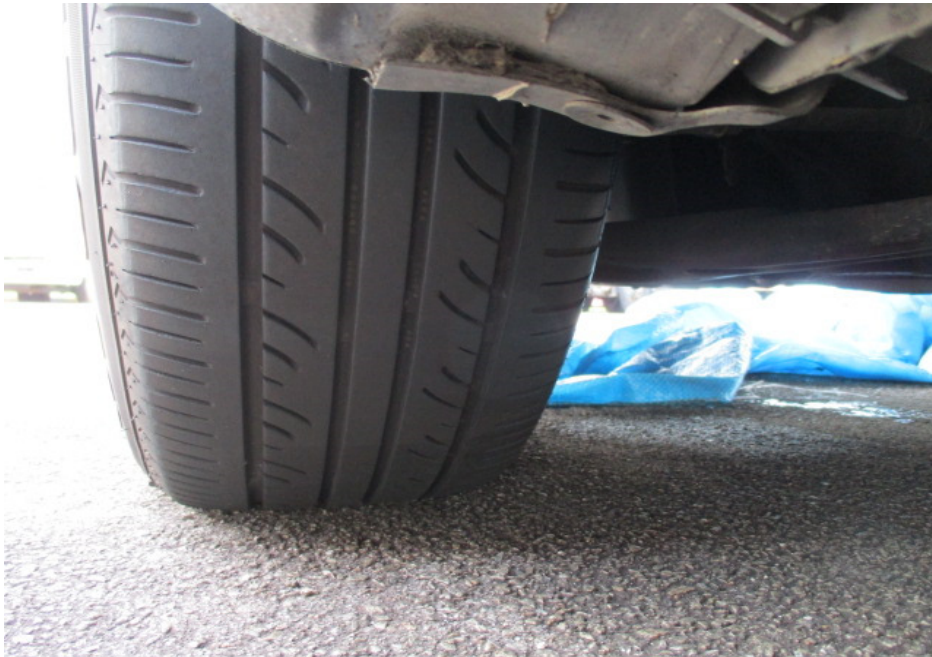
Photo 6 shows the condition of the front left tyre of the Motor Car, which was observed to be in serviceable condition with remaining tread depth of approximately 4mm. The tyre, which was wrapped around alloy wheel rim, was also observed to be sufficiently inflated for vehicular operation. There was no tear, cut or burst mark(s) on the outer and the inner sidewalls as well as across the tread of the 4 tyres.

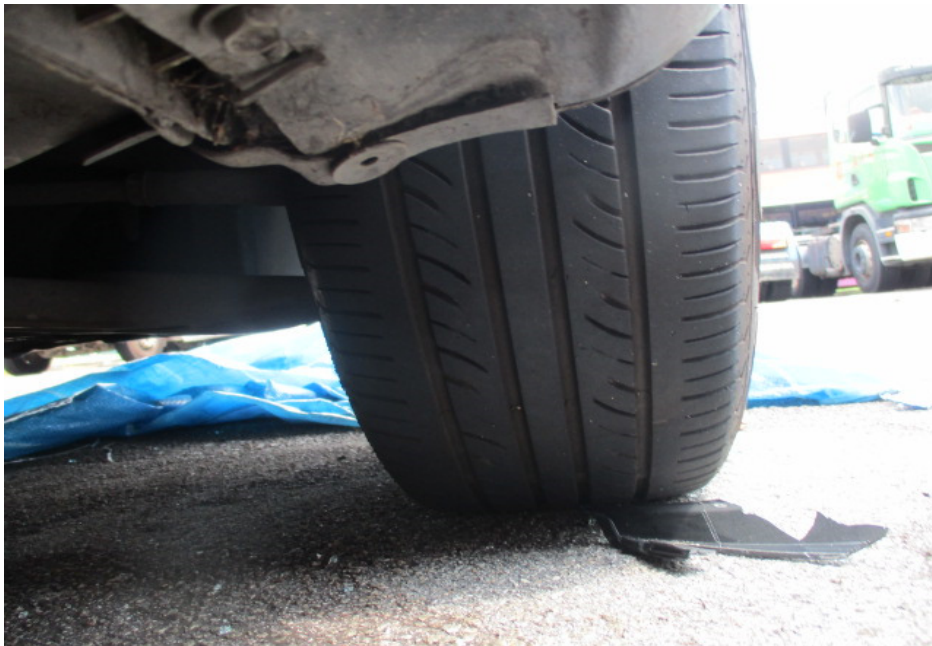
Photo 7 shows the condition of the front right tyre of the Motor Car, which was observed to be in serviceable condition with remaining tread depth of approximately 4mm. The tyre, which was wrapped around alloy wheel rim, was also observed to be sufficiently inflated for vehicular operation.

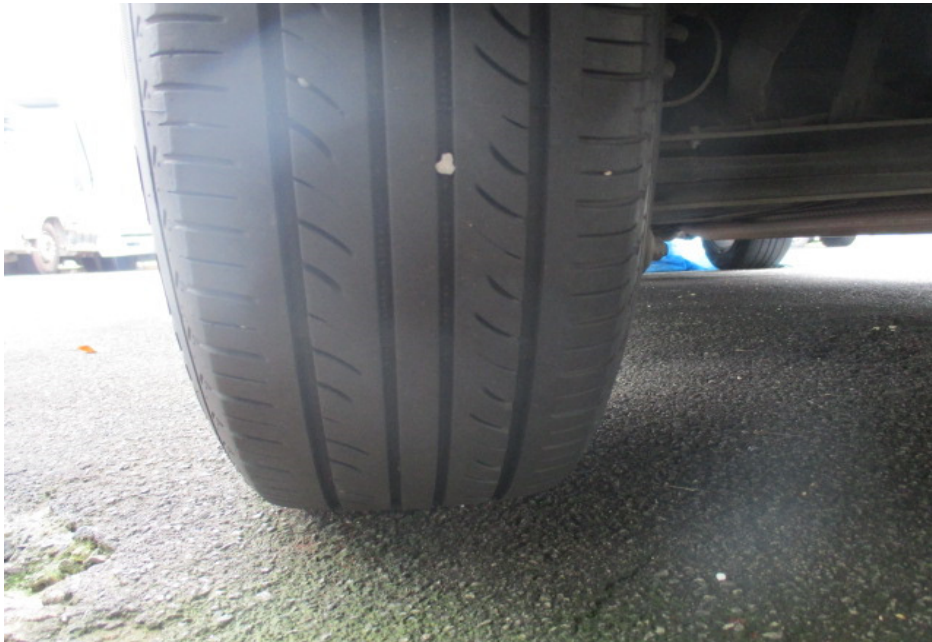
8. The 4 tyres were observed to be wrapped around alloy wheel rims that were found to be without any significant damage except for some marks of grazing nature on the outer spokes of the wheel rims, which are commonly associated to grazing against a road kerb. See photos 1 – 9 below.

Photo 8 shows the condition of the rear left tyre of the Motor Car, which was observed to be in serviceable condition with remaining tread depth of approximately 4mm. The tyre, which was wrapped around alloy wheel rim, was also observed to be sufficiently inflated for vehicular operation. There was also no significant damage found on the 4 wheel rims of the Motor Car except for some marks of grazing nature on the outer spokes of all the wheel rims.

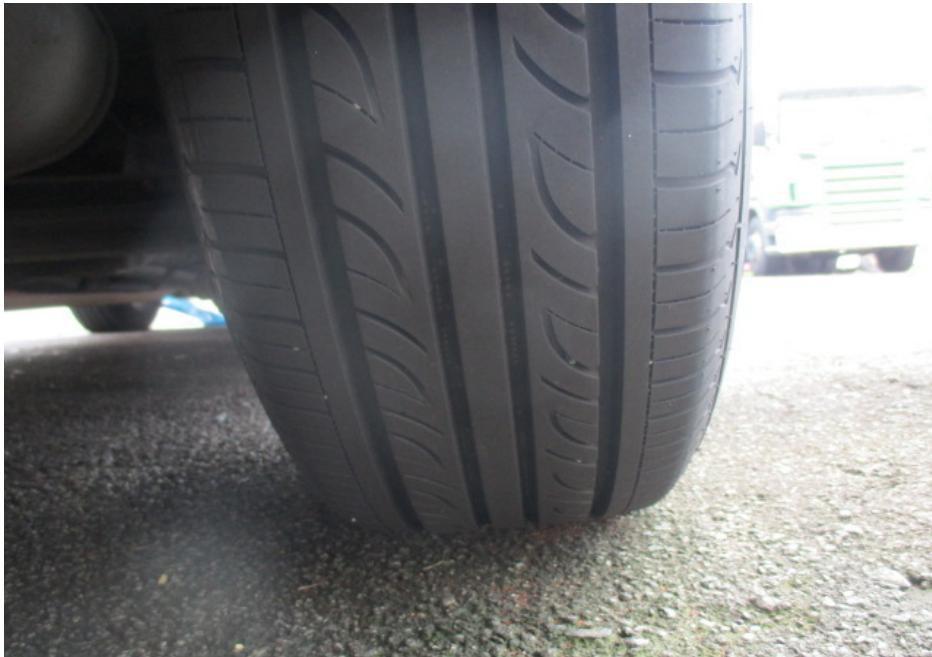
Photo 9 shows the condition of the rear right tyre of the Motor Car, which was observed to be in serviceable condition with remaining tread depth of approximately 7mm. There was also no tear, cut or burst mark(s) on the outer and the inner sidewalls as well as across the tread of the 4 tyres.

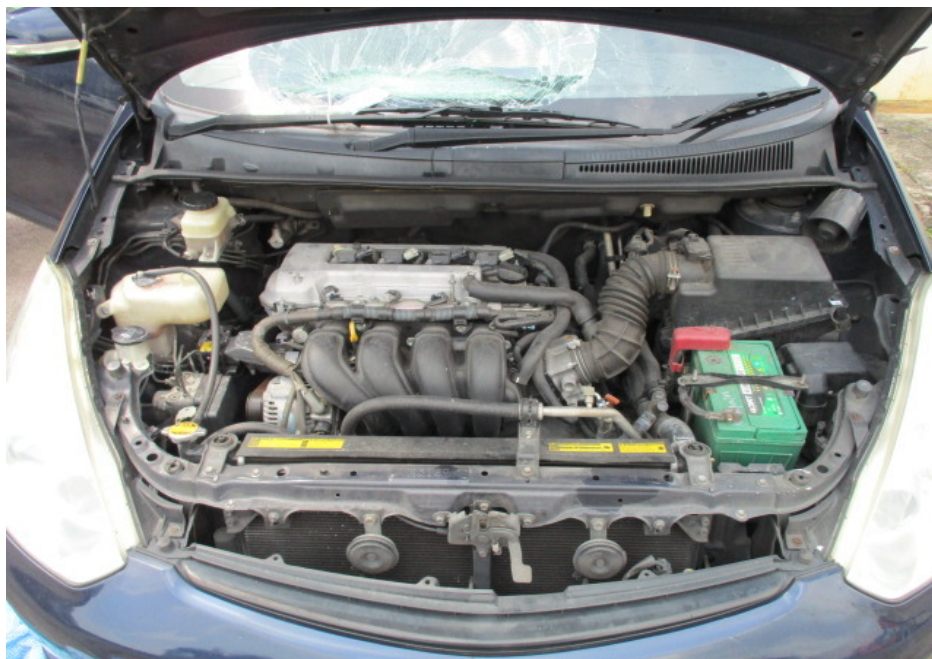
9. Upon examination of the engine compartment of the Motor Car, we had observed all the parts and components inside the engine compartment to be intact and unaffected by the accident. The brake fluid, auto transmission fluid (ATF), engine oil and engine coolant were all found to be of sufficient level for operating purposes. Visually, there was also no contamination found to these fluids.
10. Further examination of the engine compartment revealed no sign(s) or indication(s) of fluid leakage and/or fluid stain within the engine compartment of the Motor Car.
11. Our subsequent checks on the underside of the Motor Car also revealed no fluid stain. Visually, the various undercarriage components of the Motor Car were all observed to be intact and without any visible damage. See photos 10 – 14 below.

Photo 10 shows a general view of the Motor Car's engine compartment. The various parts and components inside the engine compartment were unaffected by the accident. There was also no sign(s) or indication(s) of fluid leakage and/or fluid stain within the engine compartment.

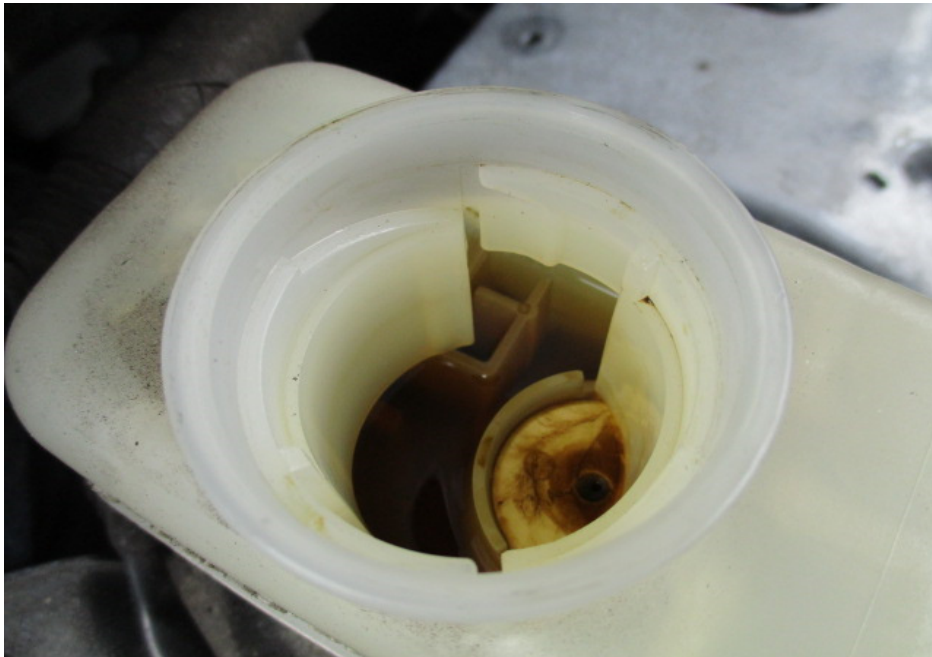
Photo 11 shows the brake fluid reservoir of the Motor Car at the time of our inspection. The brake fluid was observed to be of sufficient level and without any visible contamination.

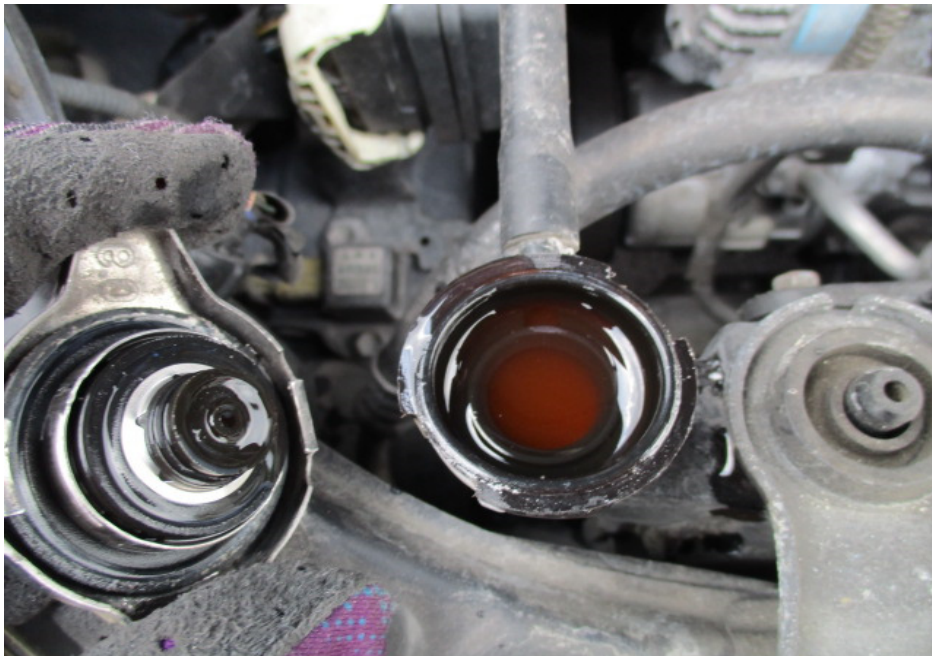
Photo 12 shows checks being carried out to the engine coolant of the Motor Car at the time of our inspection. The engine coolant was observed to be of sufficient level and without any visible contamination.

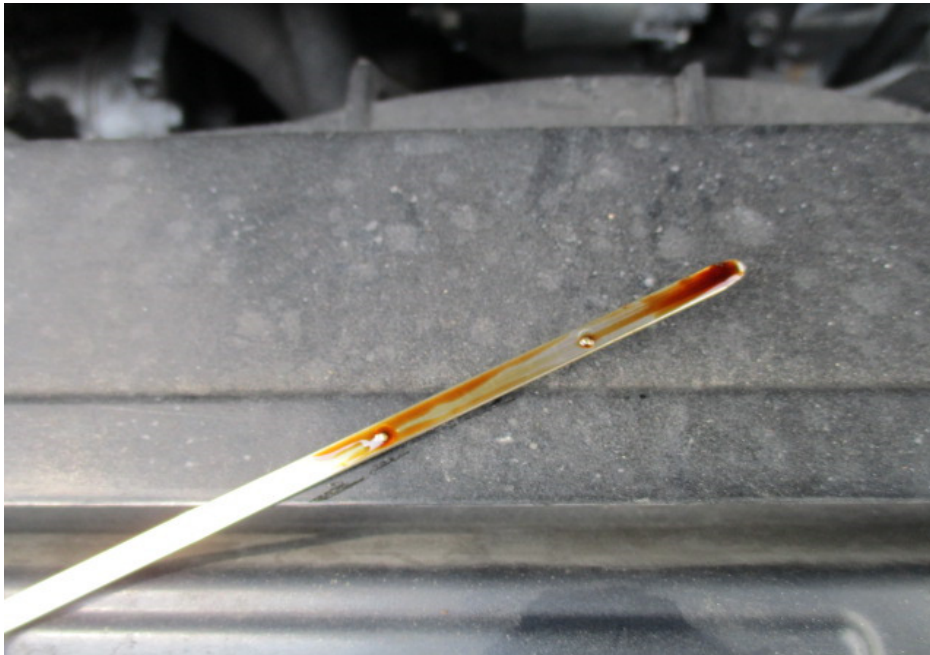
Photo 13 shows the engine oil dipstick of the Motor Car at the time of our inspection. The engine oil was observed to be of sufficient level and without any visible contamination.

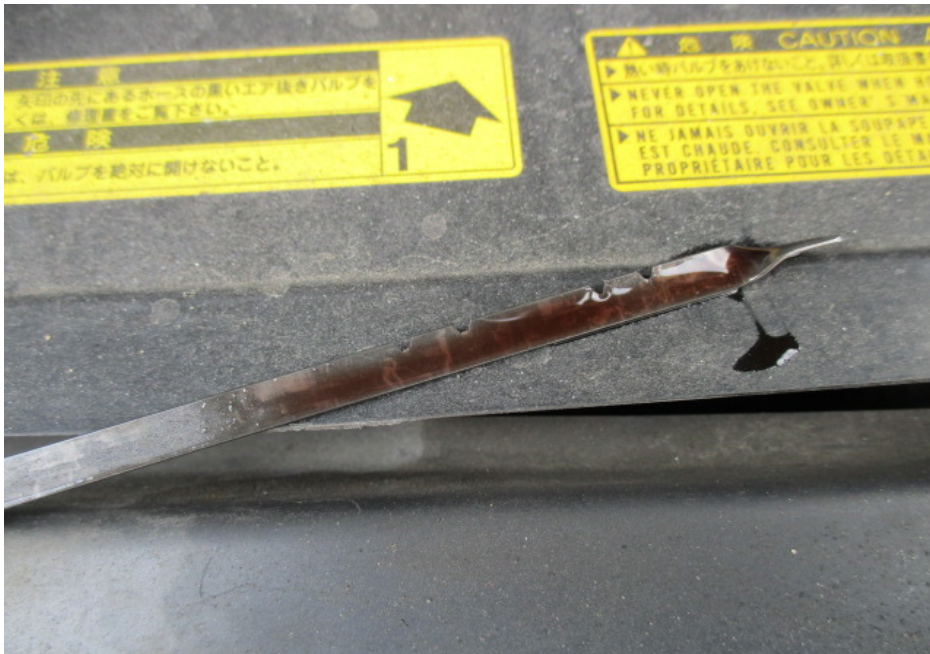
Photo 14 shows the ATF dipstick of the Motor Car at the time of our inspection. The ATF was observed to be of sufficient level and without any visible contamination.

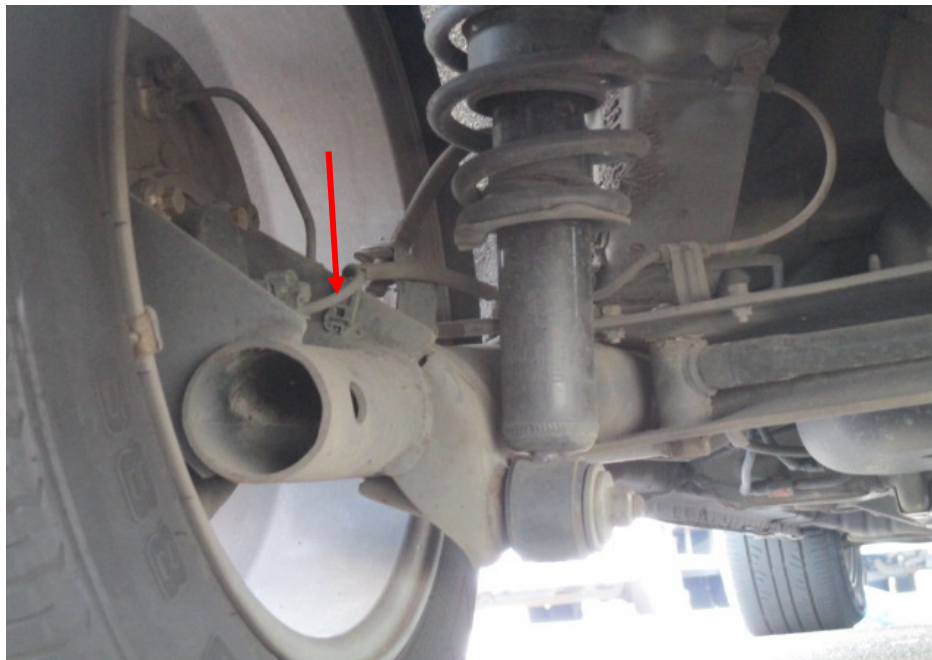
12. The mechanical components of the Motor Car's steering system and braking system were all found to be visually intact and undamaged. Our visual examination of the various steering components, which had included the rack and pinion, tie rods, tie rod ends and ball joints revealed that these components were all generally in good condition. Components of the braking system like the brake master pump, brake booster, brake calipers and brake hoses amongst others were also found to be without any damage upon our visual inspection.
13. Static tests of the steering system and braking system could not be conducted as the engine of the Motor Car was not able to start. However basing on our visual inspection of the various mechanical components, it would appear that the steering system and braking system of the Motor Car were in serviceable condition. See photos 15 - 18 below.

Photo 15 shows the brake hose (arrowed) at the rear left wheel of the Motor Car. We did not observe any leakage of brake fluid at the time of our inspection of the Motor Car. Our visual inspection of the various mechanical components of the Motor Car's braking system revealed all to be intact and without visible damage, indicating that the braking system was likely to be in serviceable condition at the material time of accident.

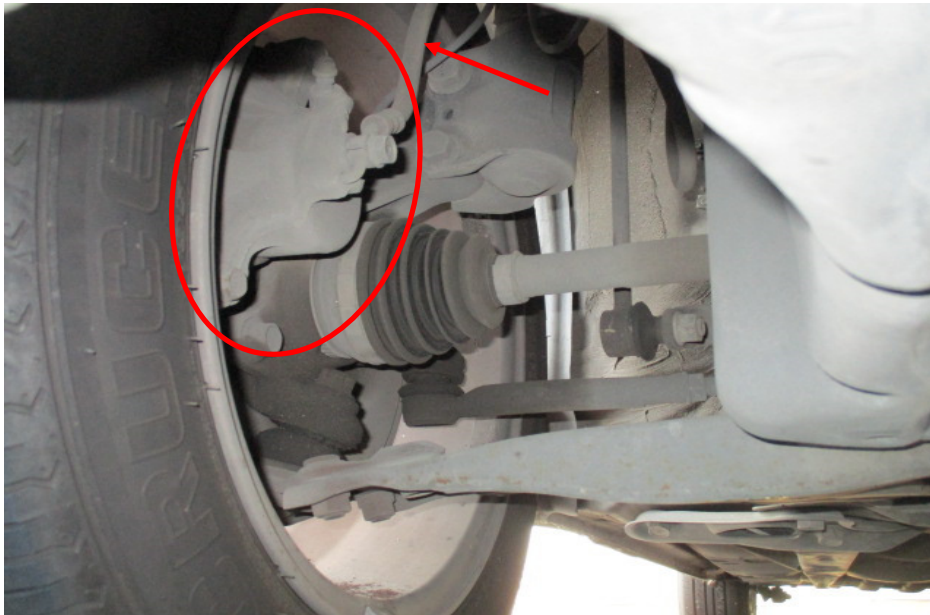
Photo 16 shows the brake hose (arrowed) at the front right wheel of the Motor Car. We did not observe any leakage of brake fluid at the time of our inspection of the Motor Car. Our visual inspection of the various mechanical components of the Motor Car's braking system, including its brake caliper (circled), revealed all to be intact and without visible damage, indicating that the braking system was likely to be in serviceable condition at the material time of accident.

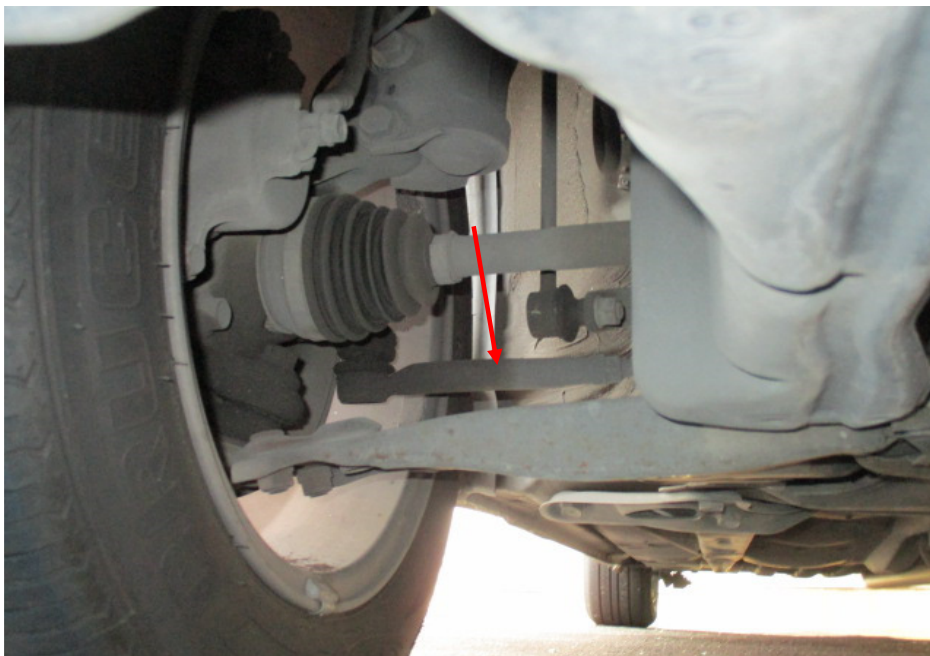
Photo 17 shows the various undercarriage components at the front right wheel of the Motor Car, in particular the steering tie rod (arrowed). The various steering components were all found to be intact, suggesting that the steering system of the Motor Car was likely to be in serviceable condition.

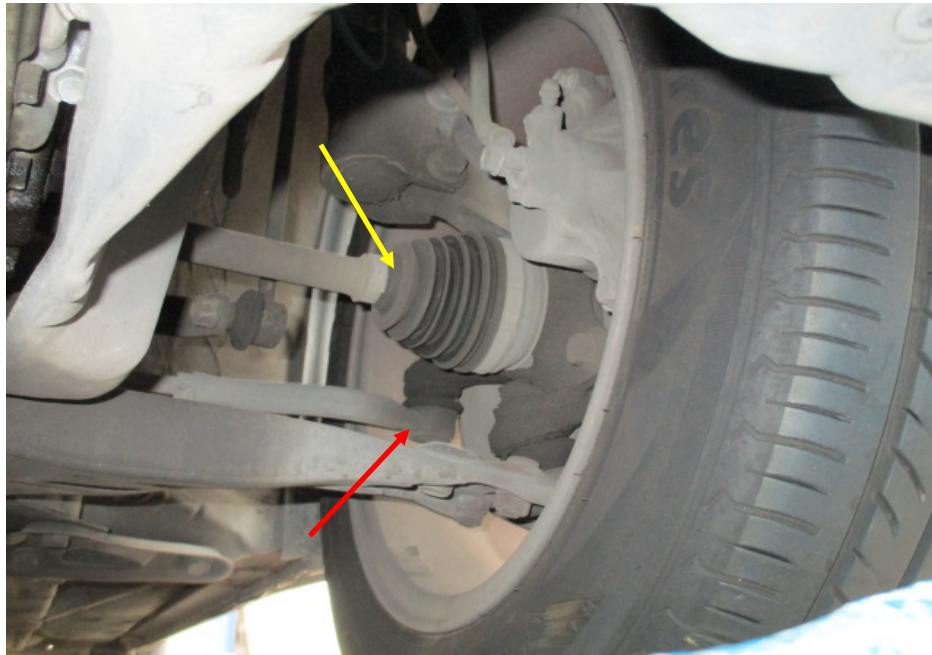
Photo 18 shows the various undercarriage components at the front left wheel of the Motor Car, which had included the steering tie rod (red arrow) and left drive shaft (yellow arrow). The various undercarriage components of the Motor Car were all found to be intact without any visible damage. There was also no sign of fluid stain observed on the various undercarriage components.
