Your Ref: TP/IP/64871/2017  
Our Ref : CI/TPD18002179/N

**Fatal Accident Investigation Team**

**MECHANICAL INSPECTION REPORT OF MOTORCYCLE FBL 2124B**

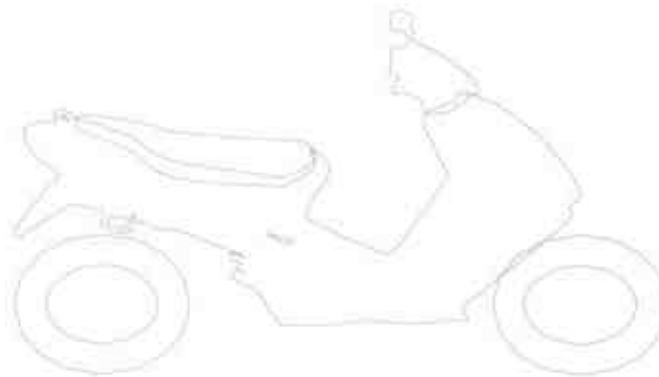
Pirelli 190/55 R17 (3mm)

Pirelli 120/70 R17 (2mm)

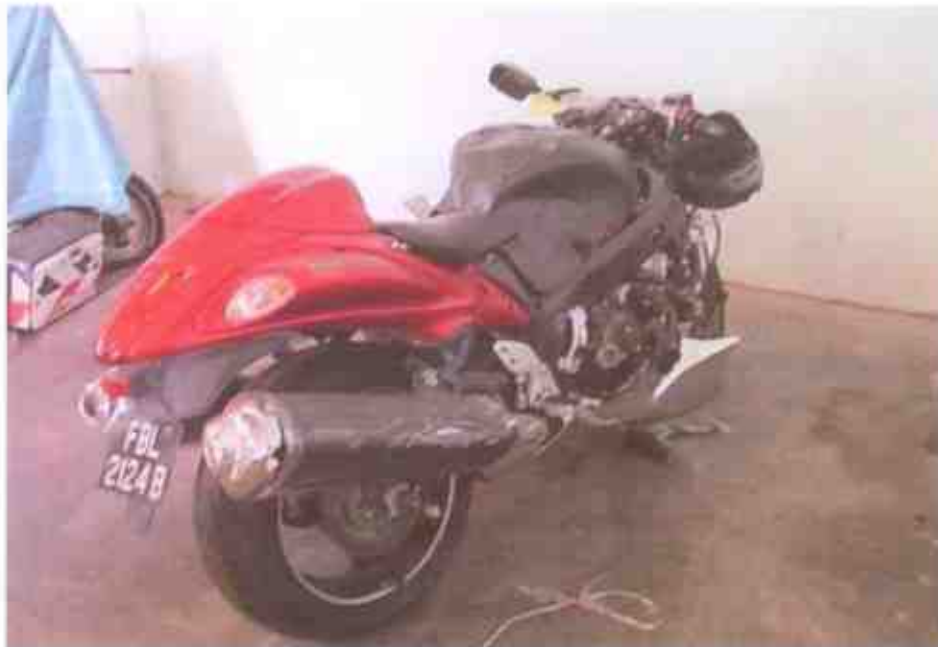
**Photo 1** shows a general view of the rear right body of the Motorcycle at the time of our inspection. The Motorcycle had sustained damages all around, significantly at its front portion and right body. The mileage of the Motorcycle was not recorded at the time of our inspection due to the damage sustained to the odometer display screen as a result of the accident.

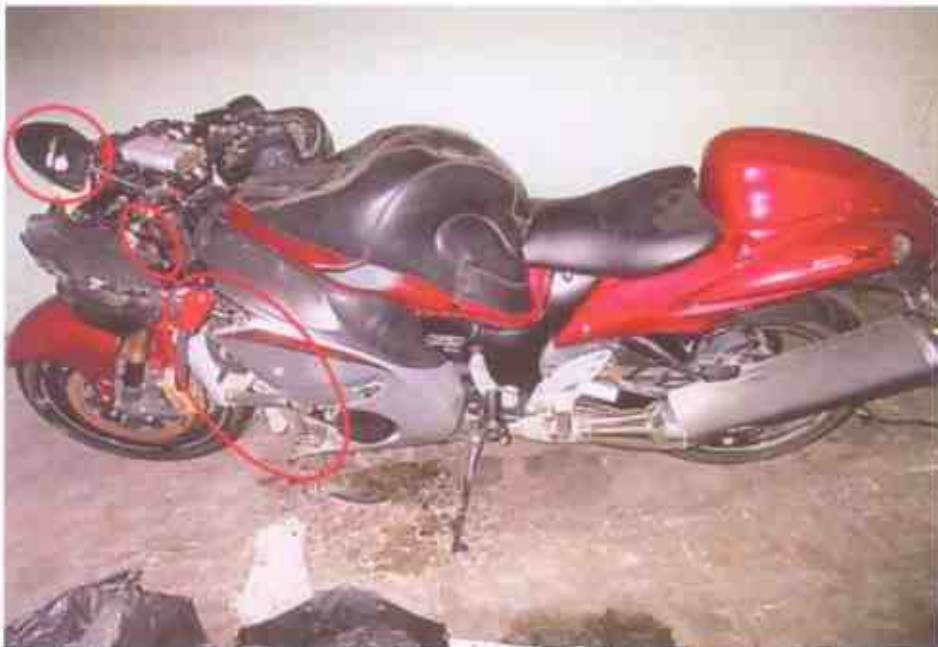
**Photo 2** shows a general view of the left body of the Motorcycle at the time of our inspection. Body parts that were found to have been damaged include its left side mirror, clutch lever and left side cover.

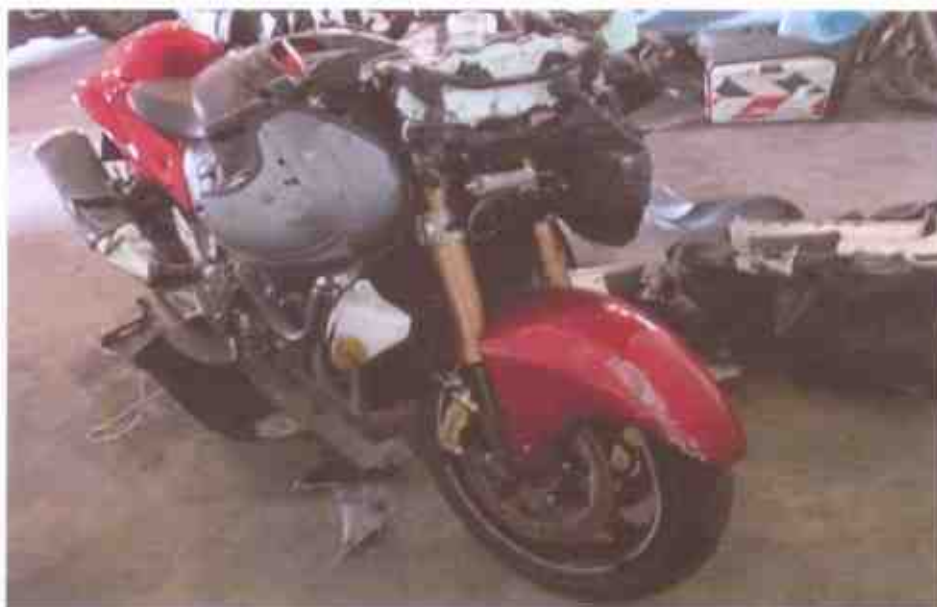
**Photo 3** shows a general view of the right body of the Motorcycle at the time of our inspection. Body parts that were found to have been damaged include its headlamp assembly, speedometer, front mudguard, right side mirror, front brake lever, front brake reservoir, right front fork slider, petrol tank, right side cover, right frame slider, rear brake pedal, right exhaust muffler, rear right side cover and right rear axle slider amongst others.

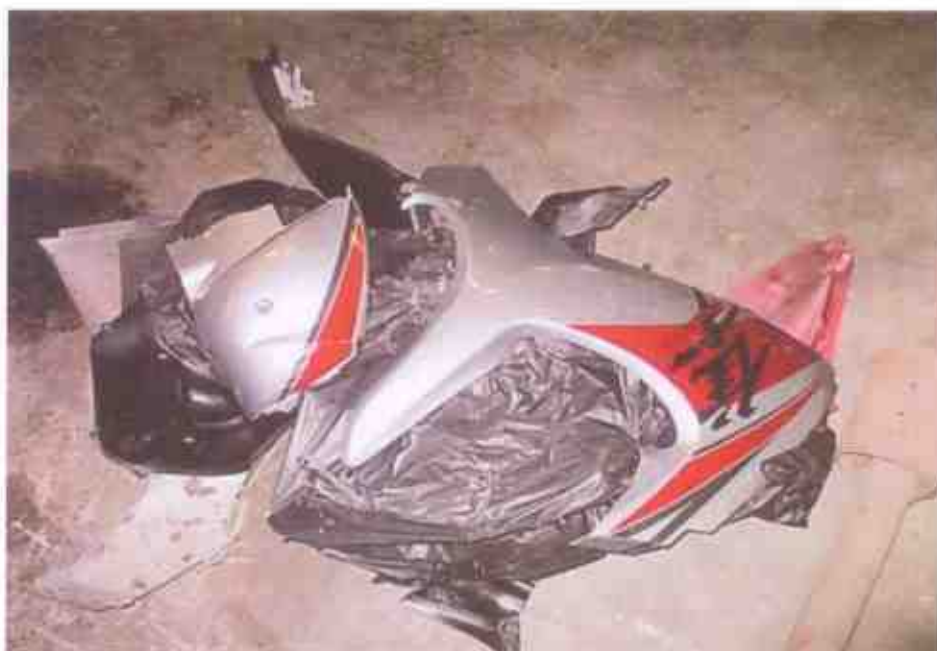
**Photo 4** shows a closer view of the damaged headlamp assembly, left side cover and right side cover of the Motorcycle at the time of our inspection.

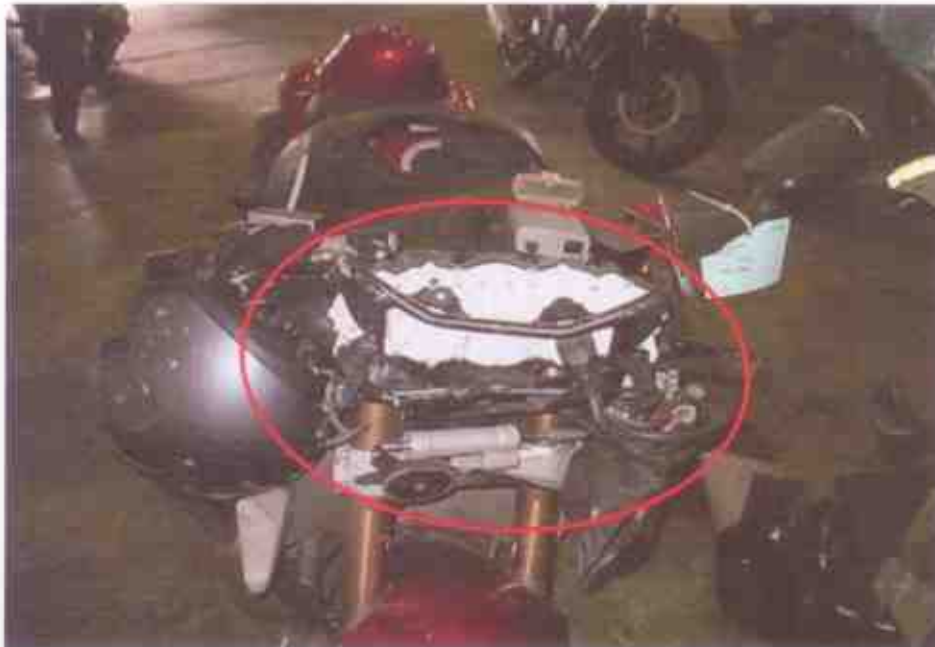
**Photo 5** shows a closer view of the headlamp assembly and speedometer (circled) which were amongst the body parts at the front body of the Motorcycle that had sustained damage as a result of the accident.

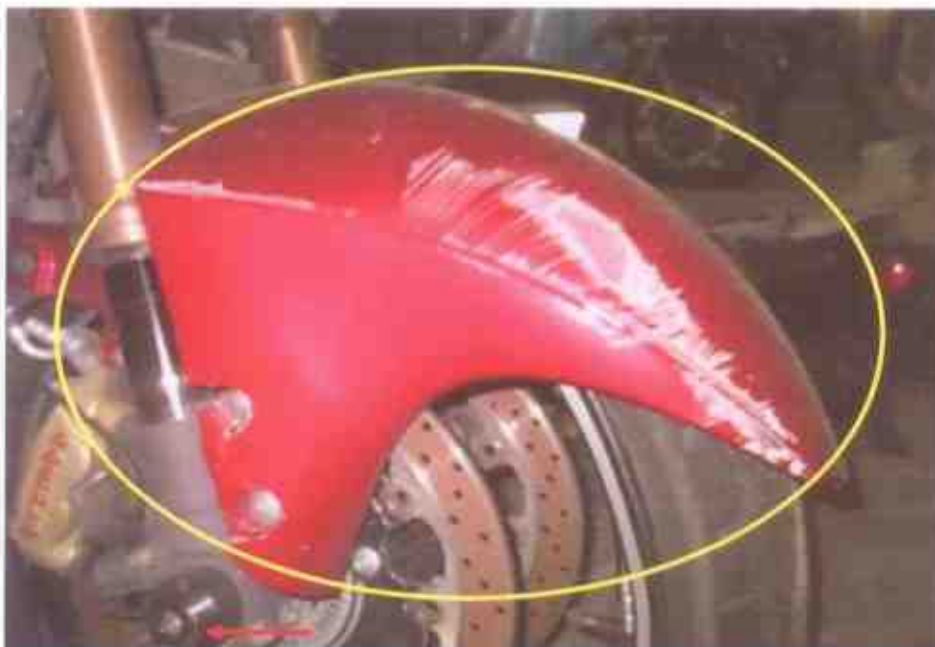
**Photo 6** shows a closer view of the front mudguard (circled) and right front fork slider (arrowed), which were amongst the body parts at the front body of the Motorcycle that had sustained damage as a result of the accident.

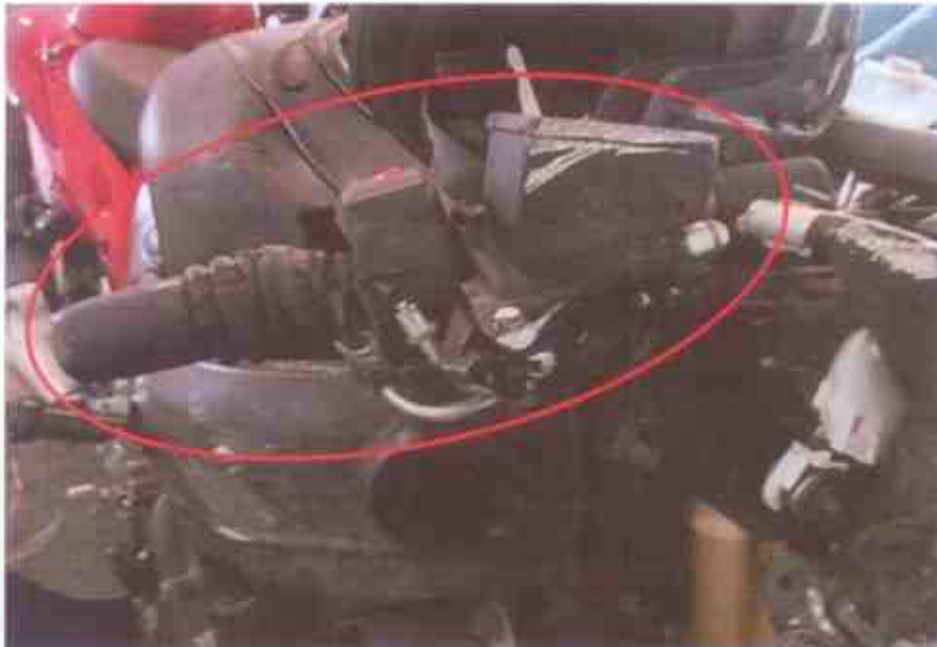
**Photo 7** shows a close up view of the front brake lever, front brake reservoir, right handlebar grip and right handlebar end (circled) of the Motorcycle. These parts were amongst the body parts of the Motorcycle which were damaged as a result of the accident.

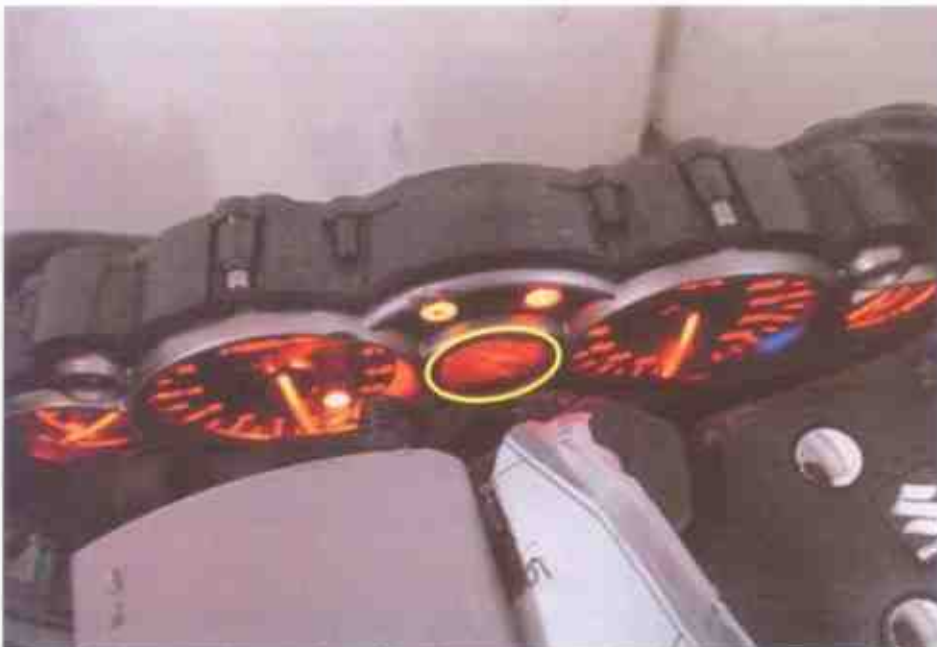
**Photo 8** shows a closer view of the damage sustained to the odometer display screen of the Motorcycle (circled) as a result of the accident.

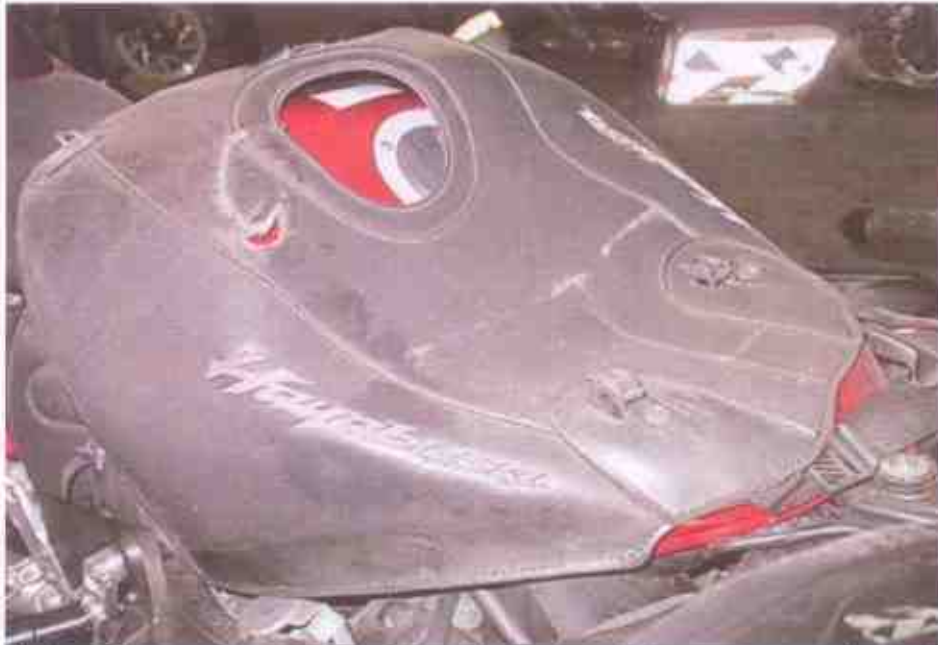
Photo 9 shows a closer view of the petrol tank, which was amongst the body parts of the Motorcycle that had sustained damage as a result of the accident.

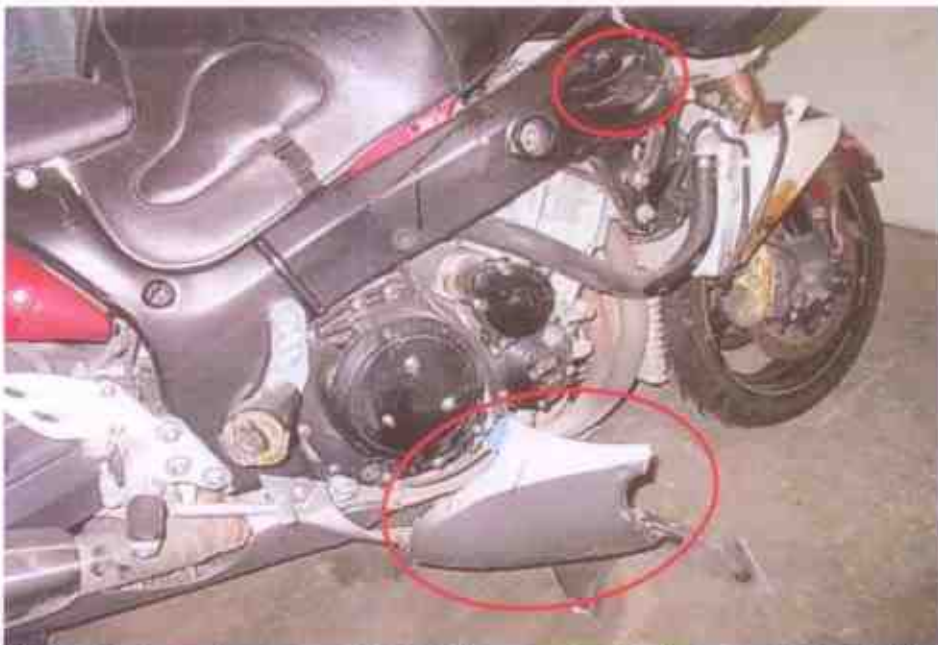
Photo 10 shows the damaged right side cover and right frame (circled) of the Motorcycle. The damage sustained at the right frame of the Motorcycle was mainly of grazing nature.

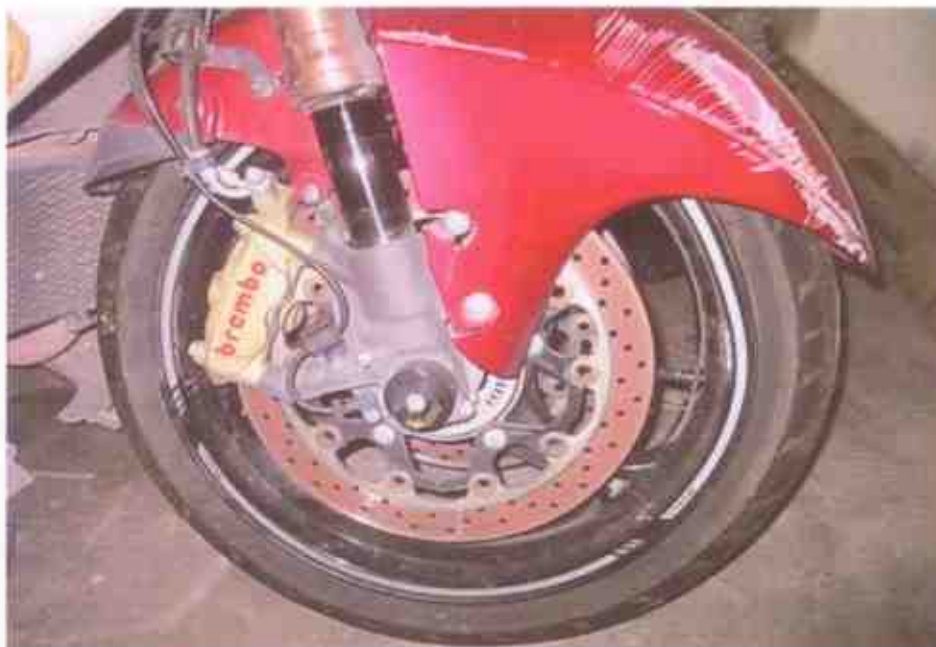
**Photo 11** shows the front wheel rim and tyre of the Motorcycle at the time of our inspection. The front tyre was observed to be in serviceable condition and sufficiently inflated for vehicular operation. There was no visible damage observed on the front wheel rim.

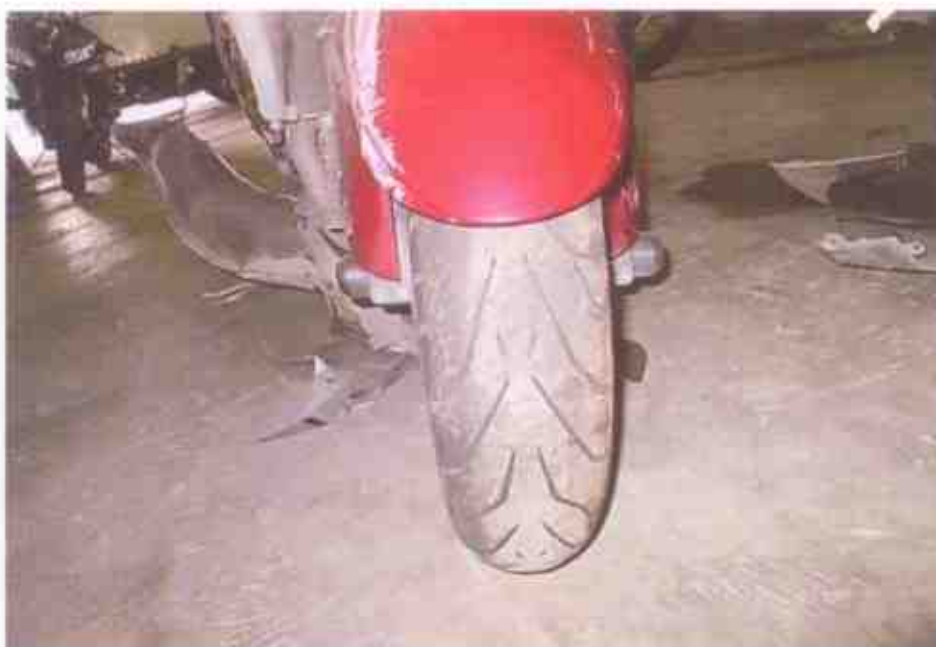
**Photo 12** shows the condition of the Motorcycle's front tyre. The front tyre was observed to be in serviceable condition with remaining tread depth of approximately 2mm. The tyre was also observed to be sufficiently inflated for vehicular operation. We did not observe any tear, burst mark(s) and/or punctured hole(s) on the sidewalls as well as across the tread of the front tyre.

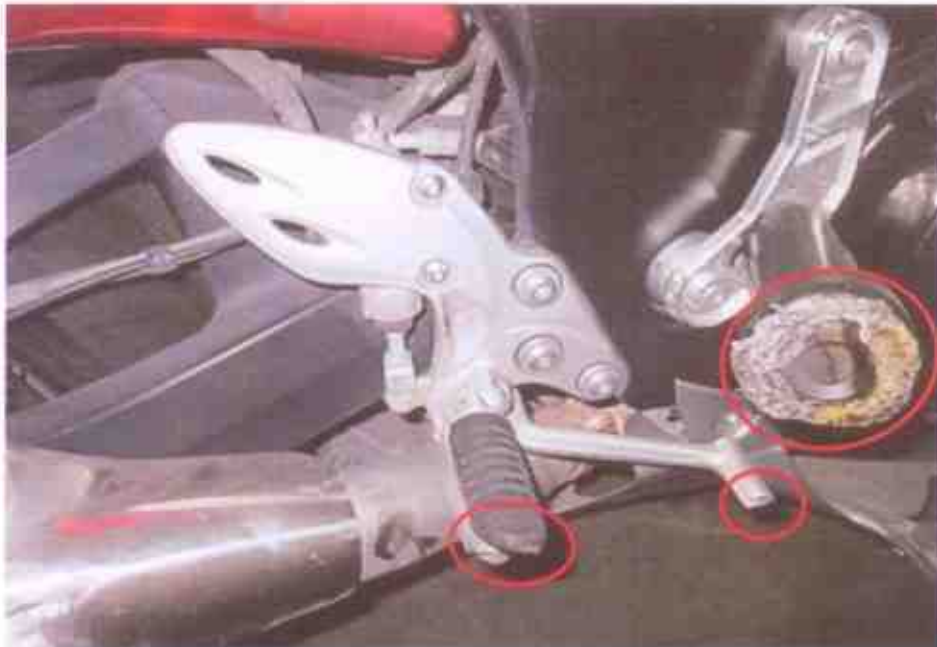
**Photo 13** shows the damaged right frame slider, rear brake pedal and right side rider footrest (circled) of the Motorcycle. The damages sustained to these parts were mainly of grazing nature.

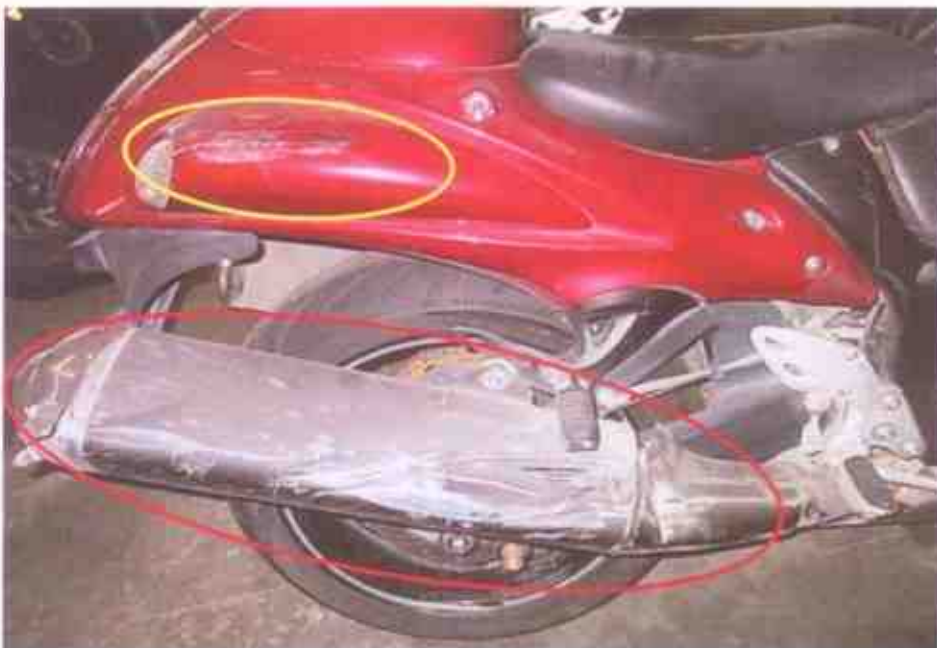
**Photo 14** shows the damaged rear right side cover and right exhaust muffler (circled) of the Motorcycle as a result of the accident.

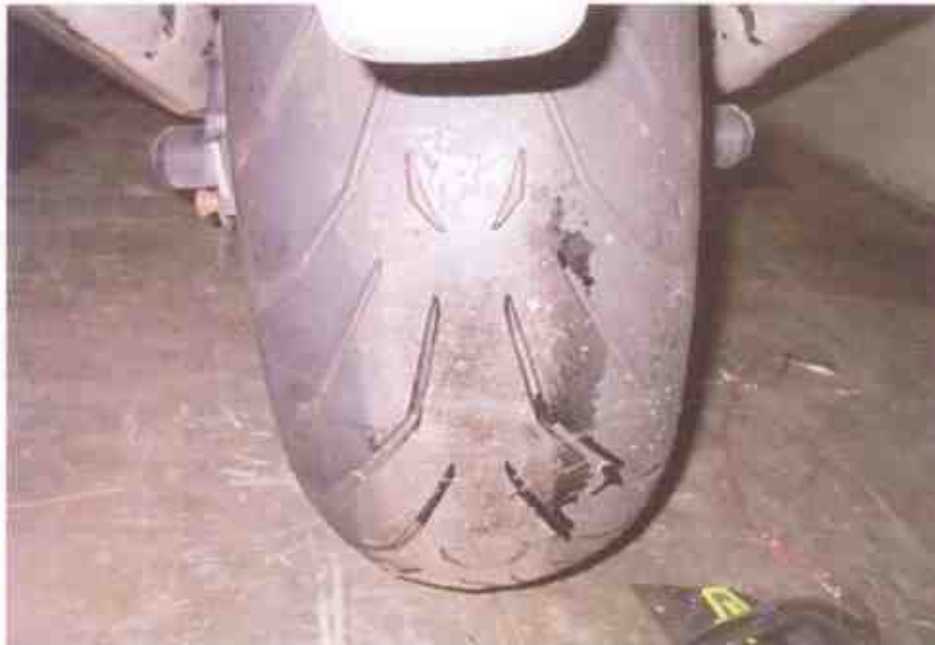
**Photo 15** shows the condition of the Motorcycle's rear tyre. The rear tyre was observed to be in serviceable condition with remaining tread depth of approximately 3mm. The tyre was also observed to be sufficiently inflated for vehicular operation. We did not observe any tear, burst mark(s) and/or punctured hole(s) on the sidewalls as well as across the tread of the rear tyre.

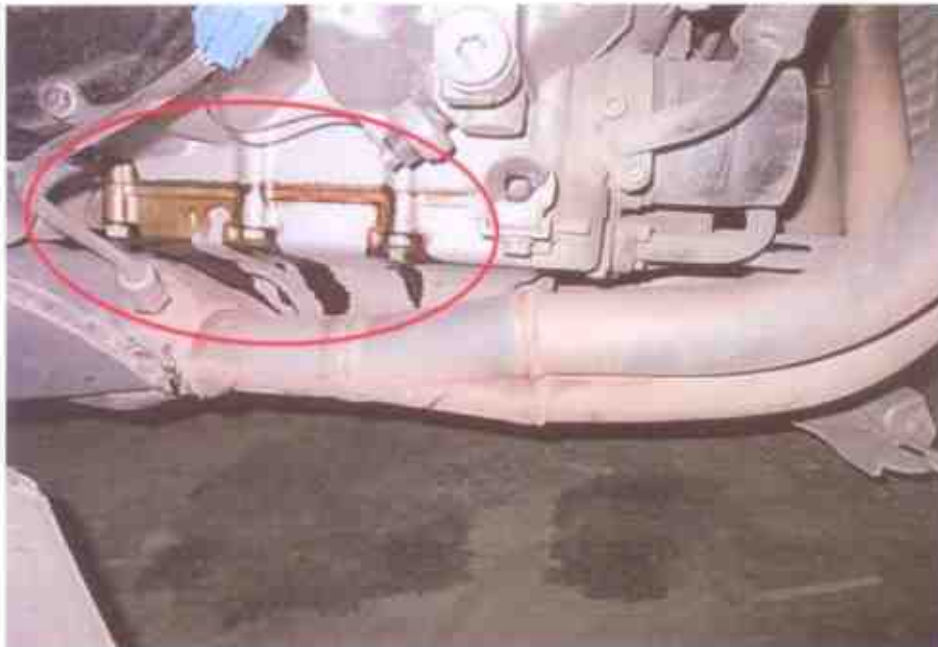
**Photo 16** shows the bottom of the Motorcycle's engine area where wet fluid stains were observed (circled), indicating that the fluid leak had occurred as a result of the accident.

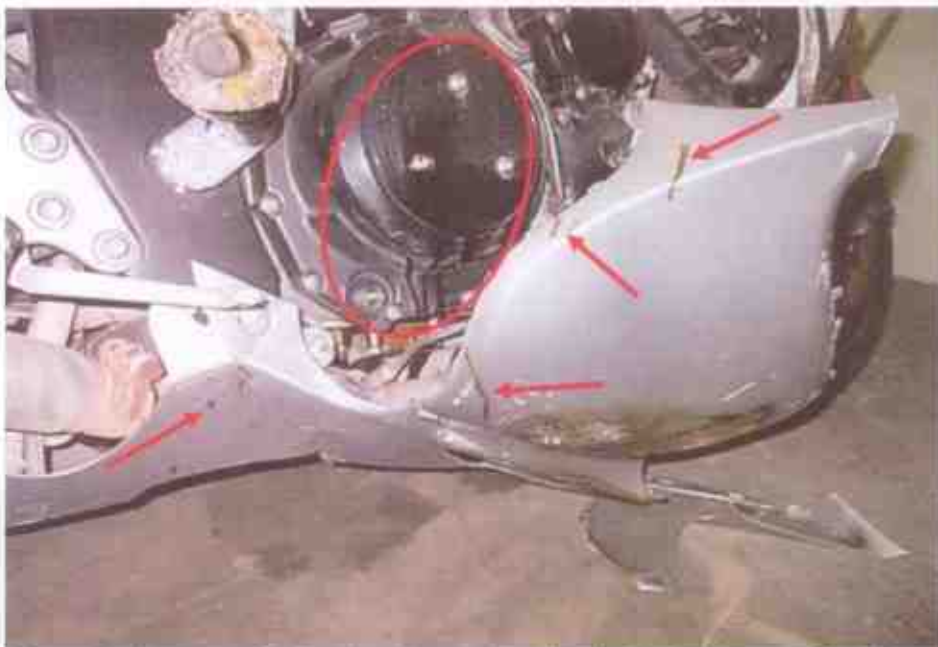
**Photo 17** shows wet fluid stains observed on the clutch plate cover (circled) and damaged right side cover (arrowed) of the Motorcycle, indicating that the fluid leak had occurred as a result of the accident.

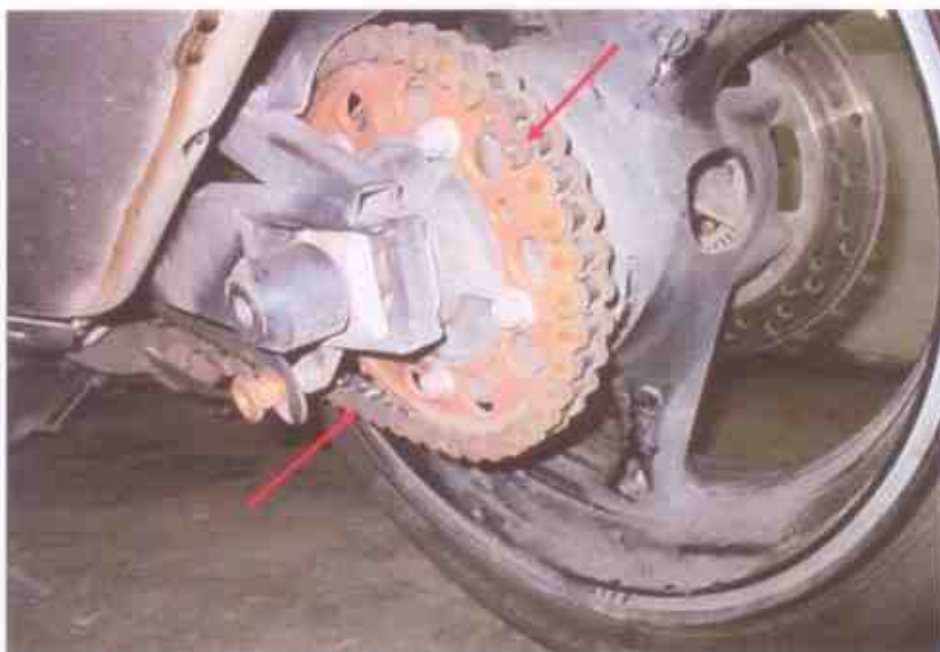
**Photo 18** shows the gear chain (arrowed) of the Motorcycle, which was observed to be intact with no misalignment. It was also adequately lubricated for operating purposes. The gear chain rotates the rear wheel of the Motorcycle.

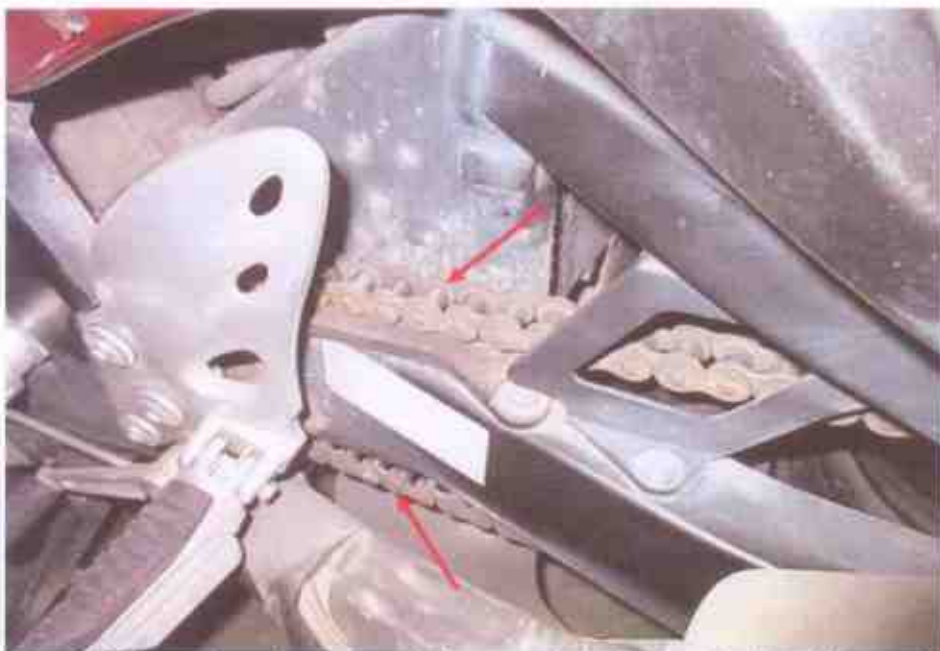
**Photo 19** shows the closer view of the gear chain (arrowed) of the Motorcycle, which was observed to be intact with no misalignment. It was also adequately lubricated for operating purposes.

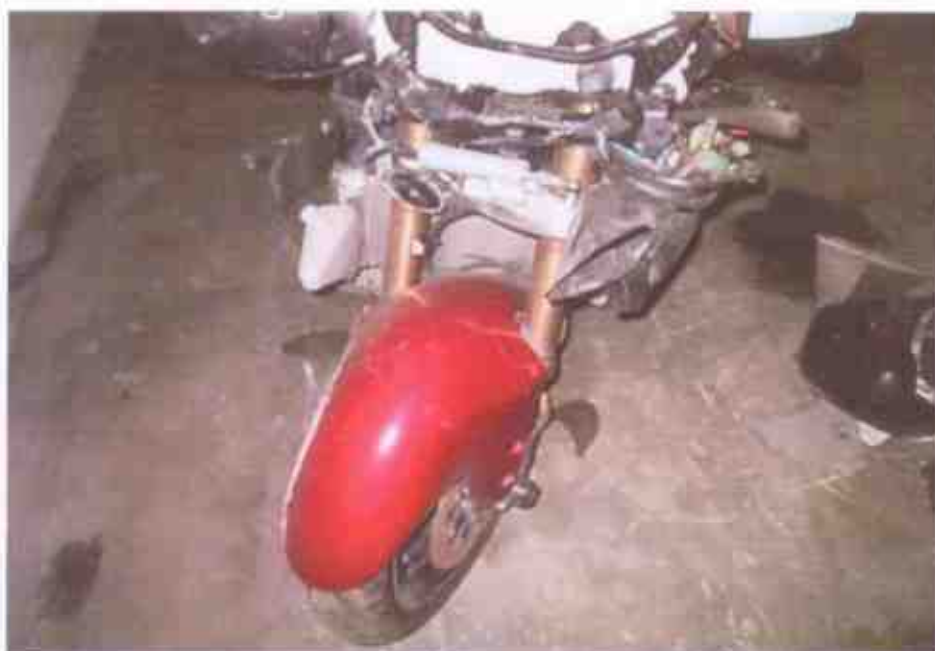
**Photo 20** shows the front wheel of the Motorcycle turned towards its full right. Turning the Motorcycle's handlebars towards the left and right did not produce any abnormal free play and/or resistance. This would indicate that the steering system of the Motorcycle was in serviceable condition at the time of our inspection.

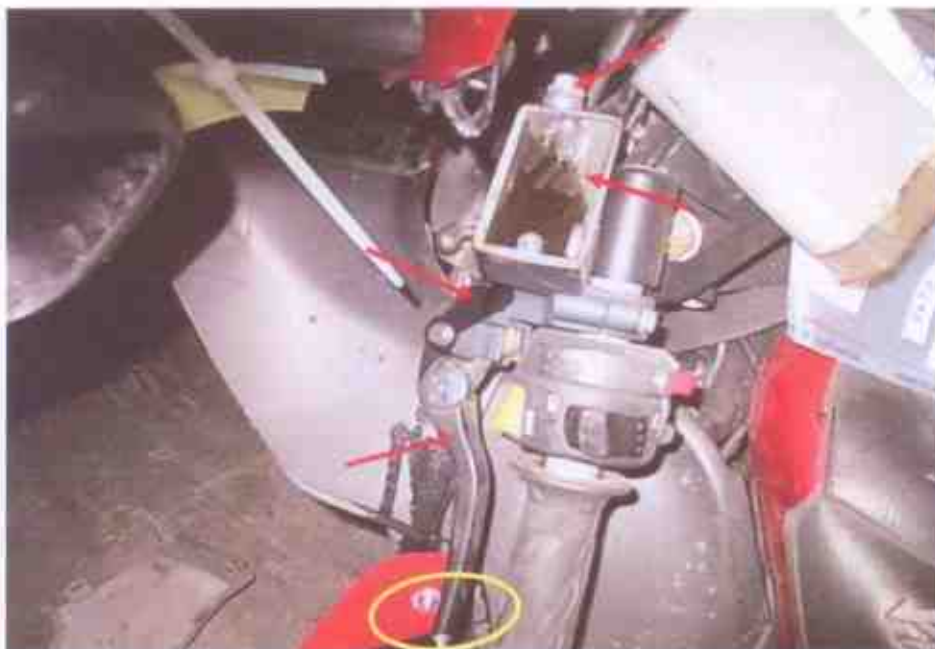
**Photo 21** shows a close up view of the clutch pump, clutch lever, clutch fluid reservoir and clutch hose (arrowed) of the Motorcycle, which are all part of the components in the hydraulic clutch system of the Motorcycle. Our visual checks of these various components revealed all to be intact with no visible damage except for the clutch lever. The hydraulic clutch fluid was observed to be of sufficient level and without contamination for operational purposes. No leakage of clutch fluid was also observed. We were unable to carry out an operational test of the Motorcycle's hydraulic clutch system due to the damage sustained to the clutch lever (circled).

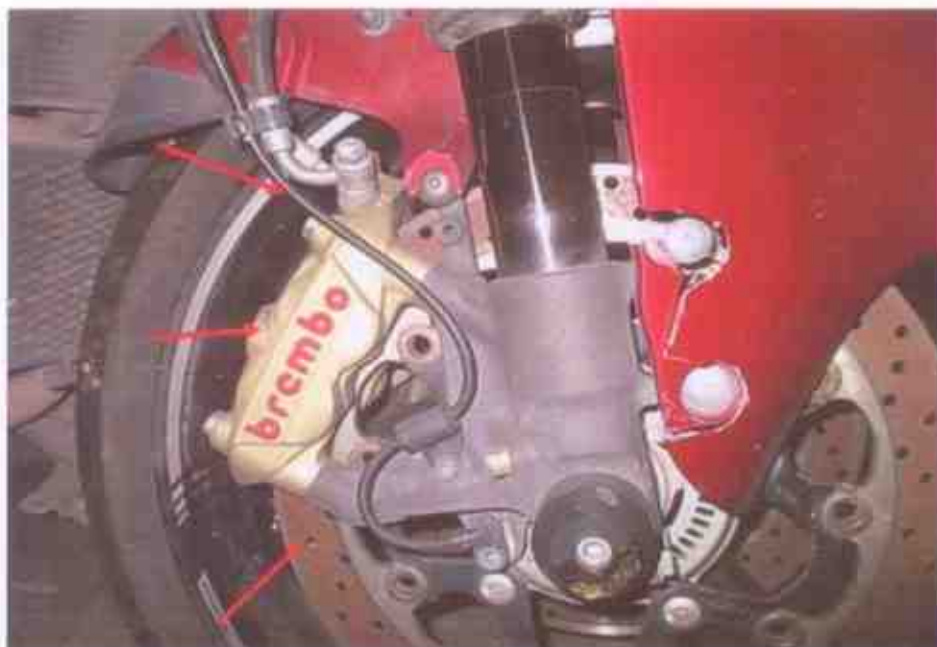
**Photo 22** shows a close up view of the front brake caliper, front brake disc and front brake hose (arrowed) of the Motorcycle, which are all part of the components in the hydraulic front brake system of the Motorcycle. Our visual checks of these various components had revealed all to be intact with no visible damage. No leakage of brake fluid was also observed.

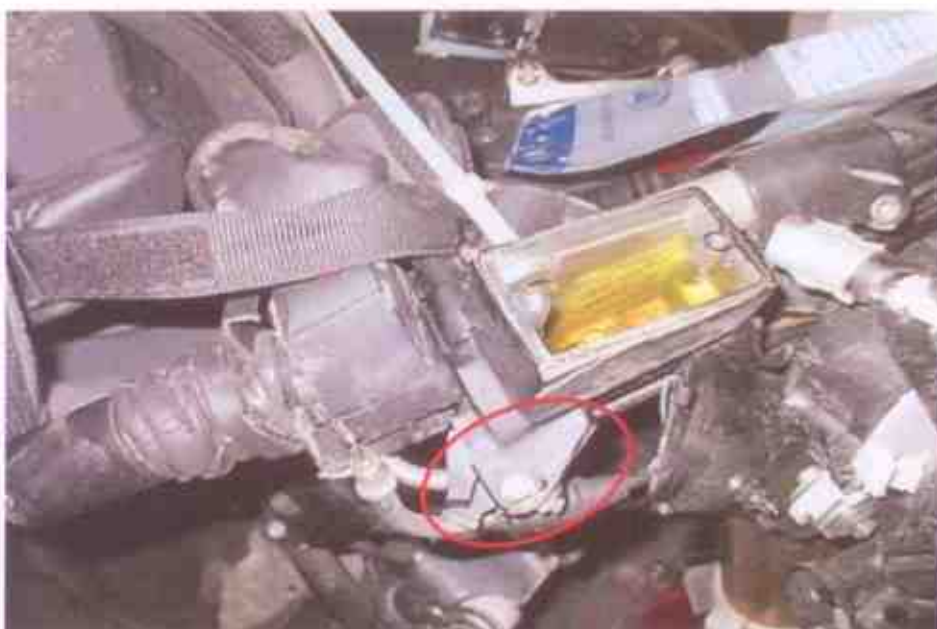
**Photo 23** shows the brake fluid reservoir for the front brake of the Motorcycle. The brake fluid was observed to be of sufficient level and without contamination for operational purposes. We were unable to carry out an operational test of the Motorcycle's front braking system due to the damage sustained to the front brake lever (circled).

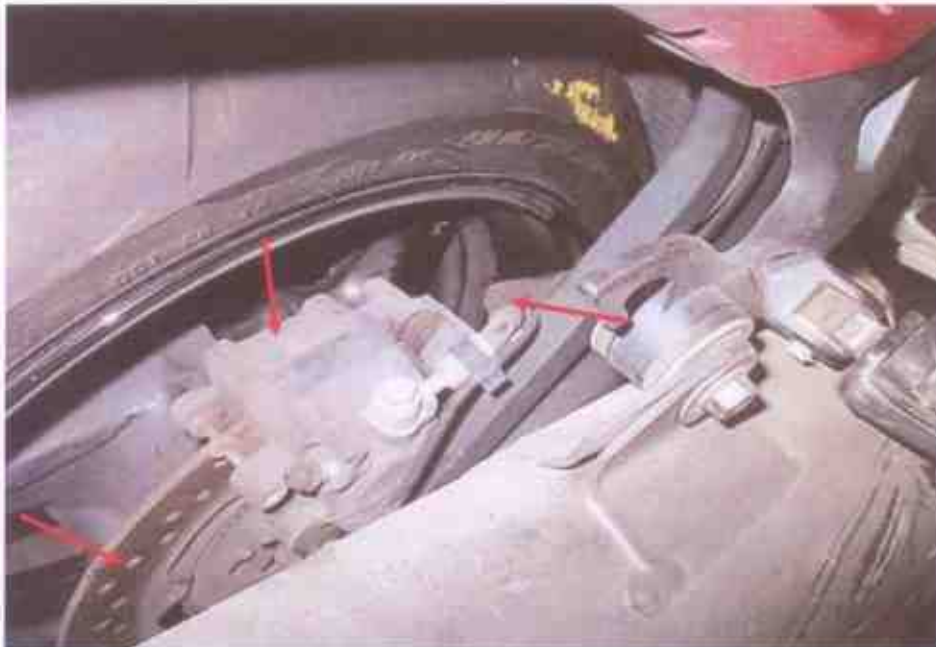
Photo 24 shows a close up view of the rear brake caliper, rear brake disc and rear brake hose (arrowed) of the Motorcycle, which are all part of the components in the hydraulic rear brake system of the Motorcycle. Our visual checks of these various components revealed all to be intact with no visible damage. No leakage of brake fluid was also observed.
