Affiliated to Federation Internationale Des Experts En Automobile				
AIG ASIA PACIFIC INSURANCE PTE LTD		Ref : CS3/LCR17010953/qb-1		
78 SHENTON WAY #08-16 CHARTIS BUILDINGS SINGAPORE 079120		Date : 05-02-2018		 
		Code : LCR

1. Policy Particulars :- THIRD PARTY CLAIM				
Insured Veh.	SLG 2500G	Veh. Inspected	SJR 3172D	
Policy No.		Coverage (\$)	0.00	
Claim No.	4716038108SG003	Excess (\$)	0.00	
Assign From	KHOO KAY ENG	Assign Date	02/02/2018

VEHICLE DAMAGE INSPECTION REPORT

ADJUSTMENT ON REPAIR COST FOR VEHICLE NO. SJR 3172D

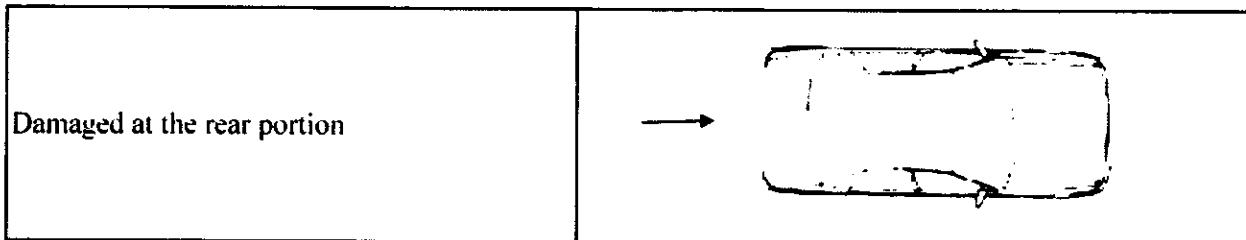
POINT OF IMPACT

Our visual inspection of the vehicle revealed that the damages noted are at the rear portion.

We have inspected the actual damages found on the vehicle and recommend the replacement of parts and repairs accordingly. The estimated repair cost is \$11,232.30. The repairer has agreed to undertake the repairs at our adjusted lump sum amount of \$7,900.
