# LKK Auto Consultants Pte Ltd

**PRELIMINARY ADVICE OF VEHICLE NO. YN 3741E**

## ADJUSTMENT ON REPAIR COST FOR VEHICLE NO. YN 3741E

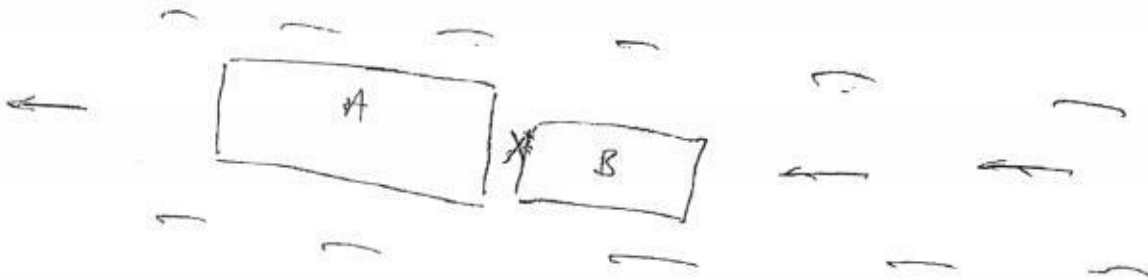
SKETCH PLAN

His Judge vehicle in front of me, not enough time to break as wet surface during that accident
