Your Ref: G0046683  
Our Ref :CS/AVI18002494/D

12 February 2018

**TECHNICAL INVESTIGATION REPORT OF FIRE INCIDENT INVOLVING THE  
INSURED VEHICLE SGG 2789A ON 02 FEBRUARY 2018**

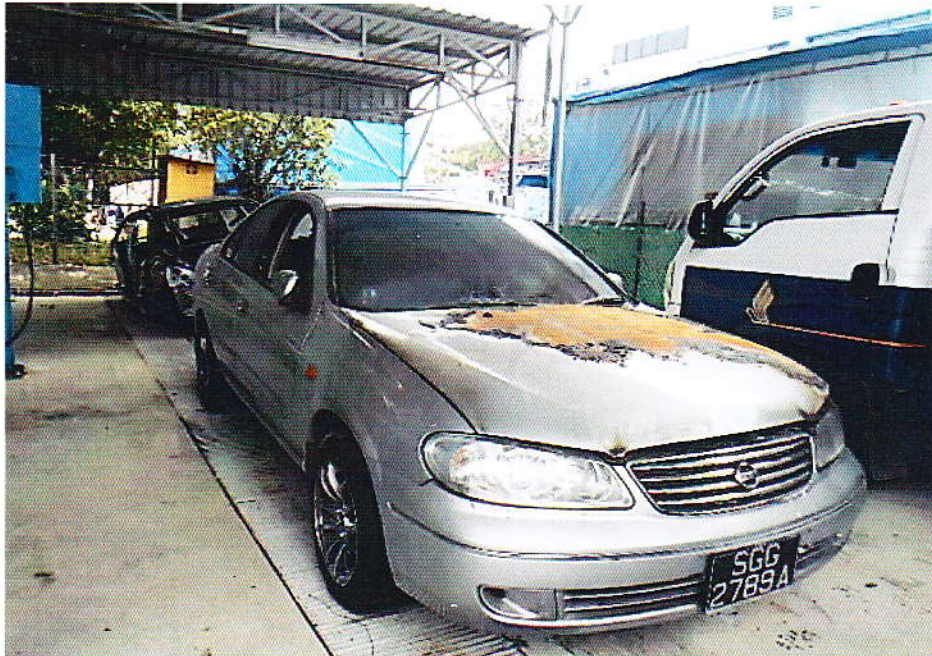
**Photo 1** shows a general view of the front right portion of the Insured Vehicle at the time of my inspection. The fire damage to the Insured Vehicle was confined to its frontal portion. Its front bumper, front bonnet, front grille, front right headlamp and front right fender were amongst the body parts that were found to have been affected as a result of the fire.

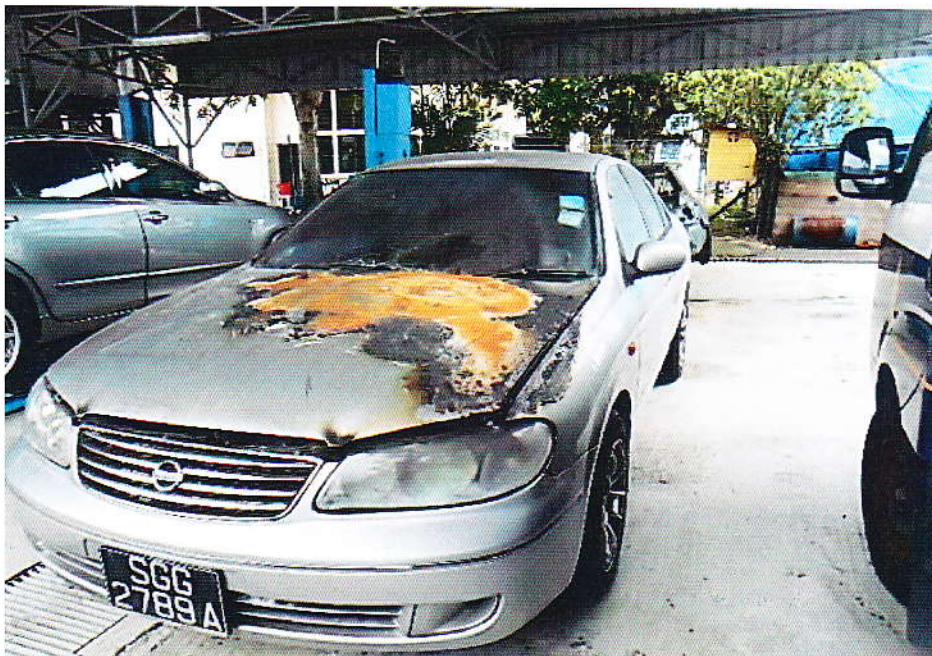
**Photo 2** shows a general view of the front left portion of the Insured Vehicle at the time of my inspection. The fire damage to the Insured Vehicle was confined to its front portion. Its front bumper, front bonnet, front left headlamp and front left fender were amongst the body parts that were found to have been affected as a result of the fire.

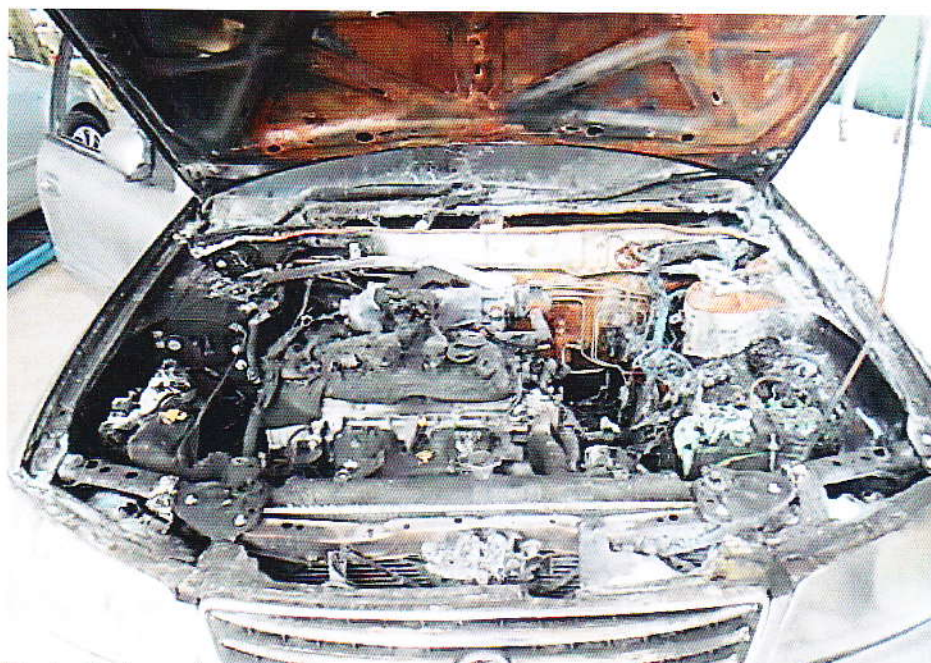
**Photo 3** shows the engine compartment of the Insured Vehicle at the time of my inspection. The entire engine compartment of the Insured Vehicle was observed to be severely burnt. Most of the parts inside the engine compartment were found to be burnt and/or melted as a result of the fire.

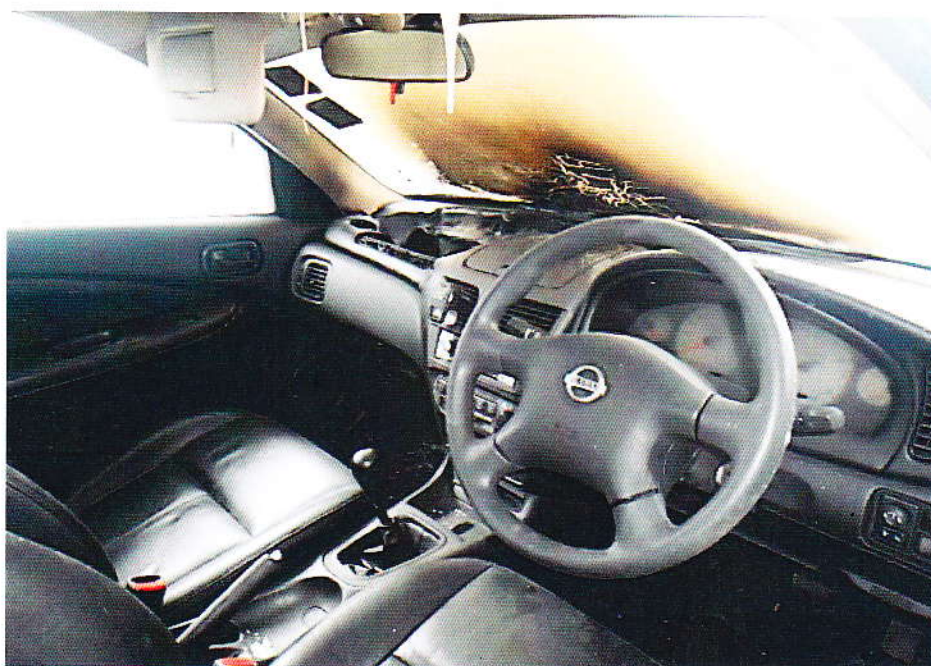
**Photo 4** shows the interior compartment of the Insured Vehicle, which was observed to be partially burnt and/or melted. The front dashboard and roof upholstery were amongst the parts that were found to have been burnt and/or melted as a result of the fire.

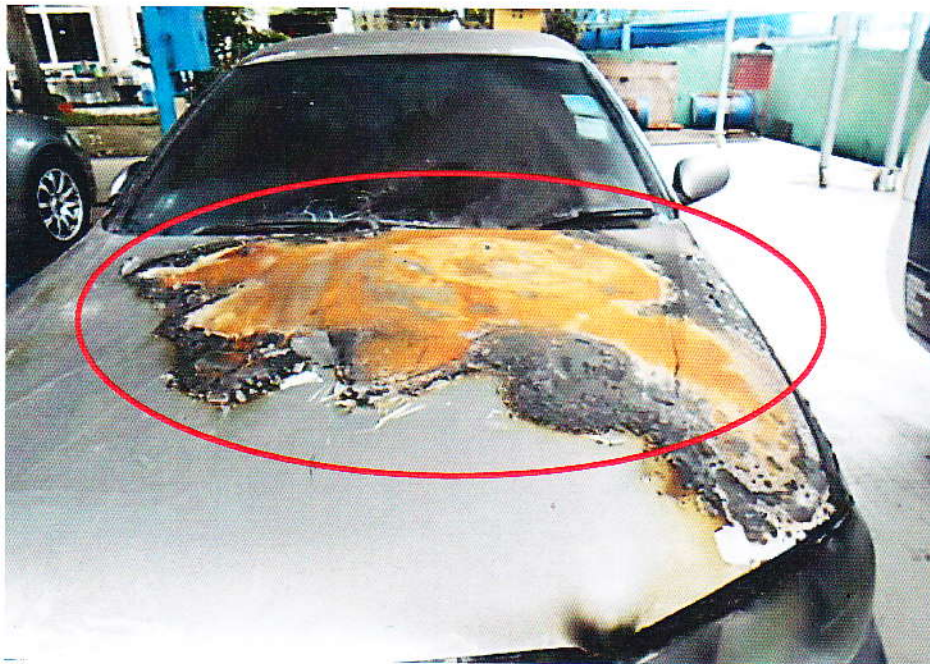
8. For this particular case, the fire appears to have originated within the engine compartment of the Insured Vehicle, somewhere around the left and towards the rear of the engine compartment. This can be determined from the burn pattern and the rust that had developed on the front bonnet of the Insured Vehicle, at both its top and under side.
9. The presence of rust on a steel/metal material body panel of a vehicle that was involved in a fire incident is a consequence of that body panel being exposed to natural environmental condition after the layers of paint and its related compounds were melted due to prolong exposure of that particular body panel to high heat intensity. Such physical evidence can hence be used to determine the origin of the fire. See photo 5 - 7 below.

**Photo 5** shows the rust (circled) that was found on the top side of the front bonnet of the Insured Vehicle. The presence of rust on a steel/metal material body panel of a vehicle that was involved in a fire incident is a consequence of that body panel being exposed to natural environmental condition after the layers of paint and its related compounds were melted due to prolong exposure of high heat intensity to that body panel. Such physical evidence can normally indicate where the fire of a vehicle had originated.

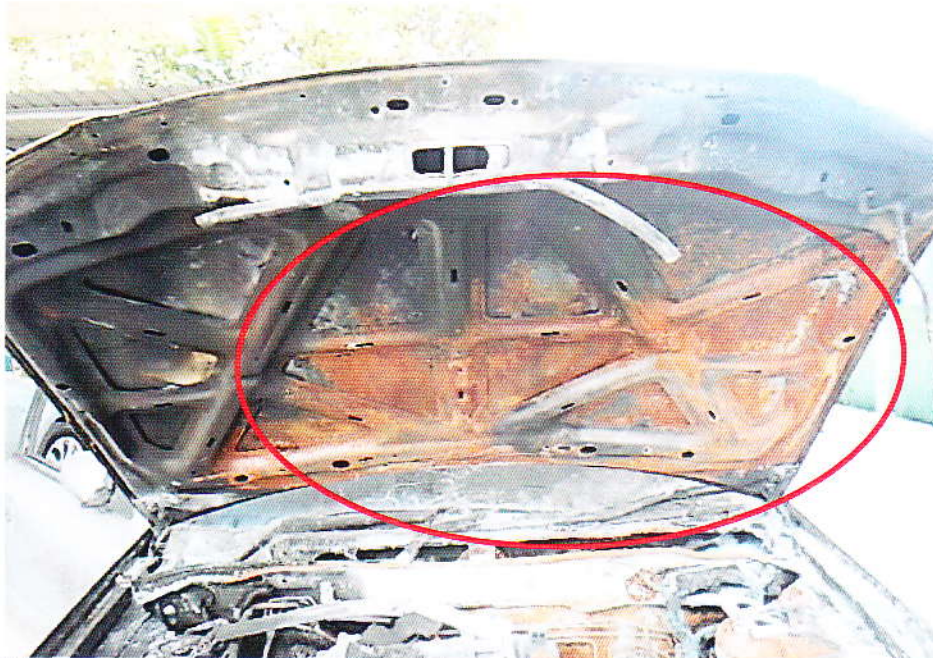
**Photo 6** shows the rust (circled) that was found on the underside of the front bonnet of the Insured Vehicle, directly under the area of the top side of the front bonnet, where rust had also developed.

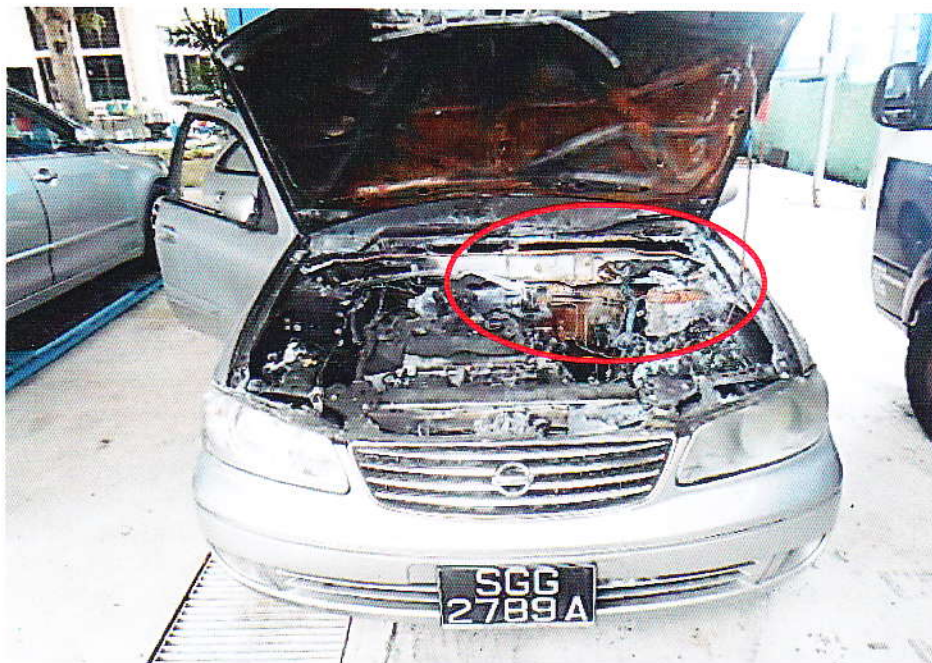
**Photo 7** shows a general view of where the fire to the Insured Vehicle had originated, which was somewhere around the left and towards the rear of the engine compartment (circled). This was established given the localized area on the Insured Vehicle where rust had developed.

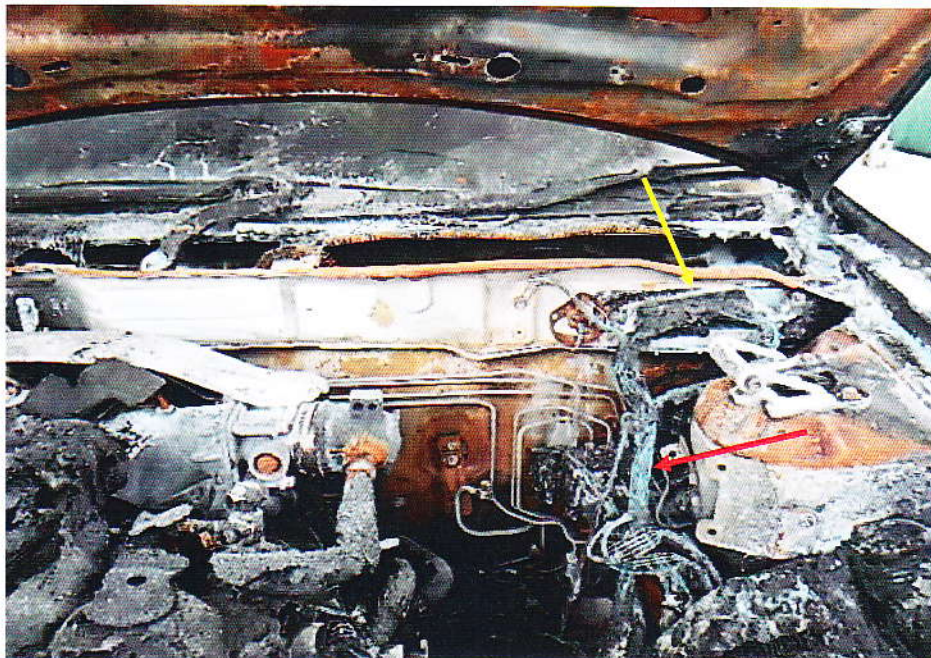
10. Upon closer examination of the area around the left rear of the engine compartment, which was where the fire to the Insured Vehicle had likely started, I had found greenish residue on several stretches of original factory fitted wirings leading towards the Engine Control Module (ECM) of the Insured Vehicle. The presence of greenish residue indicates internal heating of copper wires, a sign of an electrical short circuit occurring. The greenish residue is normally left behind from oxidation as a result of chemical reaction involving the copper wires. This physical evidence would then appear to suggest that the cause of fire to the Insured Vehicle could have possibly been due to electrical in nature. See photo 8 – 11 below

Photo 8 shows the wirings around the left rear of the engine compartment, which is in the immediate vicinity where the fire to the Insured Vehicle had likely started. Greenish residue was found on the wirings (red arrow) leading to the Engine Control Module (ECM) (yellow arrow). The presence of such greenish residue suggests occurrence of an electrical short circuit.

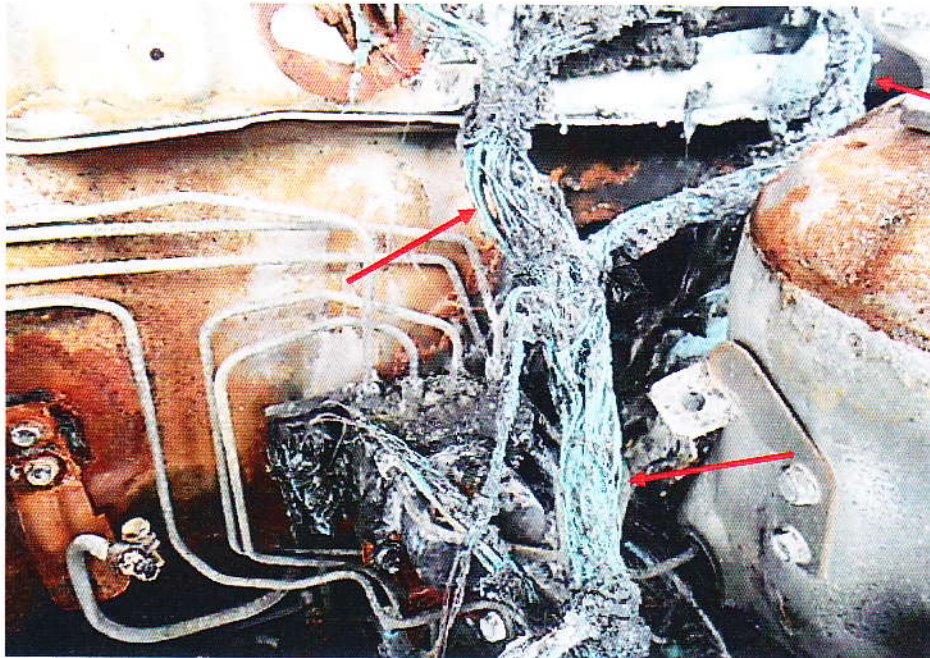
**Photo 9** shows the wirings with greenish residue (arrowed) leading to the Engine Control Module (ECM). The presence of such greenish residue suggests occurrence of an electrical short circuit.

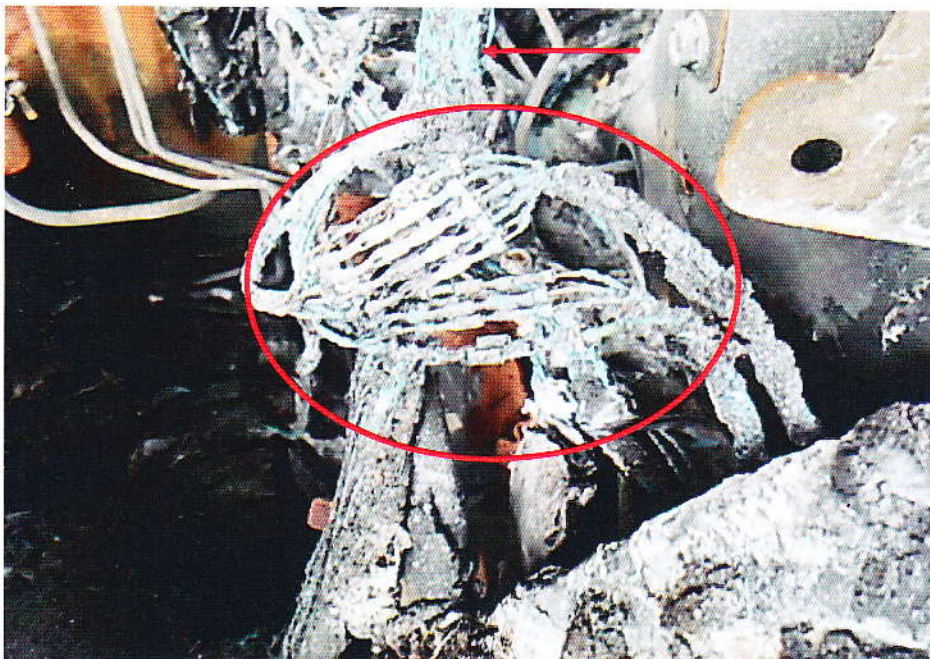
**Photo 10** shows another stretch of wirings with greenish residue (arrowed and circled) at the rear left area of the Insured Vehicle's engine compartment. The presence of such greenish residue suggests occurrence of an electrical short circuit.

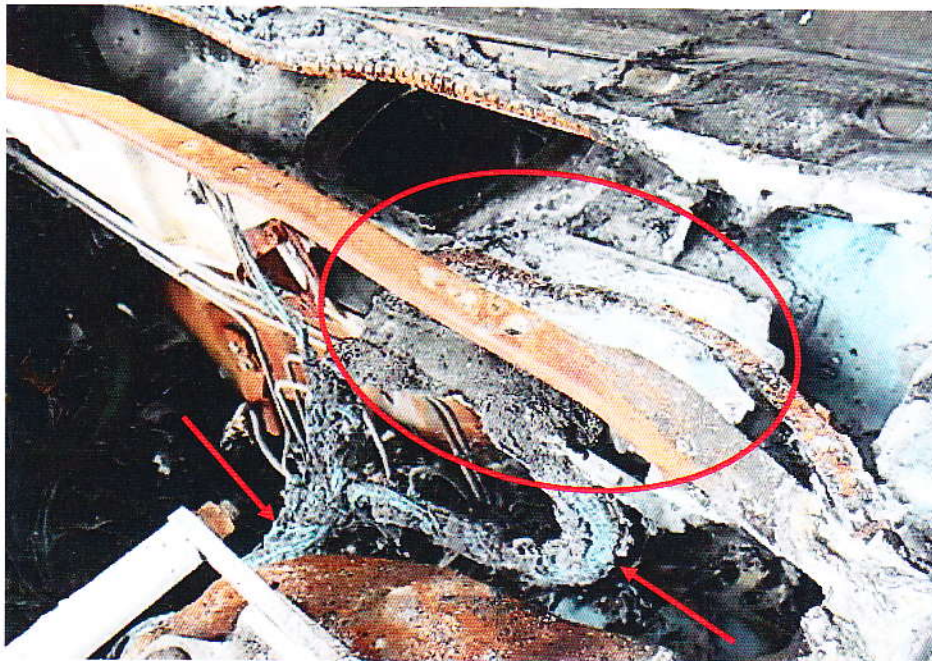
Photo 11 shows a closer view of the Engine Control Module (ECM) (circled). The wirings leading to this Engine Control Module (ECM) was found with greenish residue (arrowed) suggesting occurrence of an electrical short circuit.

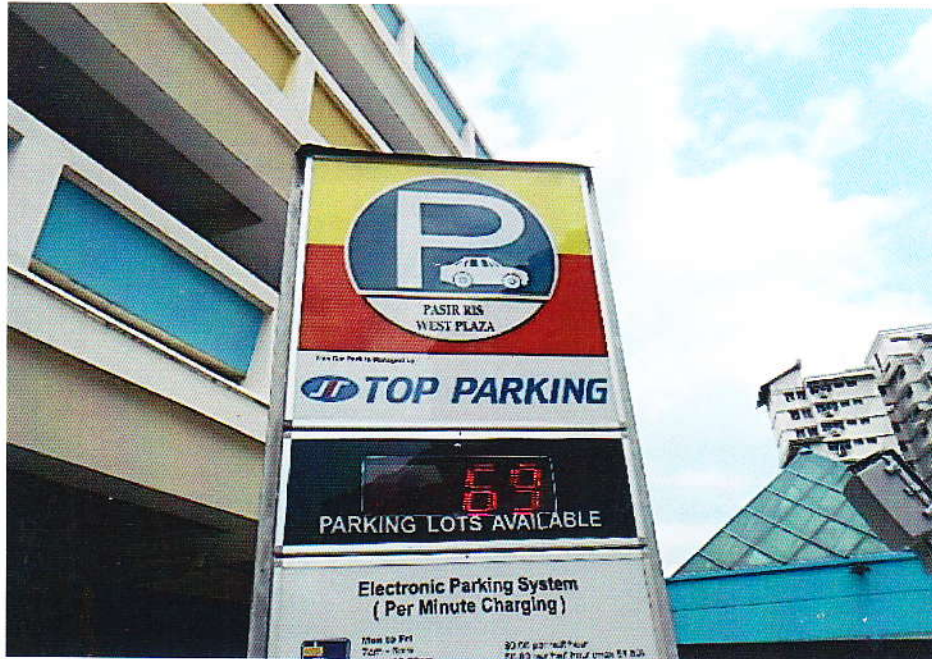
Photo 12 shows the location where the Insured Vehicle had caught fire. This was at Block 734 multi storey carpark of Pasir Ris West Plaza.

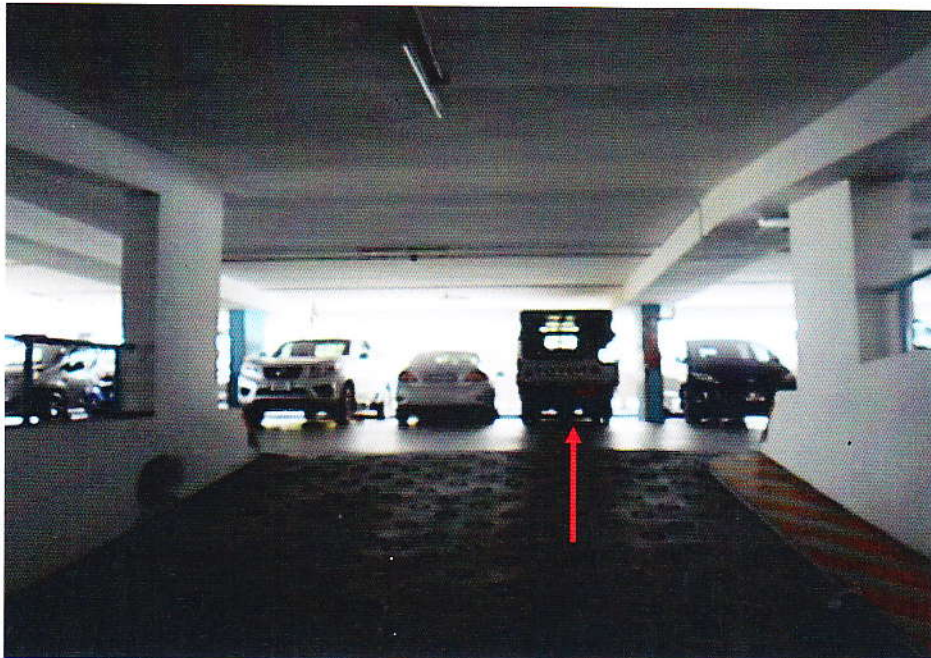
Photo 13 shows a general view of parking lot 43 (arrowed). The parking lot was observed to be directly facing the upslope ramp from deck C to deck D. The left side of the parking lot was a pillar while the right side was 2 other parking lots.

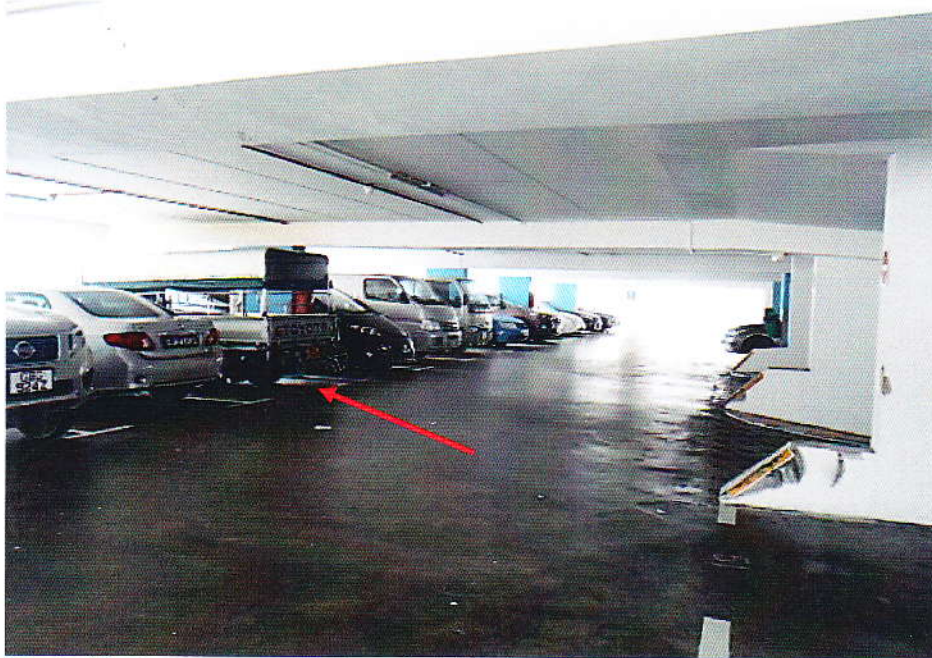
**Photo 14** shows a general view of parking lot 43 (arrowed). The parking lot was observed to be directly facing the upslope ramp from deck C to deck D. The left side of the parking lot was a pillar while the right side was 2 other parking lots.

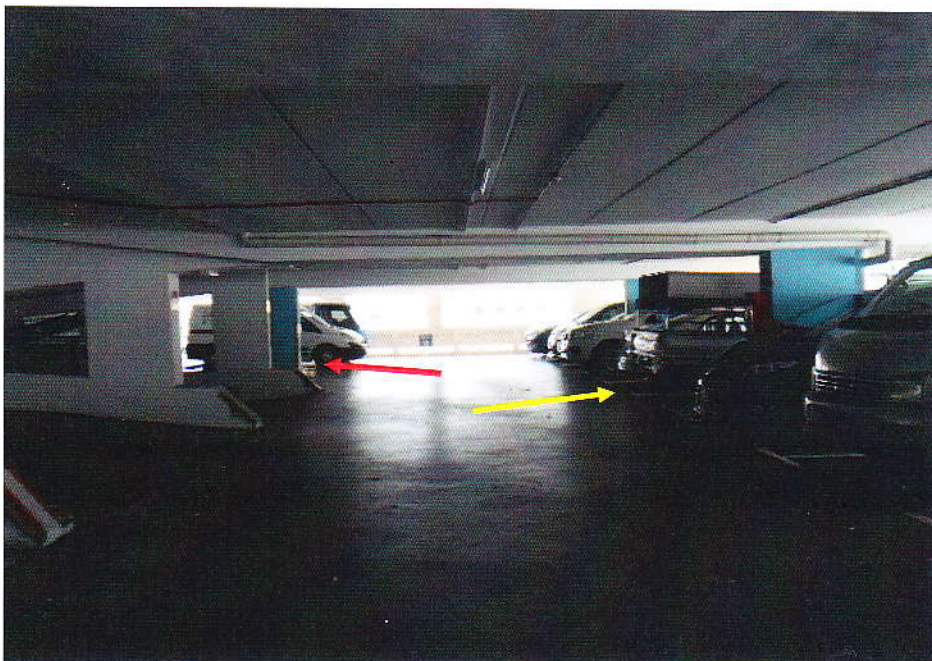
**Photo 15** shows a general view of parking lot 43 (yellow arrow). The parking lot was observed to be directly facing the upslope ramp from deck C to deck D. The lift lobby for deck D was also noted to be opposite and towards the right (red arrow) of the parking lot.
