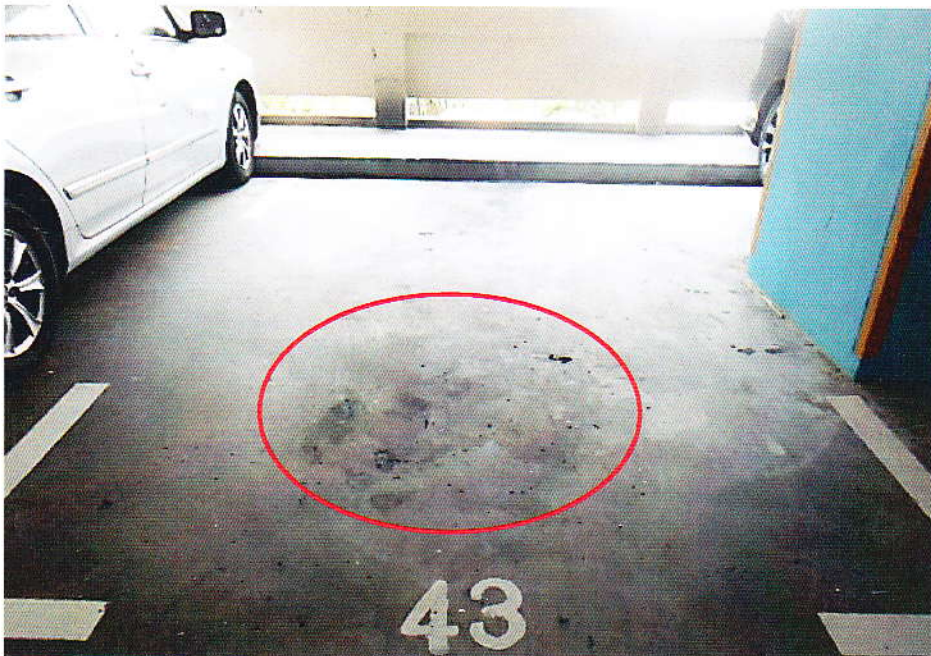
Photo 16 shows a general view of the slight burnt marks and burnt residual remains (circled) that were found within the parking lot. This was towards the front centre of the parking lot, where the Insured Vehicle was parked.

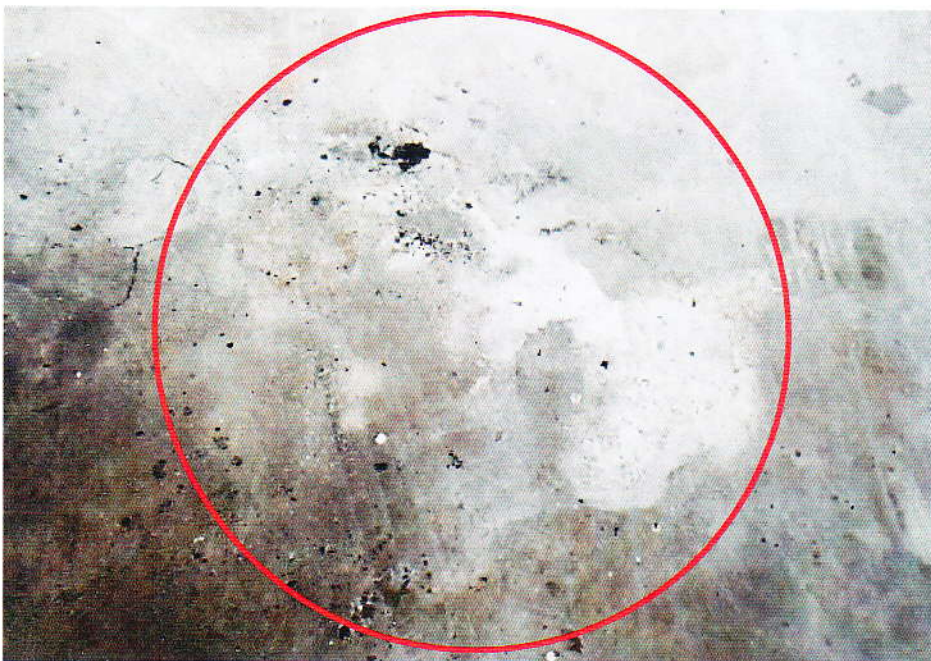
Photo 17 shows a closer view of the slight burnt marks and burnt residual remains (circled) that were found within the parking lot. This was towards the front centre of the parking lot, where the Insured Vehicle was parked.

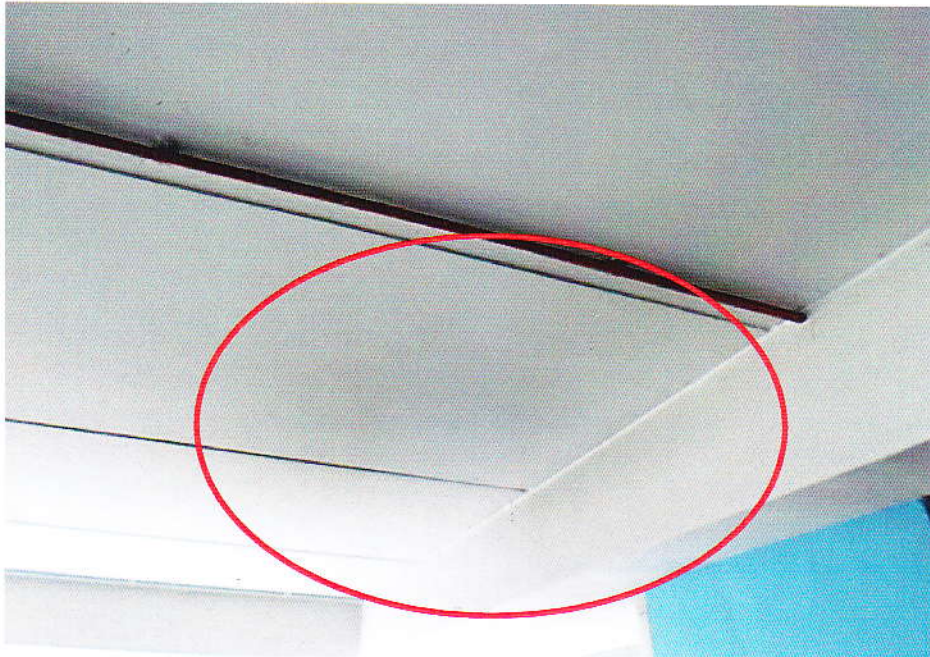
Photo 18 shows the slightly blackened ceiling (circled) that was directly above parking lot 43.

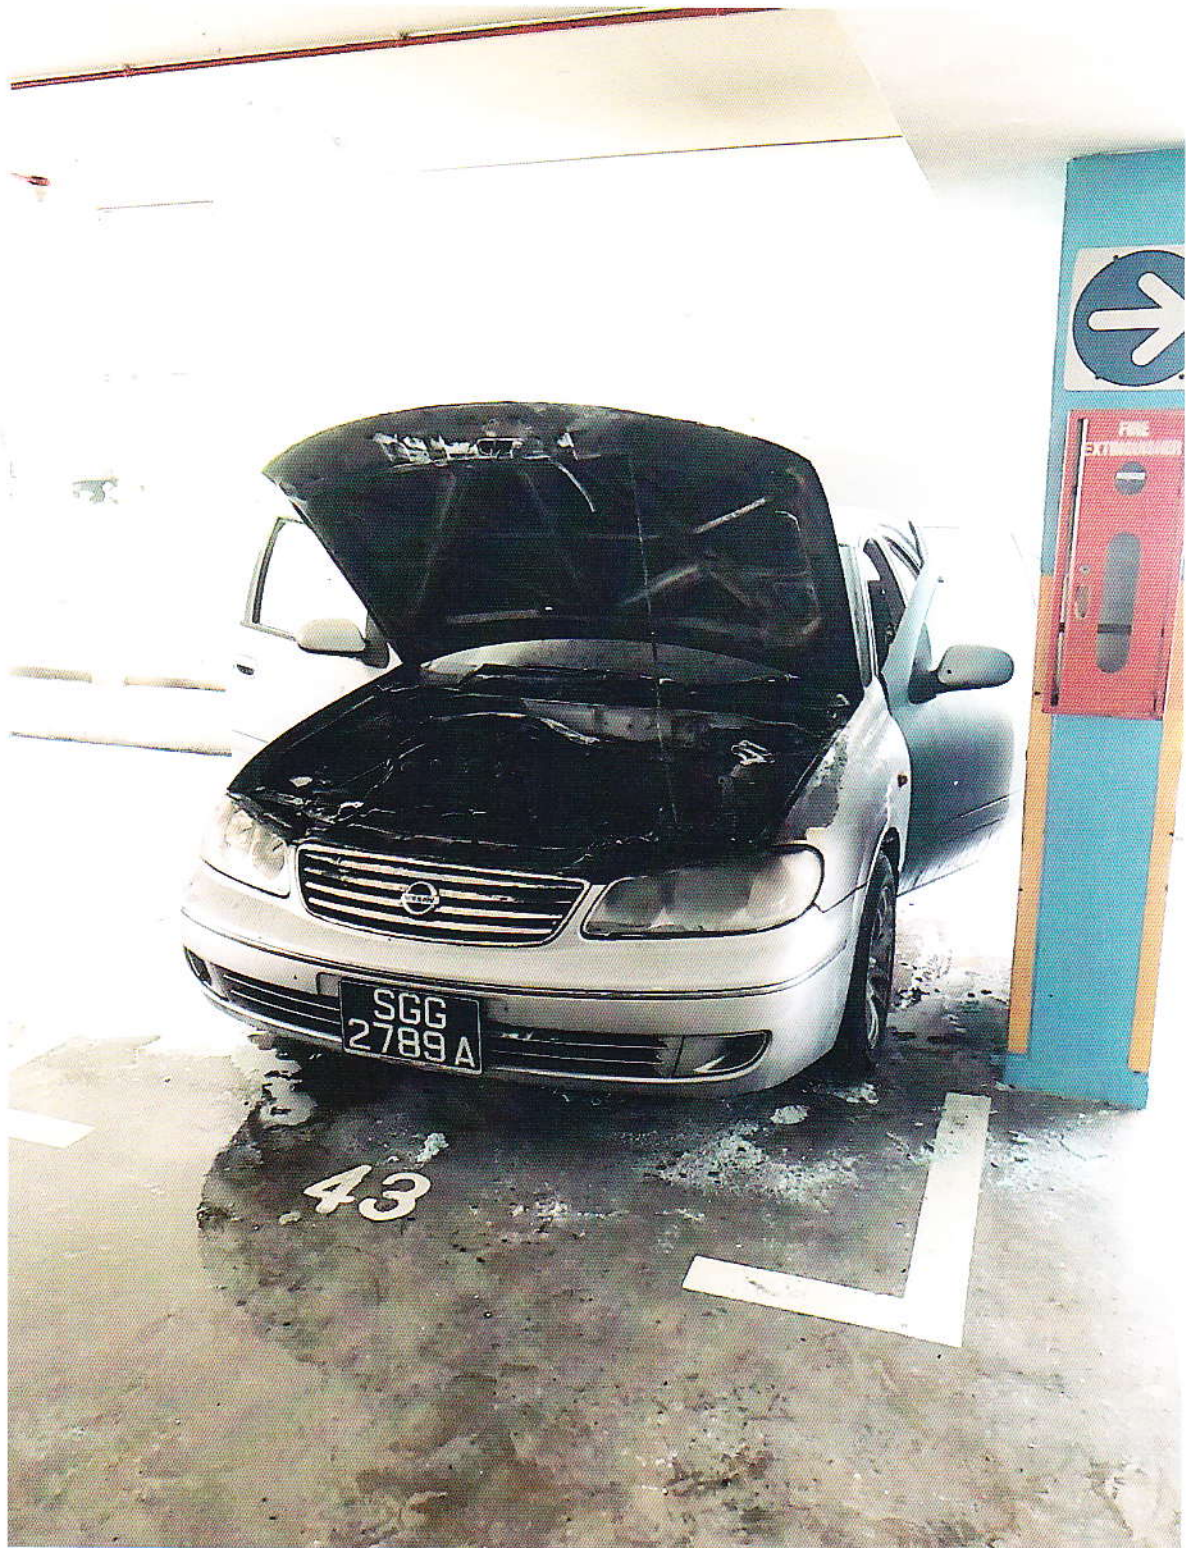
Photo 19 shows the Insured Vehicle at the incident scene before it was towed away. There appears to be no abnormal foreign material(s) and/or object(s) found on the ground in the immediate area where the Insured Vehicle was parked. In general, the information that could be gathered from these photographs had corresponded to the events that were related to me by Mr Leo.

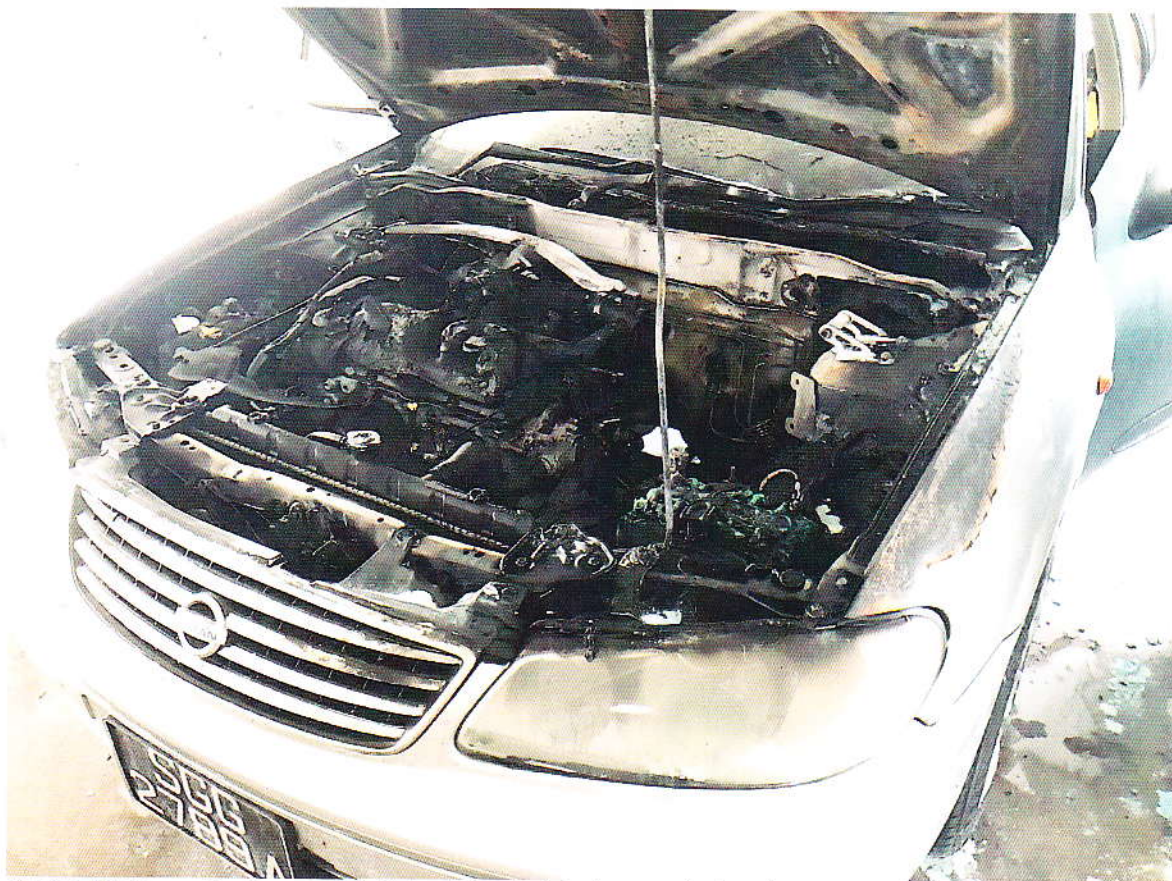
Photo 20 shows the Insured Vehicle at the incident scene before it was towed away. The damages of burnt nature to the Insured Vehicle was observed to be similar to the damages as seen during my inspection of the Insured Vehicle.
