Your Ref: G0046683  
Our Ref :CS/AVI18002494/D

12 February 2018

**Aviva Ltd**

**TECHNICAL INVESTIGATION REPORT OF FIRE INCIDENT INVOLVING THE INSURED VEHICLE SGG 2789A ON 02 FEBRUARY 2018**

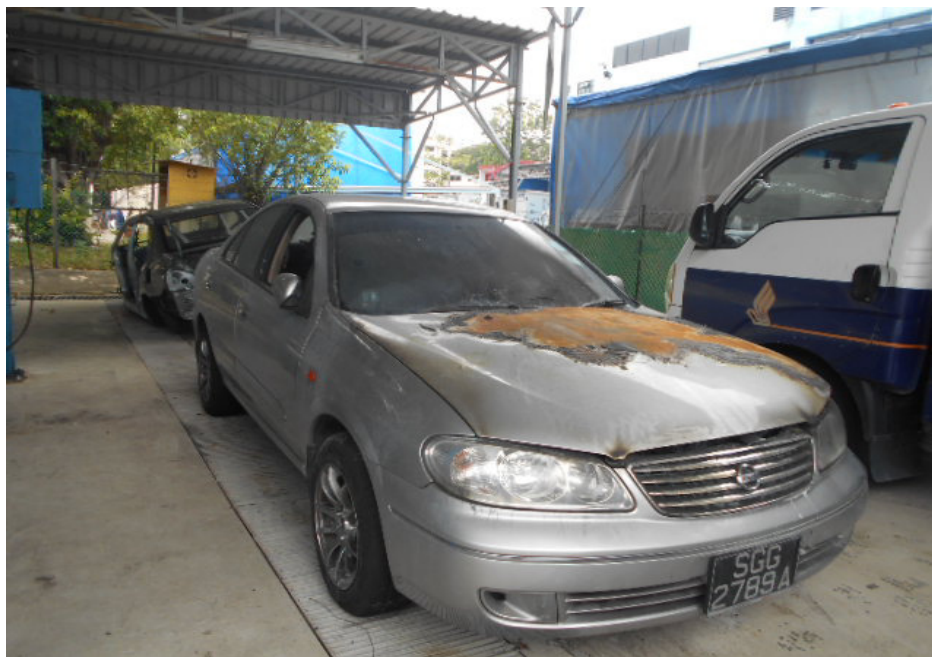
**Photo 1** shows a general view of the front right portion of the Insured Vehicle at the time of my inspection. The fire damage to the Insured Vehicle was confined to its frontal portion. Its front bumper, front bonnet, front grille, front right headlamp and front right fender were amongst the body parts that were found to have been affected as a result of the fire.

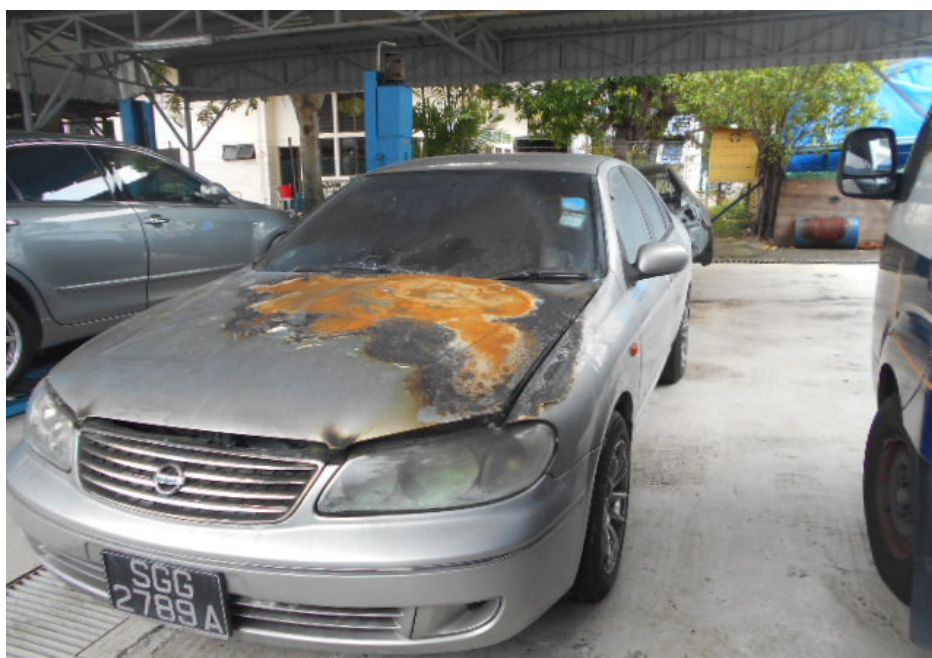
**Photo 2** shows a general view of the front left portion of the Insured Vehicle at the time of my inspection. The fire damage to the Insured Vehicle was confined to its front portion. Its front bumper, front bonnet, front left headlamp and front left fender were amongst the body parts that were found to have been affected as a result of the fire.

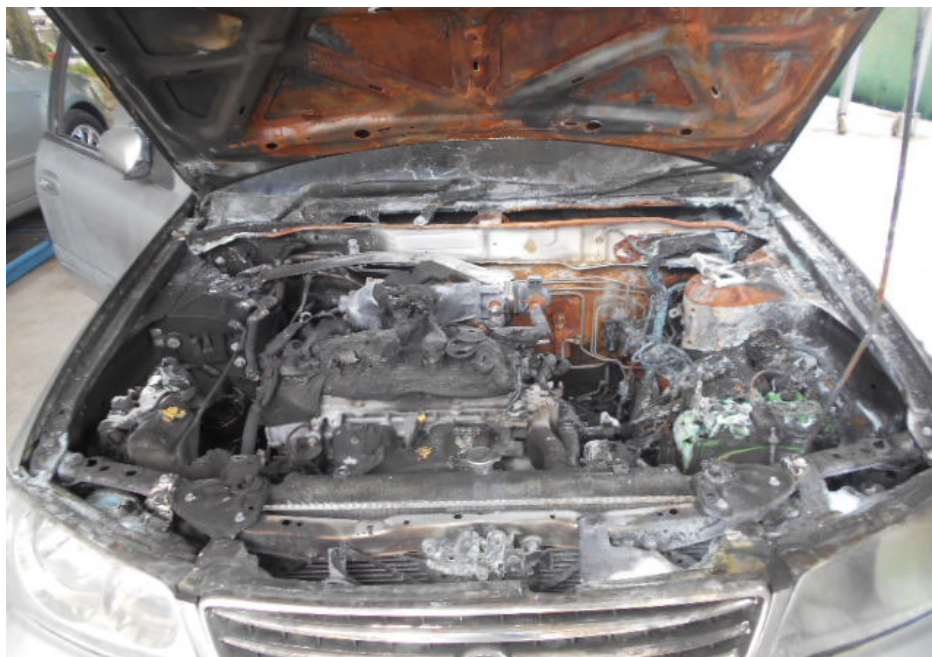
**Photo 3** shows the engine compartment of the Insured Vehicle at the time of my inspection. The entire engine compartment of the Insured Vehicle was observed to be severely burnt. Most of the parts inside the engine compartment were found to be burnt and/or melted as a result of the fire.

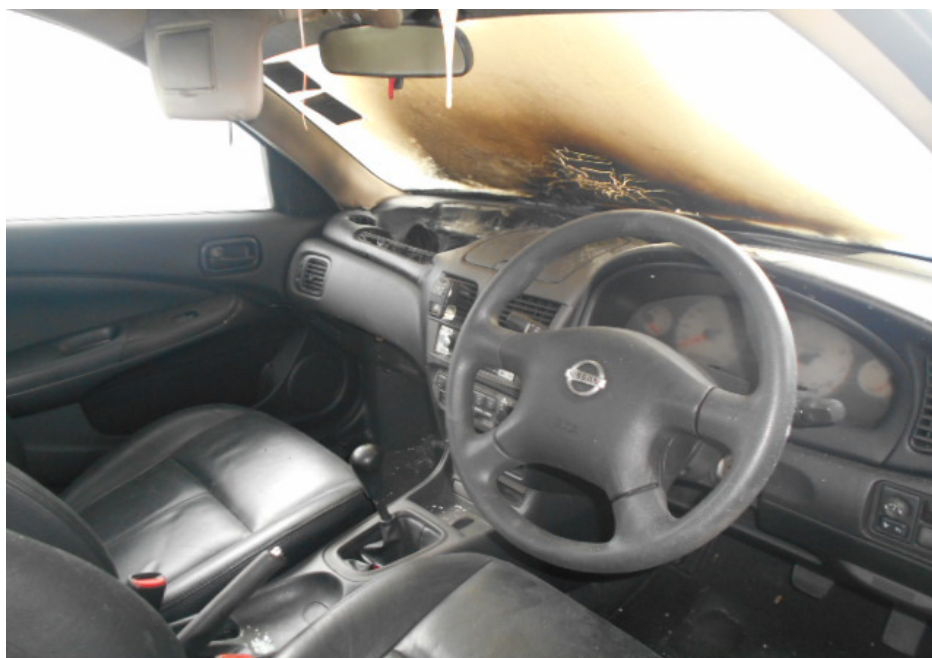
**Photo 4** shows the interior compartment of the Insured Vehicle, which was observed to be partially burnt and/or melted. The front dashboard and roof upholstery were amongst the parts that were found to have been burnt and/or melted as a result of the fire.

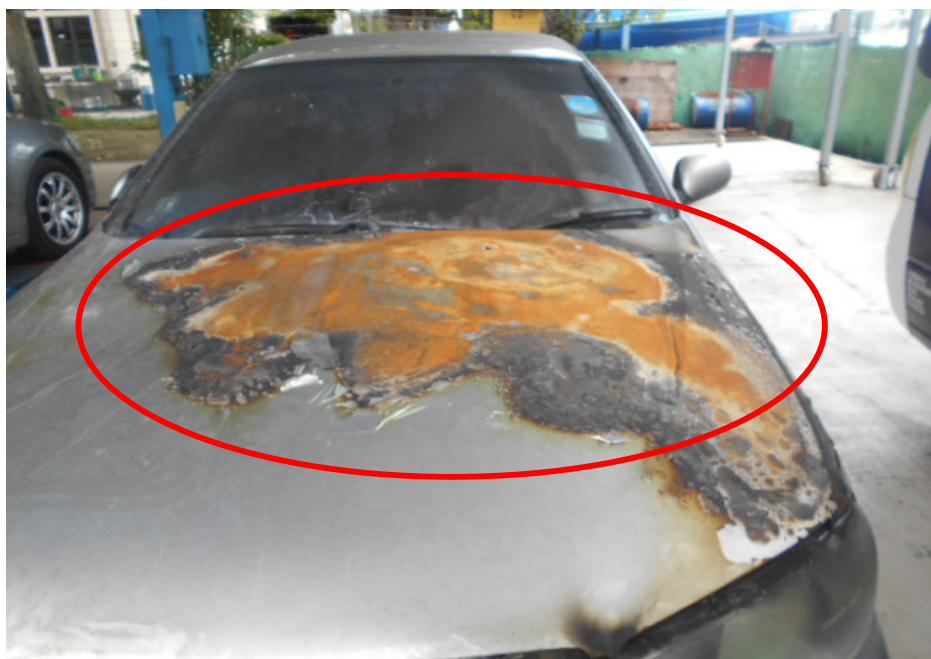
8. For this particular case, the fire appears to have originated within the engine compartment of the Insured Vehicle, somewhere around the left and towards the rear of the engine compartment. This can be determined from the burn pattern and the rust that had developed on the front bonnet of the Insured Vehicle, at both its top and under side.
9. The presence of rust on a steel/metal material body panel of a vehicle that was involved in a fire incident is a consequence of that body panel being exposed to natural environmental condition after the layers of paint and its related compounds were melted due to prolong exposure of that particular body panel to high heat intensity. Such physical evidence can hence be used to determine the origin of the fire. See photo 5 - 7 below.

**Photo 5** shows the rust (circled) that was found on the top side of the front bonnet of the Insured Vehicle. The presence of rust on a steel/metal material body panel of a vehicle that was involved in a fire incident is a consequence of that body panel being exposed to natural environmental condition after the layers of paint and its related compounds were melted due to prolong exposure of high heat intensity to that body panel. Such physical evidence can normally indicate where the fire of a vehicle had originated.

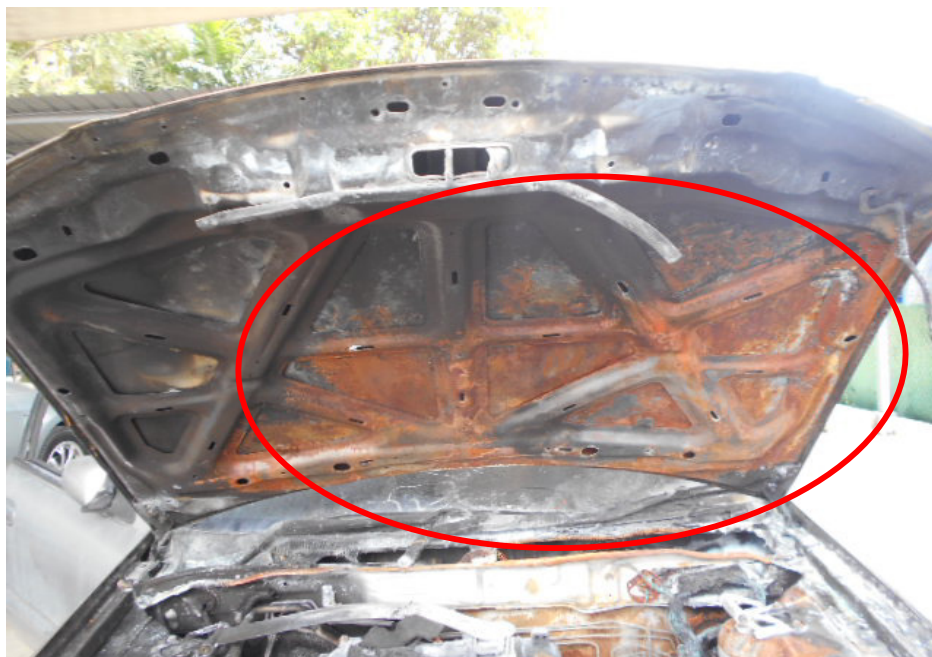
**Photo 6** shows the rust (circled) that was found on the underside of the front bonnet of the Insured Vehicle, directly under the area of the top side of the front bonnet, where rust had also developed.

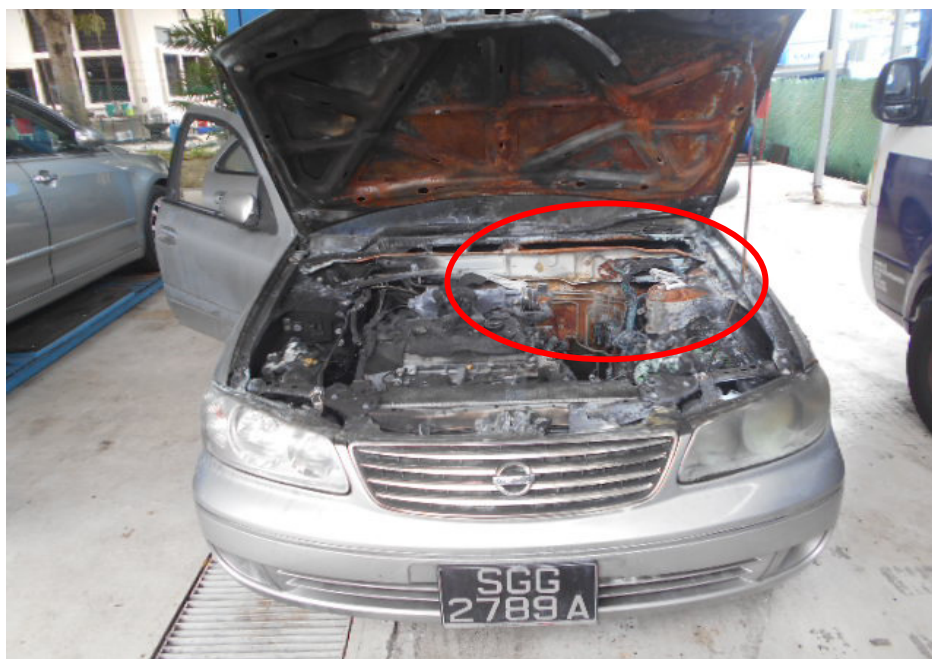
**Photo 7** shows a general view of where the fire to the Insured Vehicle had originated, which was somewhere around the left and towards the rear of the engine compartment (circled). This was established given the localized area on the Insured Vehicle where rust had developed.

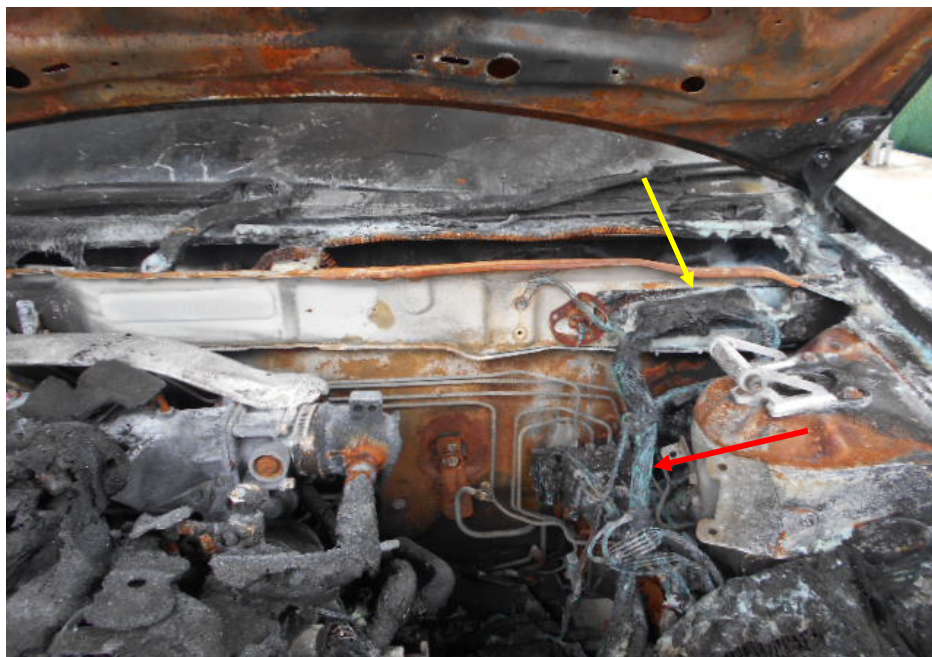
10. Upon closer examination of the area around the left rear of the engine compartment, which was where the fire to the Insured Vehicle had likely started, I had found greenish residue on several stretches of original factory fitted wirings leading towards the Engine Control Module (ECM) of the Insured Vehicle. The presence of greenish residue indicates internal heating of copper wires, a sign of an electrical short circuit occurring. The greenish residue is normally left behind from oxidation as a result of chemical reaction involving the copper wires. This physical evidence would then appear to suggest that the cause of fire to the Insured Vehicle could have possibly been due to electrical in nature. See photo 8 – 11 below

**Photo 8** shows the wirings around the left rear of the engine compartment, which is in the immediate vicinity where the fire to the Insured Vehicle had likely started. Greenish residue was found on the wirings (red arrow) leading to the Engine Control Module (ECM) (yellow arrow). The presence of such greenish residue suggests occurrence of an electrical short circuit.

30. Having investigated and technically analysed the damages of burnt nature to the Insured Vehicle, I am of the view that the cause of fire to the Insured Vehicle was of electrical in nature. For this particular case, the fire had originated along the wiring inside the engine compartment, somewhere around the left rear of the engine compartment. The wiring was an original factory wiring leading to the Engine Control Module (ECM) of the Insured Vehicle.

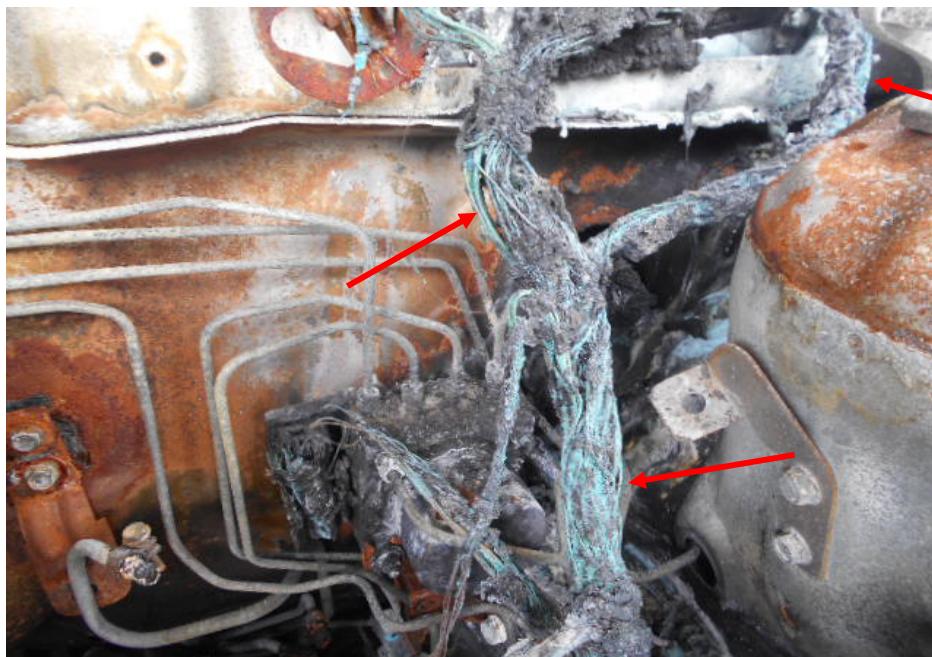
**Photo 9** shows the wirings with greenish residue (arrowed) leading to the Engine Control Module (ECM). The presence of such greenish residue suggests occurrence of an electrical short circuit.

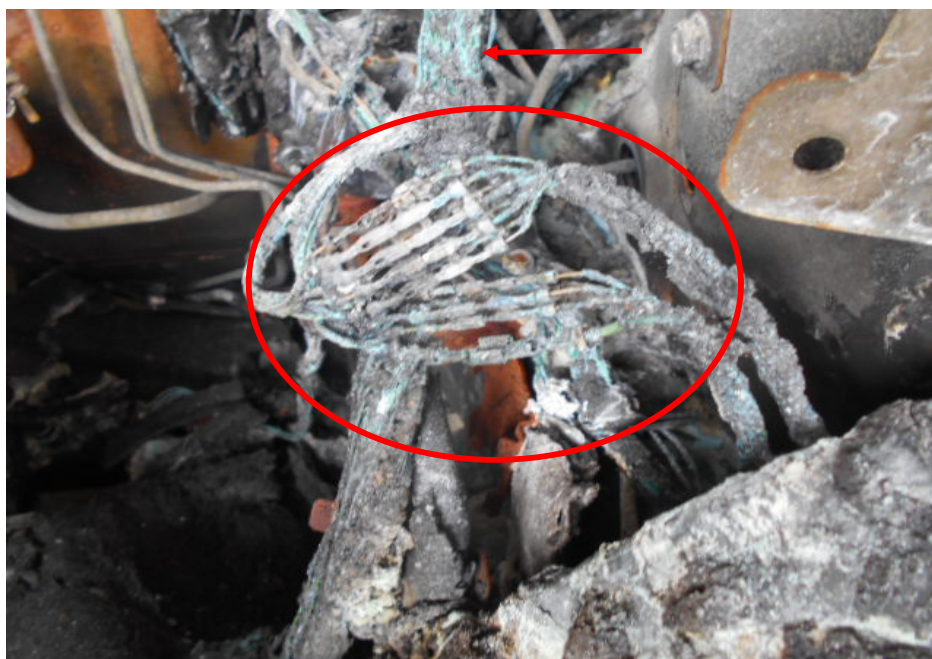
**Photo 10** shows another stretch of wirings with greenish residue (arrowed and circled) at the rear left area of the Insured Vehicle's engine compartment. The presence of such greenish residue suggests occurrence of an electrical short circuit.

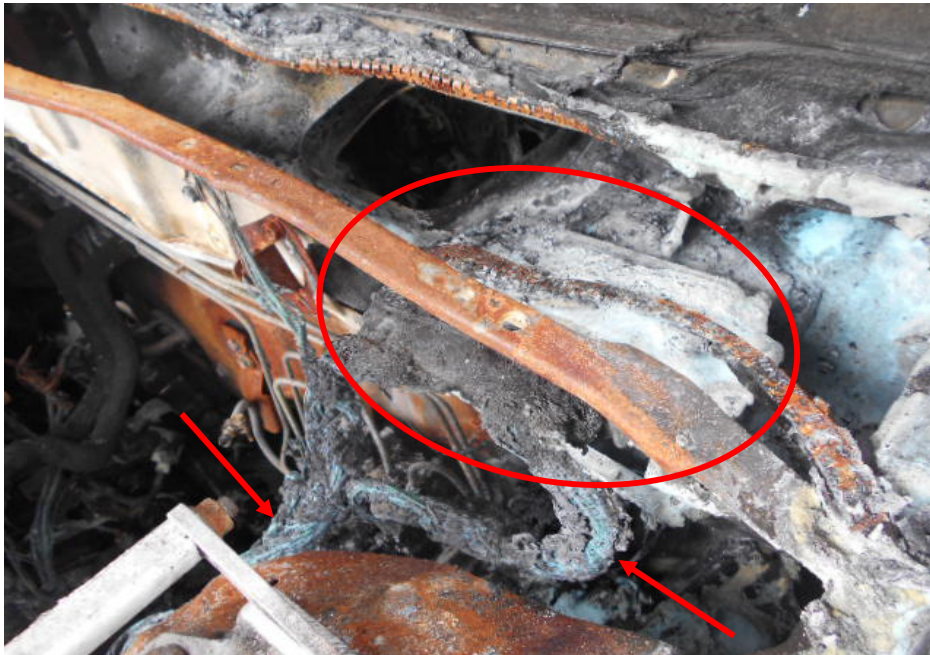
**Photo 11** shows a closer view of the Engine Control Module (ECM) (circled). The wirings leading to this Engine Control Module (ECM) was found with greenish residue (arrowed) suggesting occurrence of an electrical short circuit.

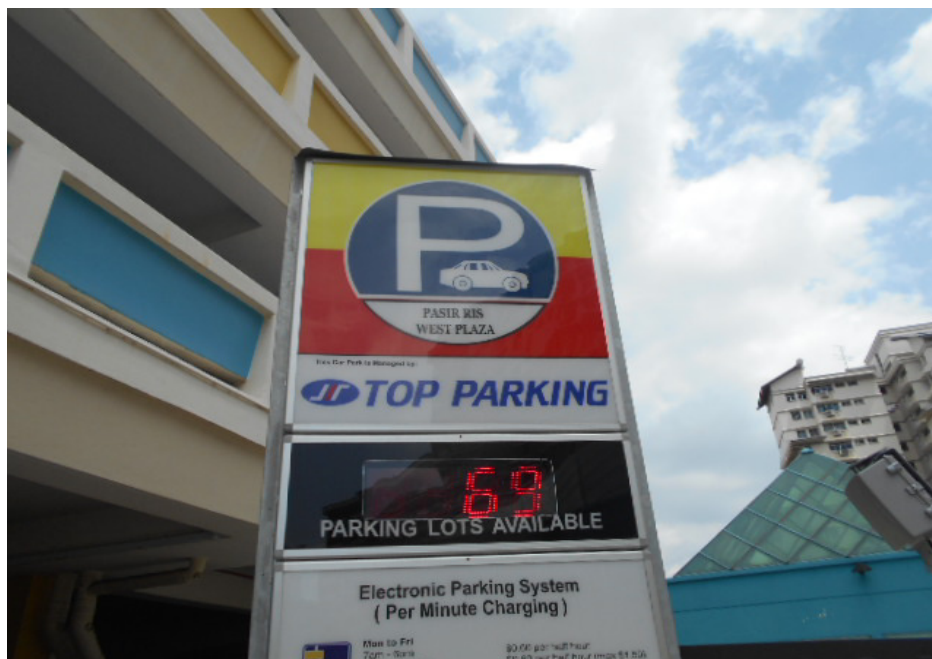
**Photo 12** shows the location where the Insured Vehicle had caught fire. This was at Block 734 multi storey carpark of Pasir Ris West Plaza.

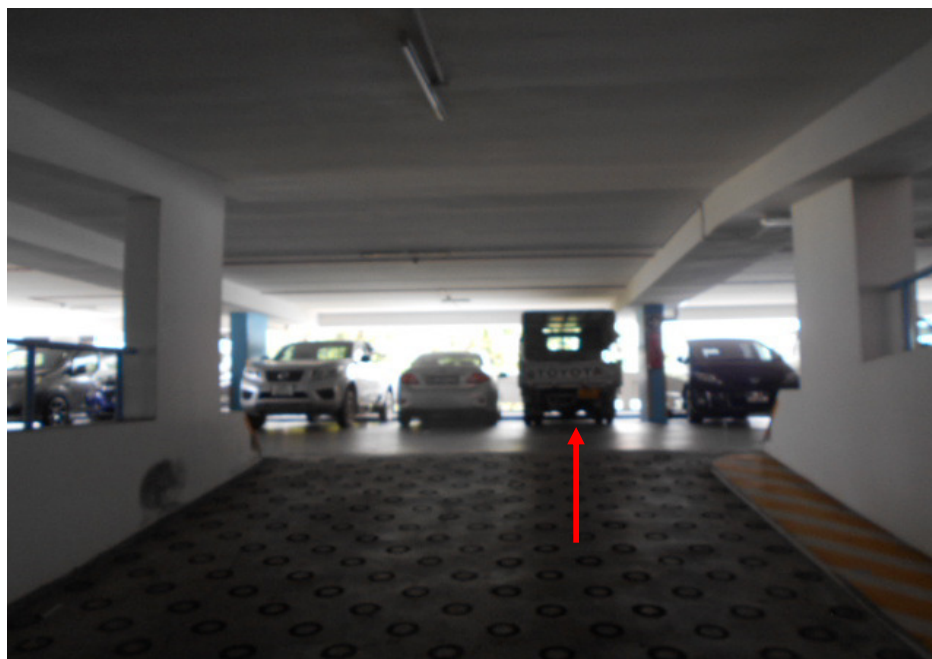
**Photo 13** shows a general view of parking lot 43 (arrowed). The parking lot was observed to be directly facing the upslope ramp from deck C to deck D. The left side of the parking lot was a pillar while the right side was 2 other parking lots.

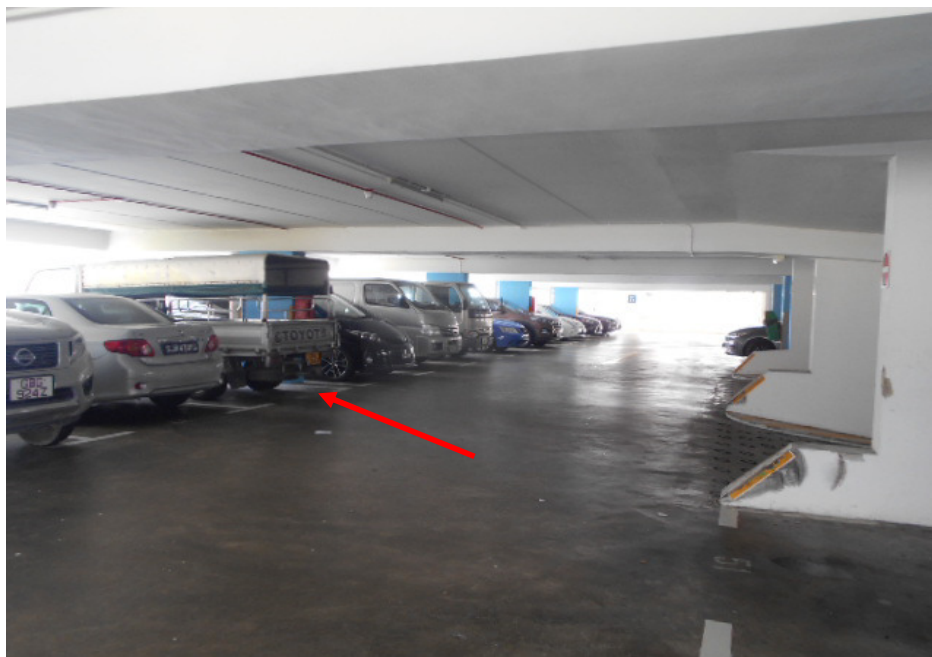
**Photo 14** shows a general view of parking lot 43 (arrowed). The parking lot was observed to be directly facing the upslope ramp from deck C to deck D. The left side of the parking lot was a pillar while the right side was 2 other parking lots.

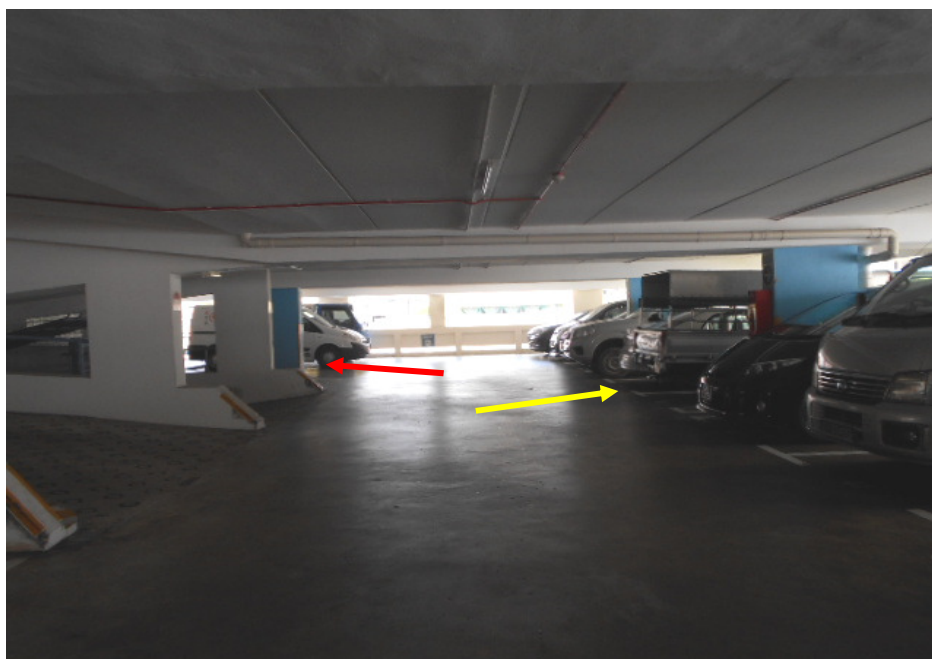
**Photo 15** shows a general view of parking lot 43 (yellow arrow). The parking lot was observed to be directly facing the upslope ramp from deck C to deck D. The lift lobby for deck D was also noted to be opposite and towards the right (red arrow) of the parking lot.

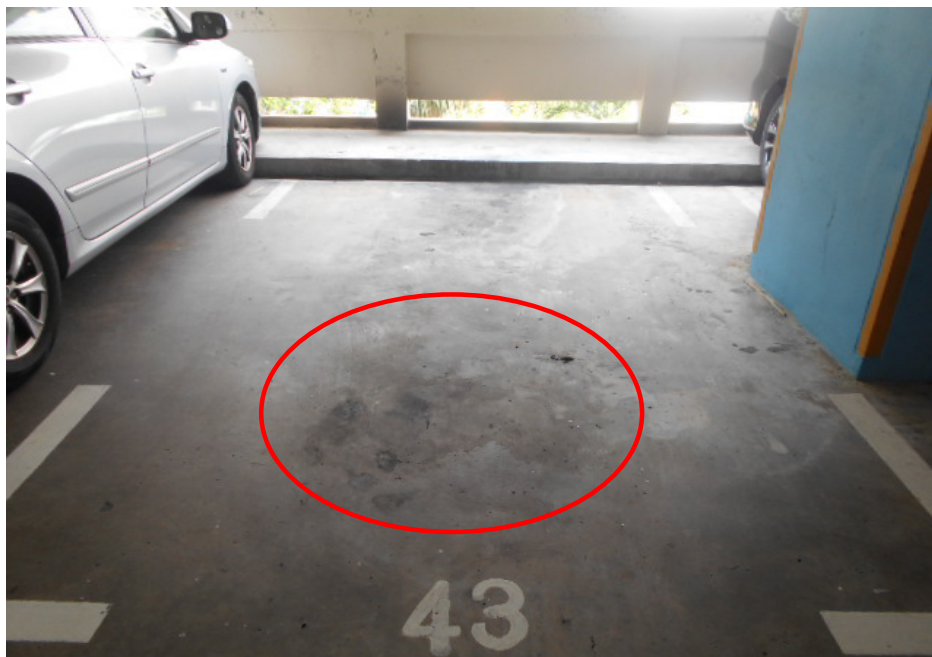
**Photo 16** shows a general view of the slight burnt marks and burnt residual remains (circled) that were found within the parking lot. This was towards the front centre of the parking lot, where the Insured Vehicle was parked.

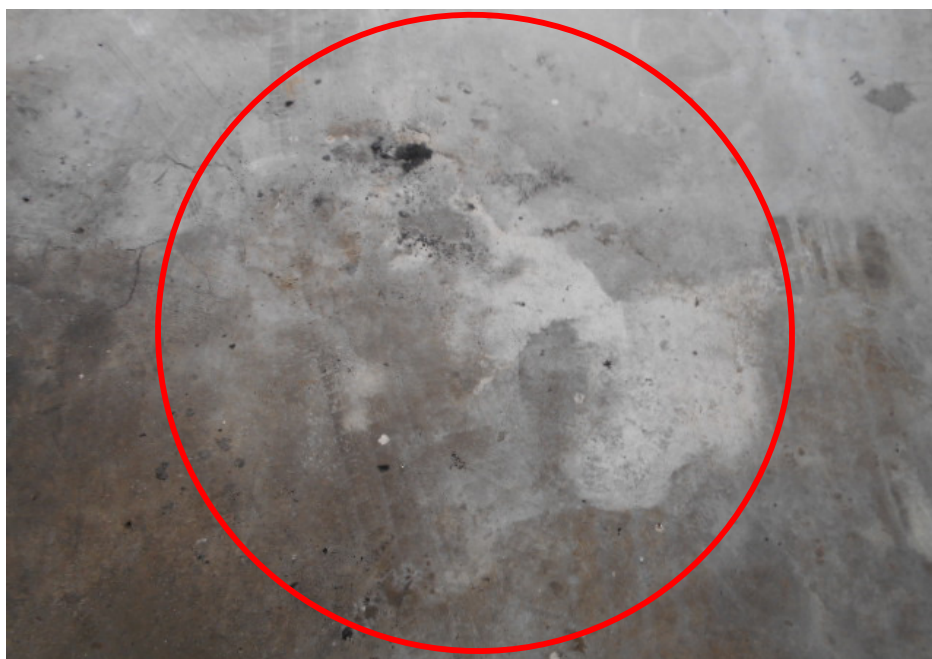
**Photo 17** shows a closer view of the slight burnt marks and burnt residual remains (circled) that were found within the parking lot. This was towards the front centre of the parking lot, where the Insured Vehicle was parked.

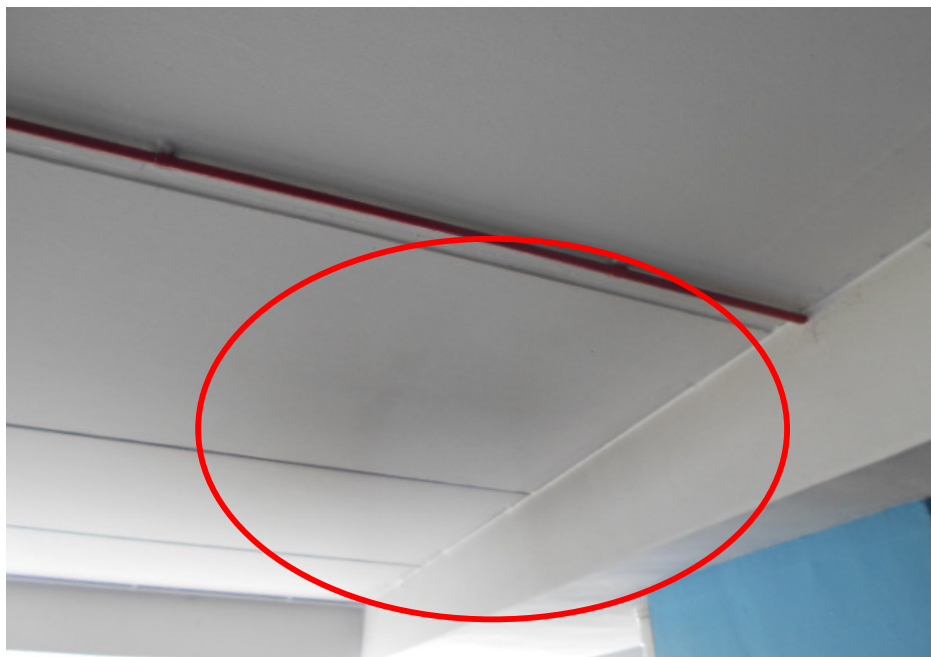
**Photo 18** shows the slightly blackened ceiling (circled) that was directly above parking lot 43.

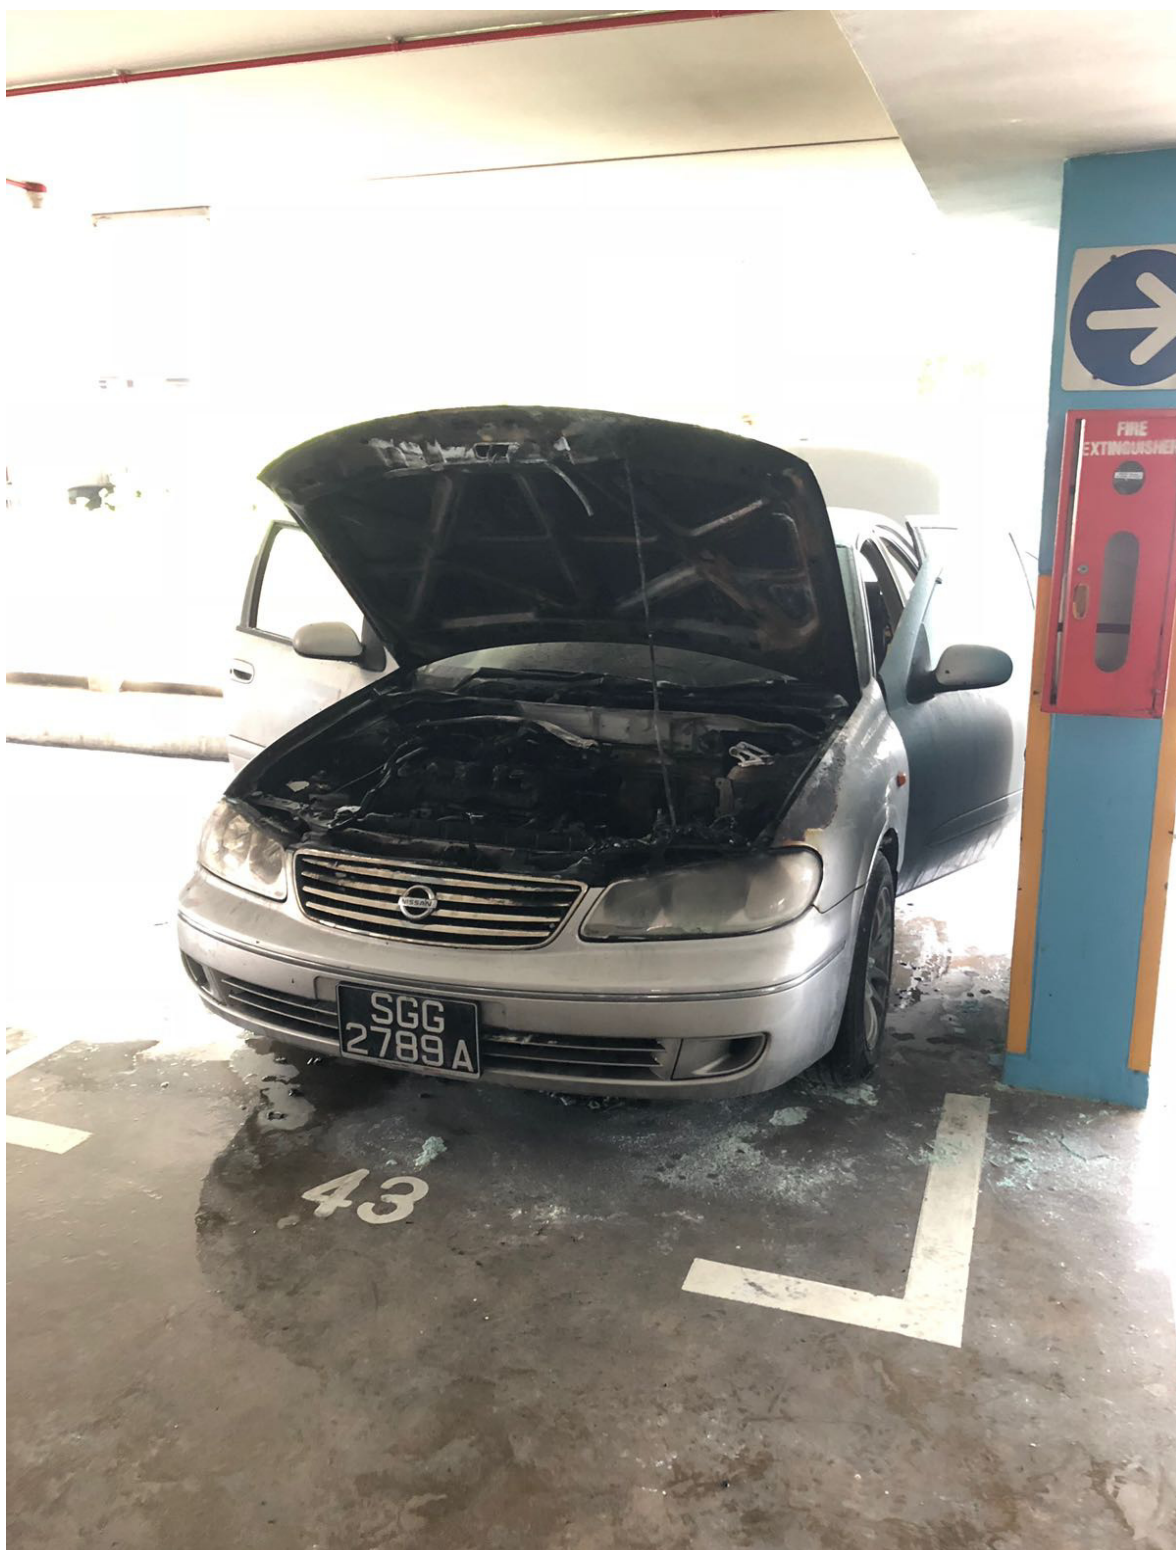
**Photo 19** shows the Insured Vehicle at the incident scene before it was towed away. There appears to be no abnormal foreign material(s) and/or object(s) found on the ground in the immediate area where the Insured Vehicle was parked. In general, the information that could be gathered from these photographs had corresponded to the events that were related to me by Mr Leo.

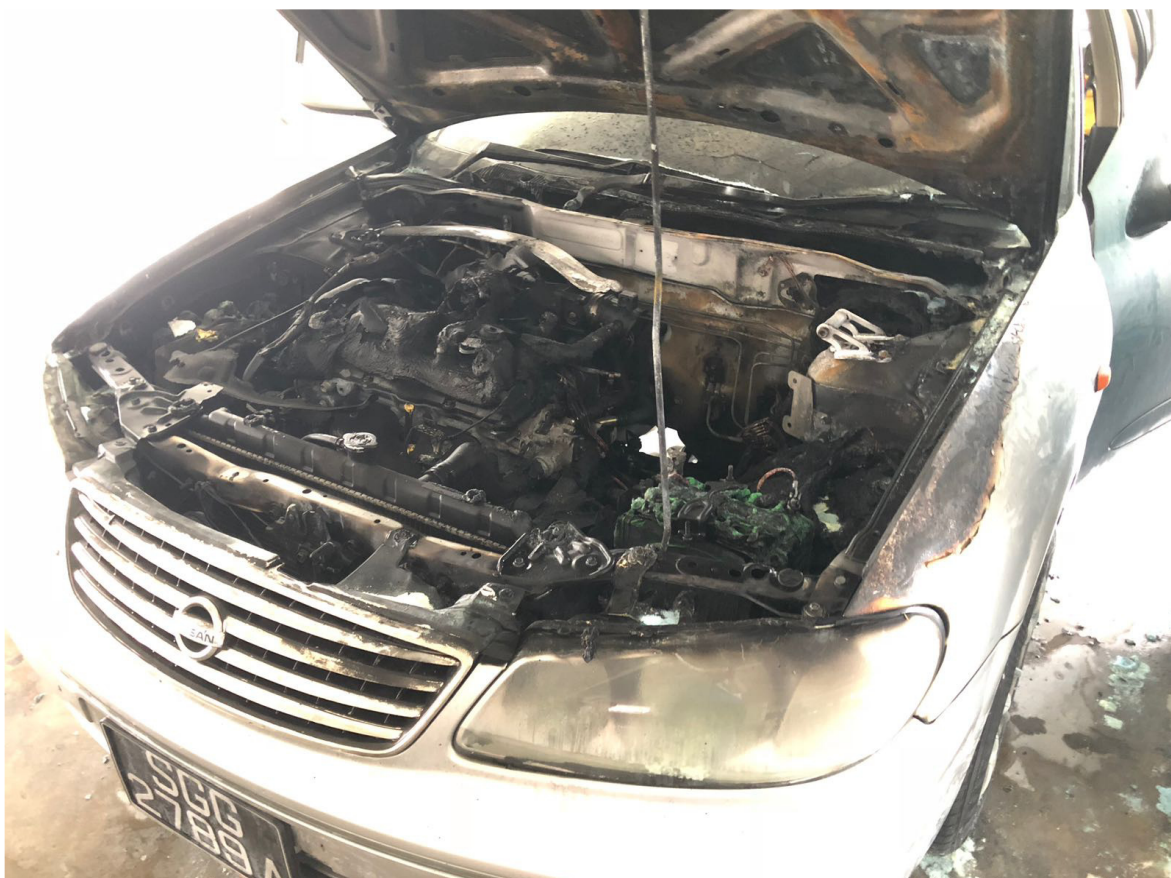
**Photo 20** shows the Insured Vehicle at the incident scene before it was towed away. The damages of burnt nature to the Insured Vehicle was observed to be similar to the damages as seen during my inspection of the Insured Vehicle.
