Insured:	TAN ZHI CHOON, ID: S8021355G		
Main Claimant:	LAU TAI HWEE, ID: S1195396D		
Vehicle Reg. No.:	SFB9969P	Date of Loss:	07/02/2018 00:00 - :59
Claim Type:	TP / 548877	Policy/Cover Note No.:	28965019SMA (Comprehensive) Coverage: 28/06/2017 - 27/06/2018
Vehicle Reg. No. (Insured):	SFW1394P	Policy No. (Claimant):	
		Excess:	
Repairer:	Hock Motors Workshop (HQ) NO 1 KAKI BUKIT AVENUE 6, #02-38 AUTOBAY @ KAKI BUKIT, 417883 Kaki Bukit - Tel: 68469707		
Handling Insurer:	MSIG Insurance (Singapore) Pte. Ltd. (HQ) - Tel: +65 6827 7888 ... [Handled by Jasmine Lok Kheng Kwei - 6594 2550]		
Adjuster:	LKK Auto Consultants Pte Ltd (HQ) - Tel: 6256-3561 ... [Imm.Advice due 08/02/2018]		
Adj Asg. Remarks:	Third Party Pre-Repair Survey

Accident Date : 07 February 2018  
Inspection Date : 07 February 2018  
Repairer Name : Hock Motors Workshop  
No.1 Kaki Bukit Ave 6 #02-02  
AutoBay, Singapore 417883

The impact damages sustained on the vehicle at the time of inspection is on the rear portion.  
(Details refer to the photographs attached)

## VEHICLE DAMAGE INSPECTION REPORT

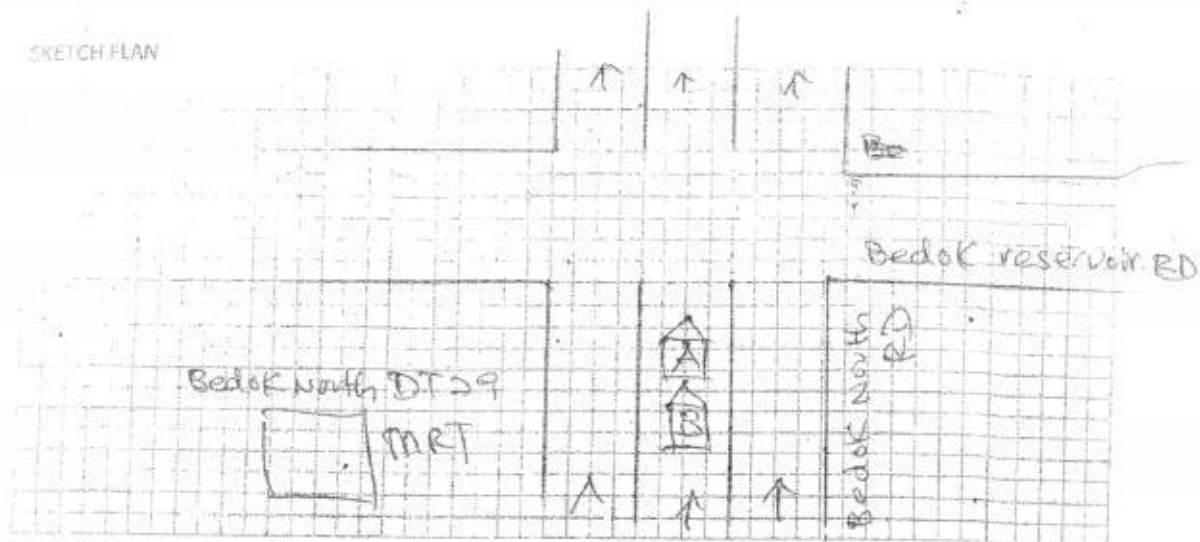
SKETCH PLAN

DESCRIBE CIRCUMSTANCES OF THE ACCIDENT

Due to traffic light turn red I stopped my vehicle suddenly vehicle B (SFV1394P) from behind and hit on to my vehicle near portion
