Your Ref: TP/IP/62725/2017
Our Ref : CI/TPD18002535/N

25 January 2018

MECHANICAL INSPECTION REPORT OF MOTOR TAXI SH 8506M

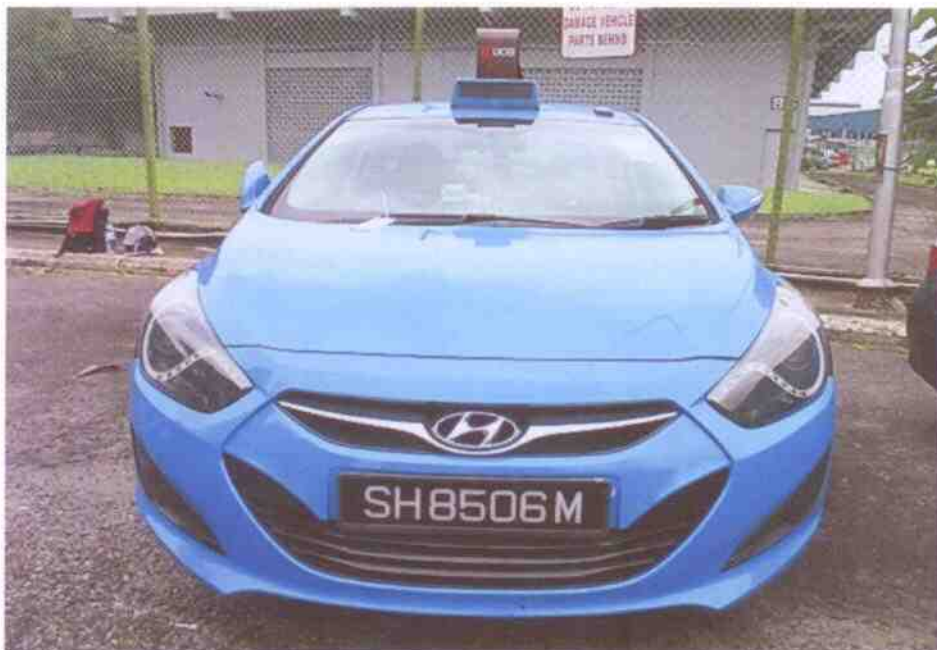
Photo 1 shows a general view of the front body of the Motor Taxi at the time of our inspection. The Motor Taxi was observed to be in good general condition except for a damaged front number plate holder. At the time of our inspection, we observed damage marks of grazing nature at both corners of the front bumper of the Motor Taxi. Similar graze marks were also observed on the left side of its rear bumper. The mileage of the Motor Taxi was not recorded as its engine could not be started despite attempts to jump start the engine.

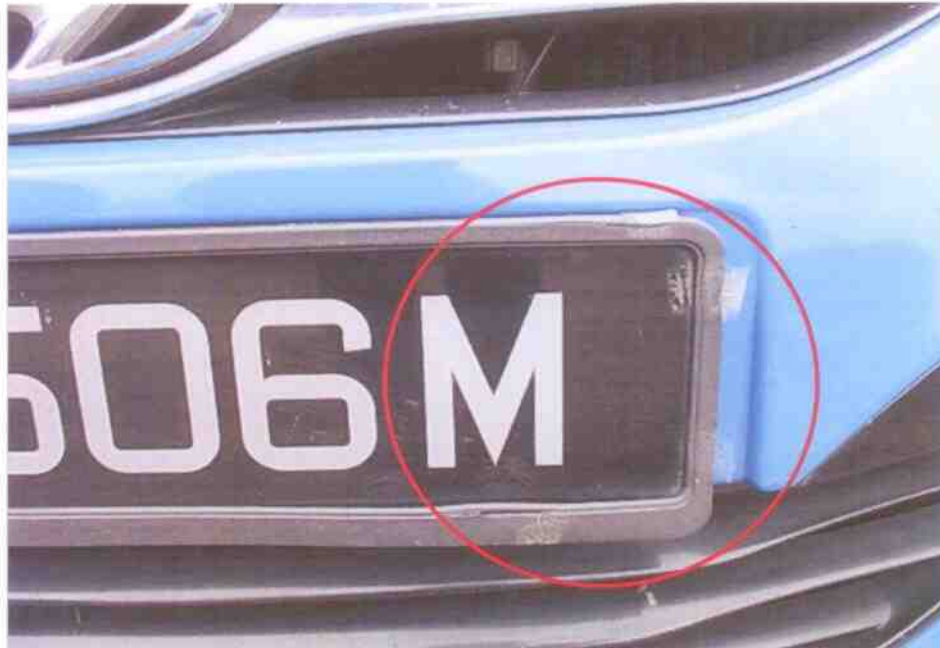
Photo 2 shows a closer view of the damaged front number plate holder of the Motor Taxi at the time of our inspection (circled).

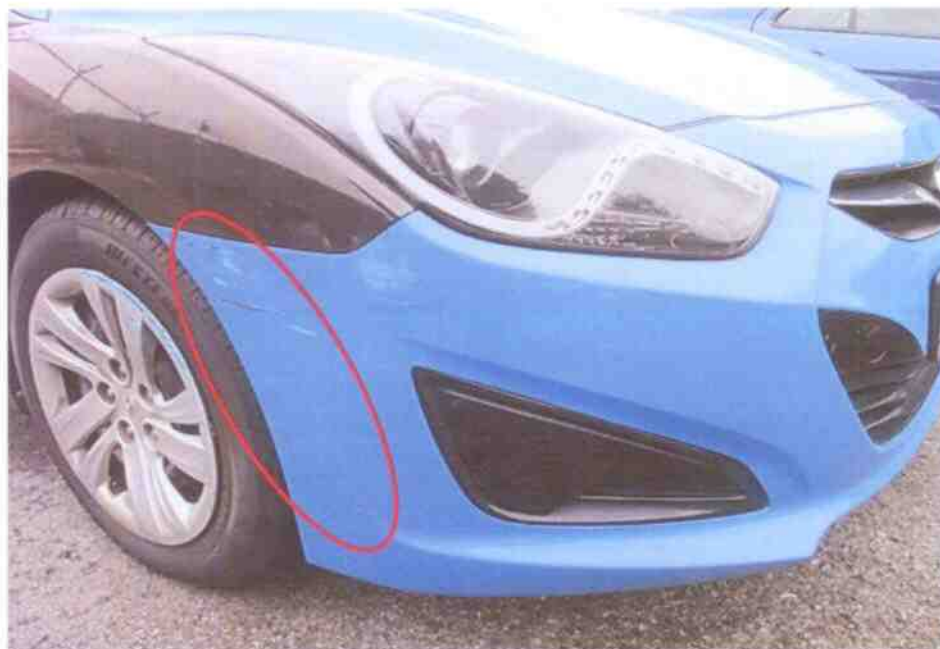
Photo 3 shows a closer view of the damage marks of grazing nature observed at the right corner of the front bumper of the Motor Taxi at the time of our inspection (circled).

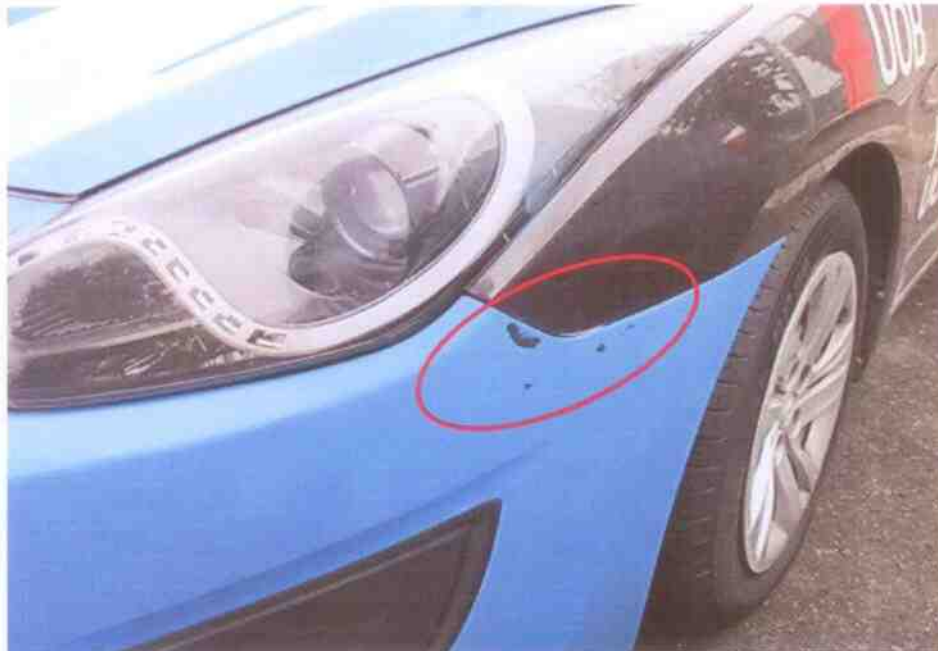
Photo 4 shows a closer view of the damage marks of grazing nature observed at the left corner of the front bumper of the Motor Taxi at the time of our inspection (circled).

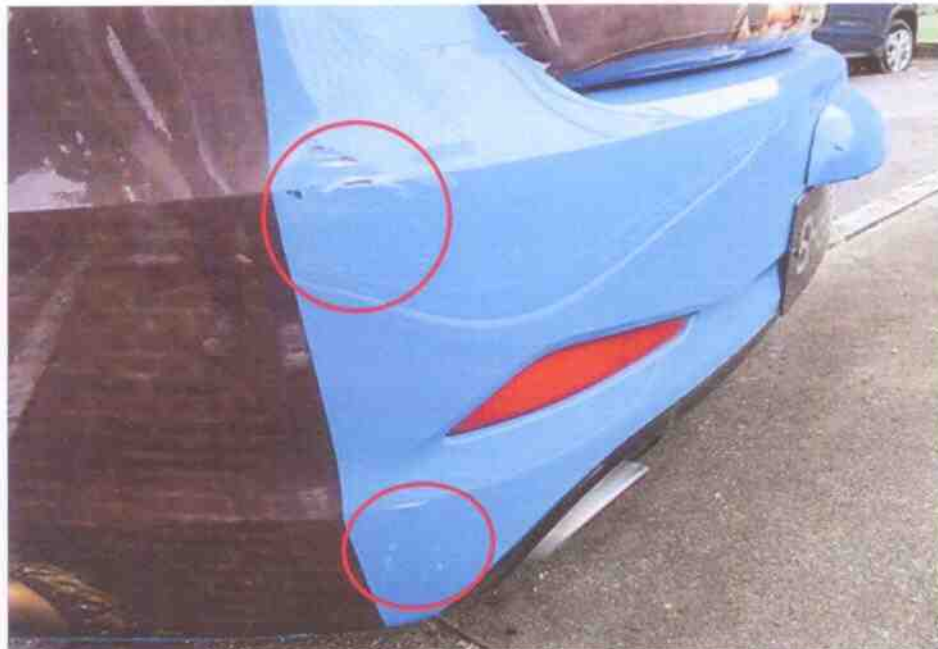
Photo 5 shows a closer view of the damage marks of grazing nature observed at the left side of the rear bumper of the Motor Taxi at the time of our inspection (circled).

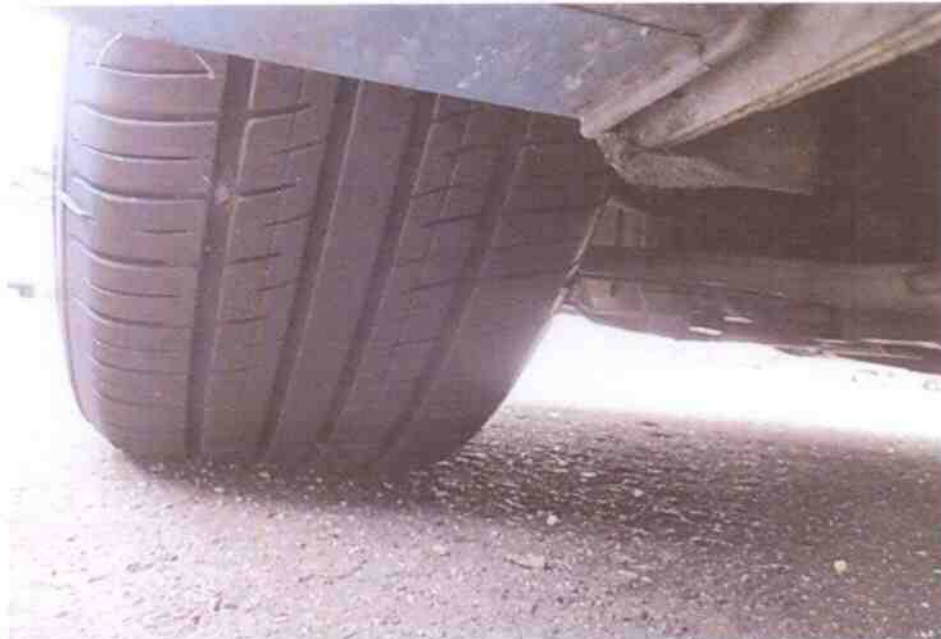
Photo 6 shows the condition of the front left tyre of the Motor Taxi, which was observed to be in serviceable condition with remaining tread depth of approximately 5mm. The tyre, which was wrapped around standard wheel rim, was also observed to be sufficiently inflated for vehicular operation. There was no tear, cut or burst mark(s) on the outer and the inner sidewalls as well as across the tread of the Motor Taxi's 4 tyres.

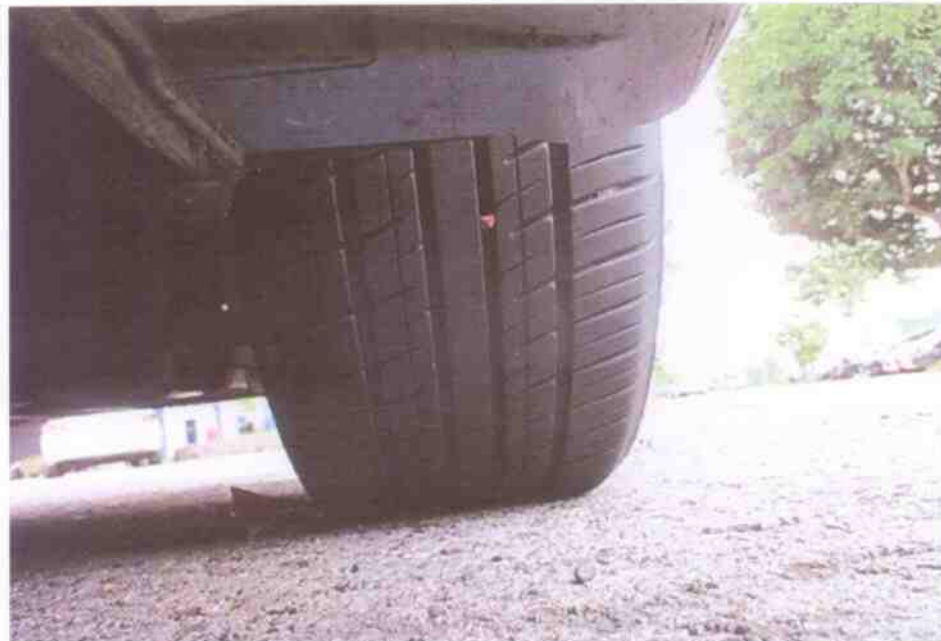
Photo 7 shows the condition of the front right tyre of the Motor Taxi, which was observed to be in serviceable condition with remaining tread depth of approximately 6mm. The tyre, which was wrapped around standard wheel rim, was also observed to be sufficiently inflated for vehicular operation.

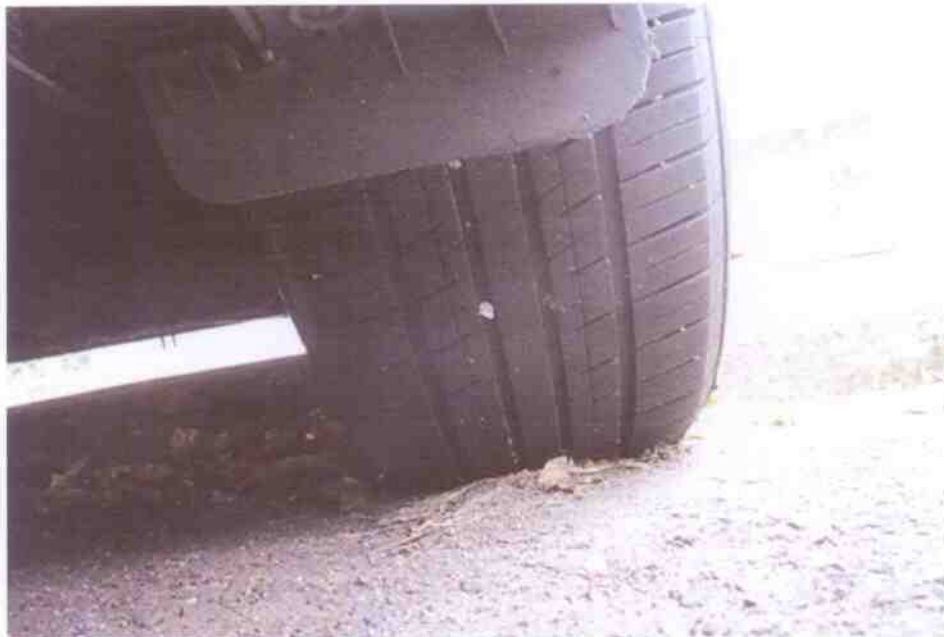
Photo 8 shows the condition of the rear left tyre of the Motor Taxi, which was observed to be in serviceable condition with remaining tread depth of approximately 6mm. The tyre, which was wrapped around standard wheel rim, was also observed to be sufficiently inflated for vehicular operation. There was no significant damage observed on the 4 wheel rims of the Motor Taxi apart for some relatively minor kerb grazing type of damage found on all the 4 wheel rims.

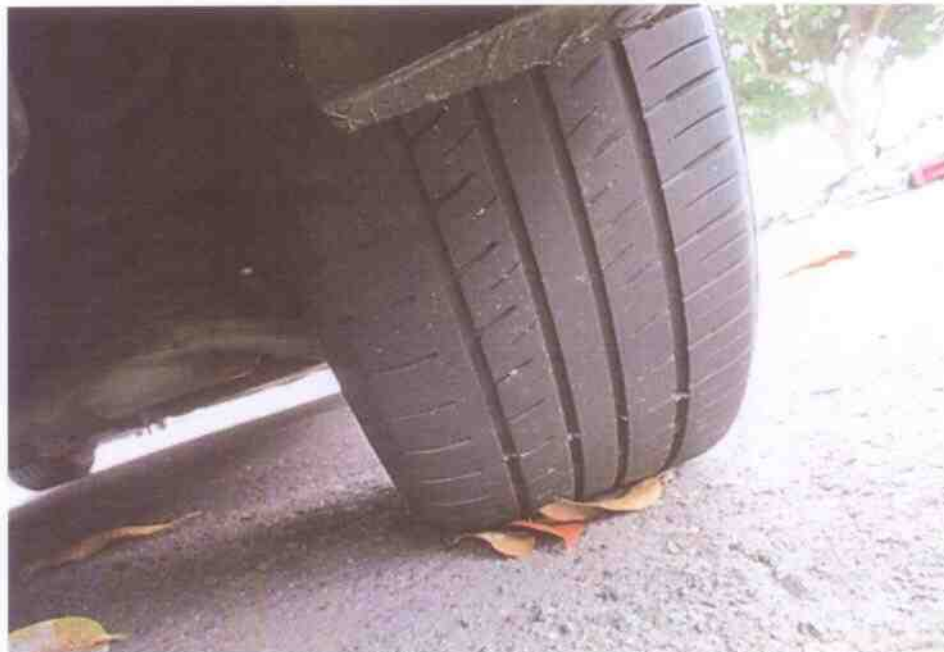
Photo 9 shows the condition of the rear right tyre of the Motor Taxi, which was observed to be in serviceable condition with remaining tread depth of approximately 4mm. There was also no tear, cut or burst mark(s) on the outer and the inner sidewalls as well as across the tread of the 4 tyres.

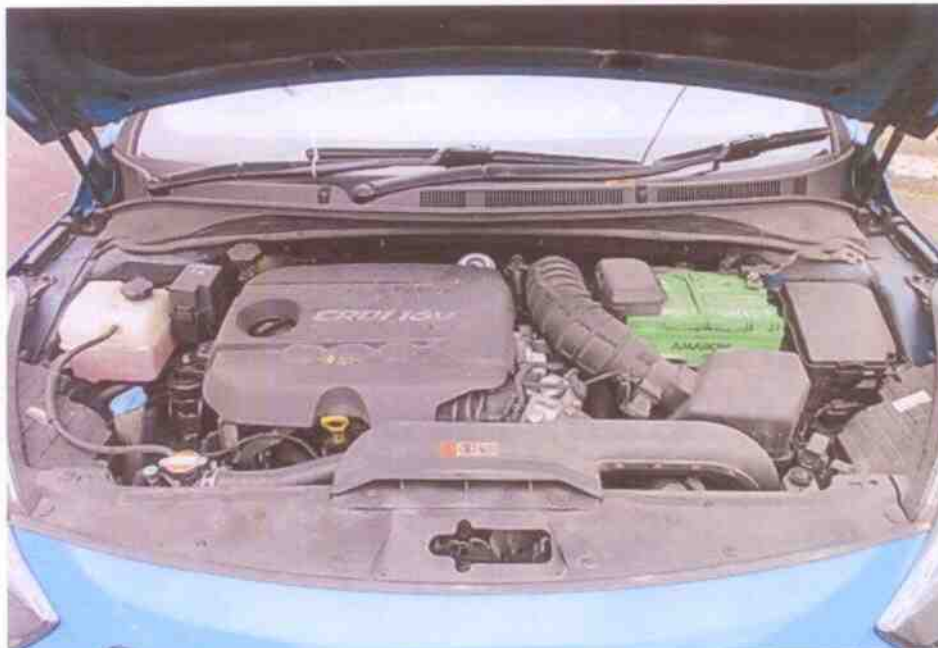
Photo 10 shows a general view of the Motor Taxi's engine compartment. The various parts and components inside the engine compartment were unaffected by the accident. There was also no sign(s) or indication(s) of fluid leakage and/or fluid stain within the engine compartment.

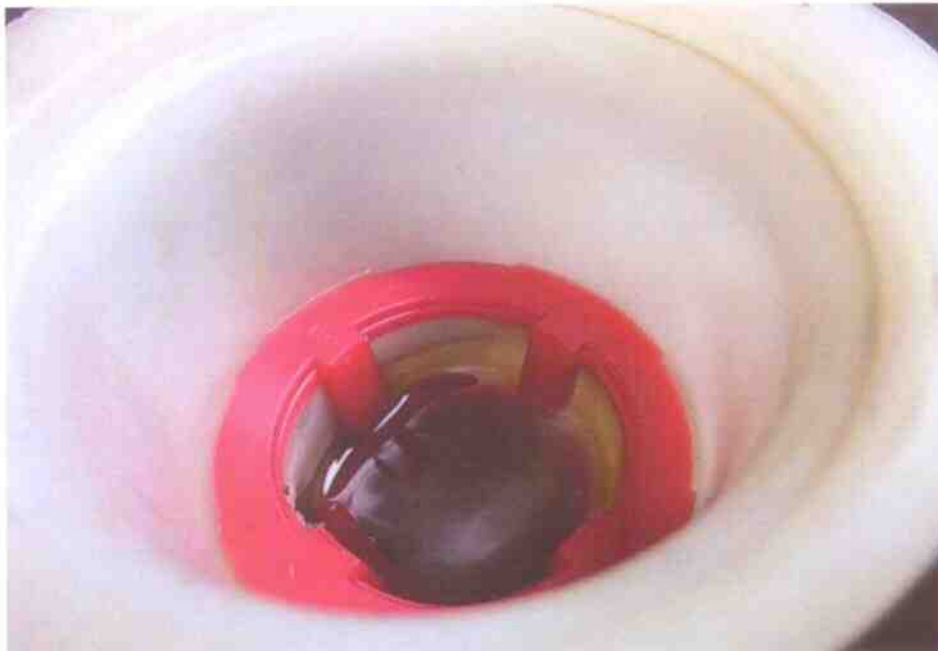
Photo 11 shows the brake fluid reservoir of the Motor Taxi at the time of our inspection. The brake fluid was observed to be of sufficient level and without any visible contamination.

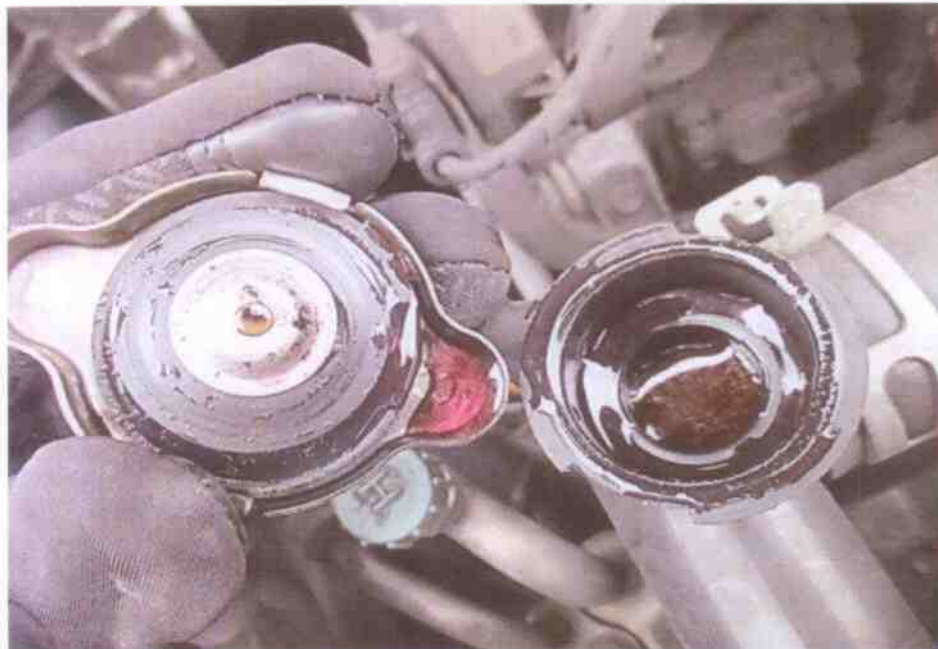
Photo 12 shows checks being carried out to the engine coolant of the Motor Taxi at the time of our inspection. The engine coolant was observed to be of sufficient level and without any visible contamination.

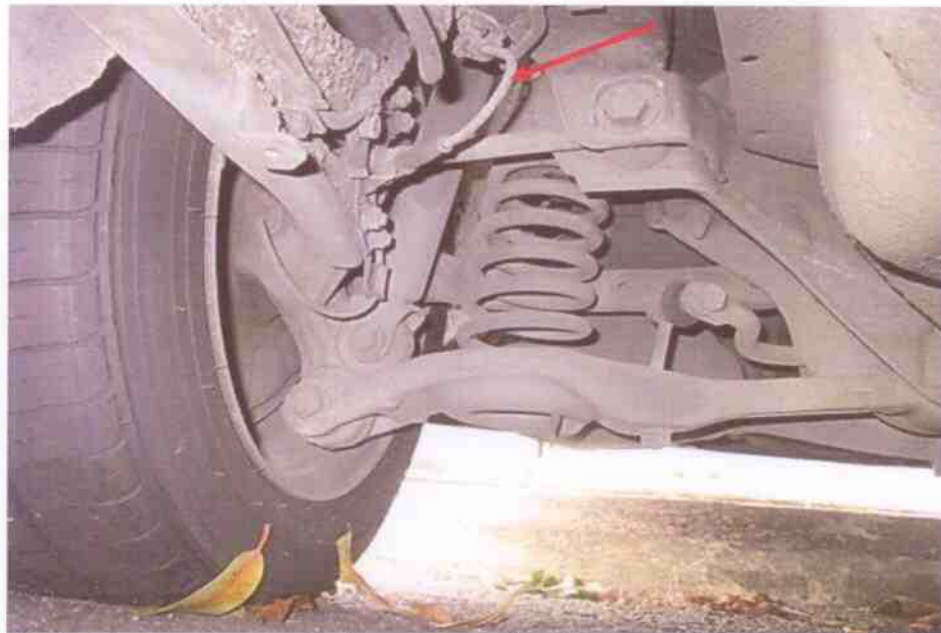
Photo 14 shows the brake hose (arrowed) at the rear left wheel of the Motor Taxi. We did not observe any leakage of brake fluid at the time of our inspection of the Motor Taxi. Our visual inspection of the various mechanical components of the Motor Taxi's braking system revealed all to be intact and without visible damage, indicating that the braking system was likely to be in serviceable condition at the material time of accident.

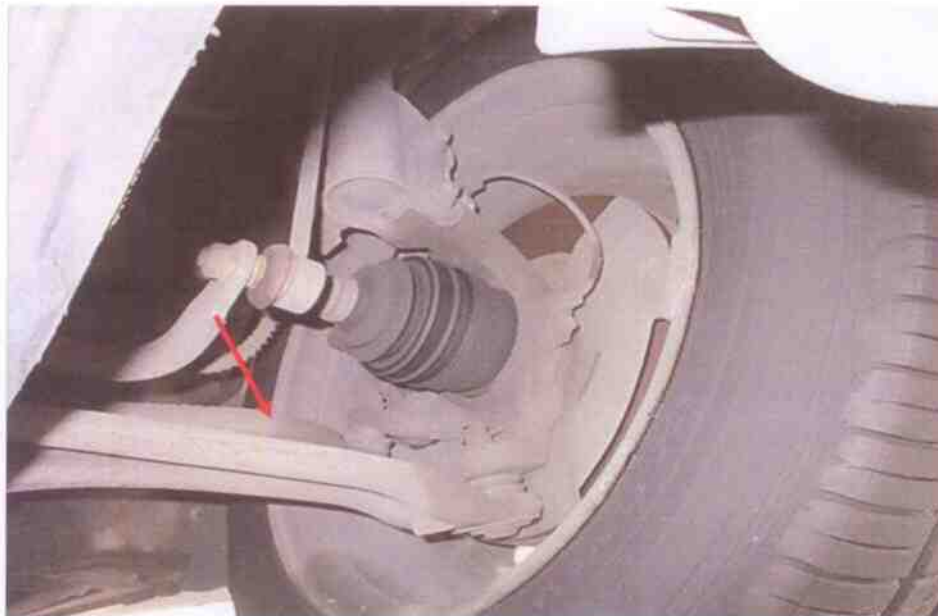
Photo 15 shows the various undercarriage components at the front right wheel of the Motor Taxi, in particular the steering tie rod (arrowed). The various steering components were all found to be intact, suggesting that the steering system of the Motor Taxi was likely to be in serviceable condition at the material time of accident.

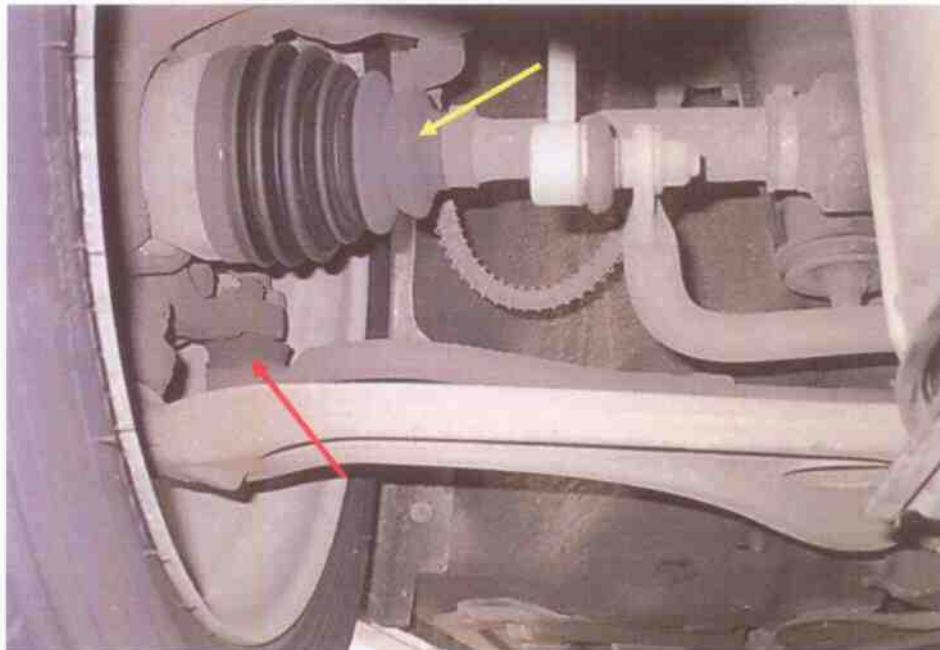
Photo 16 shows the various undercarriage components at the front left wheel of the Motor Taxi, which had included the steering tie rod (red arrow) and left drive shaft (yellow arrow). The various undercarriage components of the Motor Taxi were all found to be intact without any visible damage. There was also no sign of fluid stain observed on the various undercarriage components.
