Your Ref: 4489450453SG-001
Our Ref : CI/AIG18002539/Z

M/s AIG Asia Pacific Insurance Pte Ltd

**TECHNICAL INVESTIGATION REPORT OF FIRE INCIDENT INVOLVING THE
INSURED VEHICLE SDW 78H ON 25th January 2018**

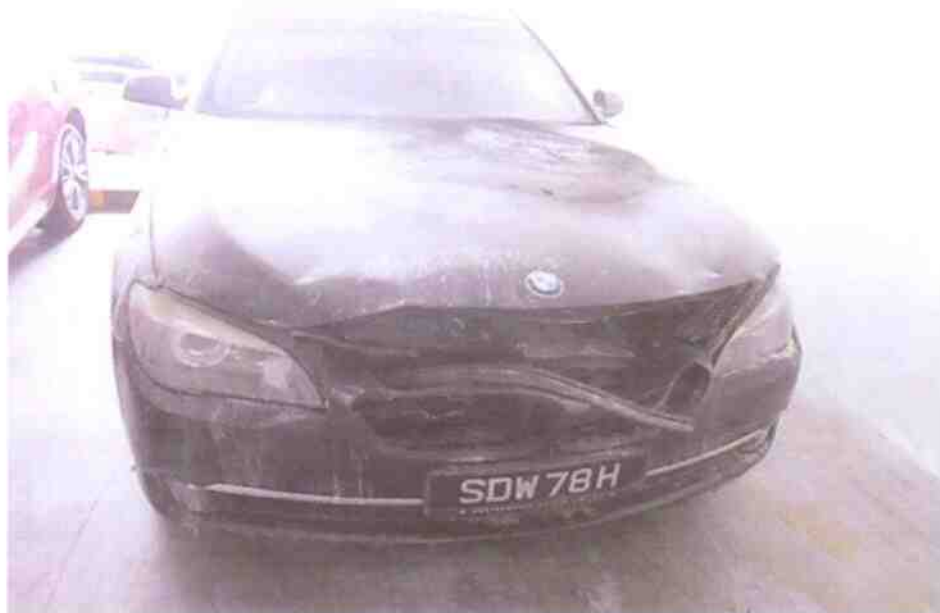
Photo 1 shows the general view of the front portion of the Insured Vehicle at the time of our inspection. The fire damage to the Insured Vehicle was confined to its front portion. Its front bonnet, front windscreen and front windscreen wipers were amongst the body parts that were found to have been affected as a result of the fire.

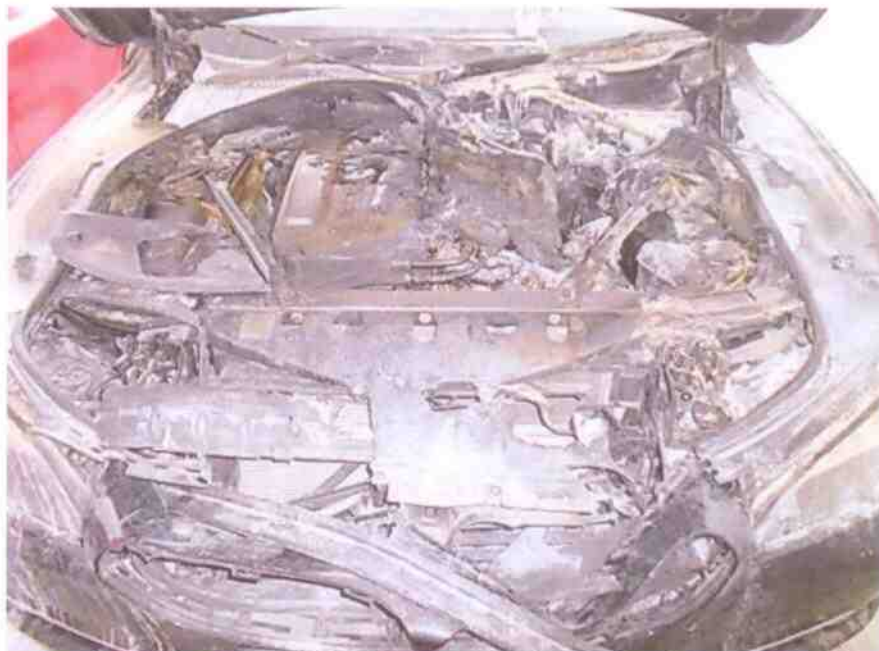
Photo 3 shows the engine compartment of the Insured Vehicle at the time of our inspection. The rear left side of the entire engine compartment of the Insured Vehicle was observed to be partially burnt. The parts around the rear left side of the engine compartment were found to be burnt and/or melted as a result of the fire.

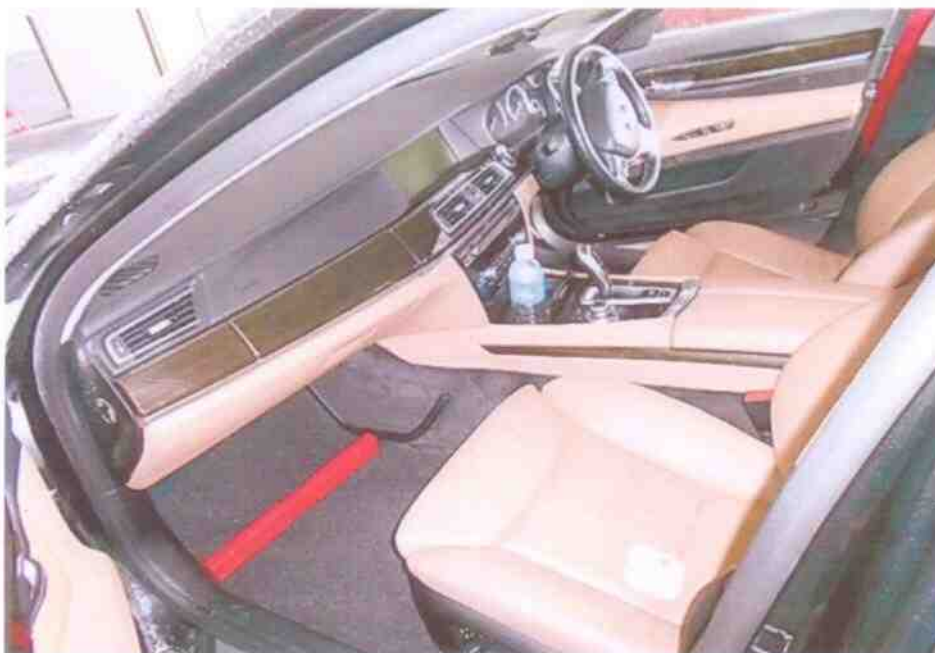
Photo 4 shows the interior compartment of the Insured Vehicle, which was observed to be relatively unaffected by the fire.

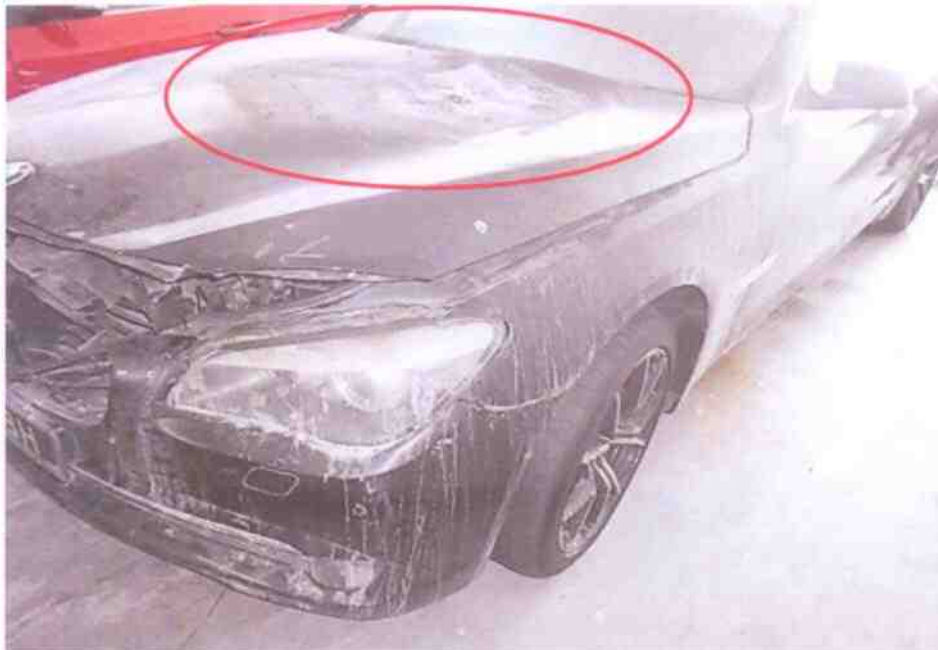
8. For this particular case, the fire appears to have originated within the engine compartment of the Insured Vehicle, somewhere around the rear left side of the engine compartment. This can be determined from the burn pattern and the high heat intensity burn marks (whitish burn marks) found on the rear left side of the bonnet of the Insured Vehicle and also the discolouration of the insulating material that had developed on the underside of the front bonnet, at the rear left side portion.

9. The whitish burn marks are a result of exposure to prolonged heat intensity. Rust would normally start to develop around these areas soon after a fire as prolonged exposure to high heat intensity usually causes steel/metal material body parts to be exposed to natural environmental condition. The discolouration of the insulating material on the underside of the front bonnet, around the rear left side area, is an indication that the rear left side area of the engine compartment had sustained exposure to prolonged high heat intensity. See photos 5 & 6 below.

Photo 5 shows the burn pattern and whitish burn marks (circled) that were found on the rear left side of the front bonnet of the Insured Vehicle. Such whitish burn marks are a result of exposure to prolonged heat intensity, which may indicate where the fire had started. Rust would also begin to develop on these areas soon after the fire.

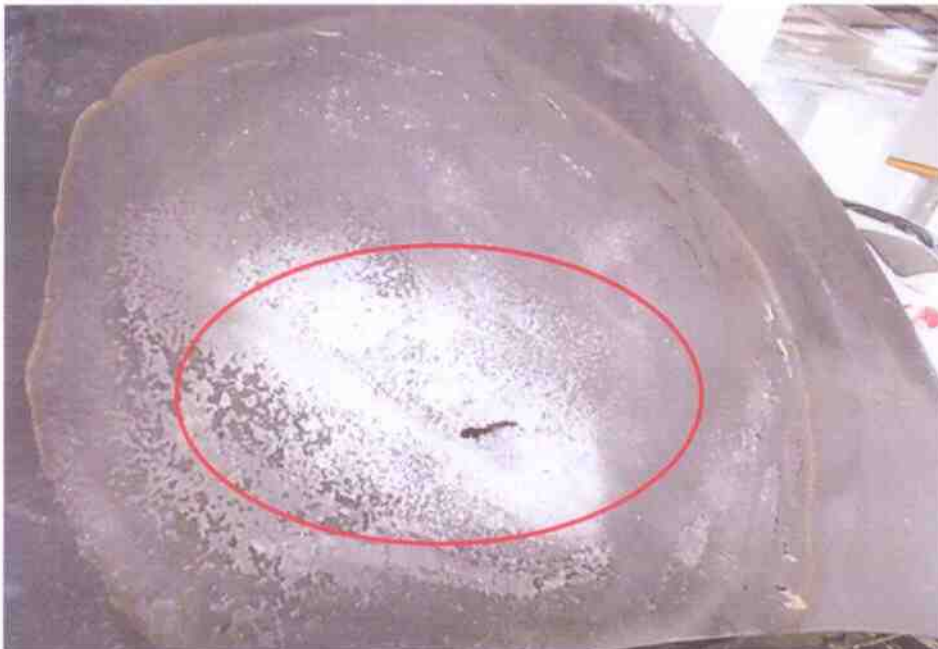
Photo 6 shows a close-up view of the burn pattern and whitish burn marks (circled) that were found on the rear left side of the front bonnet of the Insured Vehicle. Such whitish burn marks are a result of exposure to prolonged heat intensity, which may indicate where the fire had started. Rust would also begin to develop on these areas soon after the fire.

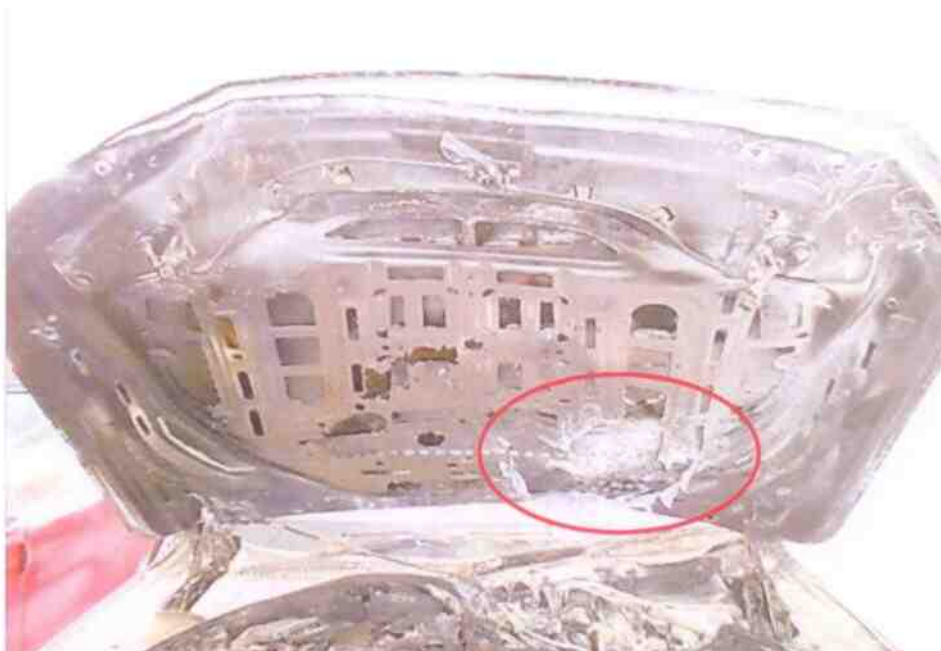
Photo 7 shows the discolouration of the insulating material on the underside of the front bonnet, around the rear left side area (circled). The discolouration of the insulating material is an indication that the rear left side area of the engine compartment had sustained exposure to prolonged high heat intensity. Hence the fire to the Insured Vehicle can be determined to have originated towards the rear left side of the engine compartment.

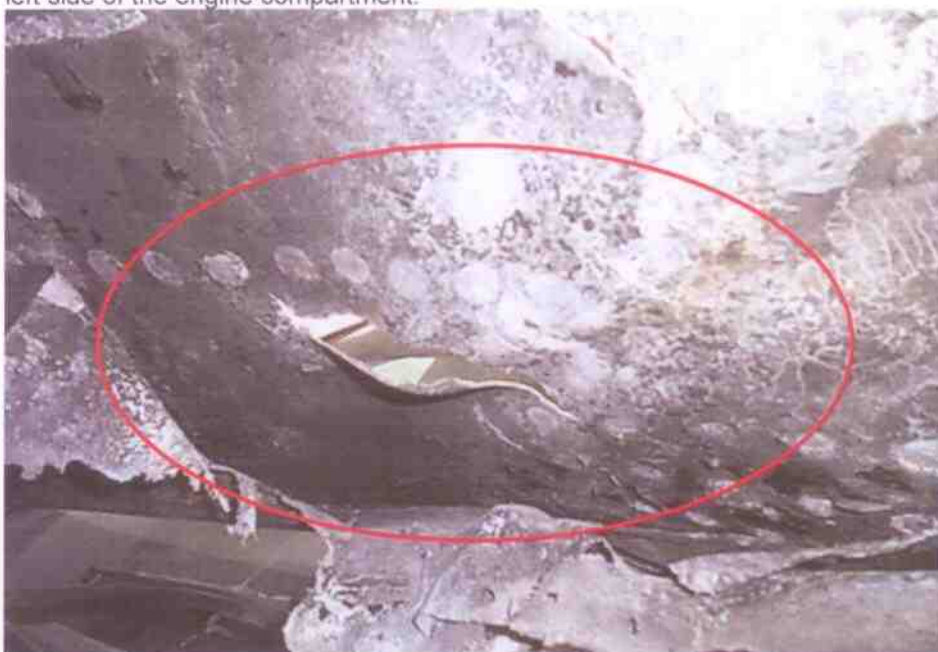
Photo 8 shows a close-up view of the discolouration of the insulating material on the underside of the front bonnet, around the rear left side area (circled). The discolouration of the insulating material is an indication that the rear left side area of the engine compartment had sustained exposure to prolonged high heat intensity. Hence the fire to the Insured Vehicle can be determined to have originated towards the rear left side of the engine compartment.

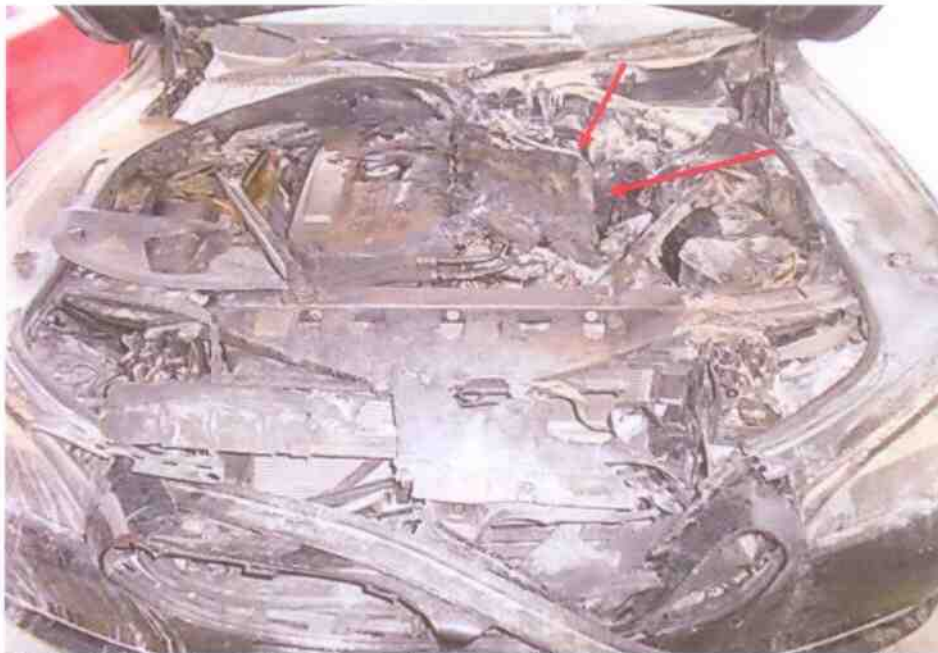
10. Upon closer examination of the rear left side of the engine compartment which was where the fire to the Insured Vehicle had likely started, we had found several stretches of burnt wiring around the Insured Vehicle's engine compartment. These wirings were original factory fitted wirings that were mainly around the rear left side of the engine compartment near the ECM. Such condition normally indicates internal heating of copper wires which is a sign of an electrical short circuit occurring. This would then appear to suggest that the cause of fire to the Insured Vehicle could have possibly been due to electrical in nature. See photos 9 to 13 below.

Photo 9 shows the wirings around the rear left side of the engine compartment which is near to the vicinity where the fire to the Insured Vehicle had likely started.

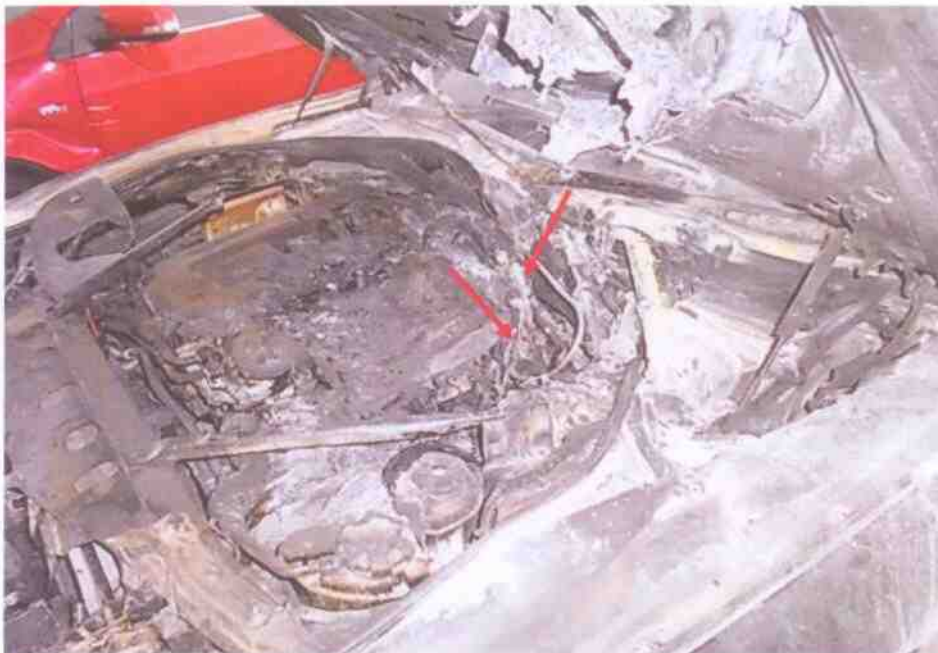
Photo 10 shows the wirings around the rear left side of the engine compartment which is near to the vicinity where the fire to the Insured Vehicle had likely started.

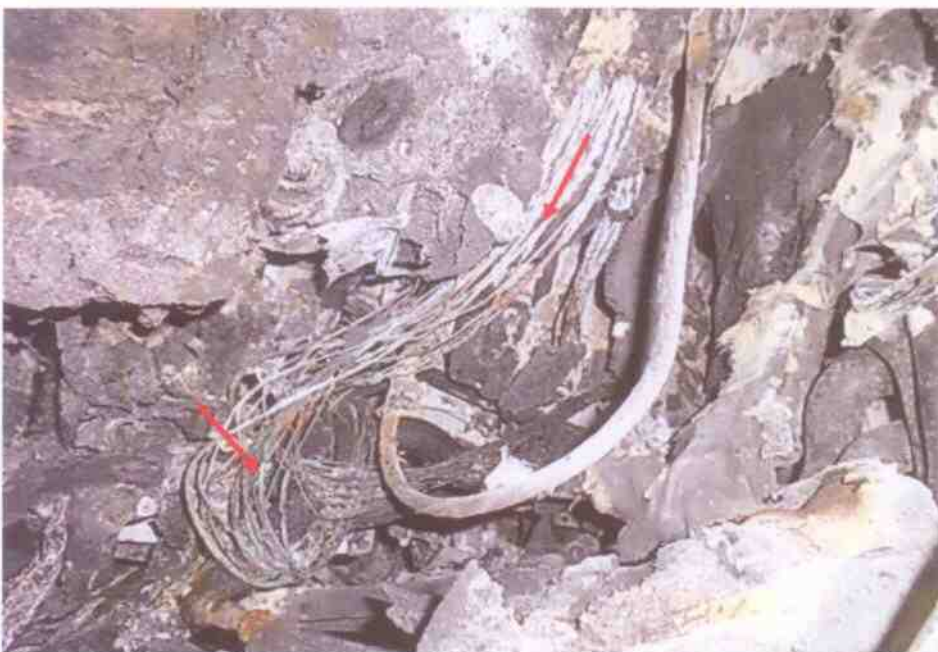
Photo 11 shows a close-up view of the wirings around the rear left side of the engine compartment which is near to the vicinity where the fire to the Insured Vehicle had likely started.

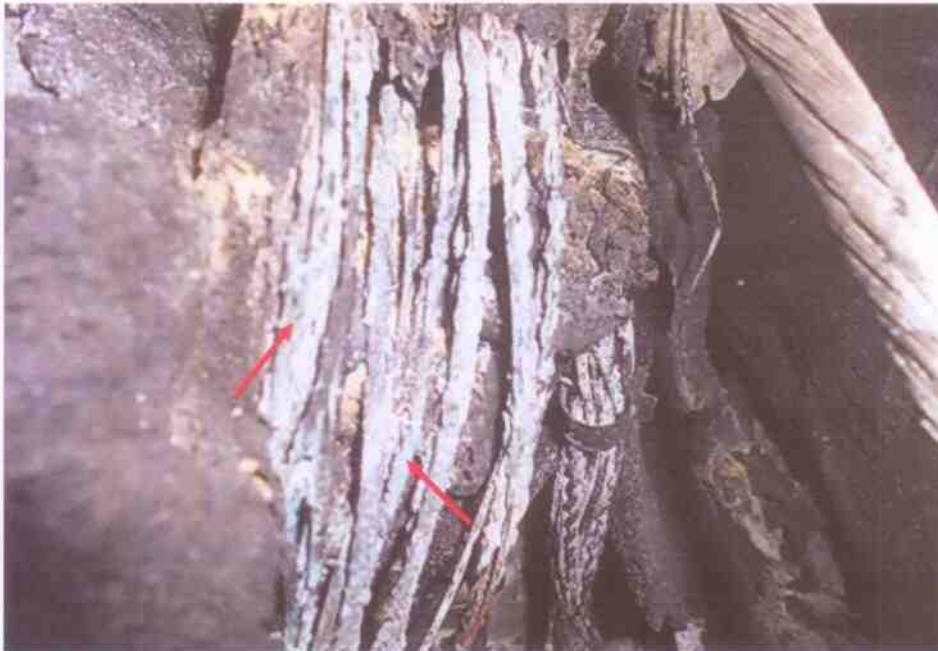
Photo 12 shows a closer view of the burnt wirings (red arrows) at the rear left side of the engine compartment. Such condition normally indicates internal heating of copper wires which is a sign of an electrical short circuit occurring.

28. The possibility of the fire being due to electrical in nature would then seem more likely given that engine overheating and external factors would both seem unlikely. The fire being due to electrical nature is also supported by the condition of the wirings that were found in the engine compartment of the Insured Vehicle, which was earlier discussed in paragraph 10 above.

30. Having investigated and technically analysed the damages of burnt nature to the Insured Vehicle, we are of the view that the cause of fire to the Insured Vehicle was of electrical in nature. For this particular case, the fire had originated along the wiring inside the engine compartment, somewhere around the rear left area of the engine compartment.
31. We did not find any evidence which had suggested that the cause of fire to the Insured Vehicle was due to poor maintenance and/or recurring electrical problem.
32. There were no modification(s) or additional electronic and/or electrical component(s) fitted on the Insured Vehicle at the time of our inspection of the Insured Vehicle.

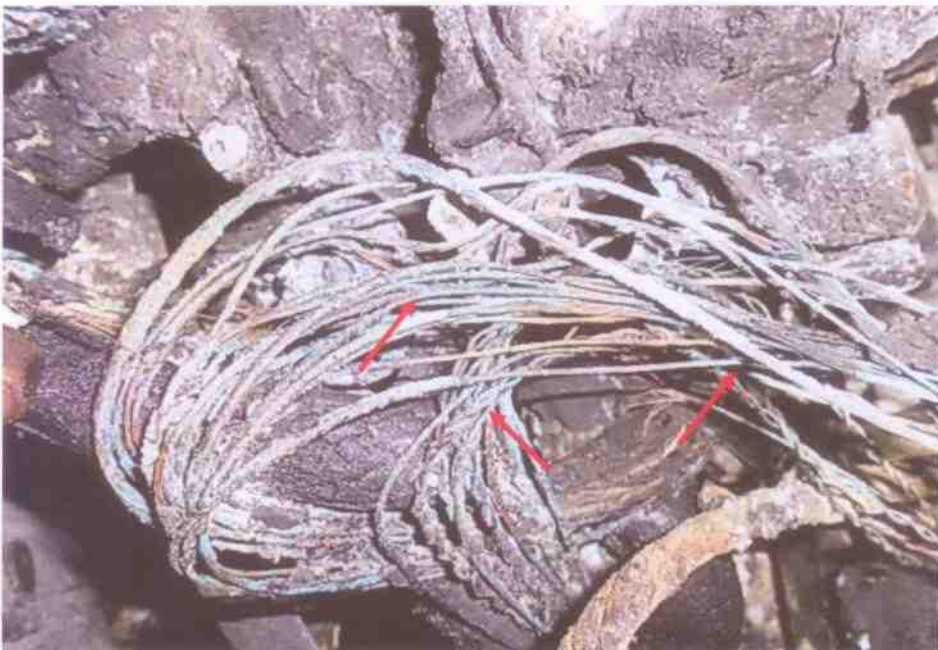
Photo 13 shows a close up view of the burnt wirings (red arrows) at the rear left side of the engine compartment. Such condition normally indicates internal heating of copper wires which is a sign of an electrical short circuit occurring.

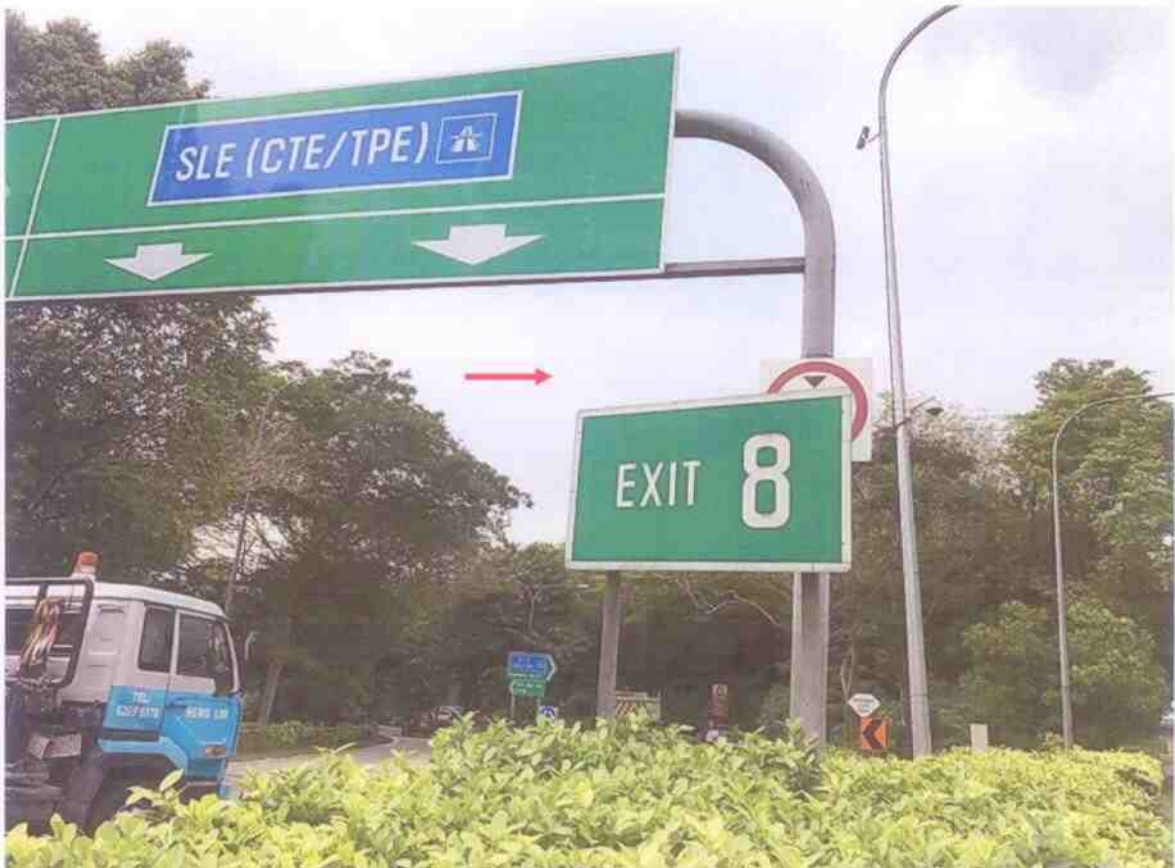
Photo 14 shows the general view of where the Insured Vehicle located at the time of incident. This was at a white painted island in between junction of BKE & Kranji Rd/SLE (CTE/TPE) (Exit 8).

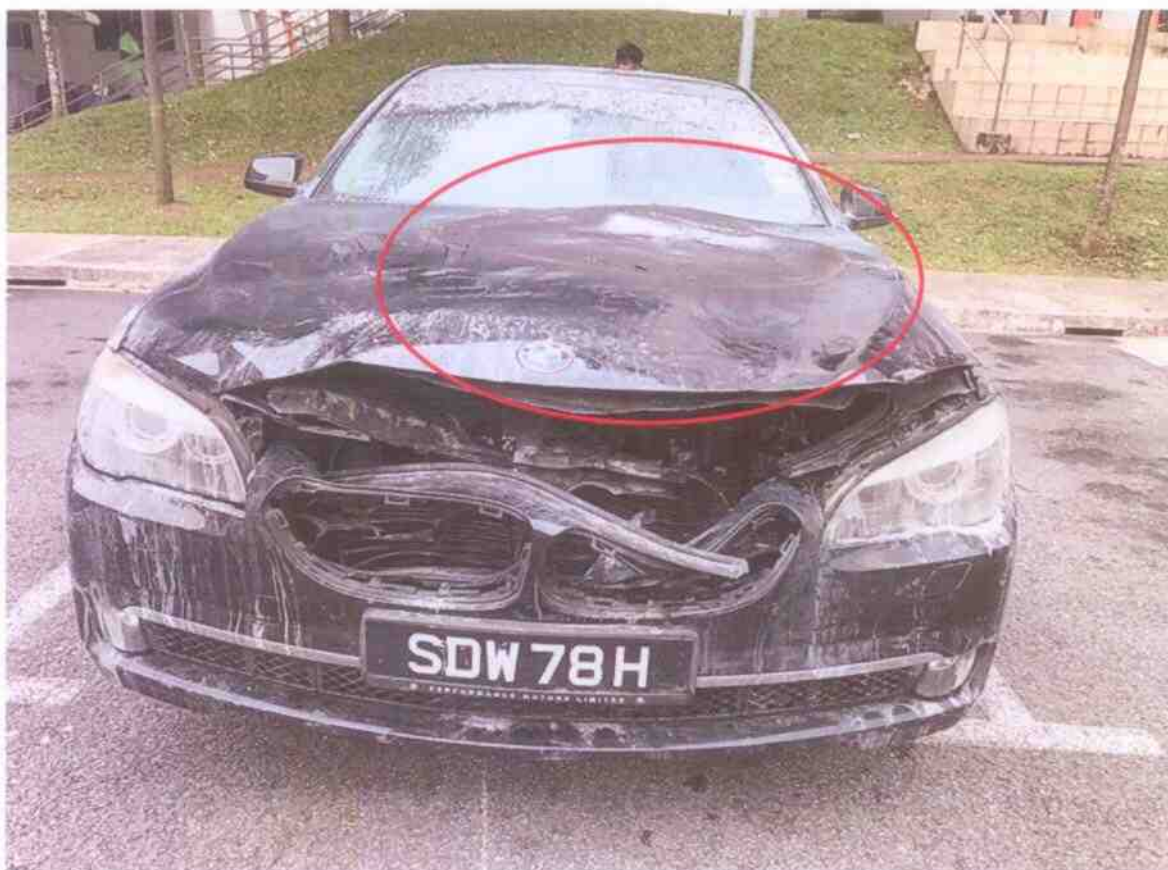
Photo 15 shows a closer view of the Insured Vehicle after the fire was extinguished (circled).

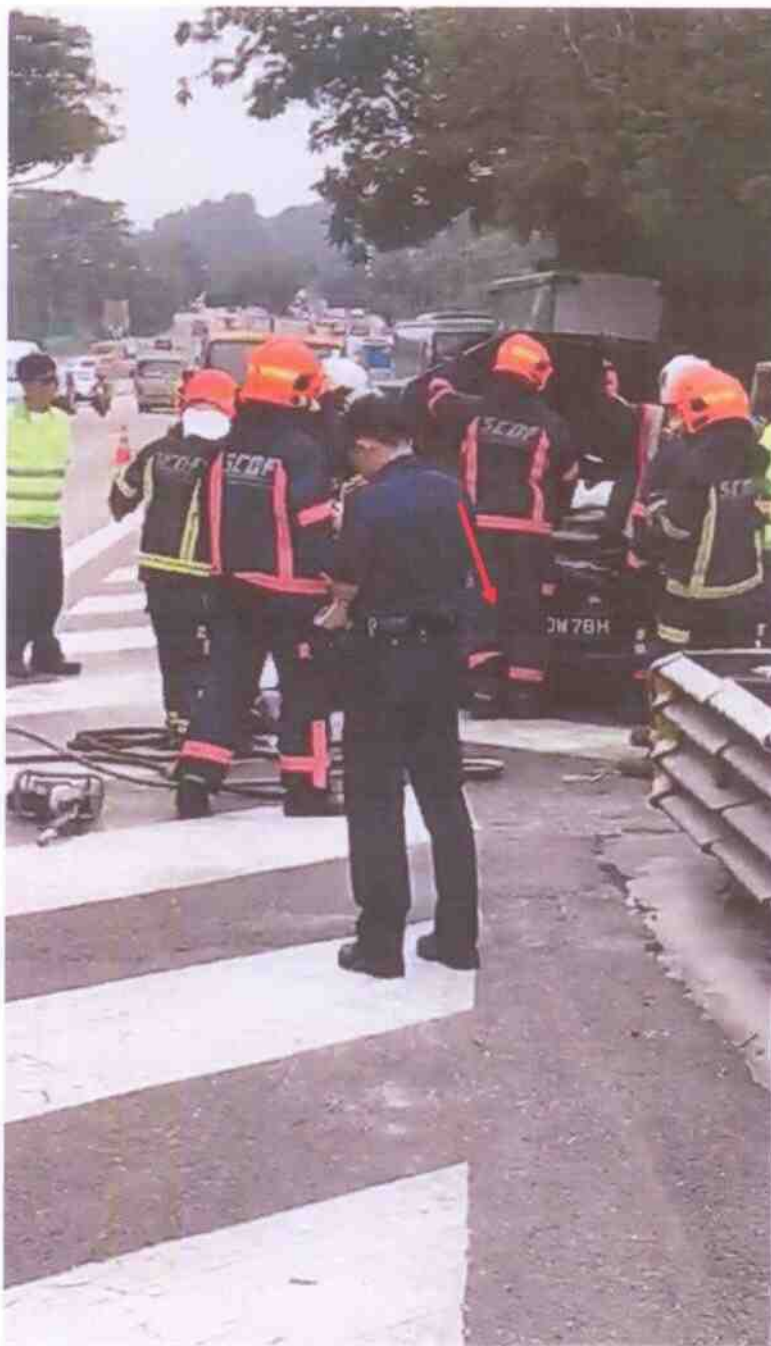
Photo 16 shows a general view of where the Insured Vehicle was positioned at the time of the incident. SCDF officers were seen attending to extinguish the fire.
