Your Ref: TP/IP/59561/2017
Our Ref : CI/TPD18001964/Z

Fatal Accident Investigation Team

MECHANICAL INSPECTION REPORT OF MOTOR VAN GBE 6269C

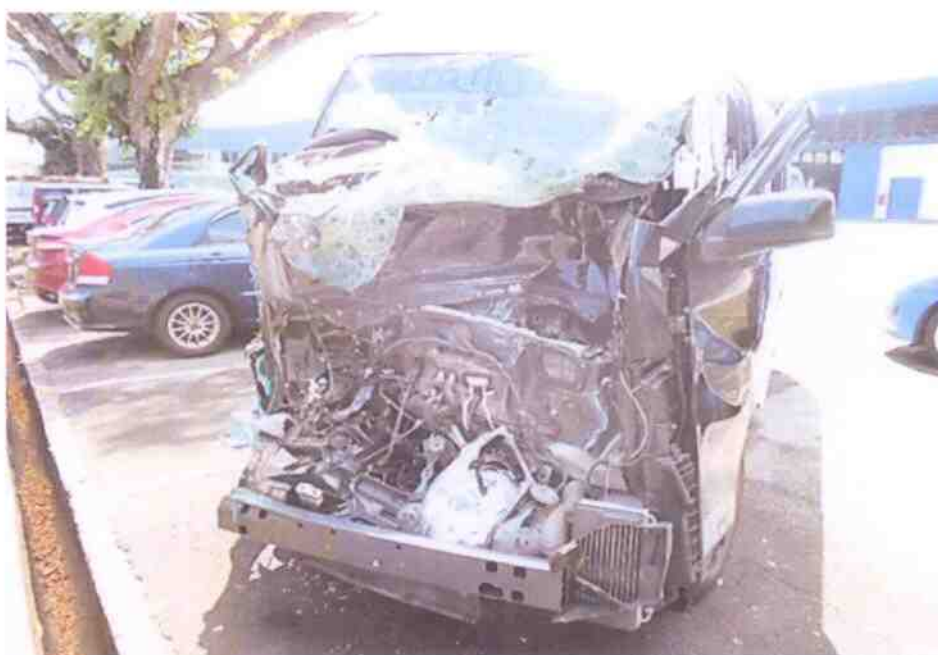
Photo 1 shows a general view of the frontal portion of the Motor Van at the time of our inspection. The Motor Van was observed to have sustained extensive impact damage at its frontal portion. The impact force was significant, causing the various parts and components inside the engine compartment to be damaged.

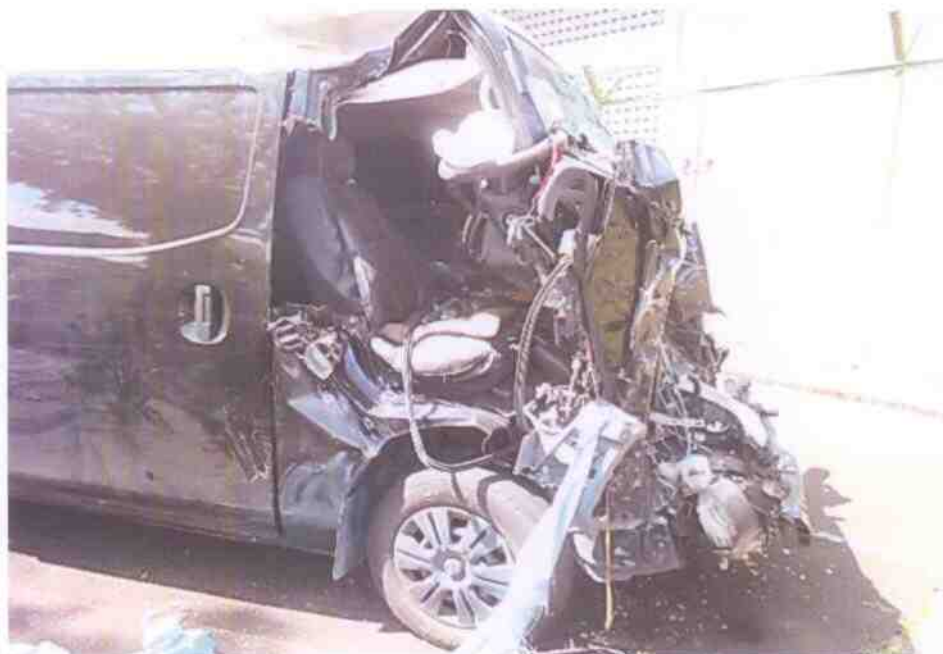
Photo 2 shows a general view of the front right portion of the Motor Van at the time of our inspection. The Motor Van was observed to have sustained extensive impact damage at its frontal portion.

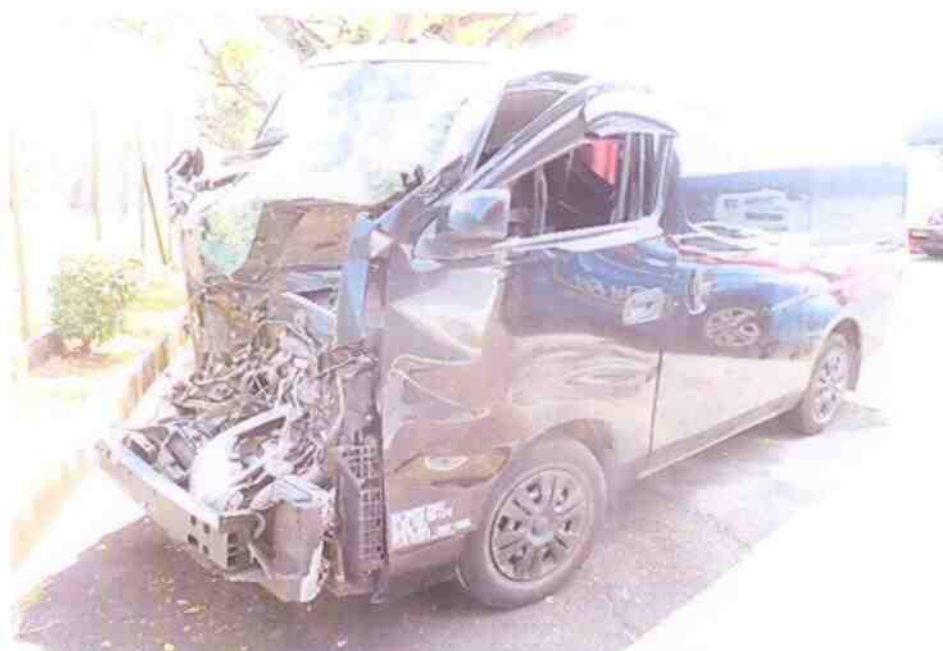
Photo 3 shows a general view of the front left portion of the Motor Van at the time of our inspection. The Motor Van was observed to have sustained with extensive impact damage at its frontal portion.

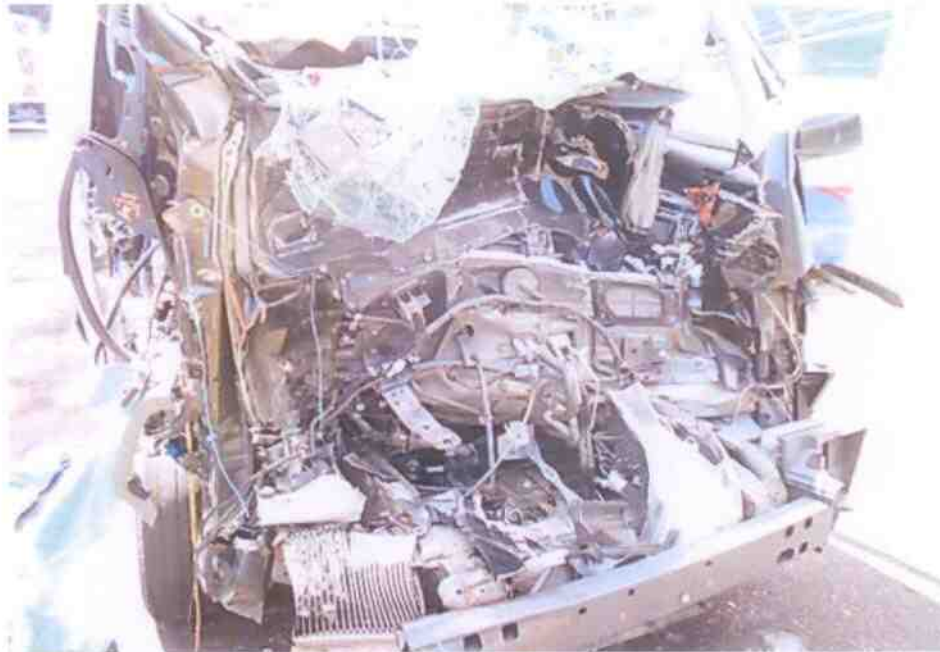
Photo 4 shows a closer view of the damage at the frontal portion of the Motor Van's engine. The impact force was significant, causing the various parts and components inside the engine compartment to be pushed inwards, towards the rear of the Motor Van.

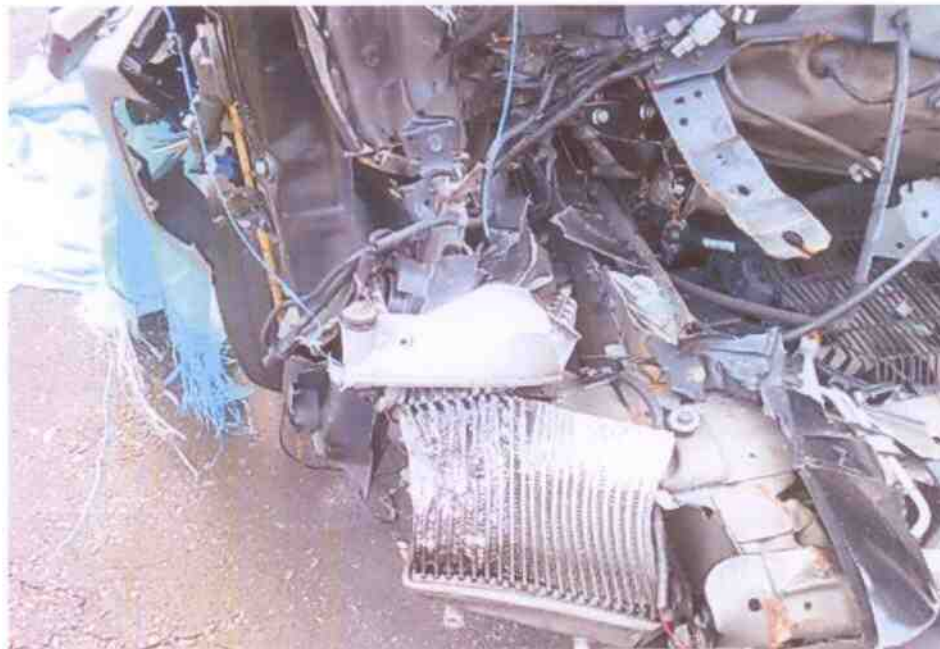
Photo 5 shows a closer view of the damage at the frontal right portion of the Motor Van. The impact force was significant, causing the various parts and components inside the engine compartment to be pushed inwards, towards the rear of the Motor Van.

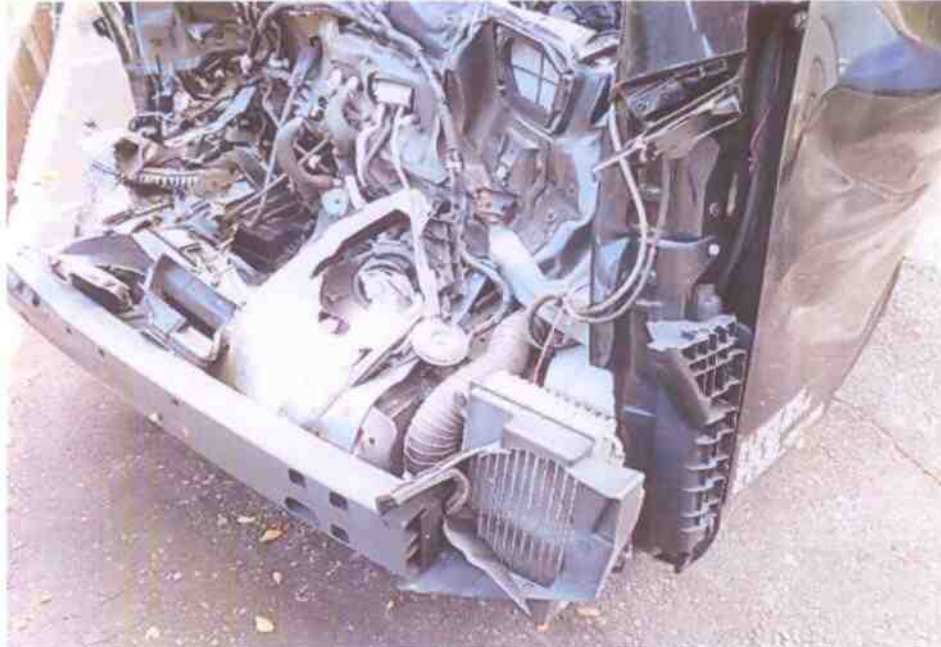
Photo 6 shows a closer view of the damage at the frontal left portion of the Motor Van. The impact force was significant, causing the various parts and components inside the engine compartment to be pushed inwards, towards the rear of the Motor Van.

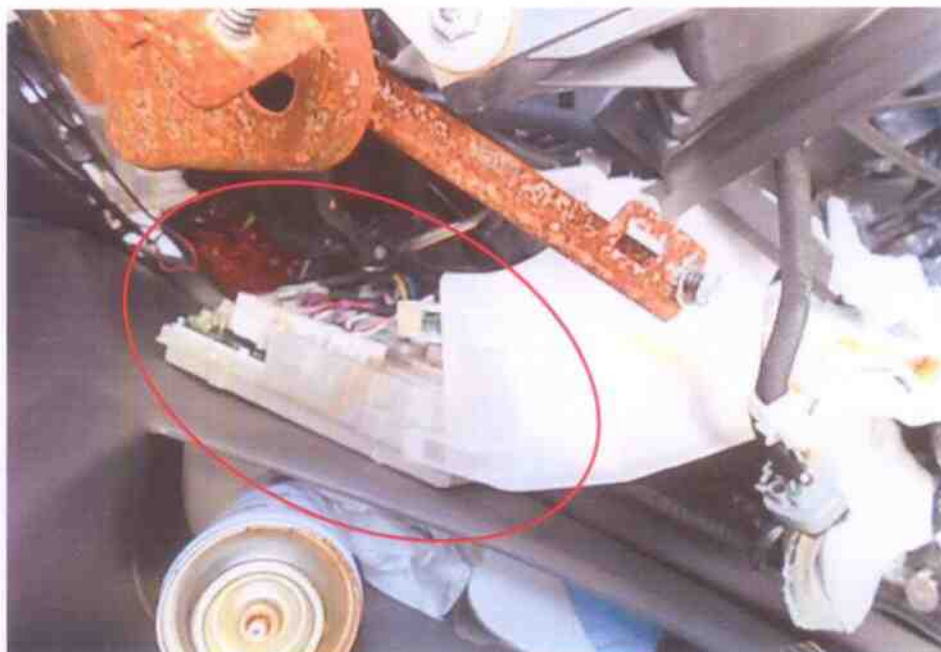
Photo 7 shows a closer view of the damaged fuse box at the frontal left portion of the Motor Van. The impact force was significant, causing the various parts and components inside the engine compartment to be pushed inwards, towards the rear of the Motor Van.

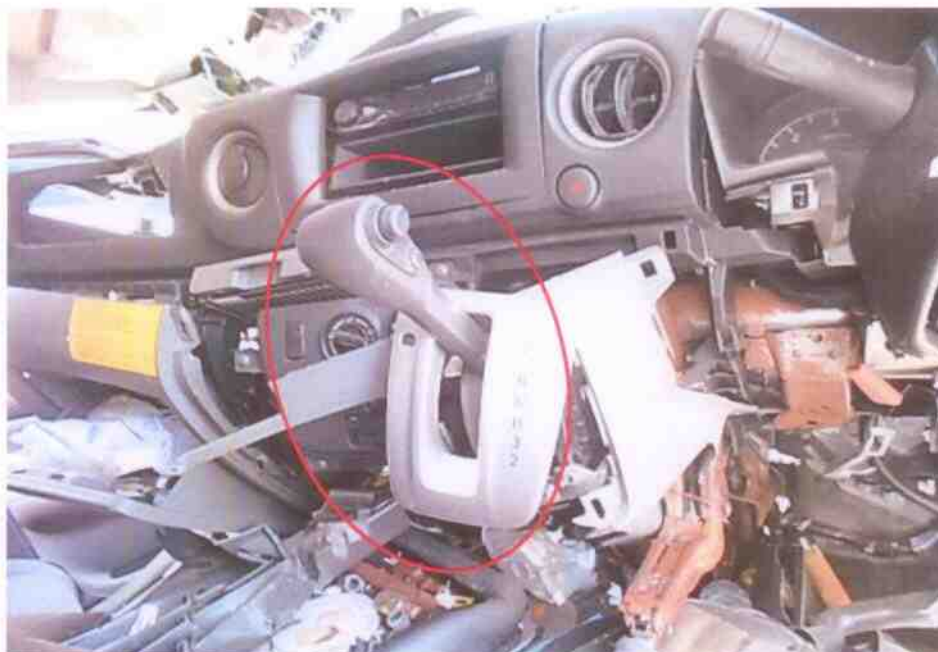
Photo 8 shows a closer view of the damage gear knob at the interior portion of the Motor Van. The impact force was significant, causing the various parts and components inside the engine compartment to be pushed inwards, towards the rear of the Motor Van including its transmission system.

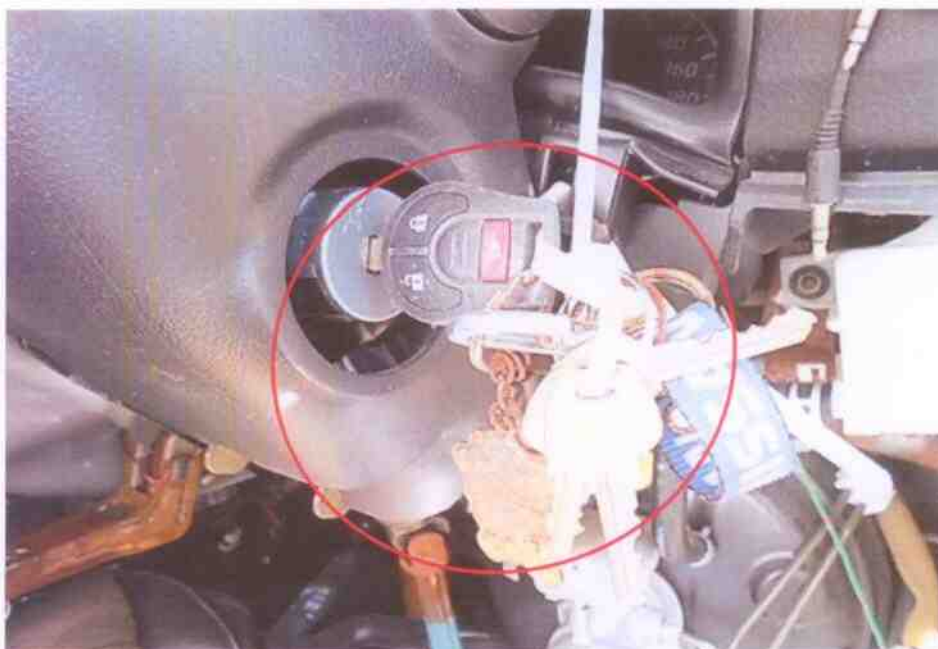
Photo 9 shows a closer view of the damage at the ignition section of the Motor Van. The impact force was significant, causing the various parts and components inside the interior compartment to be pushed inwards, including its ignition system.

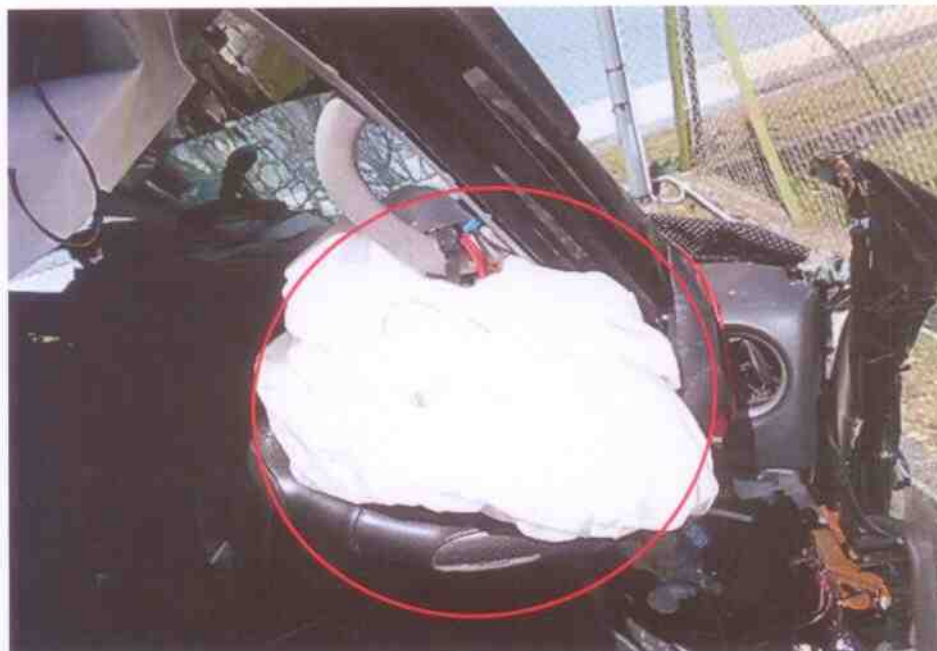
Photo 10 shows a closer view of the detached right front door of the Motor Van. The impact force was significant, causing the various parts and components inside the engine compartment to be pushed inwards, towards the rear of the Motor Van. That includes the driver's airbag activation.

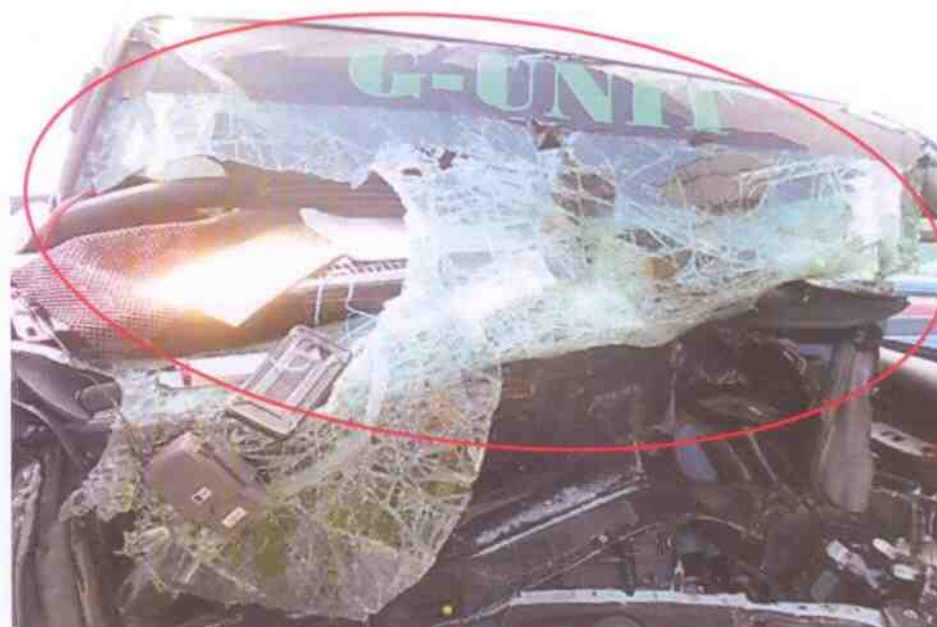
Photo 11 shows a closer view of the damage at the windscreen area of the Motor Van. The impact force was significant, causing the windscreen to sustain a shattering cracked.

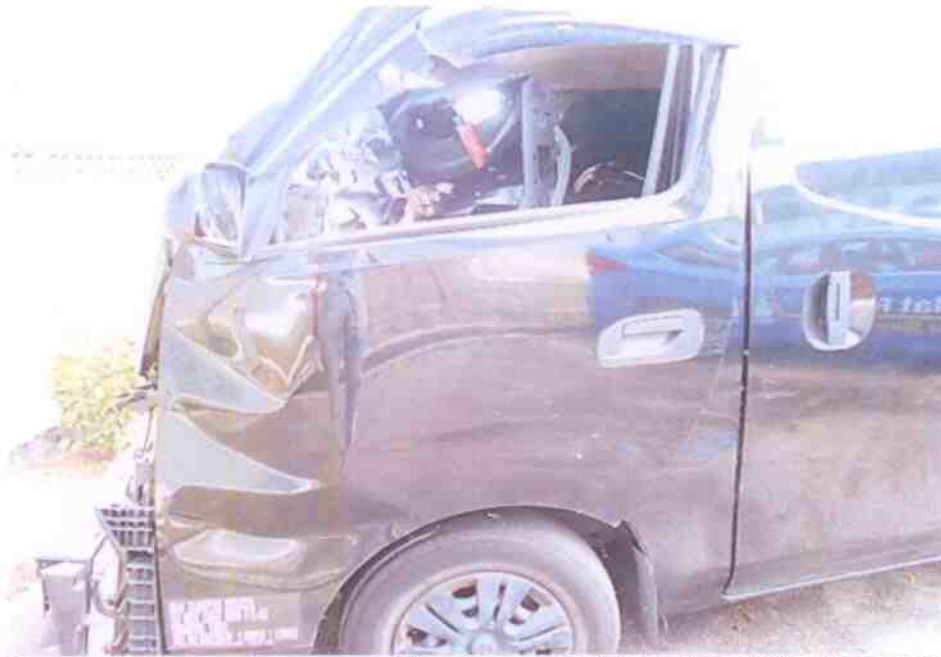
Photo 12 shows a closer view of the damaged left front door of the Motor Van. The impact force was significant, causing the various parts and components inside the engine compartment to be pushed inwards, towards the rear of the Motor Van.

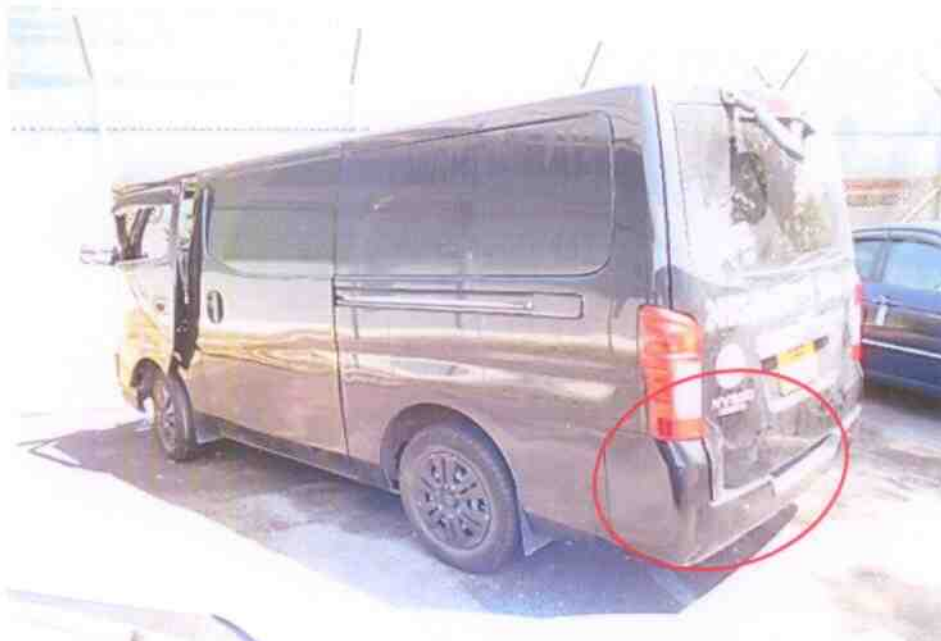
Photo 13 shows a general view of the rear left portion of the Motor Van at the time of our inspection. The rear portion was observed to have sustained with minor damages likely not related to the accident.

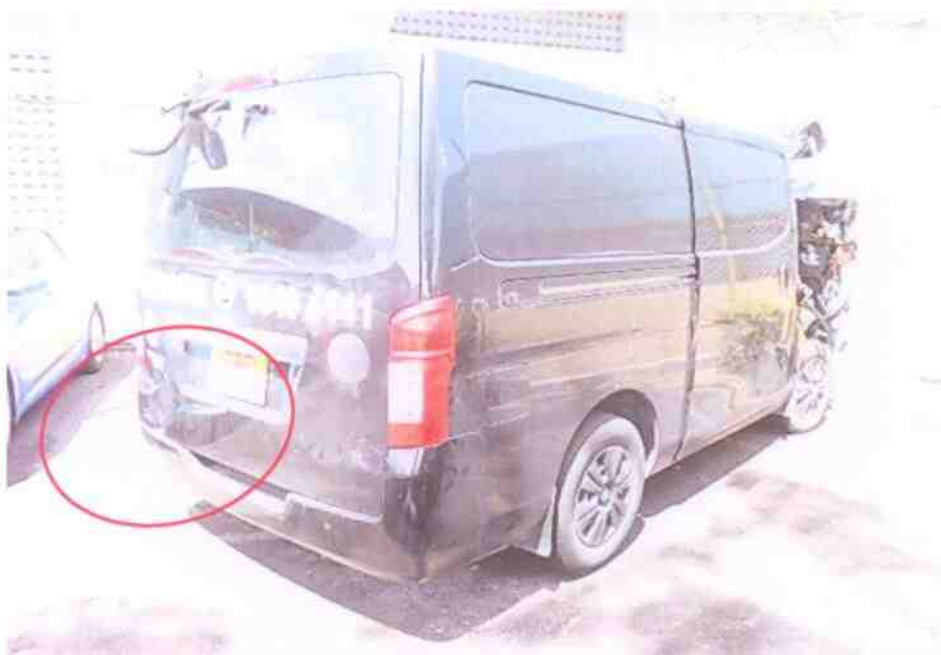
Photo 14 shows a general view of the rear right portion of the Motor Van at the time of our inspection. The rear portion was observed to have sustained with minor damages likely not related to the accident.

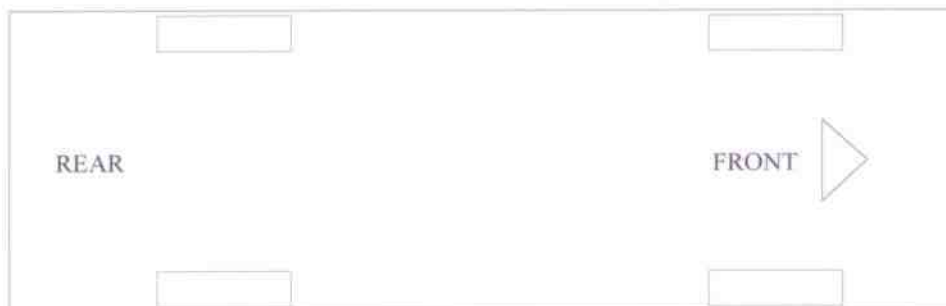
Dunlop SP 175M
195 R15C (0.2mm)
(Below minimum requirement of 1mm)

Bridgestone RD-613 Steel
195 R15C (2mm)
(Inner core exposed)

Michelin Agilis
195 R15C (0.5mm)
(Below minimum requirement of 1mm)

Dunlop SP 175M
195 / 80 R15 (1.6mm)
(Exposed inner core & tyre cut).

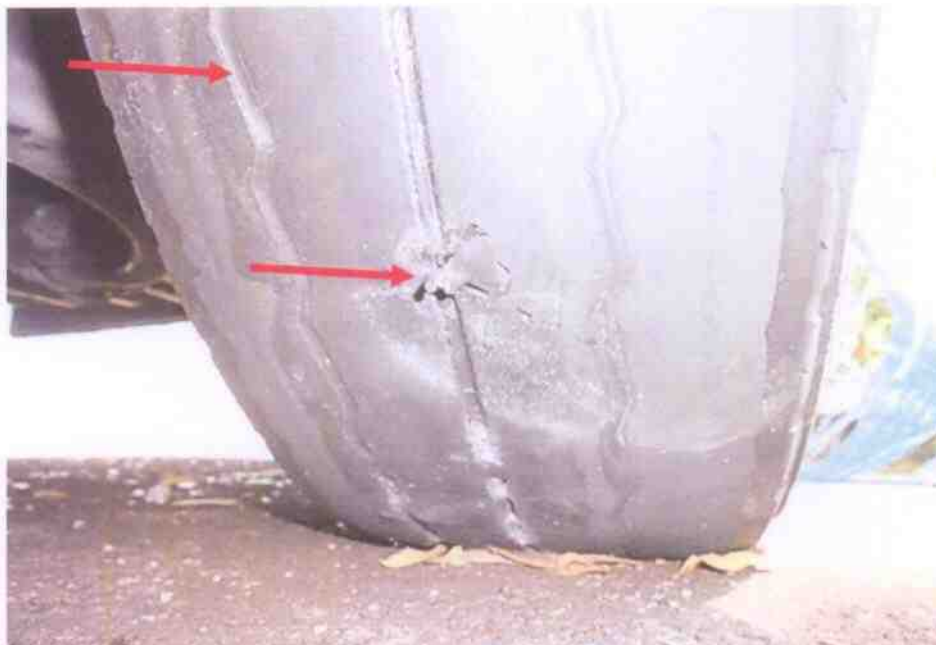
9. As for the front left & front right tyres of the Motor Van, the tread patterns were still visible with remaining tread depth of approximately 2mm (Front left tyre) & 1.6mm (Front right tyre). The front right tyre was also observed to be cut at the middle surface of the tyres likely due to the accident. Further investigation reveals that the inner cores of both tyres were found to be exposed around the outer side of the tyre surface. Hence, concludes that both tyres were not in serviceable condition.

Photo 15 shows the condition of the front right tyre of the Motor Van, which was found to be cut at across the tread pattern of the tyres. However, the tread pattern was still visible (1.6mm) & observed to be inflated for operational purposes.

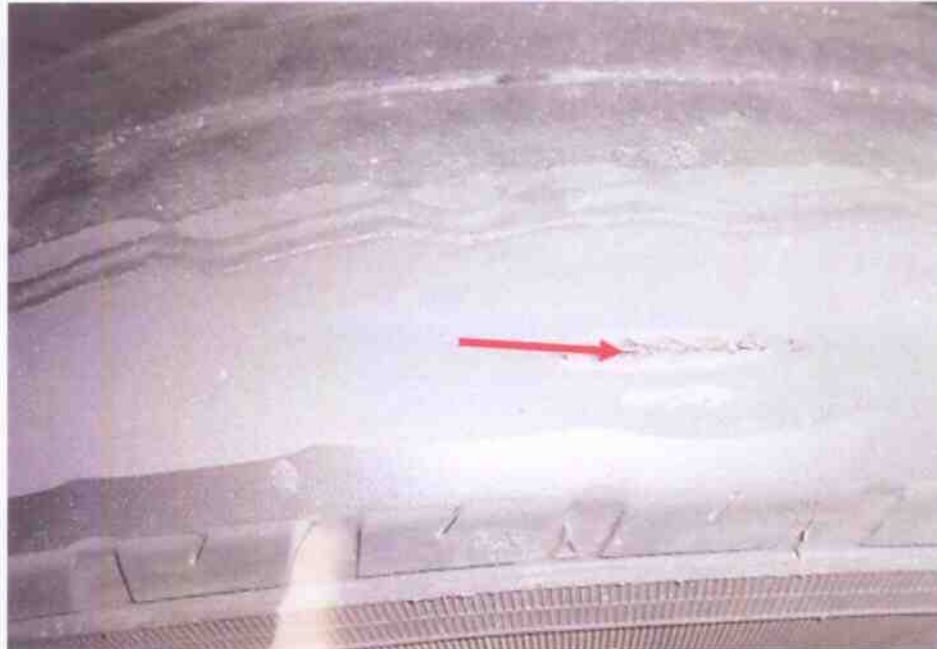
Photo 16 shows the condition of the front right tyre of the Motor Van. Although the tread pattern was still visible, the inner core of the tyre was found to be exposed at the outer side of the tyres.

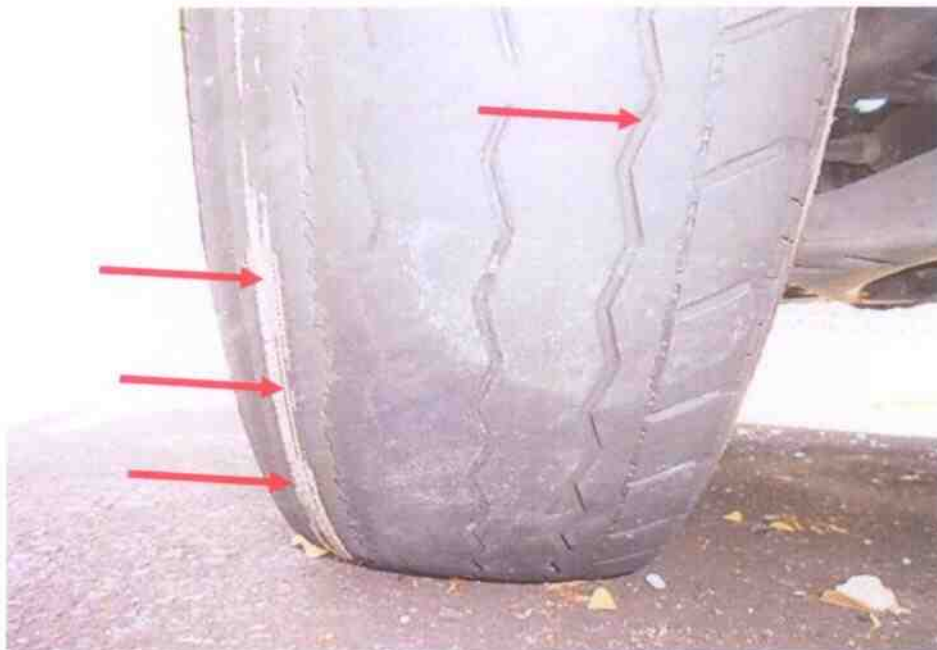
Photo 17 shows the condition of the front left tyre of the Motor Van, which was observed not to be in serviceable condition. Although the tread pattern was still visible, the inner cores of the tyre were found to be exposed at the outer side of the tyres.

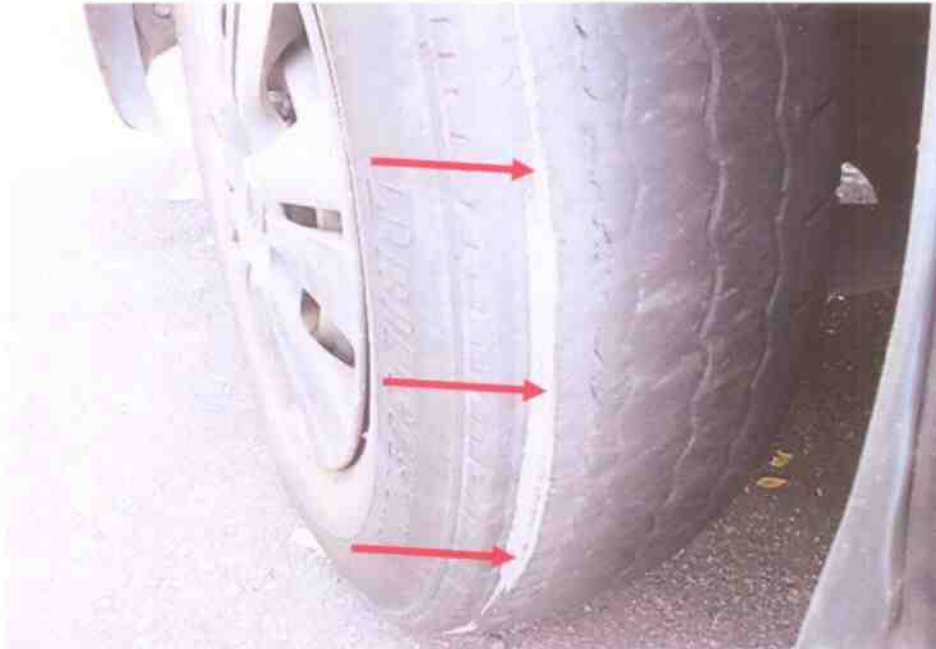
Photo 18 shows the condition of the front left tyre of the Motor Van, which was observed not to be in serviceable condition. Although the tread pattern was still visible, the inner core of the tyre was found to be exposed at the outer side of the tyres.

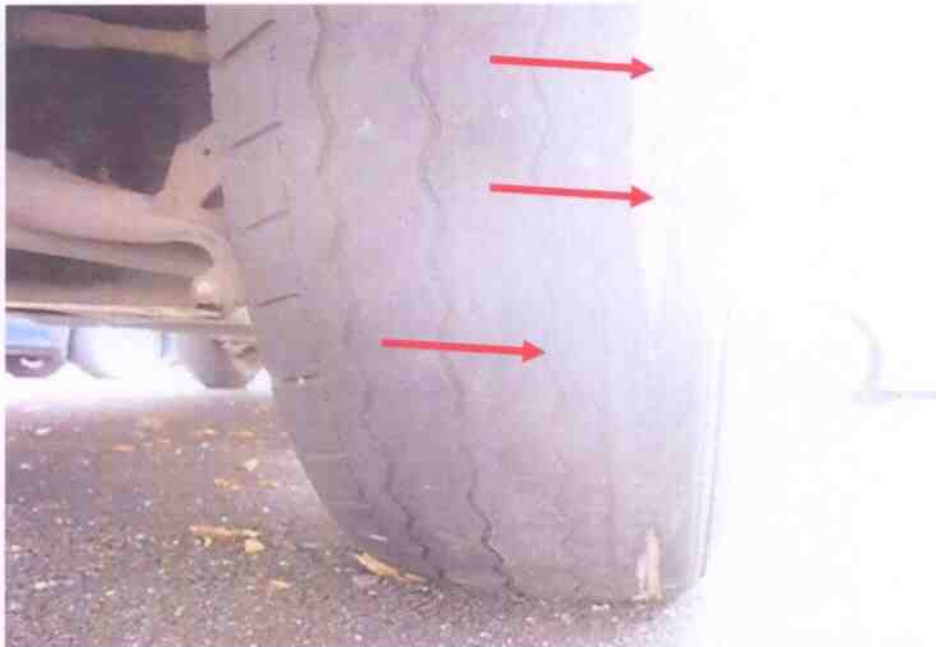
Photo 19 shows the condition of the front left tyre of the Motor Van, which was observed not to be in serviceable condition. Although the tread pattern was still visible, the inner core of the tyre was found to be exposed at the outer side of the tyres.

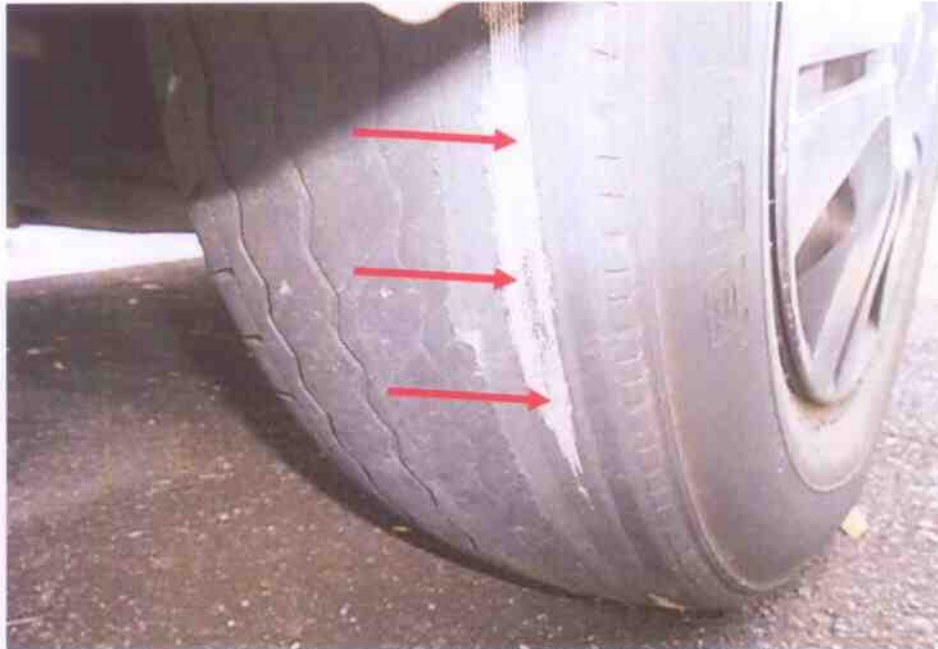
Photo 20 shows the condition of the front left tyre of the Motor Van, which was observed not to be in serviceable condition. Although the tread pattern was still visible, the inner core of the tyre was found to be exposed at the outer side of the tyres.

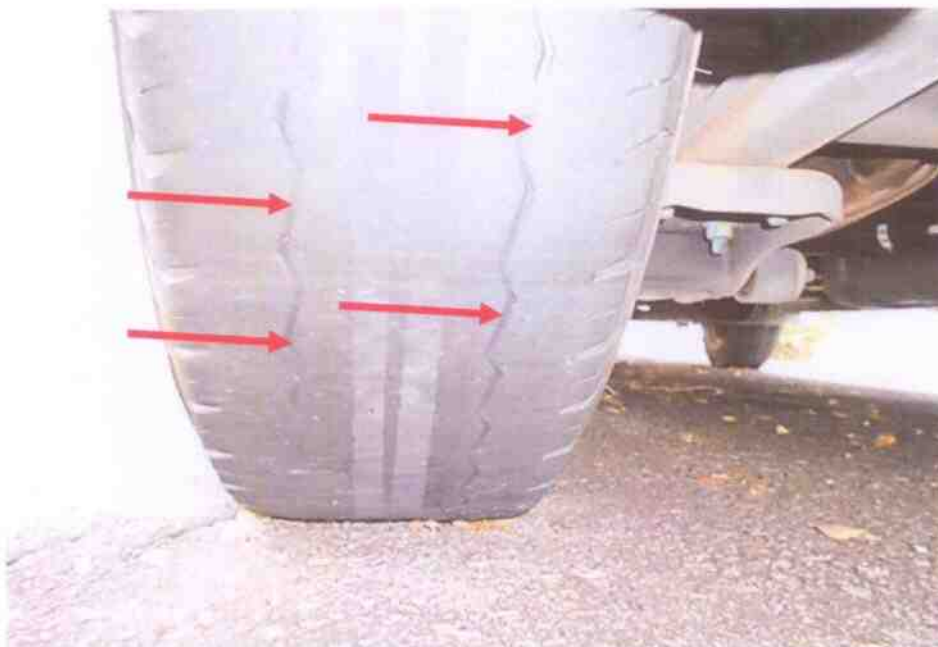
10. Although the tread pattern was still visible for the rear left & rear right tyres of the Motor Van, its tread depth was found to be 0.5mm (Rear right tyre) & 0.2mm (Rear left tyre) which falls below the minimum range of 1mm for operational purposes. Hence, concludes that both tyres were not in serviceable condition.

Photo 21 shows the condition of the rear left tyre of the Motor Van, which was observed not to be in serviceable condition. Although the tread pattern was still visible, its tread depth was found to be (0.5mm) below the minimum range of 1mm.

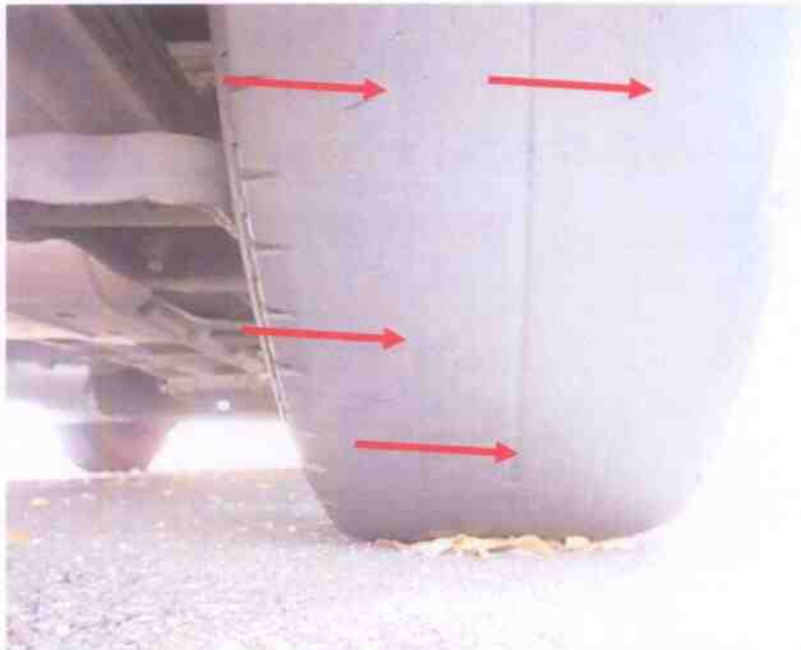
Photo 22 shows the condition of the rear right tyre of the Motor Van, which was observed not to be in serviceable condition. Although the tread pattern was still visible, its tread depth was found to be (0.2mm) below the minimum range of (1mm).

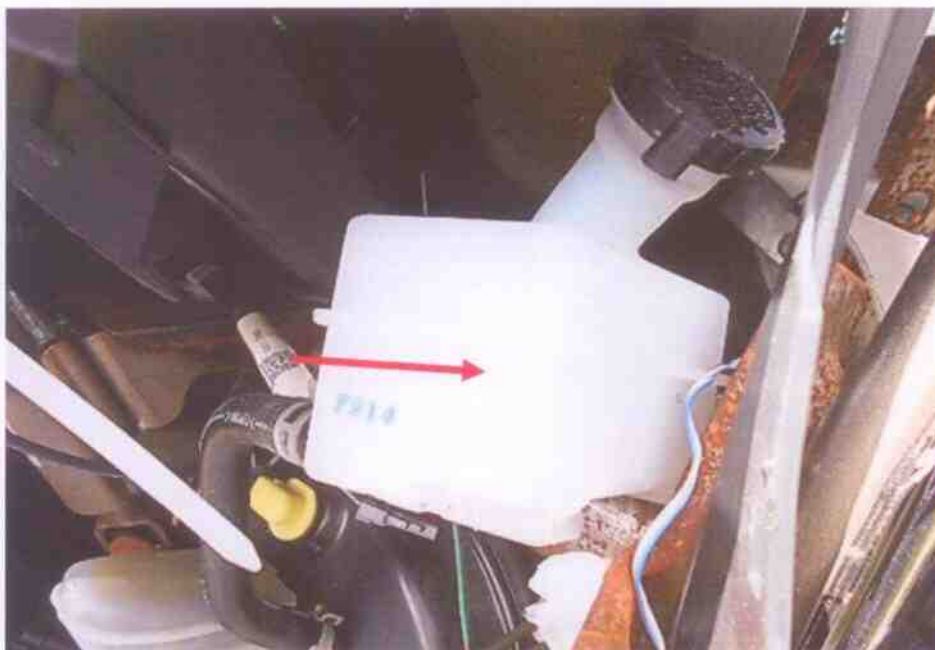
Photo 23 shows the close up view of the brake fluid reservoir that indicates empty likely due to the accident impact.

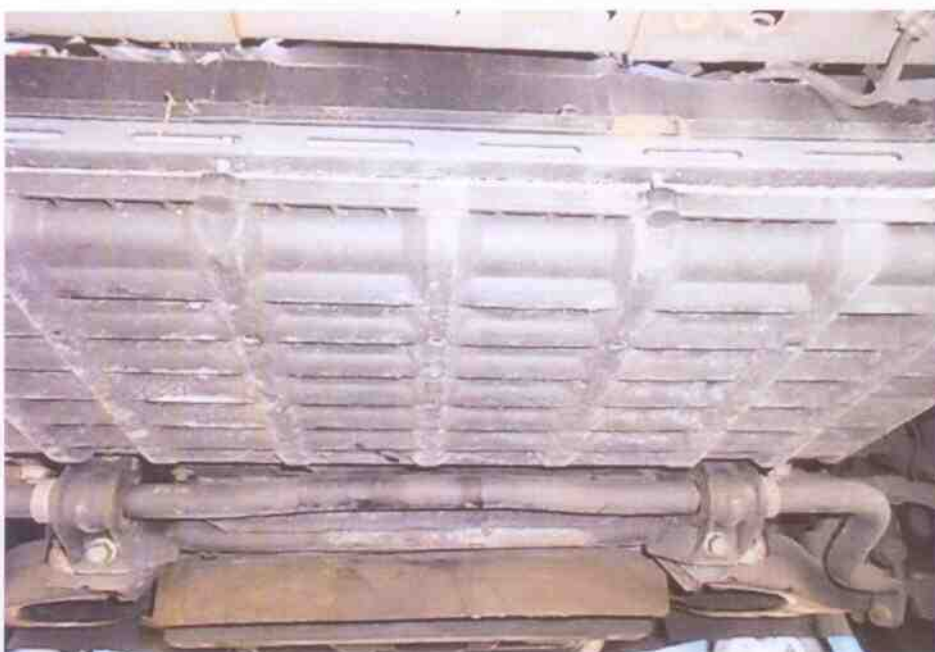
Photo 24 shows the close up view of the radiator undercarriage was observed to be unaffected by the accident.

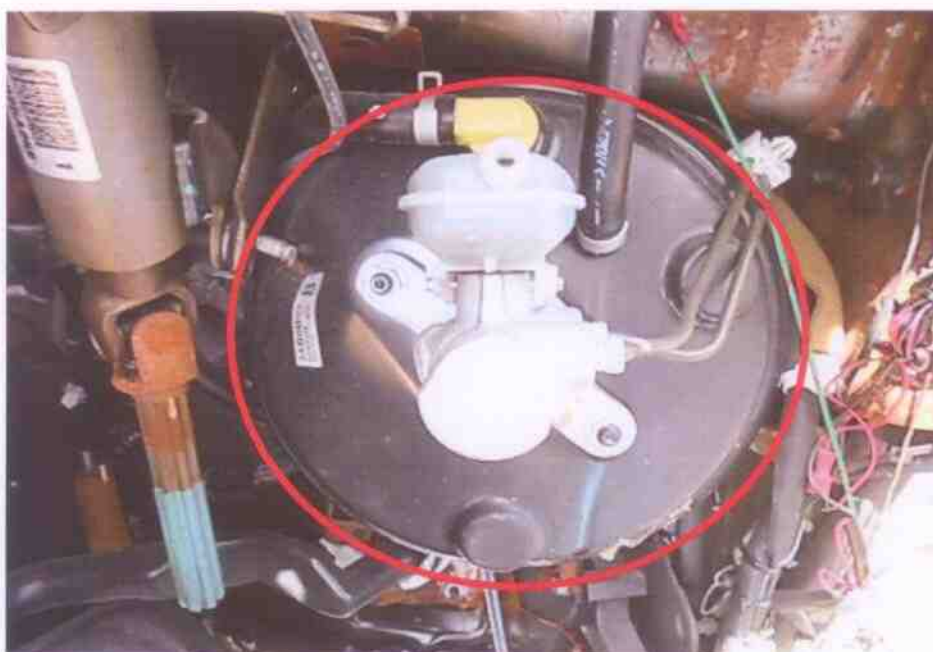
Photo 25 shows the close up view of the brake booster that was observed to be damaged likely due to the accident impact.

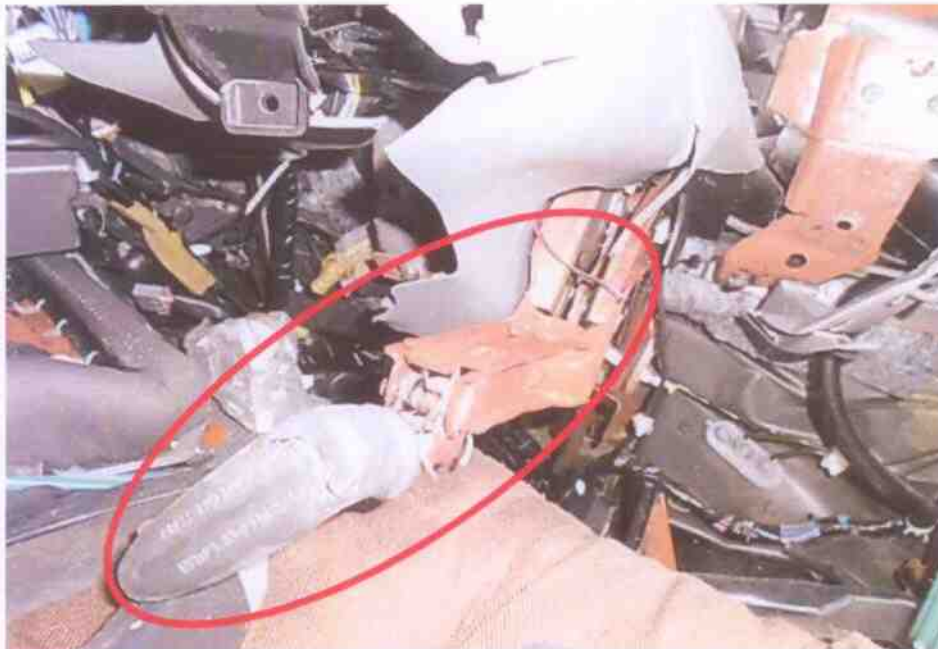
Photo 26 shows the close up view of the hand brake that was observed to be damaged likely due to the accident impact

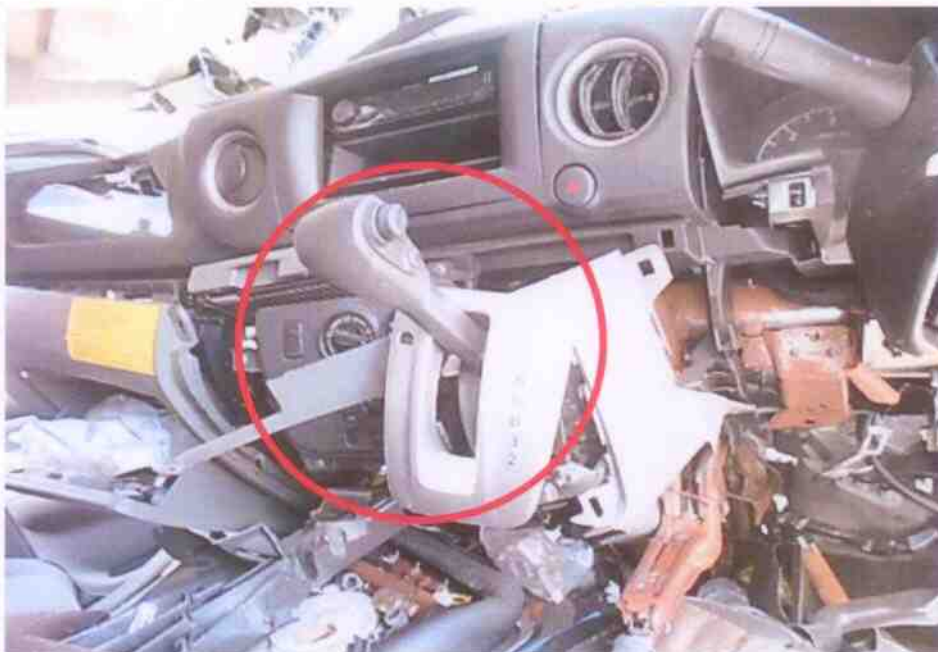
Photo 27 shows the close up view of the gear knob for transmission control that was observed to be damaged likely due to the accident impact

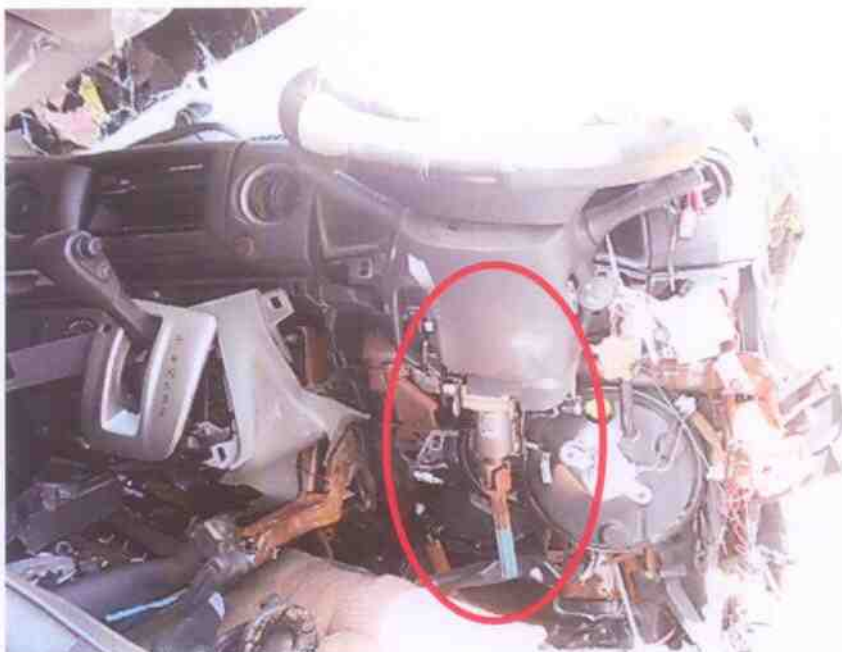
Photo 28 shows the close up view of the steering wheel rod that was observed to be damaged likely due to the accident impact

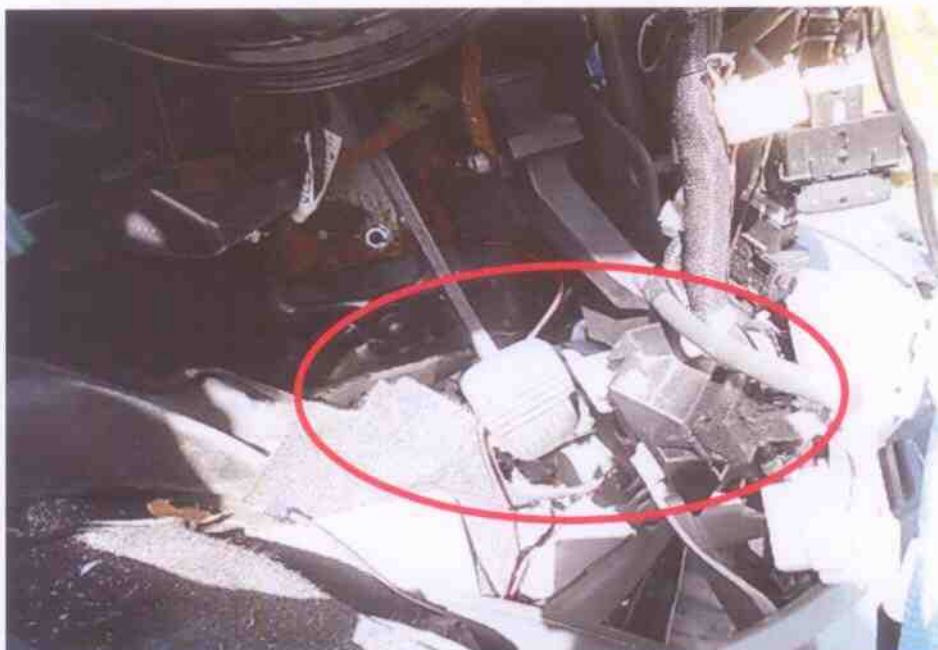
Photo 29 shows the close up view of the brake pedal & acceleration pedal that was observed to be damaged likely due to the accident impact

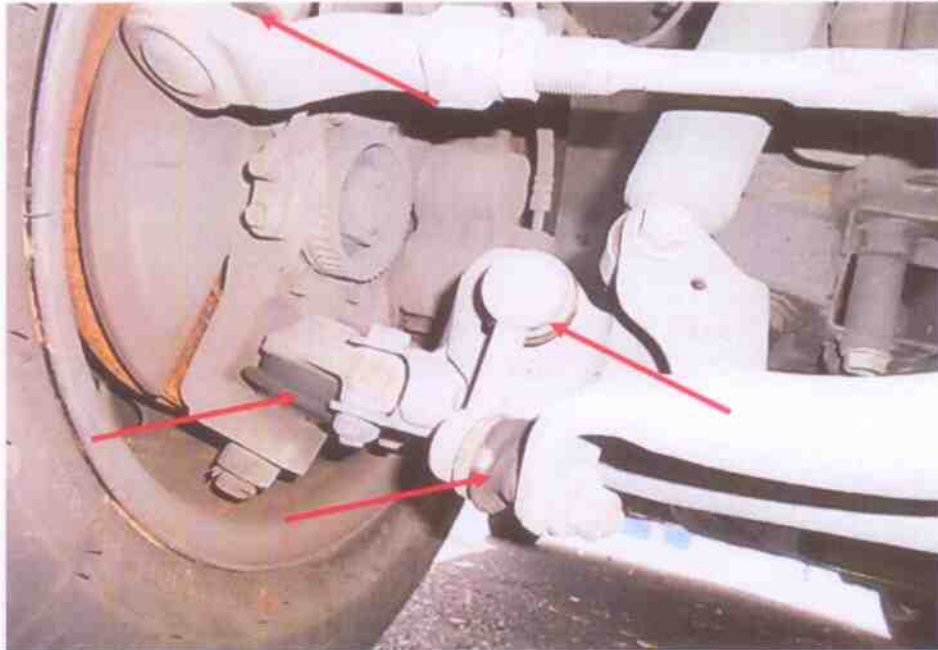
Photo 30 shows the front right steering tie rod & steering components of the Motor Van. It was observed to be unaffected by the accident.

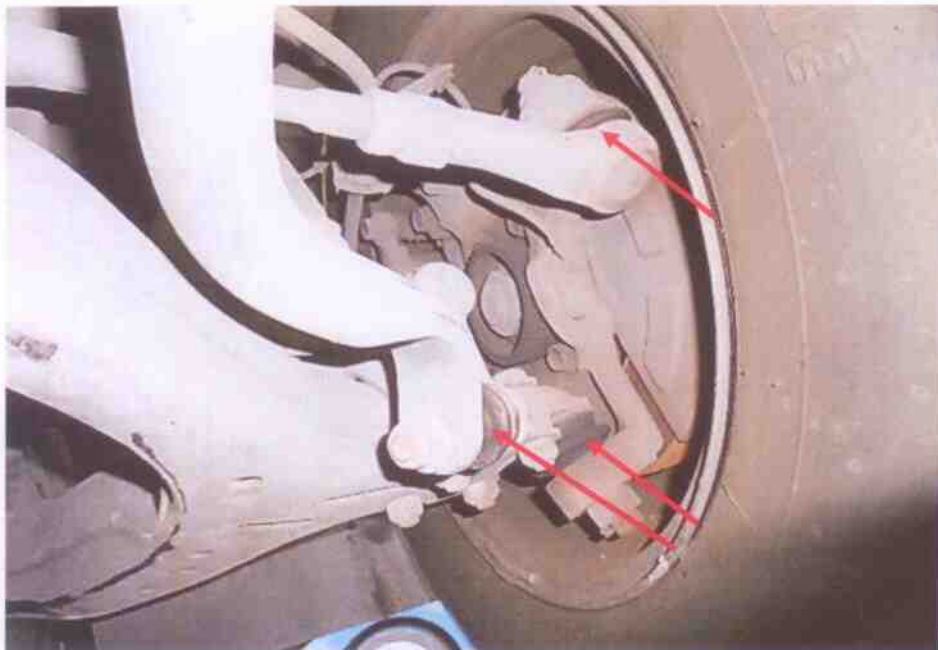
Photo 31 shows the front left steering system of the Motor Van. It was observed to be unaffected by the accident.

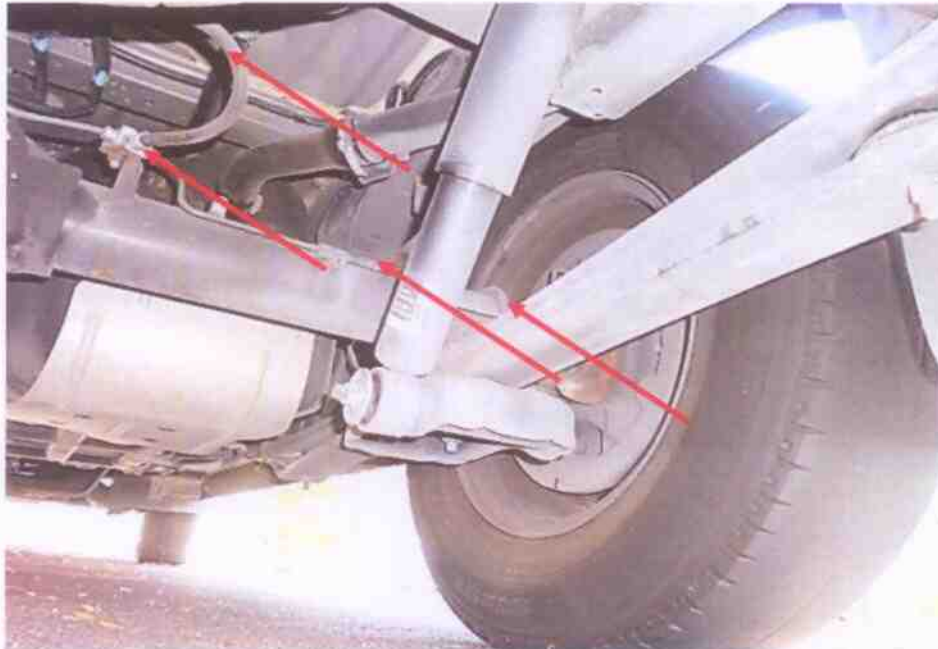
Photo 32 shows the braking components at the rear right wheel of the Motor Van. We did not observe any leakage of brake fluid at the time of our inspection of the Motor Van.

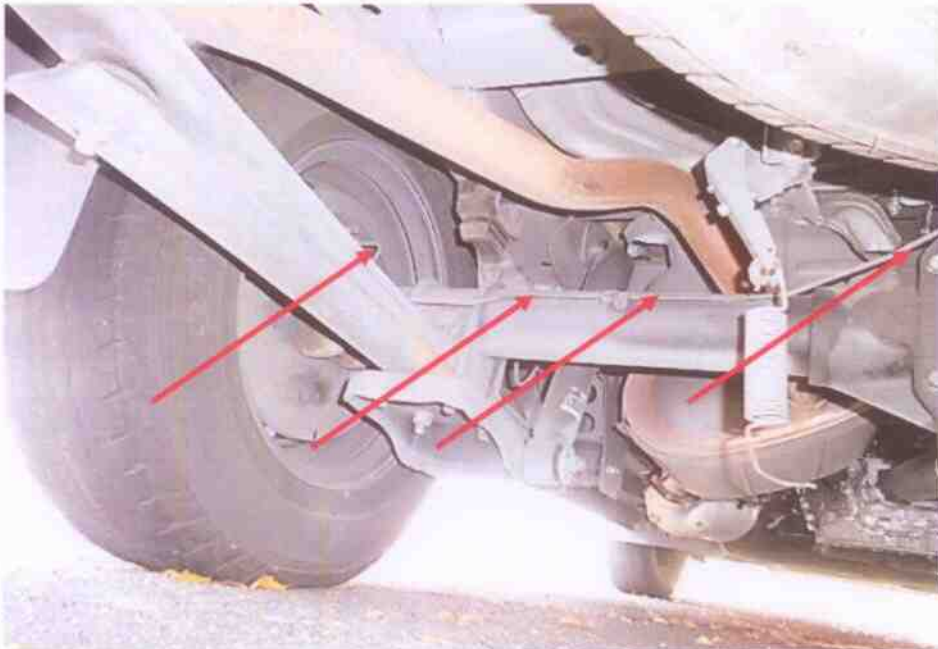
Photo 33 shows the braking component at the left right wheel of the Motor Van. We did not observe any leakage of brake fluid at the time of our inspection of the Motor Van.

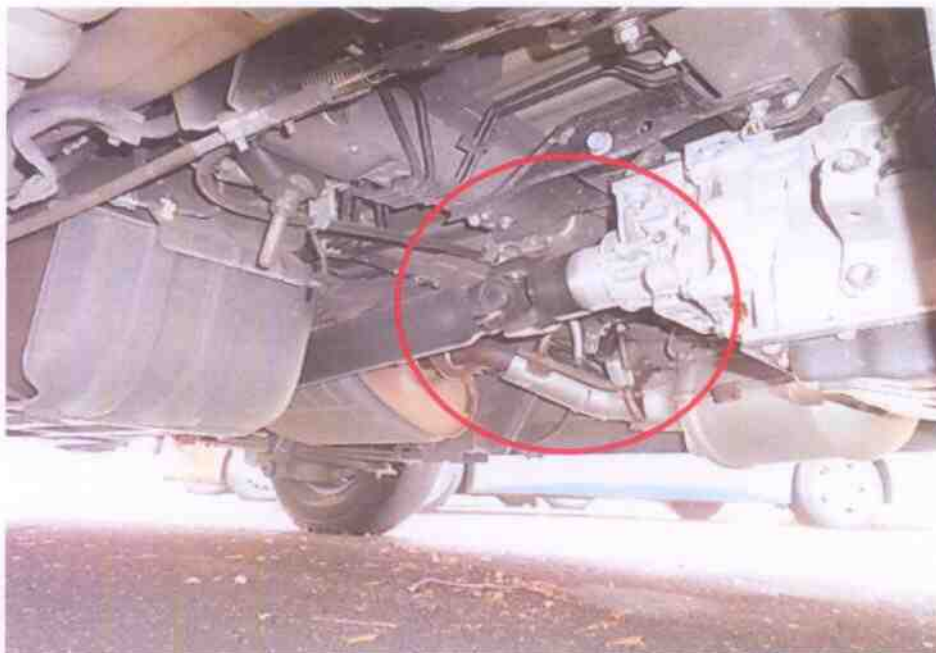
Photo 34 shows the engine transmission of the Motor Van. It was observed to be in good condition at the time of our inspection of the Motor Van.
