Your Ref: TP/IP/59561/2017
Our Ref : CI/TPD18001964/Z

Fatal Accident Investigation Team

MECHANICAL INSPECTION REPORT OF MOTOR VAN GBE 6269C

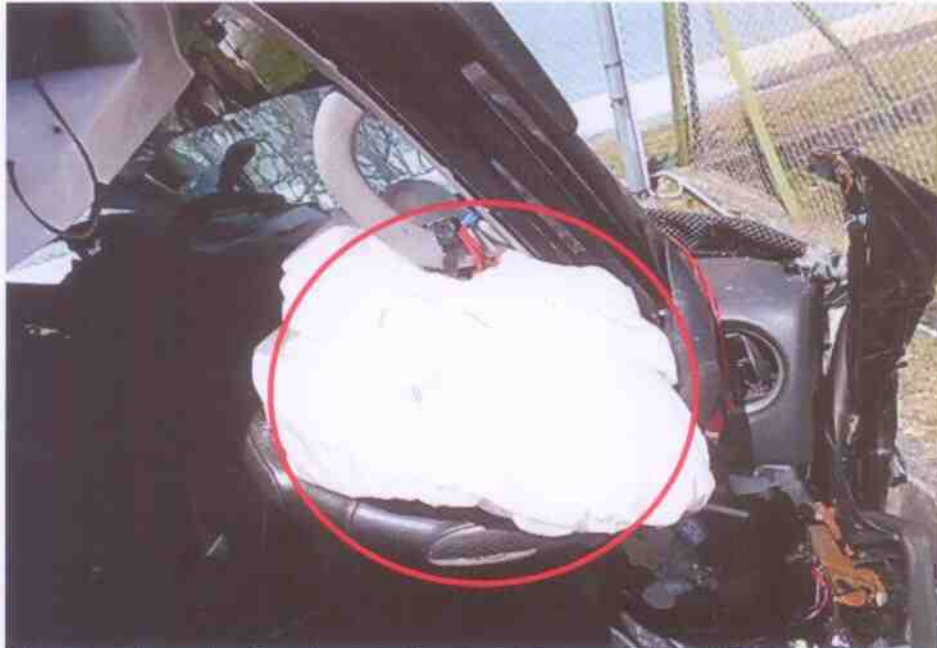
Photo 35 shows the Supplemental Restraint System (SRS) of the Motor Van was however likely to be in normal operating condition at the material time of the accident. The evidence of the deployed front passenger's airbag indicates that the impact sensors and control module of the Motor Van's SRS were all in serviceable condition at the material time of accident.
