Your Ref: TP/IP/67923/2017  
Our Ref :CI/TPD18002544/Z

**Fatal Accident Investigation Team**  
Traffic Police Department  
Singapore Police Force  
10 Ubi Avenue 3  
Singapore 408865

### **MECHANICAL INSPECTION REPORT OF MOTORCYCLE FBF 8025X**

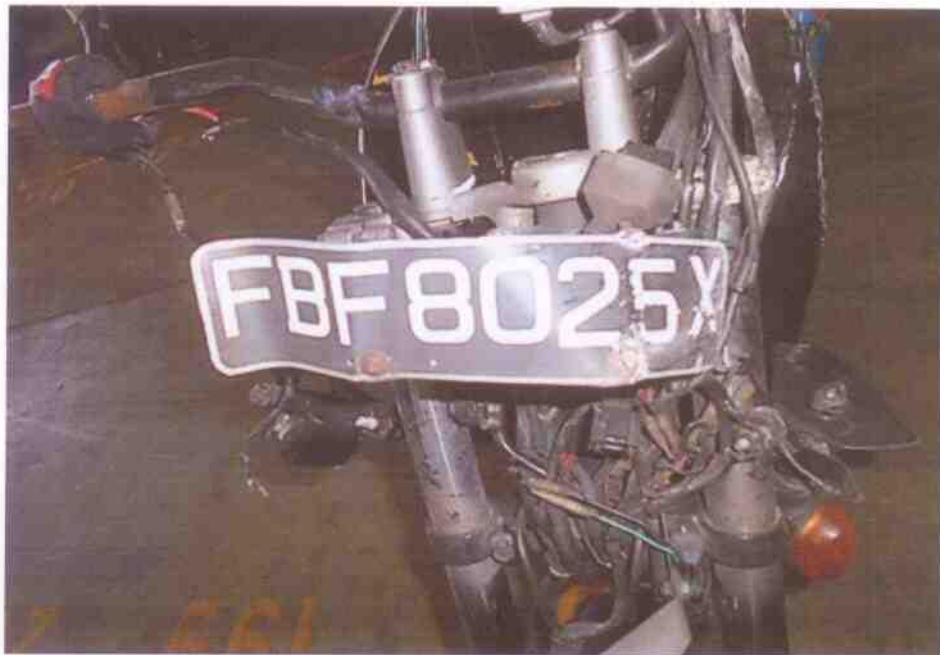
Photo 1 shows the Motorcycle number plate for identification.

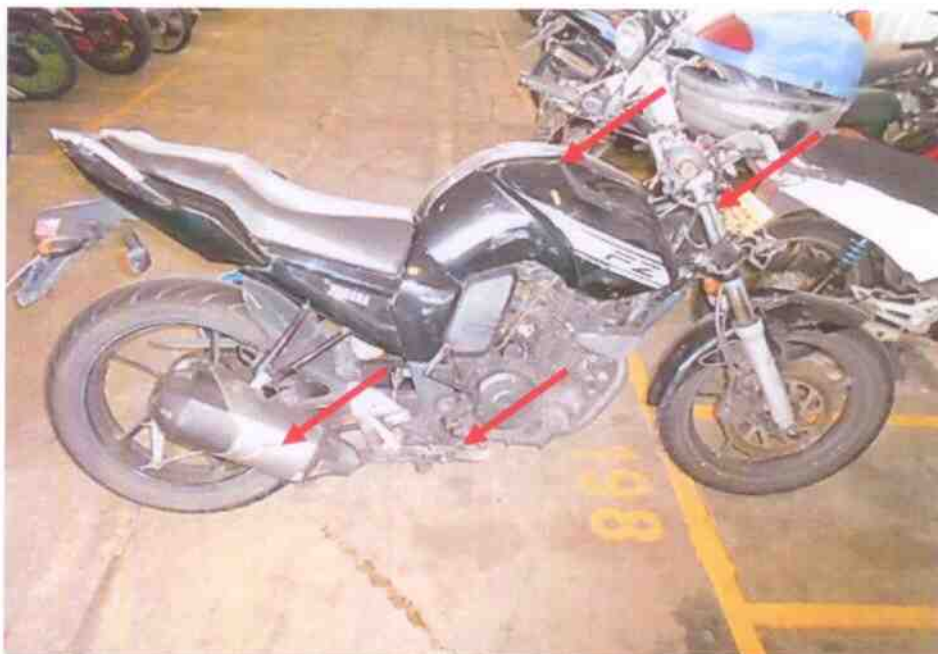
**Photo 2** shows a general view of the right body of the Motorcycle at the time of our inspection. The Motorcycle was observed to have sustained with relatively extensive impact due to the accident collision. Amongst the body parts damaged was its front fork, brake pedal, fuel tank.

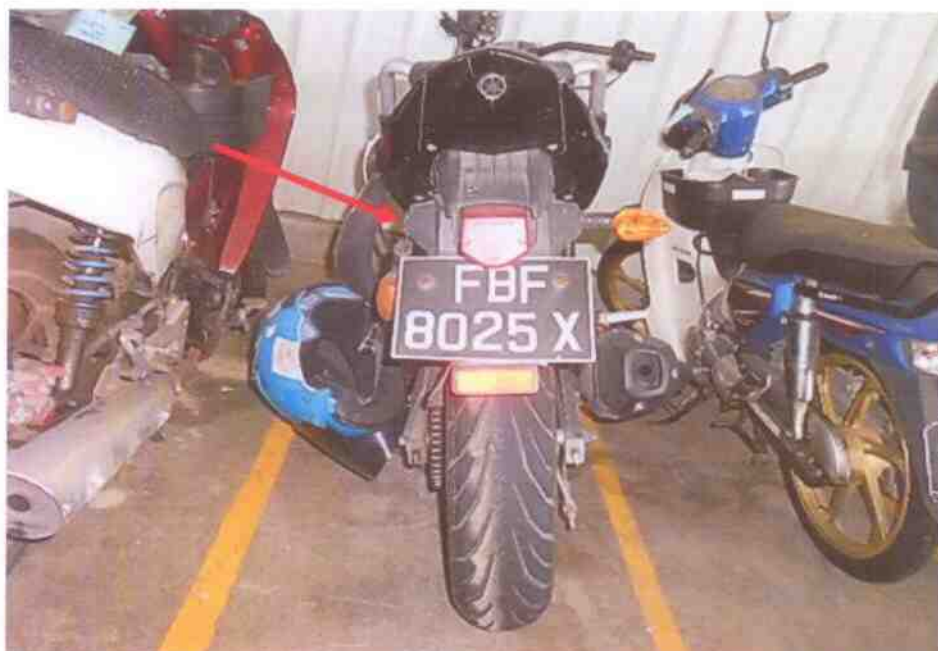
**Photo 3** shows a general view of the rear body of the Motorcycle at the time of our inspection. The Motorcycle was observed to have sustained damages at the frontal portion, along both its left side and right side.

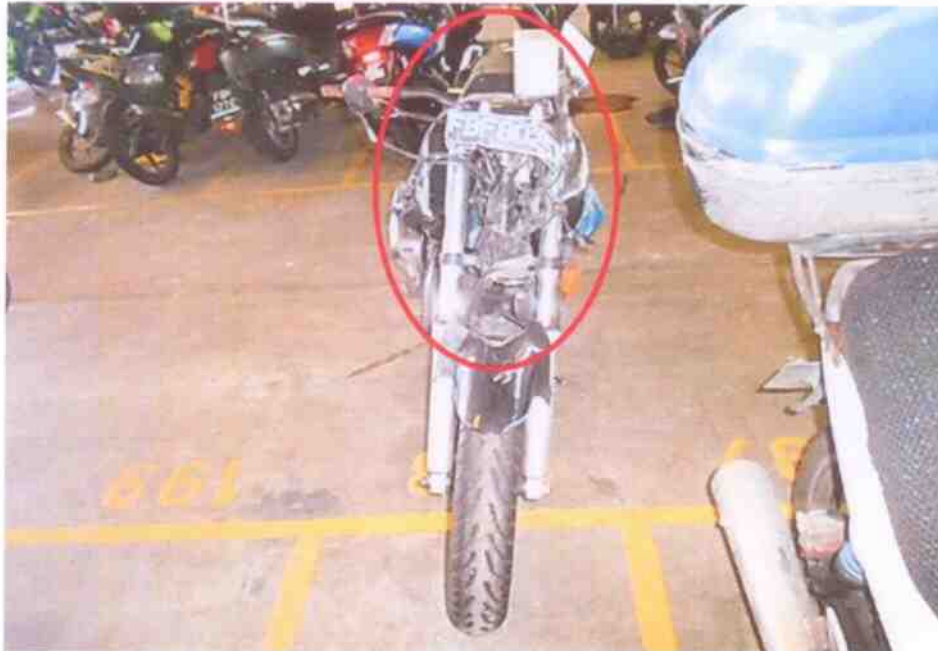
**Photo 4** shows a general view of the frontal portion of the Motorcycle at the time of our inspection. The Motorcycle was observed to have sustained relatively extensive impact due to the accident collision.

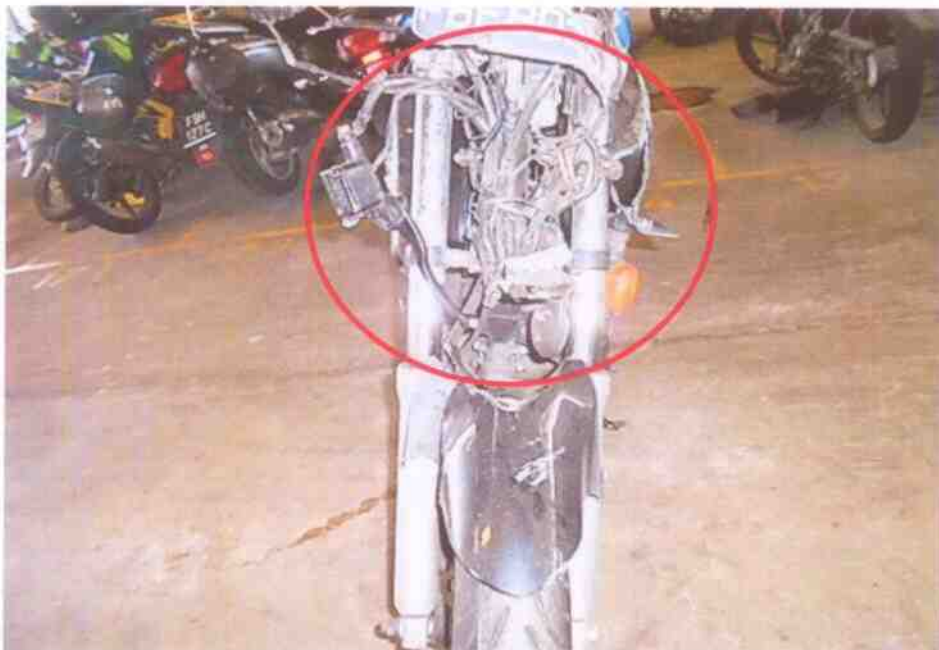
**Photo 5** shows a close-up view of the frontal portion of the Motorcycle at the time of our inspection. The Motorcycle was observed to have sustained relatively extensive impact including missing speedometer & dislodged brake fluid reservoir (circled) likely due to the accident collision.

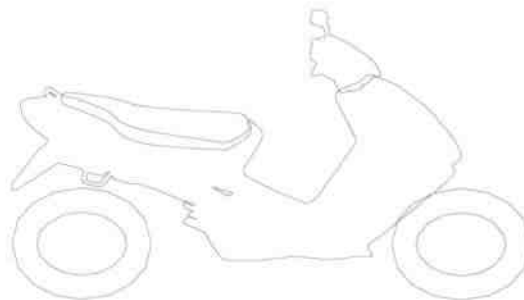
7. The condition of the Motorcycle's 2 tyres was observed to be in serviceable condition. The tread pattern of the 2 tyres was clearly visible. We did not observe any tear, burst mark(s) and/or punctured hole(s) on the sidewalls as well as across the tread of the 2 tyres. The 2 tyres were both observed to be sufficiently inflated for vehicular operation. The tyre brand, tyre size and remaining tread depth of the 2 tyres were recorded as follows:-

Pirelli 140/70 - 17 (3mm)

Pirelli 110/70 - 17 (2mm)

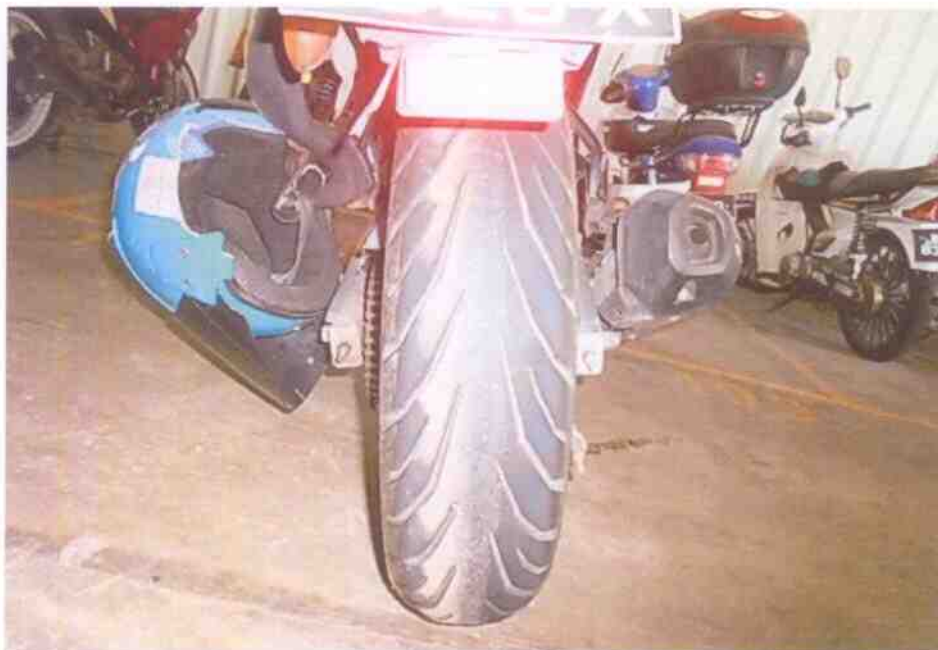
**Photo 6** shows the rear tyre of the Motorcycle at the time of our inspection. The rear tyre was observed to be in serviceable condition with remaining tread depth of approximately 3mm. The tyre was also observed to be sufficiently inflated for vehicular operation. There was no significant damage observed on the rear wheel rim & tyre.

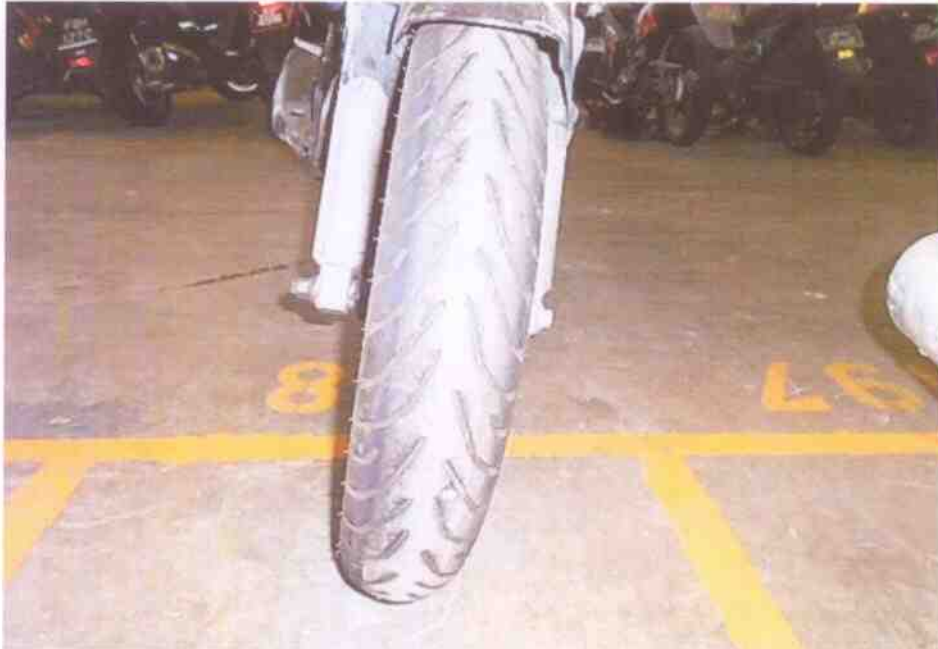
**Photo 7** shows the front tyre of the Motorcycle at the time of our inspection. The pattern of the tread was clearly visible. There was no tear, burst mark(s) and/or punctured hole(s) on the sidewalls as well as across the tread of the front tyre.

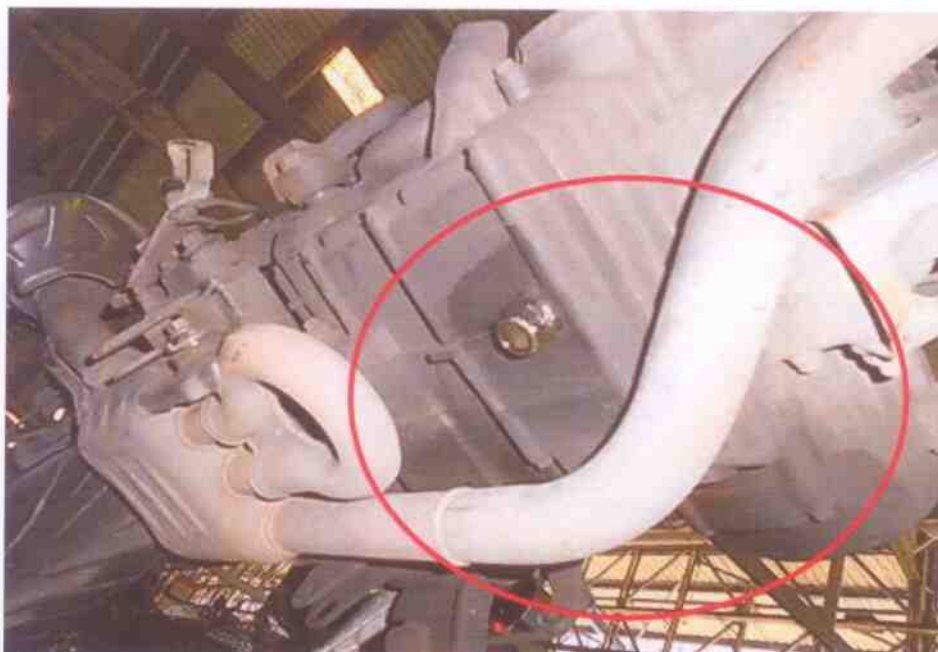
9. Upon examination of the engine area of the Motorcycle, we had observed that the various engine related parts and components were intact with no visible damage. The engine underside was however observed to be covered with fluid, suggesting leakage of fluid. There was no accumulation of dust and/or dirt particles on the engine housing where the fluid stains had formed. This would indicate that the fluid leakage was a fresh leak and likely to be a result of the accident.
10. Although the gear chain of the Motorcycle found to be intact but its drive train support bar was observed to be misalignment likely due to the accident. Free play tension test was conducted but found unacceptable due to its tension was too loose at time of our inspection. However, its gear chain was found adequately lubricated for operating purposes. See photo 8 – 11 below.

**Photo 8** shows sign(s) or indication(s) of fluid leakage observed around the engine's underside area of the Motorcycle.

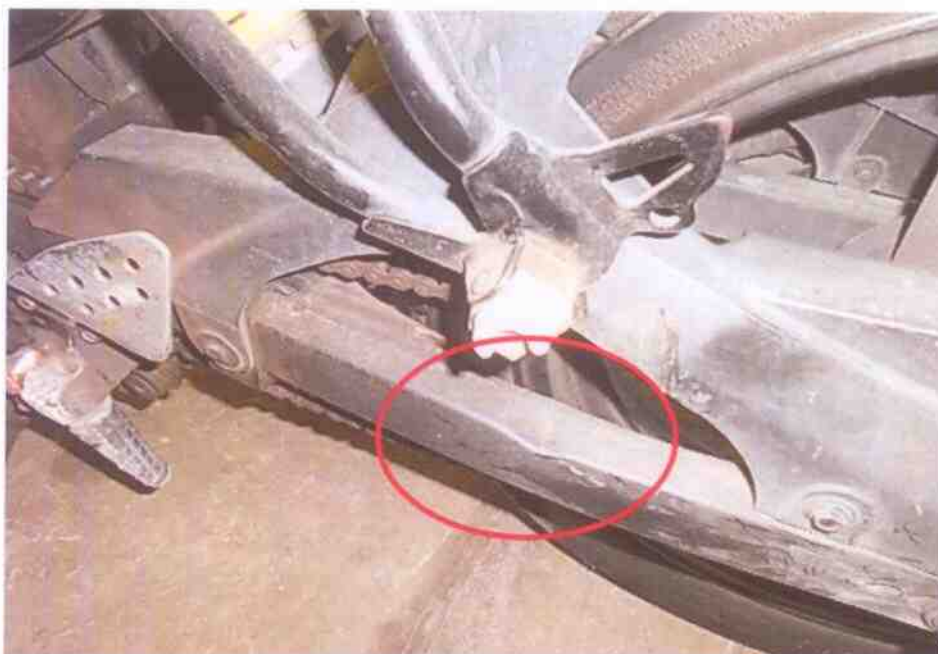
**Photo 9** shows the misalignment of the drive train support bar likely due to the accident's collision impact.

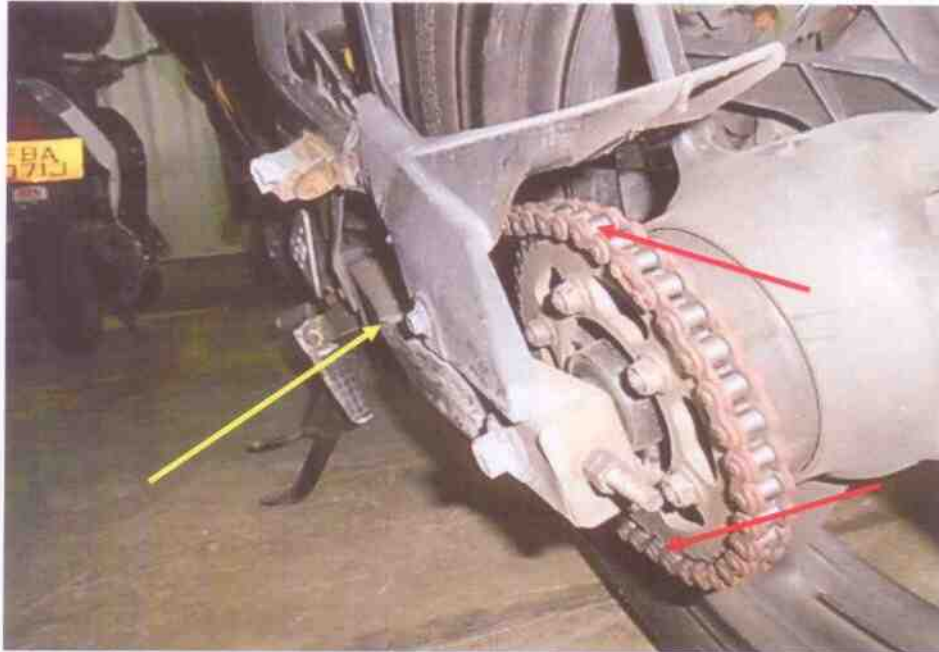
Photo 10 shows the general view of the chain gear (red arrowed) of the Motorcycle. It was adequately lubricated for operating purposes. However, misalignment of the drive train support bar (yellow arrowed) likely due to the accident's collision impact.

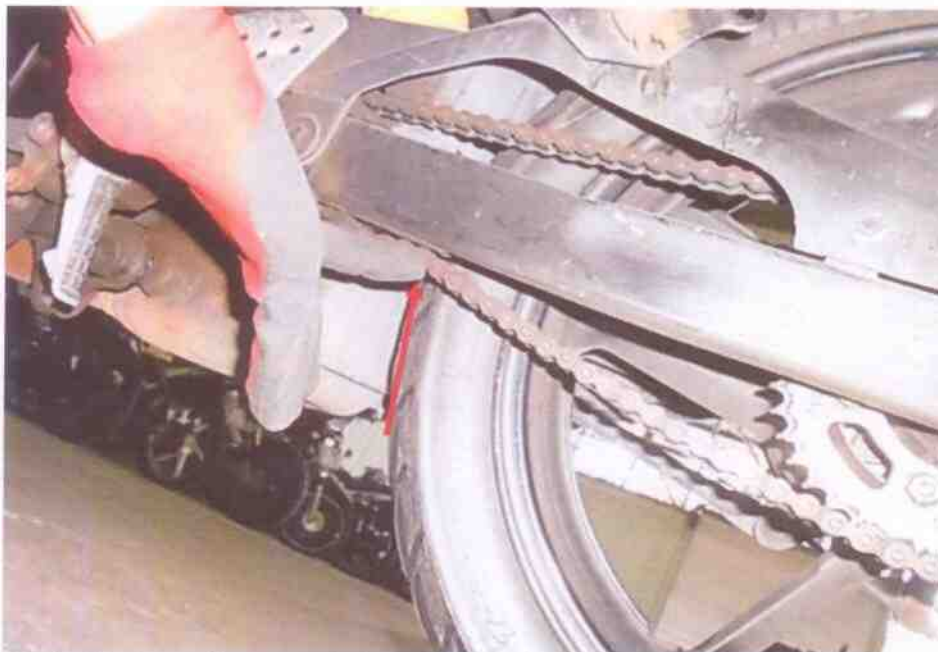
Photo 11 shows the general view of the chain gear (arrowed) of the Motorcycle. Free play tension test was conducted but found unacceptable due to its tension was too loose at time of our inspection. However, its gear chain was found adequately lubricated for operating purposes.

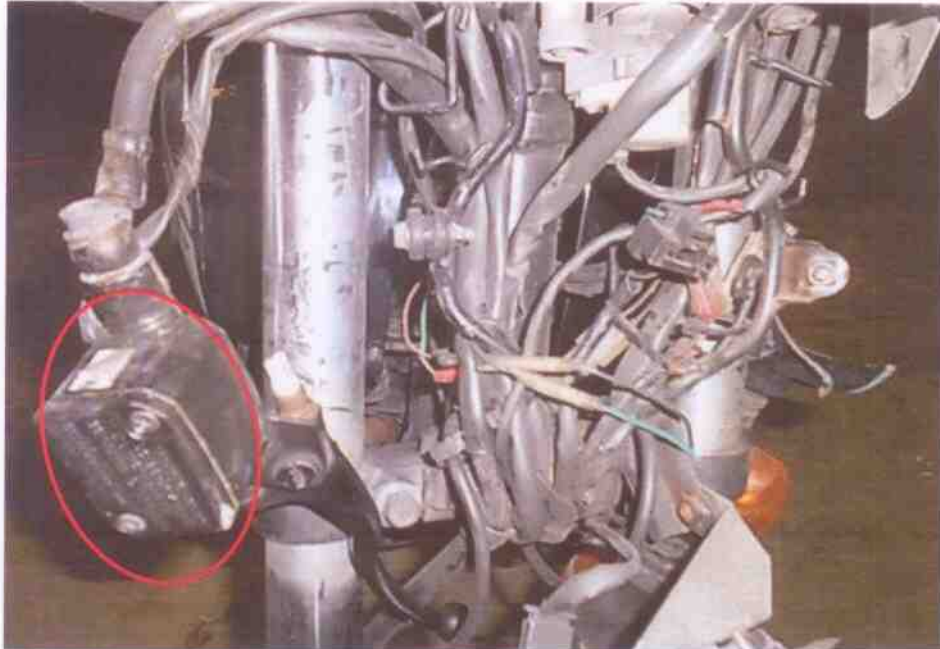
13. Static brake tests was unable to be conducted on the Motorcycle front & rear brake due to some braking components were noted to be extensively damaged such as hand brake lever, rear brake pedal & brake fluid reservoir at the material time of our inspection.

**Photo 12** shows the hand brake segment (circled) was observed to be broken off & separated from the handle bar likely due to the result of the accident. Hence, we are unable to conduct any tests on the steering system of the Motorcycle.

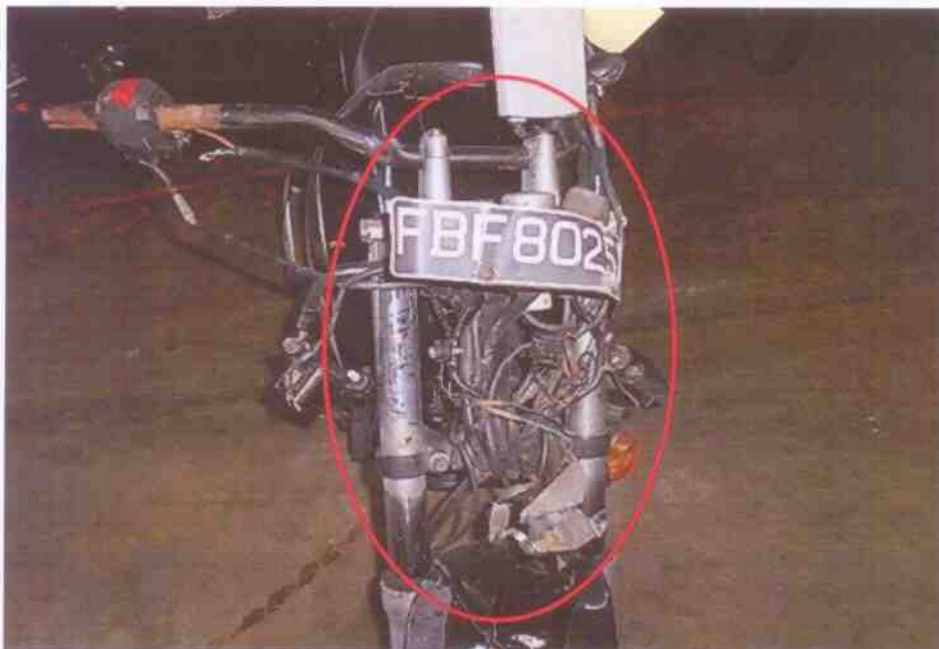
11. For this case, we were not able to conduct any test(s) on the steering system of the Motorcycle due to the damages on its front fork & handle bar. The front fork was found to be misaligned & damaged handle bar as a result of the accident, hence causing the whole steering system to be in a state of immobility.

**Photo 13** shows the front fork (circled) was observed to be misaligned as a result of the accident. Hence, we are unable to conduct any tests on the steering system of the Motorcycle.

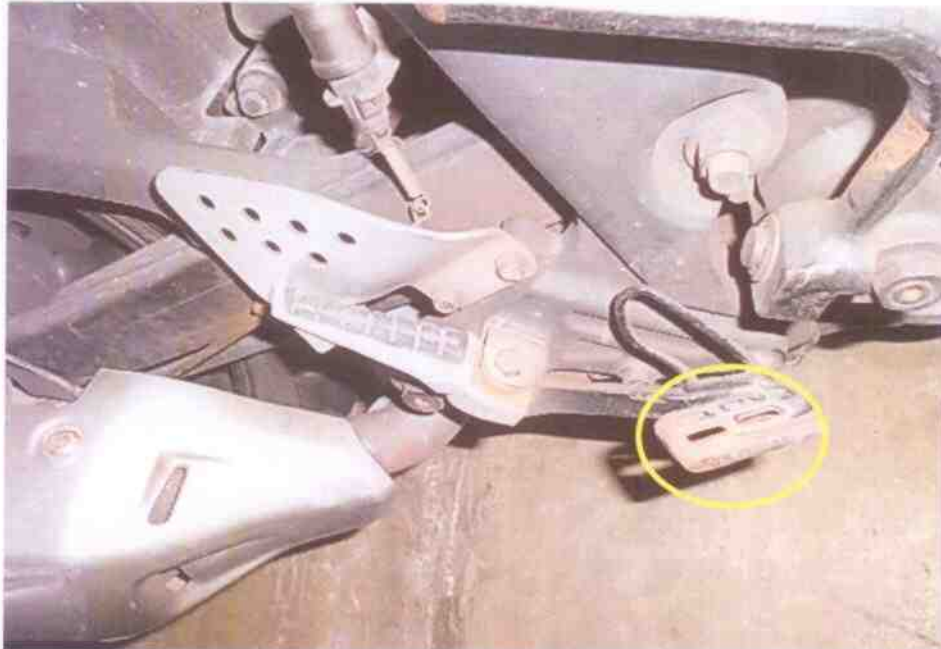
**Photo 14** shows the foot brake pedal of the Motorcycle (yellow circled), which observed to be buckled in as the result of the accidents. Hence, we are unable to conduct any brake test.

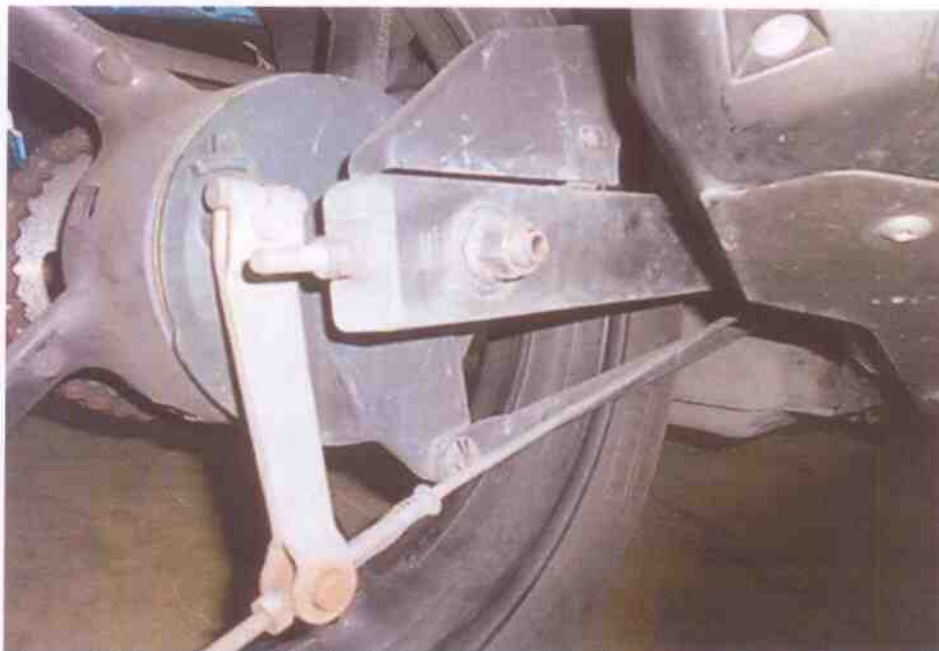
**Photo 15** shows the rear wheel of the Motorcycle. The type of brake system for the rear wheel was of mechanical type, controlled by the brake foot pedal of the motorcycle. Our checks of the cable spring and drum. This is all part of the components in the rear braking system of the Motorcycle reveal all to be intact and without damages.
