Your Ref: TP/IP/64871/2017  
Our Ref : CI/TPD18002601/N

**Fatal Accident Investigation Team**

**MECHANICAL INSPECTION REPORT OF MOTOR LORRY YP 6093L**

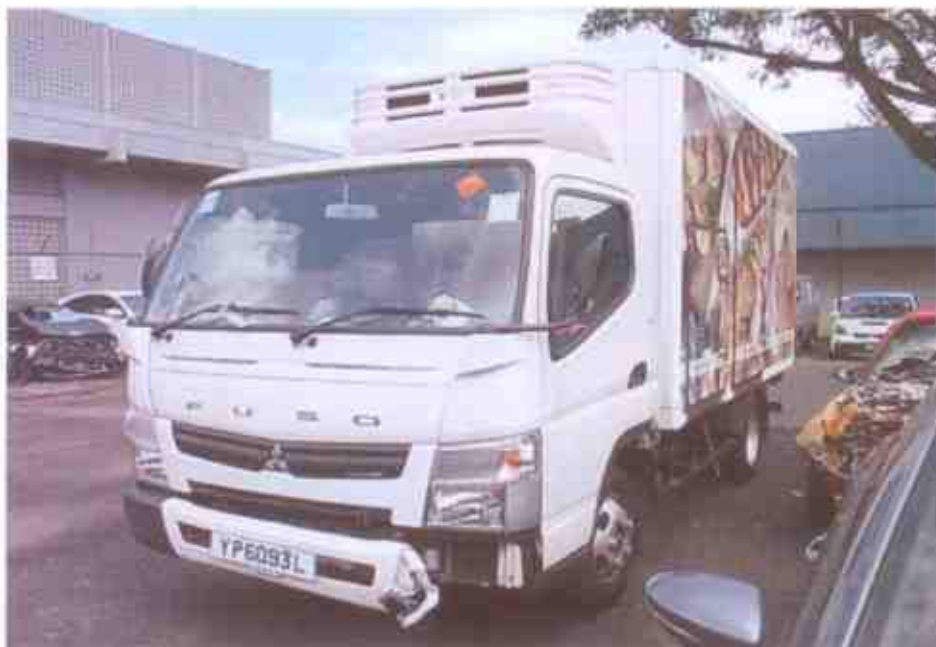
4. The mileage of the Motor Lorry at the time of our inspection was 17,837km.
5. The Motor Lorry had sustained relatively minor impact at its frontal portion, which had caused the front number plate to be slightly bent, the front bumper to be buckled on the left side and a cracked left headlight. The left side mirror of the Motor Lorry was also dislodged.

**Photo 1** shows a general view of the front left body of the Motor Lorry at the time of our inspection. The Motor Lorry was observed to be in good general condition except for some relatively minor impact damage at its front body. The left side mirror was also dislodged. The mileage of the Motor Lorry at the time of our inspection was 17,837km.

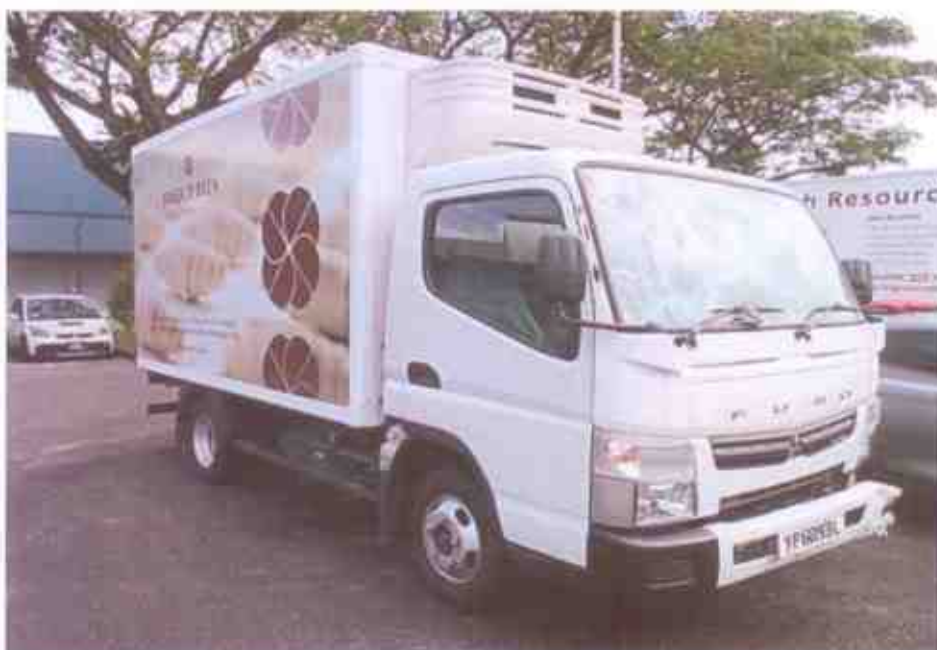
Photo 2 shows a general view of the front right body of the Motor Lorry at the time of our inspection. The Motor Lorry was observed to be in good general condition except for some relatively minor impact damage at its front body. The left side mirror was also dislodged.

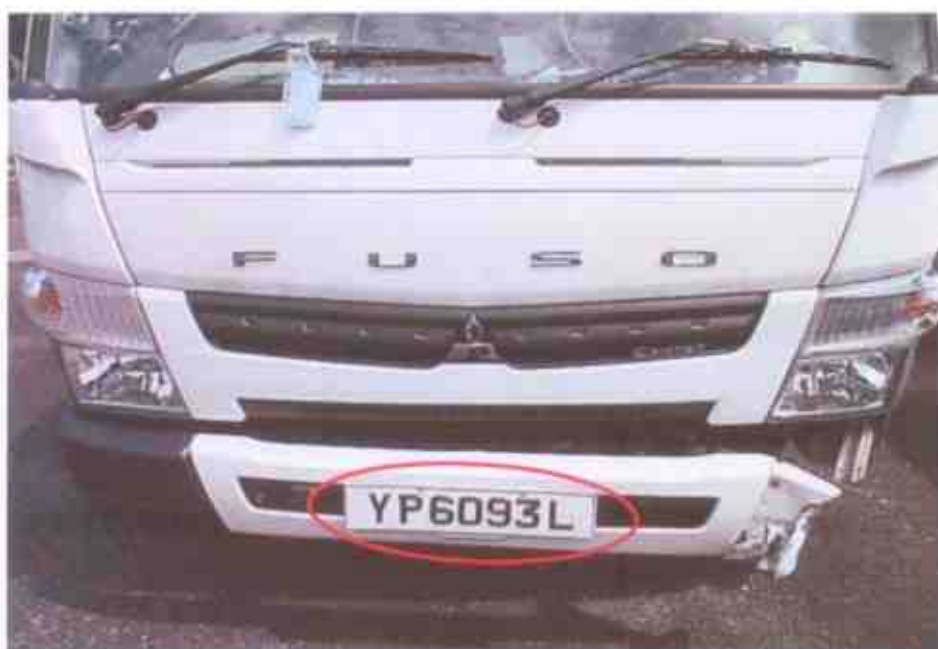
Photo 3 shows a closer view of the bent front number plate of the Motor Lorry at the time of our inspection (circled).

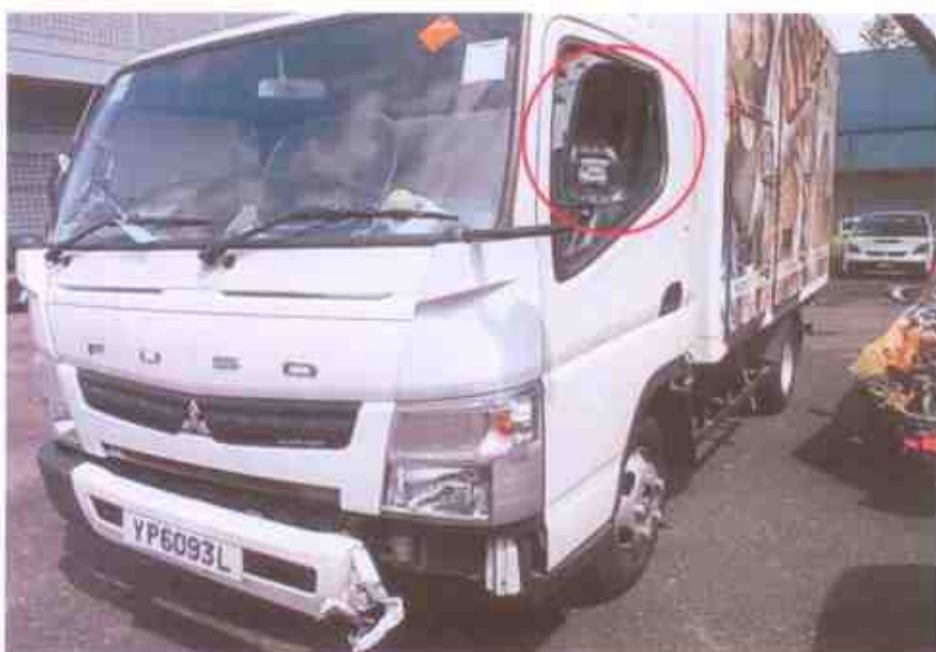
Photo 4 shows a closer view of the dislodged left side mirror of the Motor Lorry at the time of our inspection (circled).

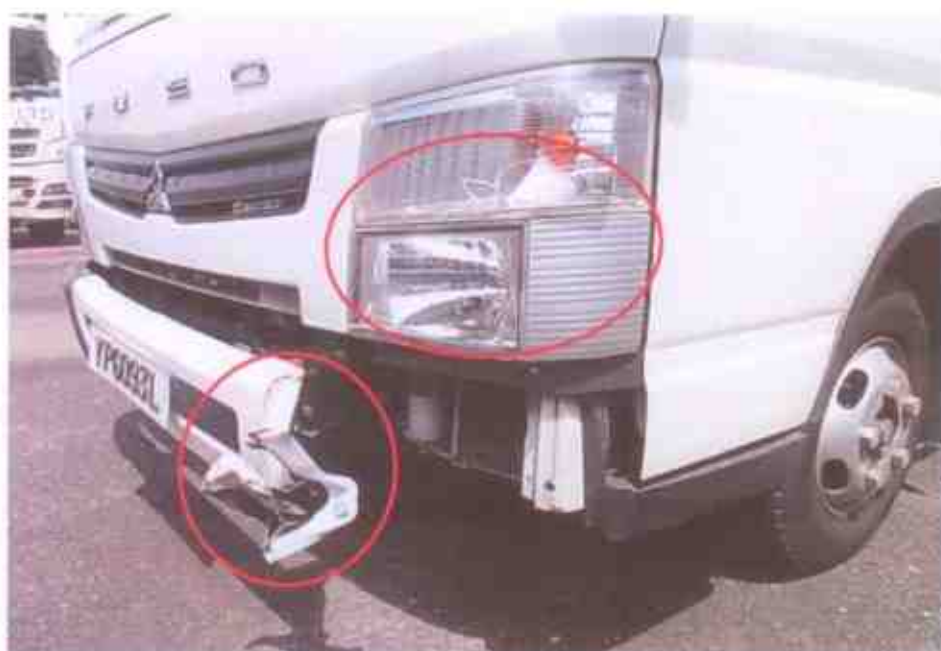
Photo 5 shows a closer view of the buckled front bumper and cracked left headlight of the Motor Lorry at the time of our inspection (circled).

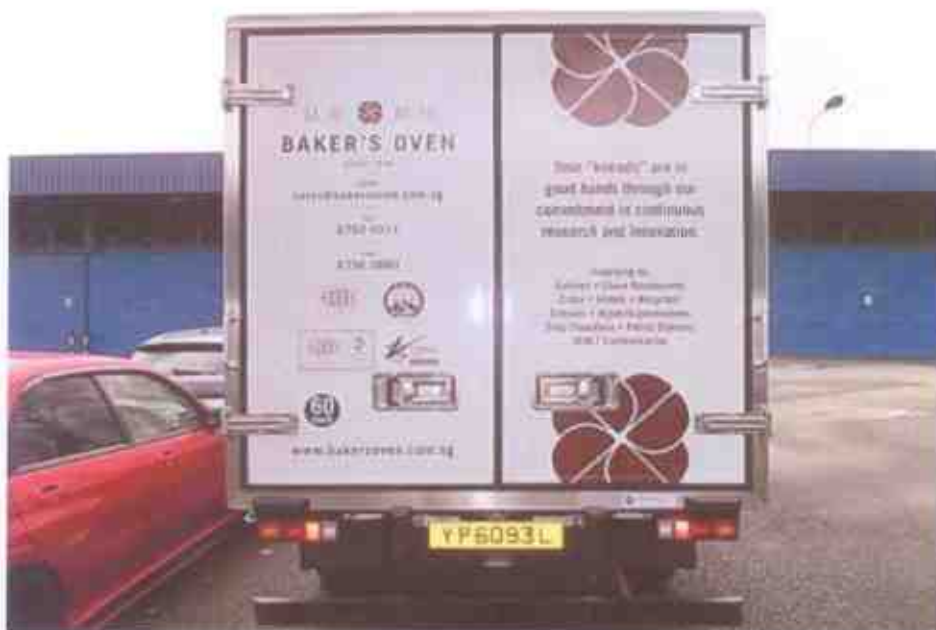
**Photo 6** shows a general view of the Motor Lorry's rear body at the time of our inspection. There was no damage found to the rear portion of the Motor Lorry.

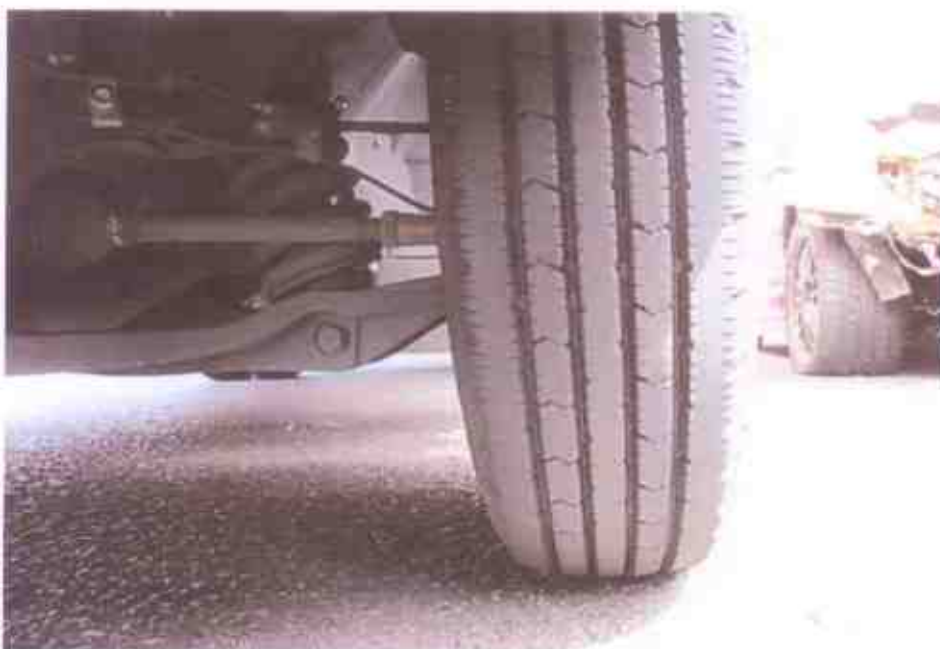
**Photo 7** shows the condition of the front left tyre of the Motor Lorry, which was observed to be in serviceable condition with remaining tread depth of approximately 8mm. The tyre, which was wrapped around standard alloy wheel rim, was also observed to be sufficiently inflated for vehicular operation. There was no tear, cut or burst mark(s) on the outer and the inner sidewalls as well as across the tread of the 6 tyres that were fitted on the Motor Lorry.

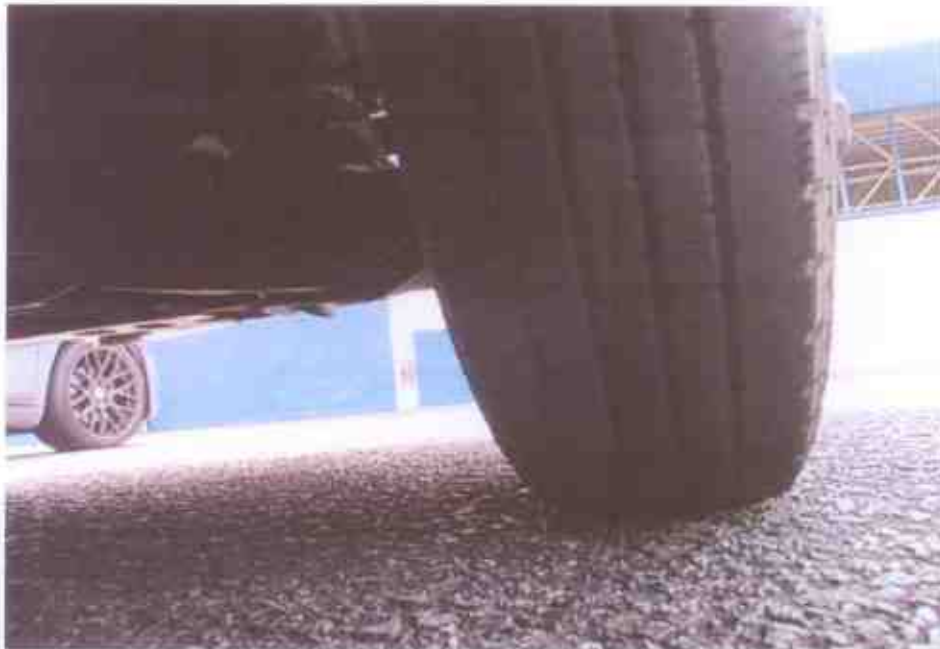
**Photo 8** shows the condition of the front right tyre of the Motor Lorry, which was observed to be in serviceable condition with remaining tread depth of approximately 6mm. The tyre, which was wrapped around standard alloy wheel rim, was also observed to be sufficiently inflated for vehicular operation.

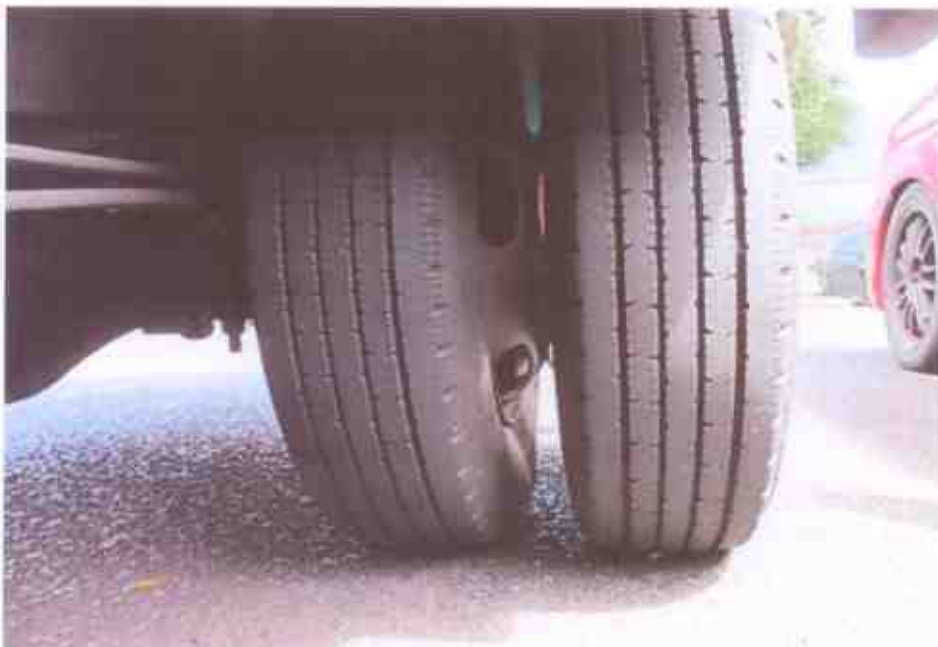
**Photo 9** shows the condition of the rear left tyres of the Motor Lorry, which was observed to be in serviceable condition with remaining tread depth of approximately 6mm. The tyres, which were wrapped around standard alloy wheel rim, were also observed to be sufficiently inflated for vehicular operation. There was also no damage found on all 6 alloy wheel rims of the Motor Lorry.

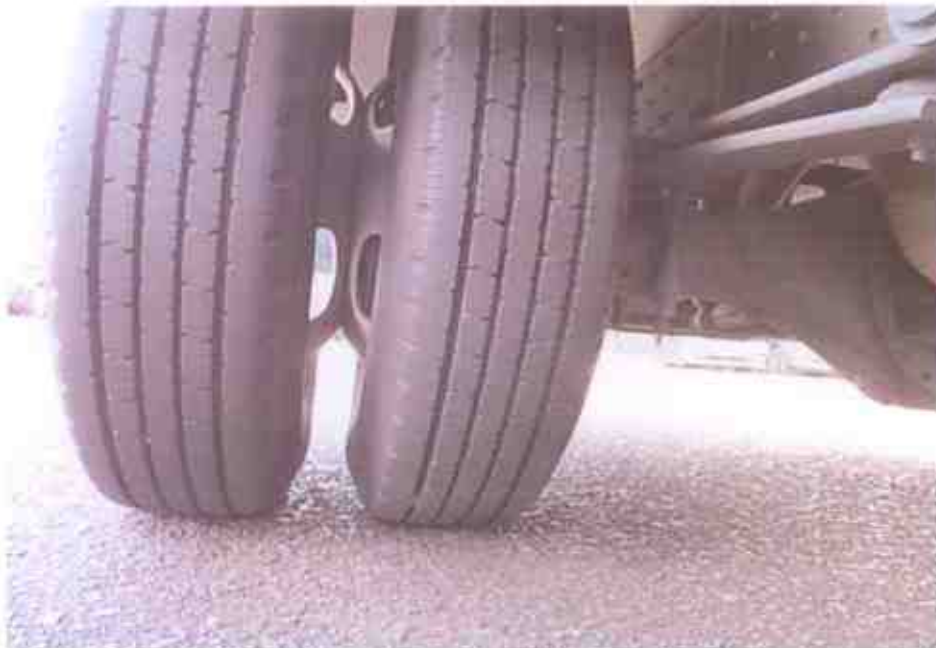
**Photo 10** shows the condition of the rear right tyres of the Motor Lorry, which were observed to be in serviceable condition with remaining tread depth of approximately 6mm. There was also no tear, cut or burst mark(s) on the outer and the inner sidewalls as well as across the tread of the 6 tyres that were fitted on the Motor Lorry.

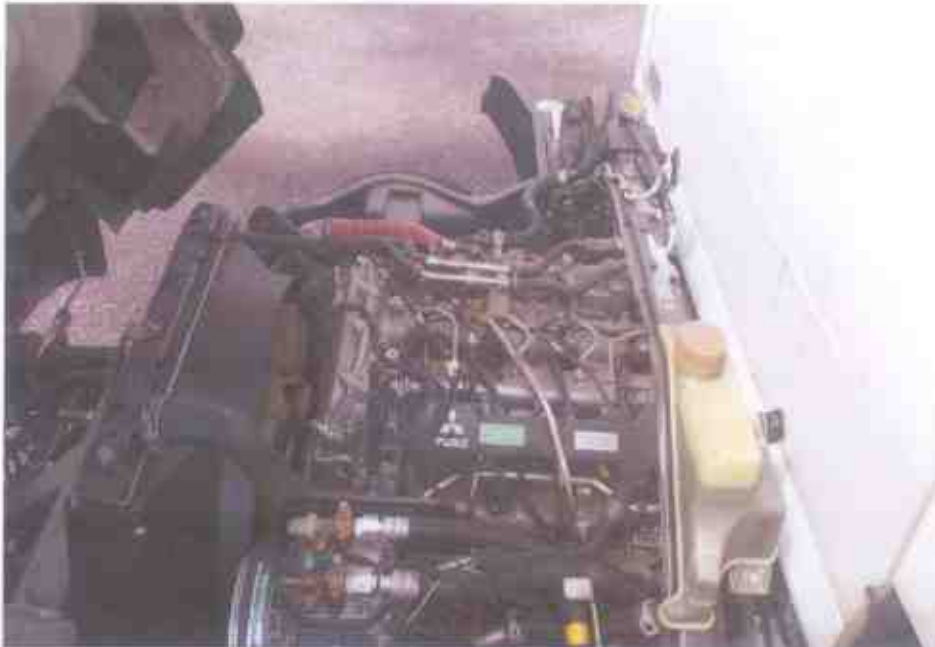
**Photo 11** shows a general view of the Motor Lorry's engine compartment, which was accessed by lifting the front cabin of the Motor Lorry. The various parts and components inside the engine compartment were unaffected by the accident. There was also no sign(s) or indication(s) of fresh fluid leakage and/or fluid stain within the engine compartment (photograph shows the engine compartment as viewed from the left front side of the Motor Lorry).

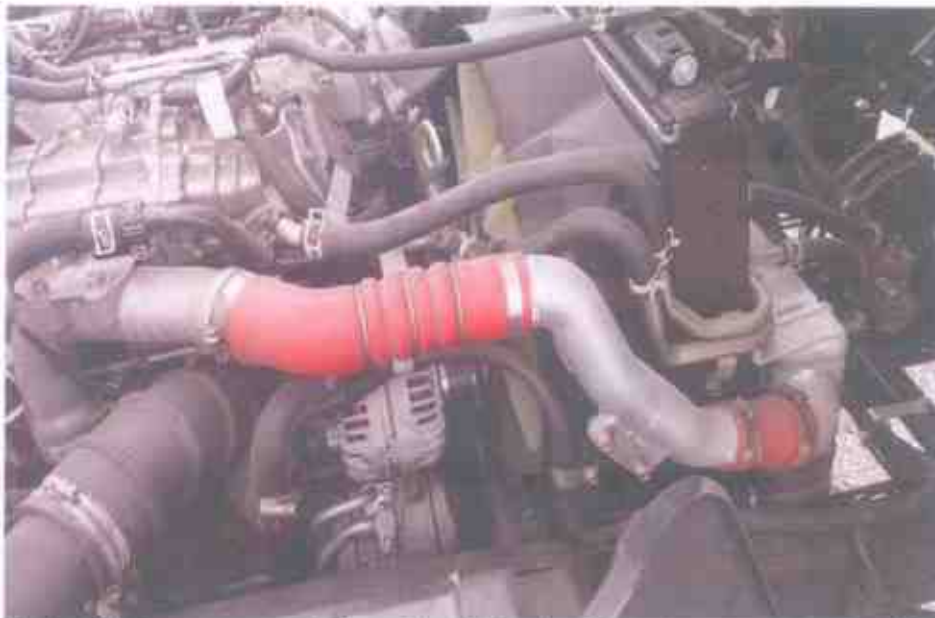
**Photo 12** shows a general view of the Motor Lorry's engine compartment, which was accessed by lifting the front cabin of the Motor Lorry. The various parts and components inside the engine compartment were unaffected by the accident (photograph shows the engine compartment as viewed from the right front side of the Motor Lorry).

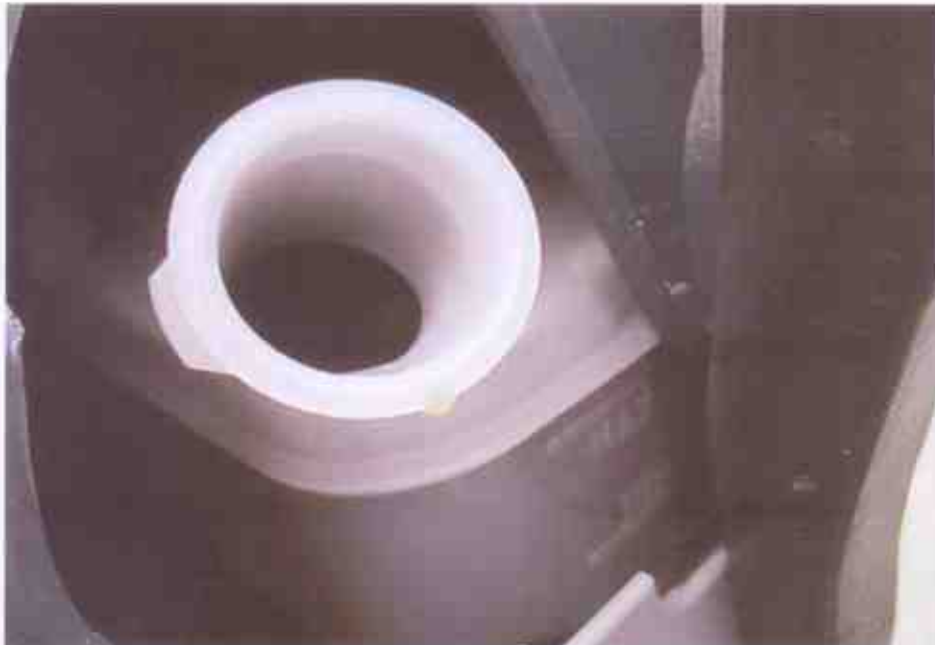
**Photo 13** shows the brake fluid reservoir of the Motor Lorry at the time of our inspection. The brake fluid was observed to be of sufficient level and without any visible contamination.

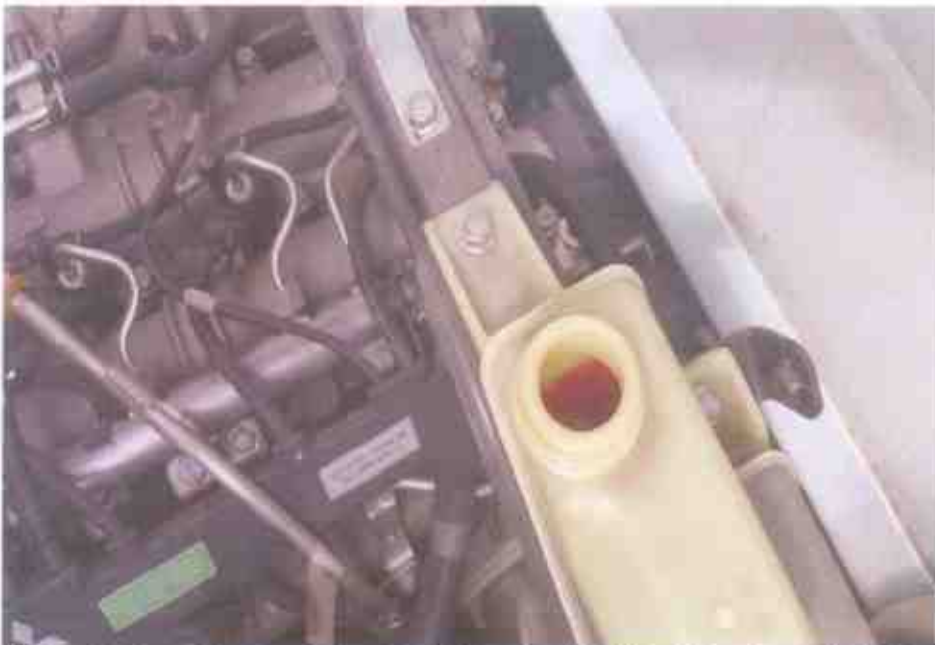
**Photo 14** shows the power steering fluid reservoir of the Motor Lorry at the time of our inspection. The power steering fluid was observed to be of sufficient level and without any visible contamination.

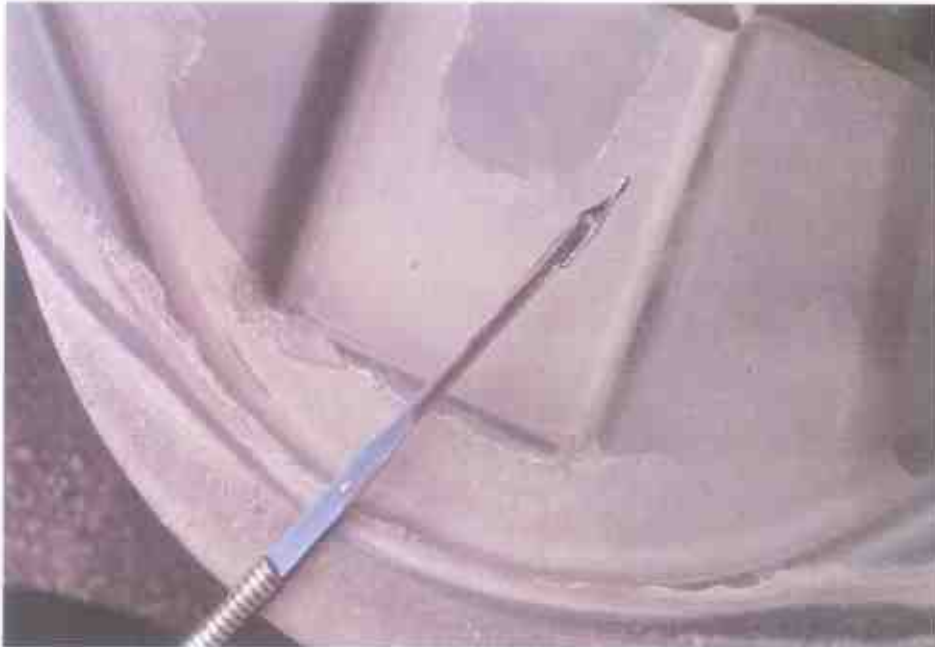
**Photo 15** shows the engine oil dipstick of the Motor Lorry at the time of our inspection. The engine oil was observed to be of sufficient level and without any visible contamination.

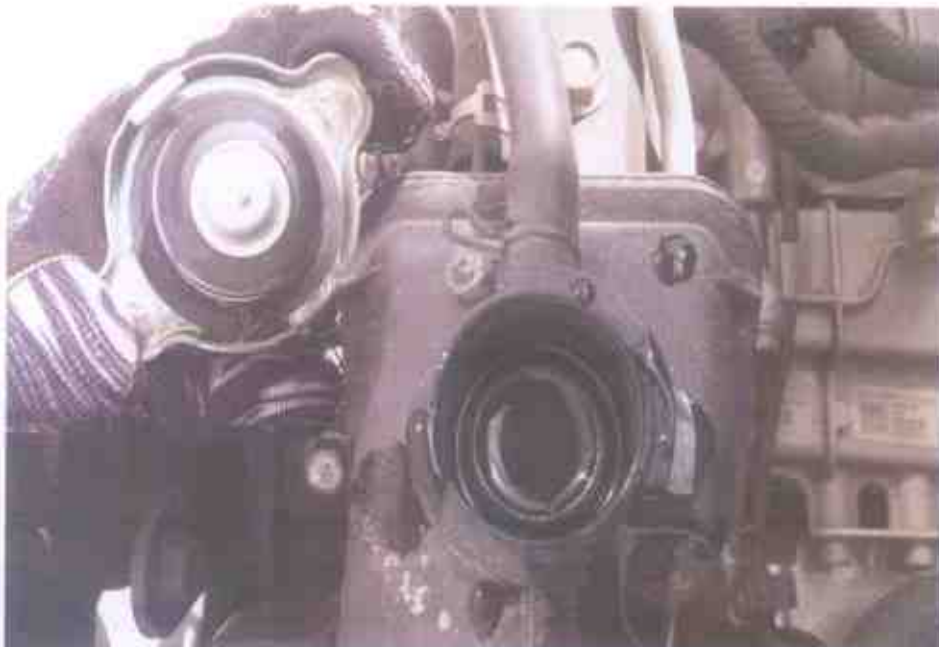
**Photo 16** shows checks being carried out to the engine coolant of the Motor Lorry at the time of our inspection. The engine coolant was observed to be of sufficient level and without any visible contamination.

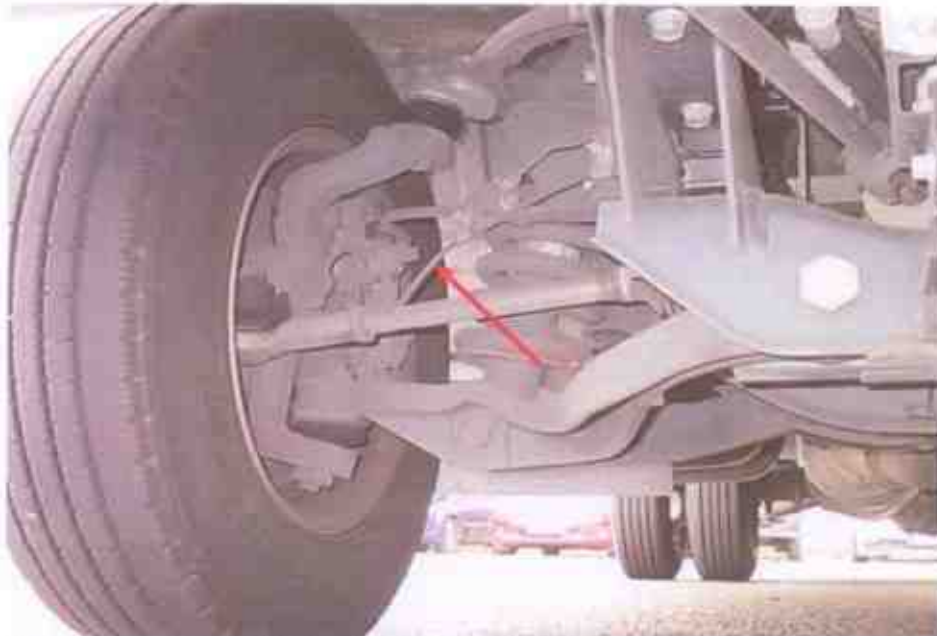
13. Static brake tests conducted on the Motor Lorry revealed no abnormality. The brake booster had responded well to the various tests conducted. There was also no abnormal movement of the brake pedal when it was depressed. In general, the static brake tests had suggested that there was no internal leakage of pressure/vacuum in the braking system of the Motor Lorry. The braking system of the Motor Lorry was likely to be in serviceable condition at the material time. This was also taking into consideration that the brake fluid was of sufficient level, and also that there was no sign(s) of brake fluid leakage along the brake hoses and brake pipes. See photos 17 - 20 below.

**Photo 17** shows the brake pipe (arrowed) at the rear left wheel of the Motor Lorry. We did not observe any leakage of brake fluid at the time of our inspection of the Motor Lorry. Our static tests of the Motor Lorry's braking system, along with our visual examination of the various mechanical components in the braking system, had indicated that there was no internal leakage of pressure/vacuum. Hence the braking system of the Motor Lorry was likely to be in serviceable condition at the material time of accident.

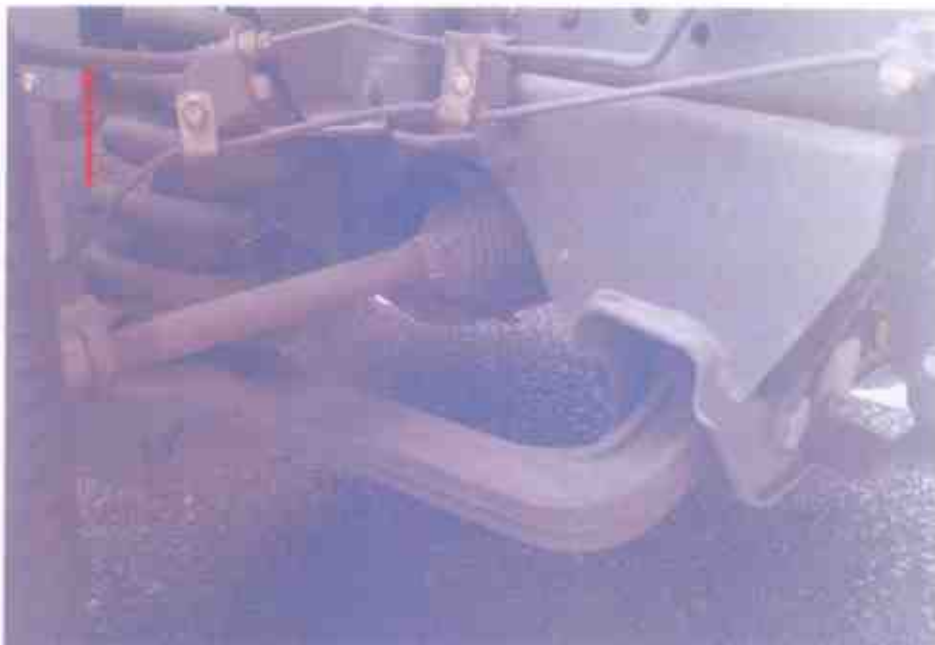
**Photo 18** shows the undercarriage components at the front right wheel of the Motor Lorry, in particular the brake hose (arrowed). The Motor Lorry's braking system was likely to be in serviceable condition at the material time of accident.

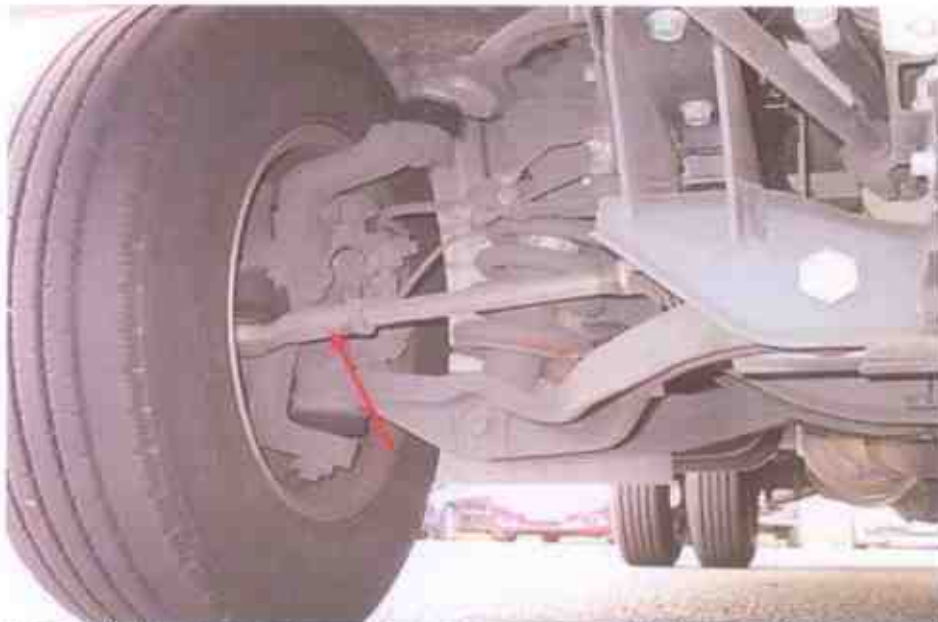
**Photo 19** shows the various undercarriage components at the front right wheel of the Motor Lorry, in particular the steering tie rod end (arrowed). The various steering mechanical components were all found to be intact, suggesting that the steering system of the Motor Lorry was likely to be in serviceable condition at the material time of accident. There was also no sign of fluid stain(s) observed on the various undercarriage components.

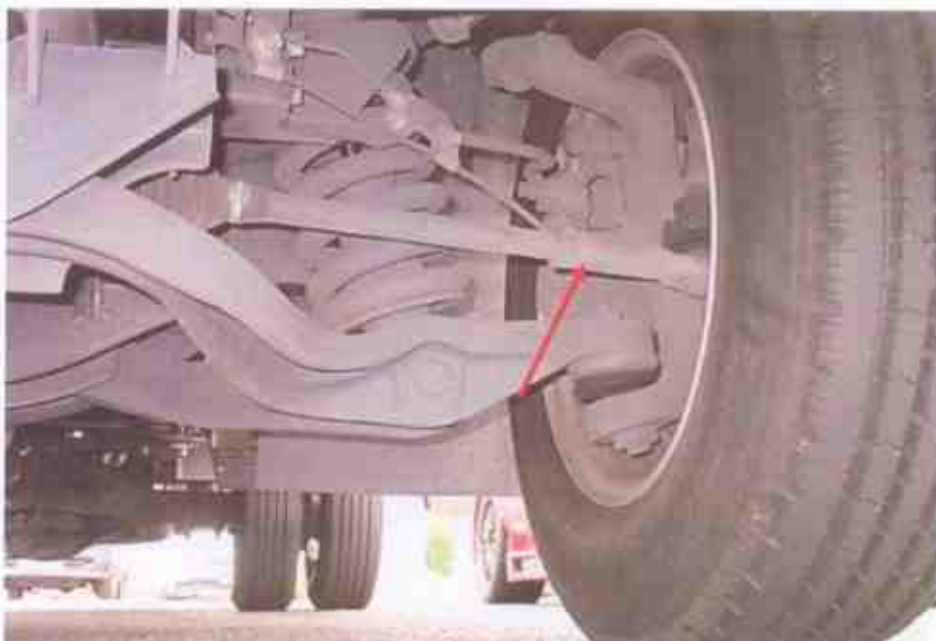
**Photo 20** shows the various undercarriage components at the front left wheel of the Motor Lorry, in particular the steering tie rod end (arrowed). The various steering mechanical components of the Motor Lorry were all found to be intact without any visible damage. There was also no sign of fluid stain(s) observed on the various undercarriage components.

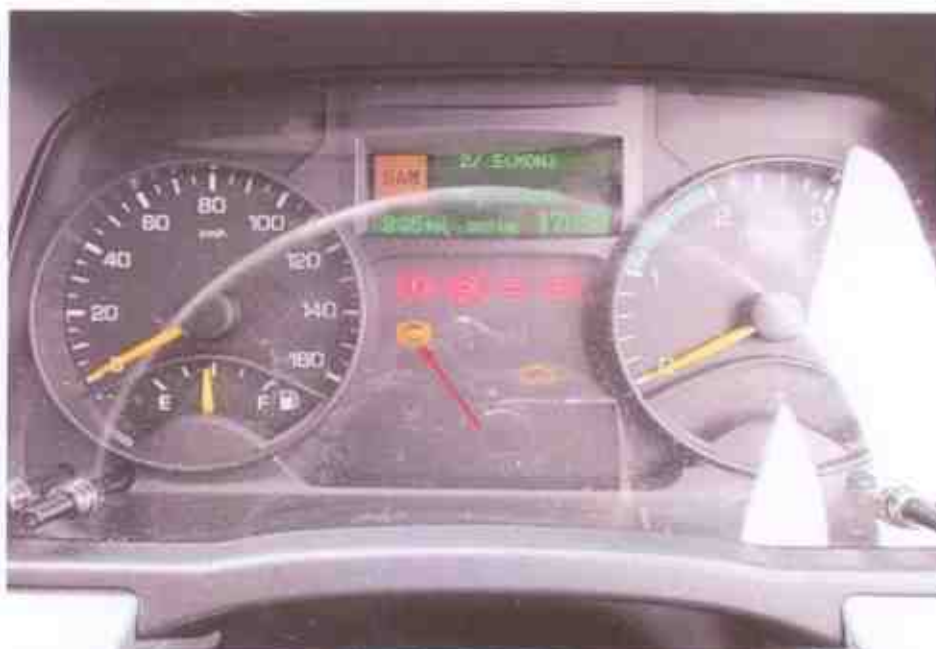
14. The Motor Lorry was fitted with electronic safety feature(s) like Anti-Brake Lock System (ABS) etc. However no test could be carried out on the functionality of these systems at the time of our inspection (engine unable to be started). See photo 21 below.

**Photo 21** shows the warning lights for the various electronic operating systems of the Motor Lorry appearing on its instrument panel when the ignition was turned on, in particular the ABS light (arrowed). However no test could be carried out on the functionality of these systems at the time of our inspection (engine unable to be started).
