Your Ref: TP/IP/02367/2018  
Our Ref : CI/TPD18002843/D

14 February 2018

**MECHANICAL INSPECTION REPORT OF POLICE MOTOR CAR QX 1026S**

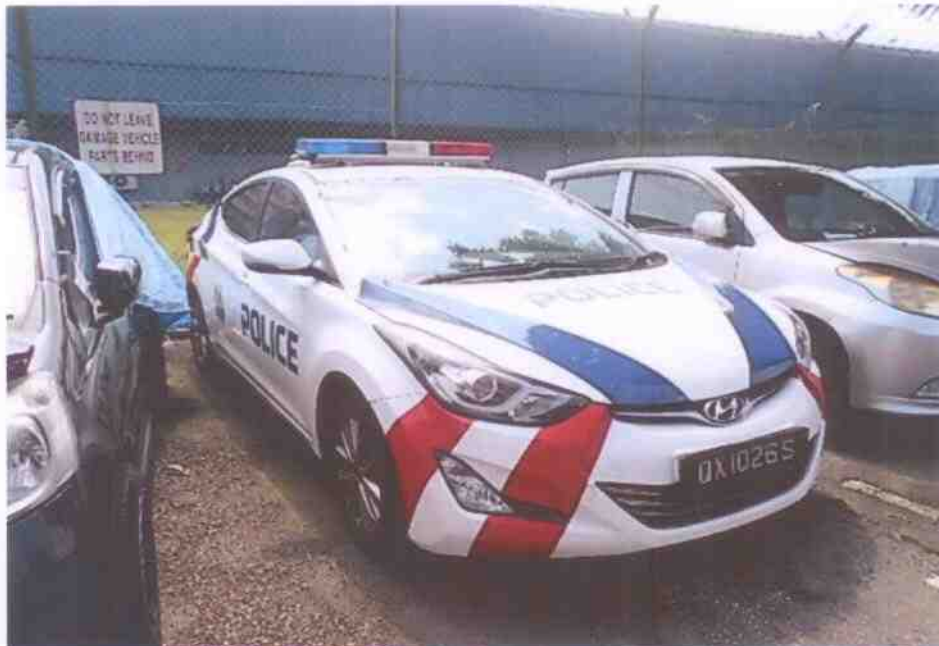
4. The mileage of the Police Car at the time of my inspection was 111,492km.
5. The Police Car was observed to have sustained relatively minor damage at its frontal portion. Its front bumper, front bumper lower grille, radiator grille, front number plate and front bonnet were amongst the body parts that were damaged as a result of the accident.

Photo 1 shows a general view of the front right body of the Police Car at the time of my inspection. The Police Car was observed to have sustained relatively minor damage at its frontal portion. Its front bumper, front bumper lower grille, front number plate and front bonnet were observed to have been damaged as a result of the accident. The mileage of the Police Car at the time of my inspection was recorded to be 111,492km.

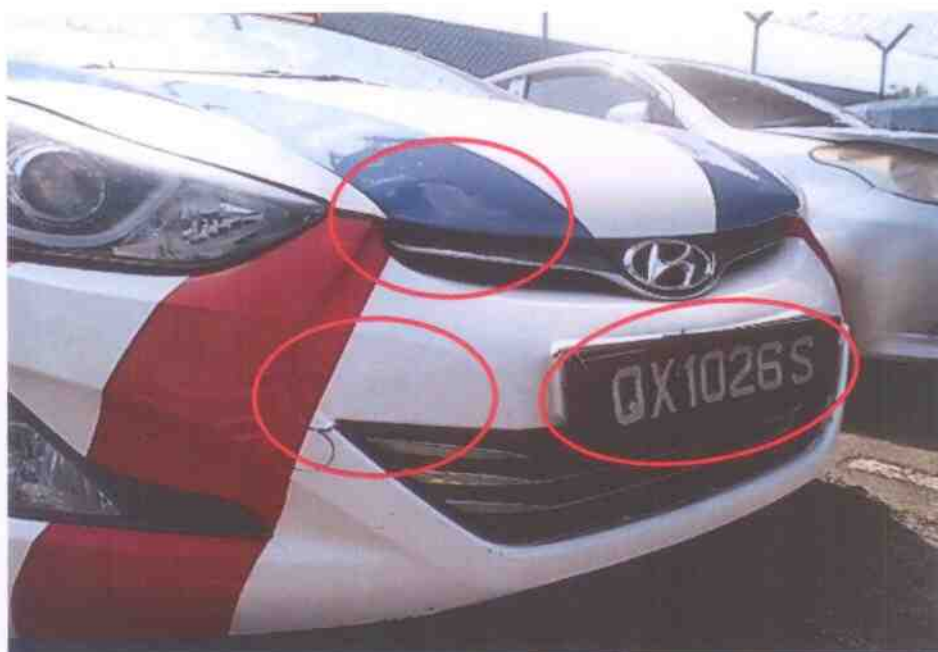
**Photo 2** shows a closer view of the damaged front bumper, front number plate and front bonnet of the Police Car (circled).

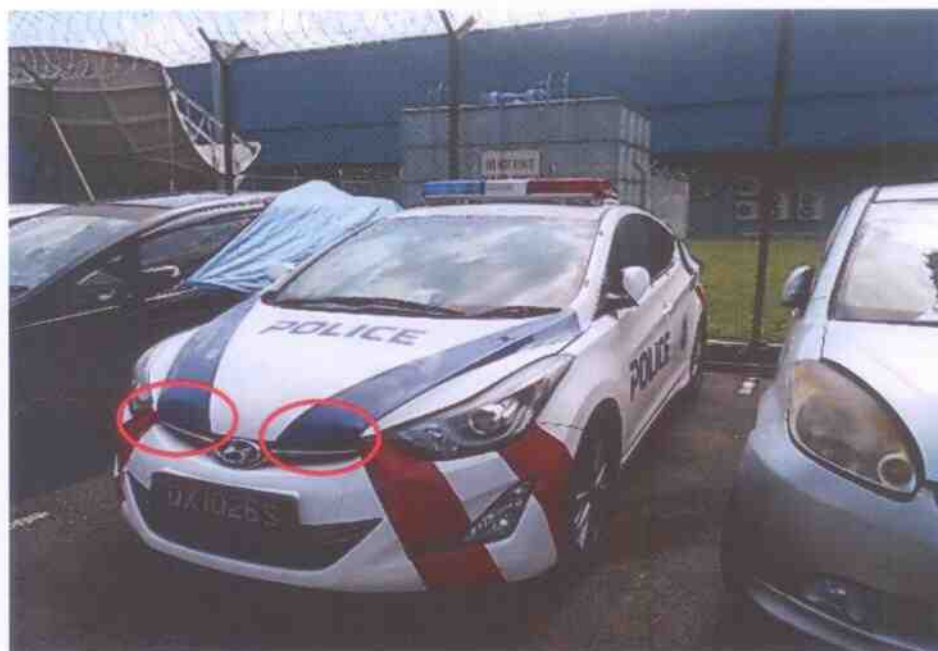
**Photo 3** shows a general view of the front left body of the Police Car at the time of my inspection. The Police Car was observed to have sustained relatively minor damage at its frontal portion. Its front bumper, front bumper lower grille, front number plate and front bonnet (circled) were damaged as a result of the accident. The mileage of the Police Car at the time of my inspection was recorded to be 111,492km.

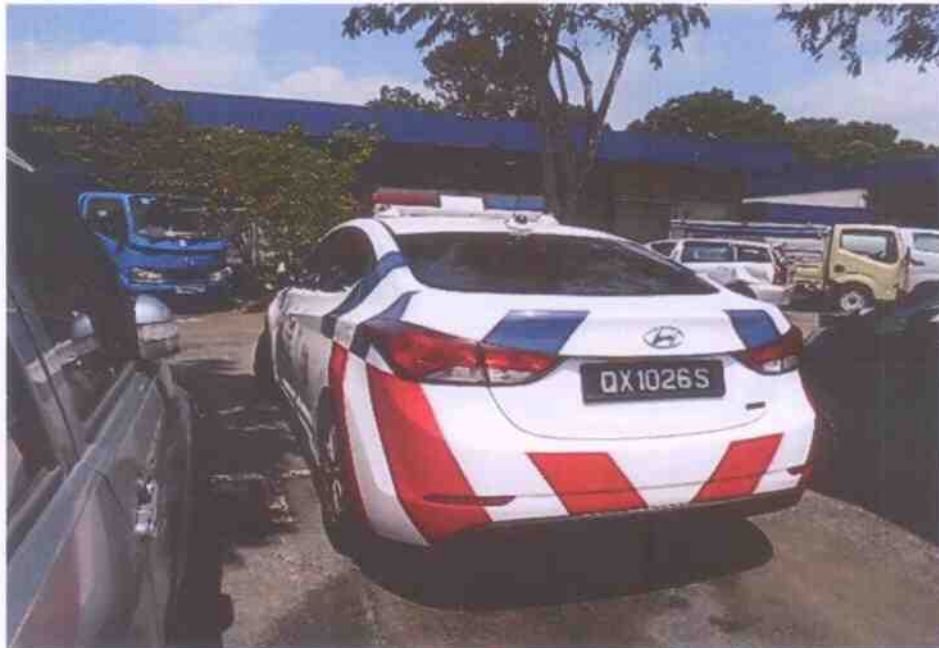
**Photo 4** shows a general view of the Police Car's rear left body at the time of my inspection. The rear portion of the Police Car was observed to have been unaffected by the accident.

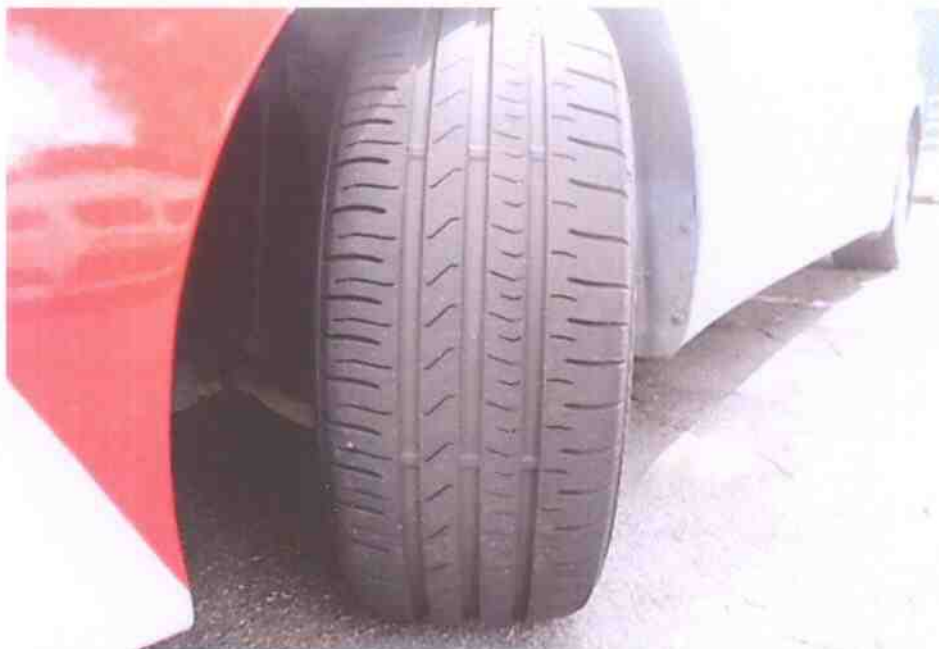
**Photo 5** shows the condition of the front left tyre of the Police Car, which was observed to be in serviceable condition with remaining tread depth of approximately 5mm. The tyre was sufficiently inflated for vehicular operation with no tear, cut or burst mark(s) on the outer and the inner sidewalls as well as across the tread. The 4 tyres of the Police Car were wrapped around standard alloy wheel rims that were without any significant damage apart for some relatively minor kerb grazing type of damage on the outer side of the wheel rims.

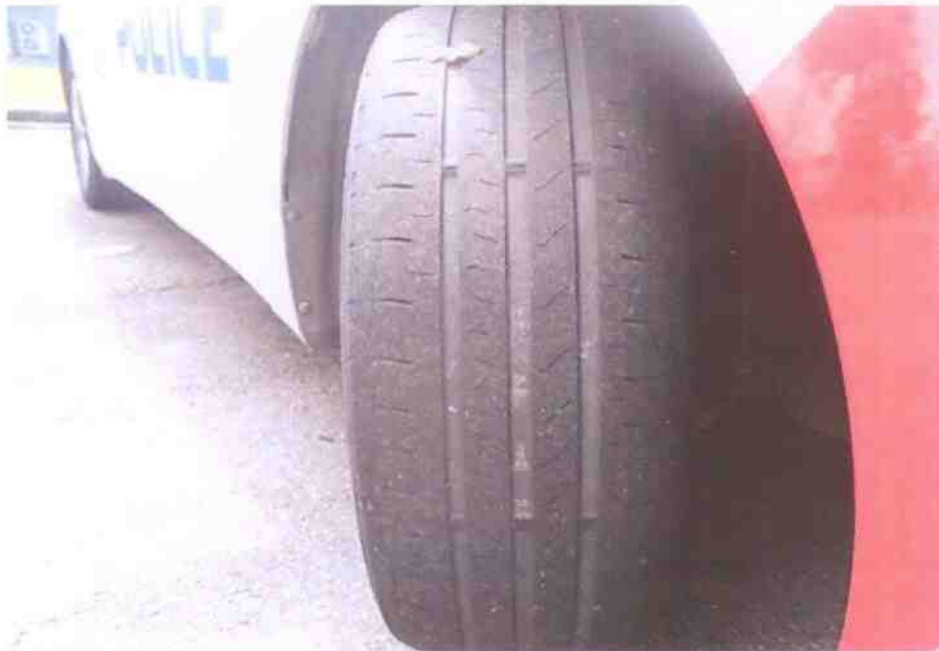
**Photo 6** shows the condition of the front right tyre of the Police Car, which was observed to be in serviceable condition with remaining tread depth of approximately 3mm. The tyre was also observed to be sufficiently inflated for vehicular operation with no tear, cut or burst mark(s).

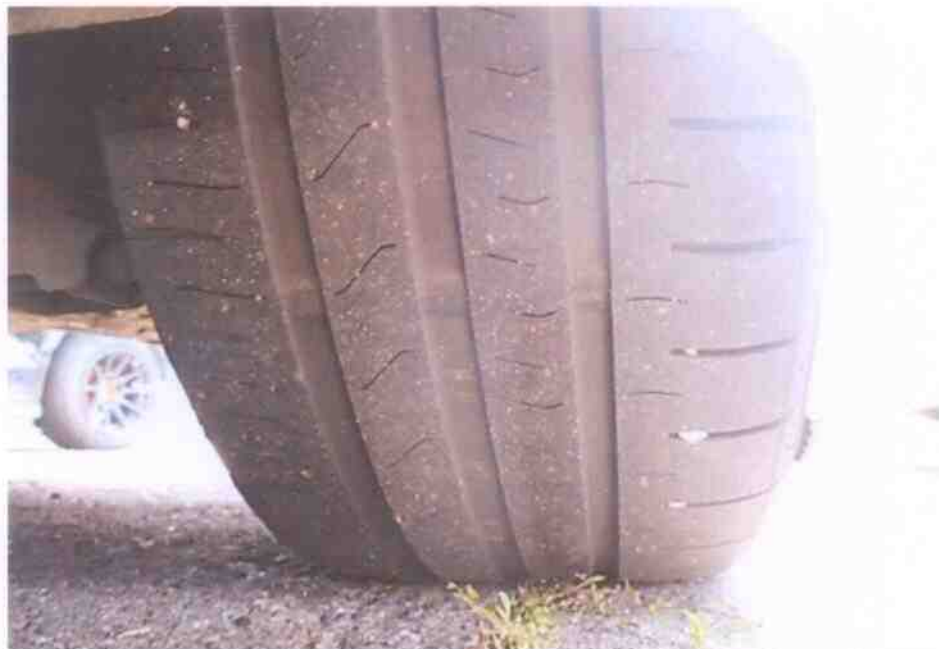
**Photo 7** shows the condition of the rear left tyre of the Police Car, which was observed to be in serviceable condition with remaining tread depth of approximately 5mm. The tyre, which was wrapped around alloy wheel rim, was also observed to be sufficiently inflated for vehicular operation. The 4 tyres of the Police Car were wrapped around standard alloy wheel rims that were without any significant damage apart for some relatively minor kerb grazing type of damage on the outer side of the wheel rims.

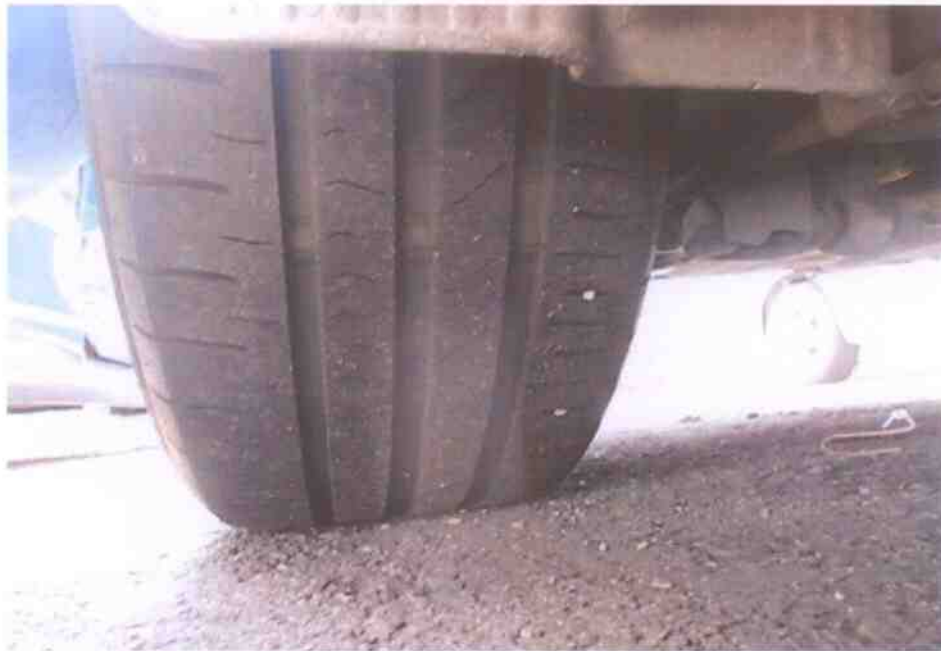
**Photo 8** shows the condition of the rear right tyre of the Police Car, which was observed to be in serviceable condition with remaining tread depth of approximately 5mm. There was also no tear, cut or burst mark(s) on the outer and the inner sidewalls as well as across the tread of the Police Car's 4 tyres.

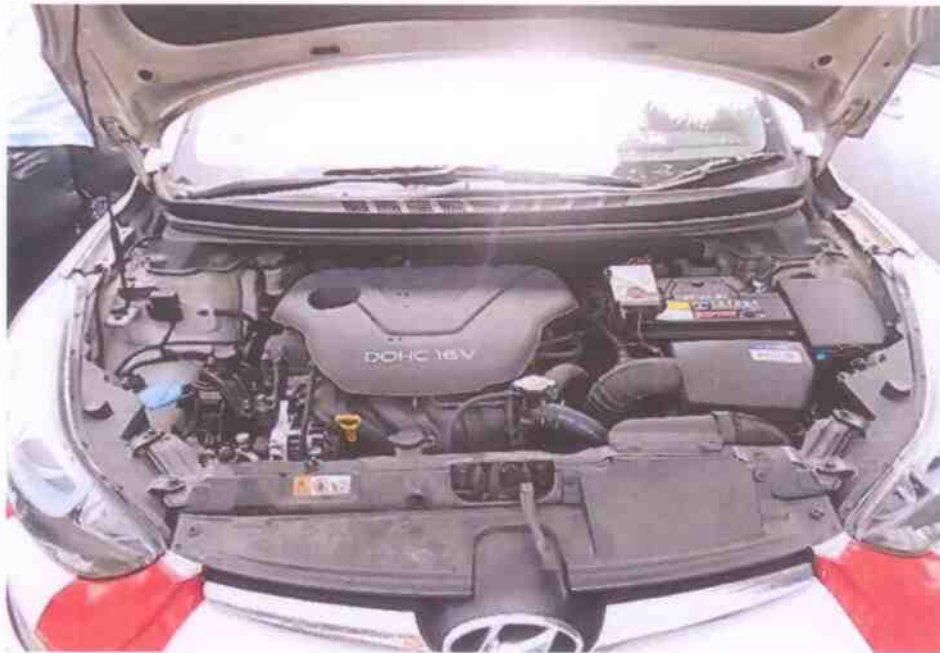
**Photo 9** shows a general view of the Police Car's engine compartment. The various parts and components inside the engine compartment were unaffected by the accident. There was also no sign(s) or indication(s) of fluid leakage and/or fluid stain within the engine compartment.

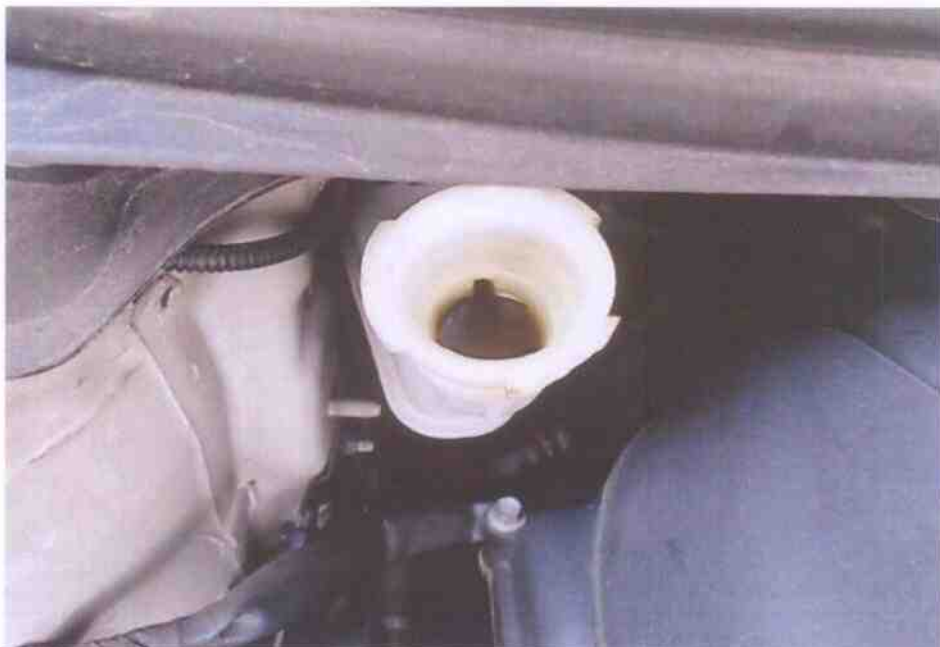
**Photo 10** shows the brake fluid reservoir of the Police Car at the time of my inspection. The brake fluid was observed to be of sufficient level and without any visible contamination.

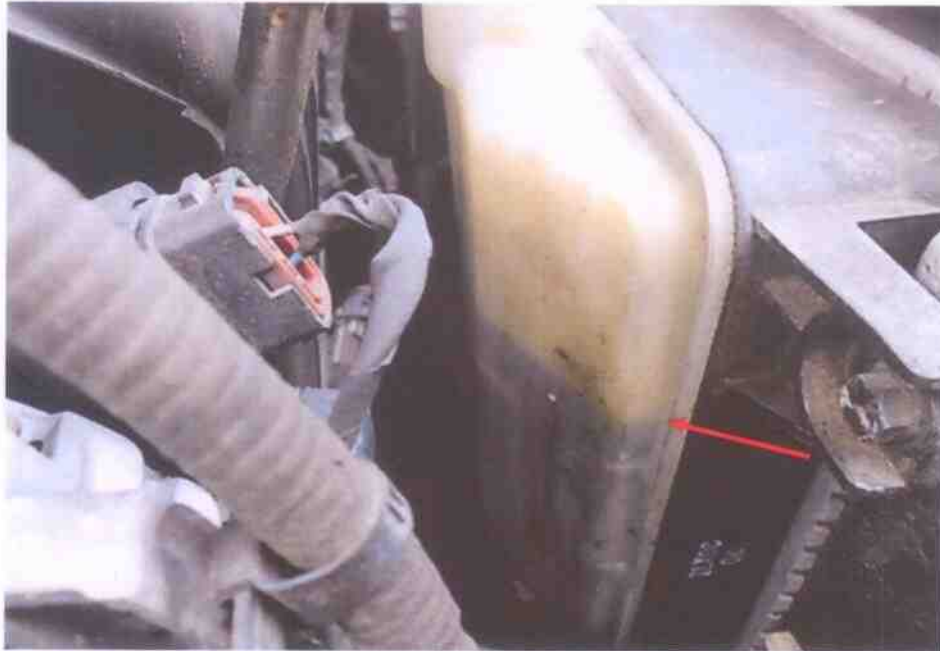
**Photo 11** shows checks being carried out to the engine coolant of the Police Car at the time of my inspection. The engine coolant was observed to be of sufficient level (arrowed) and without any visible contamination.

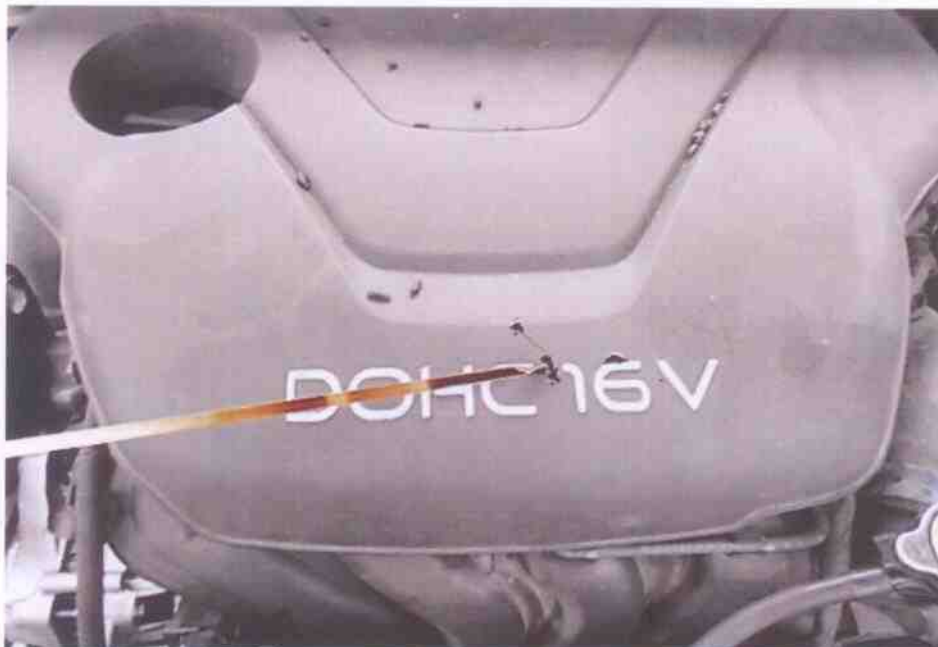
**Photo 12** shows the engine oil dip stick of the Police Car at the time of my inspection. The engine oil was observed to be of sufficient level and without any visible contamination.

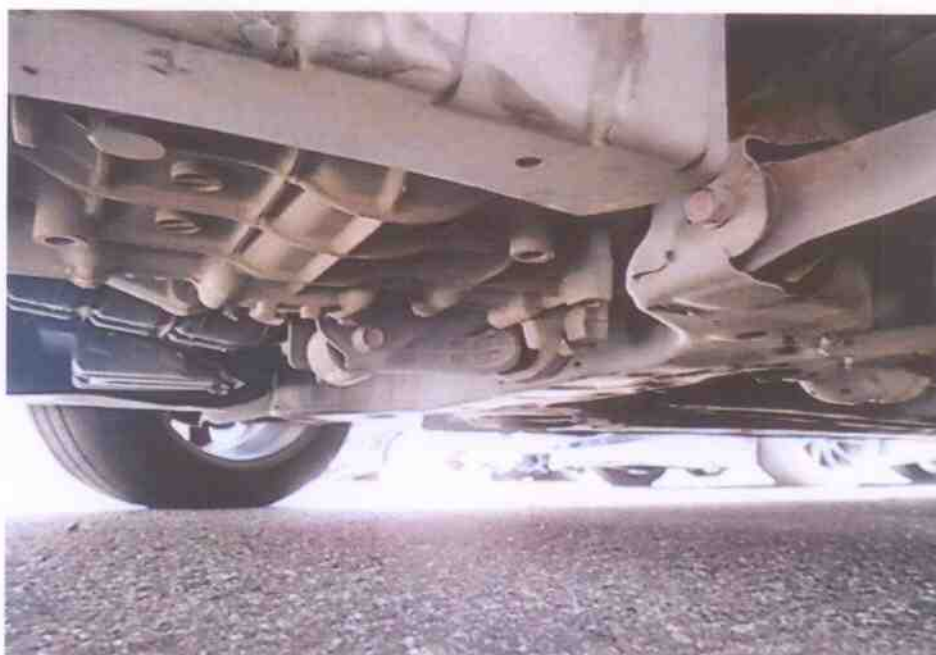
**Photo 13** shows the underside of the Police Car, at the area where the engine housing and transmission housing are located. I did not find any sign(s) or indication(s) of fluid leak and/or fluid stain(s) on the underside of the Police Car.

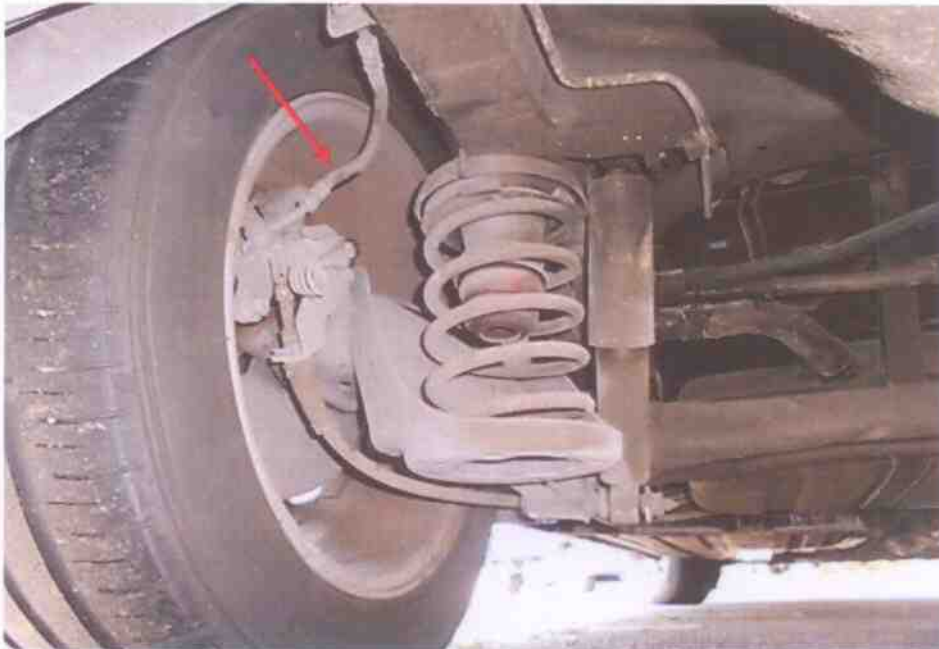
**Photo 14** shows the brake hose/pipe (arrowed) at the rear left wheel of the Police Car. I did not observe any leakage of brake fluid at the time of my inspection of the Police Car. Static tests of the Police Car's braking system had indicated that there was no internal leakage of pressure/vacuum. The undercarriage components of the Police Car were also all found to be intact and without any visible damage.

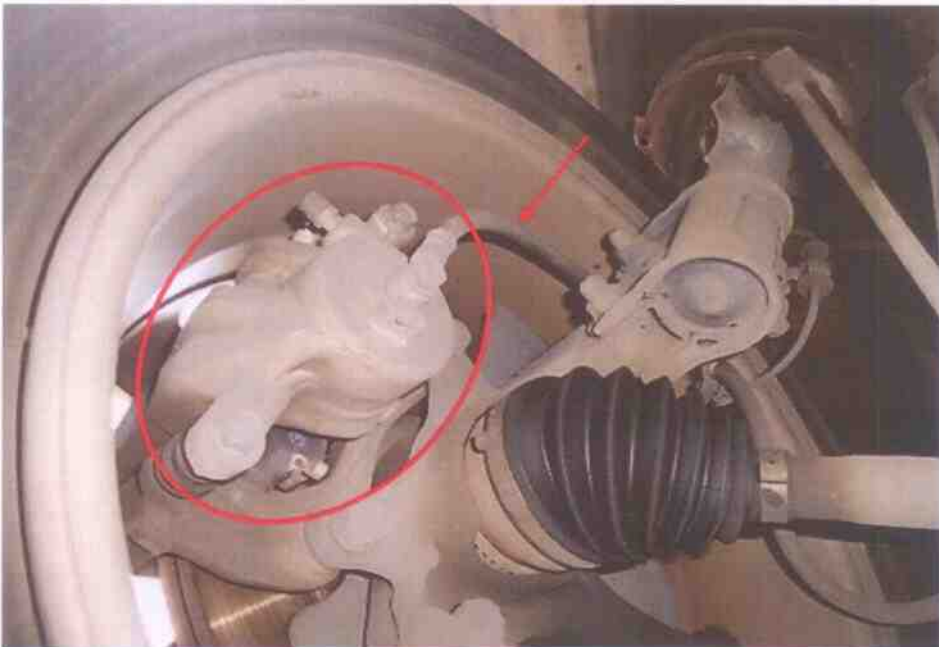
**Photo 15** shows the brake hose/pipe (arrowed) at the front right wheel of the Police Car. No leakage of brake fluid was observed. Visual examination of the various components of the braking system like the brake caliper (circled), brake booster, brake pedal etc had revealed all to be intact and without visible damage.

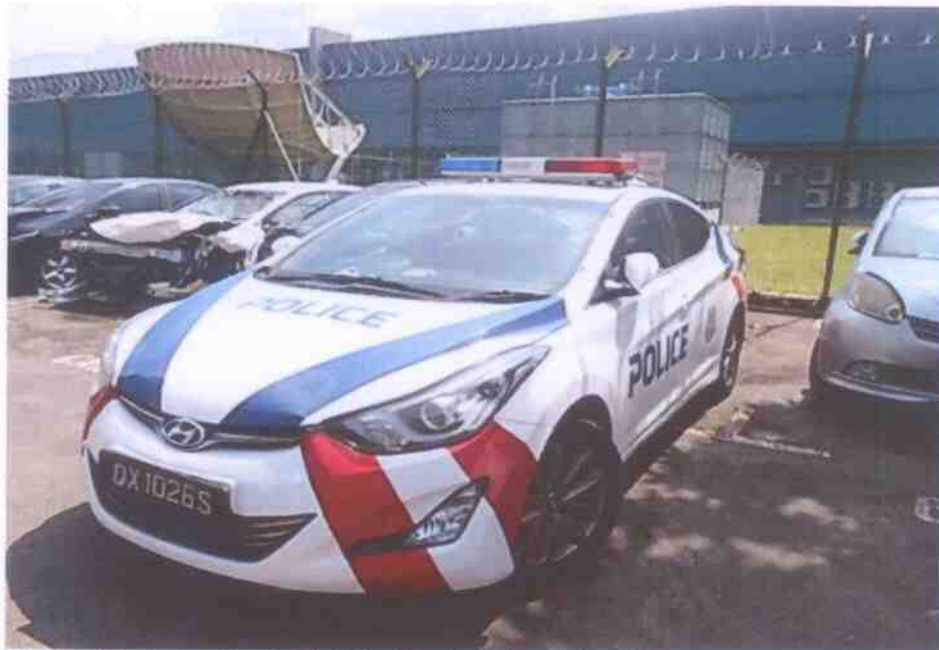
**Photo 16** shows the front left wheel of the Police Car turned to its full right. During my steering system test, I did not experience any abnormal free play and/or resistance when I had turned the steering wheel towards the left and right. This would suggest that the steering system of the Police Car was likely to be in serviceable condition at the material time of accident.

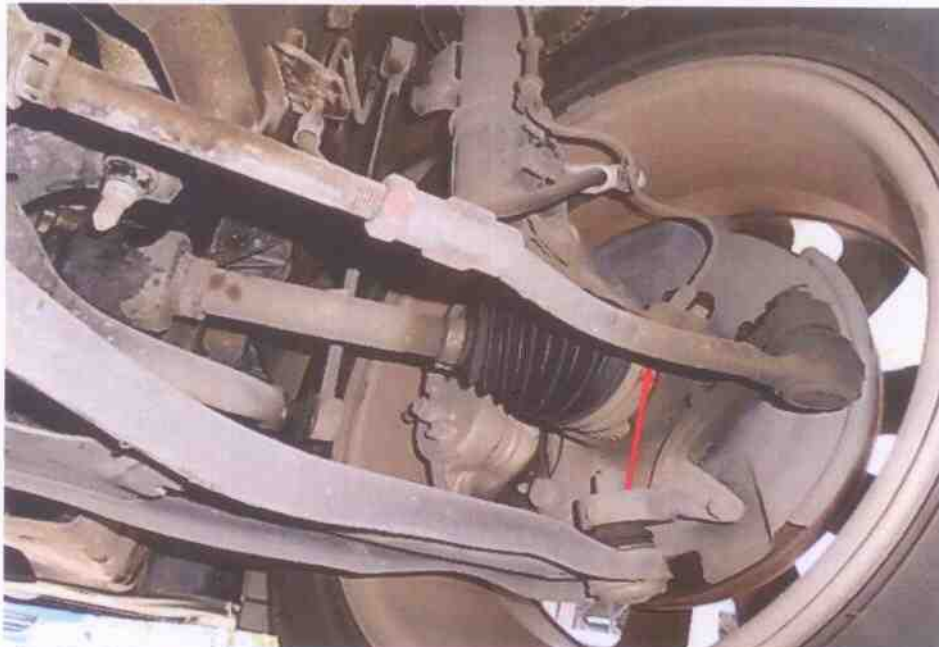
**Photo 17** shows the various undercarriage components at the front right wheel of the Police Car, in particular the steering tie rod (arrowed). The various steering components were all found to be intact, suggesting that the steering system of the Police Car was likely to be in serviceable condition at the material time of accident. There was also no sign of fluid stain observed on the various undercarriage components at the front right wheel of the Police Car.

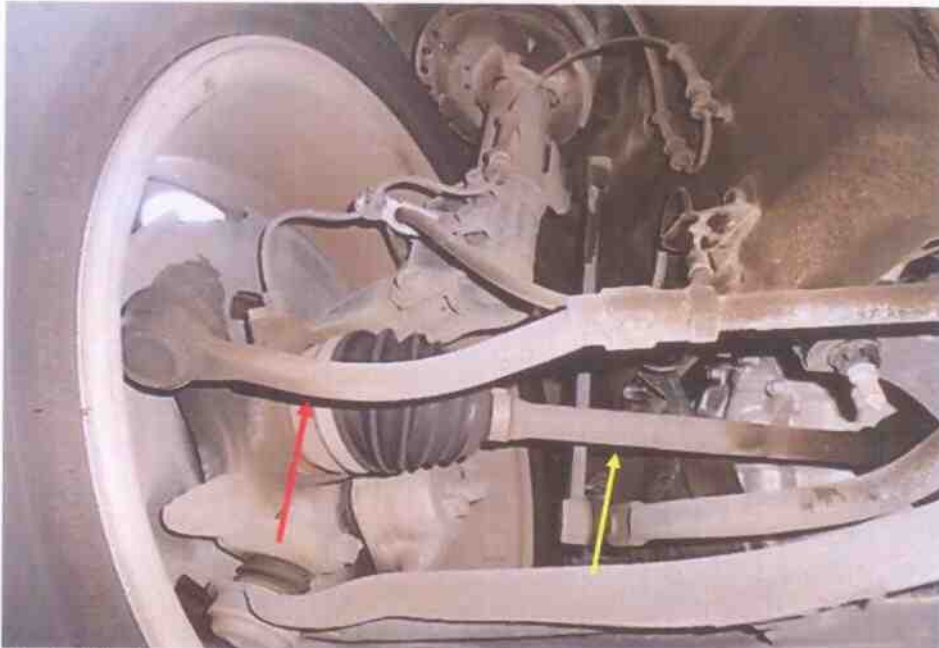
**Photo 18** shows the various undercarriage components at the front left wheel of the Police Car, which had included the steering tie rod (red arrow) and front left drive shaft (yellow arrow). The various undercarriage components of the Police Car were all found to be intact without any visible damage.

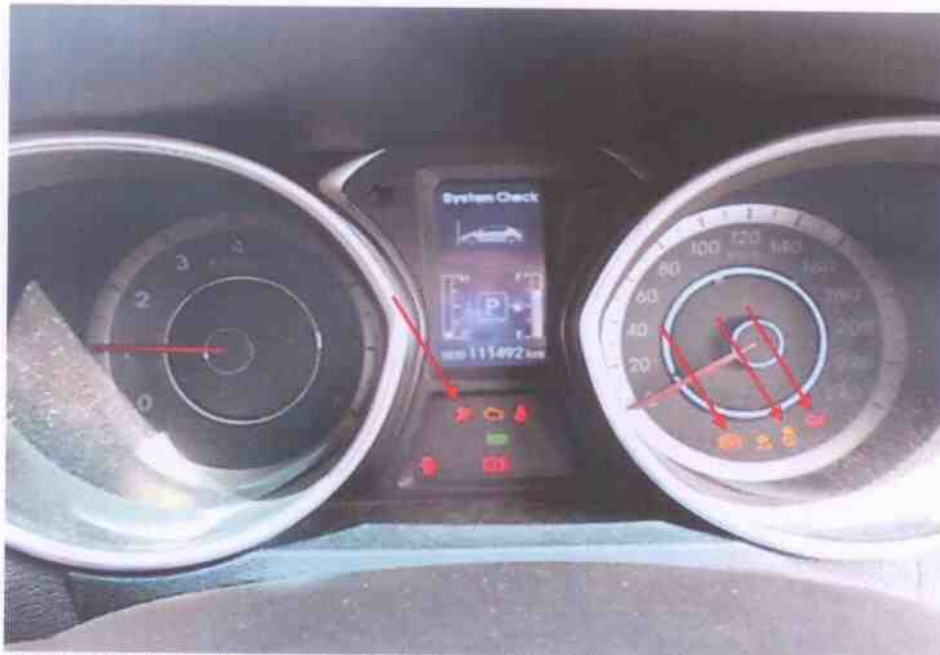
**Photo 19** shows the warning light for Anti-Lock Brake System (ABS), Electric Power Steering System (EPS), Traction Control (TC) and Supplemental Restraint System (SRS) appearing on the instrument panel of the Police Car during the self-test of its various electronic operating systems when its engine was cranked.

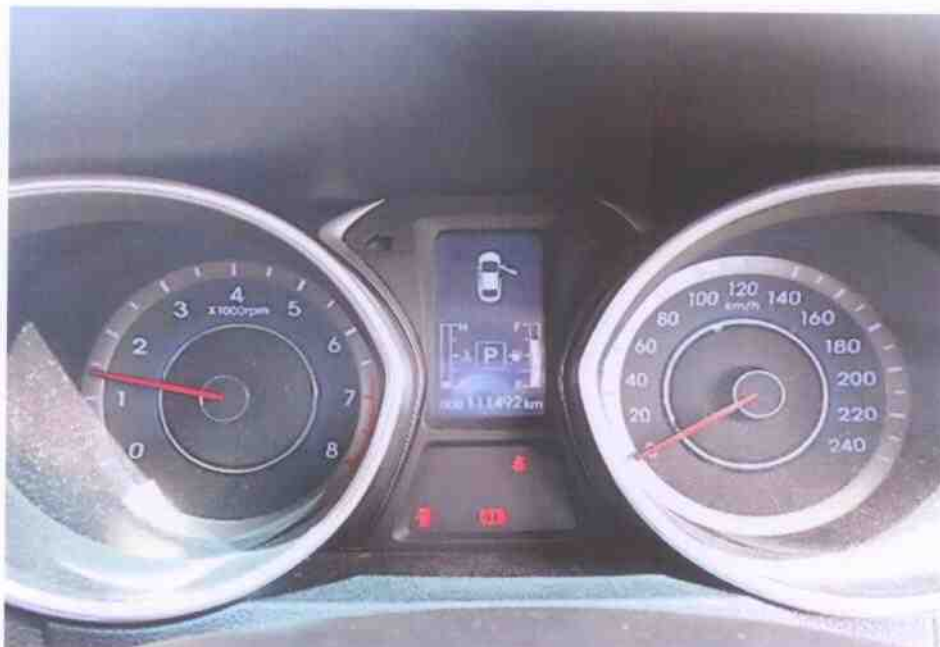
**Photo 20** shows no warning lights illuminated on the instrument panel of the Police Car after the engine was cranked. This would suggest that there was no abnormality to the various electronic operating systems of the Police Car, like the ABS, EPS, TC and SRS etc.
