Your Ref: TP/IP/01937/2018  
Our Ref : CI/TPD18002844/D

**Accident Enquiry & Investigation Team**

**MECHANICAL INSPECTION REPORT OF POLICE MOTOR CAR QX 1021E**

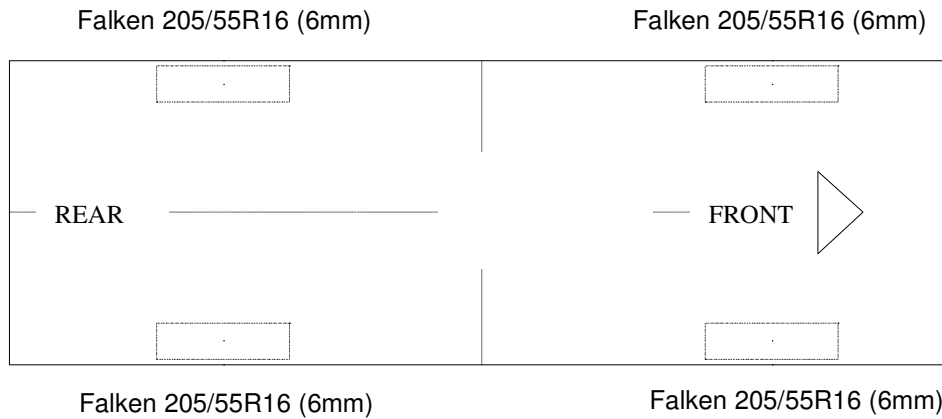
6. The condition of the Police Car's 4 tyres was observed to be in serviceable condition. I did not find any tear, cut or burst mark(s) on the outer and the inner sidewalls as well as across the tread of the 4 tyres. The 4 tyres were also observed to be sufficiently inflated for vehicular operation. The tyre brand, tyre size and remaining tread depth of the 4 tyres were recorded as follows:-

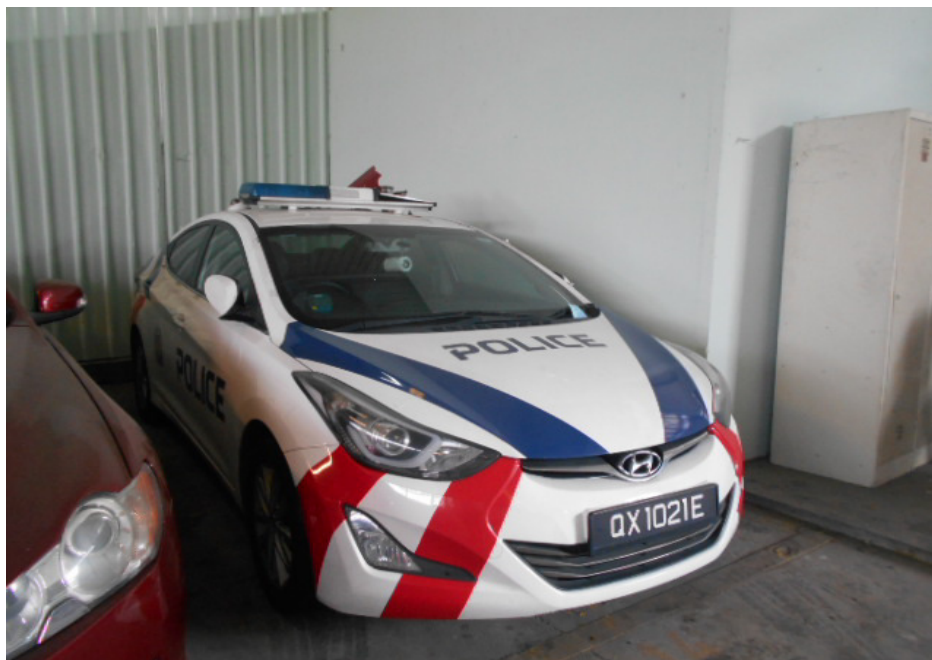
**Photo 1** shows a general view of the front right body of the Police Car at the time of my inspection. The Police Car was observed to have sustained damage at its left front portion and left centre portion. The right portion was unaffected by the accident. The mileage of the Police Car at the time of my inspection was recorded to be 142,663km.

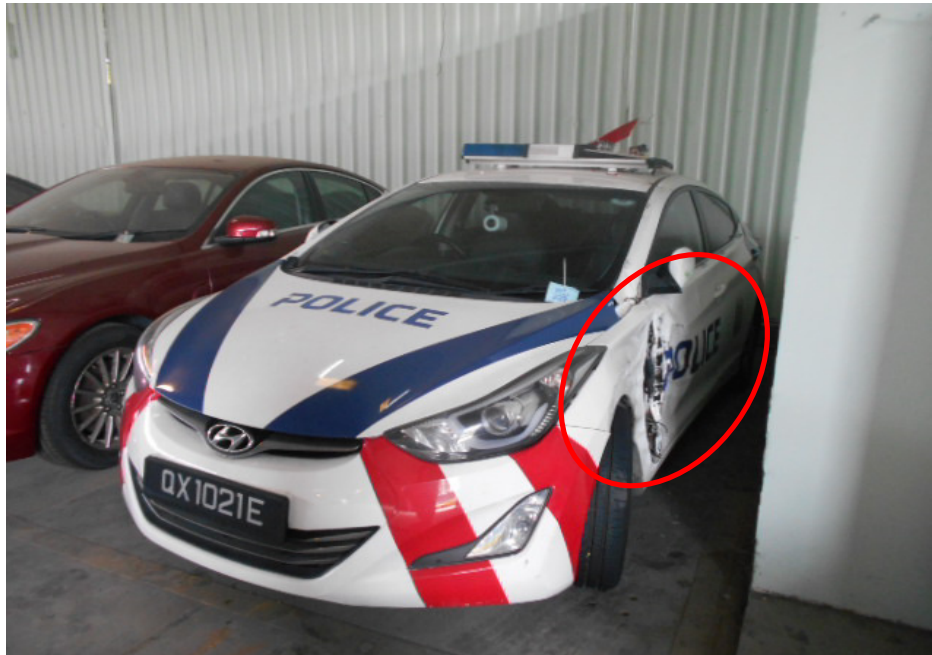
**Photo 2** shows a general view of the front left body of the Police Car at the time of my inspection. The Police Car was observed to have sustained damage at its left front portion and left centre portion (circled). Its left front fender, left front door and front bonnet were damaged as a result of the accident. Its front left undercarriage was also observed to have been affected. The mileage of the Police Car at the time of my inspection was recorded to be 142,663km.

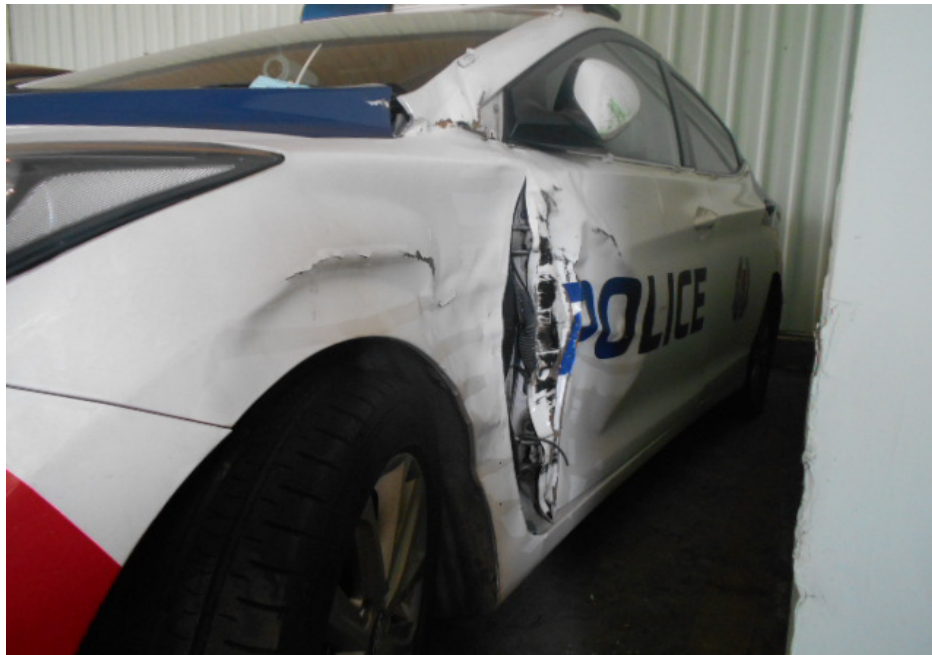
**Photo 3** shows a closer view of the damaged area of the Police Car at the time of my inspection. Its left front fender, left front door, left wing mirror and front bonnet were damaged as a result of the accident.

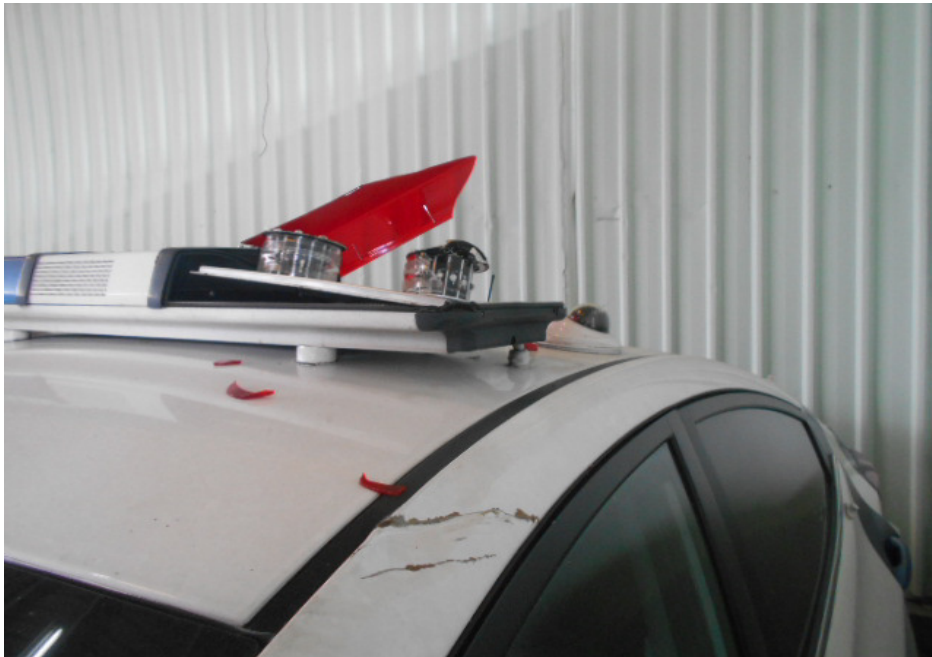
**Photo 4** shows the damage to the roof blinker of the Police Car as a result of the accident.

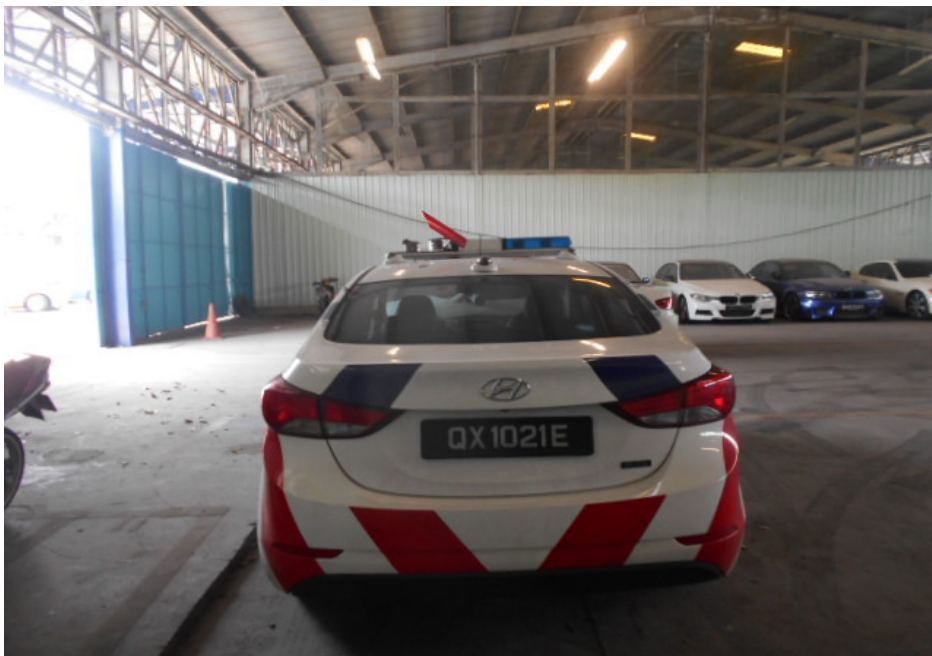
**Photo 5** shows a general view of the Police Car's rear body at the time of my inspection. There was no damage observed to the rear portion of the Police Car.

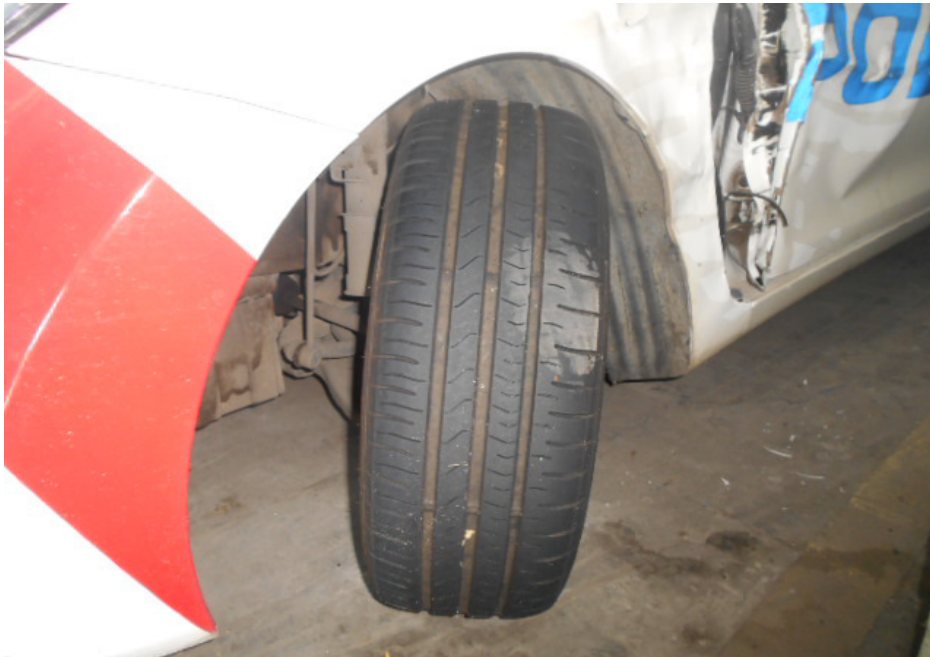
**Photo 6** shows the condition of the front left tyre of the Police Car, which was observed to be in serviceable condition with remaining tread depth of approximately 6mm. The tyre was sufficiently inflated for vehicular operation with no tear, cut or burst mark(s) on the outer and the inner sidewalls as well as across the tread. The 4 tyres of the Police Car were wrapped around standard alloy wheel rims that were without any significant damage apart for some relatively minor kerb grazing type of damage on the outer side of the wheel rims.

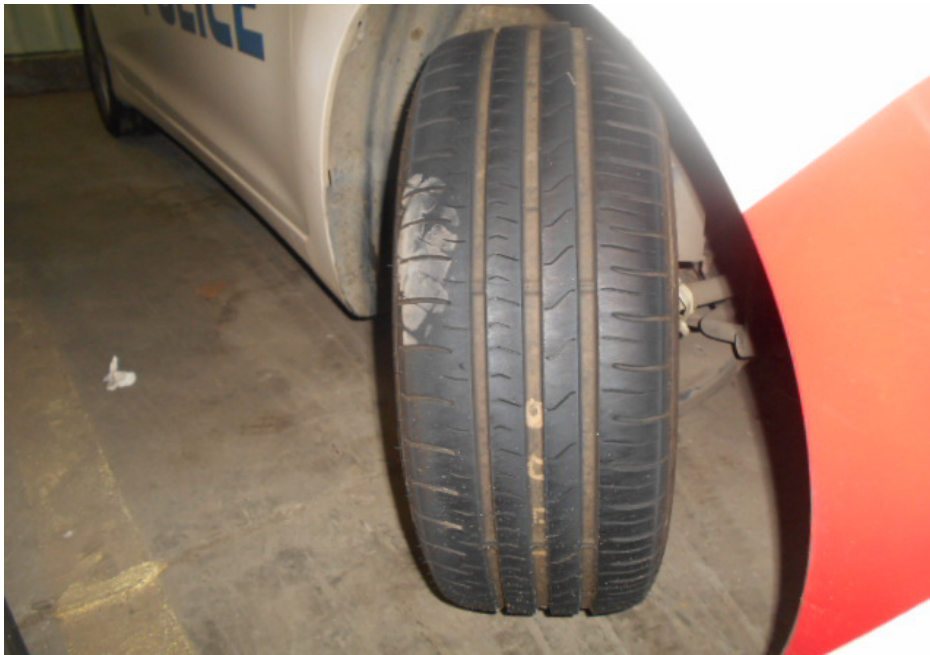
**Photo 7** shows the condition of the front right tyre of the Police Car, which was observed to be in serviceable condition with remaining tread depth of approximately 6mm. The tyre was also observed to be sufficiently inflated for vehicular operation with no tear, cut or burst mark(s).

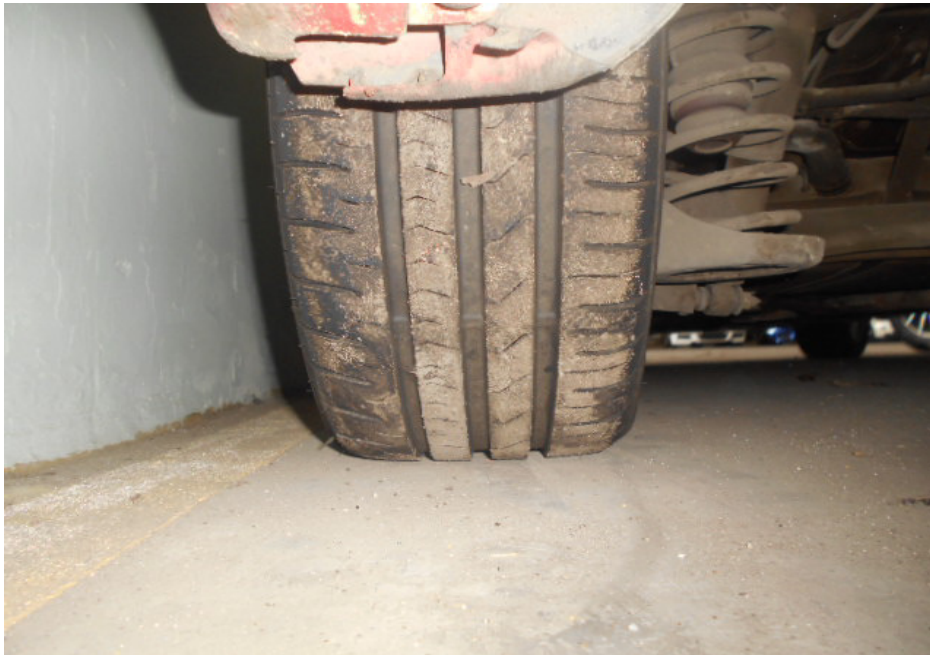
**Photo 8** shows the condition of the rear left tyre of the Police Car, which was observed to be in serviceable condition with remaining tread depth of approximately 6mm. The tyre, which was wrapped around alloy wheel rim, was also observed to be sufficiently inflated for vehicular operation. The 4 tyres of the Police Car were wrapped around standard alloy wheel rims that were without any significant damage apart for some relatively minor kerb grazing type of damage on the outer side of the wheel rims

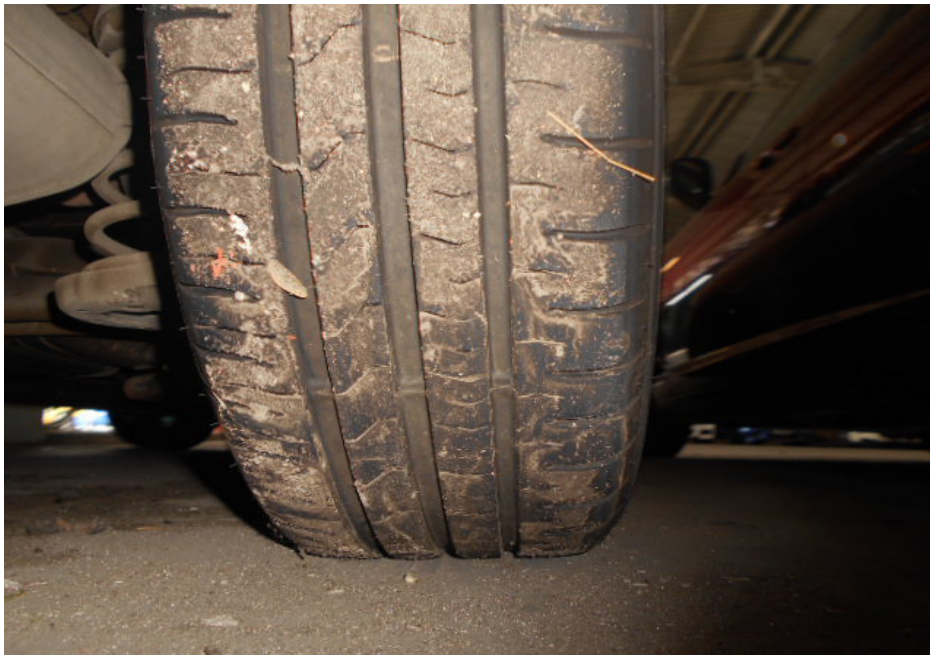
**Photo 9** shows the condition of the rear right tyre of the Police Car, which was observed to be in serviceable condition with remaining tread depth of approximately 6mm. There was also no tear, cut or burst mark(s) on the outer and the inner sidewalls as well as across the tread of the Police Car's 4 tyres.

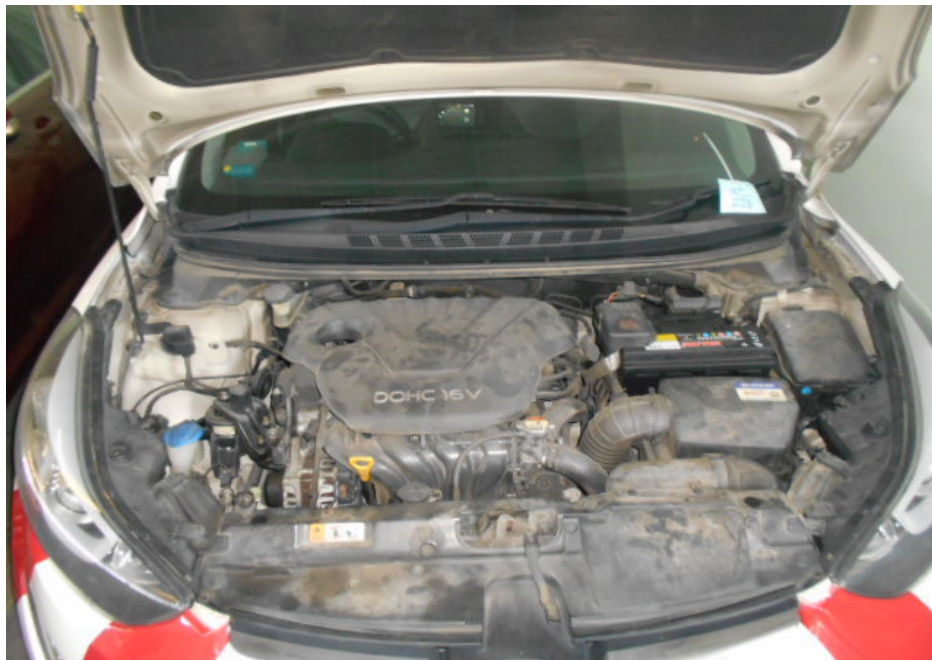
**Photo 10** shows a general view of the Police Car's engine compartment. The various parts and components inside the engine compartment were unaffected by the accident. There was also no sign(s) or indication(s) of fluid leakage and/or fluid stain within the engine compartment.

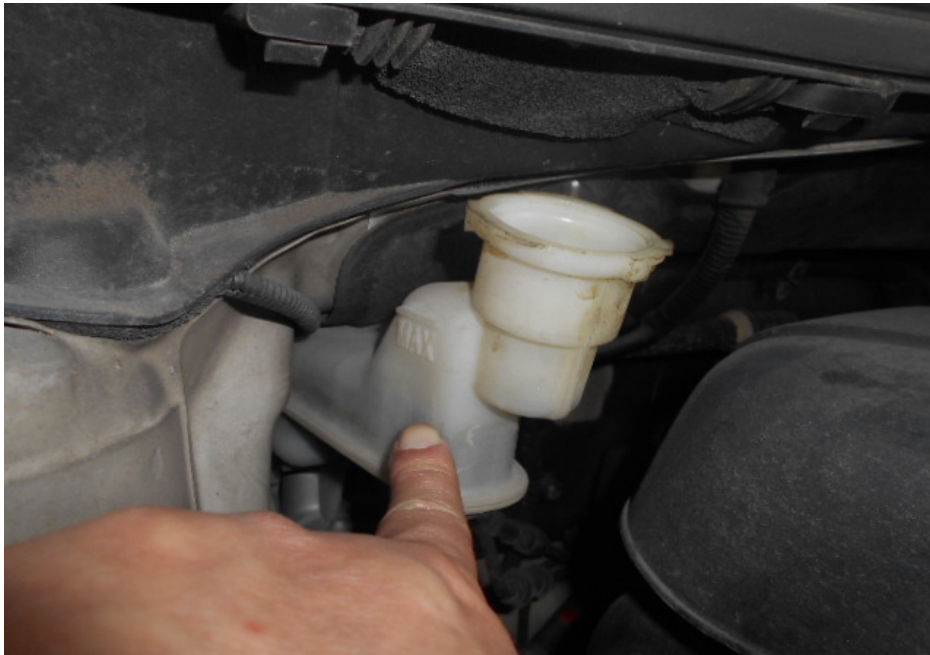
**Photo 11** shows the brake fluid reservoir of the Police Car at the time of my inspection. The brake fluid was observed to be of sufficient level (as indicated by my finger) and without any visible contamination.

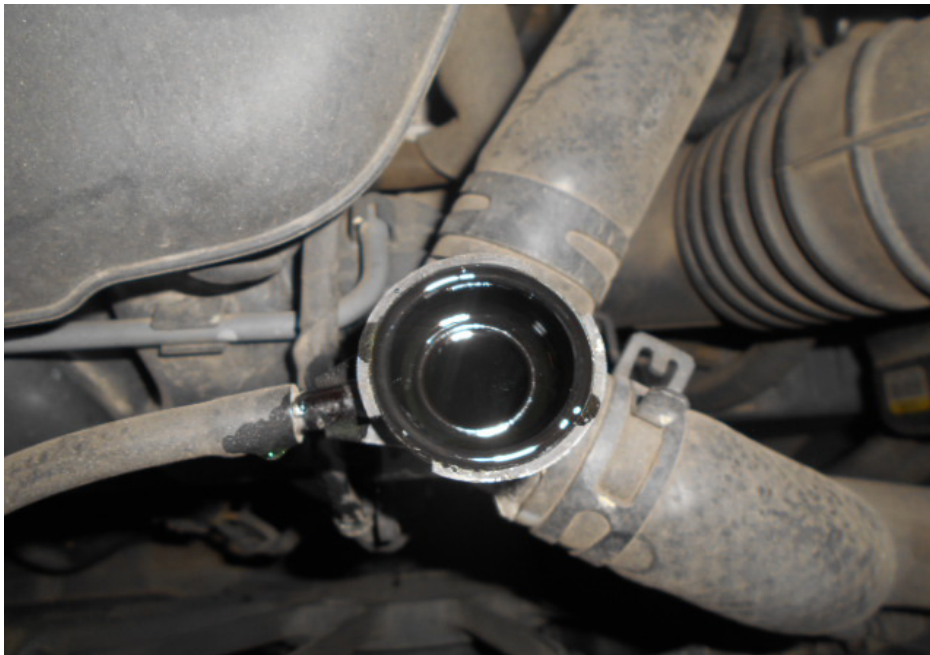
**Photo 12** shows checks being carried out to the engine coolant of the Police Car at the time of my inspection. The engine coolant was observed to be of sufficient level and without any visible contamination.

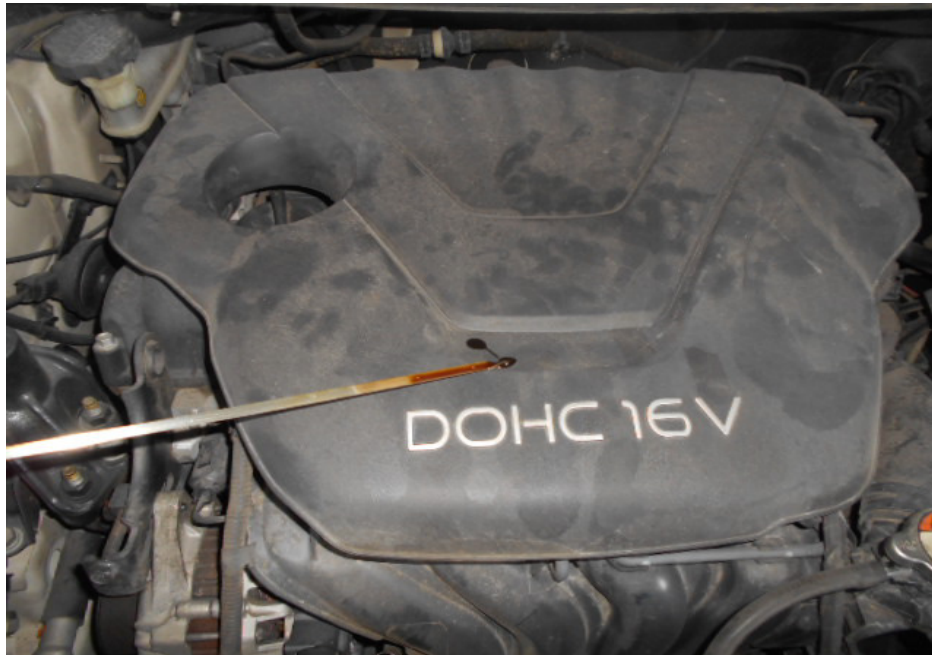
**Photo 13** shows the engine oil dip stick of the Police Car at the time of my inspection. The engine oil was observed to be of sufficient level and without any visible contamination.

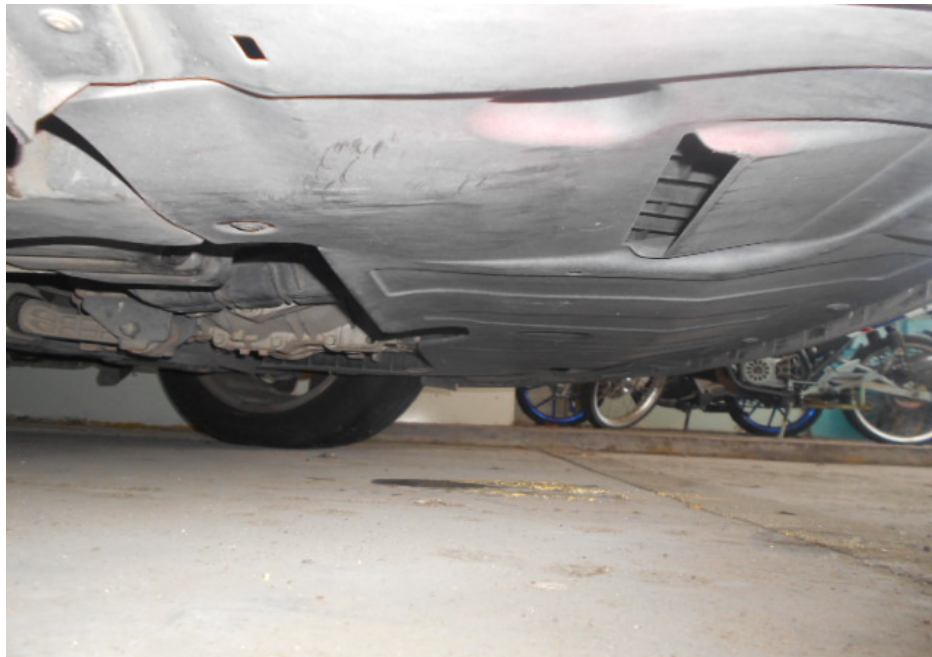
**Photo 14** shows the front underside of the Police Car. I did not find any sign(s) or indication(s) of fluid leak and/or fluid stain(s) on the underside of the Police Car.

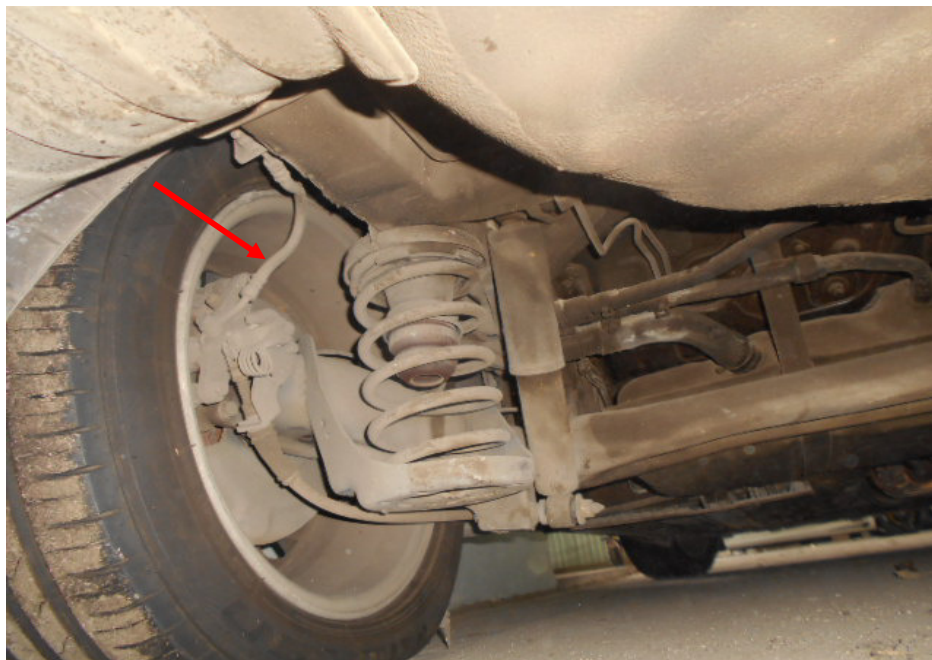
**Photo 15** shows the brake hose/pipe (arrowed) at the rear left wheel of the Police Car. I did not observe any leakage of brake fluid at the time of my inspection of the Police Car. Static tests of the Police Car's braking system had indicated that there was no internal leakage of pressure/vacuum.

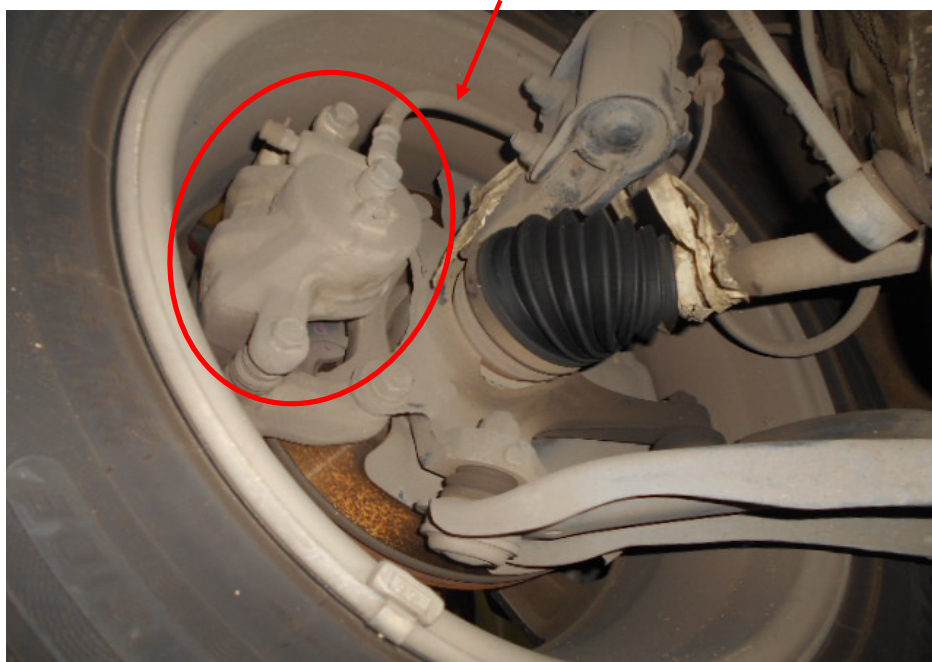
**Photo 16** shows the brake hose/pipe (arrowed) at the front right wheel of the Police Car. No leakage of brake fluid was observed. Visual examination of the various components of the braking system like the brake caliper (circled), brake booster, brake pedal etc had revealed all to be intact and without visible damage. The braking system of the Police Car was likely to be in serviceable condition.

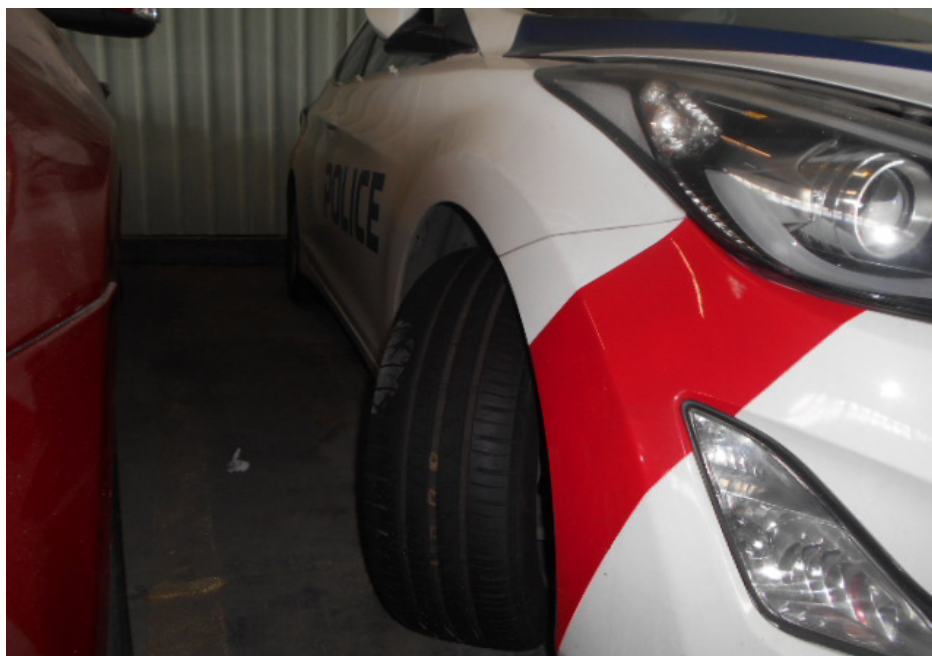
**Photo 17** shows the front left wheel of the Police Car turned to its full right. During my static steering system test, I did not experience any abnormal free play and/or resistance when I had turned the steering wheel towards the left and right. This would suggest that the steering system of the Police Car was likely to be in serviceable condition.

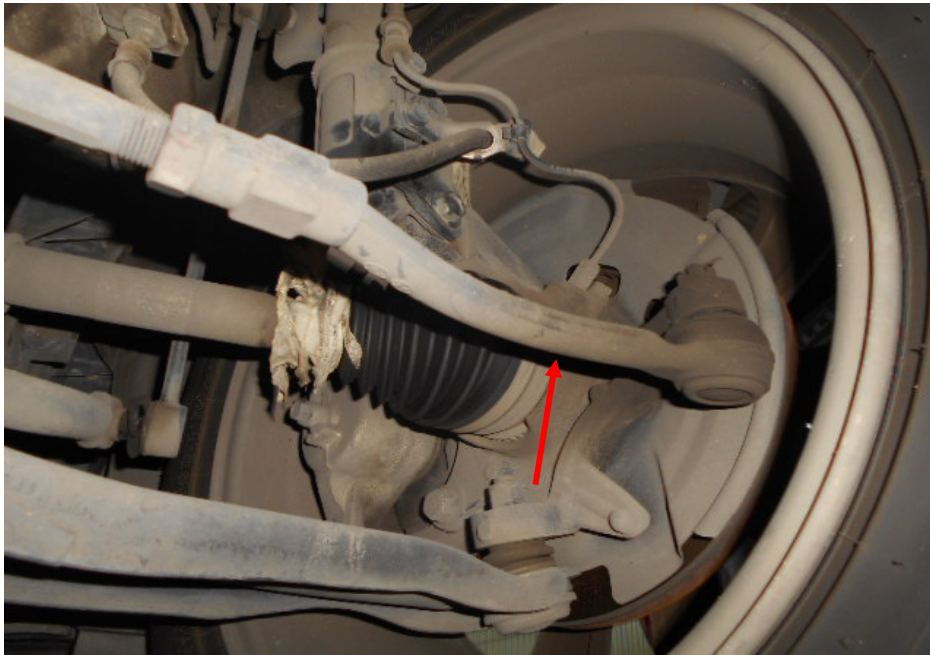
**Photo 18** shows the various undercarriage components at the front right wheel of the Police Car, in particular the front right steering tie rod (arrowed). The steering components were all found to be intact except for the front left steering tie rod. This would suggest that the steering system of the Police Car was likely to be in serviceable condition. There was also no sign of fluid stain(s) observed on the various undercarriage components at the front right wheel of the Police Car.

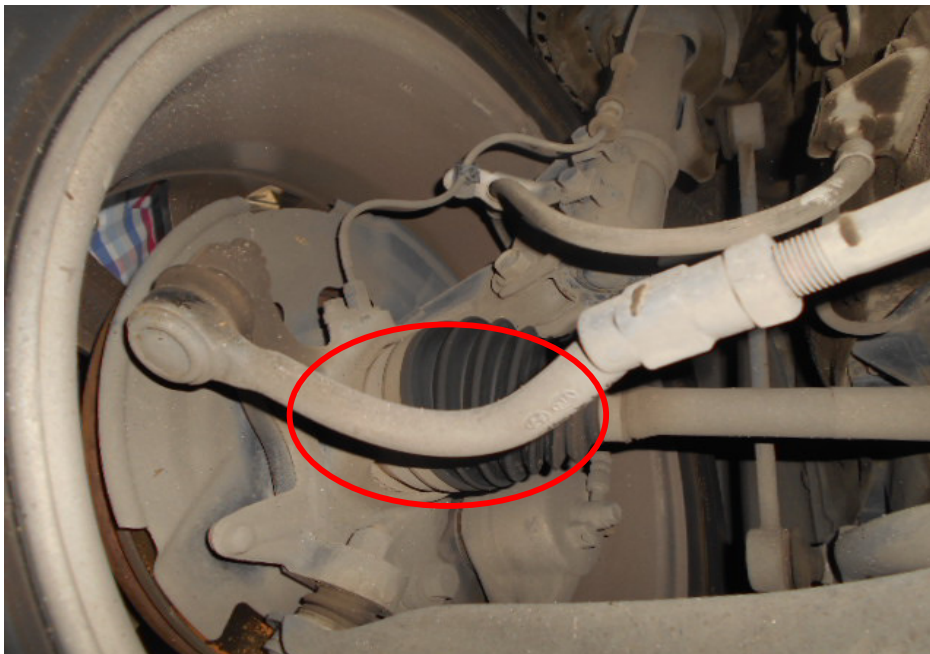
12. The Police Car's steering system could not be operationally tested as its front left steering tie rod was bent due to the accident. I was however able to carry out a static test on the steering system of the Police Car by turning the steering wheel left and right to full lock positions. My observations from this test revealed no abnormality to the steering system. I did not experience any abnormal free play and/or other resistance. My visual examination of the other undamaged steering components, which had included the steering rack and pinion, tie rod ends and ball joints revealed that these components were all generally in good condition. See photo 15 - 19 below.

**Photo 19** shows the various undercarriage components at the front left wheel of the Police Car. The front left steering tie rod was observed to be bent (circled). Such nature of damage is likely caused by an impact onto the front left wheel rim hence this damage is likely due to the accident. Given this damage, I was not able to carry out any operational test on the steering system of the Police Car.

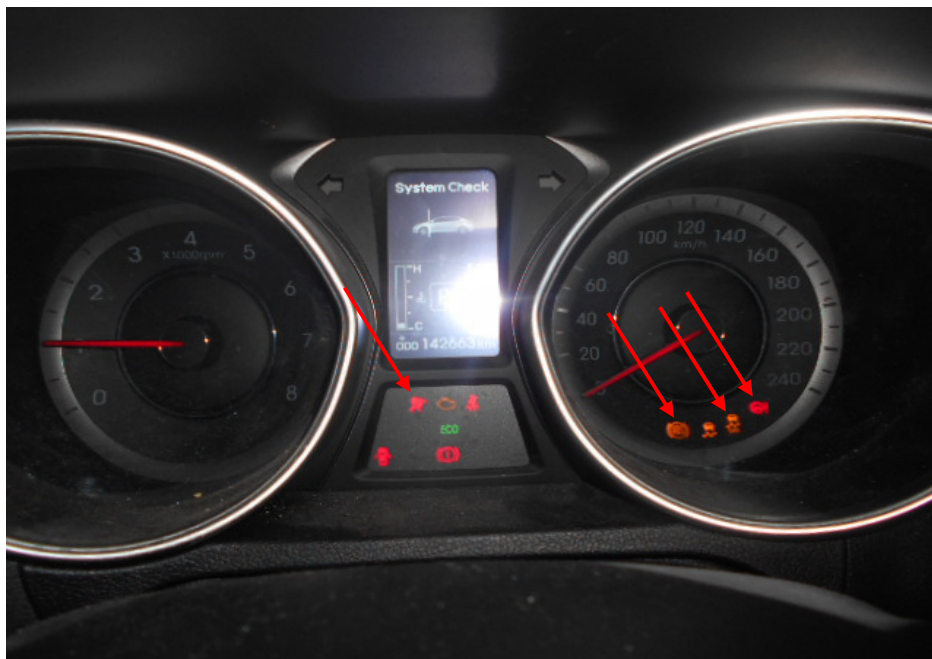
**Photo 20** shows the warning light for Anti-Lock Brake System (ABS), Electric Power Steering System (EPS), Traction Control (TC) and Supplemental Restraint System (SRS) appearing on the instrument panel of the Police Car during the self-test of its various electronic operating systems when its engine was cranked.

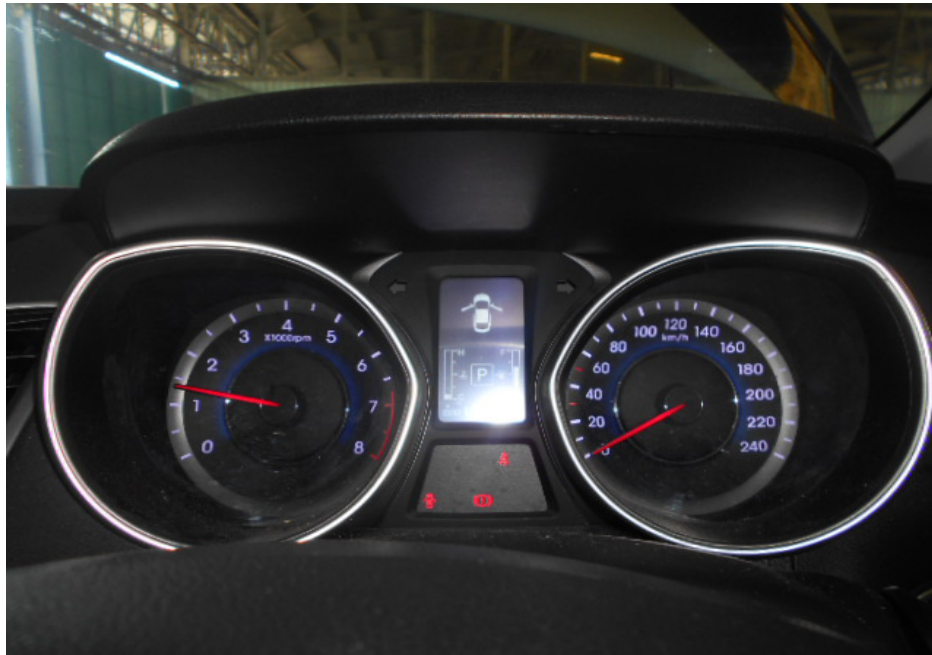
**Photo 21** shows no warning lights illuminated on the instrument panel of the Police Car after the engine was cranked. This would suggest that there was no abnormality to the various electronic operating systems of the Police Car, like the ABS, EPS, TC and SRS etc.
