Auto
Consultants
Pte Ltd

07th March 2018

M/s MSIG Insurance (Singapore) Pte. Ltd.
16 Raffles Quay #24-01
Hong Leong Building
Singapore 048581
(Motor Claims Department)

TECHNICAL FAULT ANALYSIS INVESTIGATION REPORT INVOLVING THE CEMENT MIXER TRUCK WC 8911E ON 04th FEBRUARY 2018

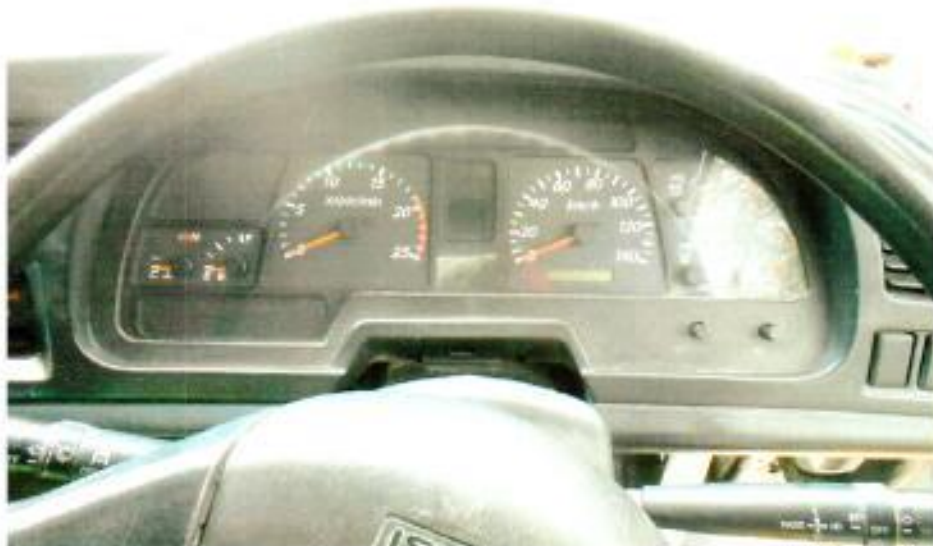
Photo 1 shows the meter on the front dashboard. Mileage (digital) was not recorded due to the Insured Vehicle's engine unable to be started.

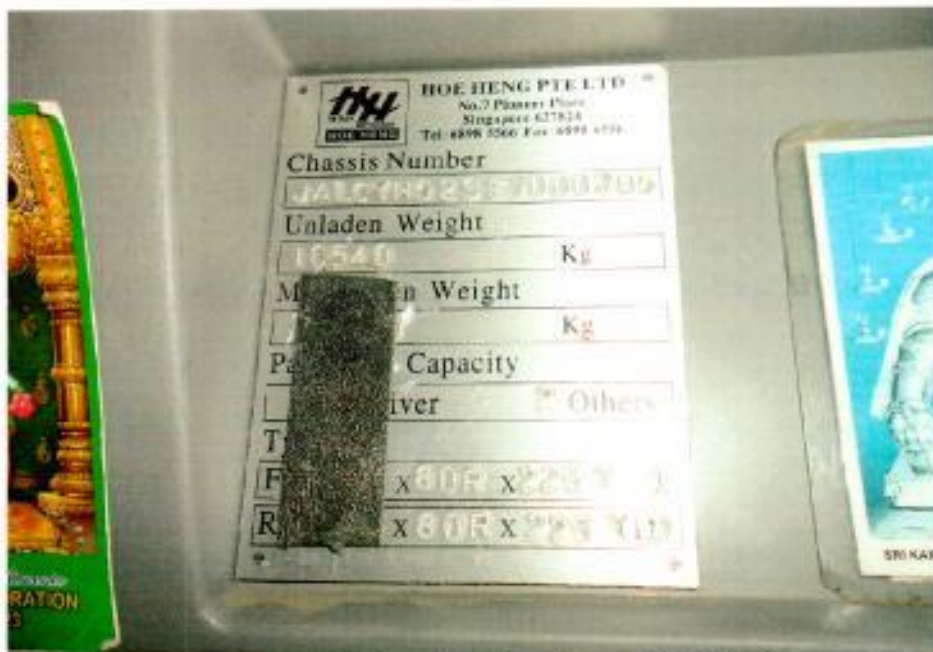
Photo 2 shows the nameplate found inside the Insured Vehicle. It was attached to the behind side of the interior cabin.

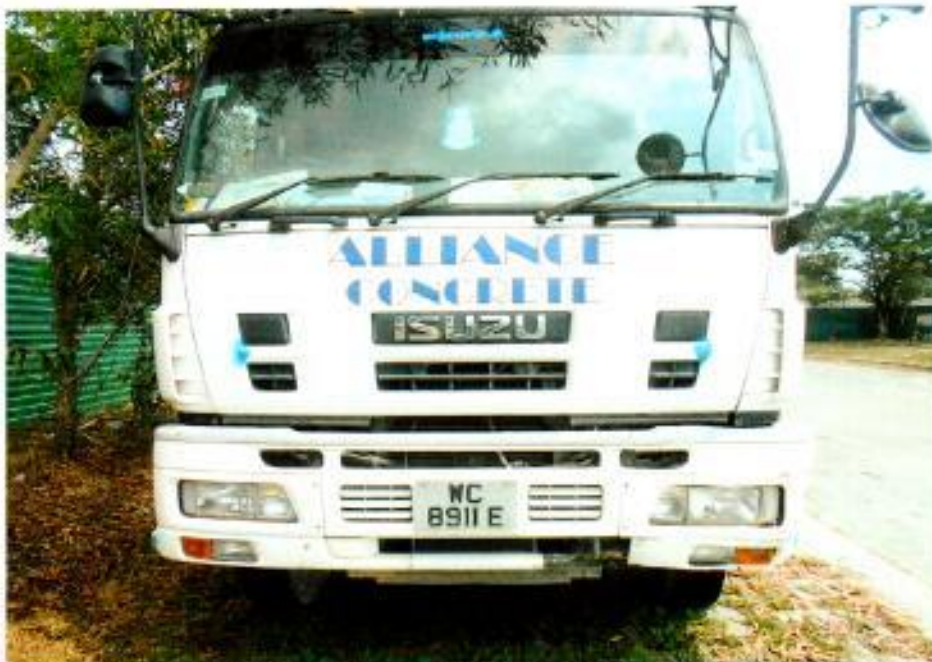
Photo 3 shows the front view of the Insured Vehicle at the time of our inspection. The Insured Vehicle was noted to be in good condition on the front portion.

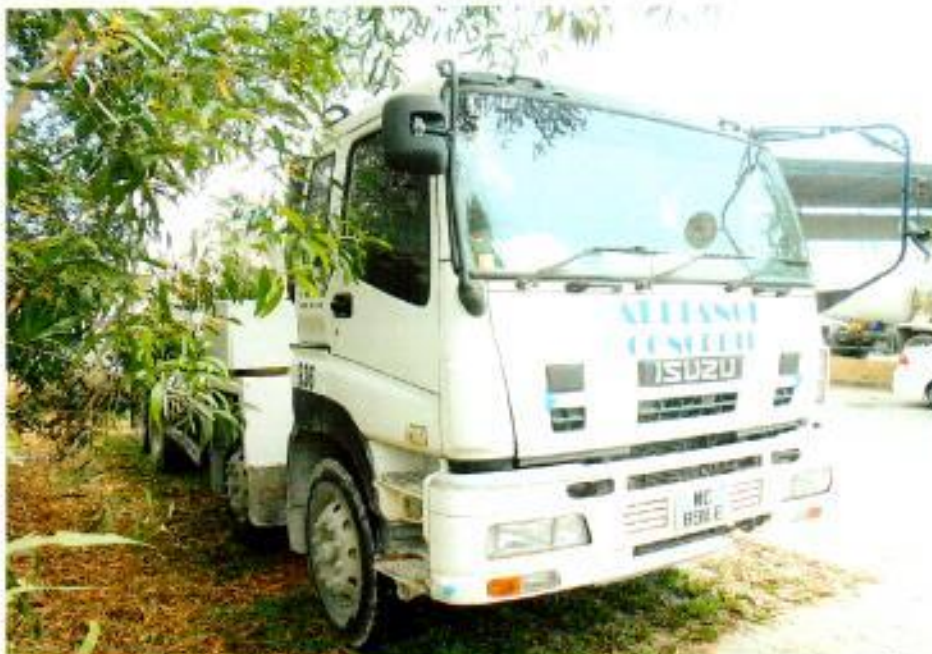
Photo 4 shows the front right view of the Insured Vehicle at the time of our inspection. The Insured Vehicle was noted to be in good condition on the front right portion.

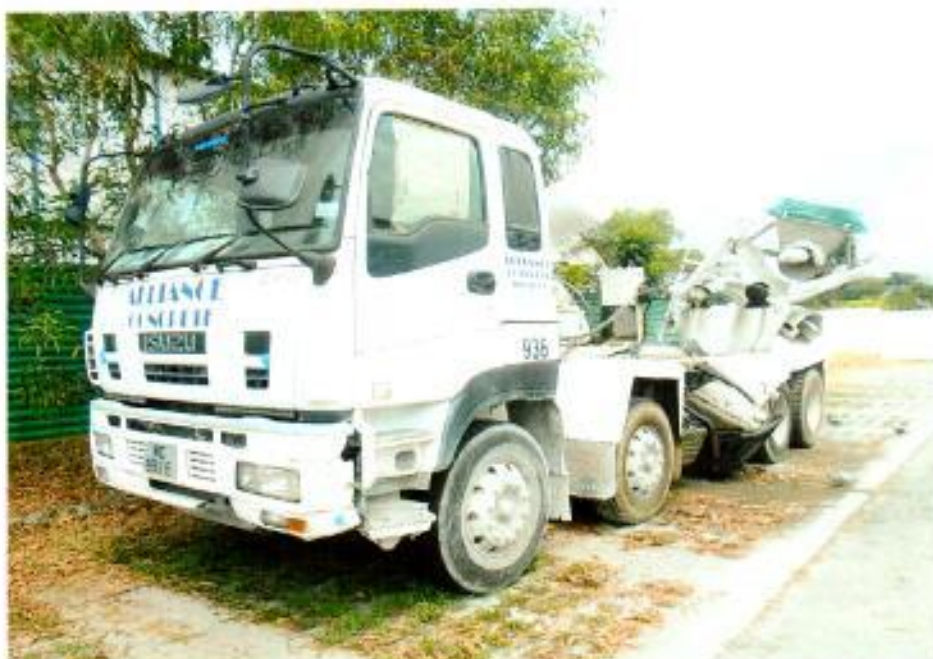
Photo 5 shows the front left side of the Insured Vehicle at the time of our inspection. The Insured Vehicle was noted to have sustained extensive damages that severely effected on most parts of the left side of the Insured Vehicle.

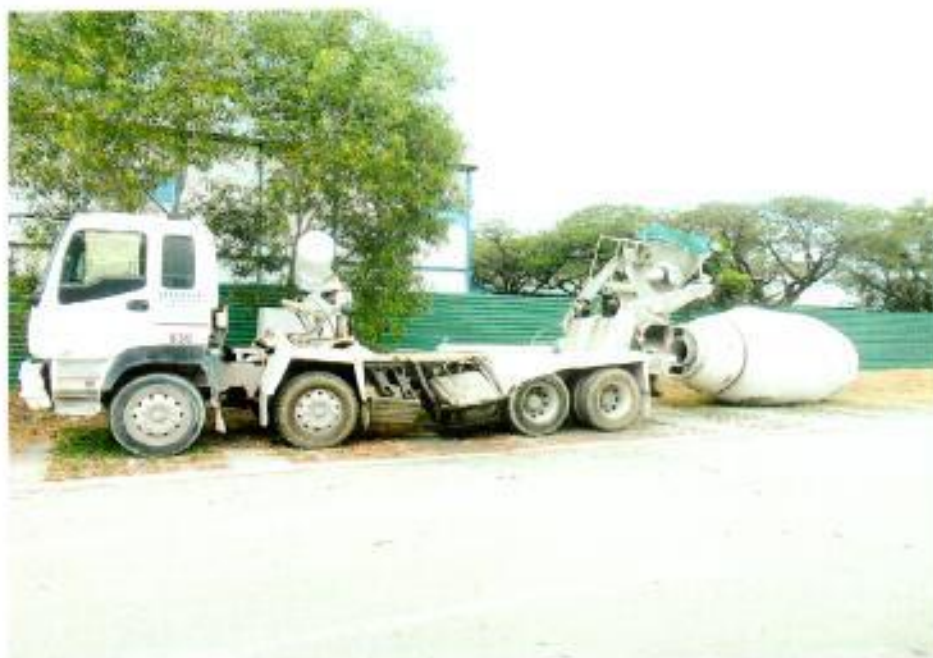
Photo 6 shows the full general view on the left side of the Insured Vehicle at the time of our inspection. The Insured Vehicle was noted to have sustained extensive damages that severely effected on most parts of the left side of the Insured Vehicle.

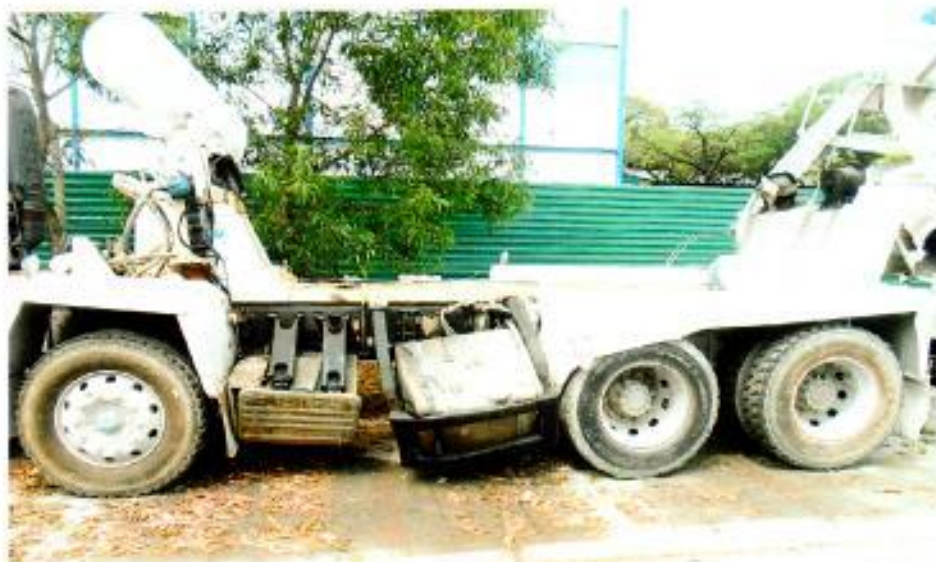
Photo 7 shows the closer view of the Insured Vehicle at the time of our inspection. The damages on some parts such as fuel tank, top tyre cover garnish and supporting parts for holding the mixer drum.

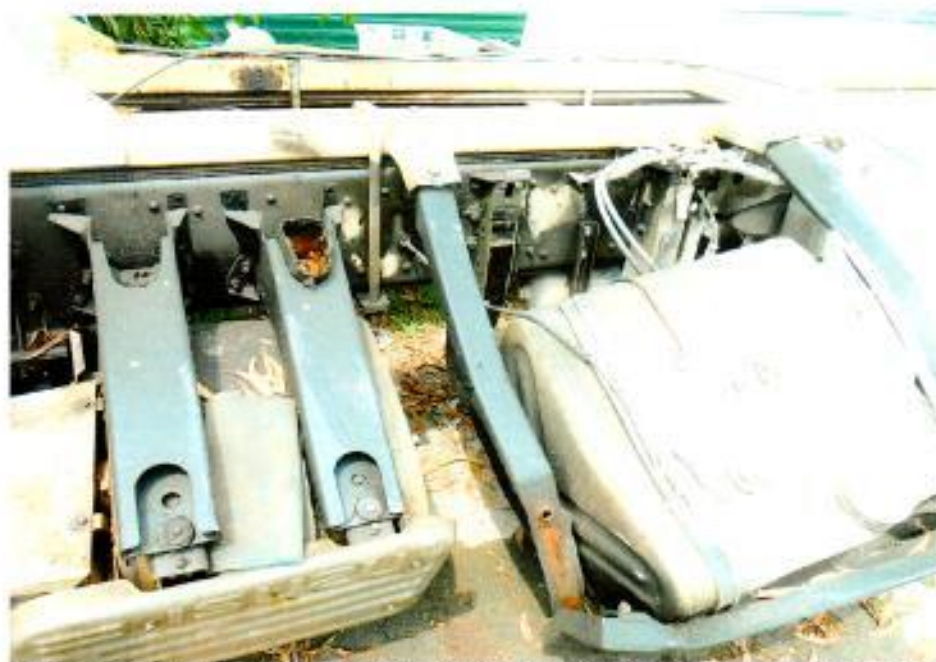
Photo 8 shows the parts that were affected due to the accident's impact at time of our inspection.

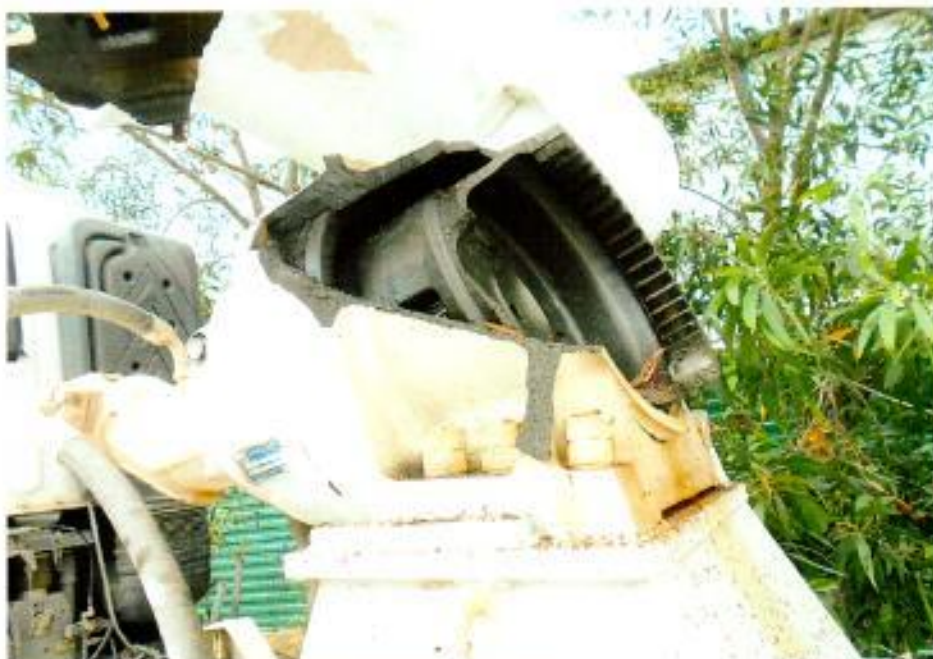
Photo 9 shows the mixer motor gear that was affected due to the accident's impact at time of our inspection.

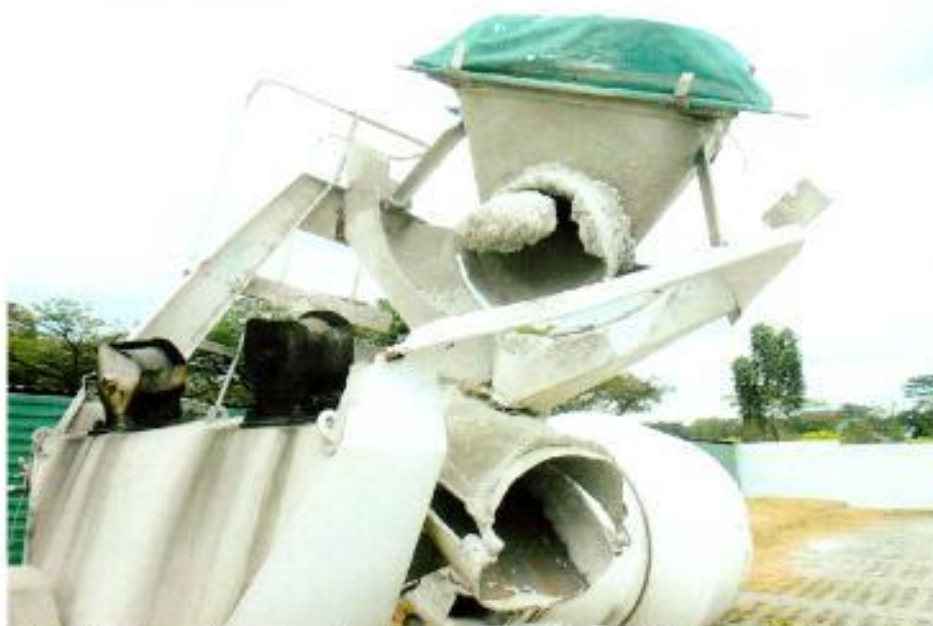
Photo 10 shows the rear parts that were affected due to the accident's impact at time of our inspection.

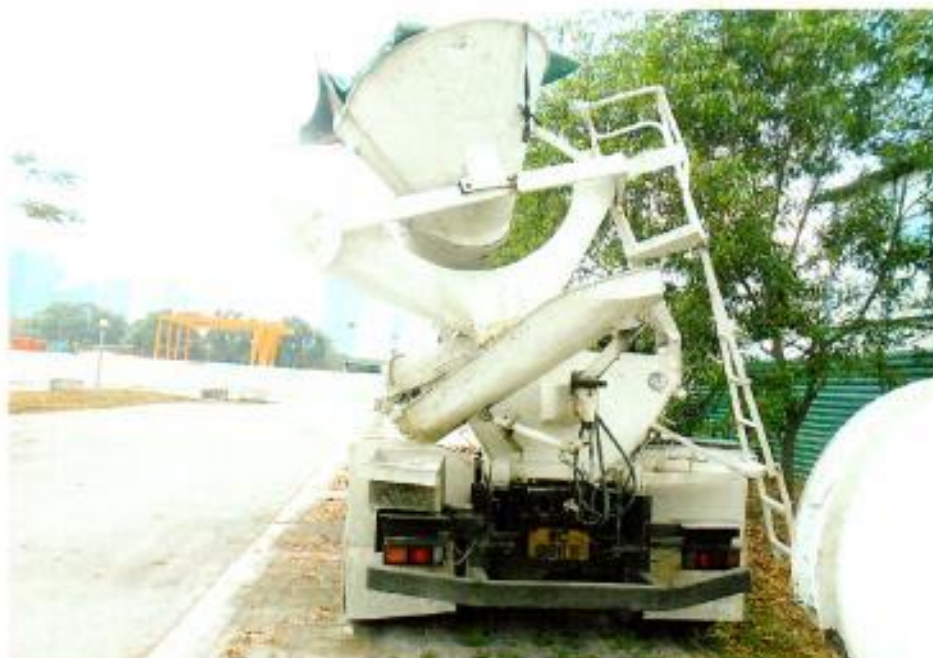
Photo 11 shows the rear view that was affected due to the accident's impact at time of our inspection.

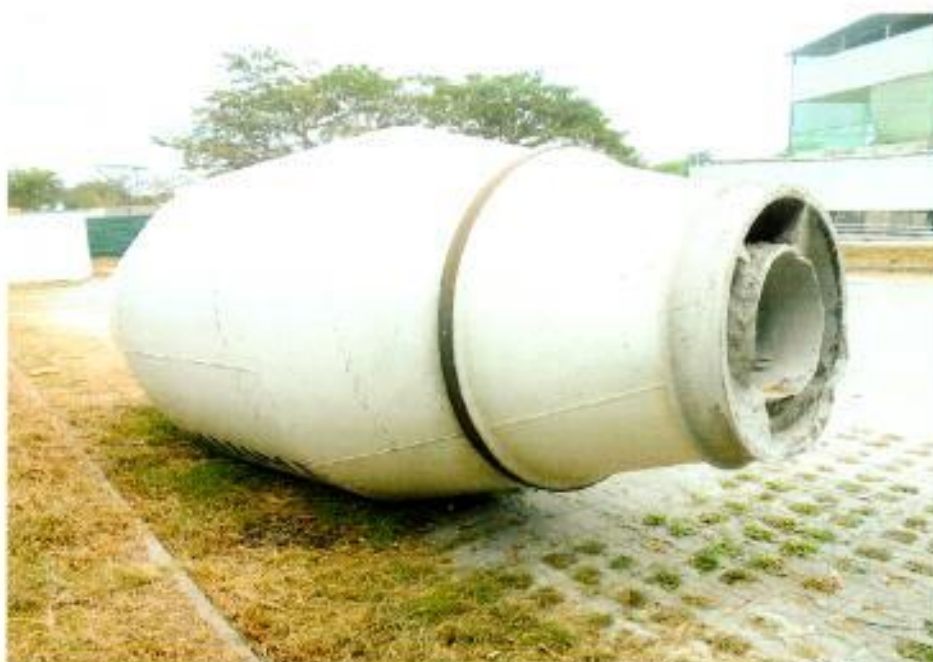
Photo 12 shows the rear view of cement mixer drum that was dislodged from the holding bracket at time of our inspection.

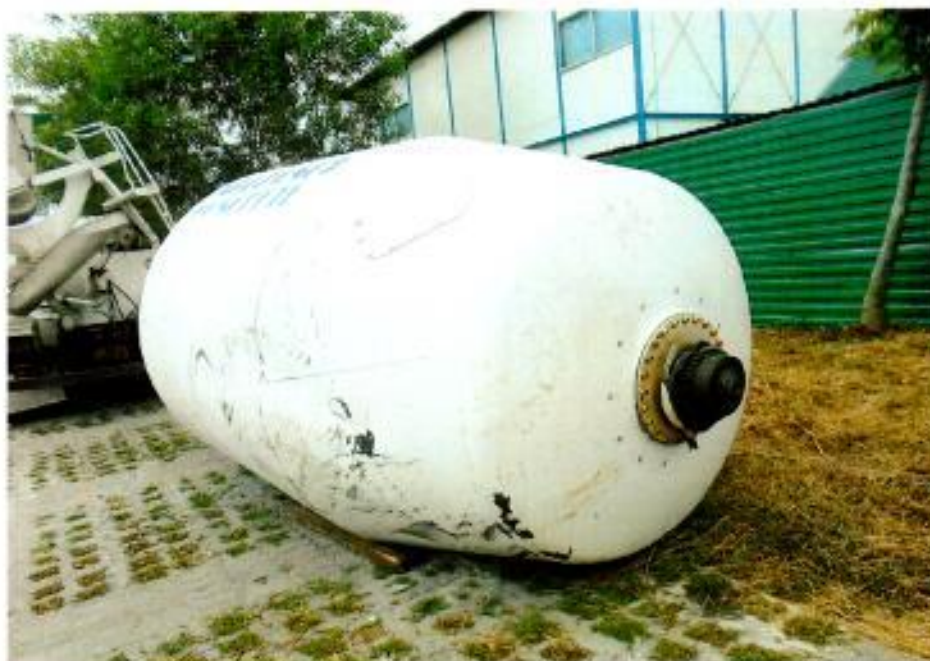
Photo 13 shows the front view of cement mixer drum that was dislodged from the holding bracket at time of our inspection.

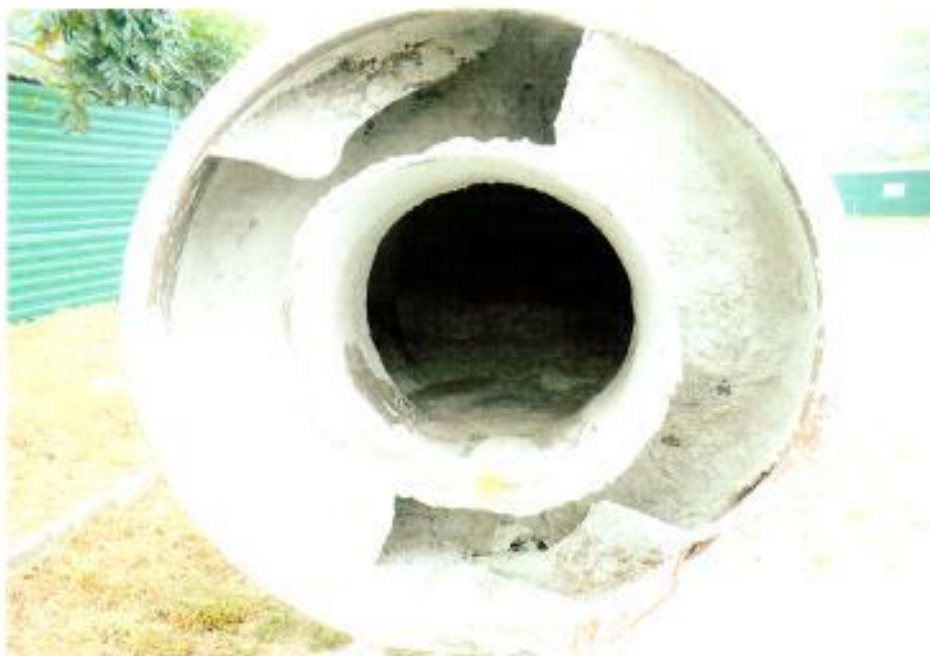
Photo 14 shows the internal view of cement mixer drum that was dislodged from the holding bracket at time of our inspection. Left over hardened cement were observed to be inside the drum.

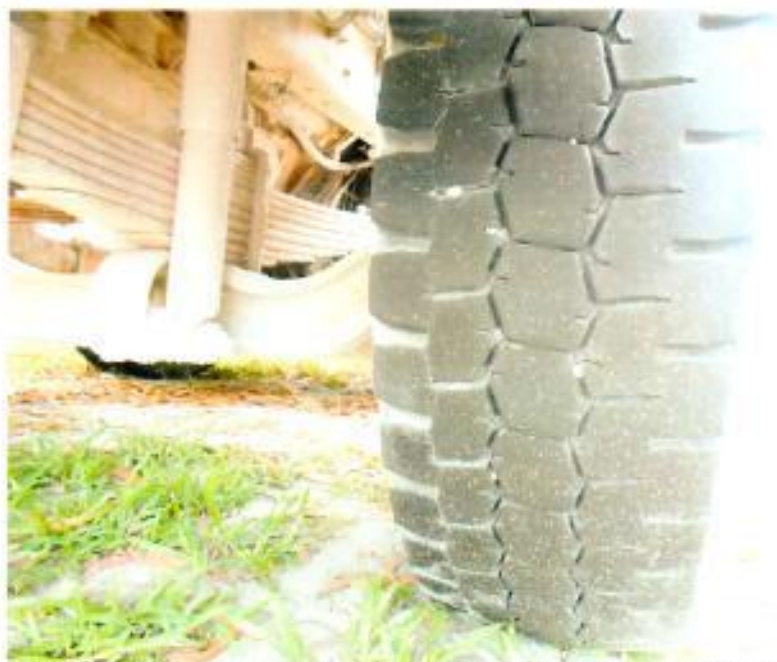
Photo 15 shows the condition of the front left tyre of the Insured Vehicle, which was observed to be in serviceable condition with remaining tread depth of approximately 5mm.

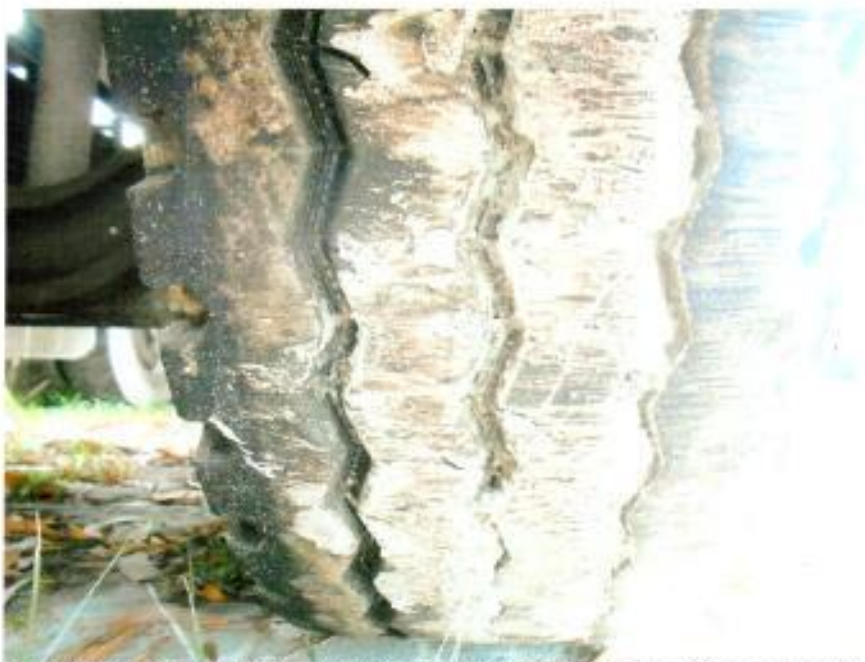
Photo 16 shows the condition of the left tyre (2nd Row) of the Insured Vehicle, which was observed to be in serviceable condition with remaining tread depth of approximately 8mm.

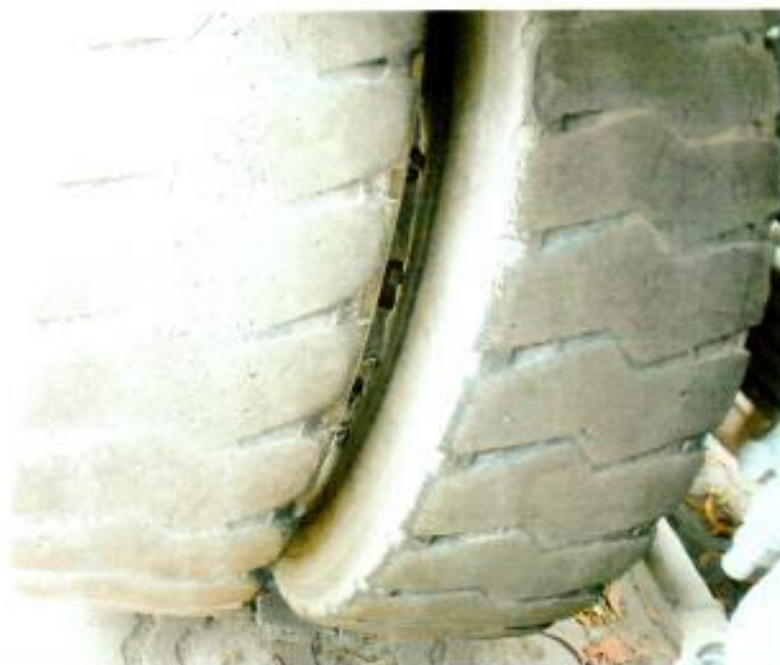
Photo 17 shows the condition of the left tyre (3rd Row) of the Insured Vehicle, which was observed to be in serviceable condition with remaining tread depth of approximately 2mm.

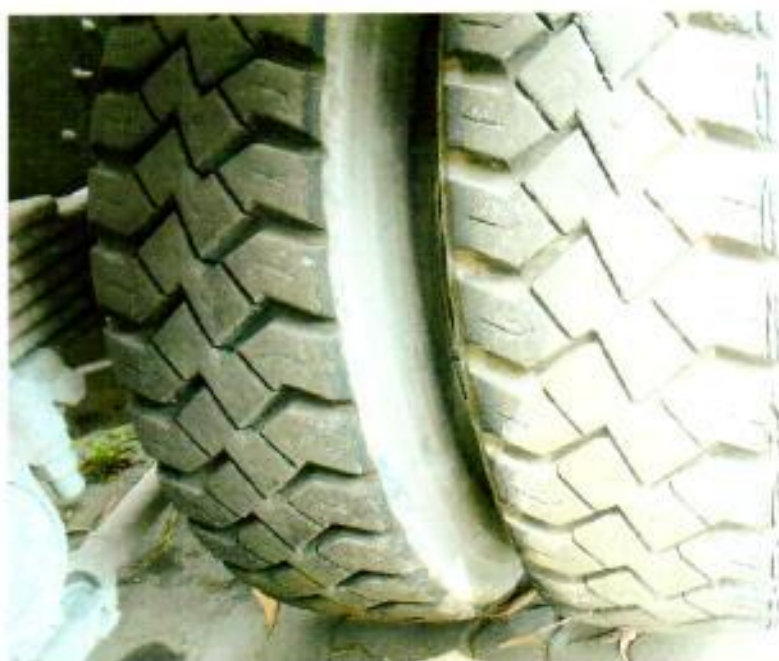
Photo 18 shows the condition of the rear left tyre of the Insured Vehicle, which was observed to be in serviceable condition with remaining tread depth of approximately 10mm.

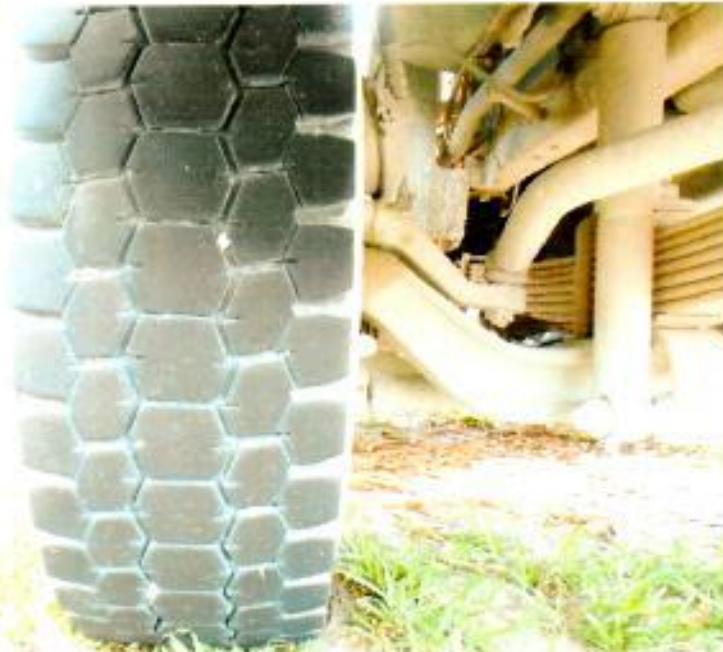
Photo 19 shows the condition of the front right tyre of the Insured Vehicle, which was observed to be in serviceable condition with remaining tread depth of approximately 10mm.

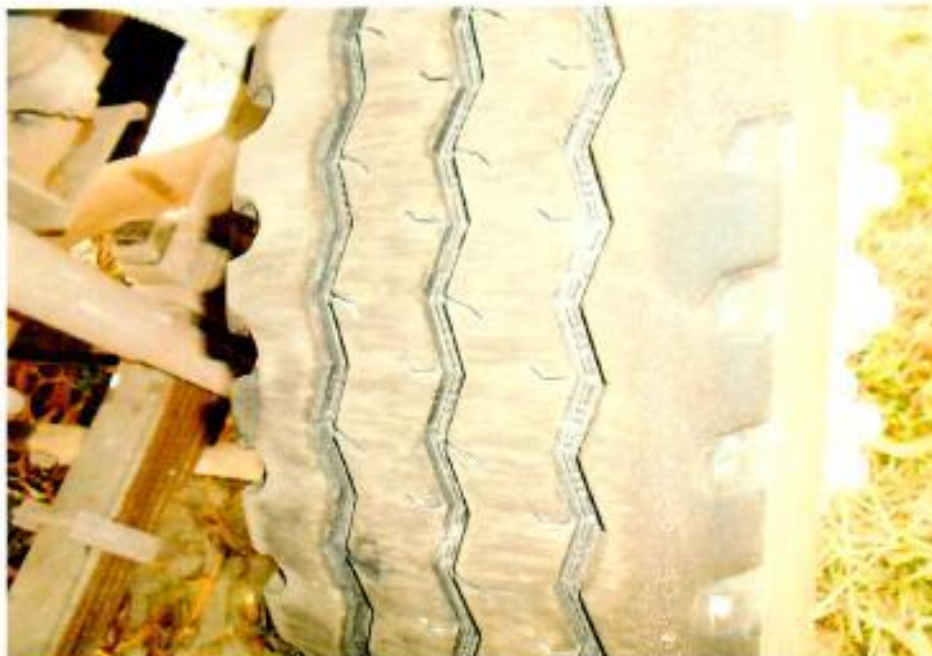
Photo 20 shows the condition of the right tyre (2nd Row) of the Insured Vehicle, which was observed to be in serviceable condition with remaining tread depth of approximately 10mm.

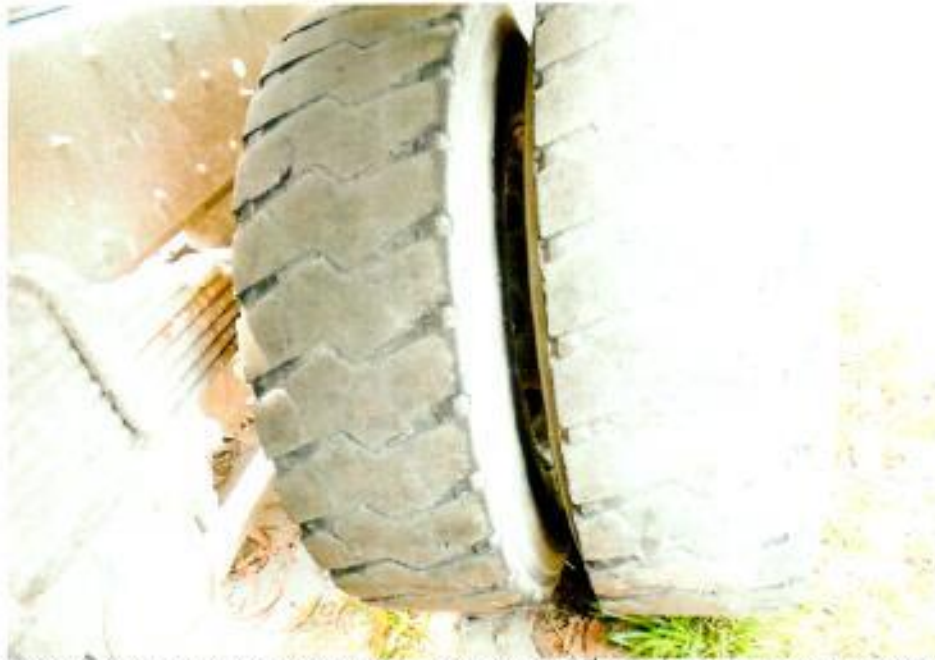
Photo 21 shows the condition of the right tyre (3rd Row) of the Insured Vehicle, which was observed to be in serviceable condition with remaining tread depth of approximately 3mm.

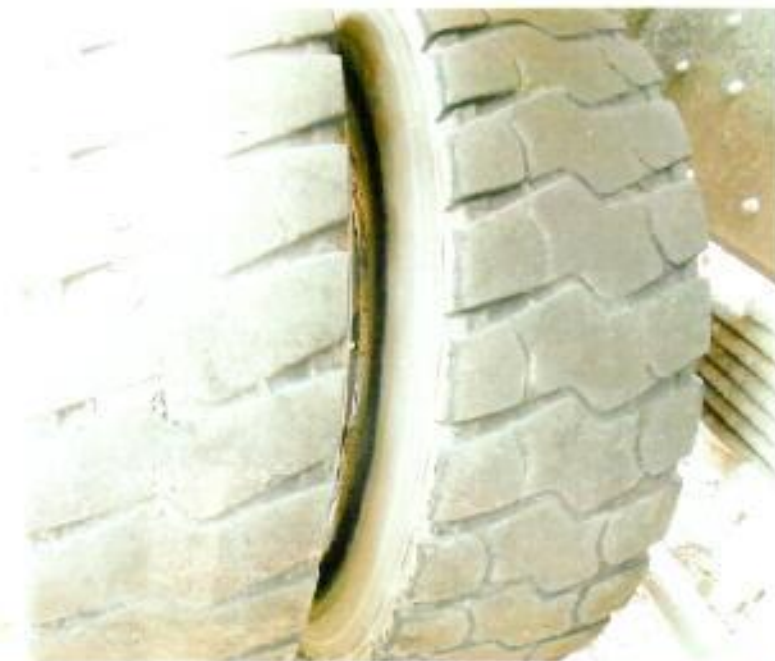
Photo 22 shows the condition of the rear right tyre of the Insured Vehicle, which was observed to be in serviceable condition with remaining tread depth of approximately 2mm.

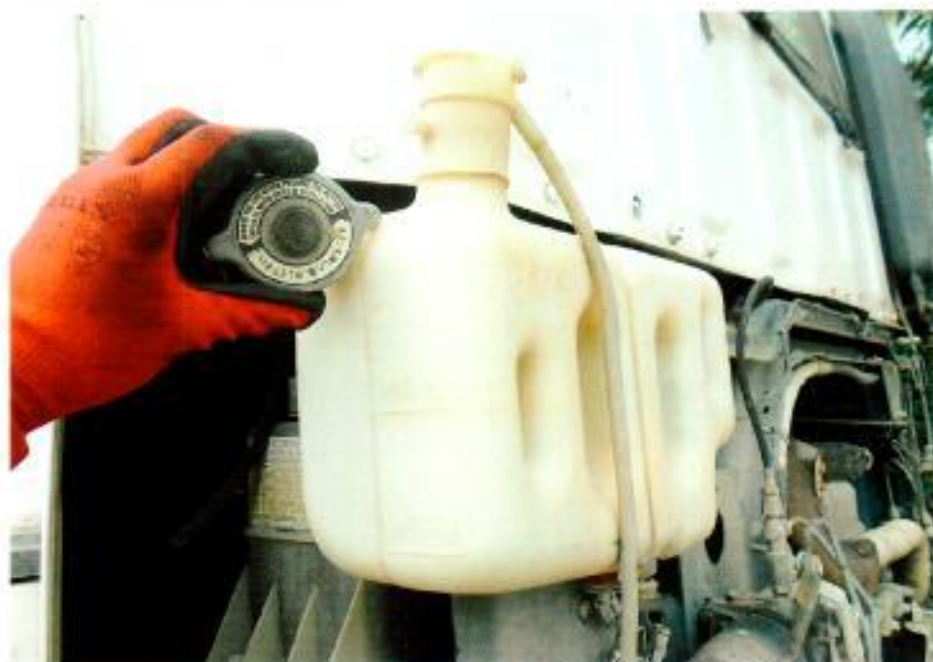
Photo 25 shows the engine coolant reservoir of the Insured Vehicle. It was found to be sufficient level without contamination.

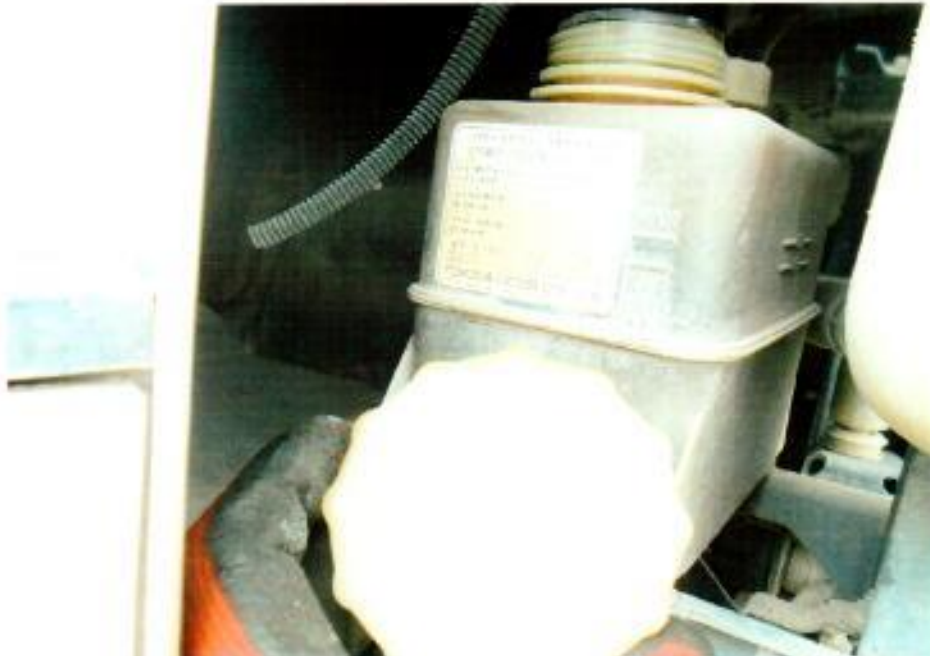
Photo 26 shows the power steering fluid reservoir of the Insured Vehicle. It was found to be sufficient level without contamination for operational purposes.

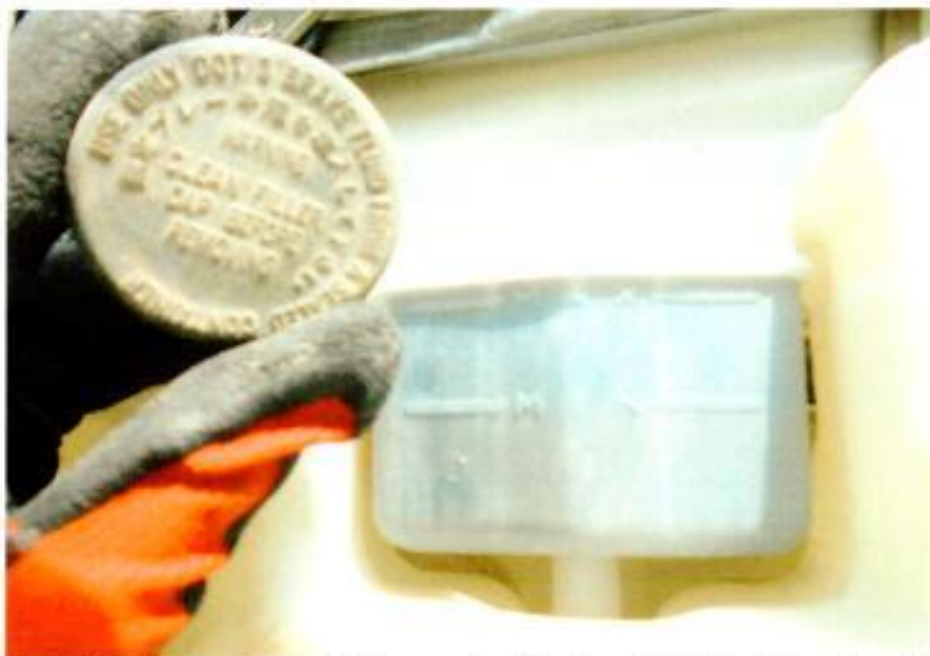
Photo 27 shows the brake fluid reservoir of the Insured Vehicle. It was found to be sufficient level without contamination for operational purposes.

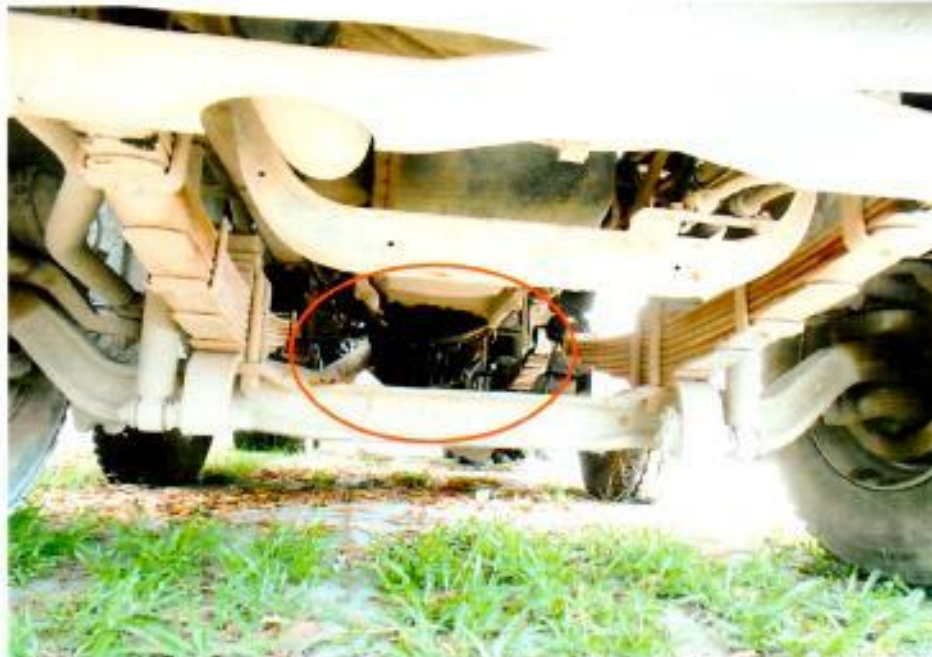
10. Our subsequent checks on the underside of the Insured Vehicle reveals some fluid stain sighted around the transmission system. Further investigation found that the fluid stain was a pre-existed prior the accident & not a fresh fluid. This was due to some dirt observed associated with the fluid stain. Conclusively, it is not likely to be related to the accident. Visually, the various undercarriage components of the Insured Vehicle were observed to be intact and without any visible damage except for the damages caused by the accident. See photo 23 – 29 below.

Photo 28 shows a general view on the undercarriage of the Insured Vehicle. It was observed to have fluid leakage at around the transmission area.

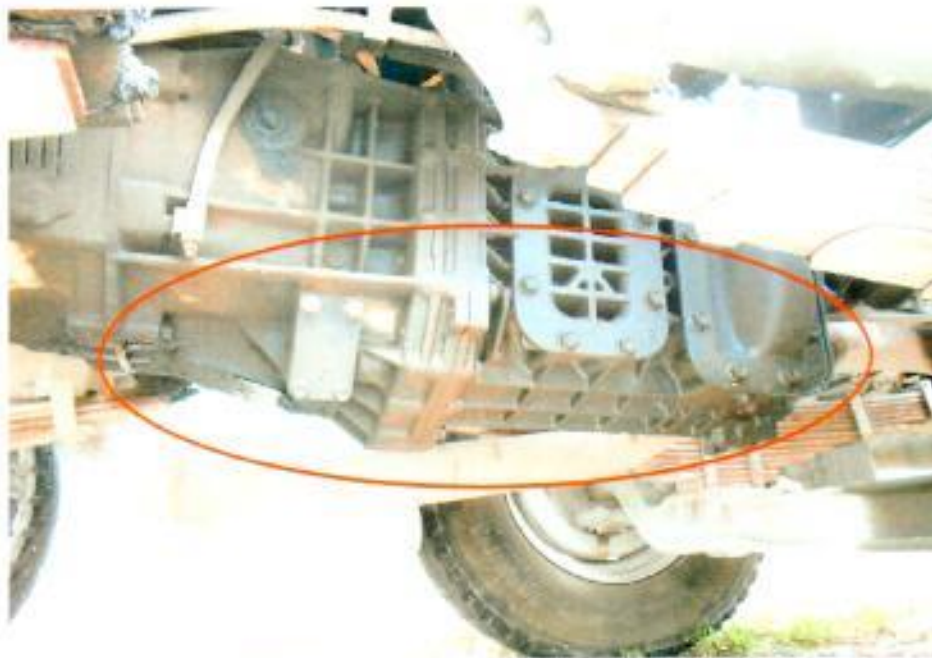
Photo 29 shows fluid leakage at around the transmission area. Further investigation found that the fluid stain was a pre-existed prior the accident & not a fresh fluid. This was due to some dirt observed associated with the fluid stain.

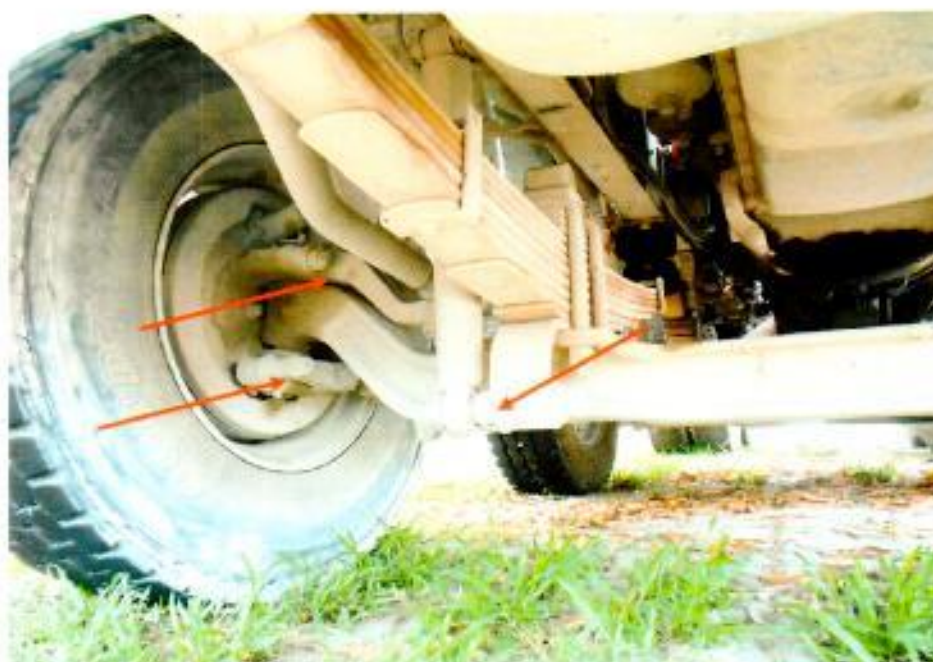
Photo 30 shows the undercarriage components at the front right wheel of the Insured Vehicle. The various undercarriage components were all observed to be intact and without any visible damage. This had included the steering rack and steering linkages (arrowed) of the Insured Vehicle.

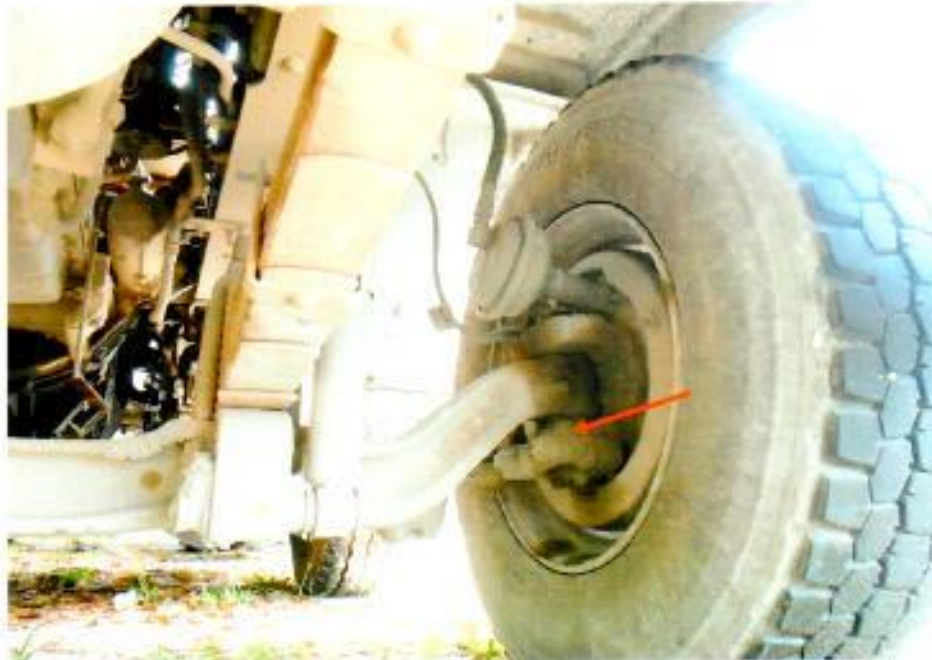
Photo 31 shows the undercarriage components at the front left wheel of the Insured Vehicle. The various undercarriage components of the Insured Vehicle were all observed to be intact and without any visible damage. This had included the steering rack (arrowed) of the Insured Vehicle, which was observed to be securely attached to the front left wheel.

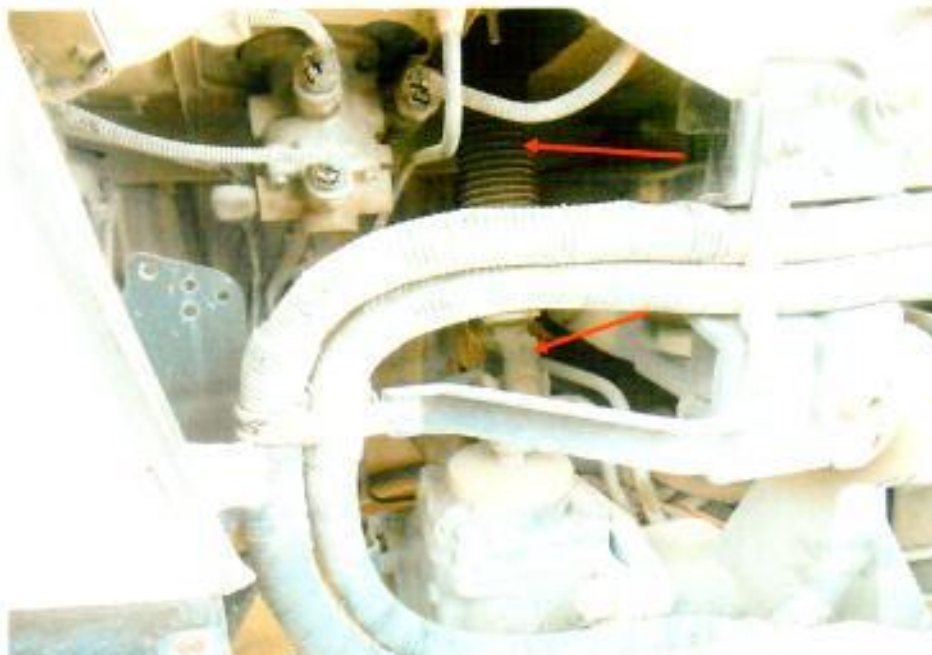
Photo 32 shows the steering wheel rod of the Insured Vehicle. It was observed to be intact and undamaged not affected by the accident's impact.

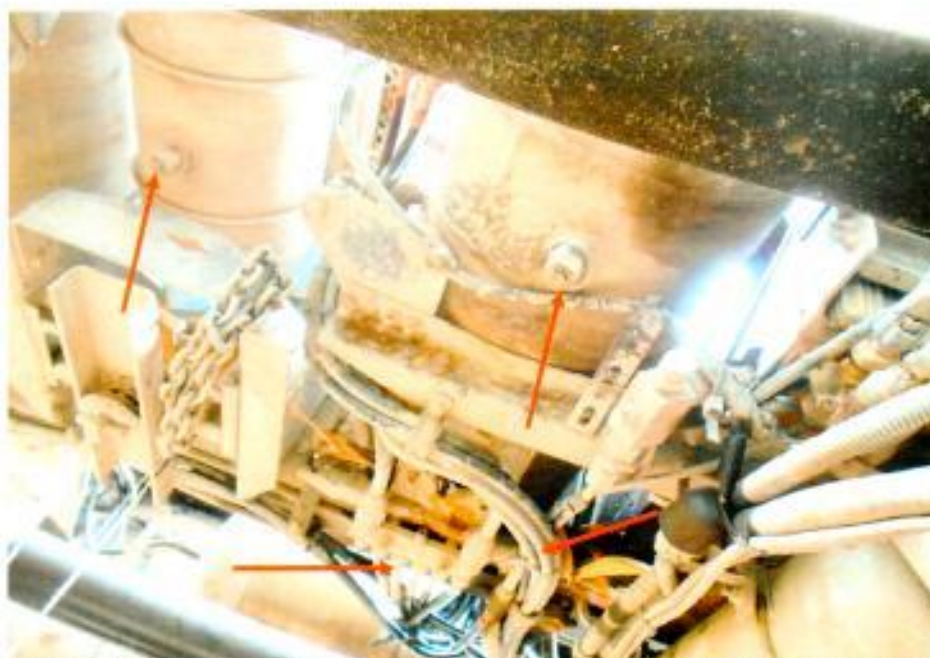
Photo 33 shows the air tanks, valves, pipes and hoses, which are some of the components for the air-assisted braking system of the Insured Vehicle. These components were mainly located around the right centre body of the Insured Vehicle, and were unaffected by the accident.

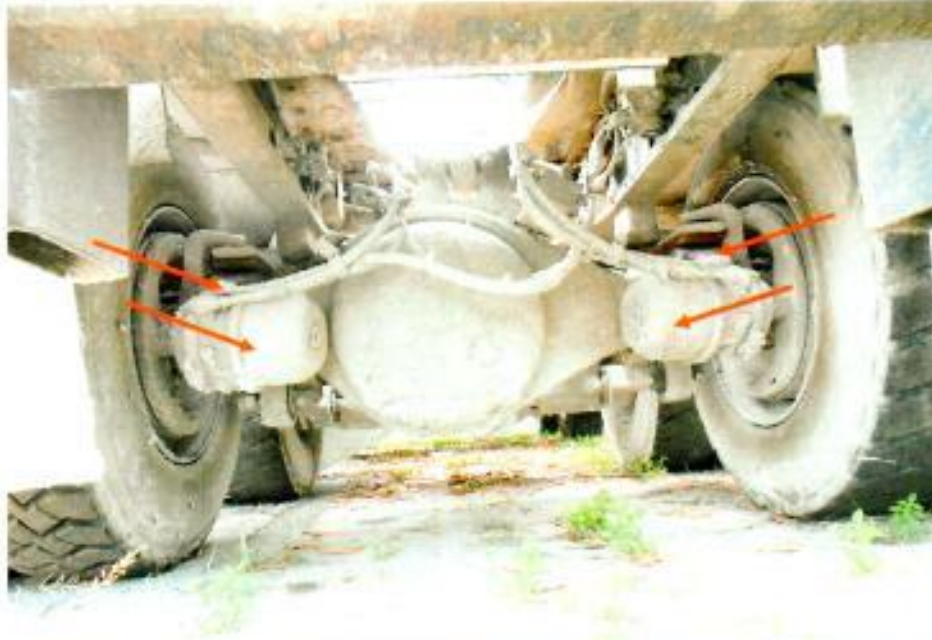
Photo 34 shows the rear undercarriage components of the Insured Vehicle. The brake cylinder & brake hoses of the Insured Vehicle were all observed to be intact and without any visible damage.

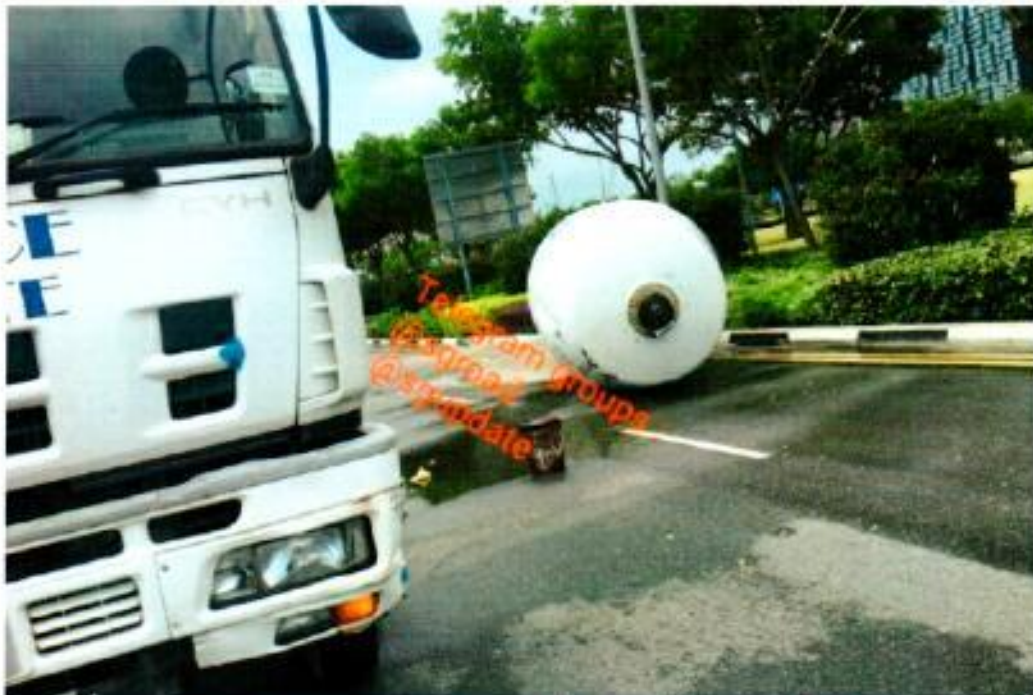
Some of the cement mixture had spilled onto the road, and three out of four lanes on Sheares Avenue had to be closed in the afternoon on Feb 4, 2018. PHOTO: TELEGRAM/SG ND1 ALL IN 1 SHARING / UPDATES

Photo 40 shows the Insured Vehicle with the dislodged of the cement mixer drum along Sheares Avenue at time of the incident.

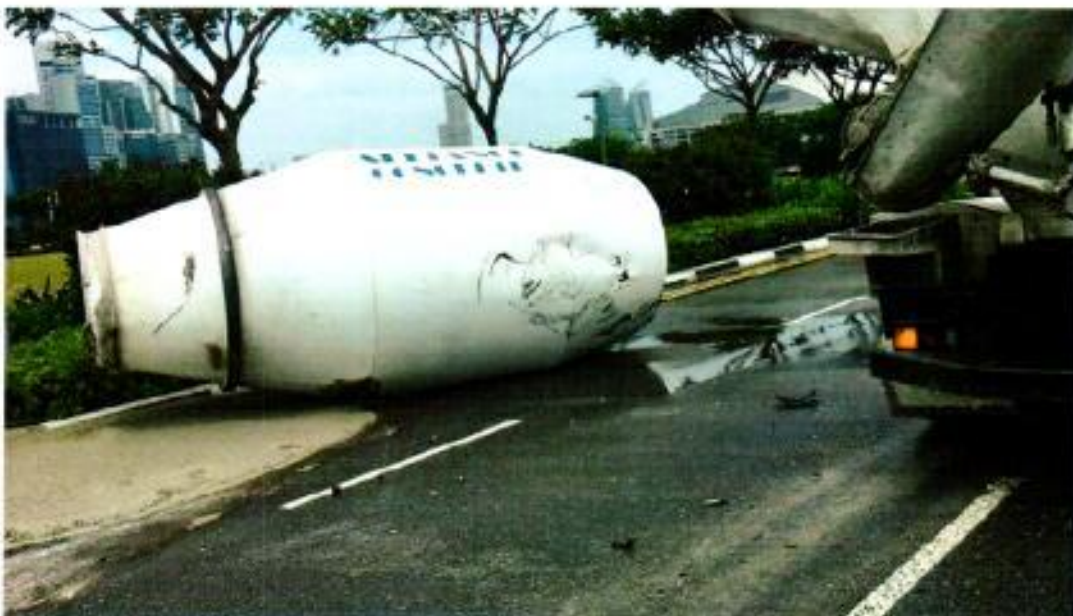
A concrete mixer was involved in an accident along Sheares Avenue on Sunday (Feb 4). (Photo: Facebook / Gary Wu)

Photo 41 shows the Insured Vehicle with the dislodged of the cement mixer drum along Shears Avenue at time of the incident.

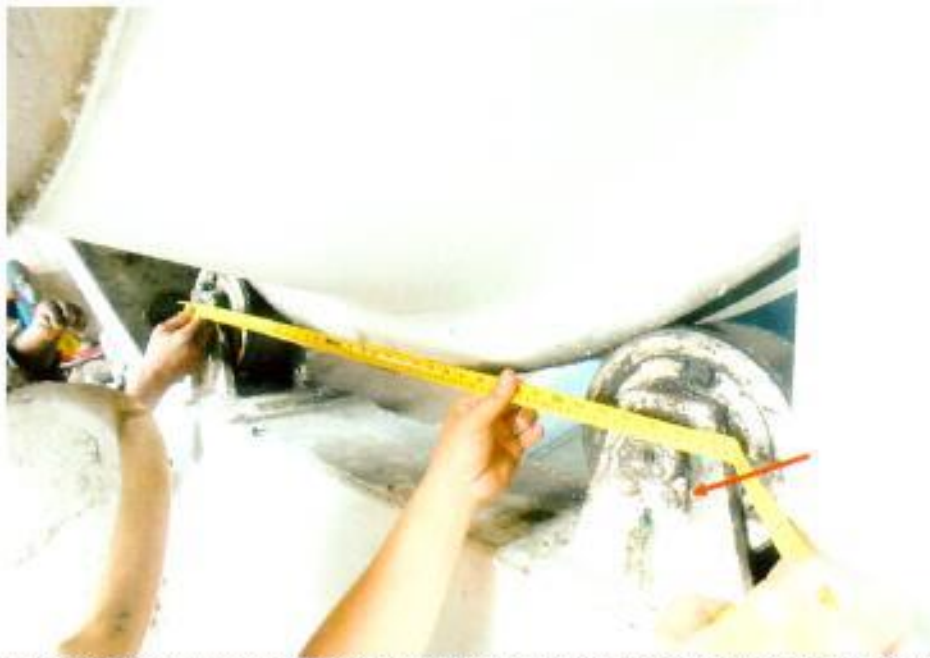
- Zicom (Japan) – 36 inches
 - Cesco (Australia) – 29 inches
 - Gethi (Malaysia) – 32 inches
34. With these findings, we are of the opinion that the roller spacing does not contributes to the incident. The measurement spacing of the rollers from the Insured Vehicle was found to be in a range of slight difference with other drum roller manufacturer.

Photo 19 shows a measurement on the roller spacing for ZICOM manufacturer. It was measured as 36 inches from centre to centre of the 02 rollers.
