Auto
Consultants
Pte Ltd

07th March 2018

M/s MSIG Insurance (Singapore) Pte. Ltd.
16 Raffles Quay #24-01
Hong Leong Building
Singapore 048581
(Motor Claims Department)

TECHNICAL FAULT ANALYSIS INVESTIGATION REPORT INVOLVING THE CEMENT MIXER TRUCK WC 8911E ON 04th FEBRUARY 2018

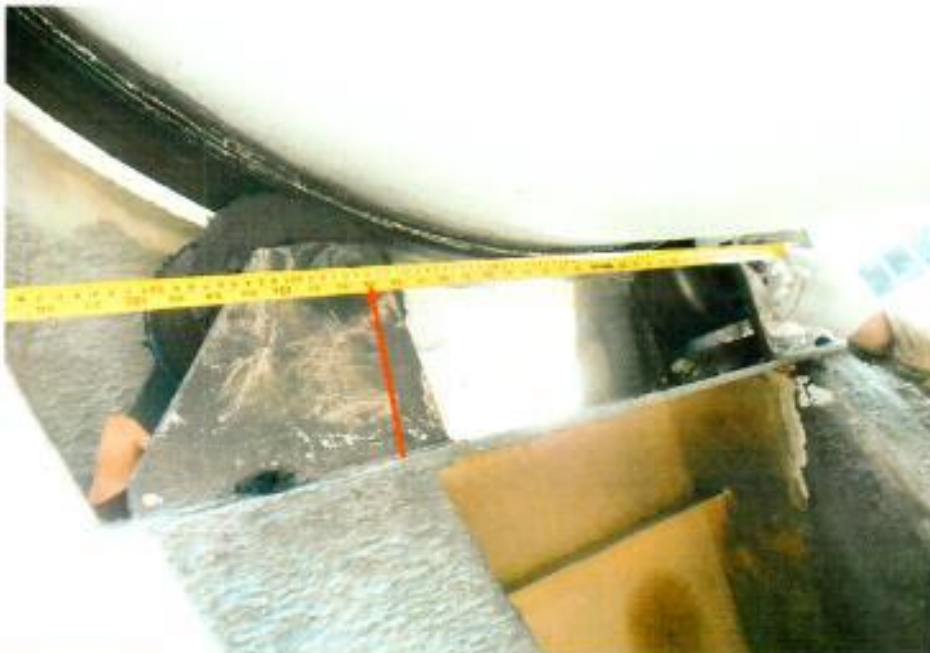
Photo 19 shows a measurement on the roller spacing for CESCO manufacturer. It was measured as 29 inches from centre to centre of the 02 rollers.

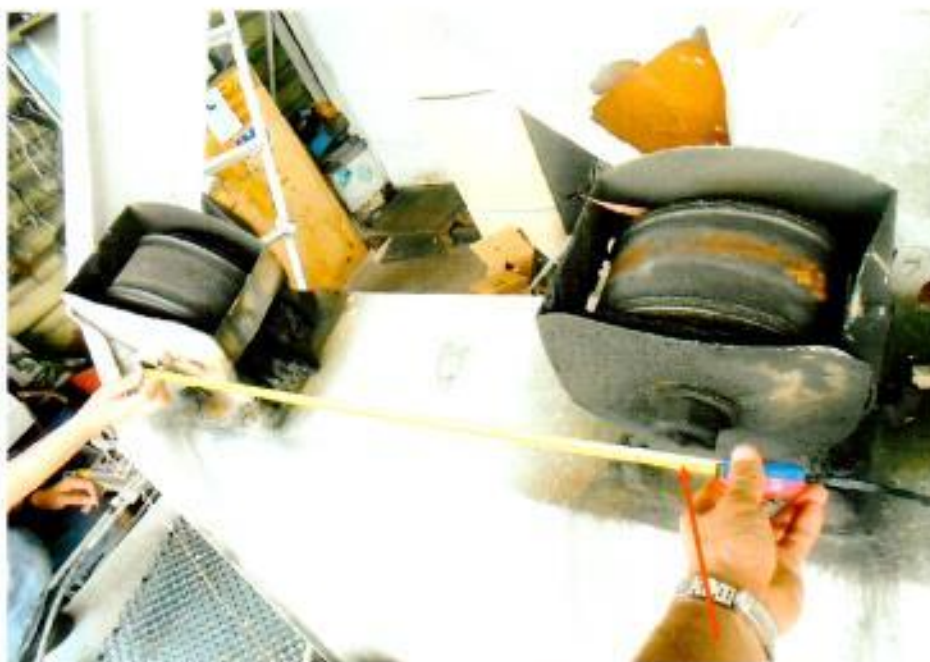
Photo 19 shows a measurement on the roller spacing for GETHI manufacturer. It was measured as 32 inches from centre to centre of the 02 rollers.

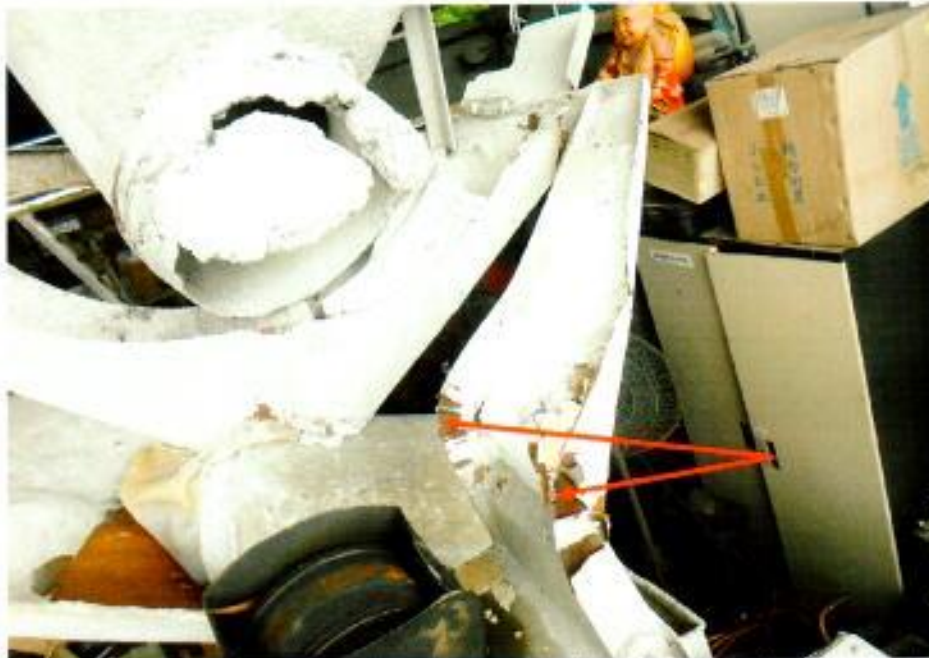
37. Given the circumstances of incident as reported, the other possibilities of the cause of dislodged cement mixer drum from the Insured Vehicle being due to the material failure that causes weaken supports on the structure would seem likely given that on further investigation to the damaged structure, we found that the bent on the frame structure was in a corroded condition. The corrosion was however covered with thick layers of paint.
38. It was believed that the possibility of the dislodged cement mixer drum was from a material failure which was from a corroded support frame for the purpose of supporting the cement mixer drum. The corrosion (rust) had weakened the material/tensile strength of the support frame over a period of time, ultimately causing the support to give way. See photo 44 & 45 below.

Photo 44 shows the material failure that was believed to cause the drum to give way. It was observed to be in a corroded condition.

41. However, having investigated and technically analysed the damages of the incident to the Insured Vehicle, we are of the view that the incident had originated from material failure on the support structure. The cause of the dislodged cement mixer drum from the Insured Vehicle was likely due to a corroded support frame that can't be seen due to a thick paint covering the parts.
42. Our investigations had also revealed that at the time of writing this report, there is no manufacturer recall of mechanical nature to similar make and model vehicle as the Insured Vehicle that may possibly be related to this incident.

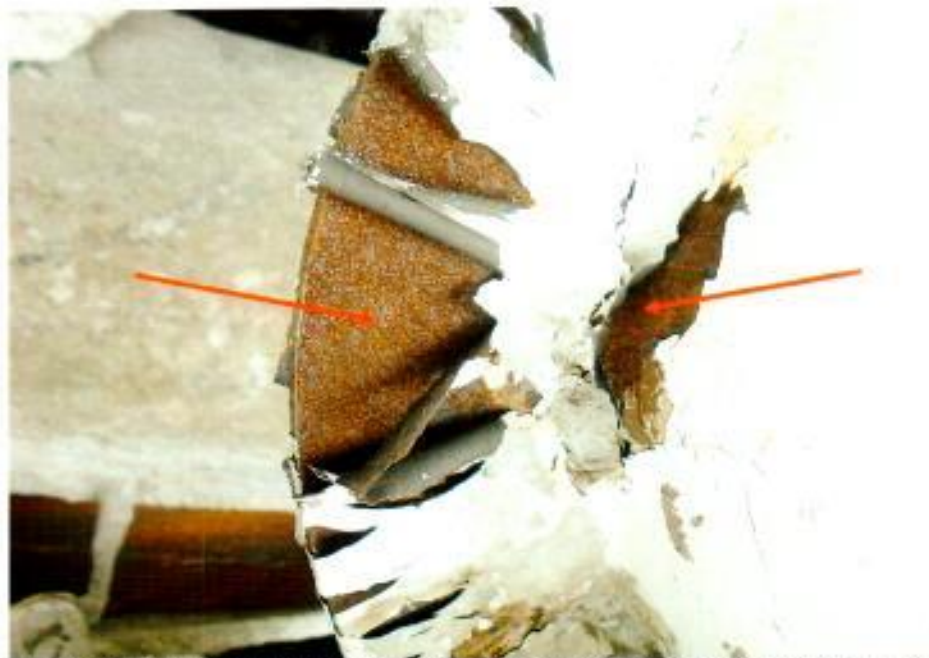
Photo 45 shows the close-up view of the corrosion support frame. It was covered with a thick paint therefore visually we can't see the corroded parts.
