Your Ref : 549528  
Our Ref : CS/MSG18002984/N

25 May 2018

**AUTOMOBILE TECHNICAL INVESTIGATION REPORT OF ACCIDENT  
INVOLVING SFT 4381Y AND SKM 2228Z ON 9 FEBRUARY 2018**

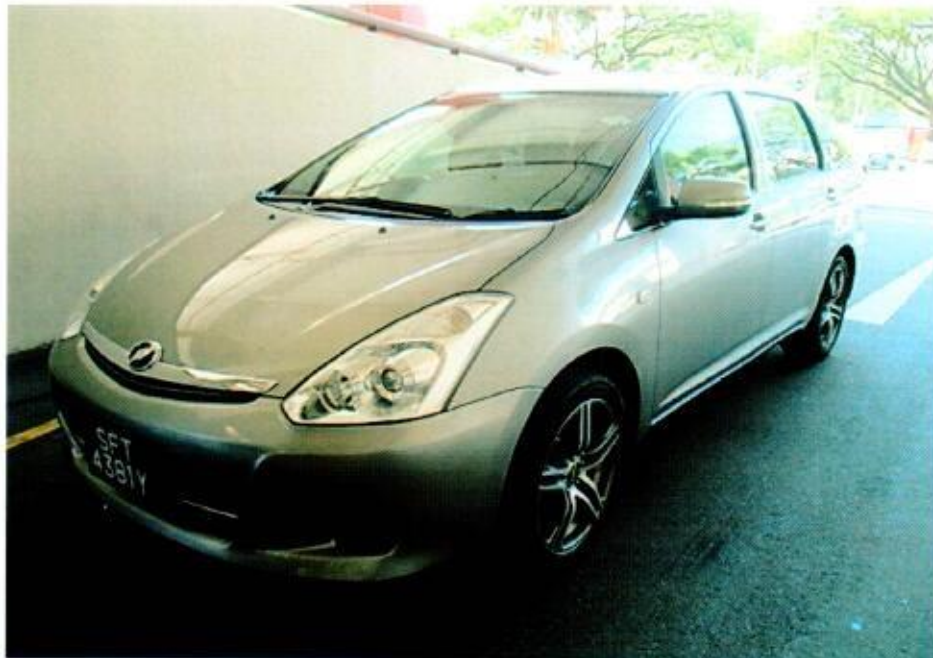
**Photo 1** shows the general left view of the front of the Toyota at the time of our inspection. Its left frontal portion was observed to have sustained relatively minor impact damage, which had affected its front bumper and front number plate.

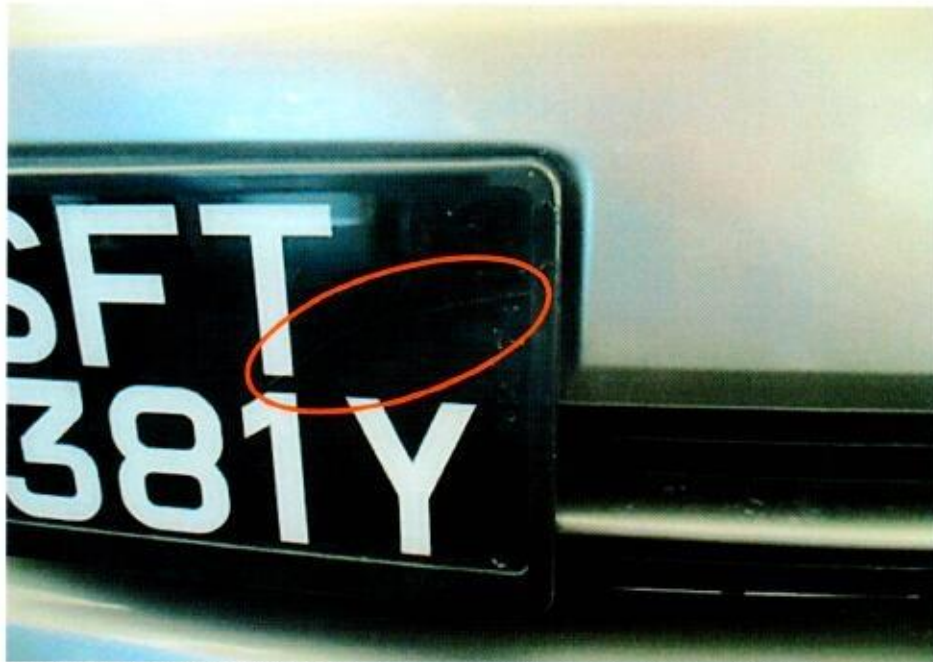
**Photo 2** shows the cracked front number plate of the Toyota (circled). This was towards the left side of the front number plate.

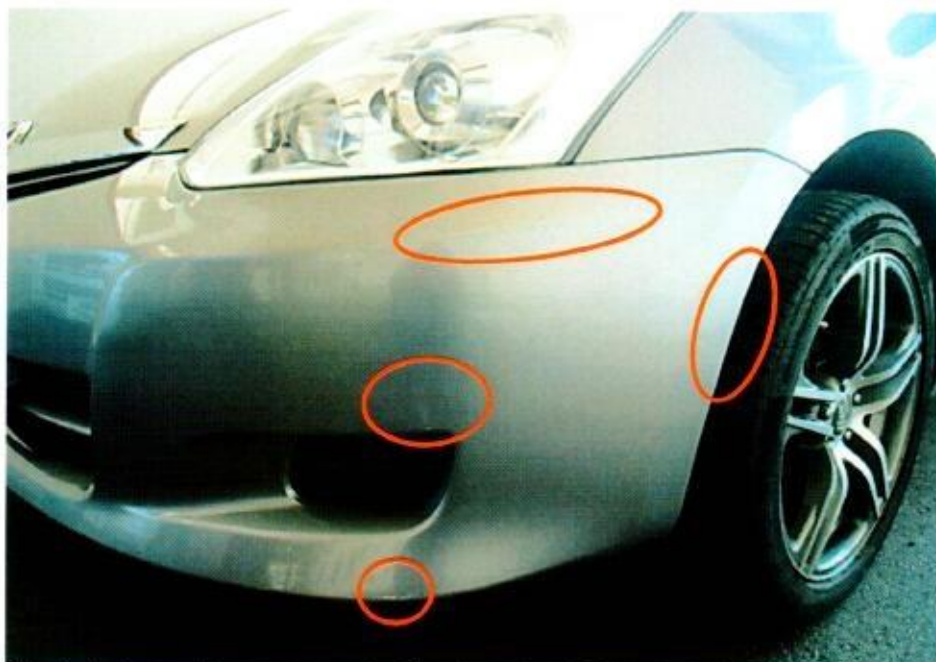
**Photo 3** shows the graze marks found on the left portion of the Toyota's front bumper (circled).

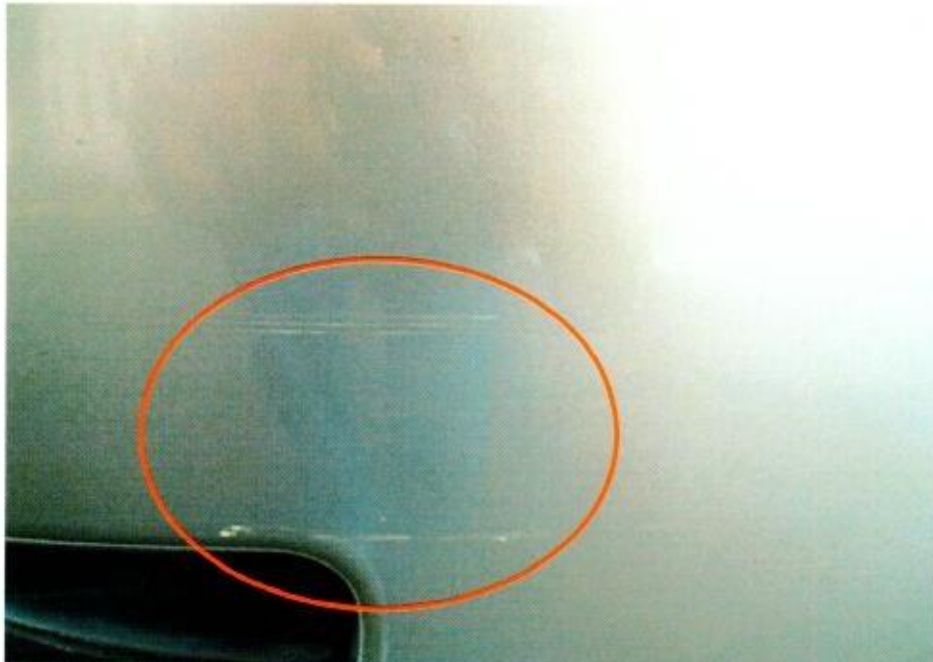
**Photo 4** shows a close up view of the graze marks found on the left portion of the Toyota's front bumper (circled).

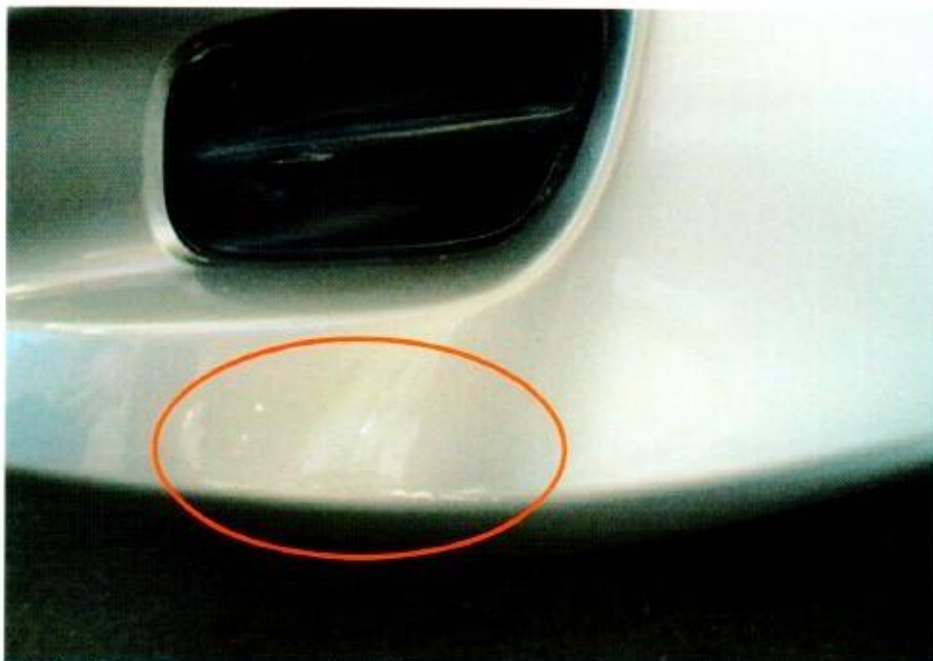
**Photo 5** shows a close up view of the graze marks found on the lower left portion of the Toyota's front bumper (circled).

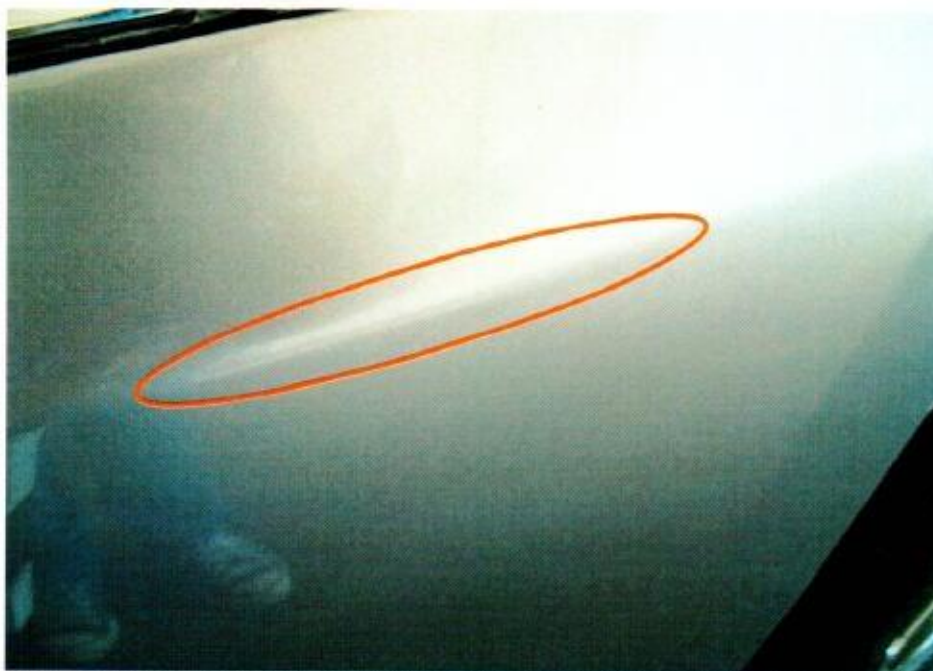
**Photo 6** shows a close up view of the graze marks found on the left portion of the Toyota's front bumper (circled).

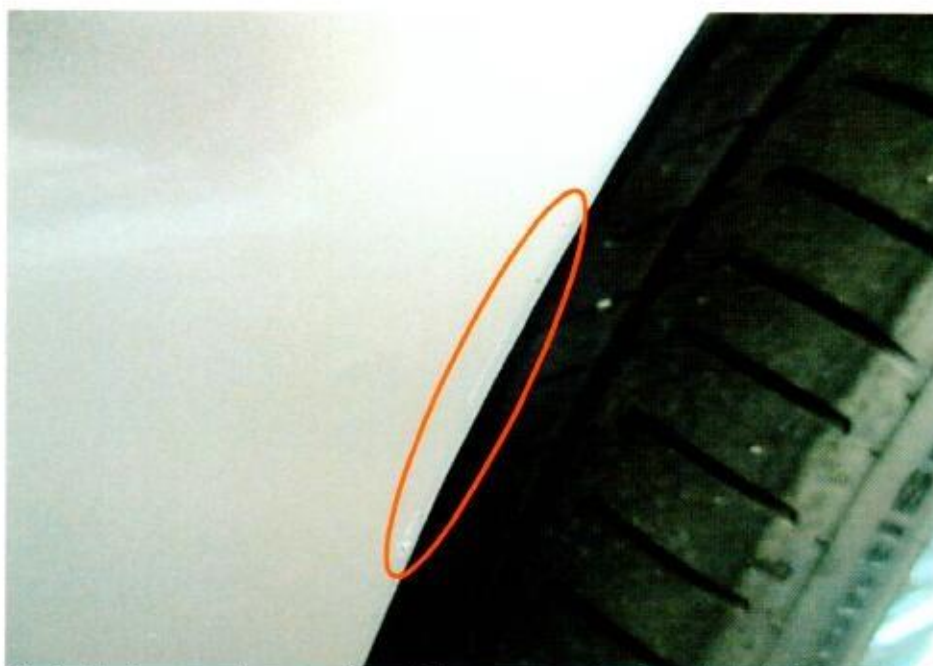
**Photo 7** shows a close up view of the graze marks found on the Toyota's left front tyre fender (circled).

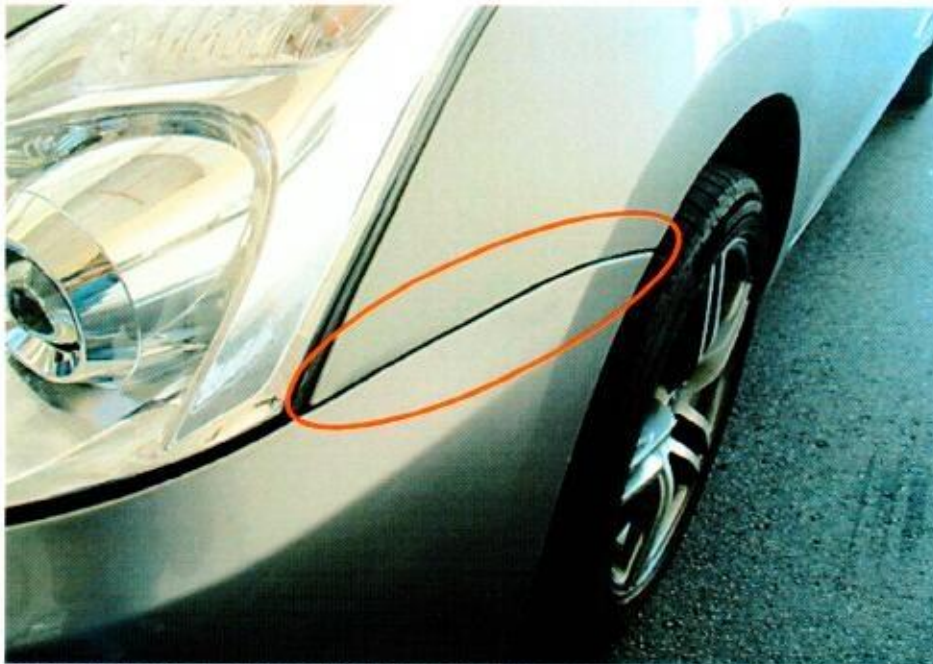
**Photo 8** shows no obvious misalignment at the corner edges of the Toyota's front bumper, adjacent to its front left fender (circled). This would indicate that the impact onto the frontal portion of the Toyota was relatively light.

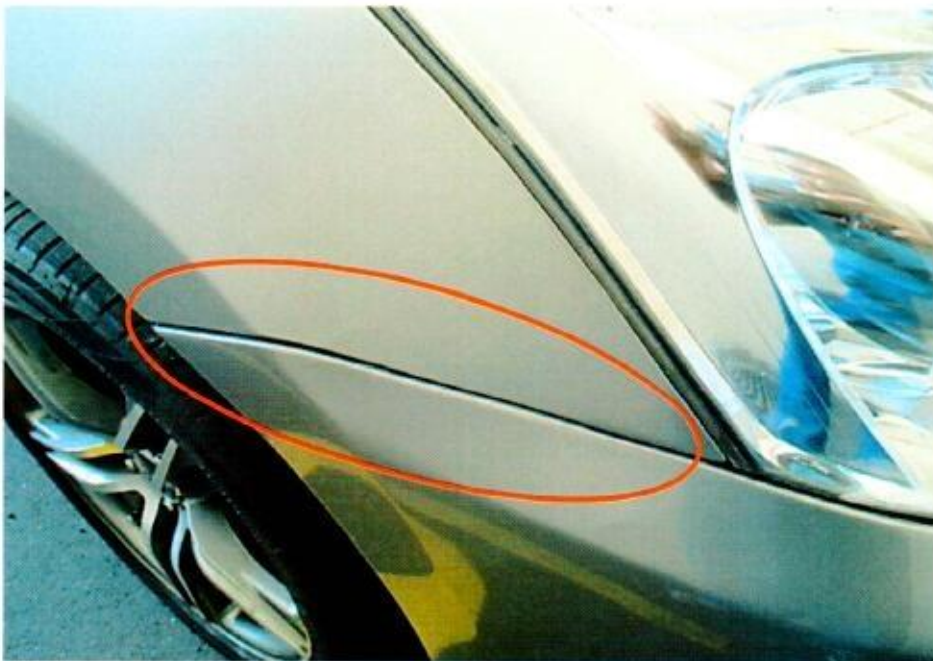
**Photo 9** shows no obvious misalignment at the corner edges of the Toyota's front bumper, adjacent to its front right fender (circled). This would indicate that the impact onto the frontal portion of the Toyota was relatively light.

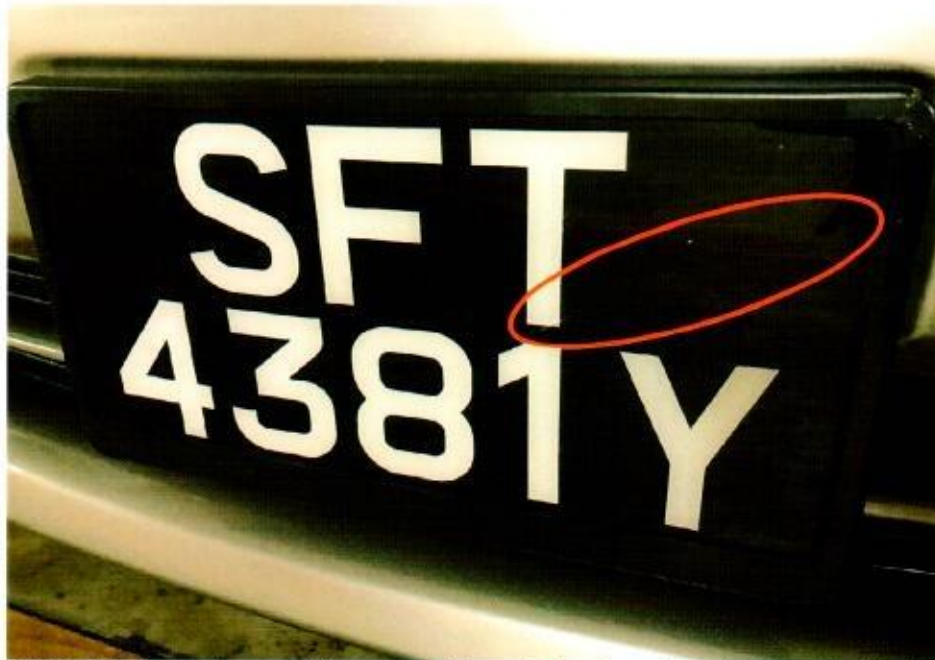
**Photo 10** shows the condition of the Toyota's front number plate as depicted in the photographs that were taken by the witness post- accident. The same crack towards the left side of the front number plate was observed (circled).

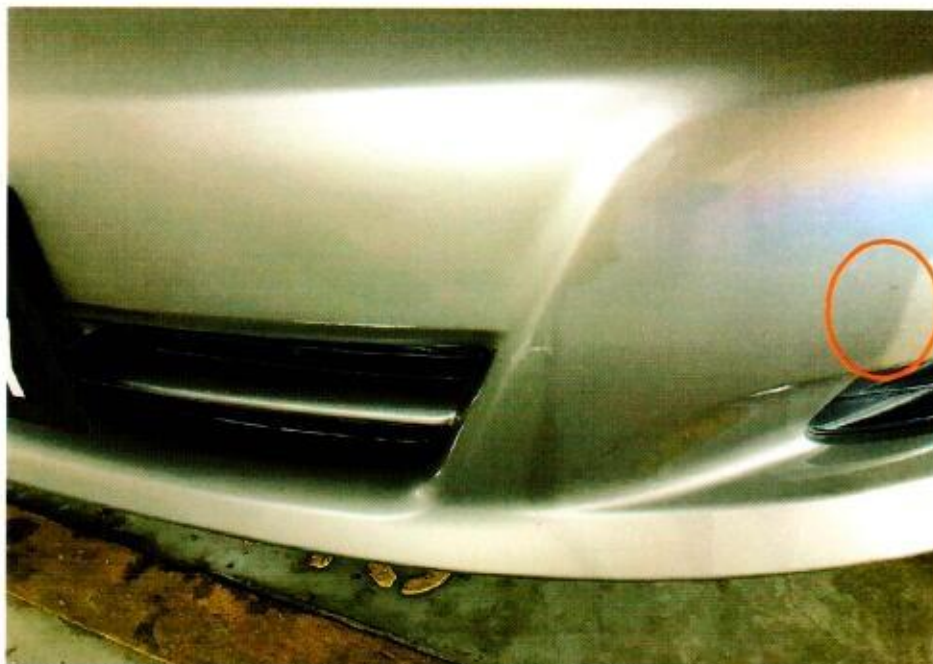
**Photo 11** shows the condition of the Toyota's front bumper as depicted in the photographs that were taken by the witness post- accident. The same graze marks on the lower left portion of the front bumper were observed (circled).

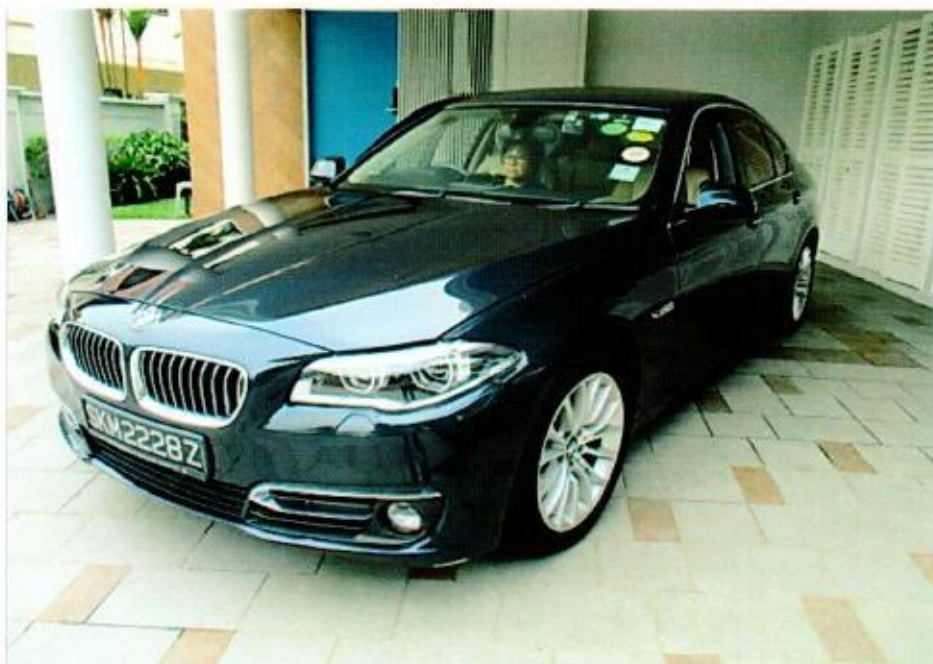
**Photo 12** shows the general left view of the front of the BMW at the time of inspection. Its front portion was observed to have sustained relatively minor impact damage, which had affected its front bumper only.

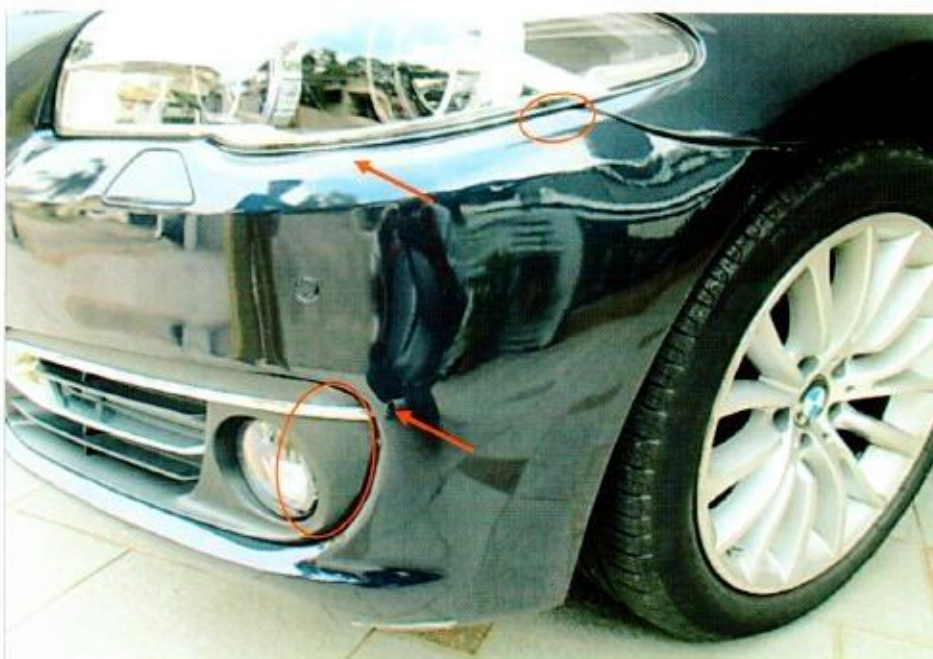
**Photo 13** shows upon closer inspection, we note that there were graze marks on the left portion of the front bumper as well as on the left fog lamp cover (circled). We also found relatively minor paint cracks on the left portion of the front bumper, adjacent to the left fog lamp cover as well as below the left headlight (arrowed).

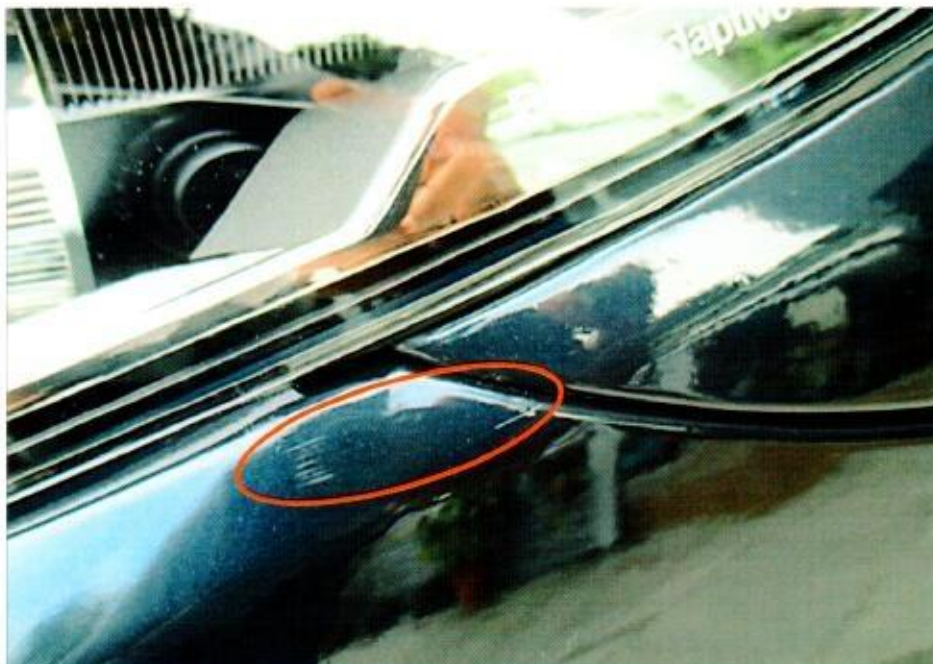
**Photo 14** shows a close up view of the graze marks found on the left portion of the front bumper (circled).

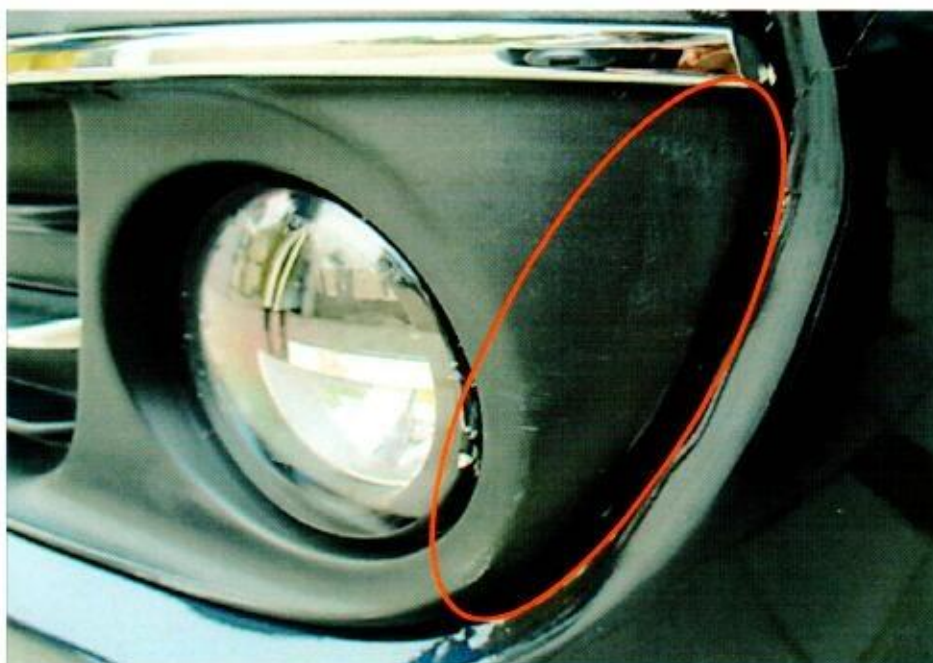
**Photo 15** shows a close up view of the graze marks found on the left fog lamp cover of the BMW (circled).

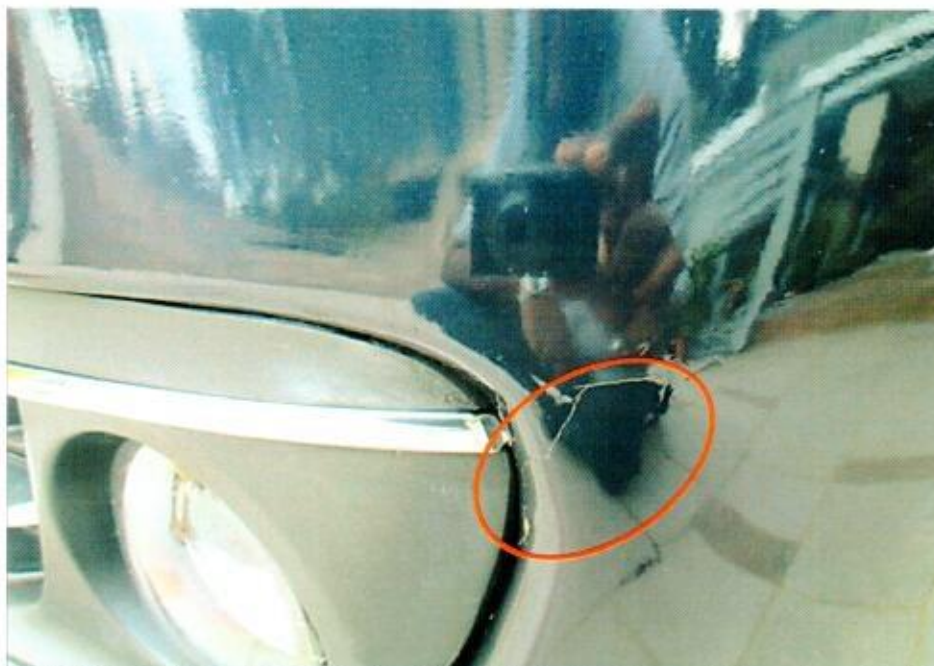
**Photo 16** shows a close up view of the relatively minor paint crack on the left portion of the front bumper, adjacent to the left fog lamp cover (circled).

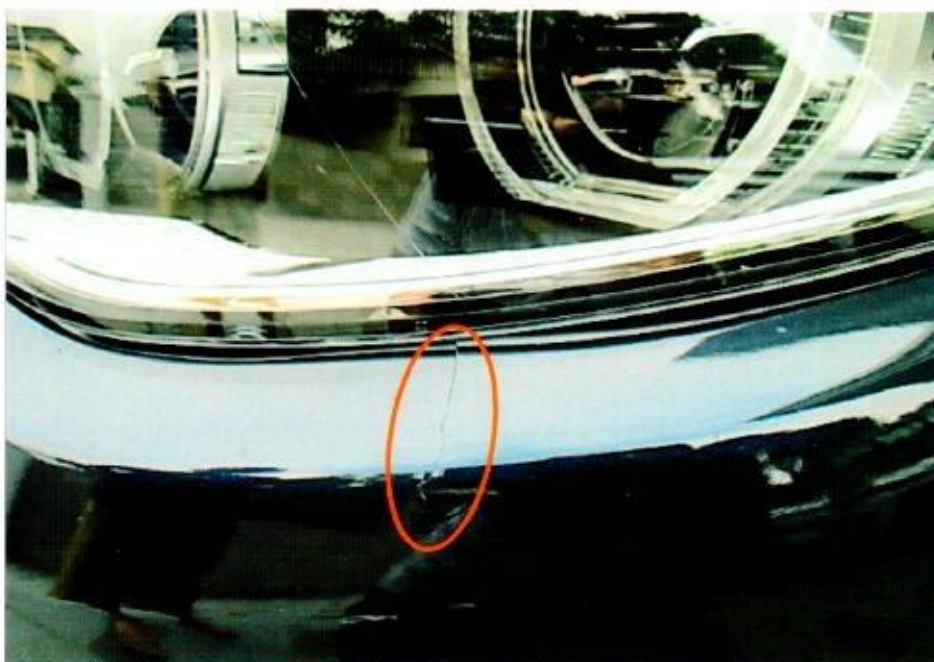
**Photo 17** shows a close up view of the relatively minor paint crack on the left portion of the front bumper, below the left headlight (circled).

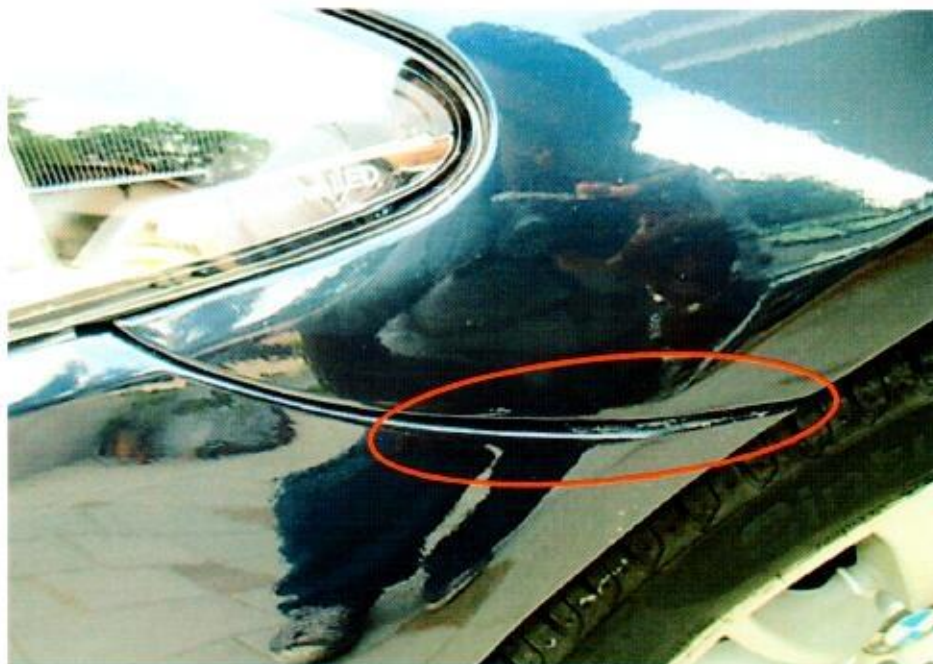
**Photo 18** shows a misalignment at the left corner edge of the BMW's front bumper (circled). The paint cracks on the left portion of the front bumper were a result of load/force pressing onto the front bumper, inwards. This load/force was significant, causing the misalignment.

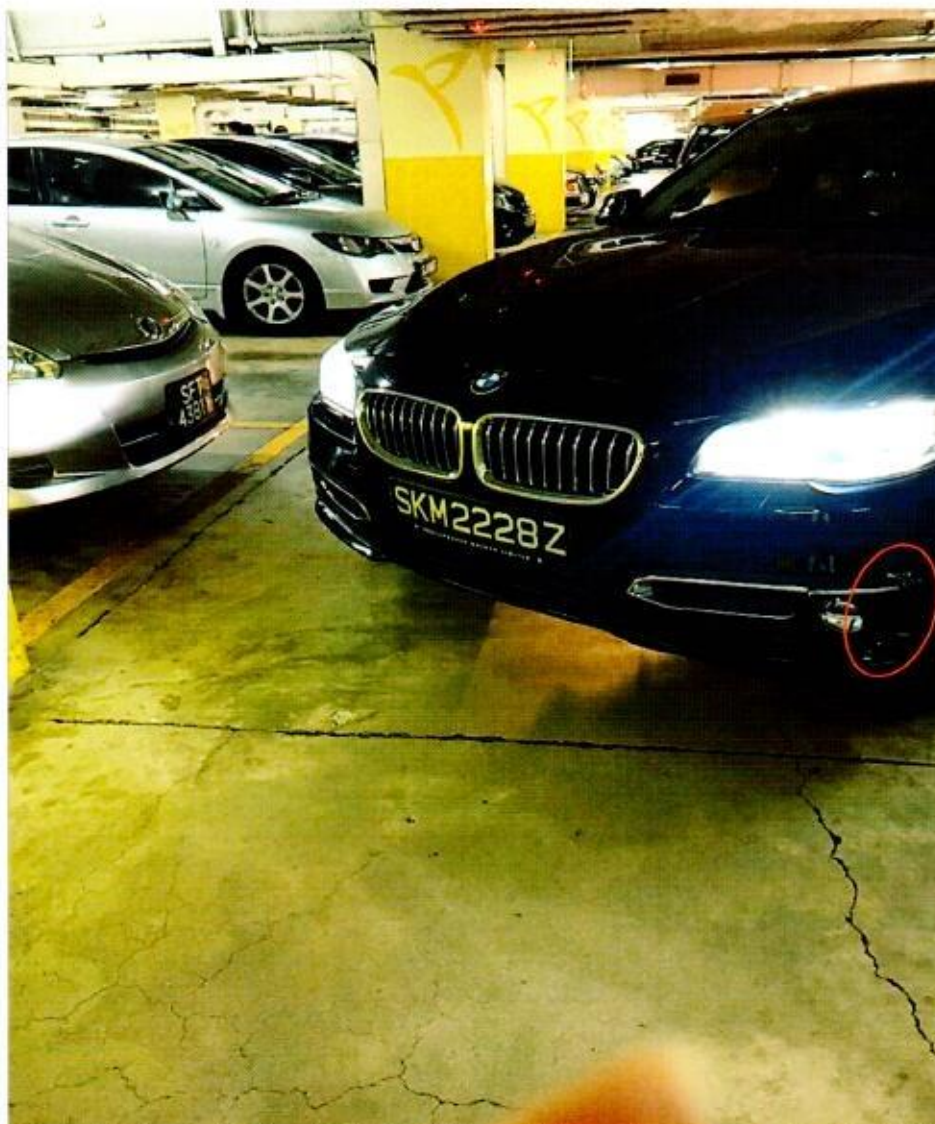
14. For this case, based on the nature of damages to the left front portion of the Toyota, it would appear that the point of contact between the Involved Motor Cars would be the left front portion of the BMW and the left front portion of the Toyota as the BMW was reversing out of the parking lot whilst the Toyota was parked. The impact may have been caused by the left front portion of the BMW grazing against the left front portion of the parked Toyota, causing the graze marks on the left front portion of the Involved Motor Cars.
15. The witness had provided Mr Chan a photograph of the Involved Motor Cars taken at the accident scene after the BMW had reversed out of the parking lot. Upon closer examination of the accident scene photograph, we noticed the same graze marks on the lower left portion of the BMW that we observed during our physical inspection. See photo 19 below.

**Photo 19** shows the Involved Motor Cars at the accident scene after the BMW had reversed out of the parking lot. Upon closer examination, we noticed the same graze marks on the lower left portion of the BMW's front bumper that we observed during our physical inspection (circled)

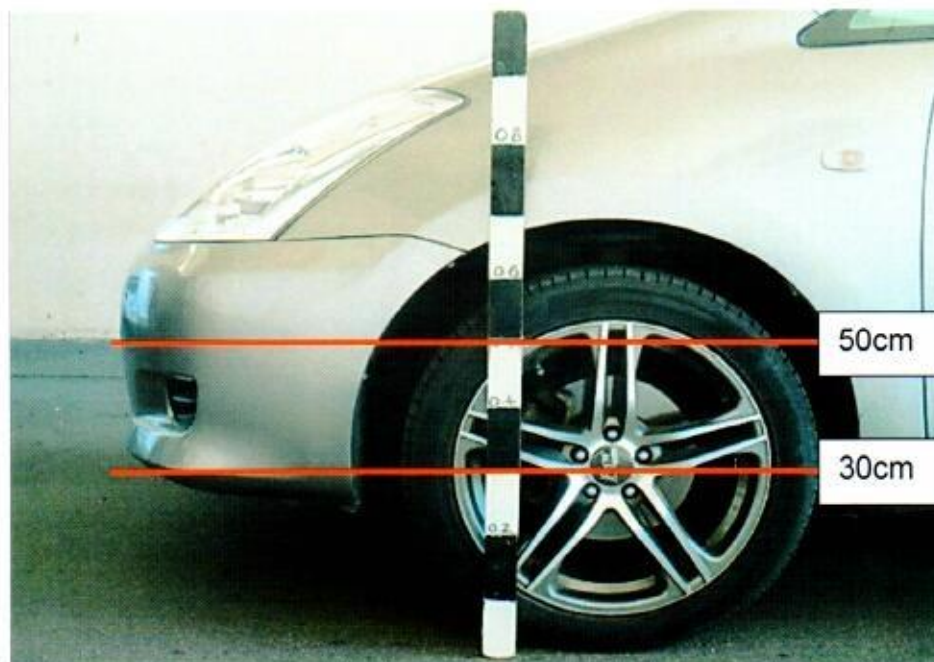
**Photo 20** shows the height measurement being conducted on the left front portion of the Toyota. The graze marks on the left front portion of the Toyota were between the height ranges of 30cm to 50cm above ground level.

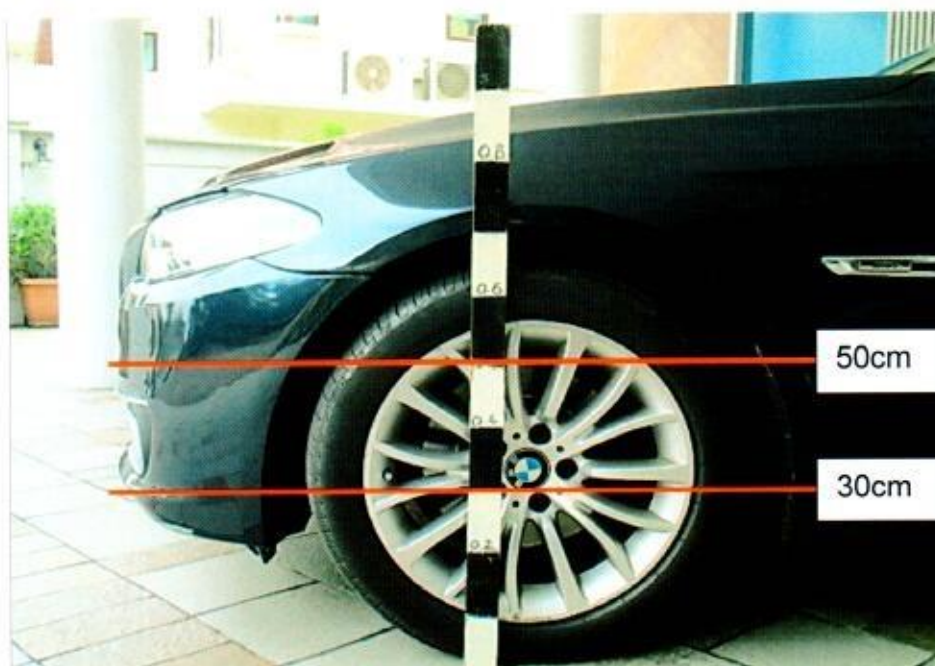
**Photo 21** shows the height measurement being conducted on the left front portion of the BMW. The paint graze marks on the left portion of the front bumper and paint crack adjacent to the left fog lamp cover of the BMW are within the 30cm to 50cm range.
