Your Ref: 549458
Our Ref : CS/MSG18002989/Z

21st February 2018

TECHNICAL INVESTIGATION REPORT OF FIRE INCIDENT INVOLVING THE MOTOR VEHICLE GBC 1145U ON 09th FEBRUARY 2018

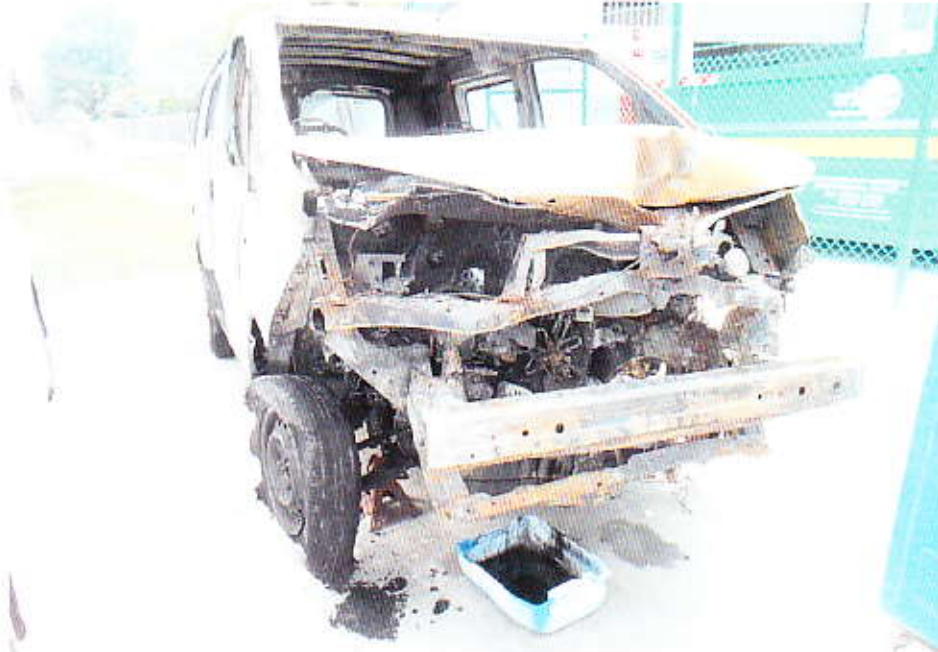
Photo 1 shows the front view of the Insured Vehicle at the time of our inspection. The Insured Vehicle was noted to have sustained fire damages that severely effected on most parts of the Insured Vehicle.

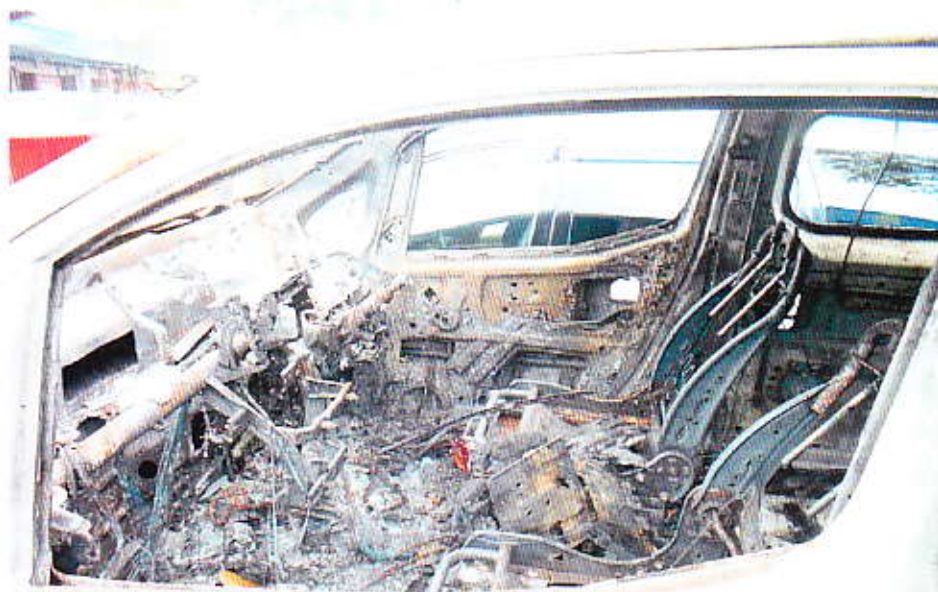
Photo 2 shows the interior view of the Insured vehicle, it was observed to have sustained with severe damages due to the fire.

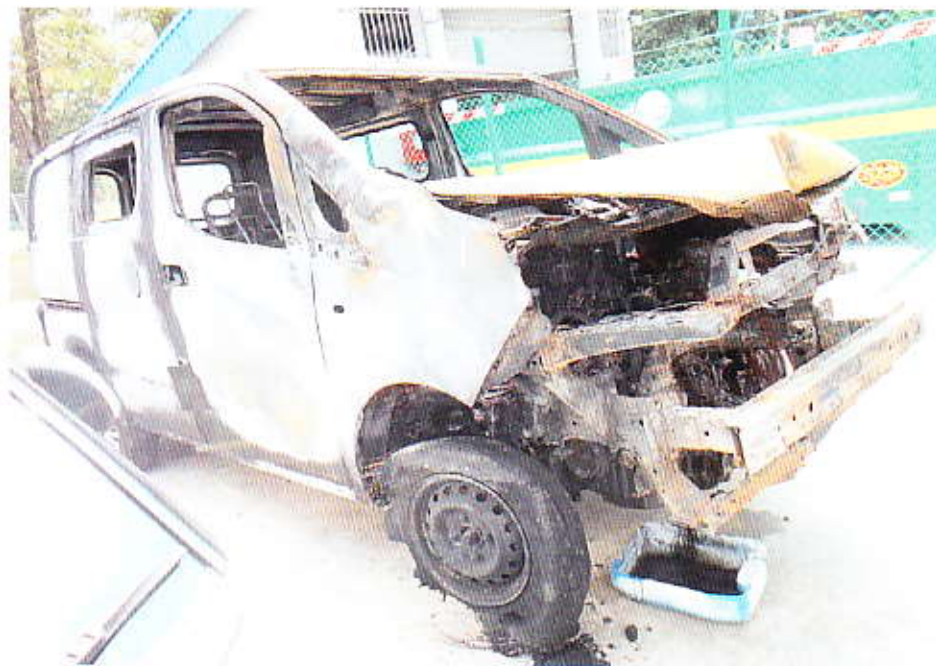
Photo 3 shows the right side of the Insured Vehicle at the time of our inspection. The Insured Vehicle was noted to have sustained fire damages that severely effected on most parts of the Insured Vehicle.

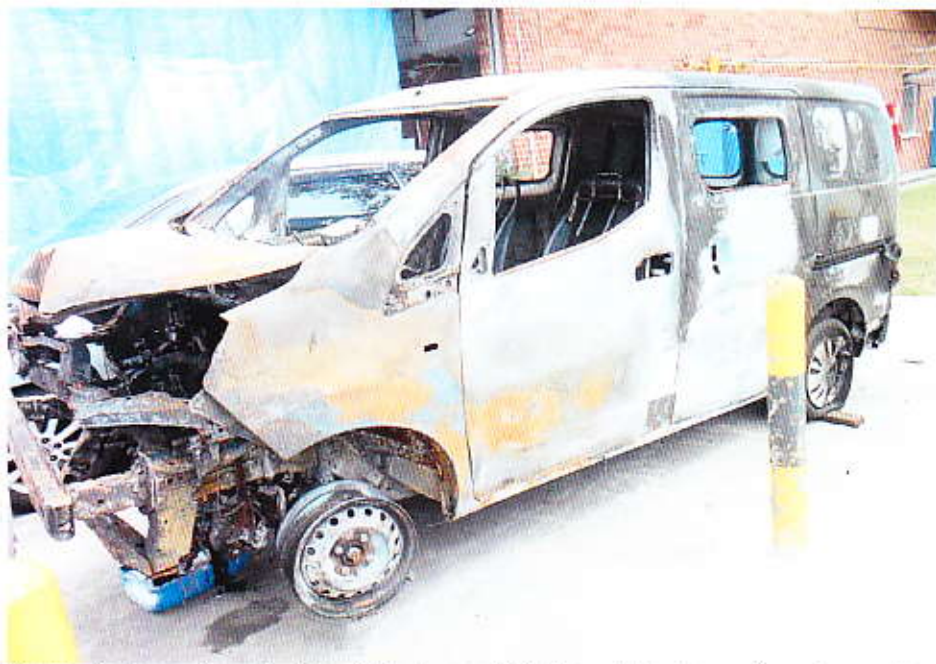
Photo 4 shows the left side of the Insured Vehicle at the time of our inspection. The Insured Vehicle was noted to have sustained fire damages that severely effected on most parts of the Insured Vehicle.

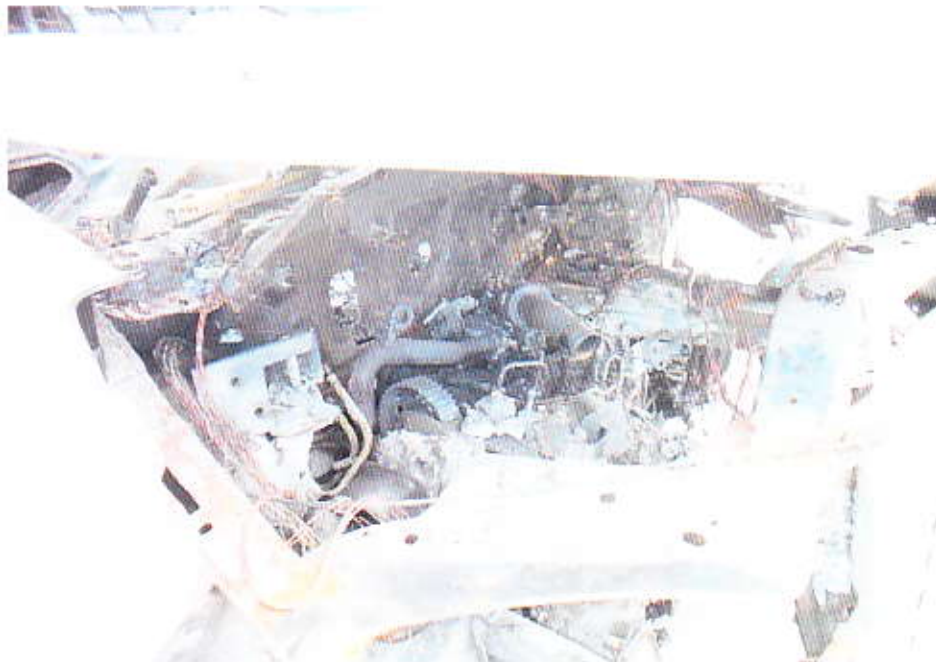
Photo 5 shows the engine compartment of the Insured Vehicle at the time of our inspection. The fire damages the entire engine compartment.

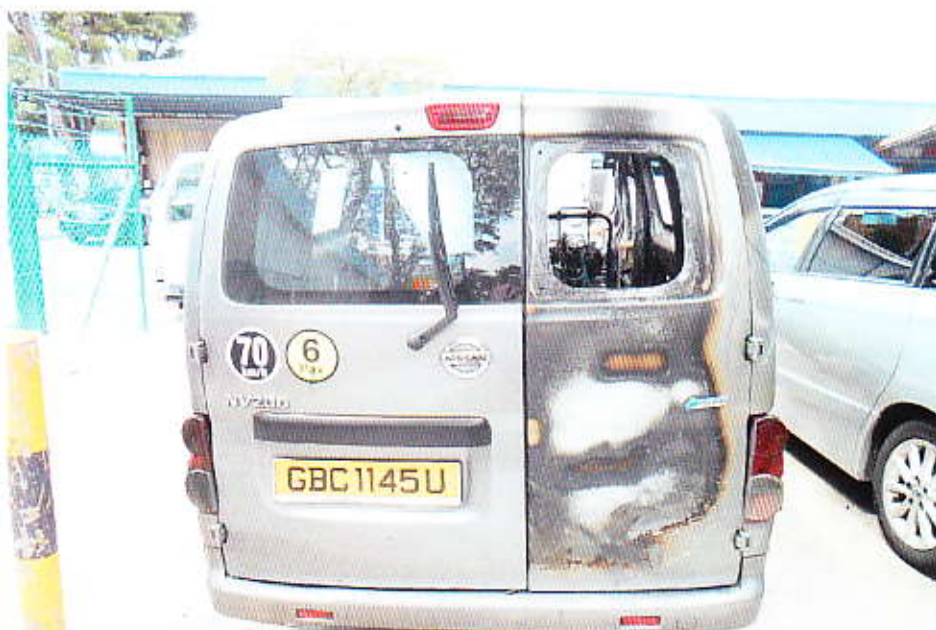
Photo 6 shows the rear portion of the Insured Vehicle at the time of inspection. Only the left hand rear door was unaffected by the fire.

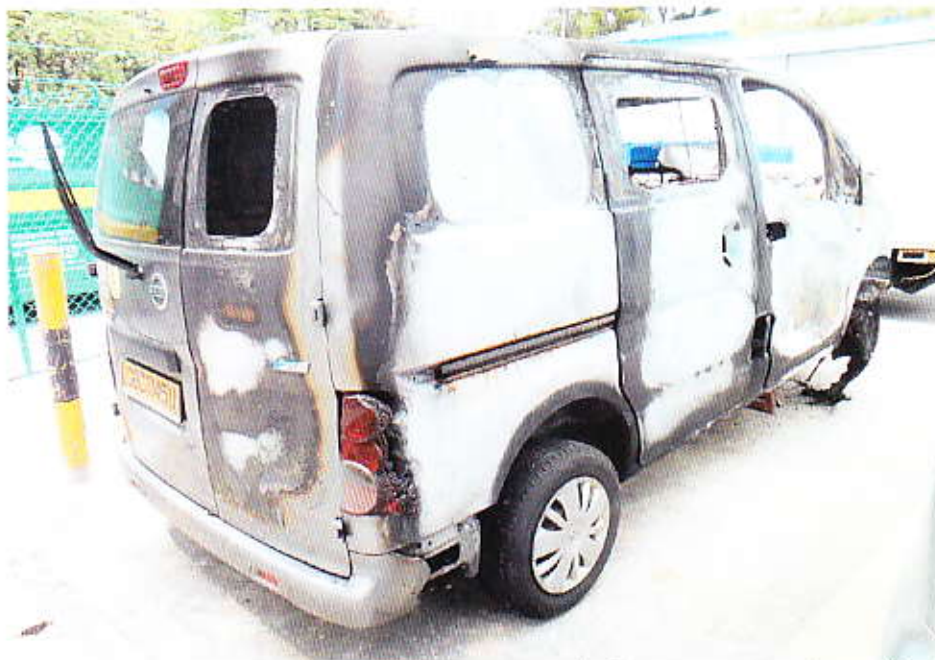
6. The whitish burn marks are a result of exposure to prolonged heat intensity. Rust would normally start to develop around these areas soon after a fire as prolonged exposure to high heat intensity usually causes steel/metal material body parts to be exposed to natural environmental condition. The rust that had developed on the Motor Vehicle is an indication that it had sustained exposure to prolonged high heat intensity. See photo 7 below.

Photo 7 shows the whitish burn marks are a result of exposure to prolonged heat intensity. Rust would normally start to develop around these areas soon after a fire as prolonged exposure to high heat intensity usually causes steel/metal material body parts to be exposed to natural environmental condition. The rust that had developed on the Motor Vehicle is an indication that it had sustained exposure to prolonged high heat intensity.

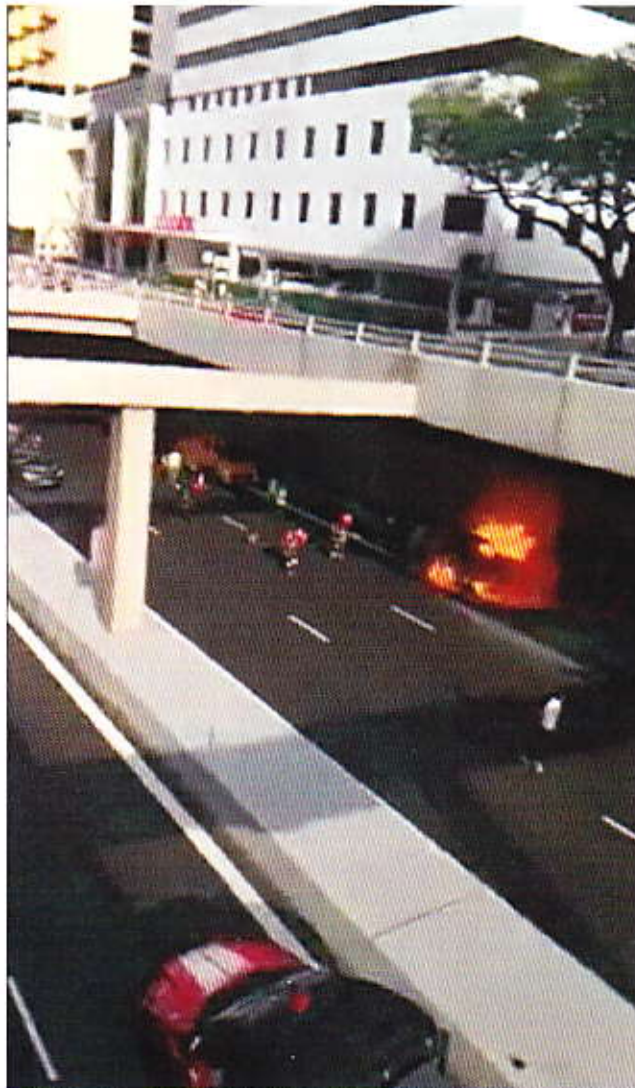
Photo 14 shows the fire incident along AYE tunnel before Outram Road exit. SCDF officers seen extinguishing the fire.

20. Other aspect that we could gather was the photograph that shows the Insured Vehicle at time of the fire incident at the incident location. The fire pattern was seen to be engulfing from the front portion of the Insured Vehicle. With reference to the photograph, there's evidence to say that the fire started from the front portion looking at the fire damages on the sidewall of the tunnel. The information given by Mr Lim also corresponds to the fire incident. See photo 14 above.

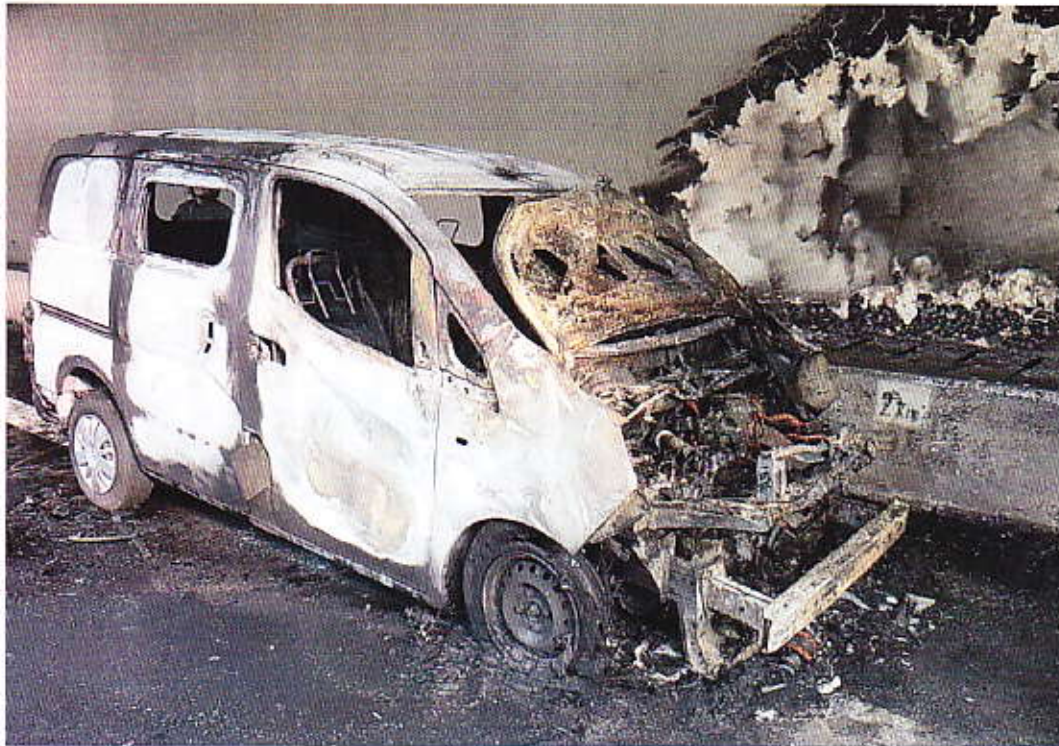
Photo 15 shows a general view of the Motor Vehicle's condition after the fire was extinguished. The fire burnt pattern mark was observed to be from the front portion.

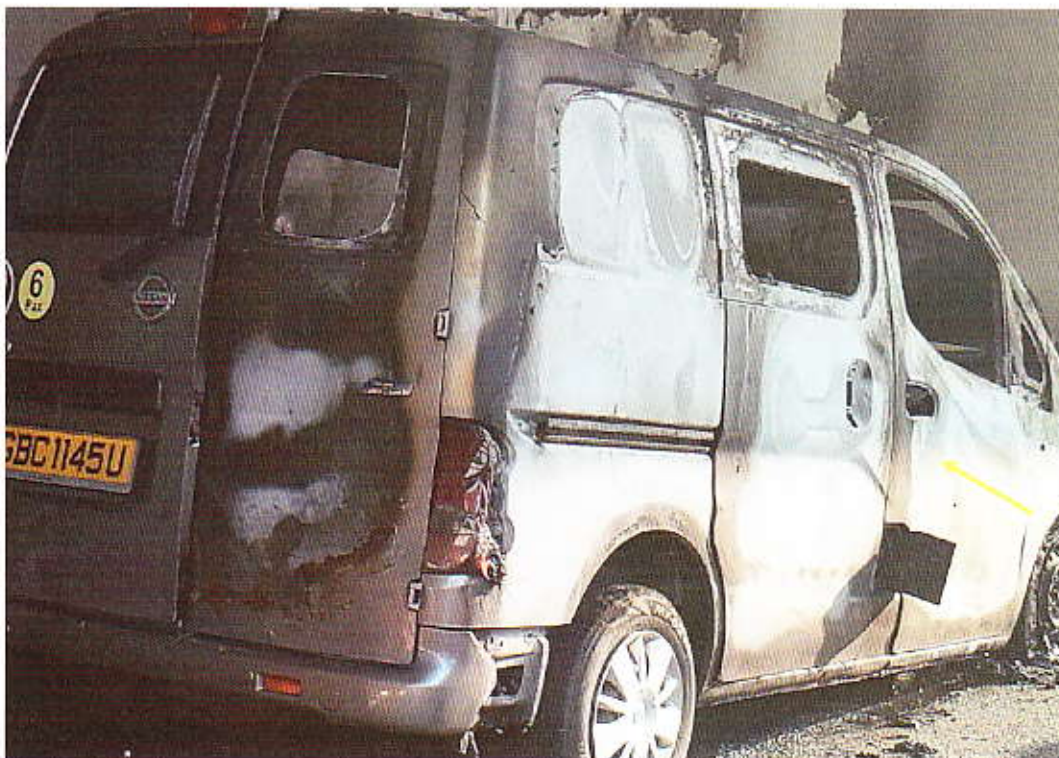
Photo 16 shows a general view of the Motor Vehicle's condition after the fire was extinguished.

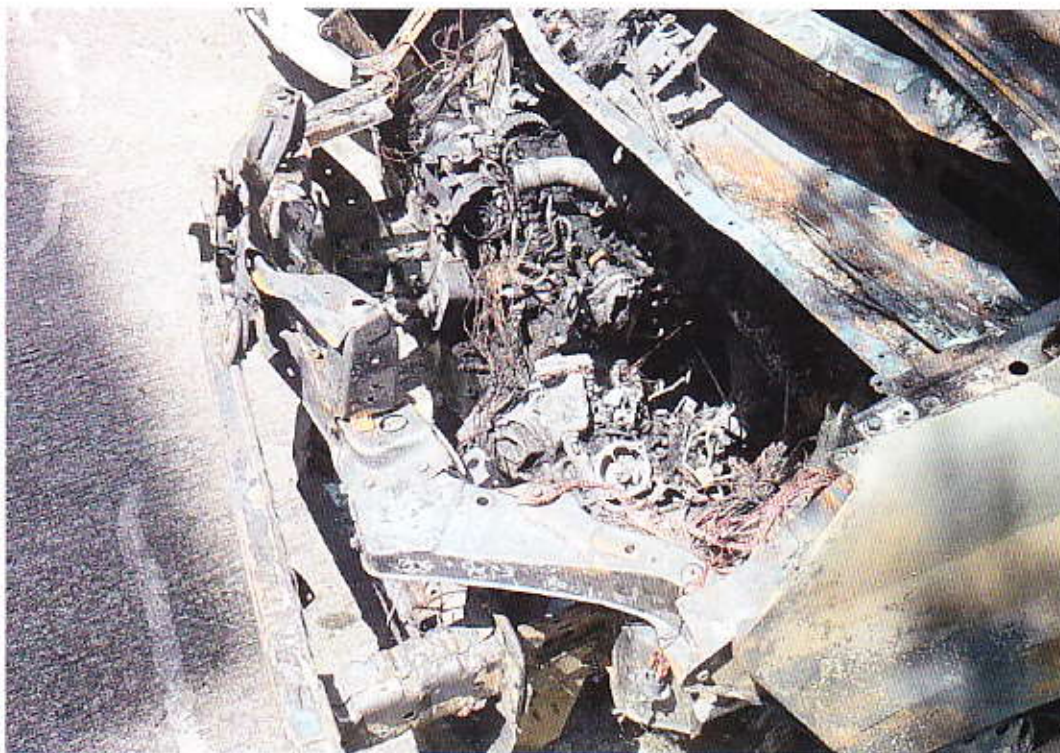
Photo 18 shows a close-up view of the burnt engine compartment after being towed.

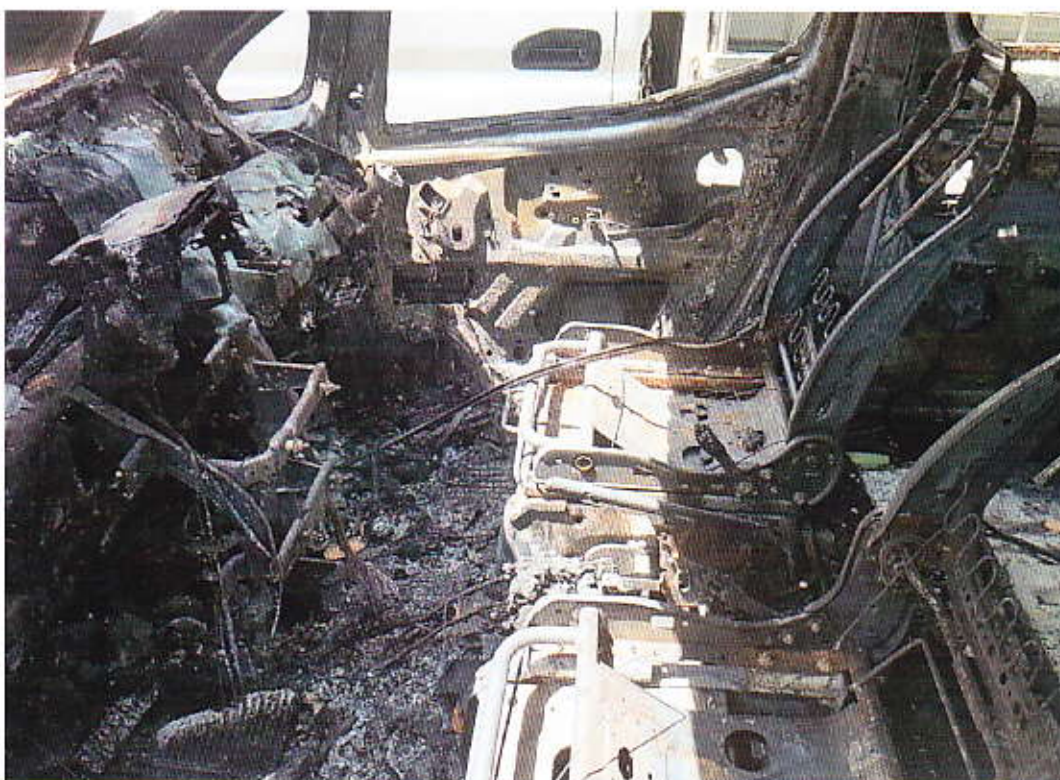
Photo 19 shows a close up view of the burnt interior compartment after being towed.

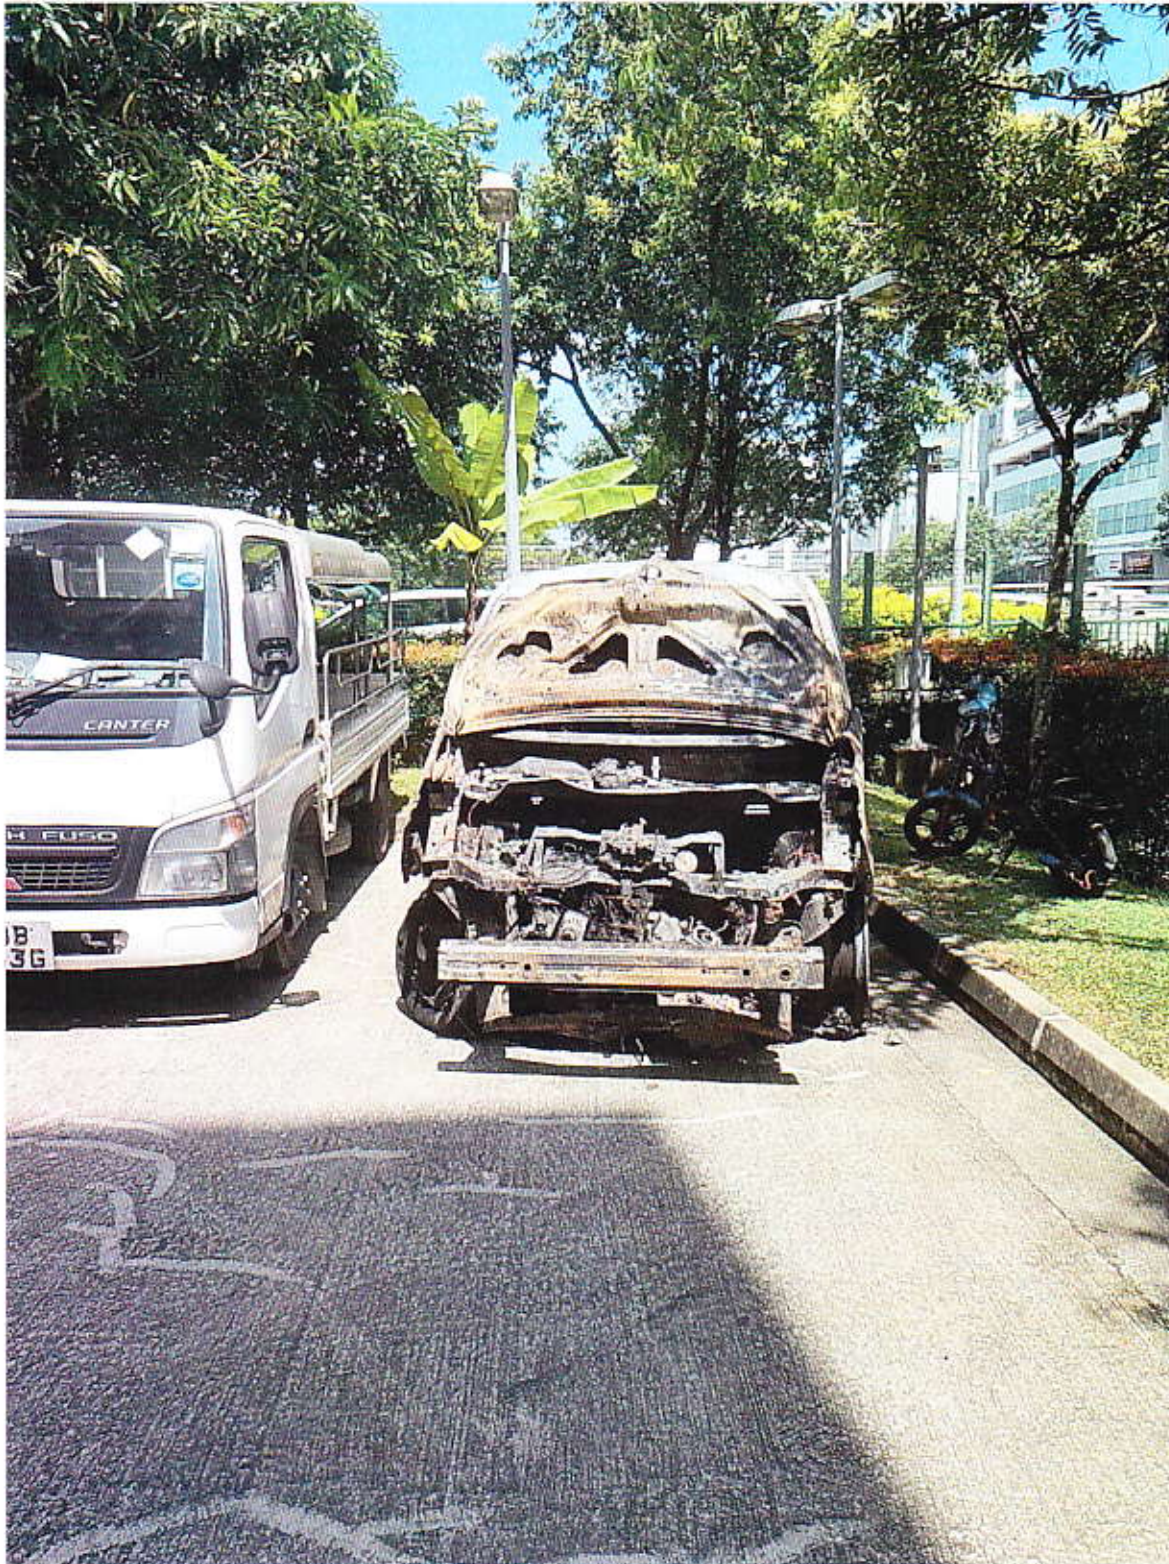
Photo 20 shows a general view of the burnt Motor Vehicle compartment after being towed.
