Your Ref: D/20180111/0006
Our Ref : CI/SPF18003083/D

Violence Against Persons Squad

CLARIFICATION REPORT

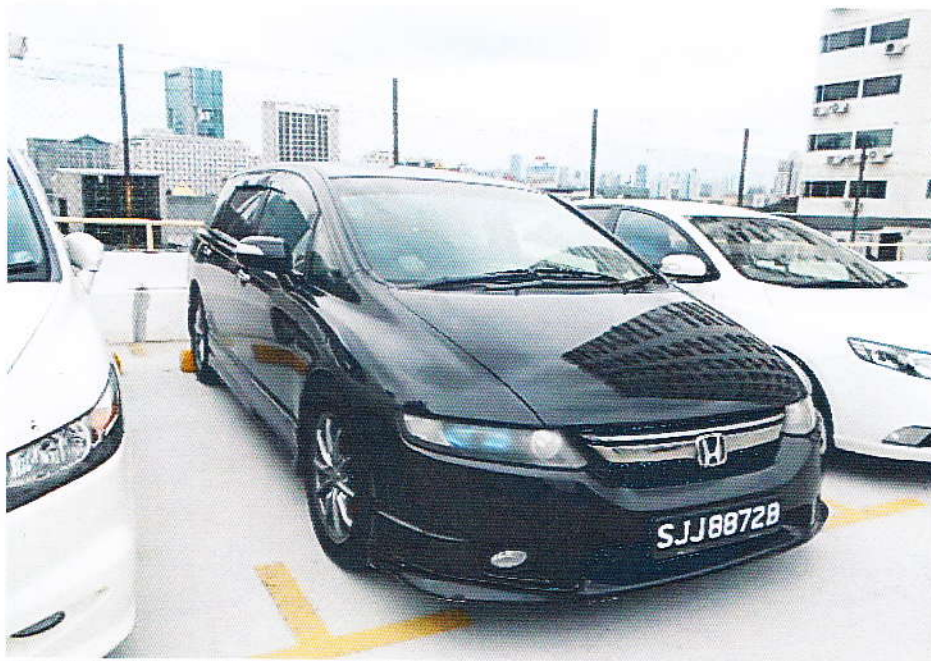
Photo 1 shows a general view of the motor car at the time of my inspection on 07 February 2018.

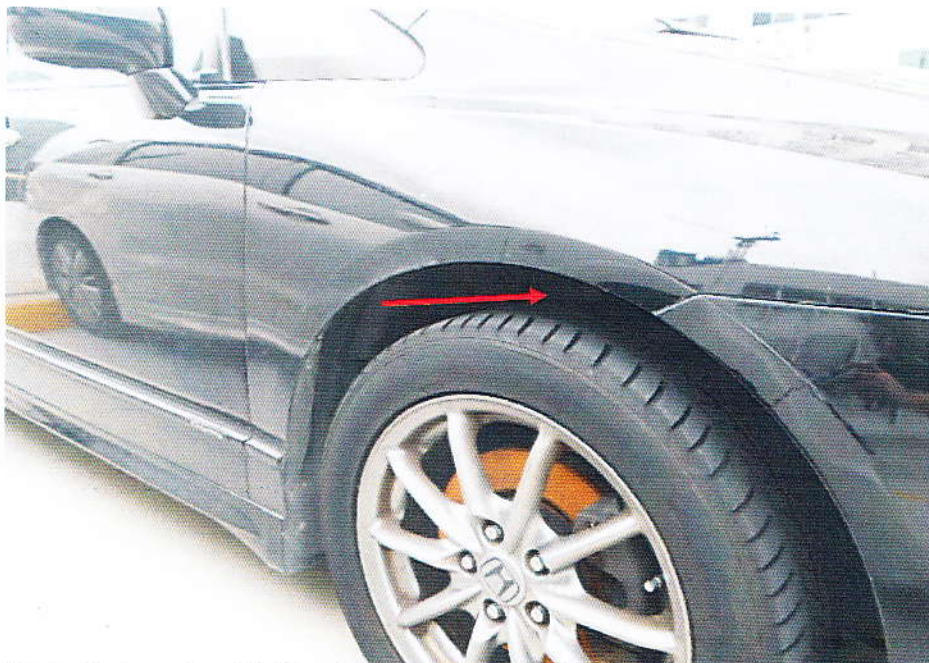
4. The location of where the wire was cut is shown in the below photographs that were taken during my inspection of the motor car. From the photographs, it can be seen that the cut wire is located between the top of the tyre and the bottom of the front right fender/body panel of the motor car. The wire is visible if one was to kneel or bend down, adjacent to the front right tyre. A person's hand can easily touch the wire, at the stretch where it was cut. See photo 1 – 4 below.

Photo 2 shows the right front of the motor car. The cut wire was located between the top of the tyre and the bottom of the front right fender/body panel of the motor car, at the area indicated by the red arrow.

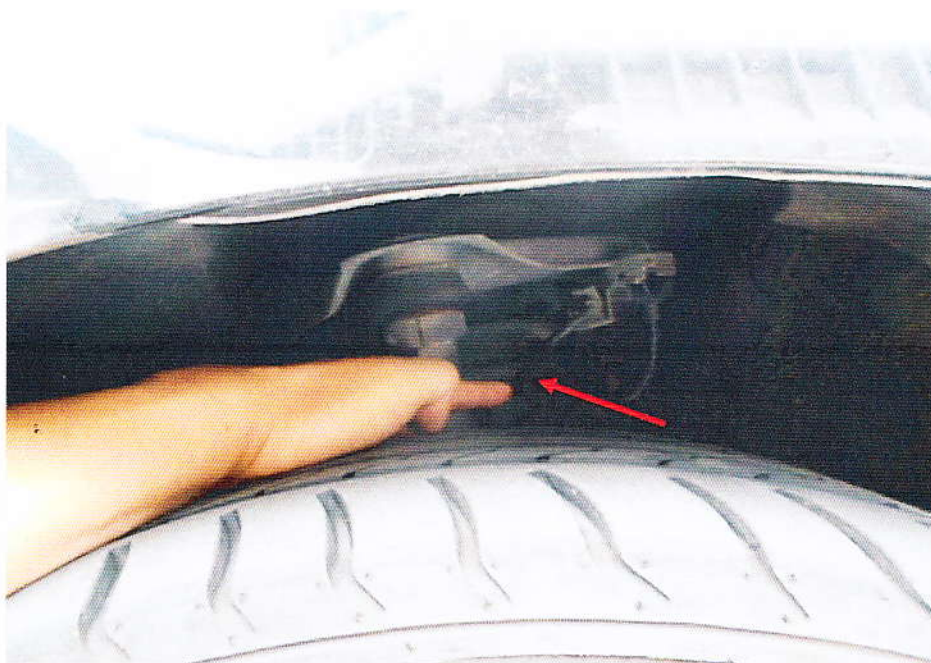
Photo 3 shows the cut wire, at the stretch where it was cut (arrowed). The wire is visible if one was to kneel or bend down at the front right tyre. I was also able to easily extend my hand to touch the wire, at the stretch where it was cut.

5. As observed during my inspection of the motor car and shown in the photographs above, a person can easily see and cut the sensor wire for the motor car's anti-lock brake system.

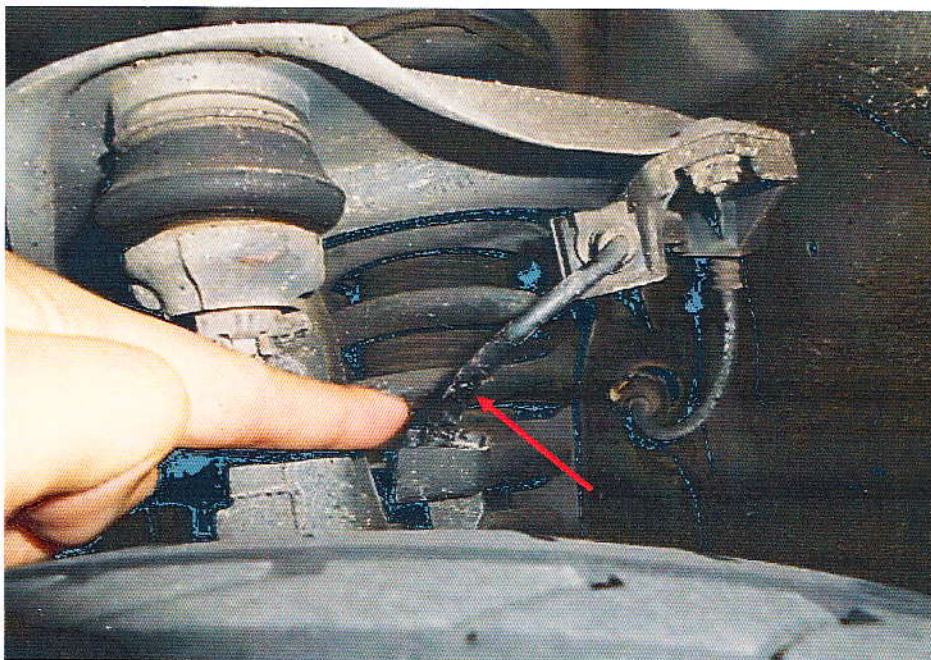
Photo 4 shows the cut wire, at the stretch where it was cut. I was able to easily extend my hand to touch the wire, at the stretch where it was cut. Black tape (arrowed) was seen on the cut wire indicating that the cut wire was repaired by cutting away the damaged section and re-joining the undamaged section before wrapping the joined section with black tape.
