Your Ref: D/20180111/0006  
Our Ref : CI/SPF18003083/D

14 February 2018

**COMMENT ON CUT SENSOR WIRE OF A MOTOR CAR'S ANTI-BRAKE LOCK SYSTEM**

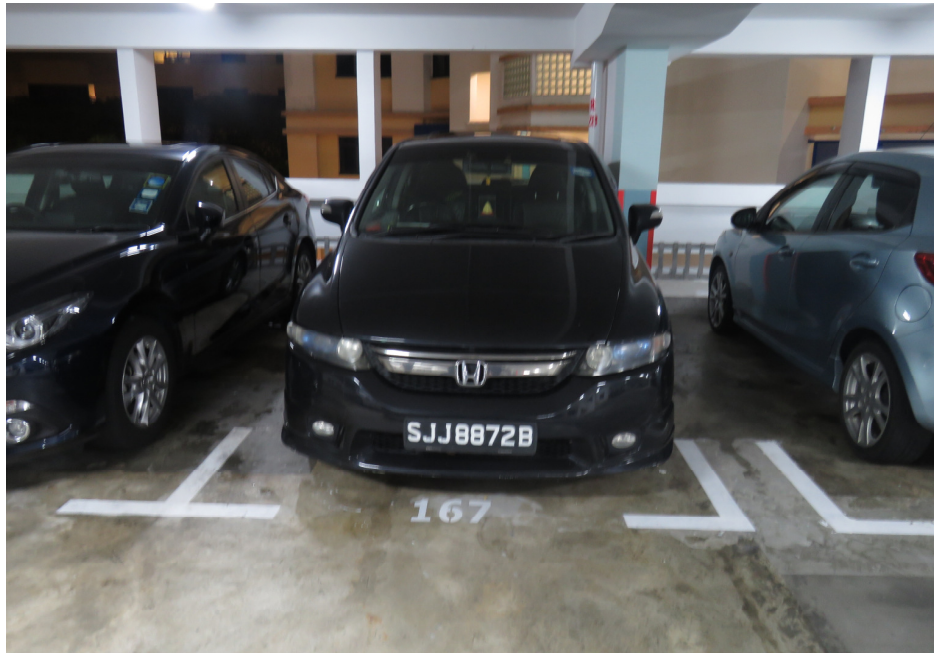
**Photo 1** shows a general view of the Motor Car (photograph provided to me by the Police). The wire that was partially cut was located at the front right wheel of the Motor Car.

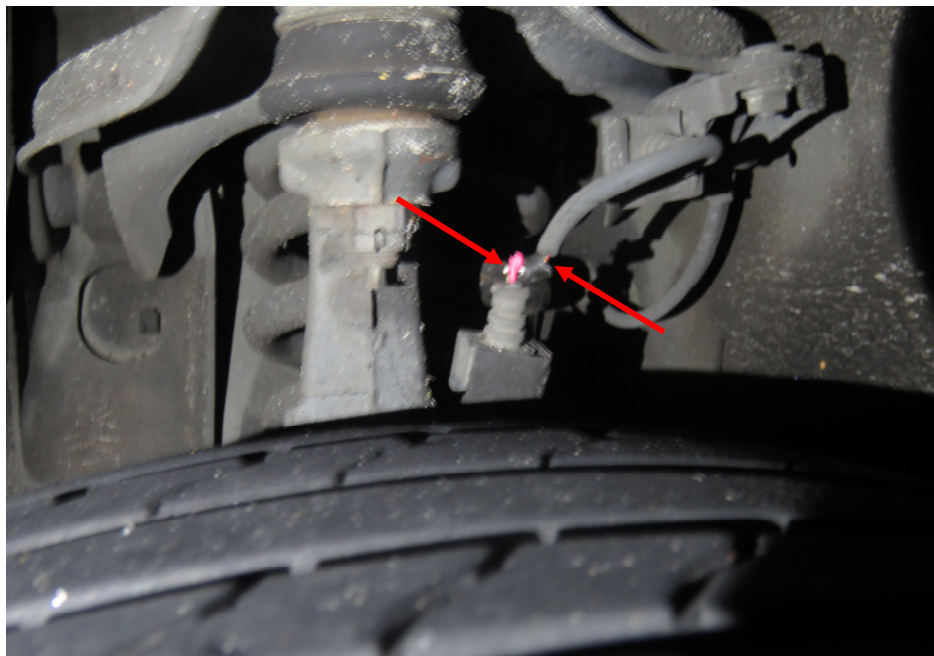
4. Upon close examination of this photograph, it would appear that the wire was partially cut at 2 sections that were relatively close to each other. The cut at both sections of the wire was at the wire insulator and did not penetrate the copper wires within the insulator.

**Photo 2** shows the affected sensor wire of the Motor Car's ABS. This was when the wire was in its original cut condition, still attached to the Motor Car. Close examination of the photograph appears to show the wire was partially cut at 2 sections (arrowed). The cut at both sections of the wire was at the wire insulator and did not penetrate the copper wires within the insulator.

8. For this case, since the affected wire was not completely cut, the functionality of the wire is hence not affected. The electronic signal from the wheel speed sensor of the Motor Car's front right wheel will still be able to be transmitted to the ABS control module via the copper wires within the wire insulator.

10. Regardless of whether the wire for the Motor Car's wheel speed sensor was partially cut or completely cut, the effectiveness and efficiency of the Motor Car's braking system will not be compromised as the primary function of the affected wire is to monitor the wheel speed of the front right wheel of the Motor Car and during normal braking, there is unlikely to be abnormal deceleration rate between the 4 wheels hence the driver will still be able to stop the Motor Car effectively during normal vehicular operation.

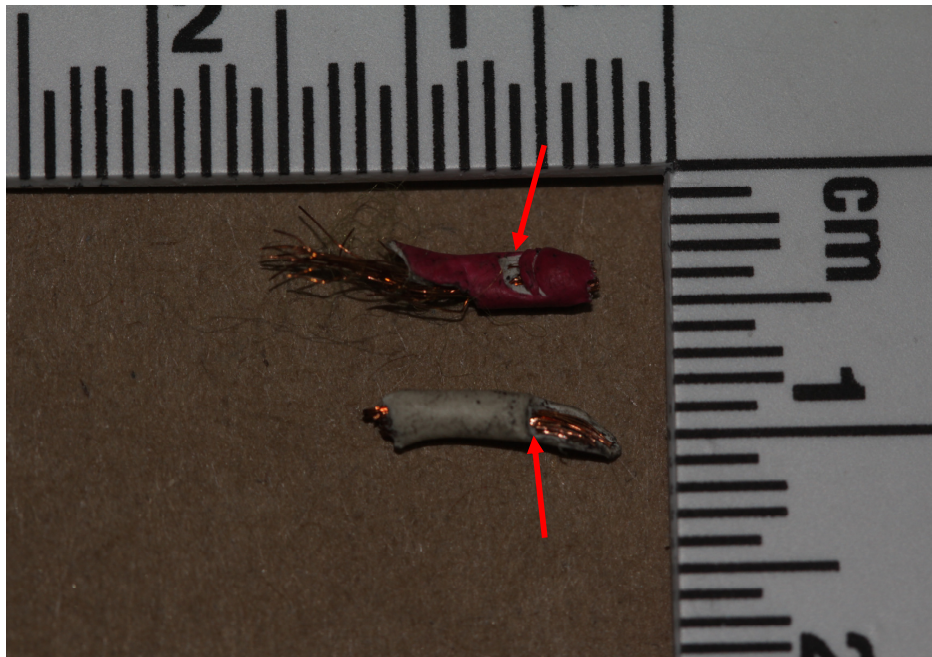
5. The affected sections of the wire were subsequently cut completely by the mechanic during the repair/rectification and these were seized by the Police. The photograph documenting the seized wire had showed the cut areas of the wire, and from the photograph, it can be established that the wire was indeed partially cut. The copper wires at the cut areas were not affected. See photo 1 – 3 below.

**Photo 3** shows the affected sections of the wire that were cut completely and subsequently seized by the Police. The copper wires at the 2 areas where the wire was cut (arrowed) was noted to be unaffected.
