Your Ref: TP/IP/07173/2018
Our Ref :CI/TPD18003133/Z

26th February 2018

MECHANICAL INSPECTION REPORT OF MOTORCYCLE JLB 8377

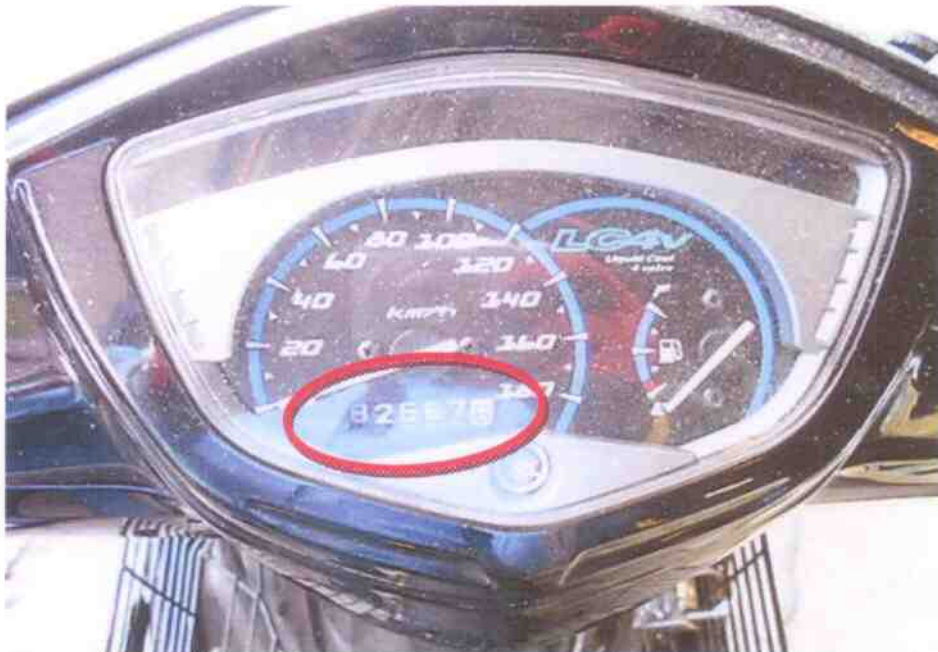
Photo 1 shows the mileage of the Motorcycle recorded at time of our inspection was 825,678km.

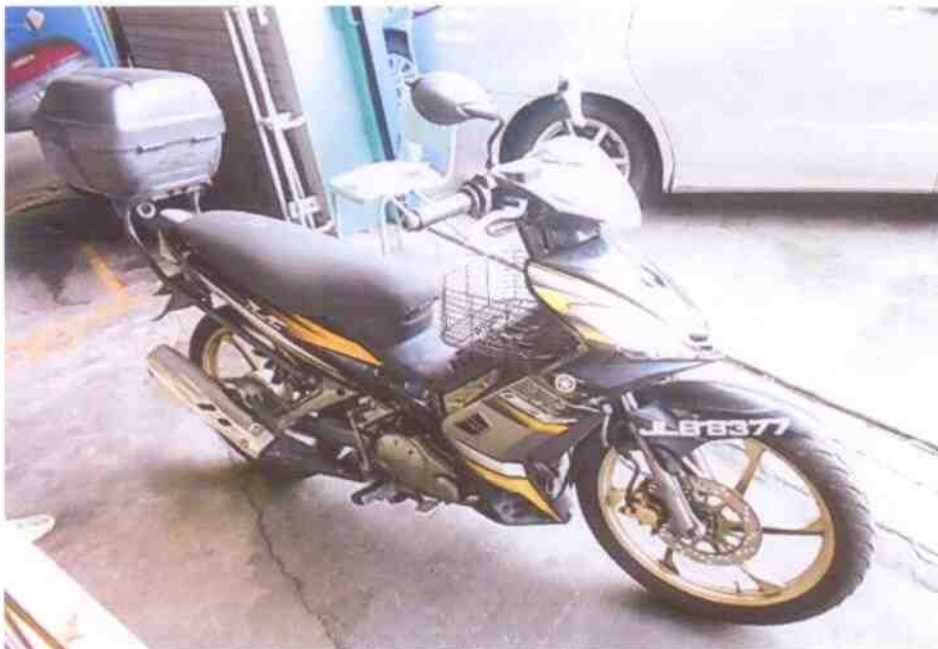
Photo 2 shows a general view of the front right body of the Motorcycle at the time of our inspection. The Motorcycle was observed to have sustained relatively minor damages at the frontal portion likely due to the accident's impact.

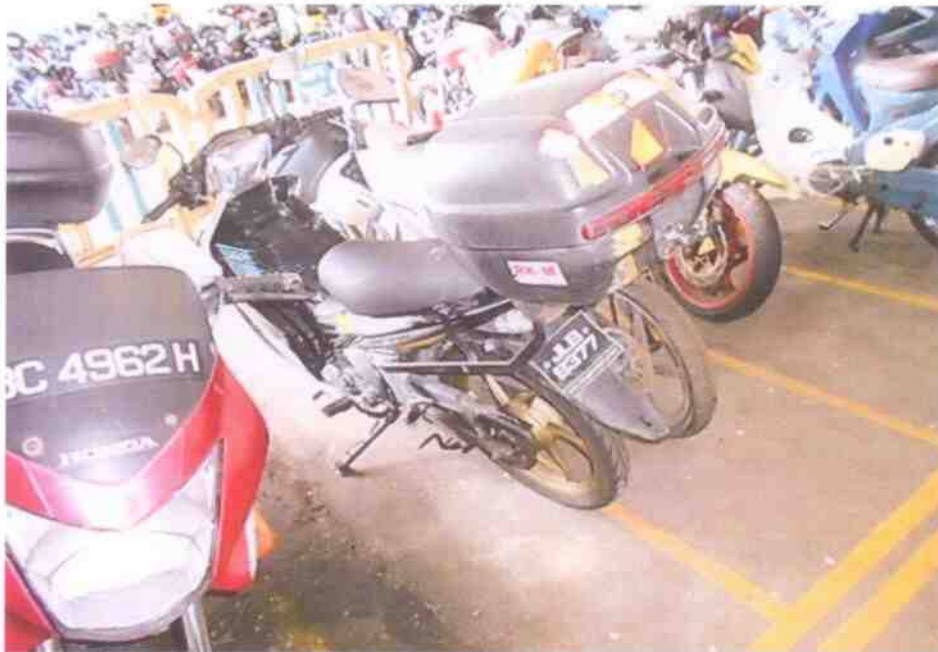
Photo 3 shows a general view of the rear left body of the Motorcycle at the time of our inspection. The Motorcycle was observed to be in good general condition at time of inspection.

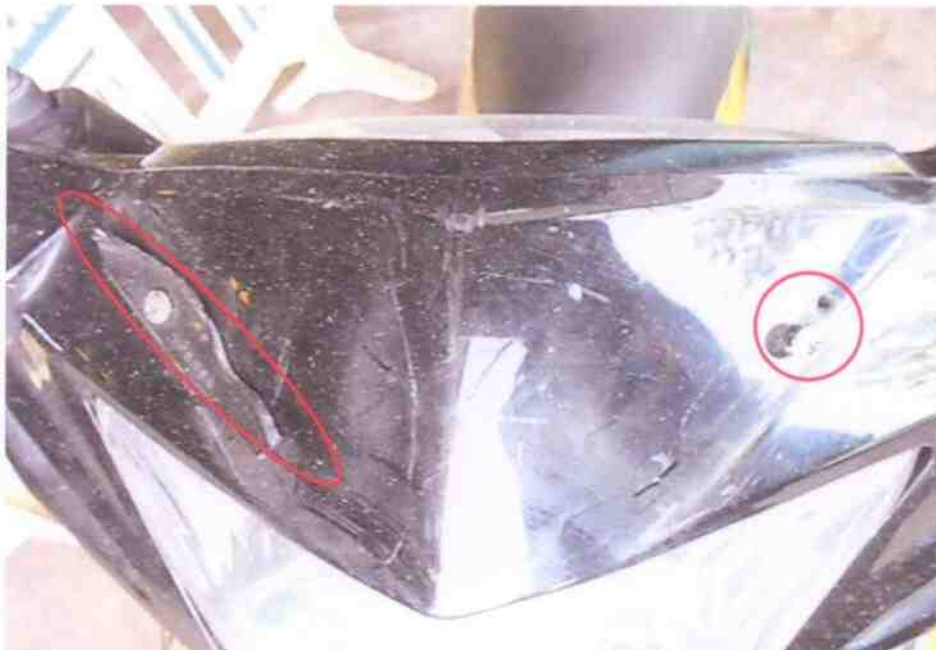
Photo 4 shows a close-up view of the front visor of the Motorcycle at the time of our inspection. It was observed to be broken & missing likely due to the accident.

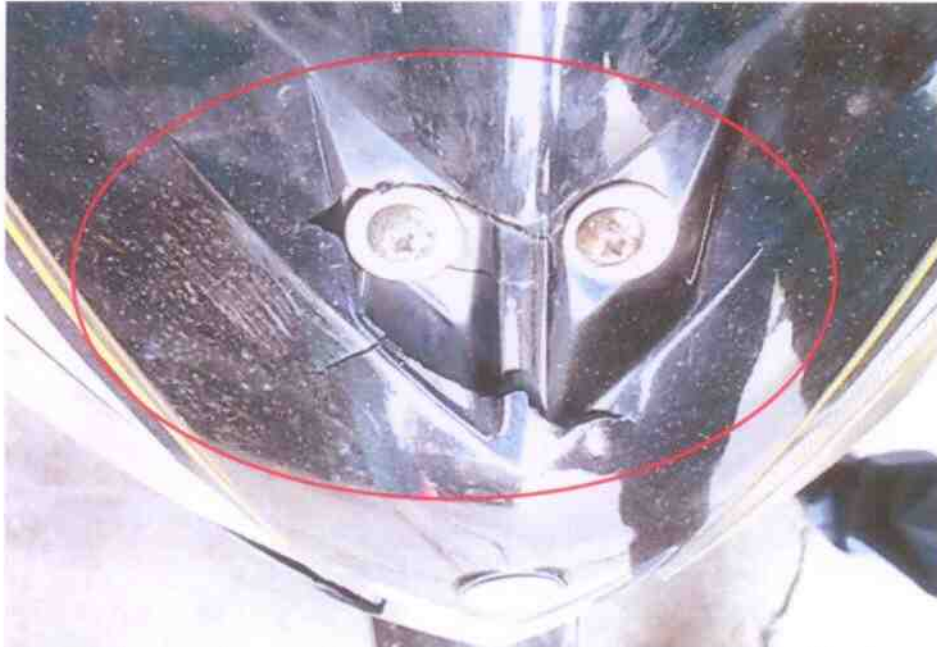
Photo 5 shows a close-up view of the front fairing of the Motorcycle at the time of our inspection. It was observed to be cracked likely due to the accident.

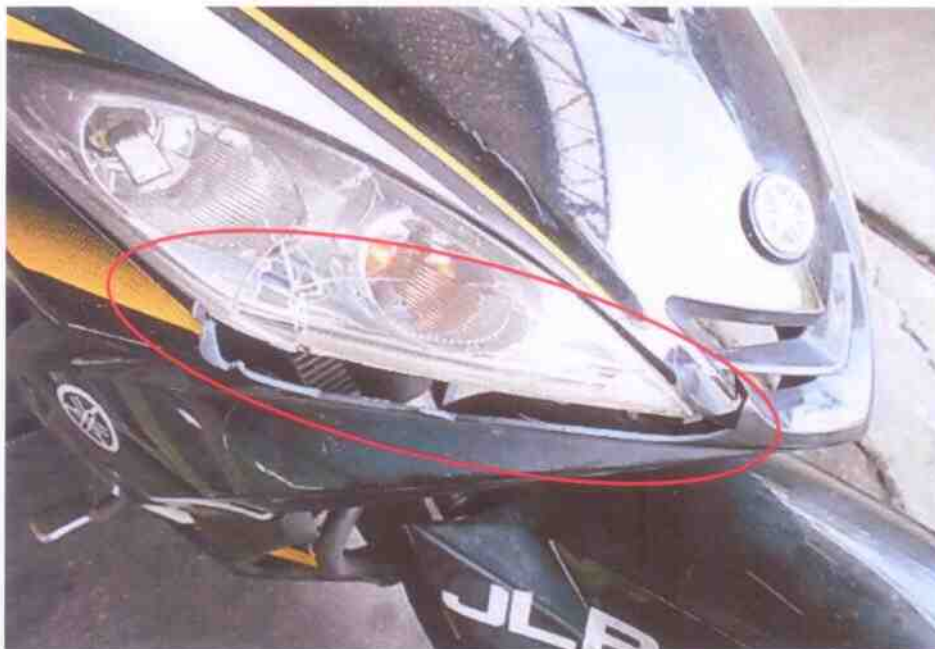
Photo 6 shows a closer view of the front right head lamp & front fairing of the Motorcycle at the time of our inspection. It was observed to be damage likely due to the accident. (Circled)

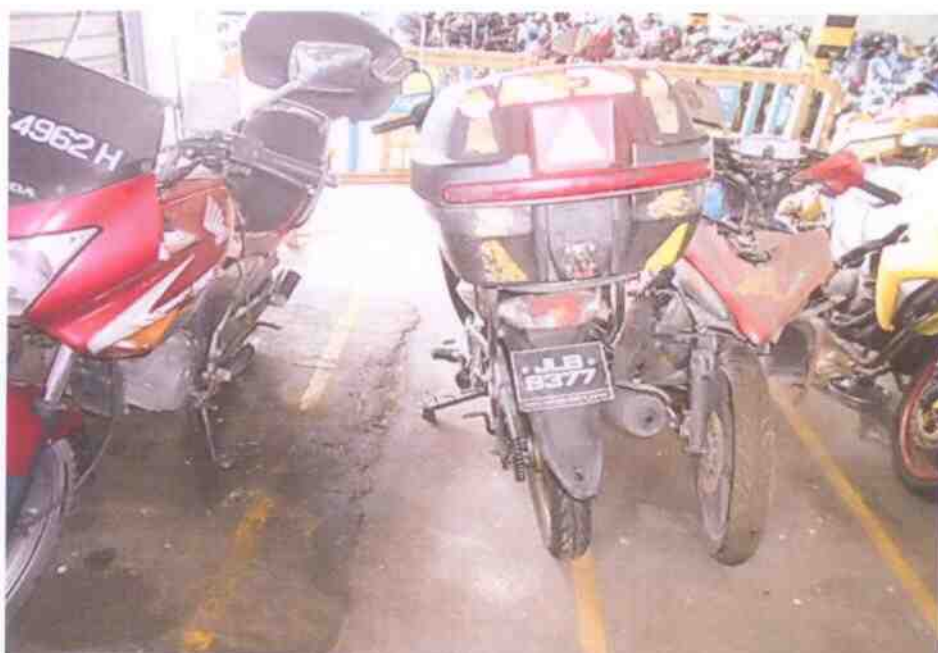
Photo 7 shows a general view of the rear portion of the Motorcycle. The Motorcycle was observed to be in good general condition at time of inspection.

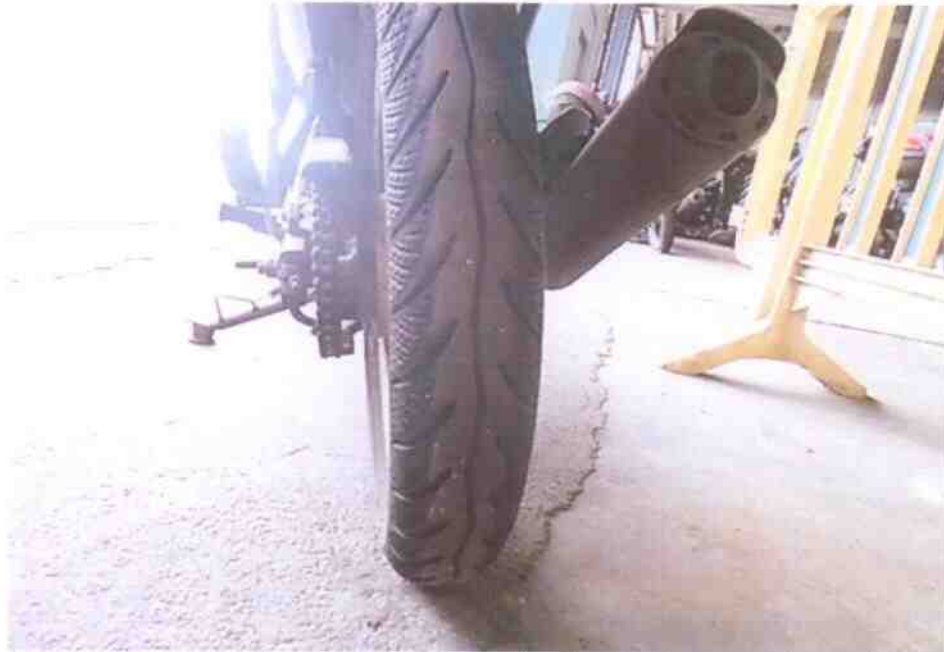
Photo 8 shows the rear tyre of the Motorcycle. The rear tyre was observed to be in serviceable condition with remaining tread depth of approximately 1.6mm. The tyre was also observed to be sufficiently inflated for vehicular operation.

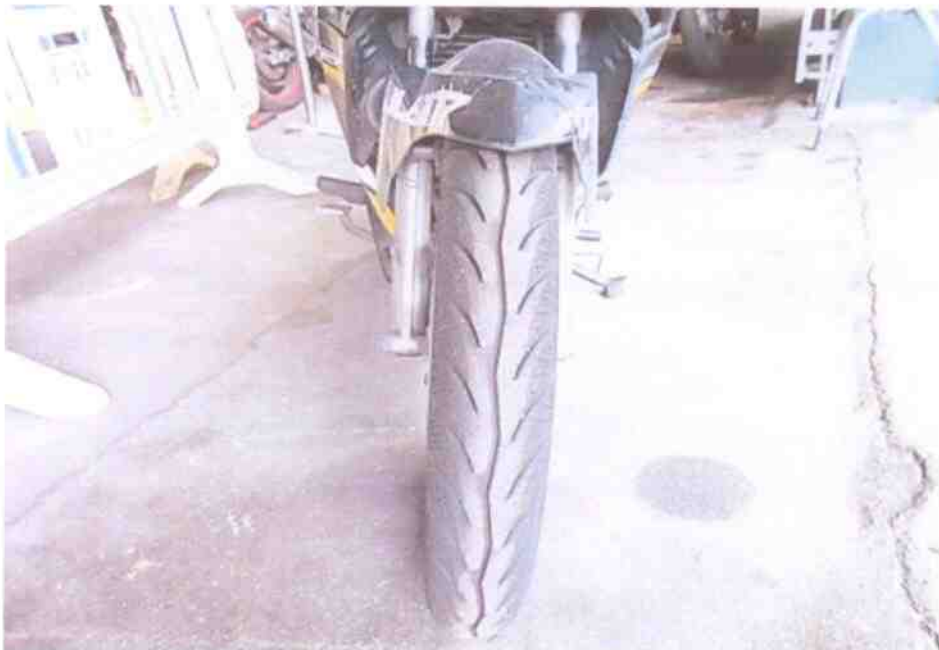
Photo 9 shows the front tyre of the Motorcycle. The front tyre was observed to be in serviceable condition with remaining tread depth of approximately 2mm. The tyre was also observed to be sufficiently inflated for vehicular operation.

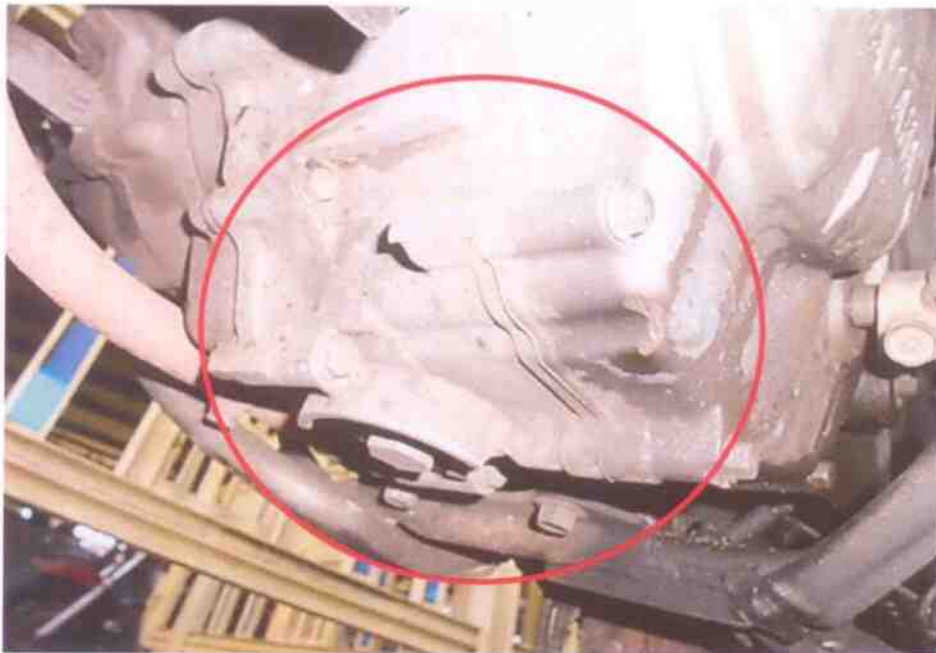
Photo 10 shows no sign(s) or indication(s) of fluid leak observed around the underside of the engine area of the Motorcycle.

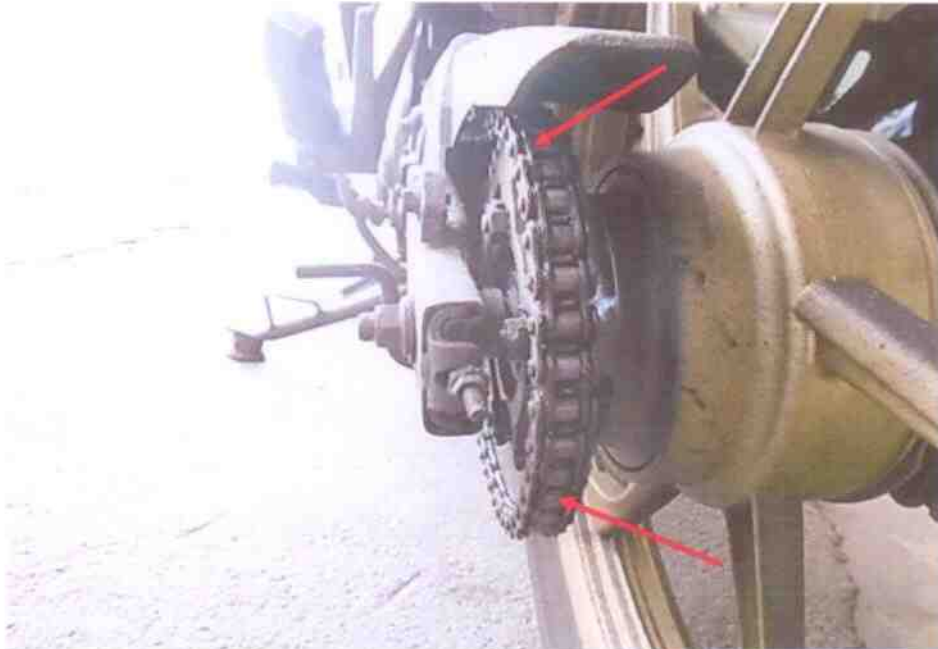
Photo 11 shows the general view of the gear train (arrowed) of the Motorcycle, which was observed to be intact with no misalignment. It was also adequately lubricated for operating purposes.

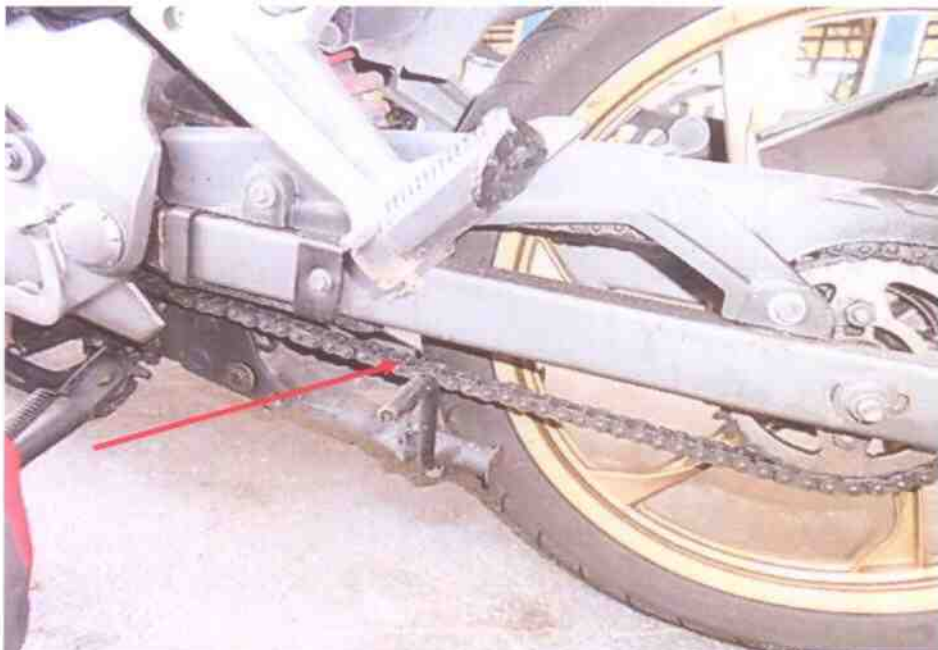
Photo 12 shows the general view of the gear train (arrowed) of the Motorcycle, which was prior the free play tension check.

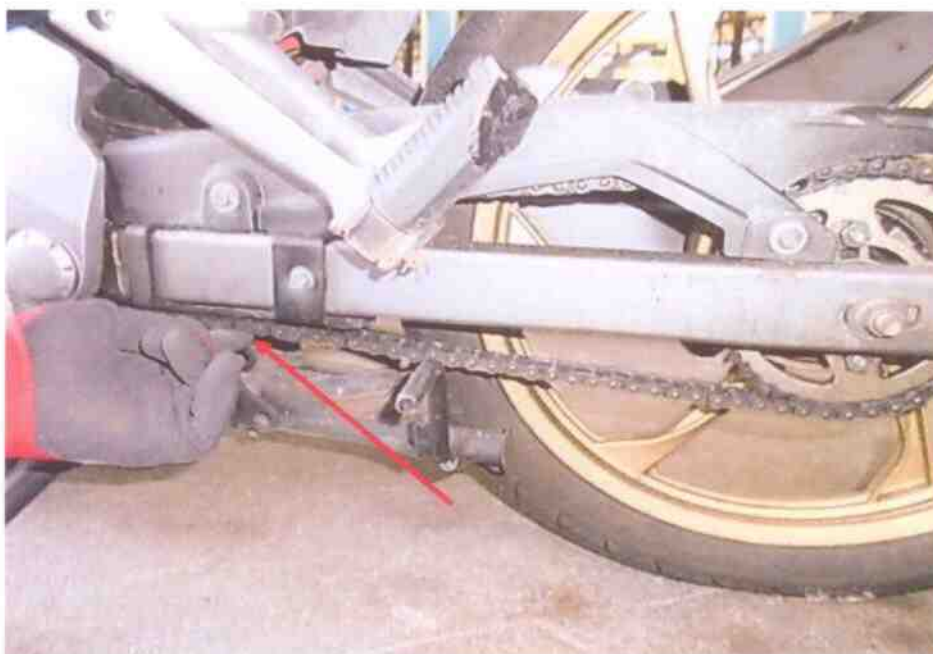
Photo 13 shows the general view of the gear train (arrowed) of the Motorcycle, which was observed to be intact with no misalignment. It was also adequately lubricated for operating purposes. Free play tension was also observed & found adequately acceptable.

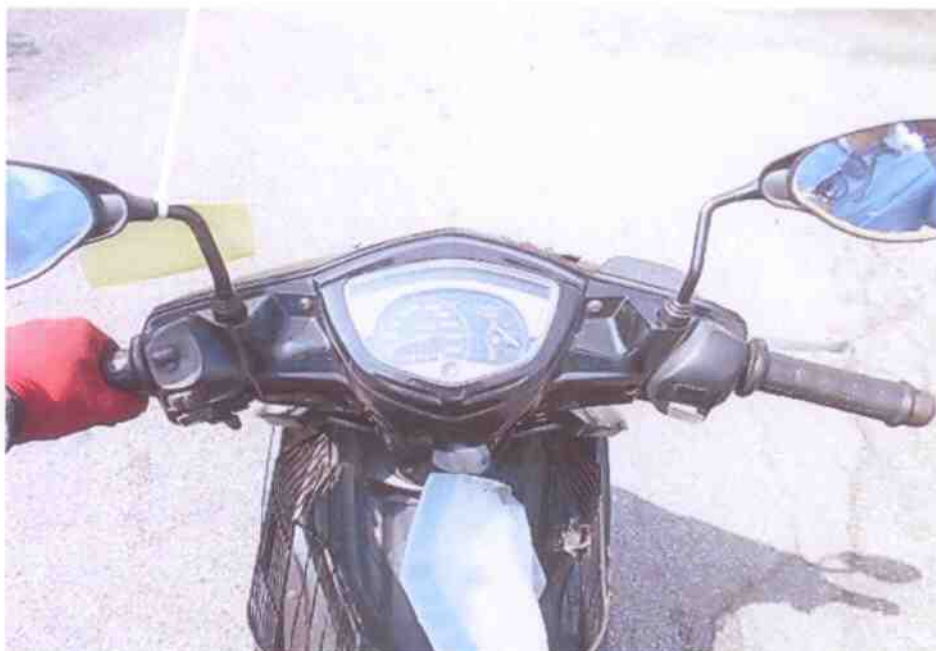
15. At the end of the short operational test, we did not observe any abnormal behaviour from the Motorcycle's front brake. The front wheel of the Motorcycle was able to stop rotating immediately upon fully depressing the brake whereas for the rear brake we found that it was less effective. The Motorcycle wheel didn't stop rotating immediately upon stepping on the brake pedal but in drifting motion. However, it did stop eventually responding to the foot brake pedal's depression.

16. Although the observations gathered during the static brake test had indicated that both the front & rear brake of the Motorcycle was in serviceable condition. The operational test conducted revealed that the rear brake was found less effective. See photo 14 - 18 below.

Photo 14 shows an operational test was conducted on the steering system & braking system.

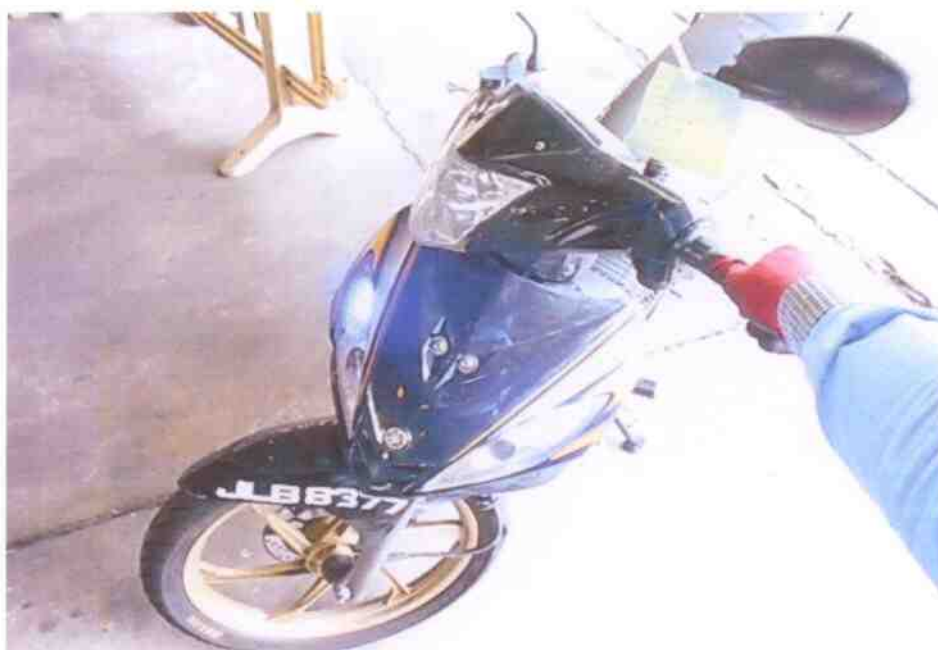
Photo 15 shows steering system test was conducted on the steering. It was observed to be in serviceable condition when we are able to turn the steering to the full left & right.

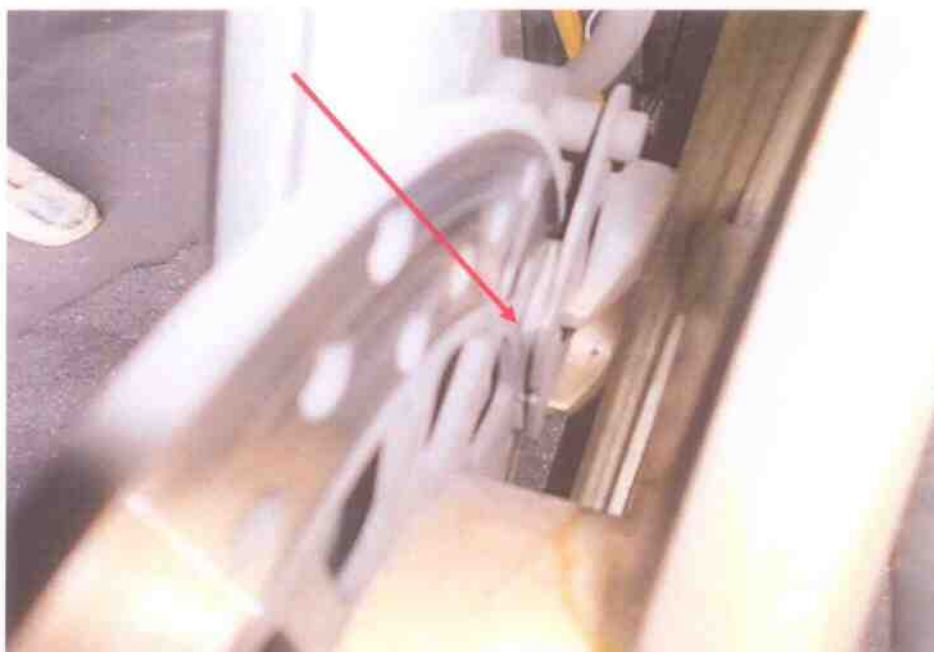
Photo 16 shows our checks on the front brake pad had also indicated that it was in serviceable condition.

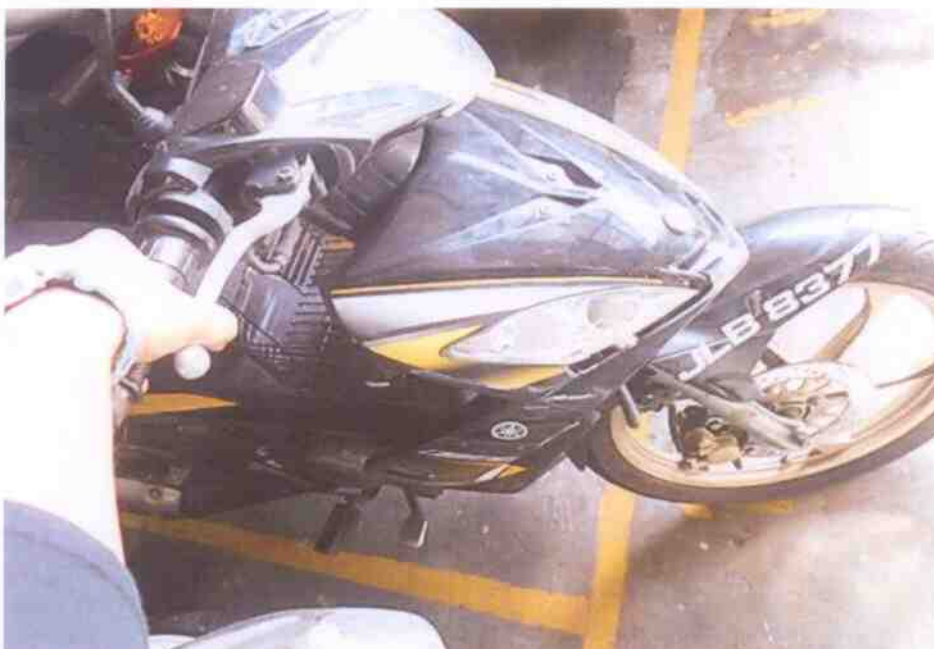
Photo 17 shows static testing of the braking of the front brake in progress. There was some resistance felt (spongy like feel) upon pressing the brake lever.

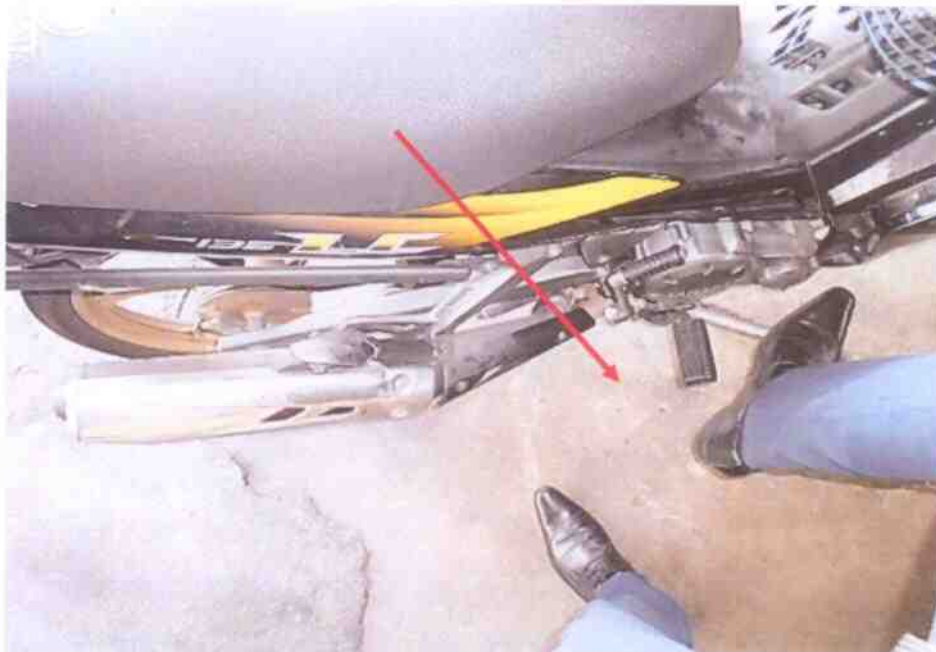
Photo 18 shows testing of the braking of the rear brake in progress. There was some resistance felt (spongy like feel) upon stepping on the brake pedal.
